Summer Low Flow Test Report

San Juan River
New Mexico and Utah

U.S. Department of the Interior
Bureau of Reclamation
Upper Colorado Region
Western Colorado Area Office
Grand Junction — Durango

April 2002

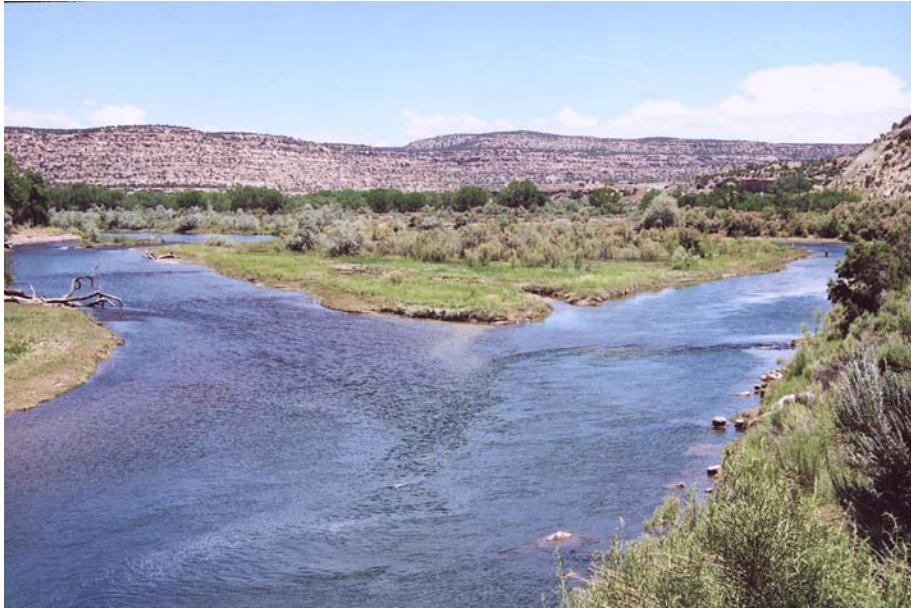
San Juan River approximately 6 miles below Navajo Dam at approximately 500 cfs.

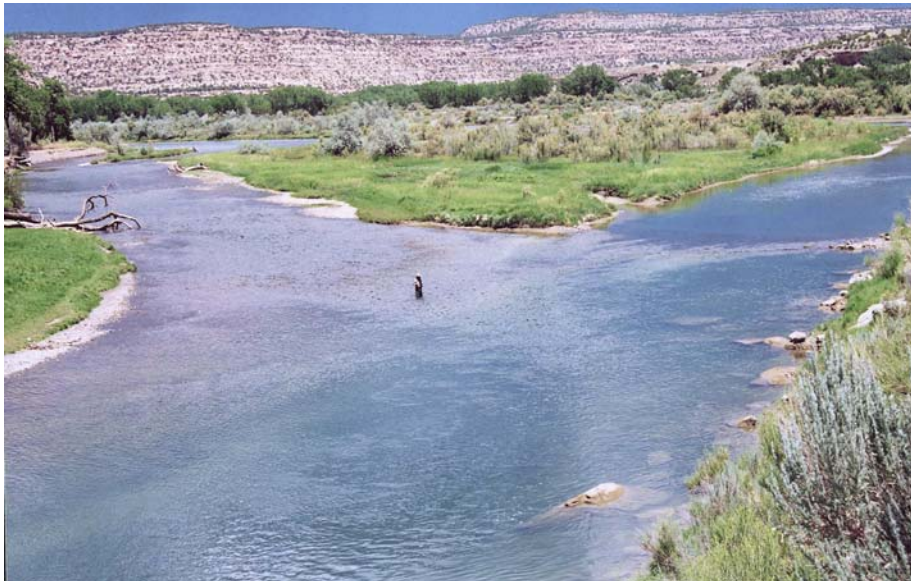
San Juan River at same location at approximately 250 cfs.

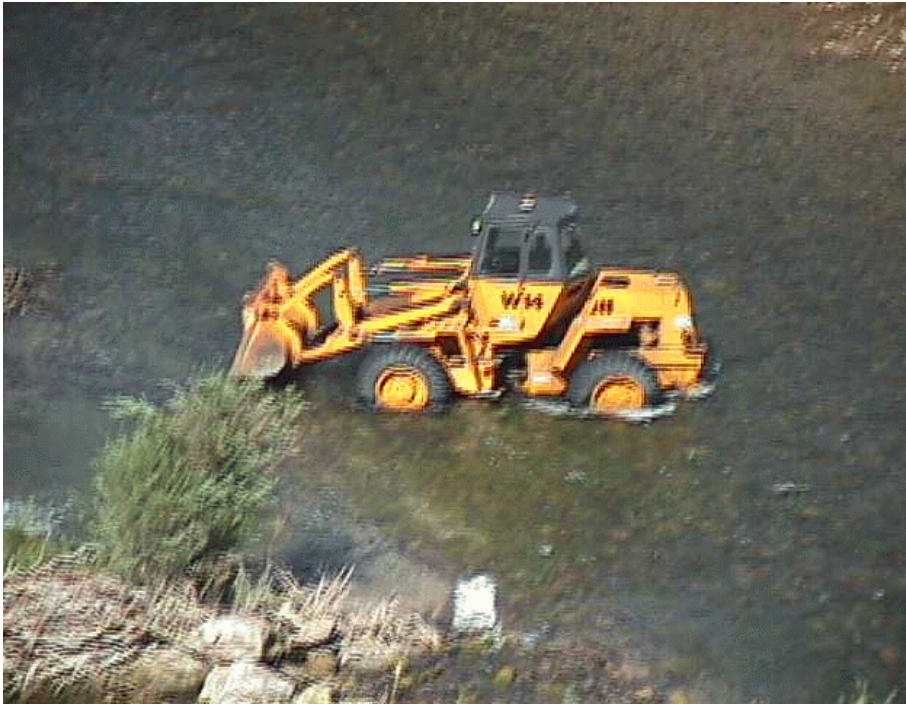
Diversion modification on the San Juan River below Navajo Dam.

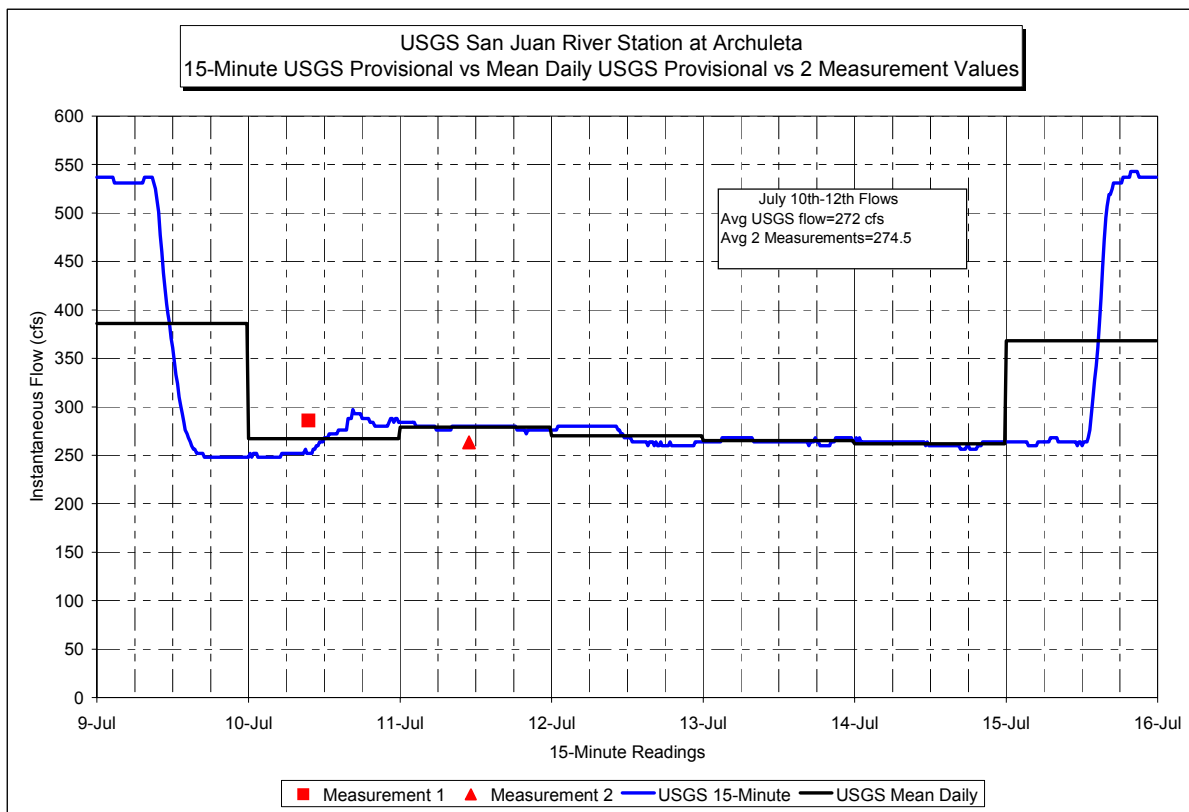
Figure 2.—This graph shows that a relatively constant flow occurs at the upper end of the river section at Archuleta and that the two Reclamation measurements capture that flow.

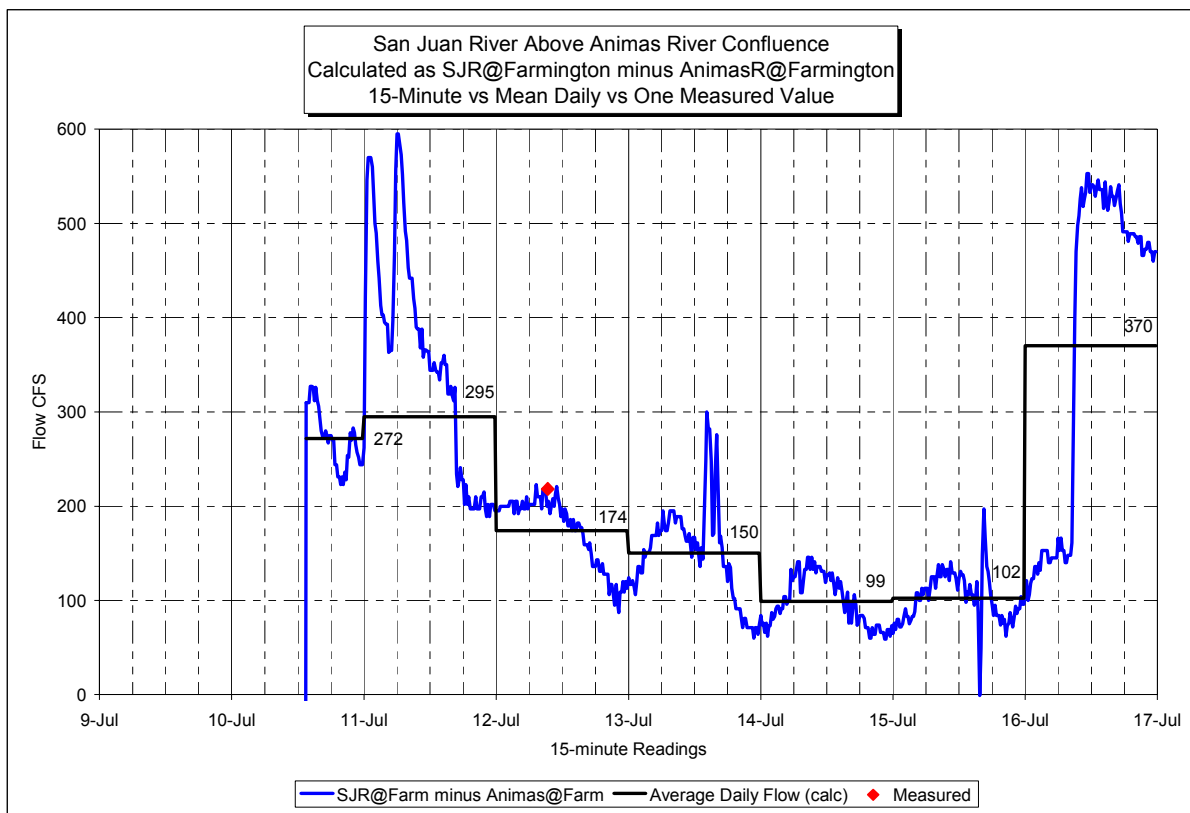
Figure 3.—This graph shows magnitude of runoff at the lower end of the river section near the Animas River confluence. Note: Farmington gauge was not in operation from July 9 through July 10.

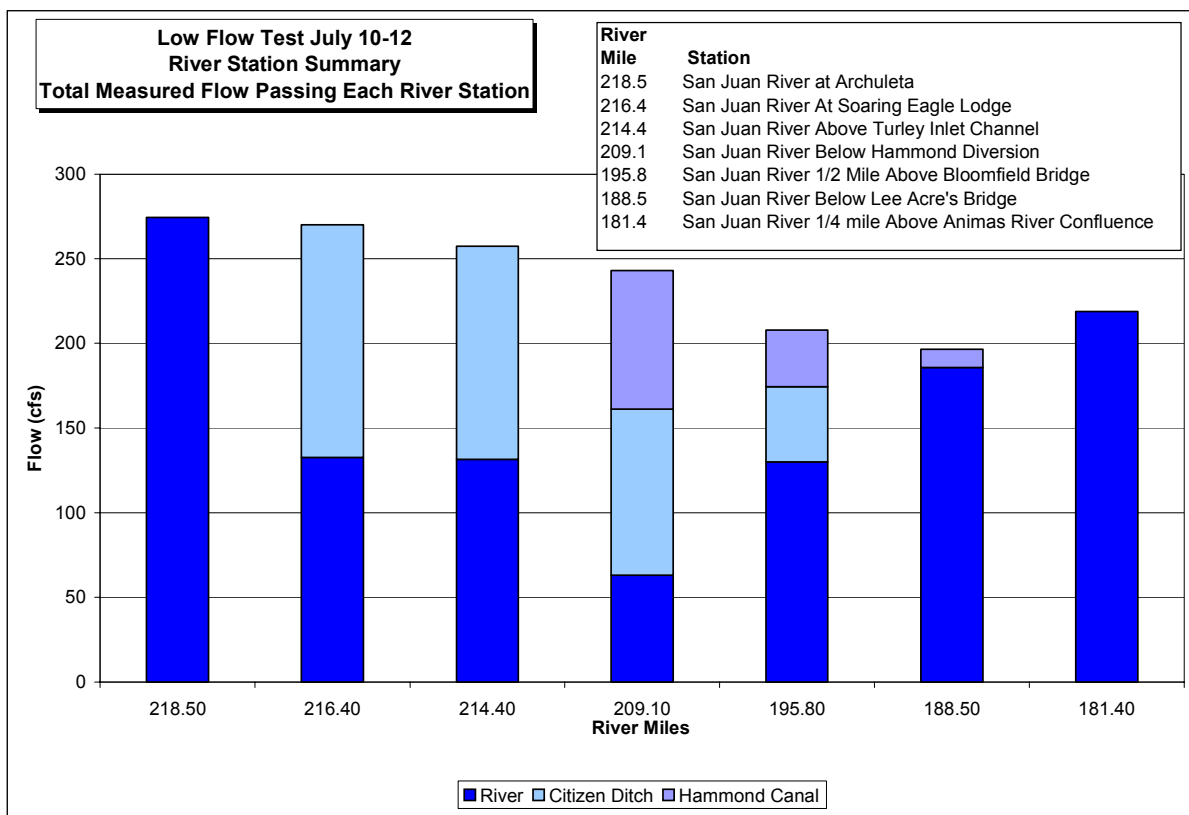
Figure 4.—Reclamation measurement of San Juan River flows at the seven mass-balance stations and the corresponding canal locations. Each bar represents the total measured flow passing each mass balance station.

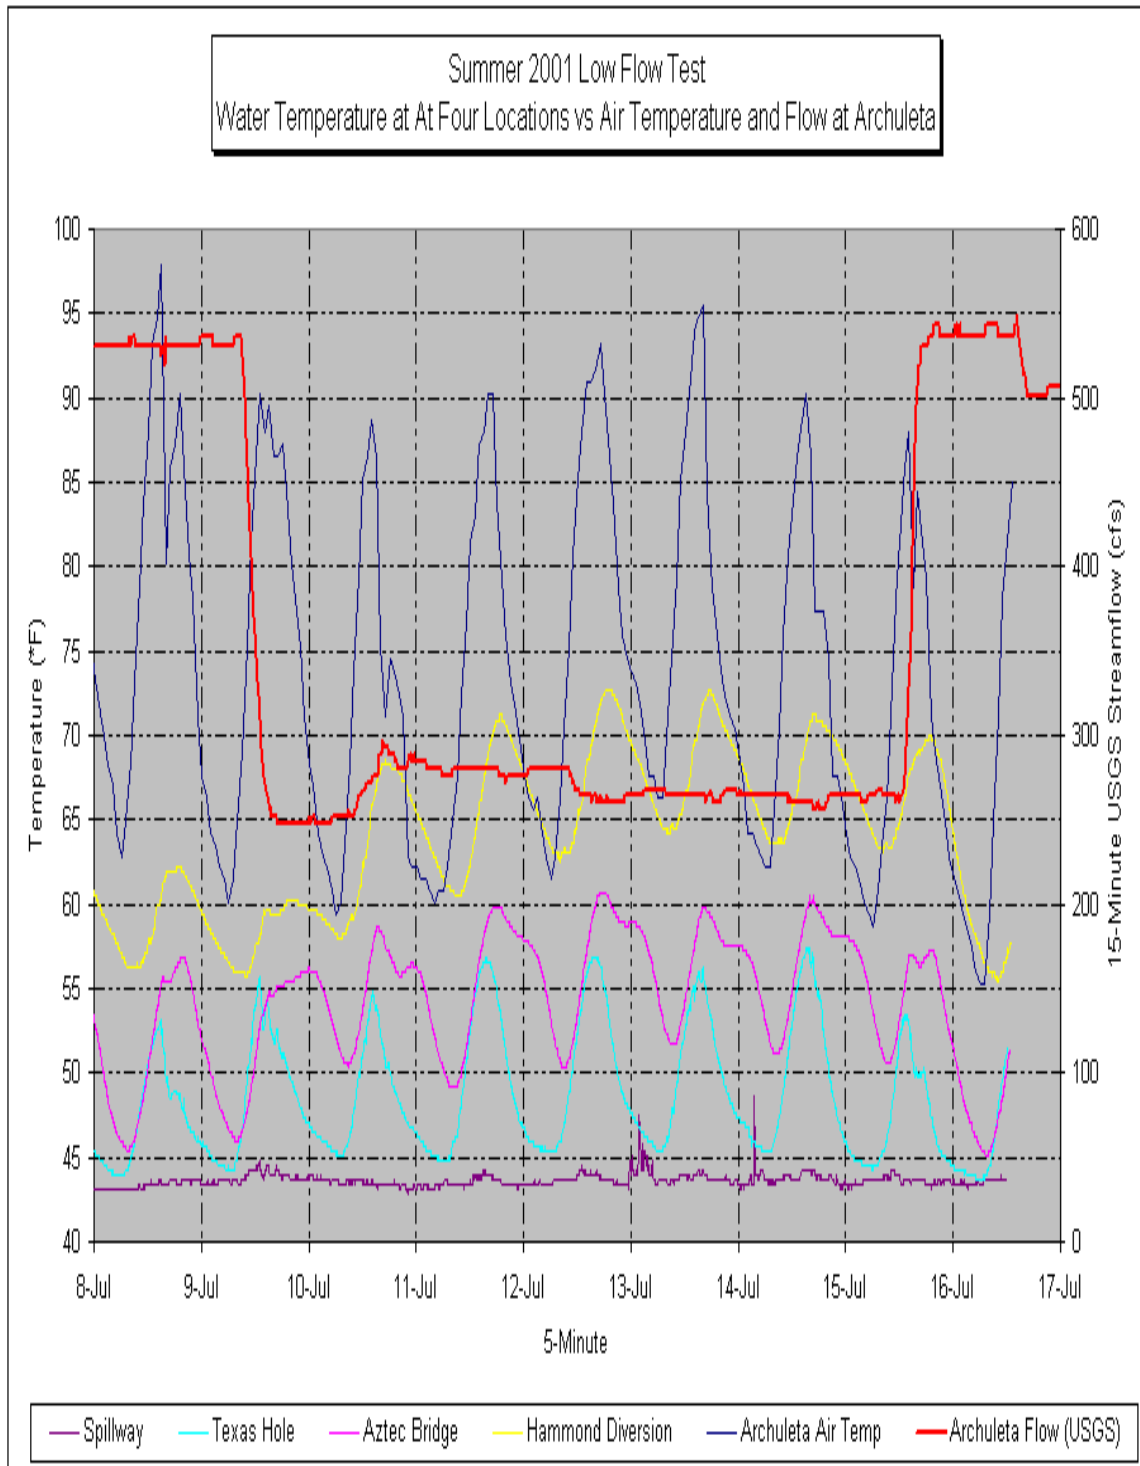
Figure C-2.—This graph shows a direct correlation between an increase in ambient air temperature and reduction in dam release and a resulting increase in river water temperature. As shown by the graph, water temperatures at the dam remain constant while an approximate 10 degree increase in daily temperature occurs at the Hammond Diversion Dam.

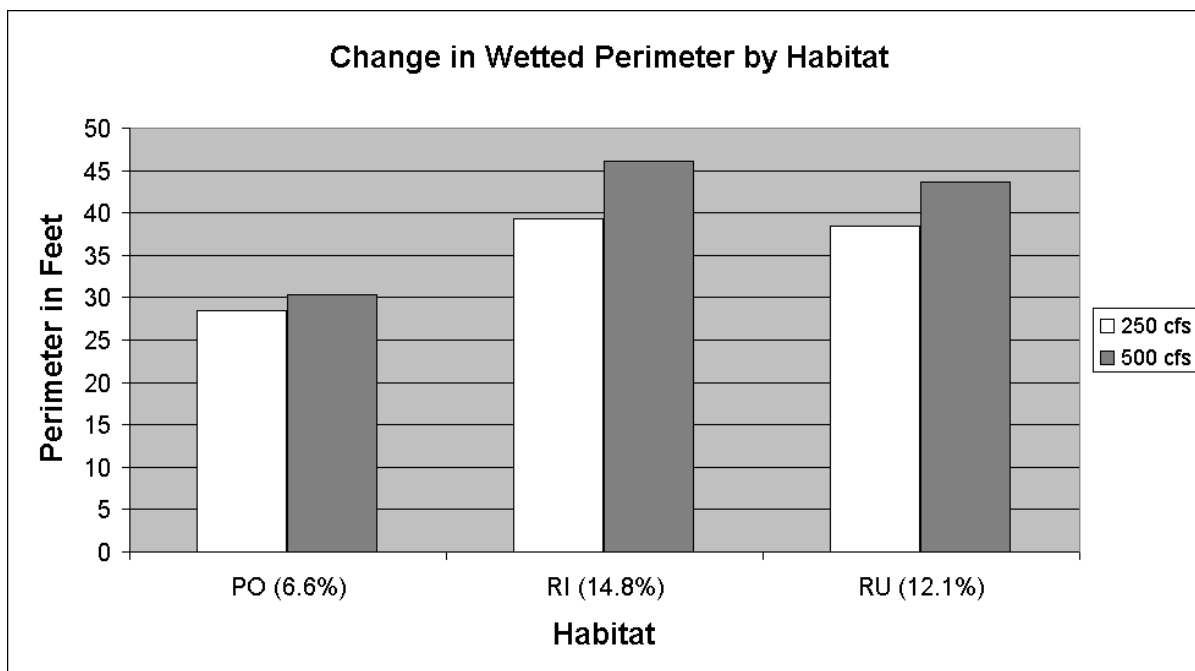
Figure C-3.—Changes in wetted perimeter by pools, riffles, and runs, comparing 500 cfs with the Test of 250 cfs on the San Juan River. Percentage change is indicated on the x-axis.

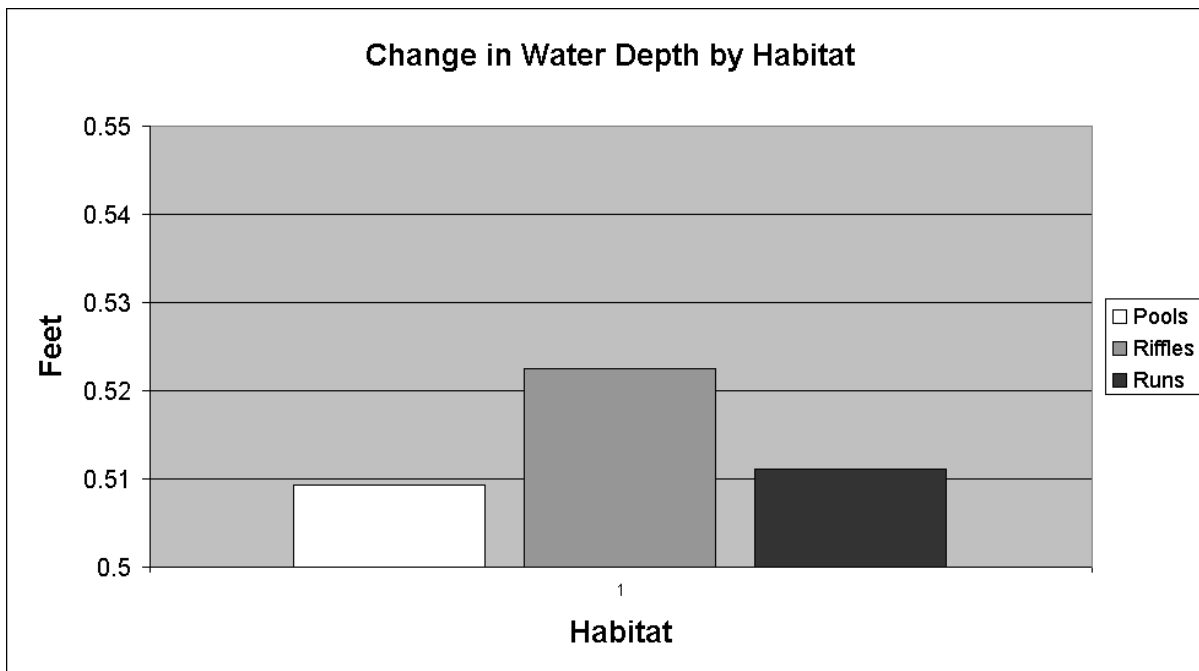
Figure C-4.—Changes in average water depth of pools, riffles, and runs, comparing 500 cfs with the Test of 250 cfs on the San Juan River.

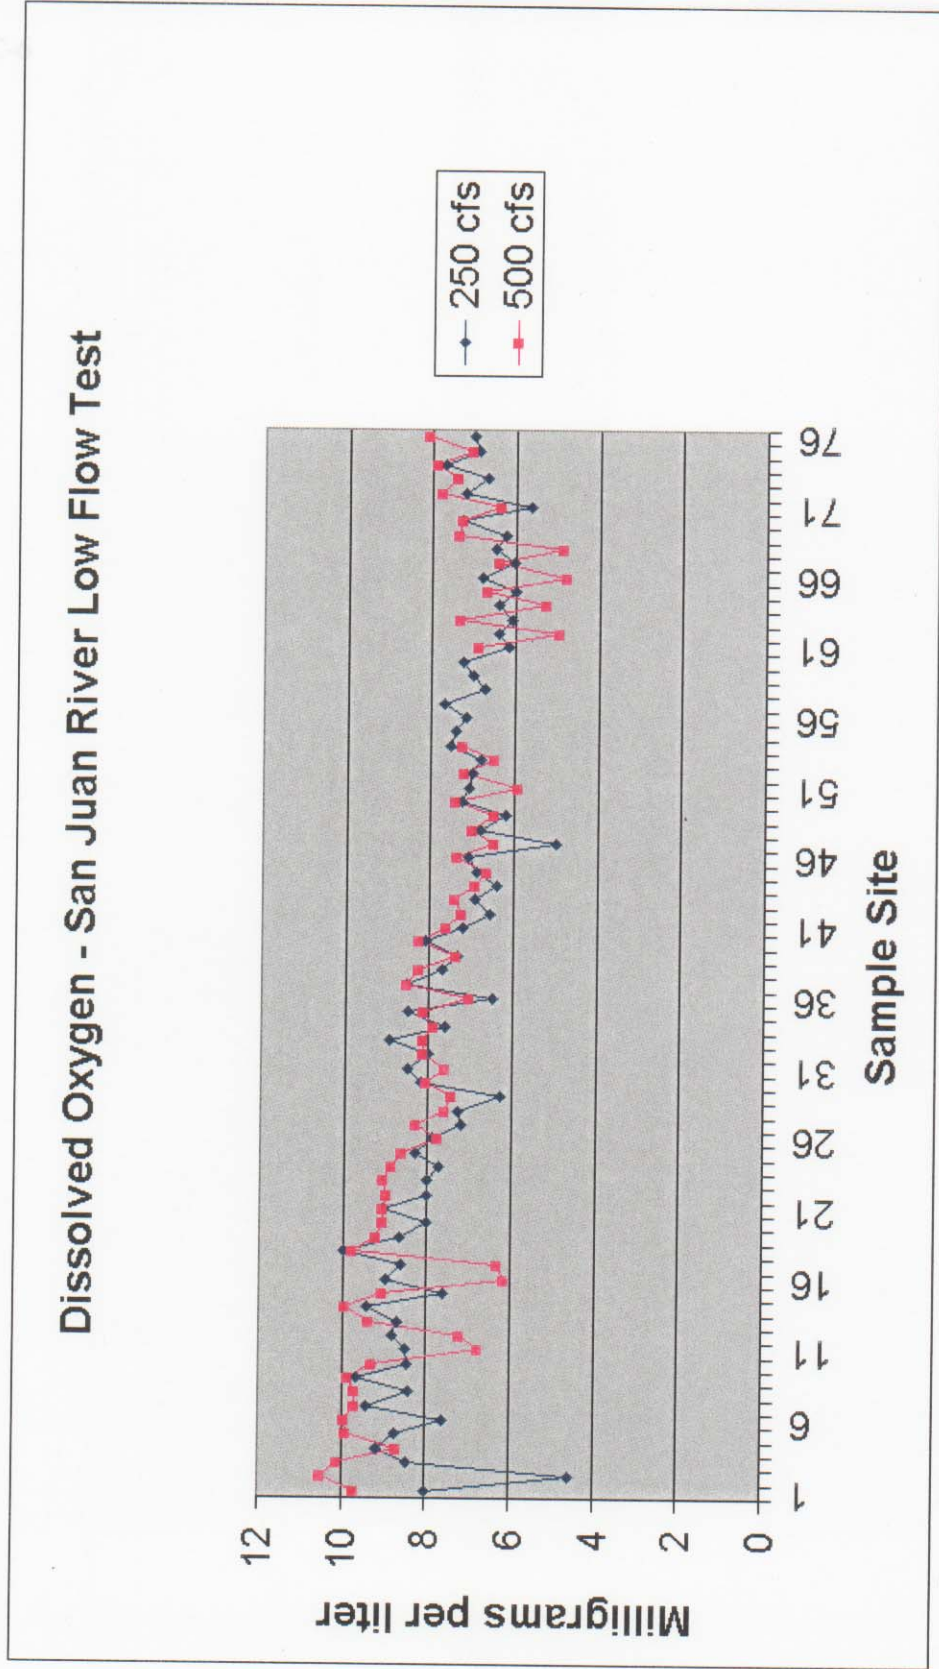
Figure C-6

Figure C-6.—Longitudinal patterns in DO for the San Juan River at 500 cfs and during the Test at 250 cfs. Sample sites are spaced 0.25-0.50 mile apart for approximately 30 miles from Citizens Ditch diversion downstream to Salmon Ruin.

Longitudinal patterns in water temperature, DO, conductivity, and salinity demonstrate differences in these water chemistry parameters at 500 cfs and 250 cfs (figures C-5 through C-8). Inflections in the temperature patterns reflect time of day that temperature was

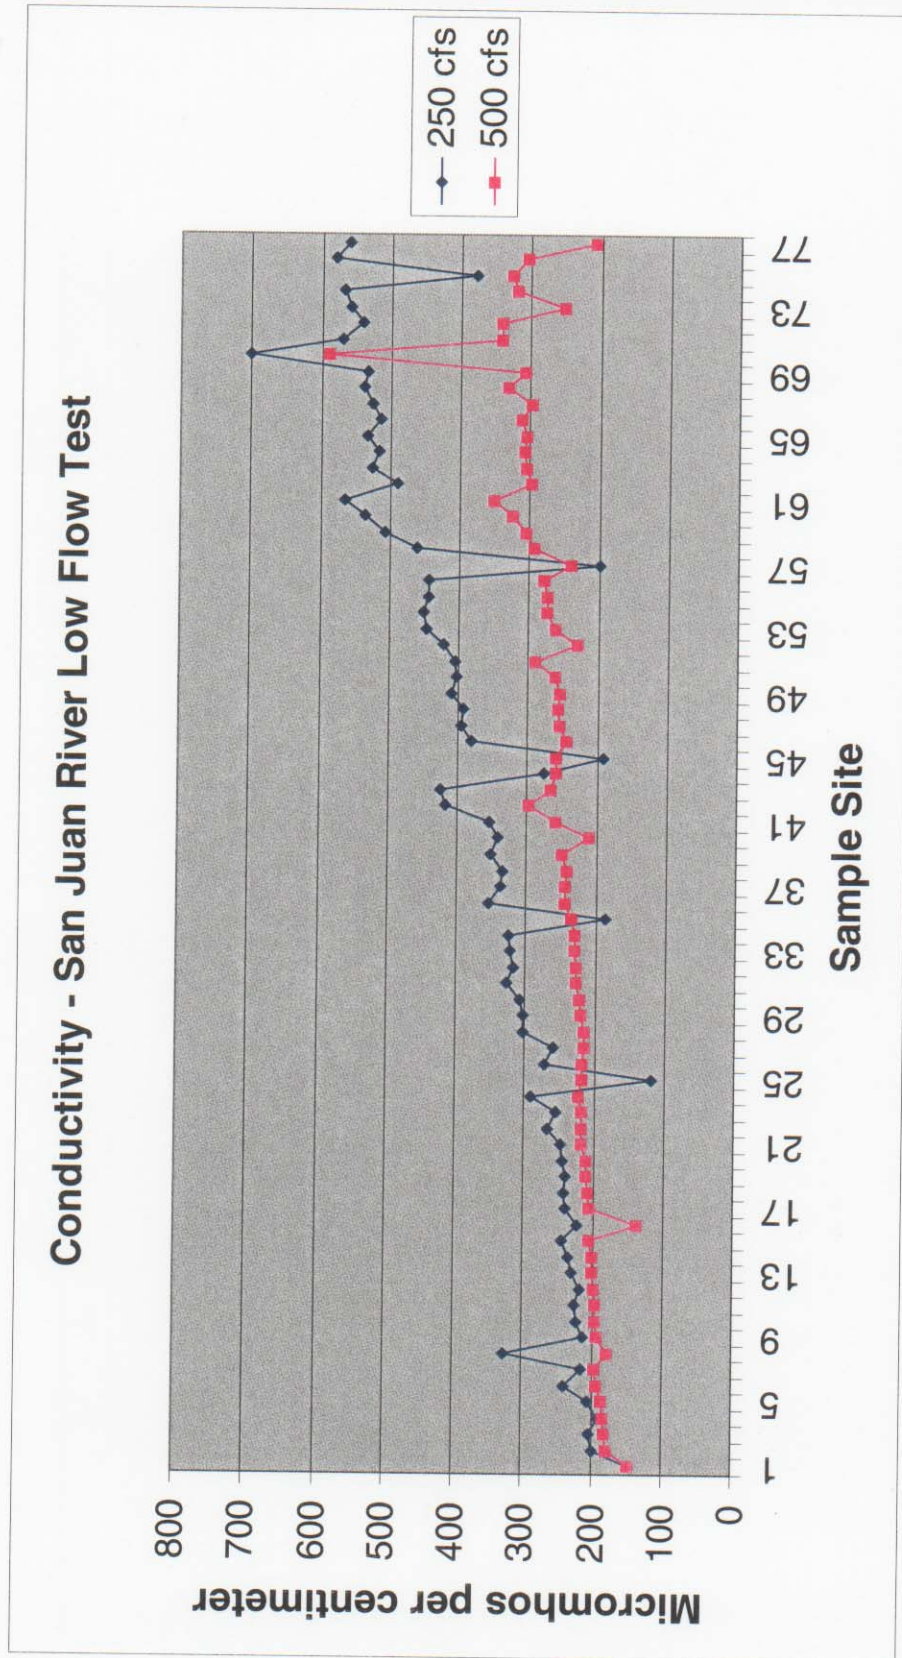
Figure C-7

Figure C-7.—Longitudinal patterns in specific conductivity for the San Juan River at 500 cfs and during the Test at 250 cfs. Sample sites are spaced 0.25-0.50 mile apart for approximately 30 miles from Citizens Ditch diversion downstream to Salmon Ruin.

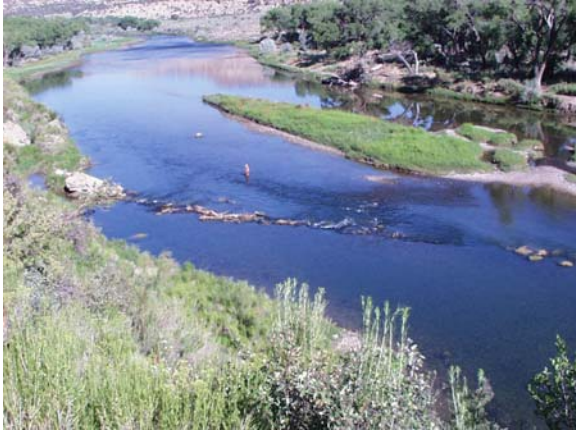
Cottonwood Diversion and Intake Gallery.

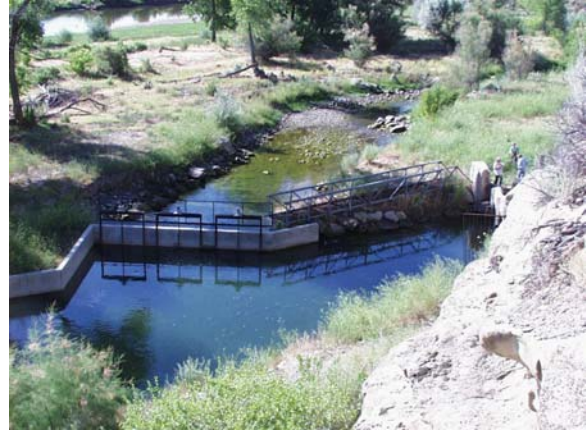
Bloomfield - Citizens Diversion and wasteway.

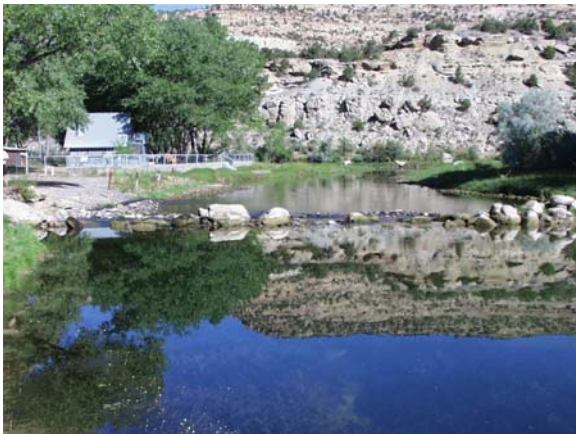
*Navajo Dam Water Users Association
intake gallery*

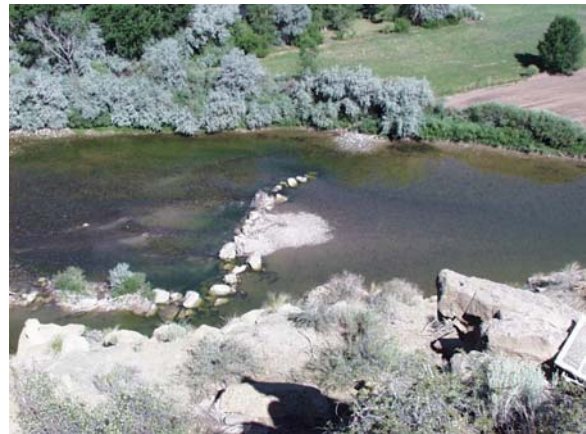
Turley-Manzanares Diversion.

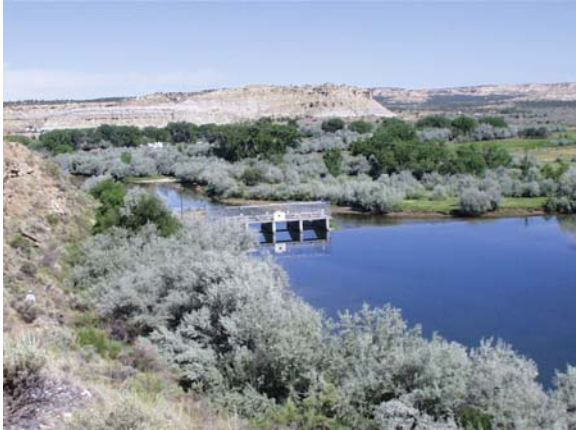
Hammond Diversion.

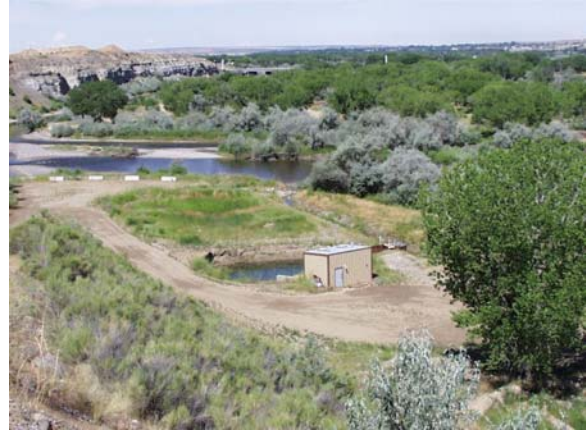
Giant Refinery channel.

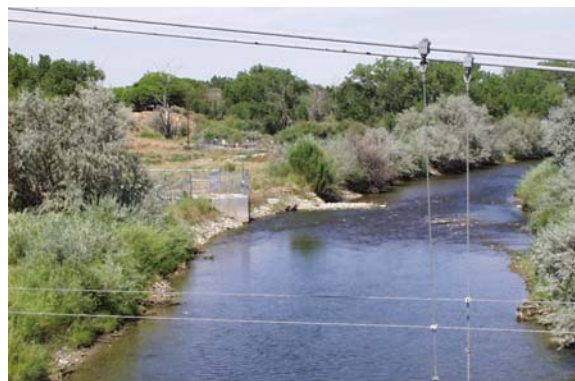
West Hammond and Lee Acres intake.
