2006 Svalbard Experimental Spill to Study Spill Detection and Oil Behavior in Ice

Summary Field Report

April 12, 2006

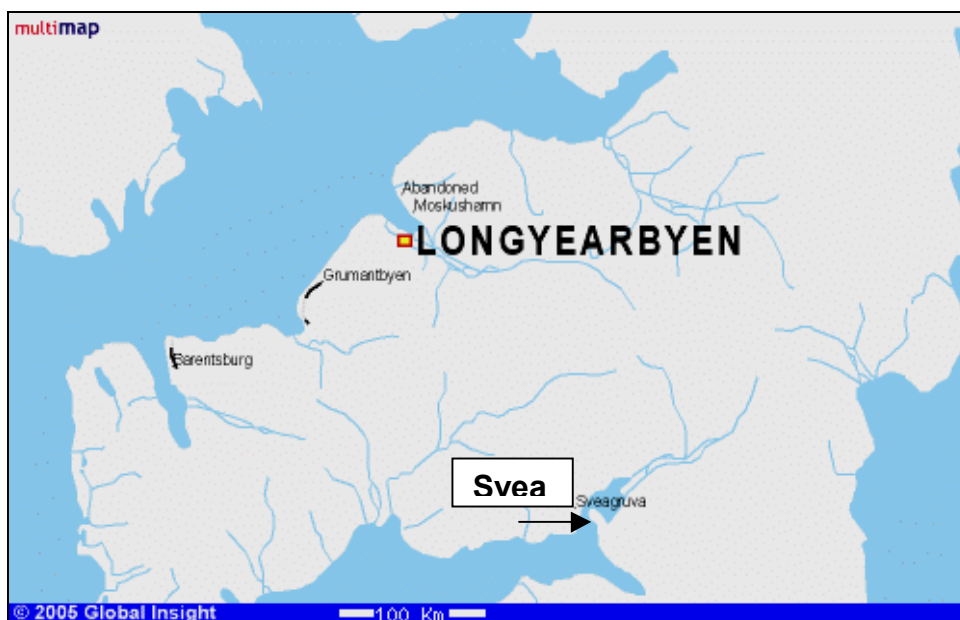
Figure 1 Location of spill site denoted by arrow.

The project was carried out on schedule in accord with the proposed daily test activities outlined in the original Test Plan (February 2006). Figure 1 shows the spill location on Spitsbergen. Figure 2 is an Aqua satellite image acquired March 27, 2006 as the oil was being discharged (250 m resolution).

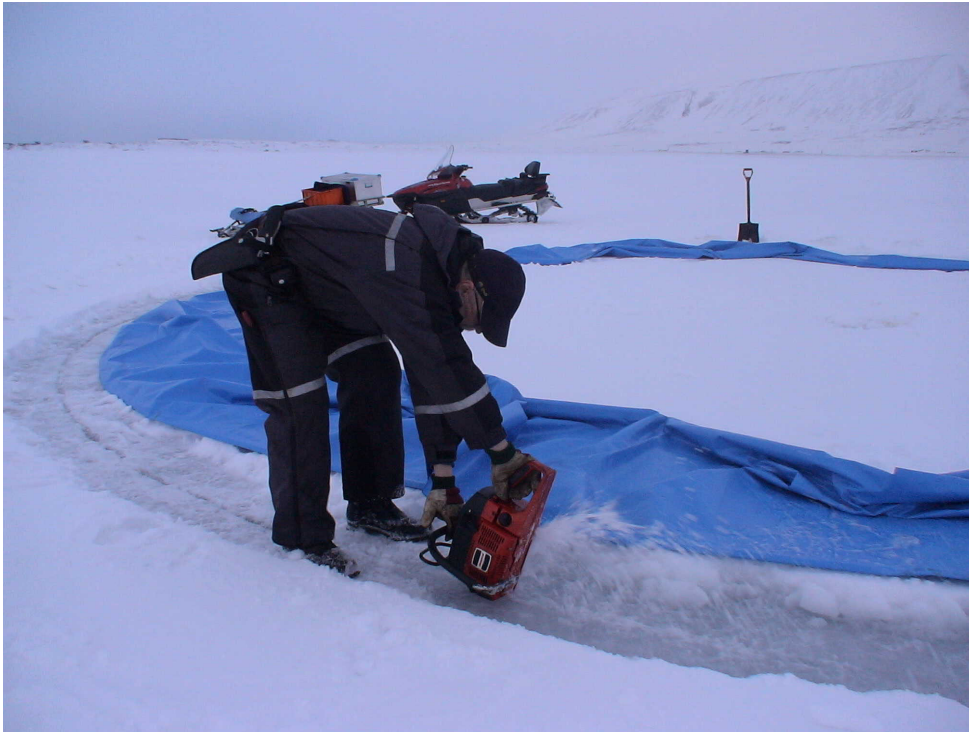
Cutting in the oil skirts February 2006

This summary field report provides a diary of field activities beginning with the successful skirt insertion in February and ending with demobilization of the scientific team on March 30.

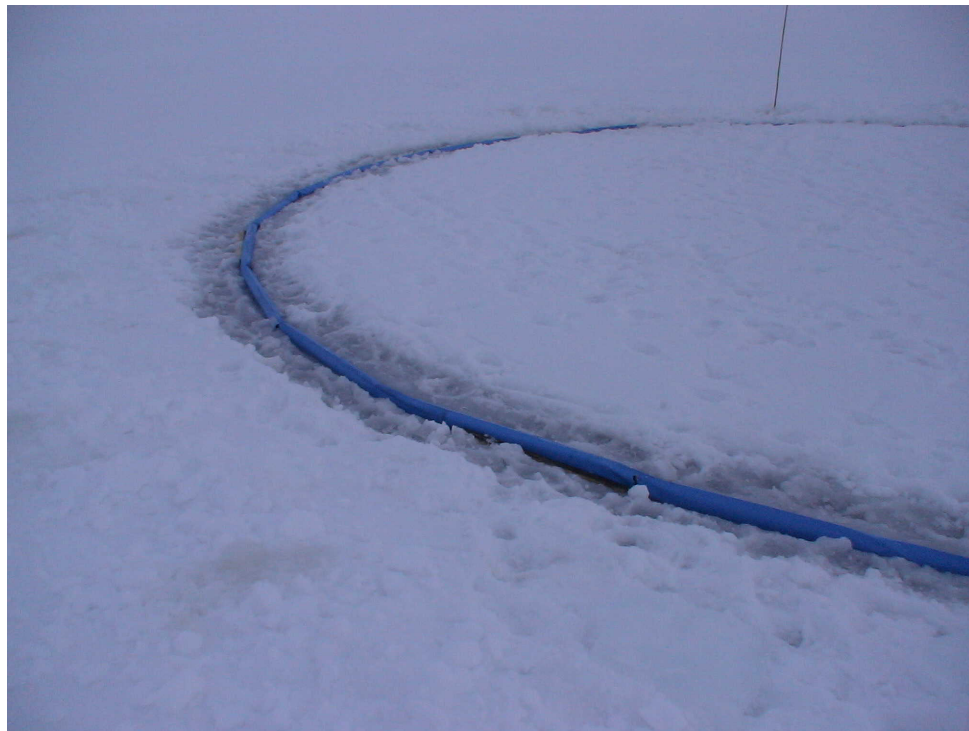
Completed skirt installation

Two spill containment skirts were installed as 11.2 m diameter circles (100 m²) through 45 cm ice, February 20-22. The two test areas were installed in line with the prevailing wind direction approximately 30 m apart. The skirt depth of 150 cm allows for ample material hanging beneath the ice. Pockets are fabricated in the skirt to contain 2x4" wooden flotation rods on top and small iron bar to weight the bottom (Note: the radar signal does not penetrate into the seawater; consequently, the presence of metal below the ice is not an issue).

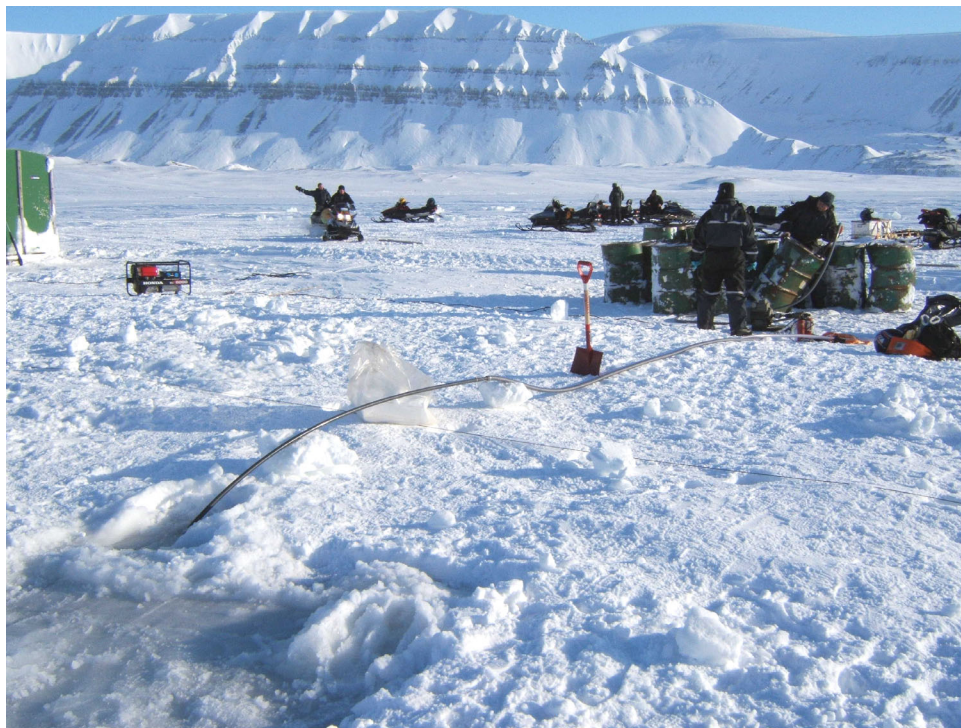
Pumping oil from drums through flexible pipe inserted 1 m inside skirt through a sloped hole drilled 2 m outside

The spill took place as scheduled on March 27. Oil was injected under the ice through a neutrally buoyant pipe inserted through an augur hole drilled at an angle just outside the skirt. A total of 3,400 litres of fresh Stratfjord crude was pumped from drums over a period of 2 hours. Air temperature at the time was -15°C, and the oil was close to ambient. No difficulties were encountered in the pumping. The progress of the oil injection was monitored and recorded by an underwater camera focused on the end of the injection pipe approximately 1 metre inside the skirt. The same camera was periodically moved to different inspection holes around the skirt perimeter to monitor the progress of the advancing oil boundary as the test area approached 90%+ coverage.

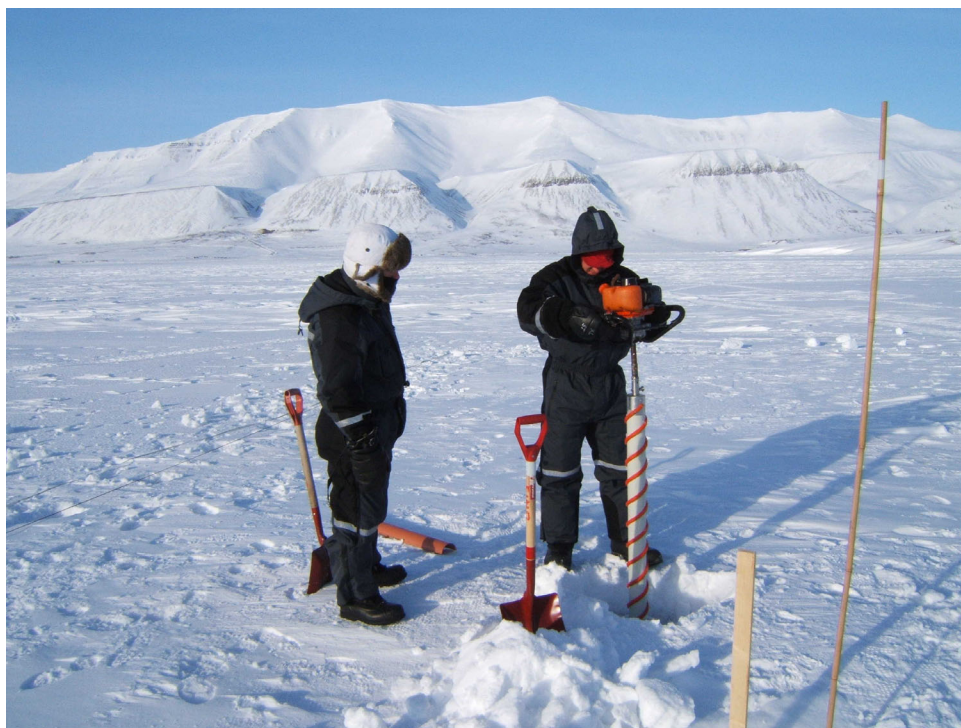
Taking an ice core

A final set of water, air and ice cores were taken on March 29 prior to demobilizing. These samples included three cores through the top 20 cm of the ice inside the test area. One of these cores confirmed the presence of oil in the brine channels to within 17 cm of the surface. In addition, one core immediately outside the skirt showed a band of very fine oil droplets (0.2 to 0.5 mm) in the skeletal layer (bottom 2.5 cm). These droplets represent an insignificant fraction of the total oil volume that was dispersed through the shearing action as the oil left the discharge pipe.

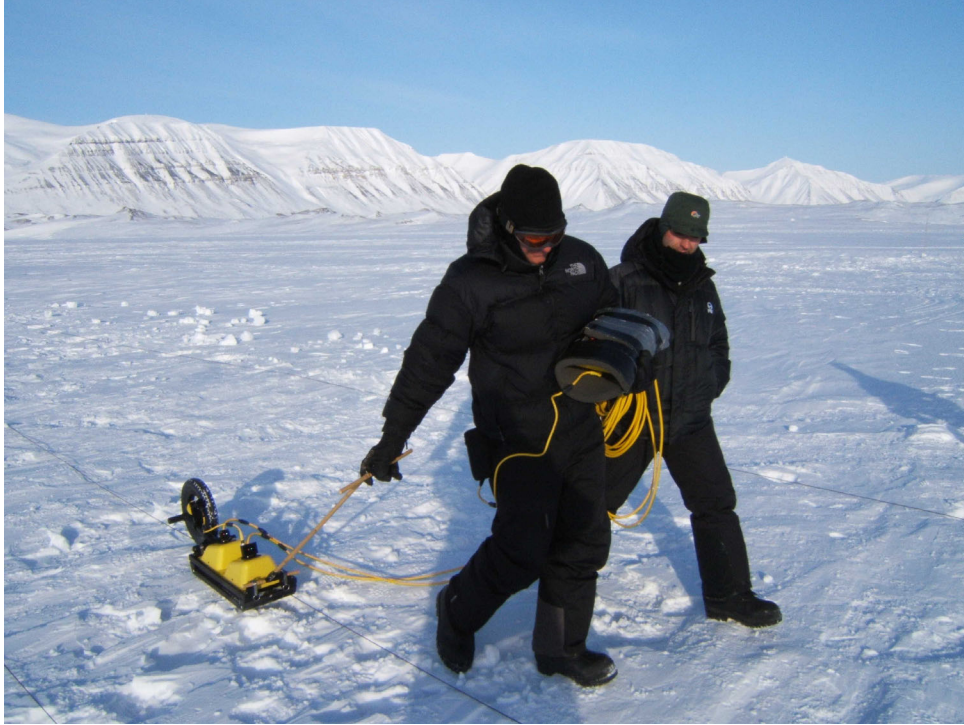
Radar surface traverse along a marked survey line

A 3-D radar survey of the ice area incorporating the chosen containment skirt was conducted on March 26 one day prior to the spill. Snow depths were measured at 80 points within the spill skirt and showed a range of 4 to 30 cm in hard undulating drifts.

Following the spill, the radar team repeated the full 3-D survey with antennas at different frequencies over the oiled site, including clean ice comparisons outside of the skirt. On

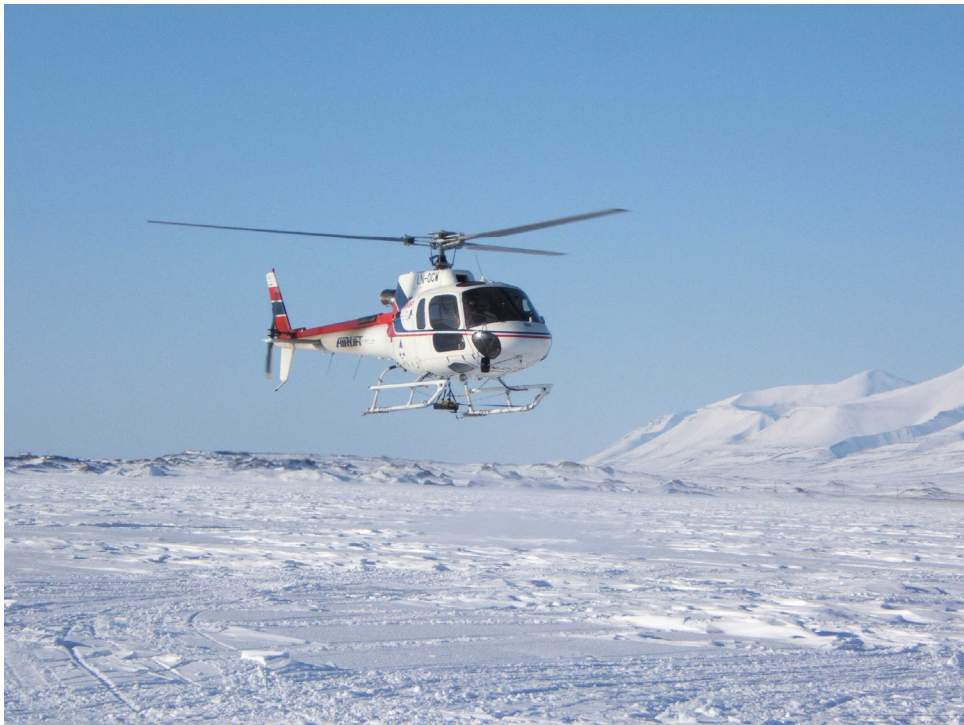
Radar being flown over the oiled area

March 28, the radar was mounted under an AS350 helicopter and flown over the spill site and surrounding area at three different altitudes (approx 3 to 12 m) and a range of forward speeds up to 20 knots.

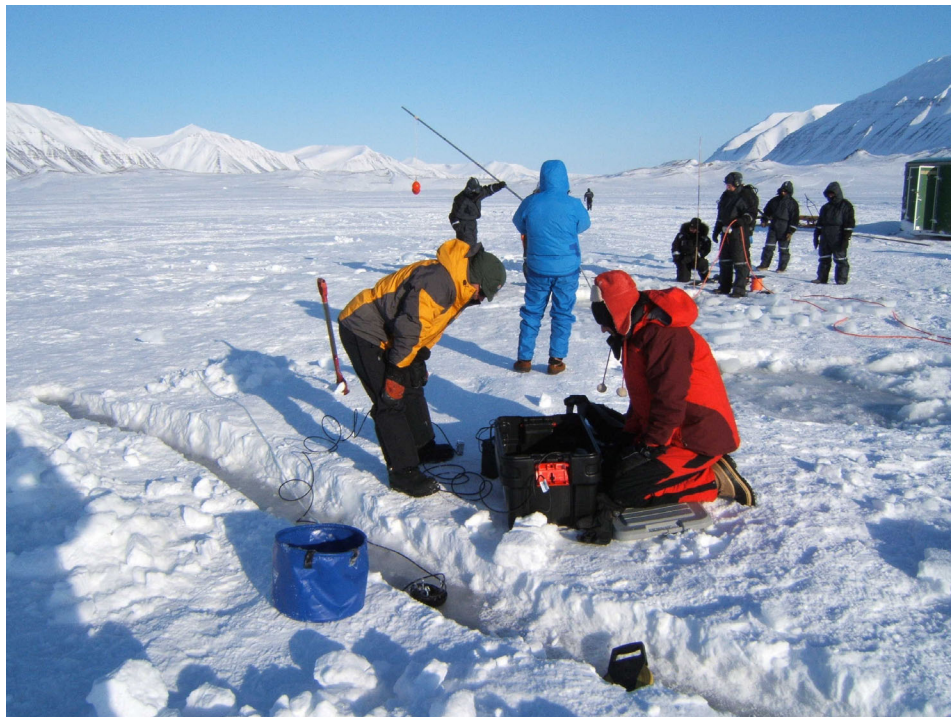
Testing the acoustics system by moving the transducer along a trench straddling clean and oiled ice. Water was used to wet the ice to improve coupling.

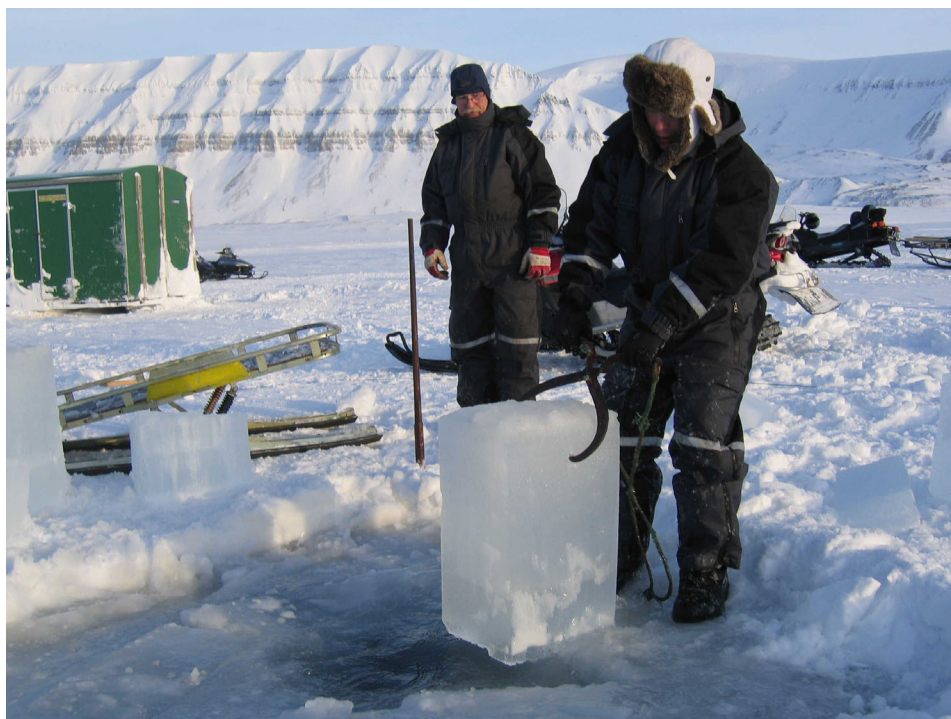
Extracting an ice block while cutting a dive hole just outside the skirt

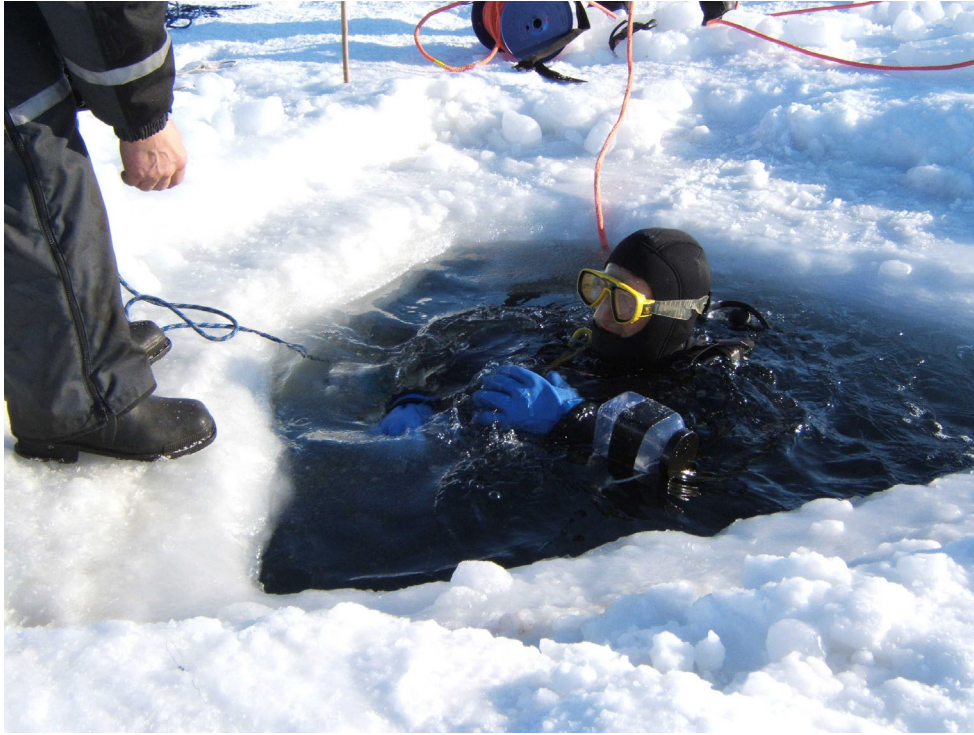
Diving operations

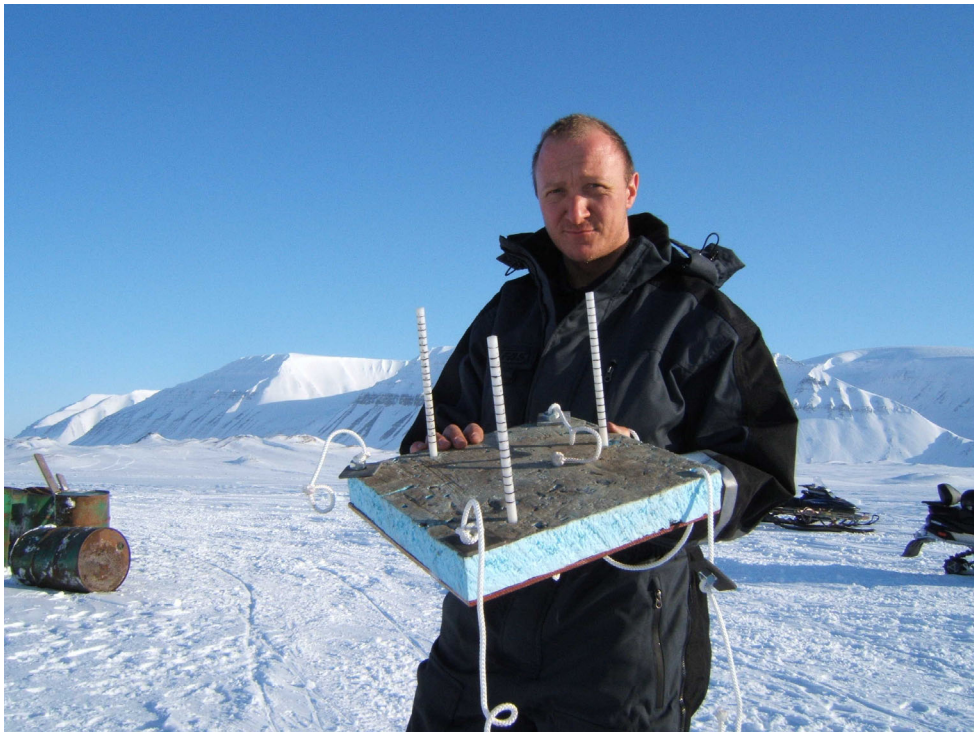
SINTEF prototype under-ice oil thickness sampler

Diving operations took place on three different occasions between March 27 and 29. A novel under-ice thickness sensor was tested and used successfully to measure the oil thickness (three points simultaneously) at different locations reached from two separate dive holes. While the average film thickness was in the 3 to 4 cm range, as expected, the natural variability in the ice thickness (± 5 cm) led to deeper pockets of oil in localized areas within the skirt. Observations and underwater photographs were taken to show the appearance of the oil layer and the progress of new ice growth at the edge of the oiled area within 48 hours of the spill.
