**Review and Comments on:
Texaco HARVEST Platform Damage Assessment**

September 25, 1987

REVIEW AND COMMENTS ON: TEXACO HARVEST PLATFORM DAMAGE ASSESSMENT

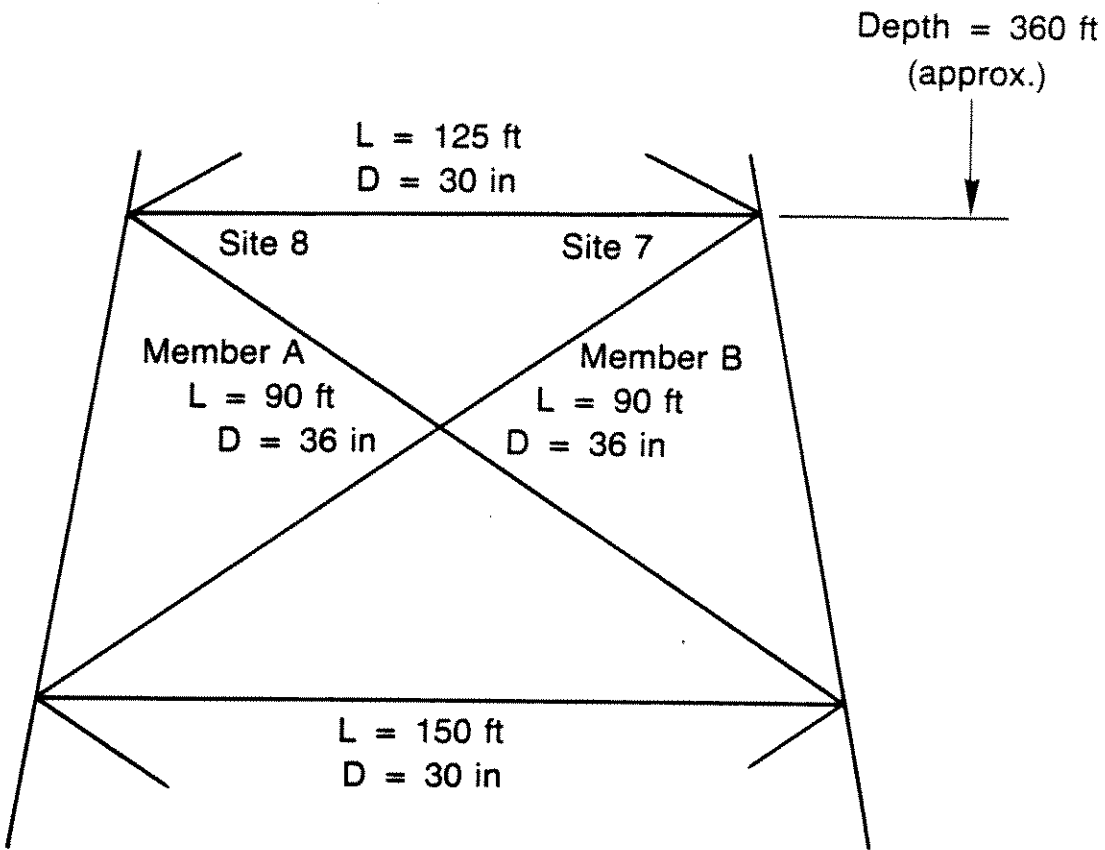
Fig. 1 — HARVEST platform damage area schematic (not to scale)

A sketch of the Site 7 and Site 8 locations is given in Fig. 1. These sites are located approximately 365 ft below the mean water level (MWL) elevation of the platform. The dimensions of the members and the properties required for the present review and assessment are given in Fig. 1 and Table 1.

The natural frequencies of the members labeled A and B in Fig. 1 can be estimated to a reasonable first approximation by considering them to be stiffness-dominated cylindrical beams. This neglects the interdependence of the subelements of the overall structure, but no computer code is readily available at this time to do a more extensive analysis. The frequencies of the first n natural modes are given by

An estimate can be made of k_s for the platform HARVEST members based on the properties and dimensions in Fig. 1 and Table 1. If it is assumed that the structural log decrement $\delta = 0.05$ to 0.10 for a steel pipe, which is reasonable in practice, then $k_s = 50$ to 100. This is a typical range of δ for a riser or conductor pipe conveying fluids. It is seen readily from Fig. 2 that reduced damping in this range limits the amplitude of displacement (from equilibrium) to $Y = \pm 0.01D$ (or ± 0.36 -in.) and less. Among the information provided by Texaco Central Offshore Engineering (January 1987) was the estimated log decrement of the structural damping for the members in question. The log decrement of the hollow steel tubulars is $\delta = 0.01$, which is considerably less than the original assumption given above. Thus the reduced damping k_s is of the order $k_s = 10$ or less, a decrease of an order of magnitude from the original estimate. Reference to Fig. 2 then gives a revised crossflow displacement amplitude of $Y = \pm 0.3D$ or somewhat greater, depending on the actual value of the structural damping. Visual observations of the vibrations of the X-frame sketched in Fig. 1 estimated the amplitudes of oscillation to be of the order of $\pm 1.0D$ and to be in the general form of breathing or crossflow oscillations normal to the plane of the X-frame when the relative orientations of the barge-mounted platform and the incident wind were aligned in the appropriate manner. These are precisely the vortex-induced vibrations which are likely to cause the most severe problems.

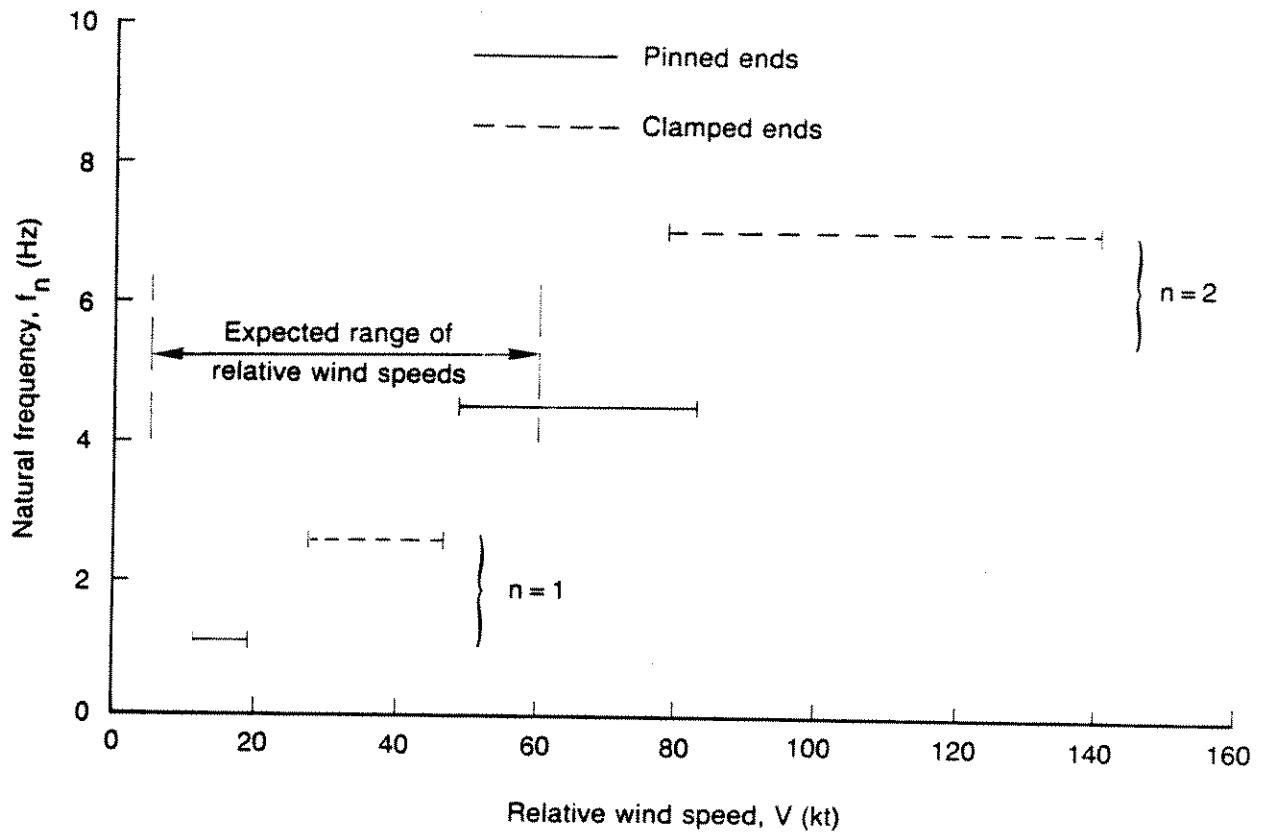
Fig. 4 — Predicted natural frequencies and relative wind speeds over which vortex shedding-induced vibrations occur

According to information provided by Texaco Central Offshore Engineering (January 1987), the winds at the offshore site were in the range of 4 to 7 on the Beaufort scale. This translates to a wind speed range of 15 to 40 kt, which is similar to the range plotted in Fig. 4. However, these winds were observed over extended time intervals at the HARVEST platform installation site when the platform was barge-mounted and stationary in the water. The observed vortex-induced vibrations also were dependent upon the wind direction relative to the members which experienced damage. This directional effect is a result of the yaw angle dependence of the vibrations. At the larger yaw angles, greater than 30 to 40 degrees from normal incidence, the vibrations become less regular and are much reduced in level due to the irregularity and complexity of the vortex shedding. This behavior was in fact observed at the site.
