# Using Satellite Radar Imagery to Detect Leaking Abandoned Oil Wells on the U.S. Outer Continental Shelf

Phase I – TECHNOLOGY DEMONSTRATION

Final Report

U.S. Minerals Management Service  
Solicitation #1435-01-99-RP-31018  
Purchase Order #0100PO17140

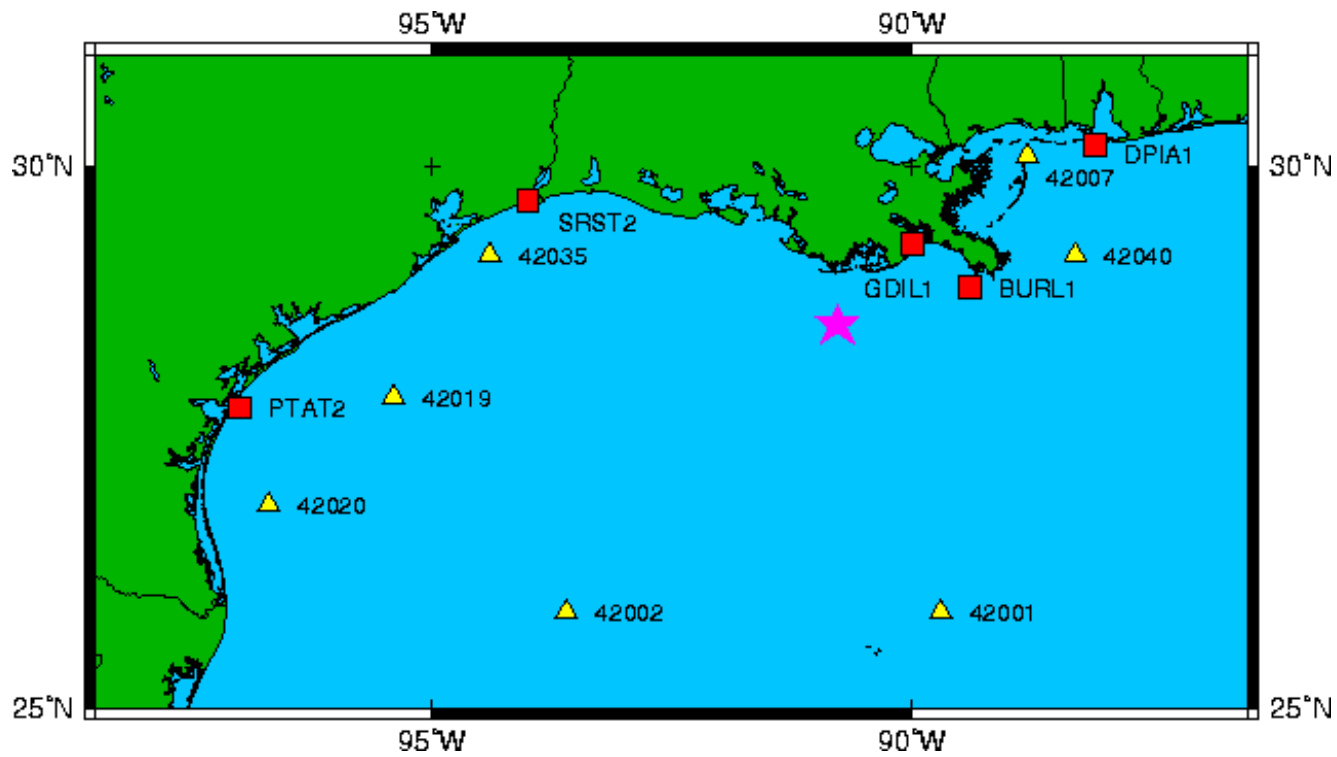
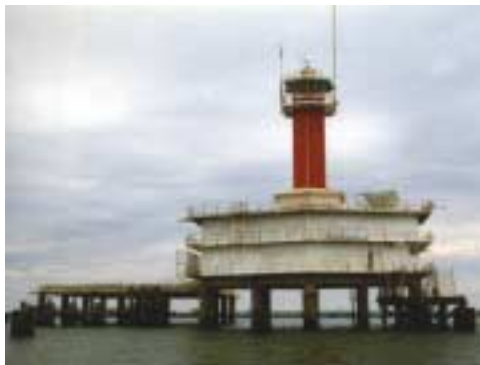
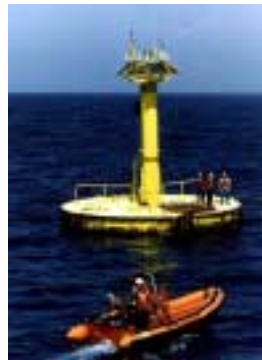
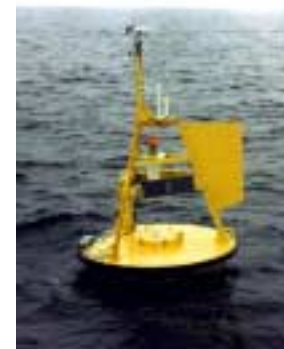
Figure 2. Top: locations of NODC weather stations in western Gulf of Mexico. Abandoned well E-1 marked by star. Bottom, left to right: BURL1 C-MAN station; 10-meter discus buoy at stations 42001 and 42002; 3-meter discus buoy at station 42040.

Twenty-five images were found in the data archive, ranging in date from May 28, 1996 to December 28, 1997 (Table 1). To evaluate their suitability for slick detection, we compiled historical weather observations from NODC stations. Two manned coastal stations (C-MAN stations GDIL1 and BURL1) and three remote data buoys (42040, 42001 and 42002) were operational in the Gulf during that period. The buoy stations and their identification codes are presented in Figure 2.

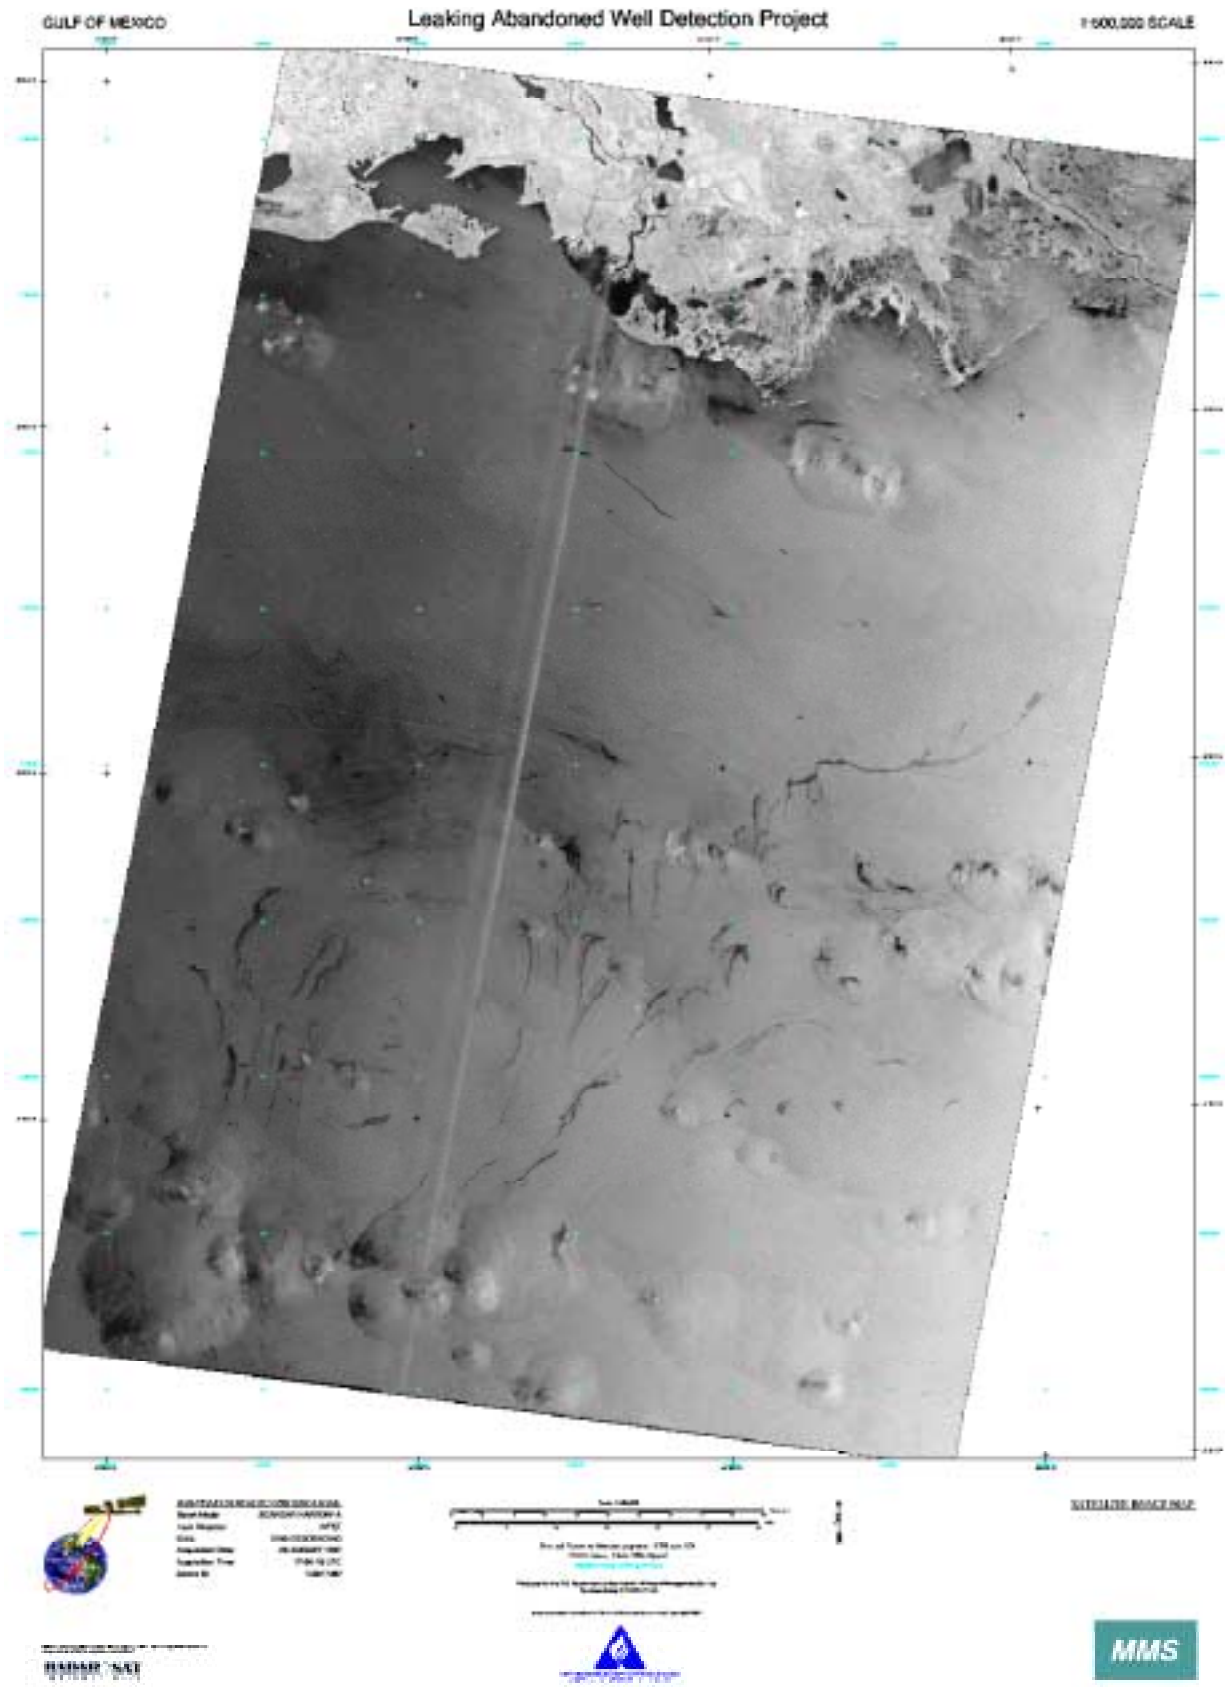
Figure 3. August 6, 1997 RADARSAT image map of study area.

The images were annotated with conventional map information and printed on semi-gloss paper using a large-format Hewlett-Packard HP2500CP DesignJet printer (Figures 3 and 4). The full-size 1:500,000 scale image maps accompany this report as rolled separates.

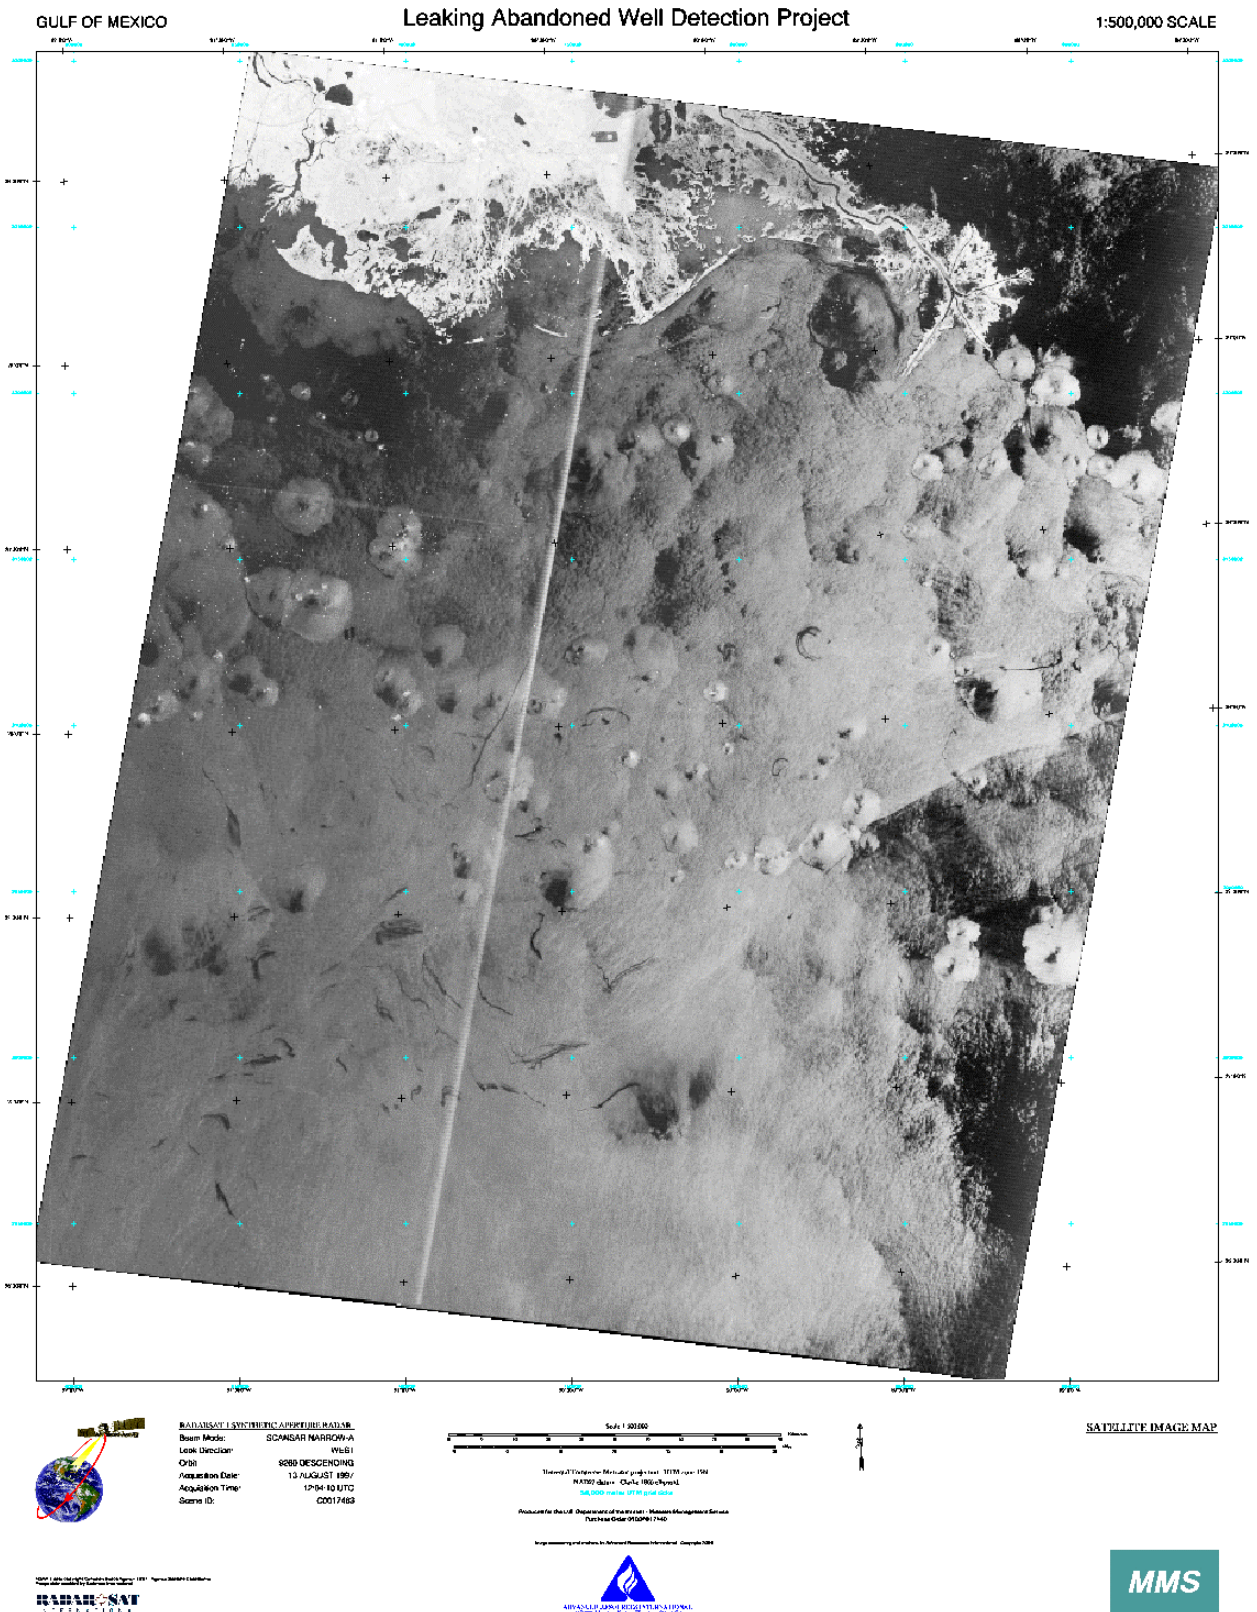
Figure 4. August 13, 1997 RADARSAT image map of study area.

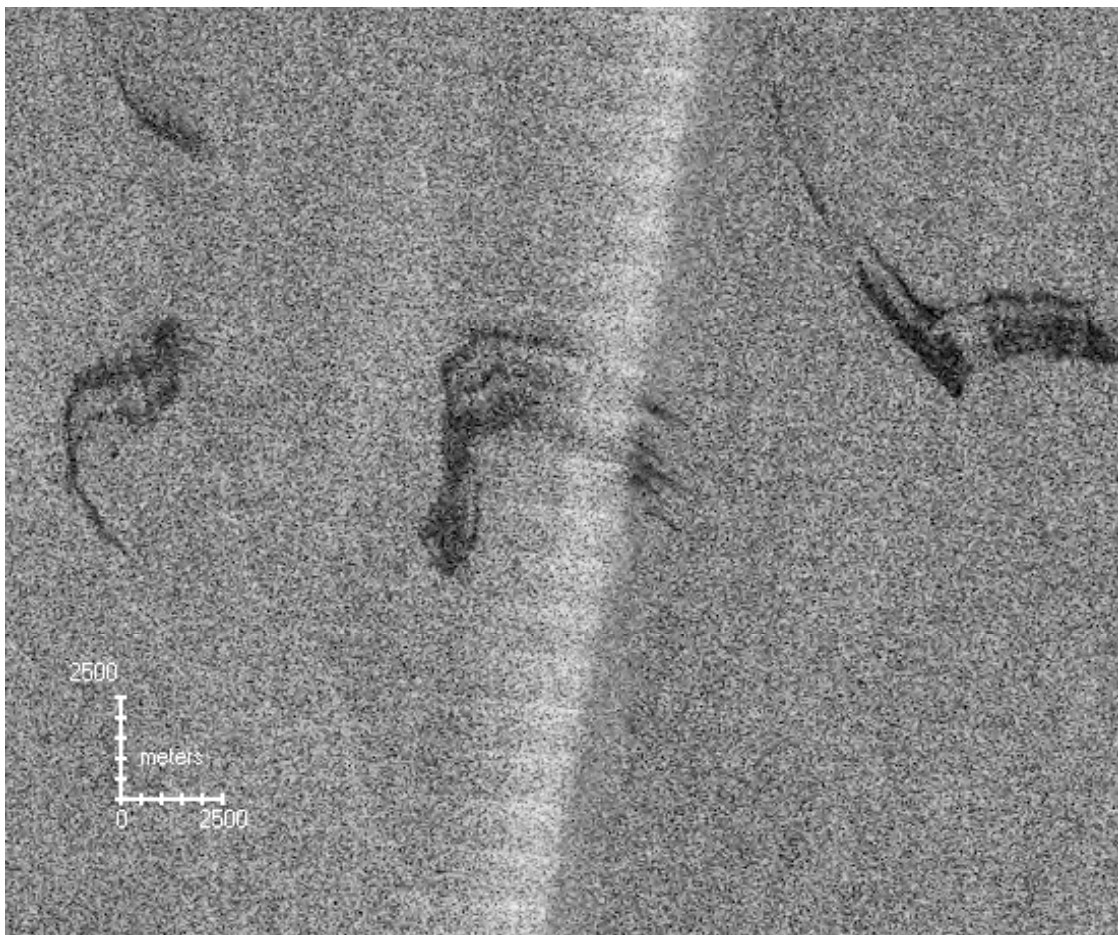
**Figure 5. Nadir anomaly (broad bright line parallel to satellite’s orbital path). Detail from southern portion of August 13 image. Dark patches are characteristic of wind-driven oil slicks caused by natural seafloor seeps.**

Both images suffer from minor quality problems inherent to older ScanSAR imagery: slight calibration variations within the imaged area; faint east-west banding, called “scalloping”; and a bright line running north and south across the image, the “nadir anomaly,” caused by an errant radar echo bouncing up off the sea surface from directly beneath the satellite (Figures 5 and 6). In general, these artifacts pose little more than cosmetic problems.

Despite these localized problems, both images were acquired under generally acceptable conditions for slick detection. Along the shelf break (200-1500 meter depth), numerous elongated slicks appear (Figure 5; Figure 8). These are characteristic of natural oil slicks caused by seafloor oil and gas seeps. In this area, well beyond the present oil and gas infrastructure and major shipping lanes, these slicks may be considered diagnostic of natural seeps. The clear discrimination of these slicks on both images provides strong evidence that imaging conditions were well within bounds for reliable oil slick detection.

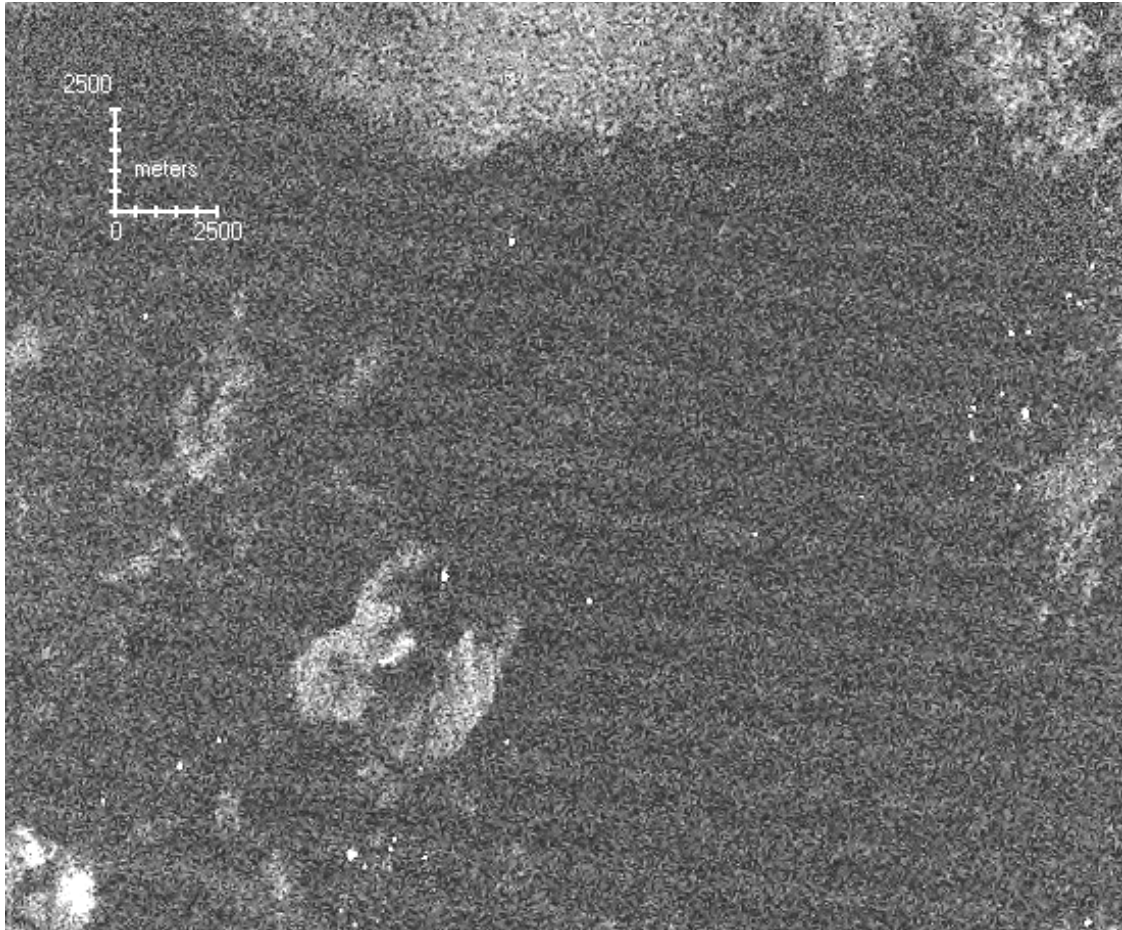
**Figure 6. Scalloping (faint banding perpendicular to satellite's orbital path). Detail from dark, low-wind region in northwestern portion of August 13 image. Production platforms are visible as discrete bright spots scattered throughout the image.**

Platforms and vessels appear as bright spots (Figure 6), generally indistinguishable until the GIS platform locations are superimposed. A few vessels can be distinguished by the presence of short, faint lines that indicate a trailing bow or stern wake.

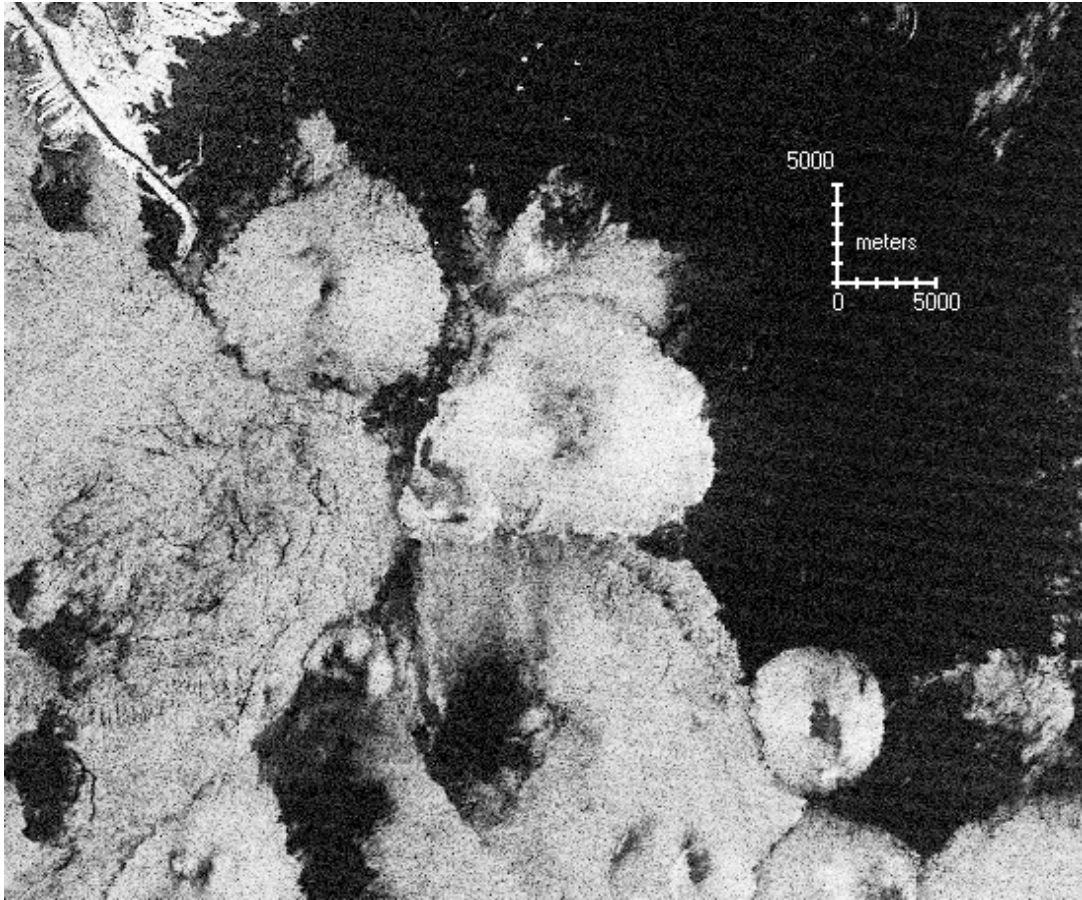
**Figure 7. Extremely variable sea-surface wind conditions. Black area to upper right is a broad region of very low wind speed (less than 1 meter per second). Circular bright patches near center indicate radial gusty winds beneath individual convection cells (probably isolated thunderstorms). Mottled are to lower left is a zone of moderate wind strength (light gray) with patches of heavy rain (black). Detail from northeastern portion of August 13 image; South Pass is visible as a thin dark channel in upper left corner.**

A more serious problem is the effect of scattered thunderstorms and extensive dark, low-wind areas across the northern and western parts of the August 13 image (Figure 7). This weather pattern is not uncommon in the Gulf during the summer months, as intense solar warming of the sea surface generates convection cells in the lower atmosphere that rapidly strengthen during the late morning hours. Isolated patches of heavy rainfall are marked by dark circular patterns on the sea surface, effectively obscuring the signature of any oil slicks in the vicinity. Gusty, non-uniform wind fields around the areas of convection create surface texture anomalies that can hinder slick identification.

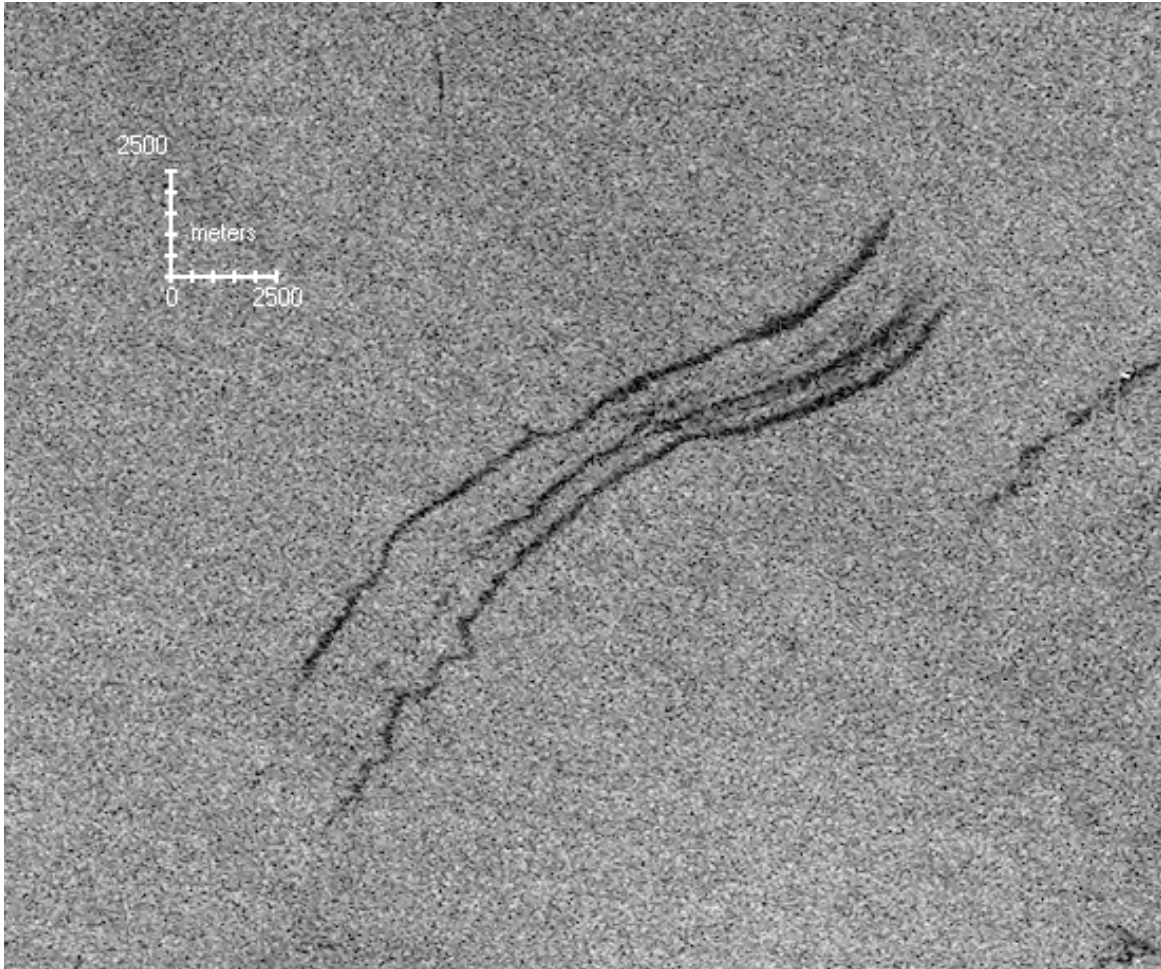
**Figure 8. Cluster of elongated, wind-driven oil slicks characteristic of natural seafloor seeps. Point of origin is beneath the northern end of each slick. As wind and current drives the floating oil away from the point of origin, the slick becomes progressively thinner and narrower due to evaporation, biodegradation and mechanical dissipation, until it no longer exerts a radar-detectable influence on sea-surface roughness and effectively disappears; in this case, 19 kilometers from the point of origin. Detail from southeastern part of August 6 image.**

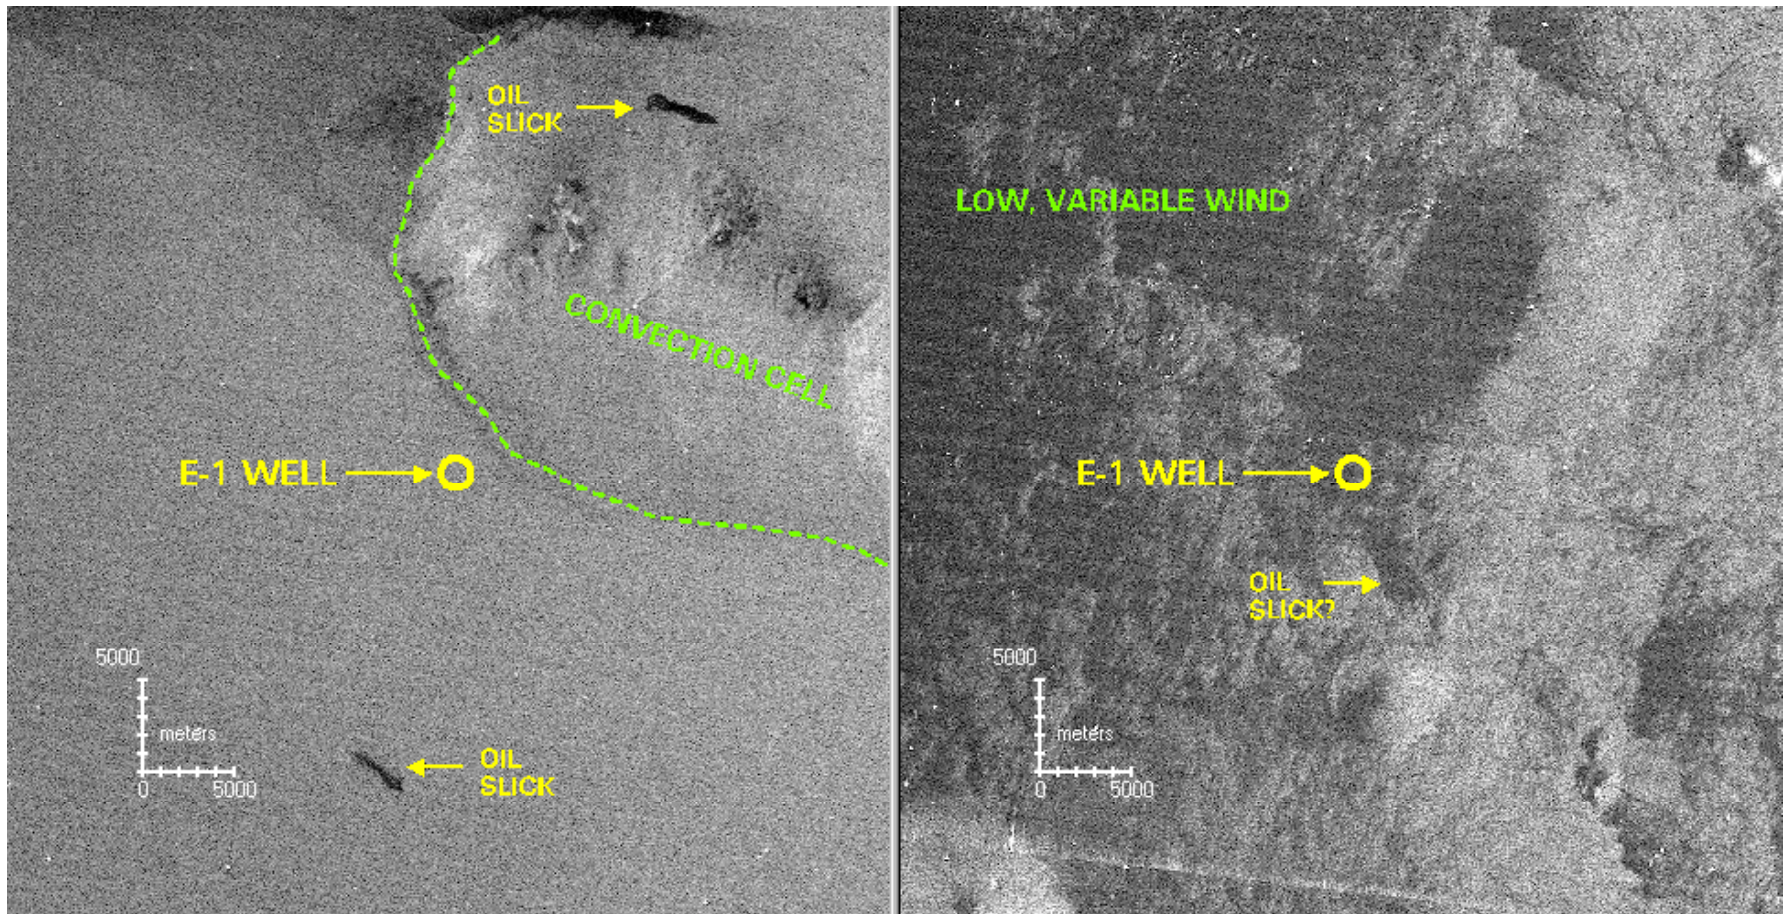
**Figure 9. Well site E-1 (yellow circle) on RADARSAT images from August 6, 1997 (left) and August 13, 1997 (right). The even gray tone and appearance of two small oil slicks on the August 6 image indicate ideal surface wind conditions for slick detection. The dark, uneven tone and heavy mottling on the August 13 image indicate variable winds near the lower limit for slick detection, possibly obscuring the presence of any oil slicks. No slicks are confidently attributable to oil leaking from the E-1 site.**

No slicks are apparent on either image that can be confidently attributed to a point source of leakage on the seafloor in the immediate vicinity of the E-1 well site. Figures 9 to 11 are a sequence of side-by-side comparisons of the August 6 and August 13 images. Each figure is zoomed in by 2x relative to the previous figure; Figure 10 represents a full-resolution enlargement (where one image pixel is represented by one hardware pixel on the display monitor of the image processing workstation).

Figure 9 is marked with interpretive notes. The August 6 image exhibits the smooth, even grey tone that indicates a relatively uniform surface wind field, although the mottled circular pattern of a large but fairly weak convection cell occurs just north of the well site. The August 13 image, however, suffers from a highly variable wind field around the well. Low-wind regions appear as very dark patches throughout the area, including a large patch that covers most of the well site itself. An indistinct extension of this dark patch, stretching southeast from the well for about 7.5 kilometers, may represent a linear-wind-driven oil slick that is obscured by the low wind speed in the area. However, we consider this unlikely.

On the August 6 image two small but very prominent oil slicks appear, clear evidence that the wind conditions around the well site were ideal for detecting oil slicks on that date. One is located 16 kilometers south-southwest of the well site; the other is 23 kilometers to the north-northeast. Both slicks are approximately 3.5 kilometers in length, 600 – 800 meters in width, terminate abruptly on both ends, and trend northwest, roughly parallel to the shoreline. Neither appears on the August 13 image. These characteristics suggest that the slicks are ephemeral surface events from a moving source, probably minor spills from small passing vessels.

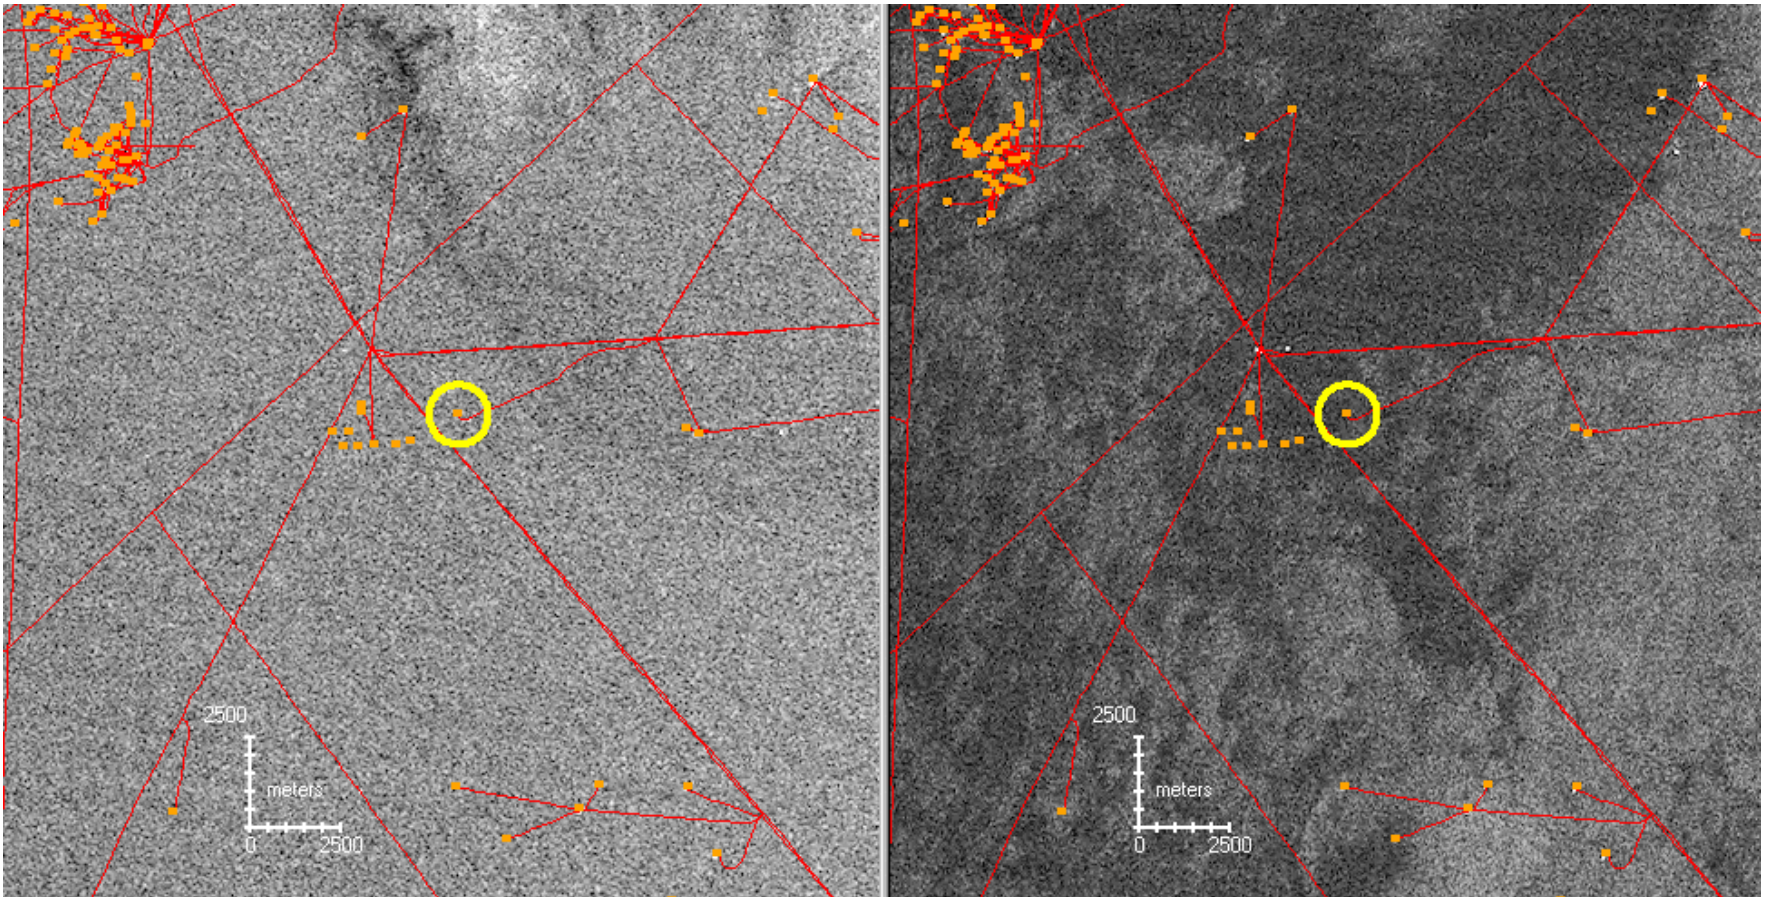
**Figure 10. Well site E-1 (yellow circle) on RADARSAT images from August 6, 1997 (left) and August 13, 1997 (right). This is a 2x enlargement of Figure 9, with pipelines overlain in red and platforms marked by orange squares.**

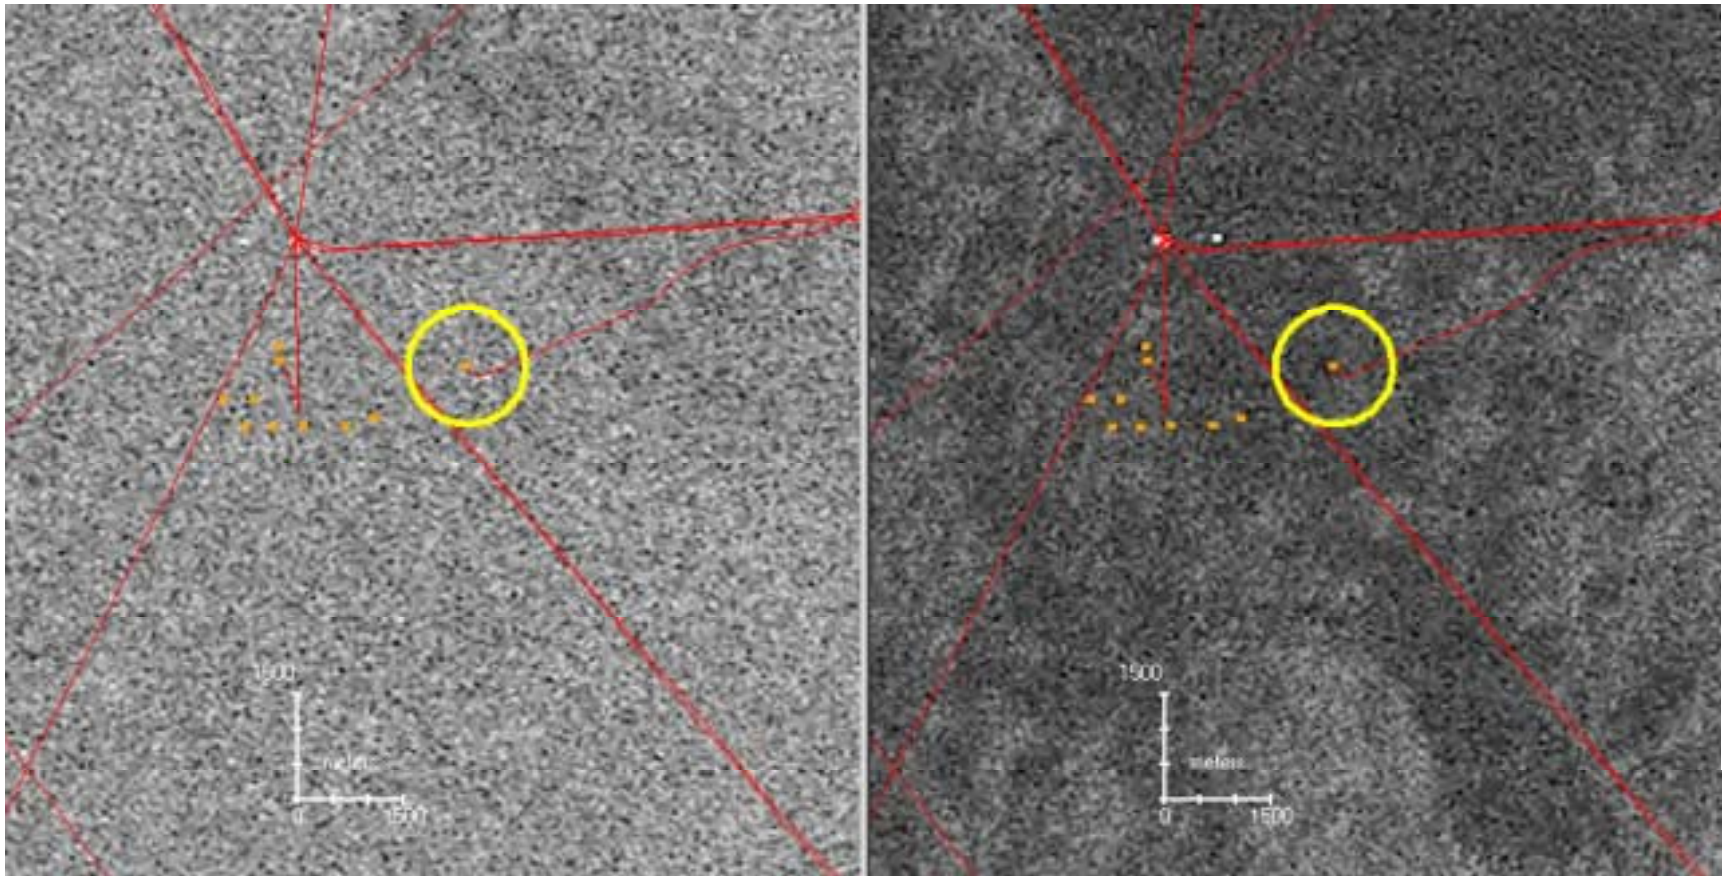
Figure 11. Well site E-1 (yellow circle) on RADARSAT images from August 6, 1997 (left) and August 13, 1997 (right). 2x enlargement of Figure 10.

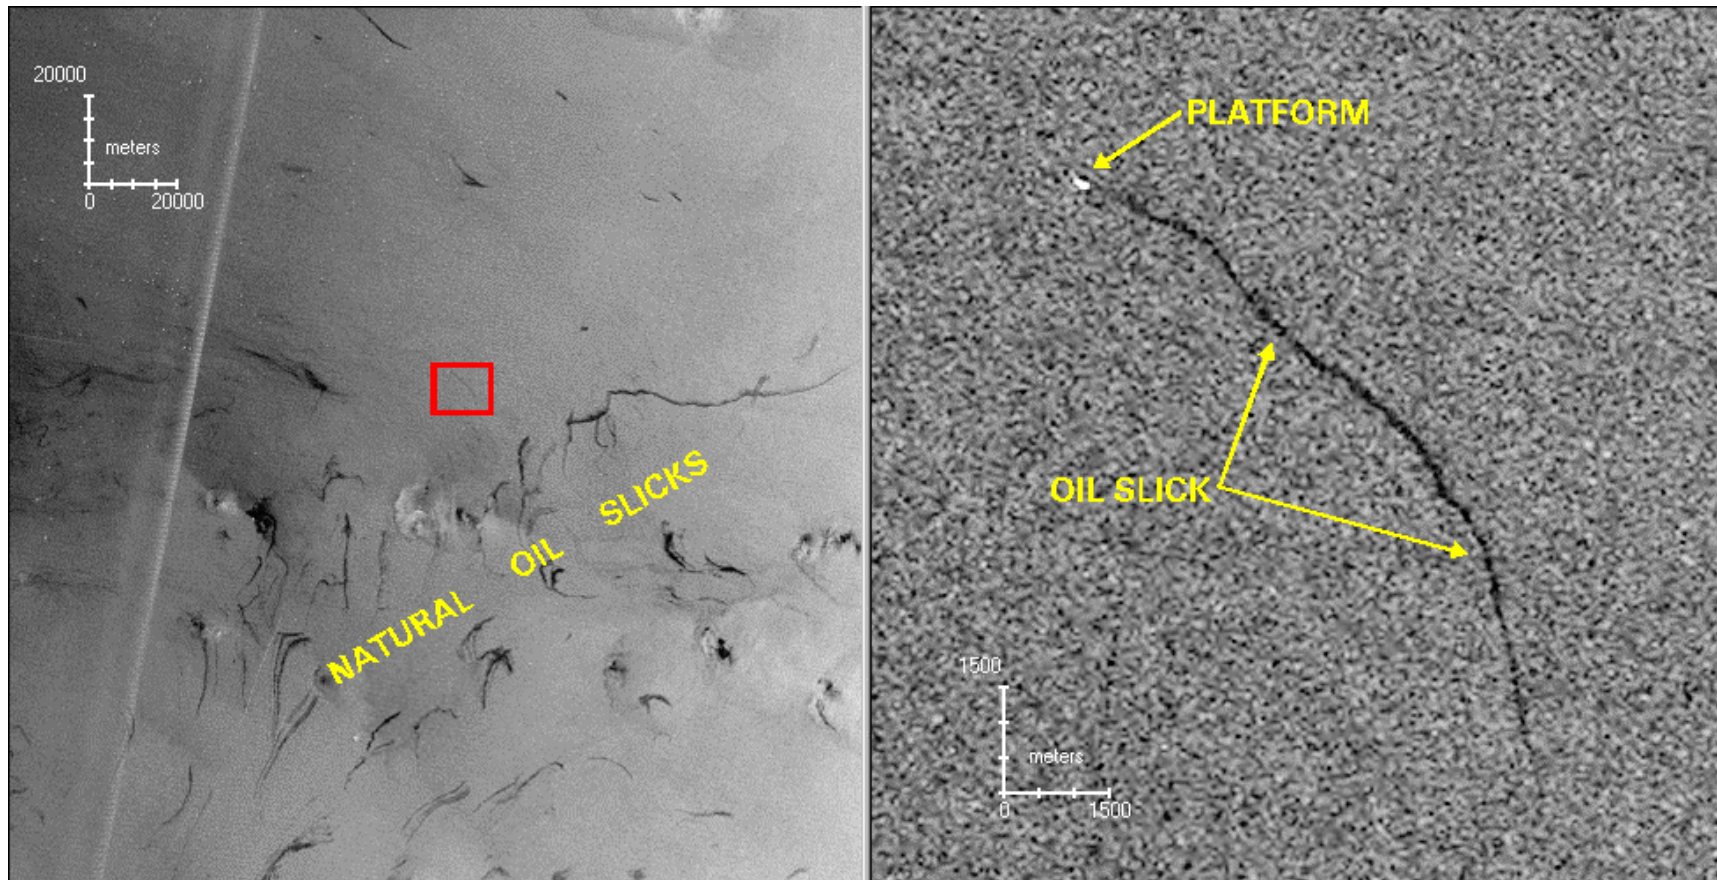
Figure 12. Oil slick emanating from production platform located in Ship Shoal South block 349, north of a large cluster of natural oil seeps on the continental shelf break. Red box marks area enlarged to the right. Detail from RADARSAT image acquired on August 6, 1997.

One additional feature of interest appears on the August 6 image. A platform in Ship Shoal South block 349, located at 28.062042 degrees North latitude, 91.062817 degrees West longitude, is obviously trailing a small, wind-driven slick that extends 11 kilometers to the southeast (Figure 12). The water depth in this area is approximately 200 meters.
