DRILL STRING SAFETY VALVE TEST PROGRAM

Adam T. Bourgoyne, Jr.
Elliot D. Coleman
Thomas T. Core
*Petroleum Engineering Department
Louisiana State University
Baton Rouge, Louisiana 70803-6417*

The objective of this task was to experimentally measure the torque required to close and open drill string safety valves for various flow rates, back pressures, and valve designs.

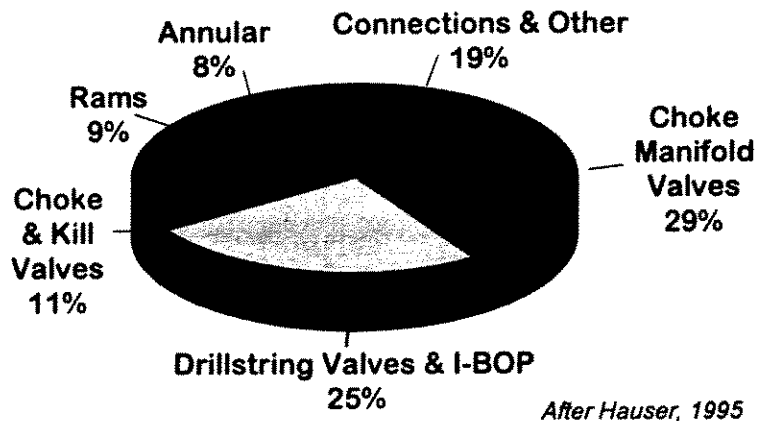
Figure 1: Results compiled from blowout preventer component pressure tests for the U. S. Outer Continental Shelf during 1993 and 1994.

A study of blowout preventer pressure test results by the Minerals Management Service (MMS) for the U.S. Outer Continental Shelf during 1993 and 1994 identified drill string safety valves (DSSV's) as one of the least reliable components of the well control system [Hauser, 1995]. Figure 1 details the results. Note that the pressure test failure rate for drill string safety valves and inside blowout preventers was about 25%. This was especially troublesome, since the

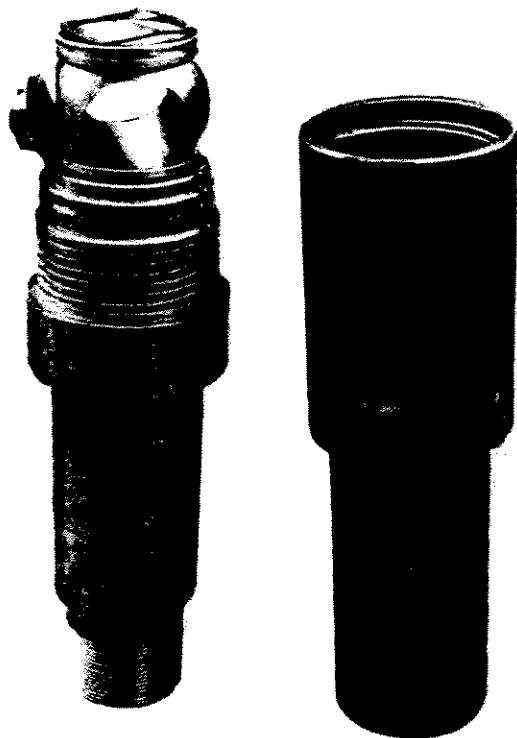
Figure 2: Photograph of the traditional *TIW* drill string safety valve.

Drill string safety valves are ball valves used to stop flow through the drill string. Shown in **Figure 2** is a photograph of a traditional *TIW* drill string safety valve. The patent has expired on this simple design which is now available from several manufacturers in addition to *Texas Iron Works* (TIW) from which it took its name. The name *TIW Valve* is often used as the generic name for a drill string safety valve. This photograph was taken during a visit to a valve manufacturing facility. The valve has been disassembled here to show the main working components.

When rotated 180 degrees, the portion of the safety valve shown on the right side of Figure 2 would accept the upper valve seat and spring and screw down over the ball. After assembly, the ball "floats" between the upper and lower seats and seals when pressure is applied against the ball. The spring assists in providing a low pressure seal. The valve stem fits into a circular hole in the valve body. The valve is operated by means of a wrench that is inserted into the valve stem and turned one quarter turn.

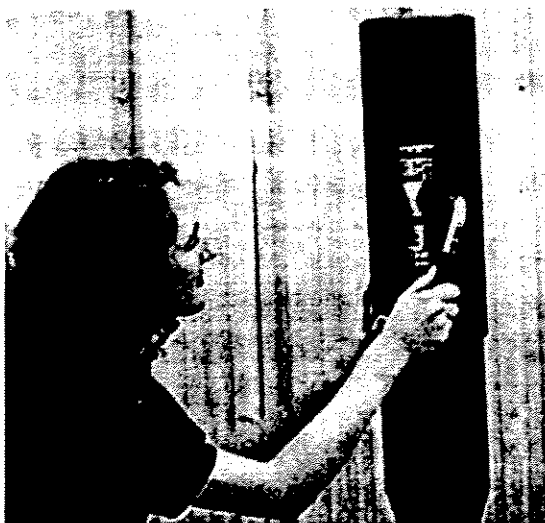
Figure 3: Photograph of a safety valve which has been cutaway and made-up on top of a section of drillpipe.

Displayed in Figure 3 is a photograph of a safety valve made-up on top of a section of drillpipe. The valve has been cutaway so that the ball and seats may be observed. This particular safety valve is a one piece valve design that eliminates the need for threads in the valve body area. This not only decreases the number of possible leak paths, but also eliminates the problem of the ball locking due to excessive make-up torque. The basic design remains with a floating ball in a cage which houses the fixed upper and lower seats.

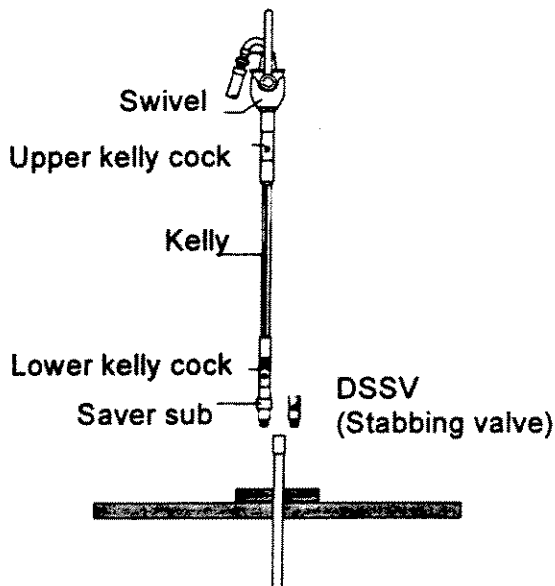
Figure 4: Schematic showing traditional locations of safety valves.

Shown in Figure 4 are the traditional locations of safety valves. Government regulations require that a safety valve, with an operating wrench, for each size drillpipe be maintained on the rig floor at all times.

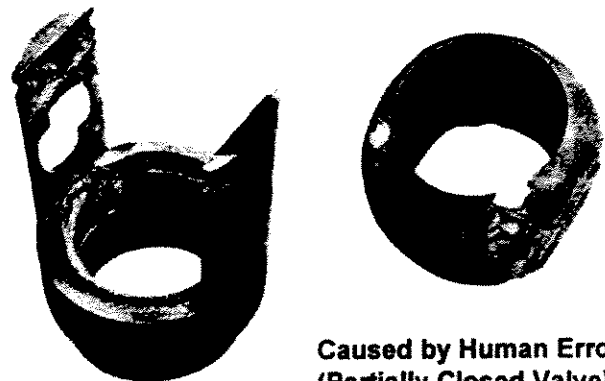
Figure 6: Photograph of ball and seat that has been eroded by mud flowing through a partially closed lower kelly valve.

Shown in **Figure 6** is a photograph of a ball and seat that has been eroded by mud flowing through a partially closed lower kelly valve. The valve was erroneously left in this position during drilling operations and would not seal during a well control event.

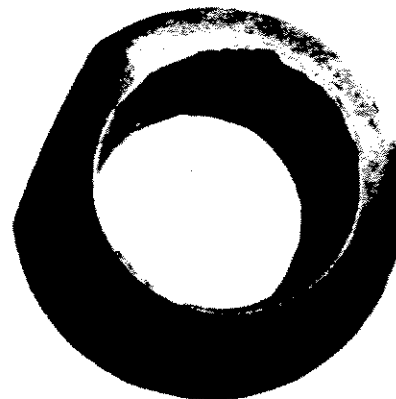
Figure 7: Safety valve ball cut by wireline.

An example of a safety valve ball cut by wireline work being done through the valve is illustrated in **Figure 7**. In order to achieve as large a bore as possible, there is not much extra sealing area on the spherical surface near the ID of the ball. This type of wear can open a leak path that can then be further eroded by flow of mud.

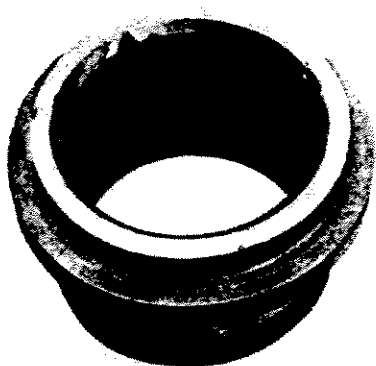
Figure 8: Valve seat cut by fluid erosion caused by over-rotation of the ball valve.

A valve seat cut by fluid erosion due to a slightly over closed valve is depicted in **Figure 8**. Wear on the valve stem stop can sometimes allow too much rotation of the ball. The design of the valve stem stop is very important. A photograph illustrating a failure in the valve stem is shown in **Figure 9**.

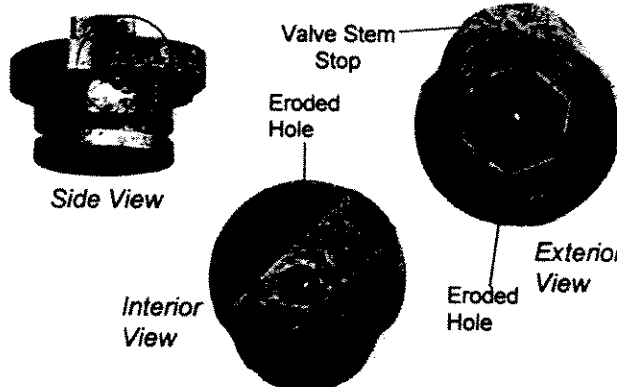
Figure 9: Photograph illustrating valve stem failure.

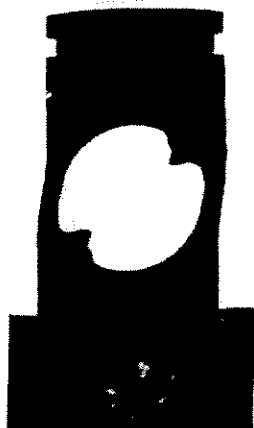
Figure 10: Ball cage deformed around stem opening by excessive torque.

Figure 10 shows a valve component that has been subject to excessive torque, which caused permanent deformation in the ball cage and valve stem stops. The resulting deformation allowed over rotation of the ball which caused seal erosion (shown in Figure 11) and metal to metal contact between the ball cage and the valve stem. This contact is apparent from the wear shown in Figure 12 on the valve stem.

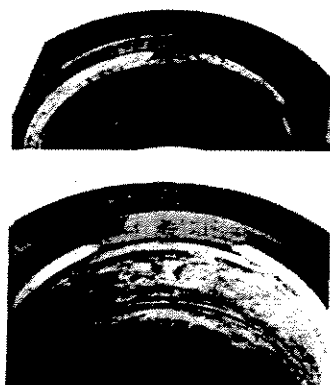
Figure 11: Seal erosion caused by over rotation of the ball.

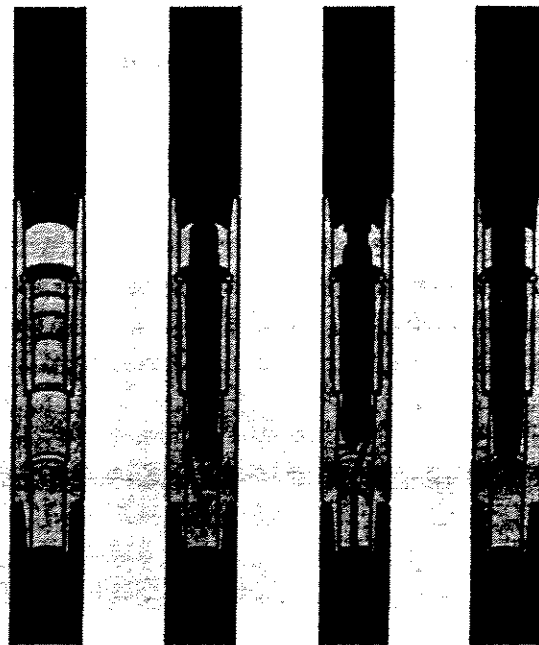
Figure 13: Schematic of a drop-in check valve.

The drop-in check valve overcomes many of the objections to a float in the drill collars. Figure 13 is a schematic of a drop-in check valve. A sub that will accept a check valve is run in the drill string near bottom. Just before it becomes necessary to pull the drill string from the well, the check valve assembly is dropped into an open drillpipe connection and pumped to bottom where it latches into the sub. If the well tries to blowout during tripping operations, the check valve will stop the flow and make it easy to stab and close the

surface safety valve as part of the shut-in procedure. In the event wireline work below the check valve becomes necessary, the drop-in check valve is wireline retrievable.

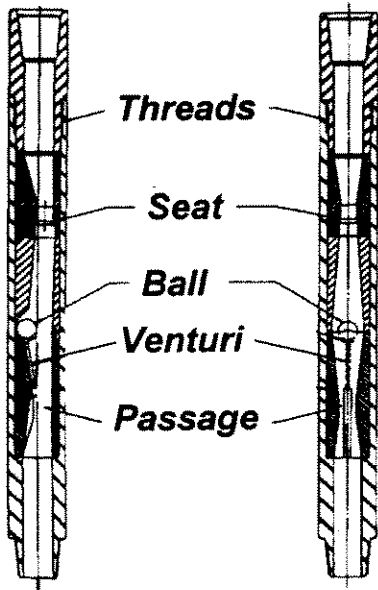
Figure 14: Velocity triggered check valve.

An example of a velocity triggered check valve is shown in **Figure 14**. This valve was designed and tested to a limited extent during the late 70's by Hughes Tool Company for Shell. It was lost in the shuffle of buy-outs during the 80's. Prototype valves are again being built by a new company. Future research will test this valve as part of the MMS project at LSU.

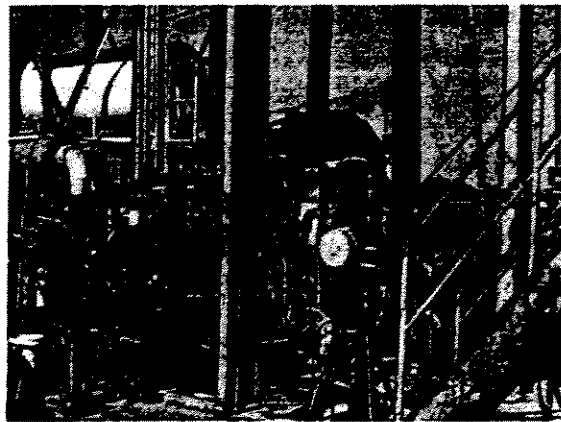
Figure 16: Test apparatus with pump in background.

The test apparatus designed for the data acquisition associated with testing the DSSV's is shown in **Figure 16** and **Figure 17**. The torque sensor is the primary data generating device used in the testing of the DSSV's. The sensor was chosen over a torque wrench because the information from the sensor is much easier to incorporate with other data taken during the experimental tests. The torque sensor is manufactured in such a way that it is simple to put the apparatus together quickly. A pneumatic actuator is used to open and close the DSSV's with the torque sensor fixed between the valve and the operator. The actuator is designed to be used

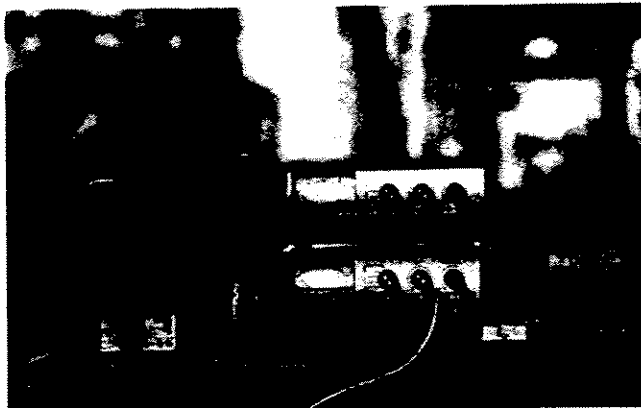
Figure 17: Test apparatus torque sensor, operator, and potentiometer

with valves that open and close through ninety degrees. The force generated by the actuator is supplied by air pressure coming in through a low pressure regulator. The actuator is easily activated using a shuttle valve located downstream from the pressure regulator. The position of the valves is determined from a signal generated by a resistance potentiometer fixed to the actuator. A check system is utilized to tell if the valve is closing completely. A microphone is fixed to the valve and the flow noise is amplified and displayed on an oscilloscope next to the valve. The operator

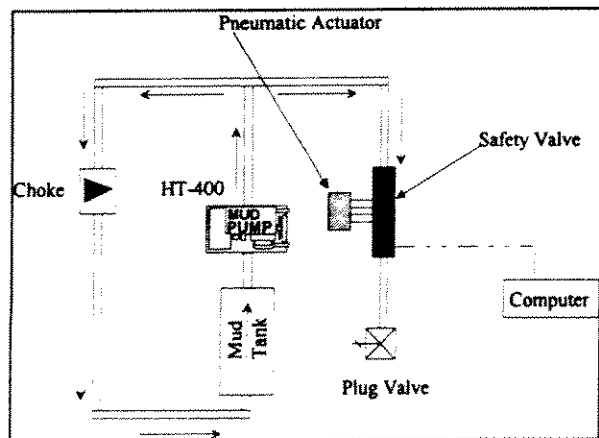
Figure 18: Static test diagram.

The testing of the DSSV's was done in two different ways: (1) a static pressure test, and (2) closing on flow. The static pressure test consists of putting the test piping and equipment in the configuration shown in Figure 18. When the test string is pressured to the test pressure set at the choke, the drill string safety valve is subjected to static pressure. The valve is then closed on this static pressure and the torque and other data is recorded. The next test point is taken by increasing the set point of the choke to a higher pressure setting.

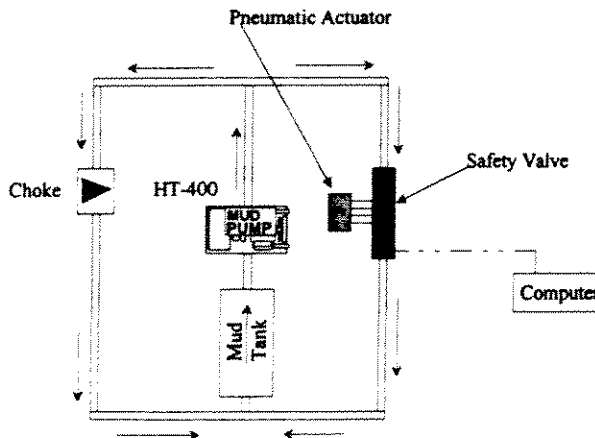
Figure 19: Flow test diagram.

The flow test configuration is shown in Figure 19. To test the valve under flowing conditions, circulation through the test piping is established at the test rate. The valve is closed on the flow and the torque and other data is recorded. To move to the next test point, the flow is increased to the next desirable level.

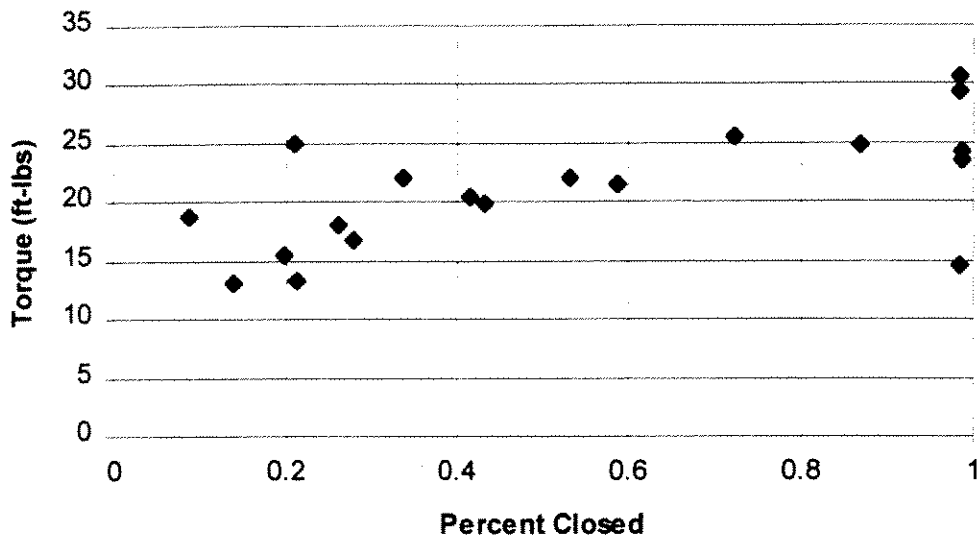
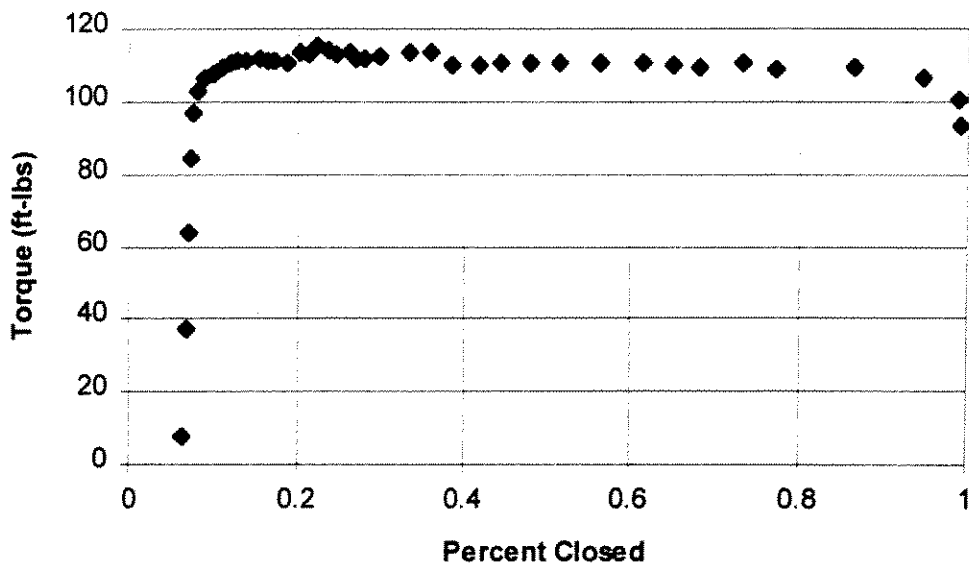
M&M LiteTorque Valve 1000 psi Static Test

M&M 2-Piece Valve (TIW) 1000 psi Static Test

Figure 20: 1000 psi Static test results.

Using the test apparatus and the testing procedures, test results for two commercially available valves were obtained from two different experiments. The static pressure test was performed on a TIW two-piece valve and an M&M LiteTorque valve. The flow test was also performed on these two valves. The static pressure test was performed at 1,000 psi on each of the valves. The collected data for the two valves are shown side by side in **Figure 20** to make a comparison between the two valve designs. Closing values of twenty-five to thirty-five foot-pounds of torque for the Lite-Torque valve are three to four times smaller than the 110 to 115 foot-pounds of torque for the two-piece (TIW) valve. **Figure 21**, the graphs for the 2,000 psi static tests, shows the LiteTorque valve torque values ranging from twenty to forty foot-pounds and the two-piece (TIW) valve torque values exceeding 300 foot-pounds. At 3,000 psi, the LiteTorque valve has torque values that do not exceed fifty-five foot-pounds and the two-piece (TIW) valve exceed 500 foot-pounds. These graphs are shown in **Figure 22**. The static pressure tests of the different valves makes the design differences of the two valves more apparent. The LiteTorque valve contains a bearing between the stem and the valve body. This bearing reduces the frictional forces between the valve stem and the valve casing. The two-piece valve based on a more conventional TIW design does not have the bearing between the stem and the casing and the frictional forces in this area cause increased torque values to be obtained.

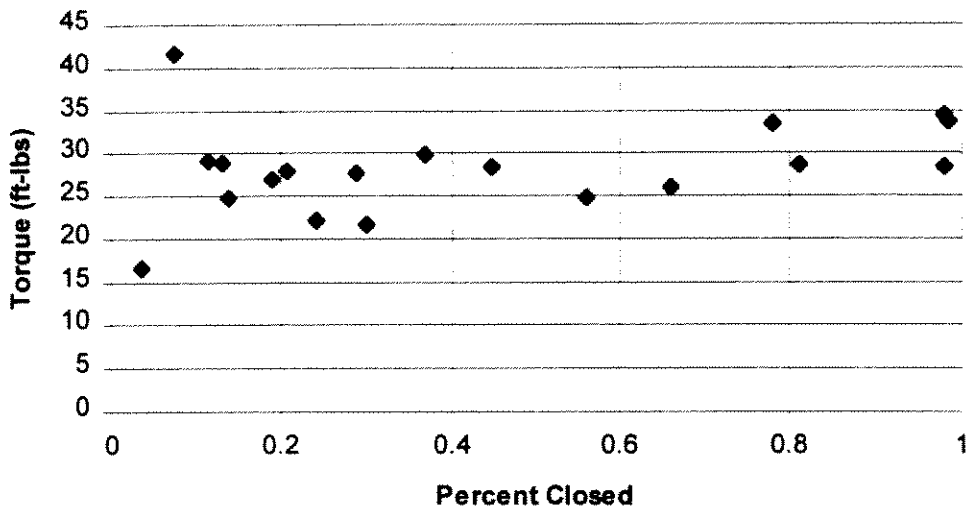
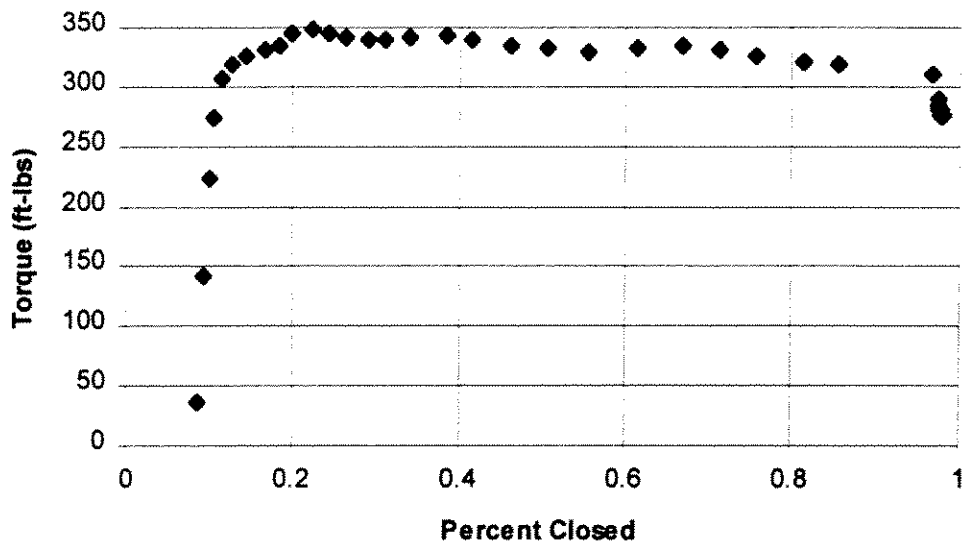
M&M LiteTorque Valve 2000 psi Static Test

M&M 2-Piece Valve (TIW) 2000 psi Static Test

Figure 21:2000 psi Static test results.

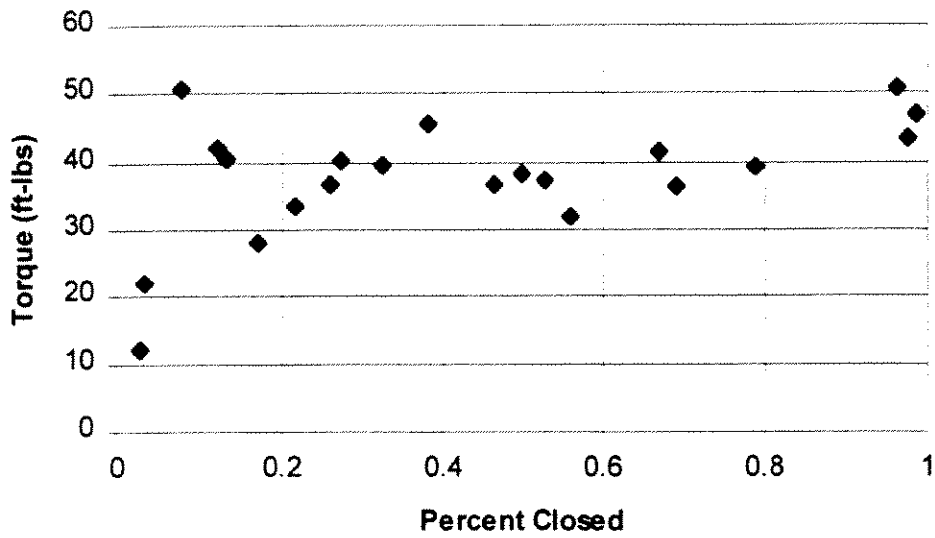
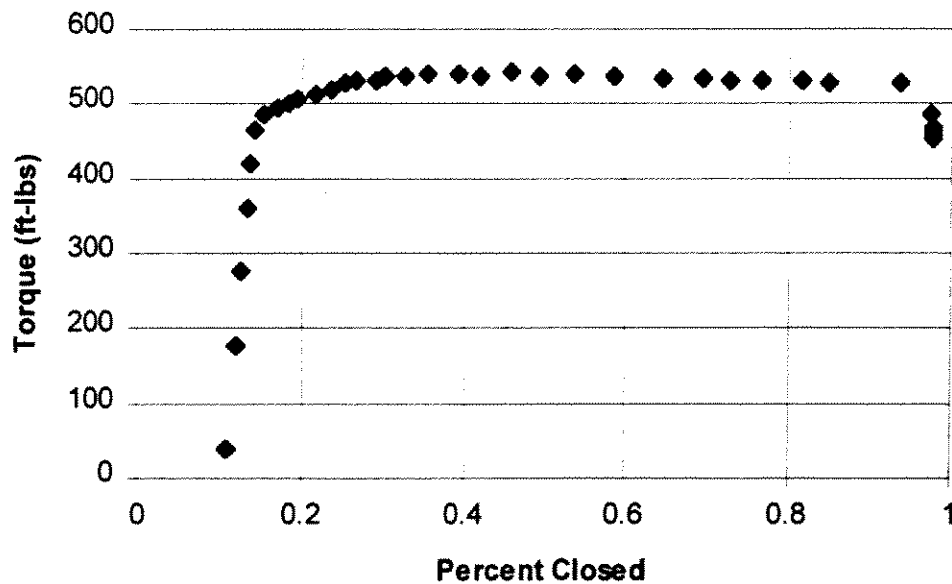
M&M LiteTorque Valve 3000 psi Static Test

M&M 2-Piece Valve (TIW) 3000 psi Static Test

Figure 22: 3000 psi Static test results.

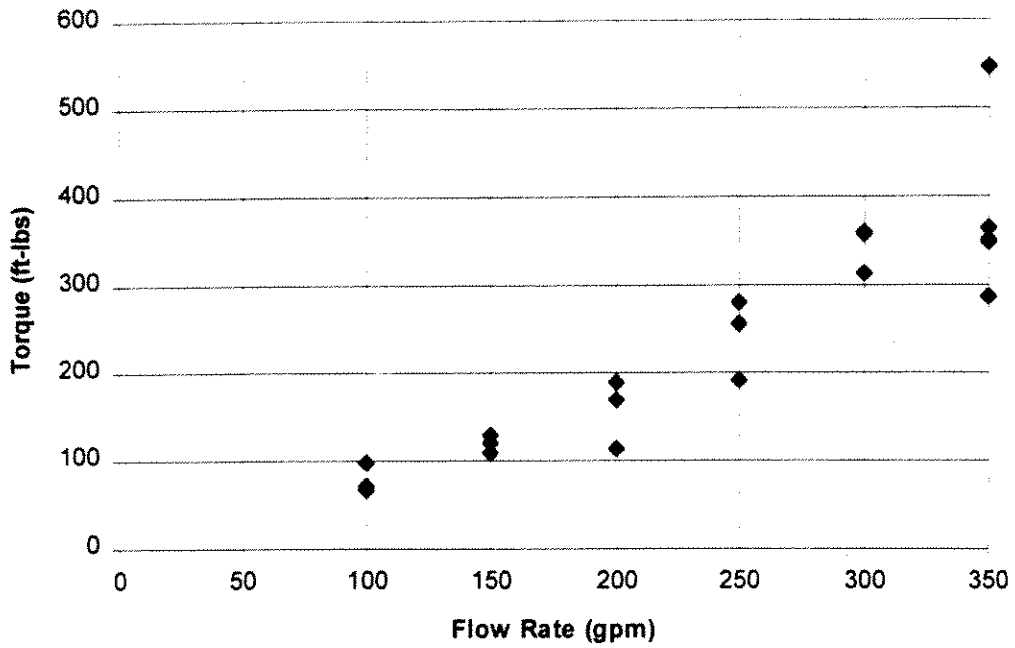
M&M LiteTorque Valve Flow Test

Figure 23: LiteTorque flow test results.

The flow test was performed using flow rates that started at 100 gallons per minute (gpm) and increased by 50 gpm up to 350 gpm. Three closing cycles were recorded at each of the flow rates for the M&M LiteTorque valve and the M&M two-piece (TIW) valve. The results for the LiteTorque valve and for the two-piece valve are shown in **Figure 23** and **Figure 24**. Although the flow test data for the two valves differs significantly in value, the condition of the two valves also varies significantly. The LiteTorque valve was flow tested after being used to calibrate the test apparatus in a variety of configurations. This particular valve had been used extensively as the "set up" valve for all of the testing procedures for many months. The two-piece TIW valve was rebuilt with completely new elastomer seals around the stem and new teflon seals in the seats. The past use the LiteTorque valve and the recent rebuild of the two-piece TIW valve make up for the difference in the torque values that were recorded in the data.

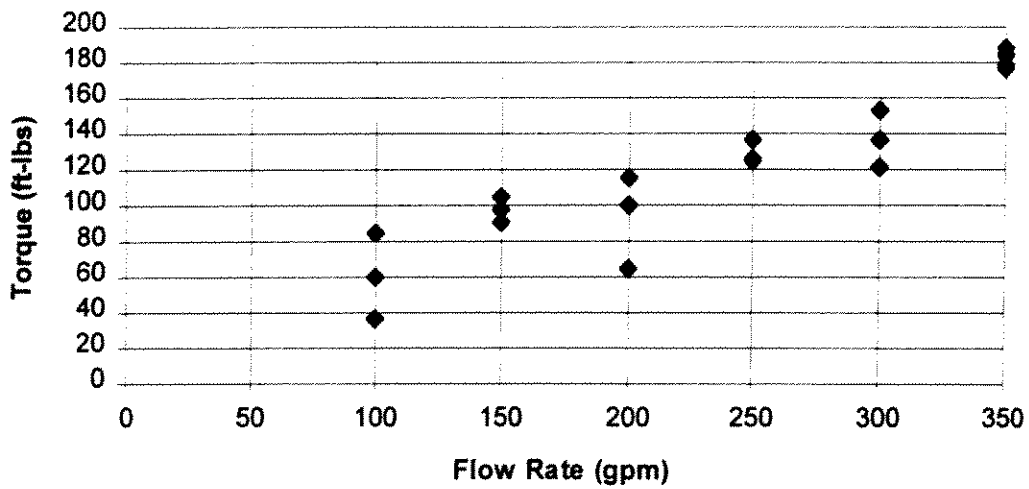
M&M 2-Piece (TIW) Valve Flow Test

Figure 24: Two-piece flow test results.
