# EFFECTS OF OFFSHORE OIL DRILLING ON PHILIPPINE REEF CORALS

J. H. Hudson, E. A. Shinn, and D. M. Robbin

An offshore drilling site in an area of extensive live-coral bottom off northwest Palawan Island, Philippines, was examined 15 months after well completion to determine effects of drilling on coral growth and survival. Core samples of 38 *Porites lutea* head corals were collected from around the drilling site and from a control reef and their histories compared using X-radiography to reveal changes in annual growth before, during and after drilling.

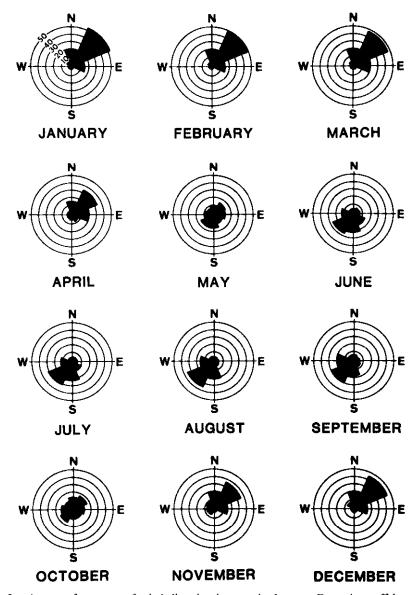
Figure 3. Average frequency of wind direction by month, January-December, offshore Palawan Island, Matinloc area. Rings indicate frequency of direction by percent (see January). Data from Naval Weather Service Command (1973).

Although wind data (Fig. 3) show that the predominant direction is from the northeast and southwest, we believe that the north-northeast (approximately 10° from magnetic north) alignment of the spur-and-groove system (Fig. 7) provides a more reliable indicator of effective current direction. It was assumed, therefore, that drill-mud plumes and cuttings would impact either north-northeast or south-southwest. Thus, the north and south transects would show the maximum effect on the coral community. Surprisingly, the zone of maximum impact, as shown in Figure 7, forms an east—west-oriented ellipse. Choi (1982), who examined the effects of drill mud on cryptic reef fauna, also found an east—west-oriented ellipse of

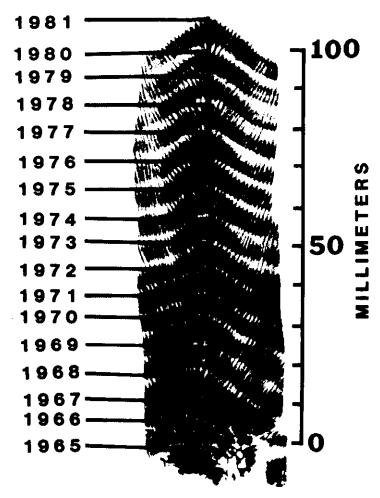
Figure 6. X-radiograph positive print of *Porites lutea* core slab from Matinloc showing annual growth bands marked along the major axis of growth. Note small amount of low-density banding within each yearly growth couplet. Highsmith (1979) recorded similar skeletal density increase with depth in Enewetak *P. lutea*.

Growth-rate measurements were recorded using the following procedure. Clear, 0.003-mil drafting acetate was taped over each X-radiograph print and a fine ink line drawn along the major axis of corallite growth. Yearly growth increments were marked off along the vertical ink line with an ink (tick) mark at the crest of each high-density growth band. Growth increments were measured to the nearest 0.01 mm using a precision caliper with dial readout. Figure 6 shows a typical X-radiograph.

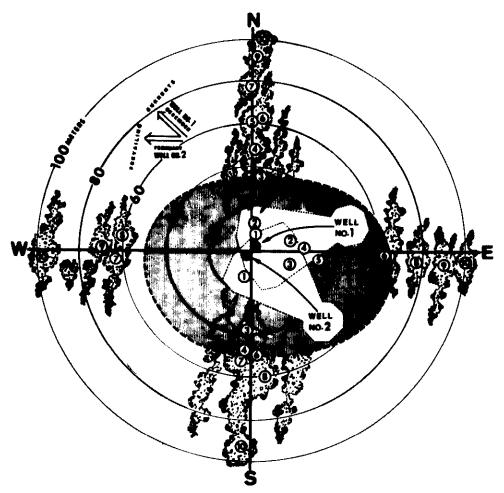
Figure 7. Plan view of Matinloc study site. Area of drilling impact is indicated by gray ellipse. Triangular outlines (drawn to scale) within impact zone indicate shape of drilling vessel and its position during drilling of each well. Small numbered circles mark location of individual *Porites lutea* cored during study (Table 1). Concentric rings indicate distance from wellheads at 20-m intervals. Shape and orientation of spur-and-groove reef formation is accurate, but size is exaggerated  $\times 2$ , and reef cover in area of impact zone has been partly omitted for clarity.

An additional factor that may have affected coral growth and survival is shade. The 60-m-long drill ship (see Fig. 7 for ship outline and positions) covered most of the east transect for a total of approximately 6 months. Hermatypic corals growing at a depth of 26 m are near their depth limit because of reduced light. Therefore, it seems likely that shade cast by a large drill ship would have a significant effect. (Shade probably explains the lack of live coral beneath a 100-year-old lighthouse along the Florida reef tract; personal observations.) Evidence in support of shade-induced growth reduction by natural means is well illustrated in Figure 5, where an *Acropora* sp. table coral can be seen encroaching over a small head coral, *Cyphastrea* sp. Although this coral was cored, its growth bands, as mentioned earlier, were too diffuse to measure. Periodic removal of weakly attached, fast-growing species, such as this table coral, by typhoons would permit a return to normal growth conditions.

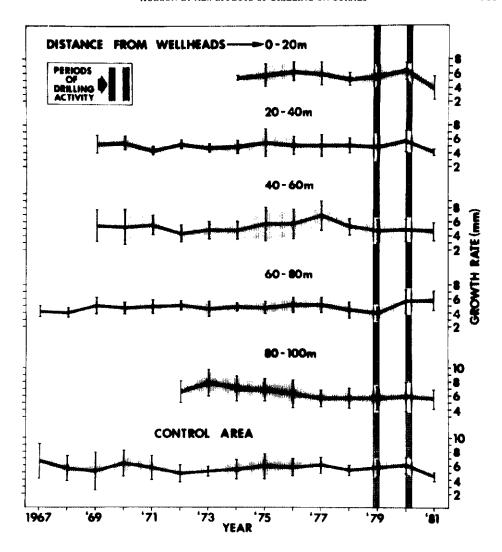
Figure 8. Growth history graphs of *Porites lutea* from Matinloc and a control reef 1.25 km northwest of the study area. Shading indicates standard deviation at the 68% confidence level.

In spite of the greatly reduced numbers of corals in the immediate area of the wells, specimens of *P. lutea* suitable for coring were found within 10 m of the wellheads on all but the west transect. Here, no *P. lutea* of suitable sampling size were seen closer than 62 m to the point of drilling. To test possible differences in effects of drilling on *P. lutea* at various distances from the point of drilling, growth rates of those corals sampled within a radius of 20 m around the wellheads were averaged and compared with growth averages of those corals growing at progressively greater distances from the drilling site (Table 1, Fig. 8). Results are as follows.

A trend of declining growth is indicated during a 2-year pre-drilling period (January 1977 to January 1979) in all but the most distant of Matinloc corals (80–100 m; Fig. 8). After drilling was initiated (November 1979), a resurgence, then decline, in growth is indicated in those corals from 0 to 40 m from the wellheads (Fig. 8). Growth rates of corals beyond this distance underwent a similar but reduced growth increase following drilling of Well No. 1 but showed little or no decline after the drilling of Well No. 2 (Fig. 8). Growth-rate averages for *P. lutea*

from a control reef 1.25 km northwest of the study site indicated a periodicity of waxing and waning growth comparable to growth-rate oscillations seen in growth averages of Matinloc corals at 0-20 and 20-40 m from the wellheads (Fig. 8).

Because of the considerable variation in growth rates (standard deviation bars shown in Fig. 8), growth records of individual corals at all sampling sites were also plotted (Fig. 9). These data clearly indicate that most Matinloc and Matinloc control *P. lutea* have a long history of widely fluctuating growth rates and that with few exceptions, reductions in growth during drilling were equalled or surpassed by growth declines in pre-drilling years.

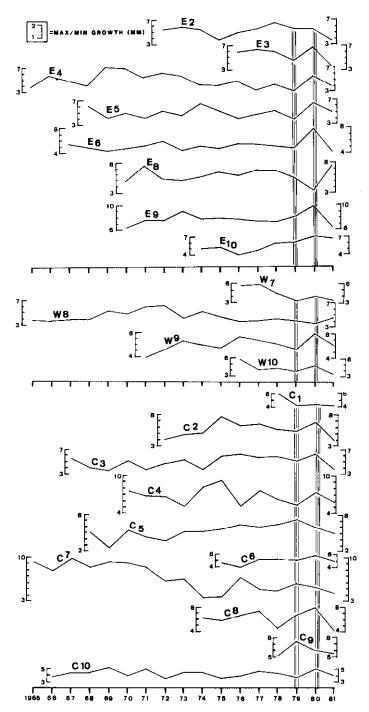
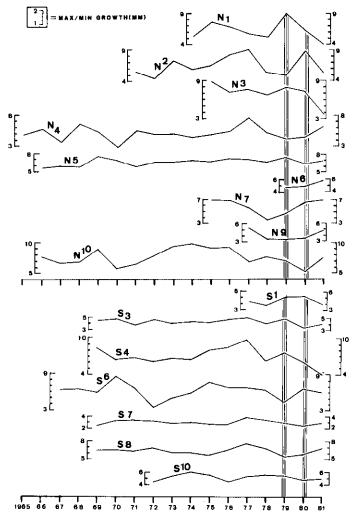
Figure 9. Growth history graphs of individual *Porites lutea* from Matinloc and a control reef. Letter/number code on graphs indicates Matinloc transects (N, S, E, W) and control reef (c). Vertical bars at years 1979–1980 indicate periods of drilling.

Figure 9 continued. See caption facing page.
