Large-Scale Ice Fracture Experiments Phase 2

Field Program Report
April 17 - May 8, 1993

February, 1994

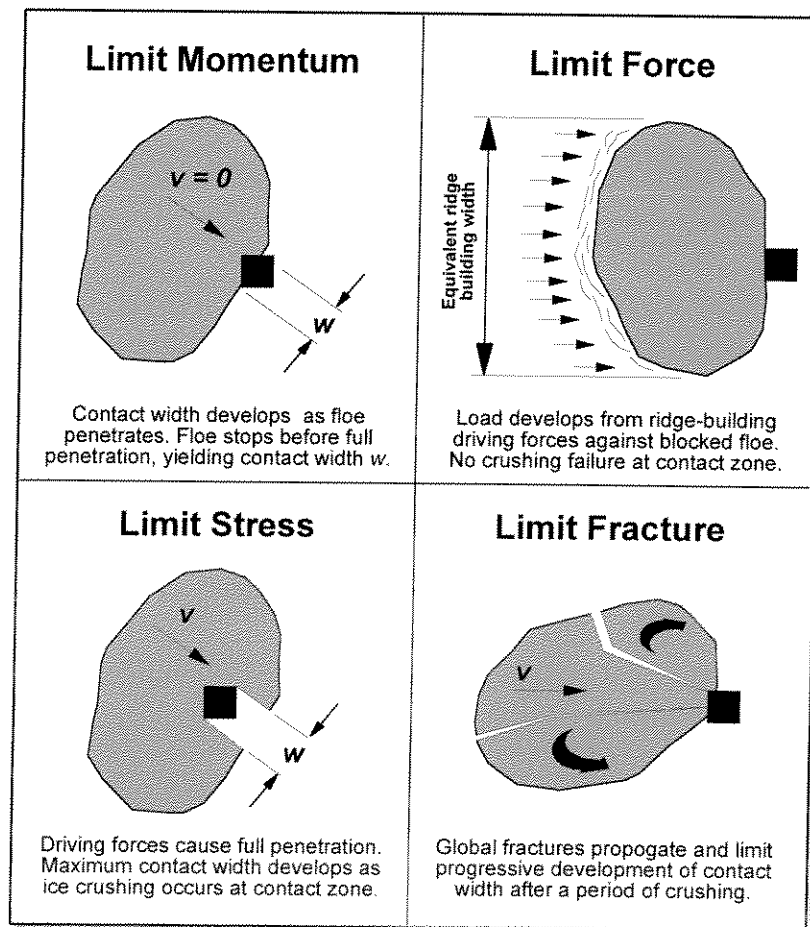
Fig. 1
Global ice load
limiting scenarios

To date, methods to estimate global ice loads on arctic structures generally assume that crushing is the primary ice failure mode. Field observations indicate that crushing occurs perhaps only 10% of the time, whereas global cracking and splitting of ice floes (at significantly lower loads) is much more frequent. Global splitting has been proposed as a fourth ice load limiting scenario (Blanchet, 1990), joining limit momentum, limit force and limit stress (Fig. 1). This has implications in the design of arctic offshore production structures against multi-year ice. By incorporating the statistics of full-scale splitting of ice floes, a reduction in probabilistic global design ice forces could be realized.

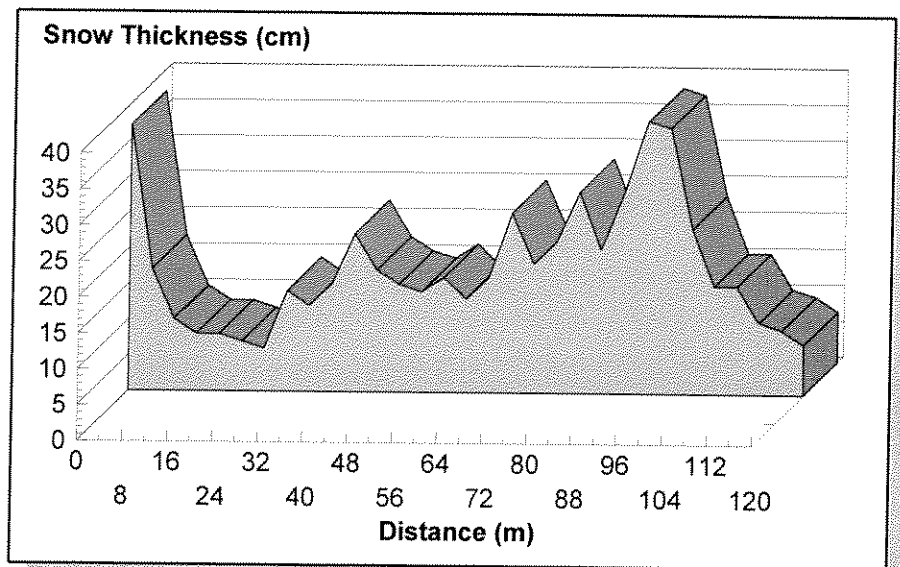
Fig. 6
Snow thickness,
Allen Bay

A hardpacked snow cover was present on the ice at Allen Bay. A region representative of the snow conditions in the test area was selected and a series of thickness and snow/ice interface temperature measurements carried out. Snow thickness measurements were taken along a straight line at 4 m intervals over a total survey length of 120 m. As shown in Fig. 6, the snow cover was undulating, producing the rippled effect typical of the Arctic, and varied in thickness from 5 or 6 cm to almost 40 cm. Spot measurements of the snow/ice interface temperature are presented in Fig. 7.

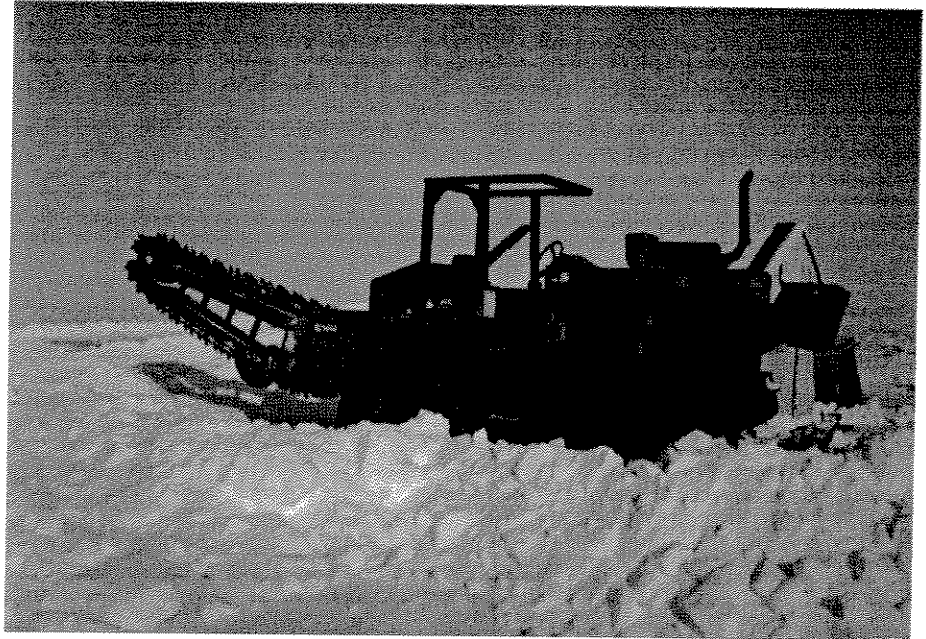
Fig. 8
R-100 DitchWitch
used for Phase 2

A second, smaller DitchWitch was also required for Phase 2. This machine was provided by the National Research Council Canada and was already in Resolute, as it was used on the 1989 and 1990 Hobson's Choice Ice Island indentation experiments. The unit was fitted with a 2.5 m long chainsaw blade and was used to cut the 0.5 m x 0.5 m specimens and the pre-crack in all specimens (see Fig. 9). This lightweight unit was ideal and cut a straight, vertical slot of width 1.6 cm. Refreezing of this slot was of concern so the slot was manually cleared of slush and occasionally flushed. Since the length of the pre-crack was 0.3 of the plate width, clearing this slot of slush was difficult for the 30 m and 80 m specimens.

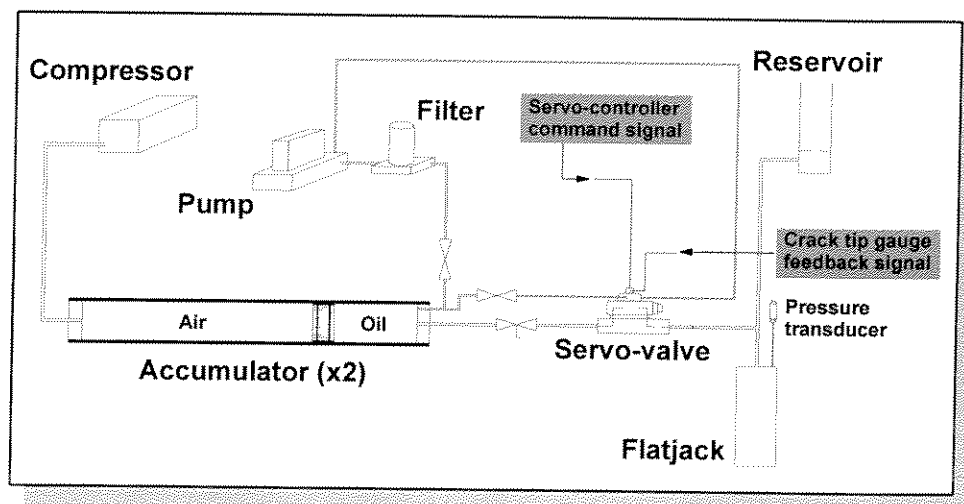
Fig. 17
Servo-controlled
loading system

The servo-controlled loading system is illustrated in Fig. 17. An air-over-oil accumulator was used to provide power to the servo-valve and was pressurized using a high pressure air compressor. Oil was then pumped into the other side of the accumulator. Oil chosen for the tests was a biodegradable vegetable based oil, so if a spill had occurred (which it did not), there would be minimal environmental impact. Filters capable of filtering to 3 microns absolute were used to ensure that dirt fragments did not interfere with the operation of the servo-valve.

A Moog Model DO79B-211 servo-valve was employed, capable of flows up to 900 litres per minute at pressures up to 35 MPa. This valve was provided free of charge to the project by Memorial University of Newfoundland.

At the outlet of the Moog valve, an orifice plate was mounted in the oil line which caused a drop in pressure and restricted the oil flow. Pressure supplied to the flatjack was at a maximum of around 1.4 MPa and flow rate was kept to an allowable range. The line then split into two, one line going to the flatjack and the second to a storage tank. The line to storage was sized to give the appropriate back-pressure at the flatjack.
