**NIPTERK P-32 SPRAY ICE ISLAND**

**ABLATION PROTECTION EXPERIMENT**

**ERCLRS.89.24**

**DECEMBER 1989**

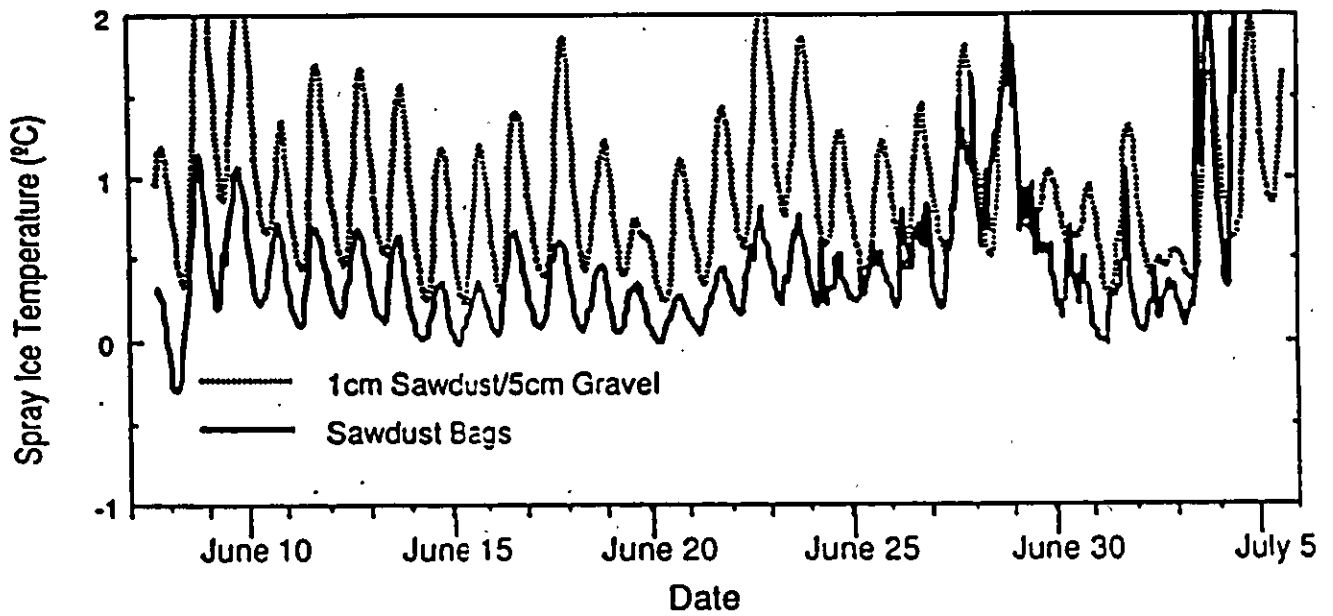
Figure 25. Spray Ice Temperatures Beneath Selected Ablation Plots

Comparisons of spray ice temperatures measured beneath the sawdust ablation subplots are indicated by the temperature - time series plots shown in Figure 25 . Again, both the spray ice and air temperatures were averaged on a daily basis. Like the gravel ablation plots, there was a strong correlation between spray ice temperature and ablation, i.e. the thicker the sawdust layer, the lower the spray ice temperature, and the less ablation observed. One anomaly was noted in the spray ice temperature data beneath the sawdust bags at the end of June. Neither air temperatures, solar radiation, nor wind speed data can adequately account for the rise in spray ice temperature observed beneath the sawdust bags. On the other hand, spray ice temperature increases documented in July for each of the sawdust subplots appeared to be attributable to warm air temperatures.

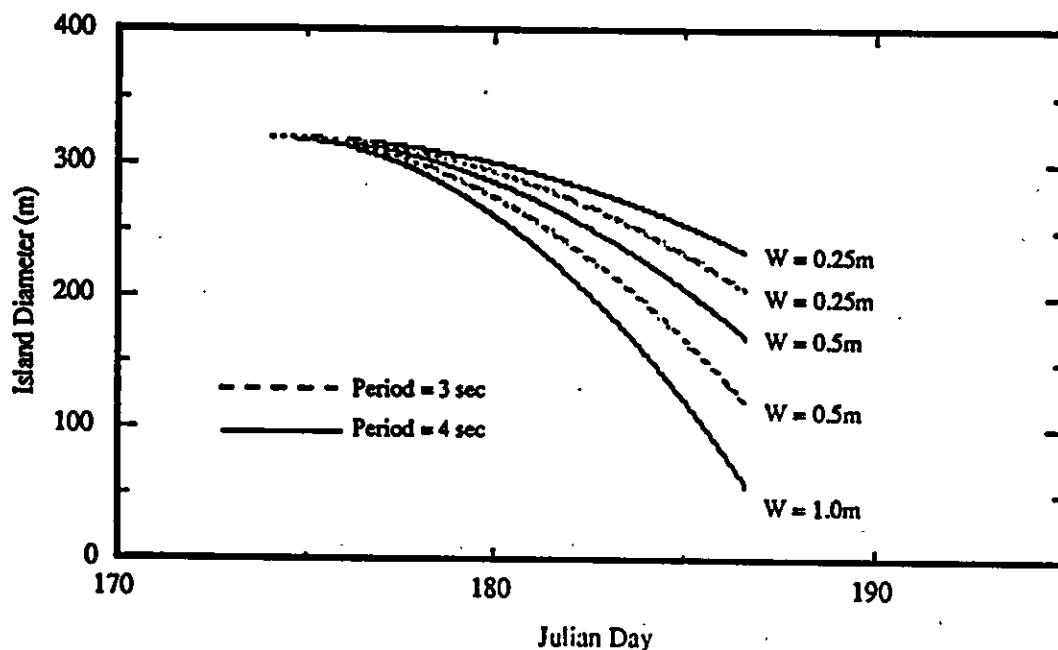
Figure 34. Results of the use of different wave parameters in the perimeter erosion model.

As can be expected, the higher wave heights and shorter periods cause the greatest amount of erosion. The closest fit to the data is achieved with an average wave height of 0.5m and a period of 4 seconds.
