JIP - STRENGTHENING, MODIFICATION AND REPAIR TECHNIQUES FOR OFFSHORE PLATFORMS

DEMONSTRATION TRIALS OF DIVERLESS STRENGTHENING AND REPAIR TECHNIQUES

FINAL REPORT

DOC REF C15800R025 Rev 0 July 1997

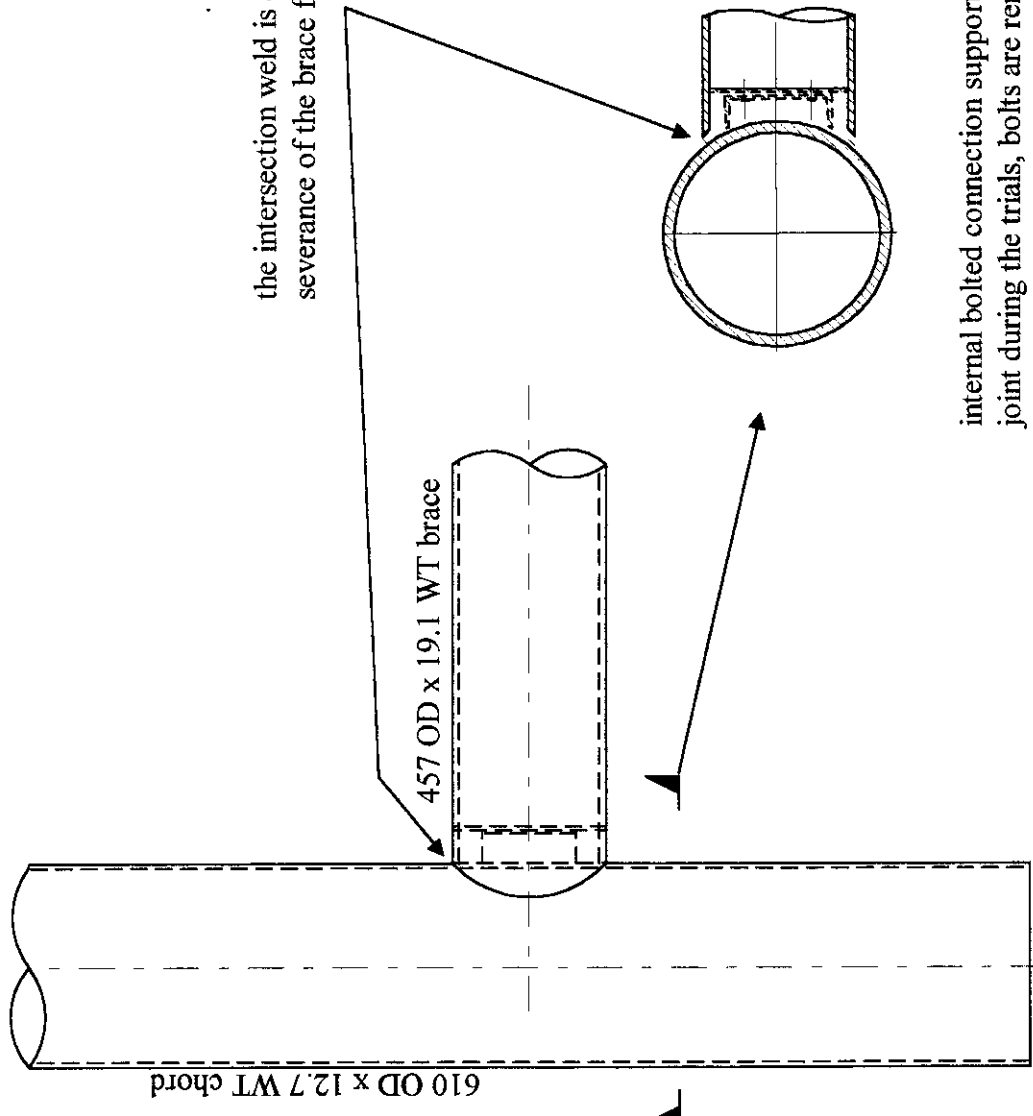
Figure 2.1: Repair of Tubular Joints

This scenario reflects a fatigue-induced crack on the chord side of the intersection weld between two tubular members (T-joints). It is assumed that the brace is severed from the chord, from the standpoint of clamp design.

The selected repair solution is a stressed grouted T-join clamp. The repair is designed to transmit the brace loads through the clamp and into the chord, bypassing the severed intersection. The strength of the clamp is derived from the studbolt pre-load which applies normal forces at the interface with the tubular member. These forces generate friction at the interface to permit the brace loads to be transmitted into the clamp steelwork. The grouted annulus between the tubular members and the clamp saddle is required to provide sufficient tolerance to allow for lack-of-fit of the clamp around the damaged T joint.

(i) Repair of tubular joints (Figure 2.1)

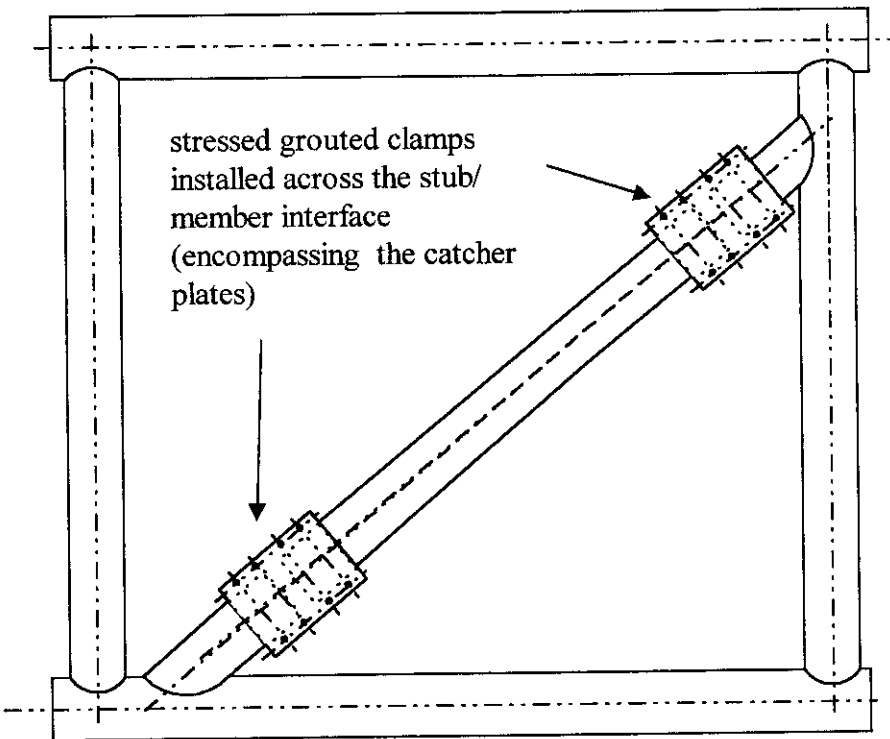
Figure 2.3: Replacement of an Existing Member

This scenario represents the replacement of a tubular member which has suffered damage. The tubular joints at each end of the damaged member are assumed to be intact.

It is assumed that the damaged section has been cut out, leaving stubs protruding from the joints. The replacement member is deployed between the stubs and temporarily held in position by simple curved catcher plates welded to, and overhanging, the ends of the member. The member is then clamped permanently to the stubs at each end. The clamps are designed to span across the connections to develop sufficient strength to transfer axial loads from the intact stubs to the replacement member. To accommodate potential misalignment between the stubs and the replacement member, stressed grouted clamps are specified. This type of clamp also permits sufficient annulus thickness to encompass the catcher plate, thereby allowing the plate to remain in-situ.

(iii) Replacement of existing member (Figure 2.3)

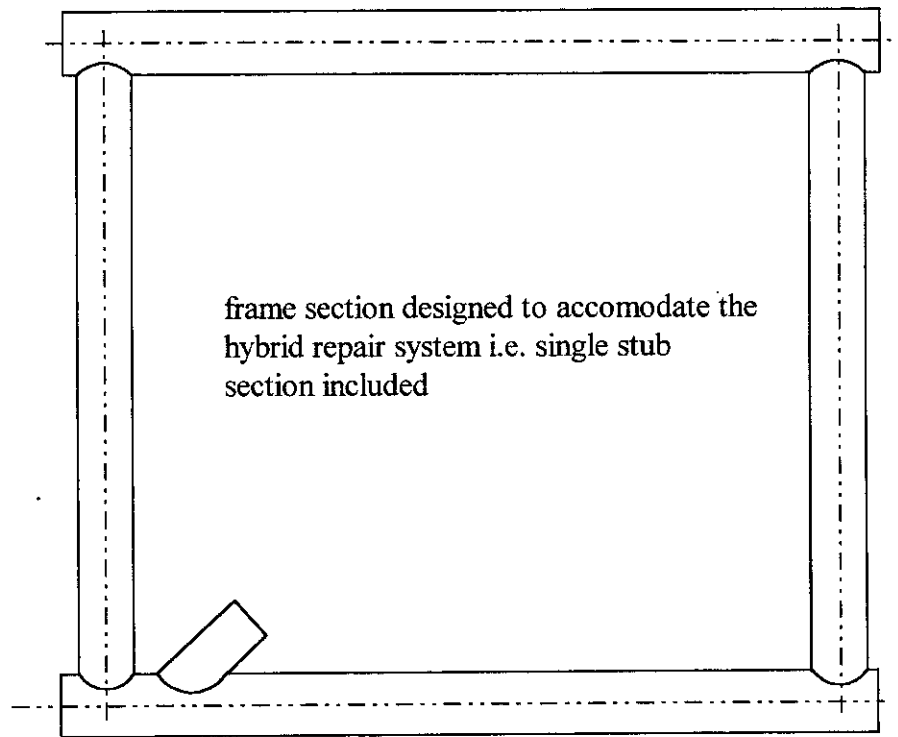
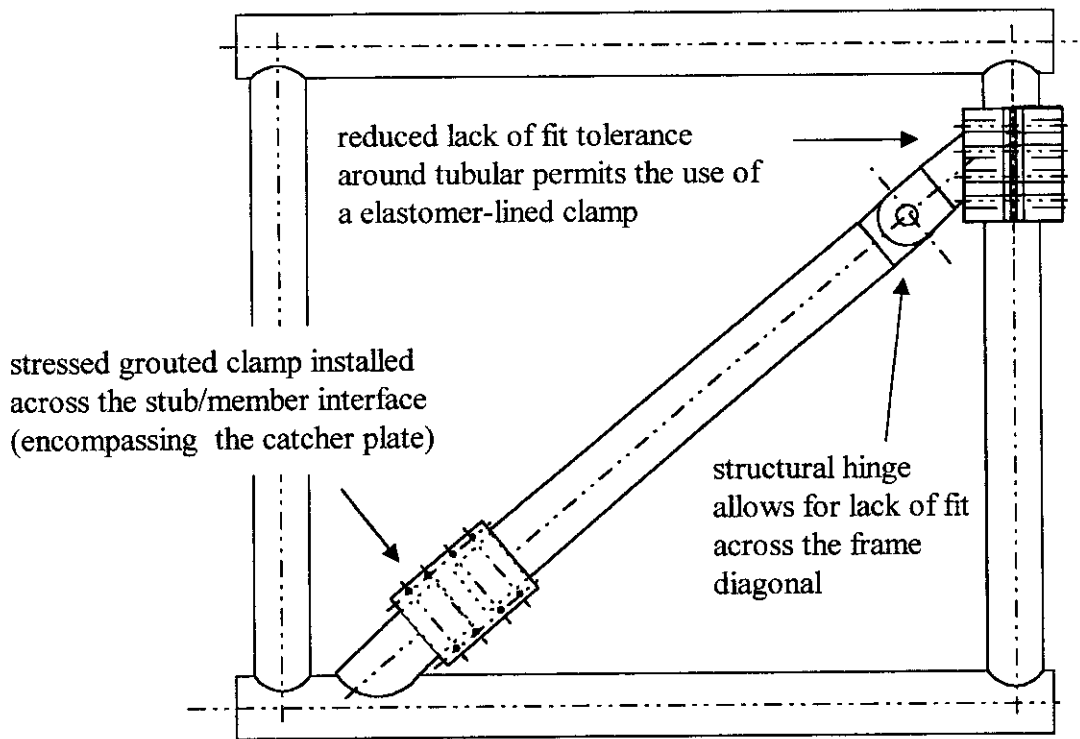
Figure 2.4: Hybrid Member Addition/Replacement

During the course of the review leading to the above selections, it became clear that two separate clamp systems were required for the tubular joint repair, one designed to permit WROV implementation and the other for ADS implementation. Further, it also became clear that, within the context of this JIP, the addition of a new member and replacement of an existing one can be combined into a single set of trials through adoption of a hybrid of the two schemes without compromising the objectives. A hybrid scheme was therefore adopted, as illustrated in Figure 2.4.

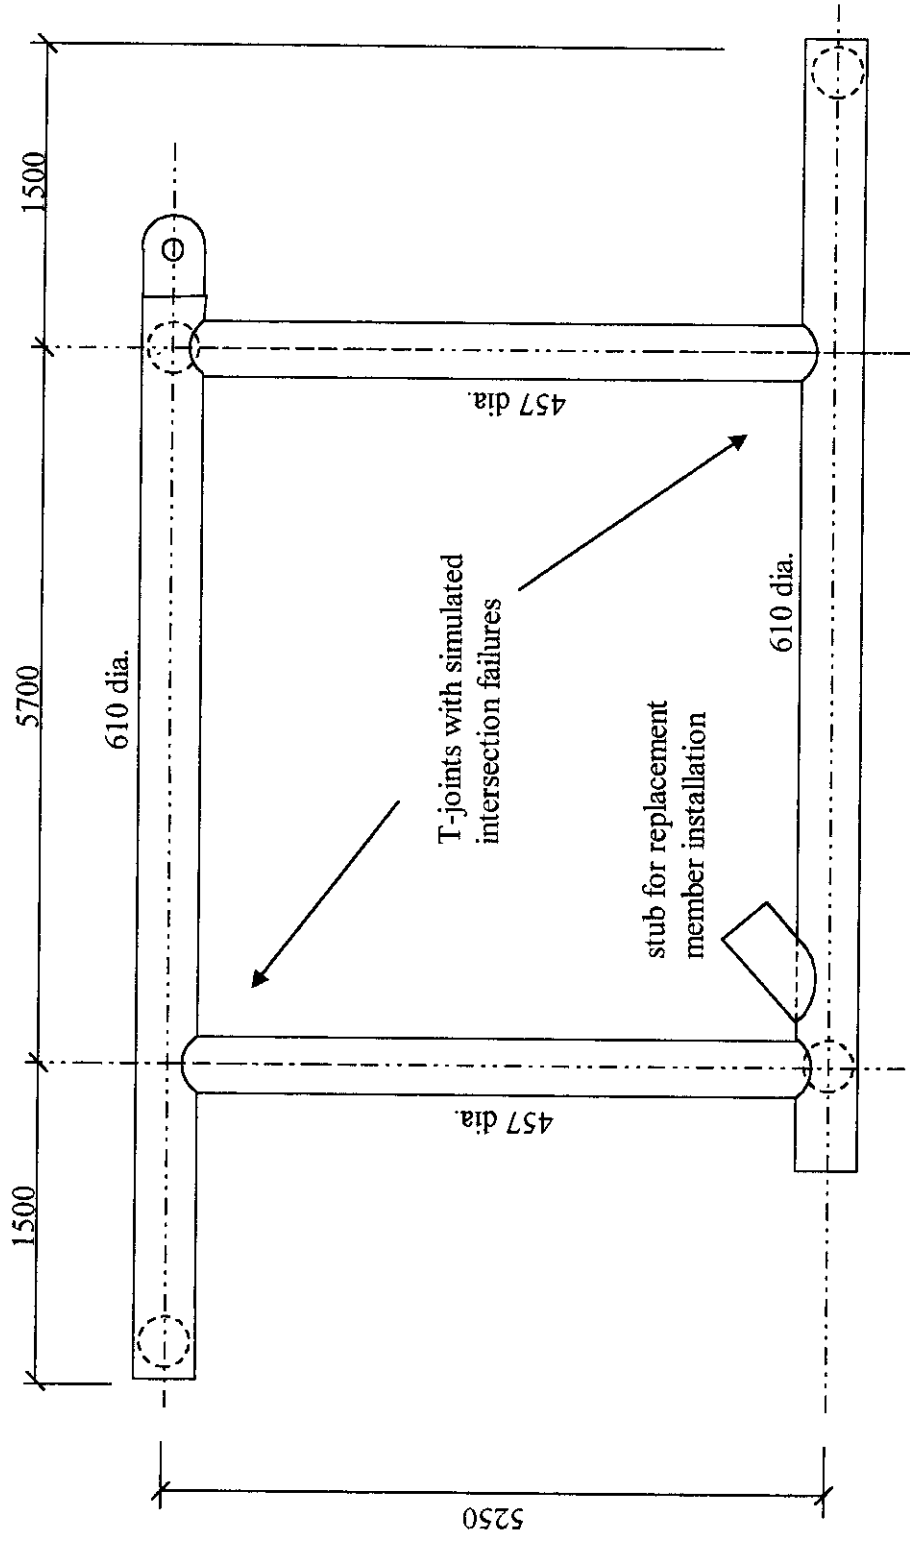
Figure 4.1: Plan View Showing Test Frame Configuration

The test frame was designed to represent a partial plan of a typical steel jacket structure. Figures 4.1 and 4.2 illustrate the test frame in the unrepaired and fully repaired conditions, respectively. The frame consisted of two 610mm diameter (ϕ) chord members at 5.25m centres. Brace members of 457mm ϕ connected the chord members to form four T-joints in the resulting frame. The intersection of the tubulars at two of the T-joints were detailed to have no weld connection between the brace and the chord. Instead, the chord and brace members at each of these T-joints were connected via an internal bolted detail. Once the repair clamp was installed the bolts were removed. Access was provided for removal of the bolts via a cut-out in the wall of the chord member. The two T-joints were geometrically identical to allow each to be repaired with a structurally identical clamp to facilitate direct comparison of the WROV and ADS systems.

A stub (406mm ϕ by 610mm long) protruded, at an angle of 40^o, from one of the chord members. The stub section and the adjacent joint were designed to represent the intact section of a damaged member (which is simulated to have been cut and removed from the frame) to permit the installation of a new member consistent with the objectives of the replacement member repair scenario. The replacement member incorporated a catcher plate at one end, for alignment with the stub. On the joint, diagonally opposite, no stub was provided. Here, the replacement member had an elastomer-lined clamp connected via a structural hinge. The clamp was designed to be installed into the frame diagonally opposite the stub, consistent with the objectives of the additional member installation.

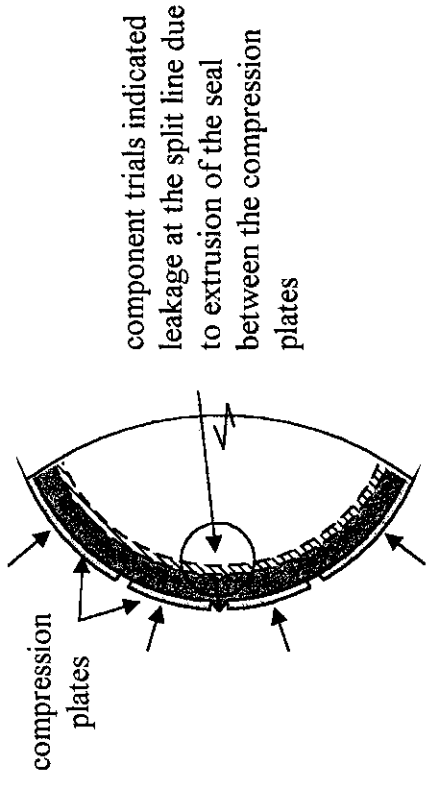
Detail 2

component trials indicated leakage at the split line due to extrusion of the seal to extrusion of the seal between the compression plates

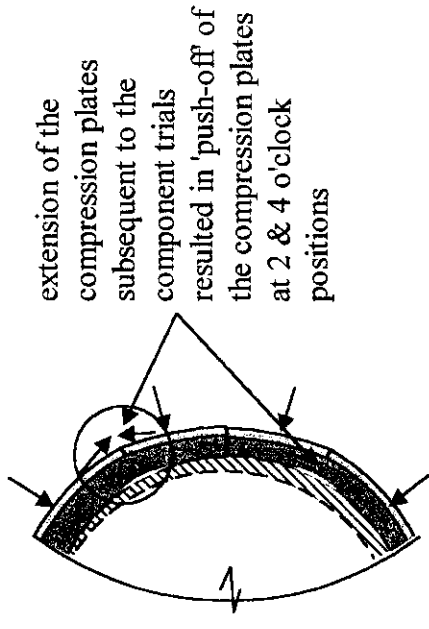
Detail 3

extension of the compression plates subsequent to the component trials resulted in 'push-off' of the compression plates at 2 & 4 o'clock positions

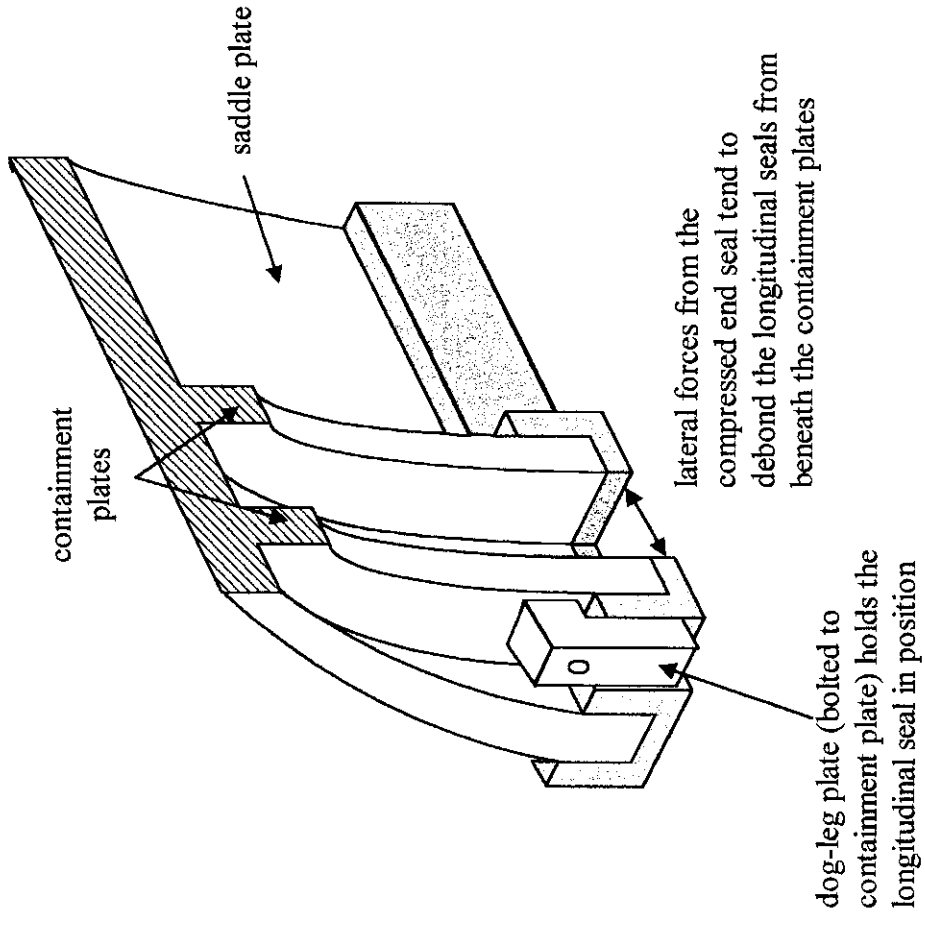
Detail 1

Figure 6.7: Clamp Split Line Sealing Details

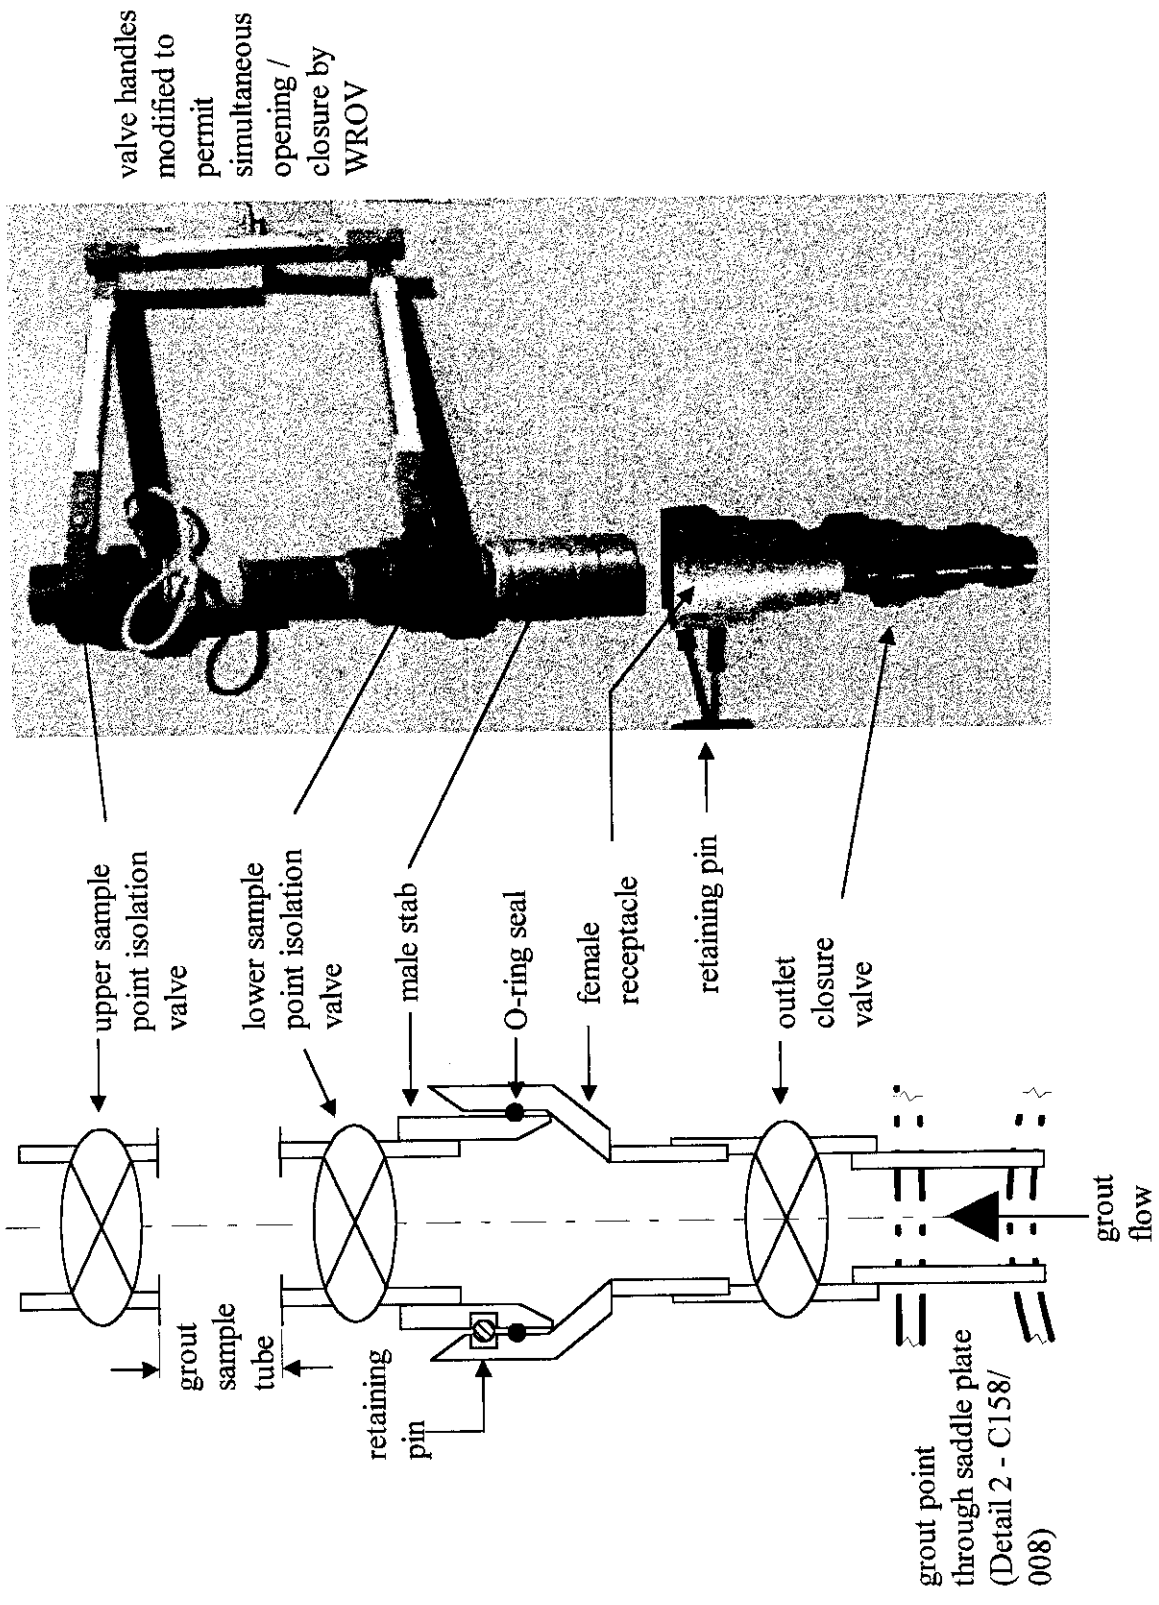
valve handles modified to permit simultaneous opening / closure by WROV

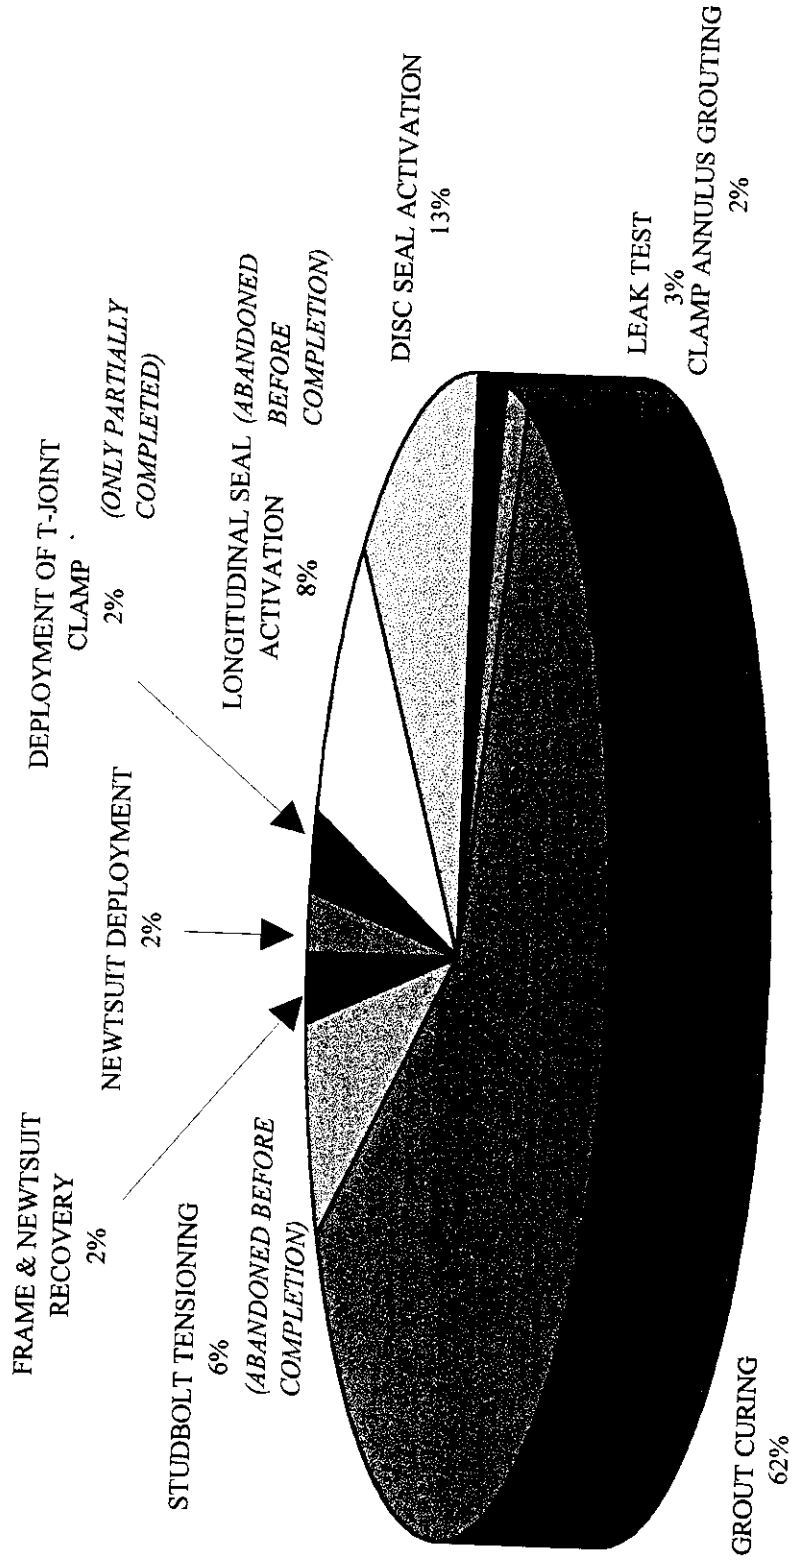
Note: With the exception of the grout curing which includes non-working hours other activity durations are based upon operational times i.e. working hours, but include non-productive time due to system or equipment failure.

OVERALL DURATION 48:49 (hrs:mins)

Figure 8.1: Demonstration Trial of NEWTSUIT ADS T-Joint Clamp Installation

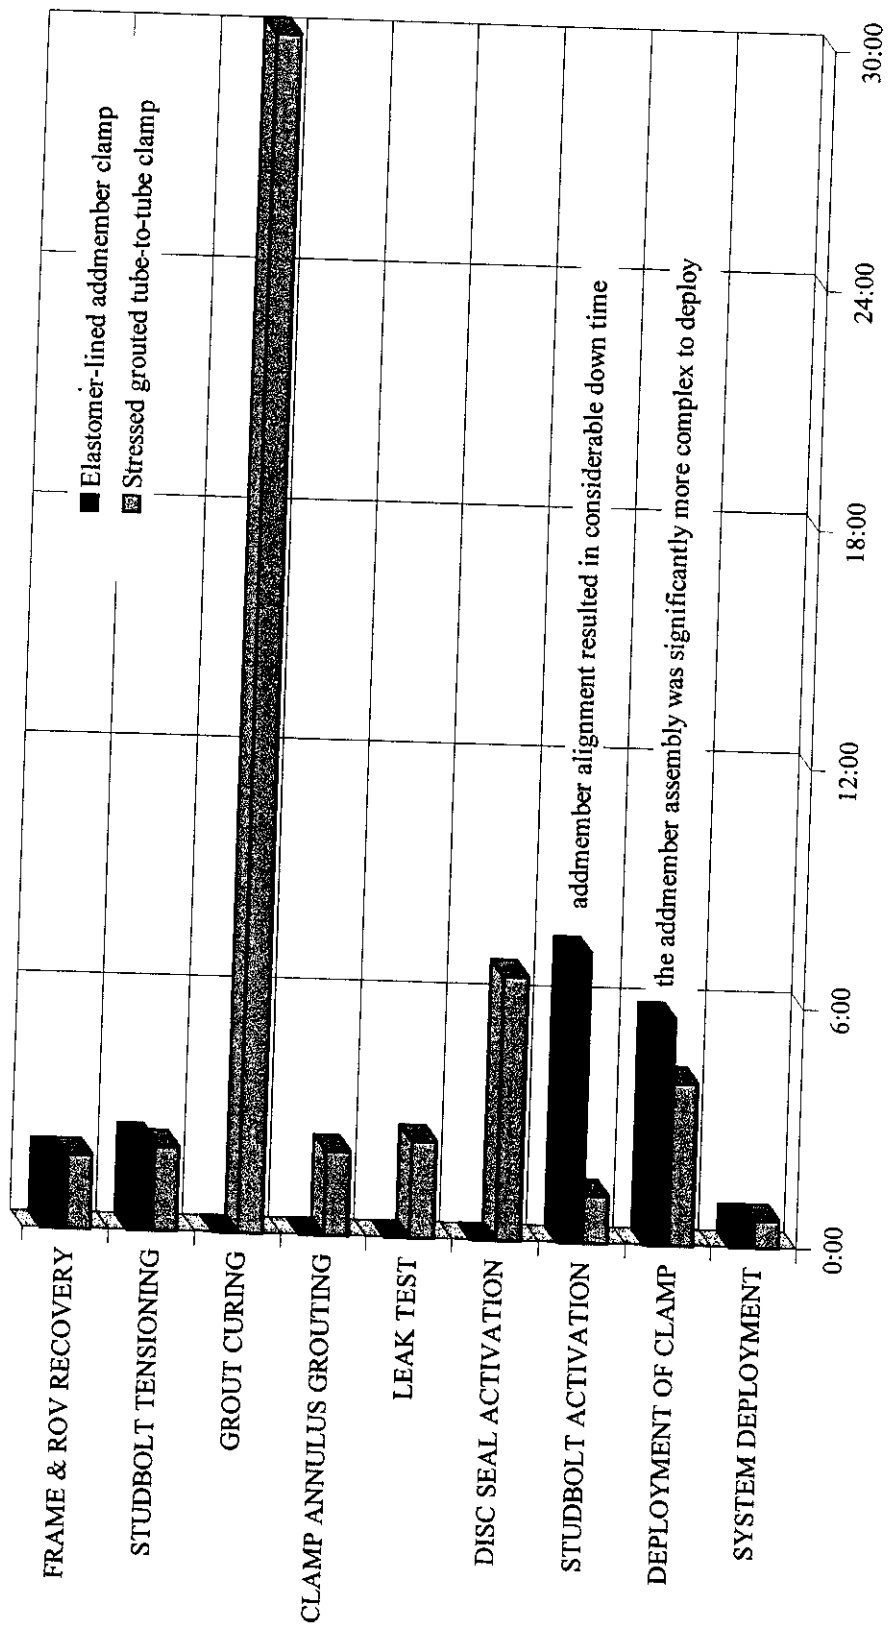
Elastomer clamp overall duration: **17:50** (hrs:mins)
 Grouted clamp overall duration: **50:54** (hrs:mins)

Figure 8.6: Grouted Clamp versus Elastomer-Lined Clamp Installation

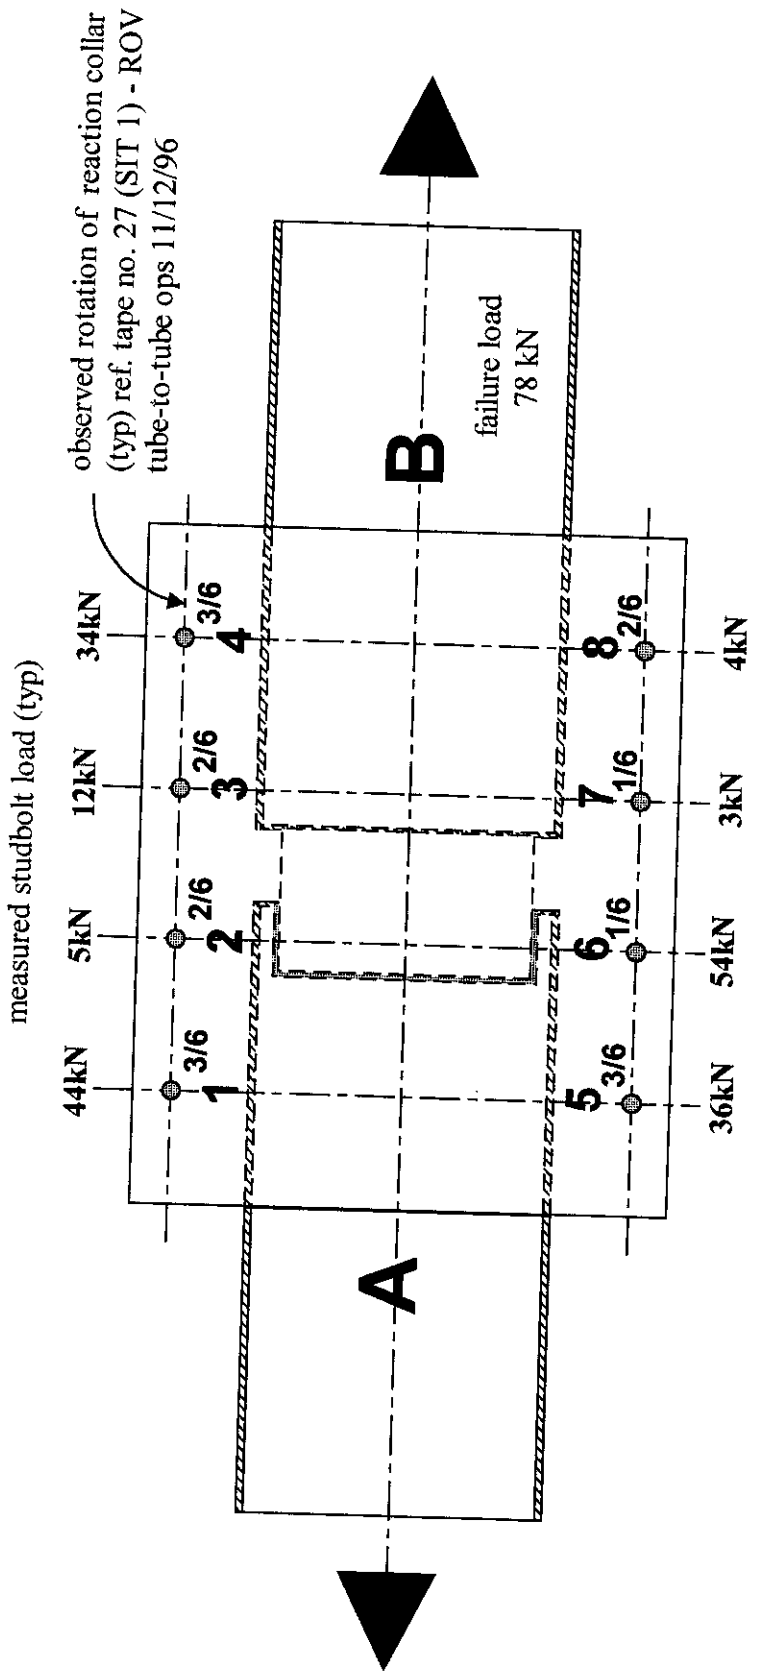
studbolt loads:
 overall = 24.0 kN
 end A = 34.75 kN
 end B = 13.25 kN

note: target tension = 155 kN per bolt (62% of yield)

Figure 9.7: Tube-to-Tube Clamp - Studbolt Tensioning

The exception relates to the tube-to-tube stressed grouted clamp for the new brace member. It was discovered during the post-trial experimental tests that the pre-load was not introduced into the studbolts. Extensive forensic examination revealed that the most likely cause was the hydraulic pump applying pressure against a blockage or clamp manifold due to an incomplete connection during stabbing of the hydraulic line.

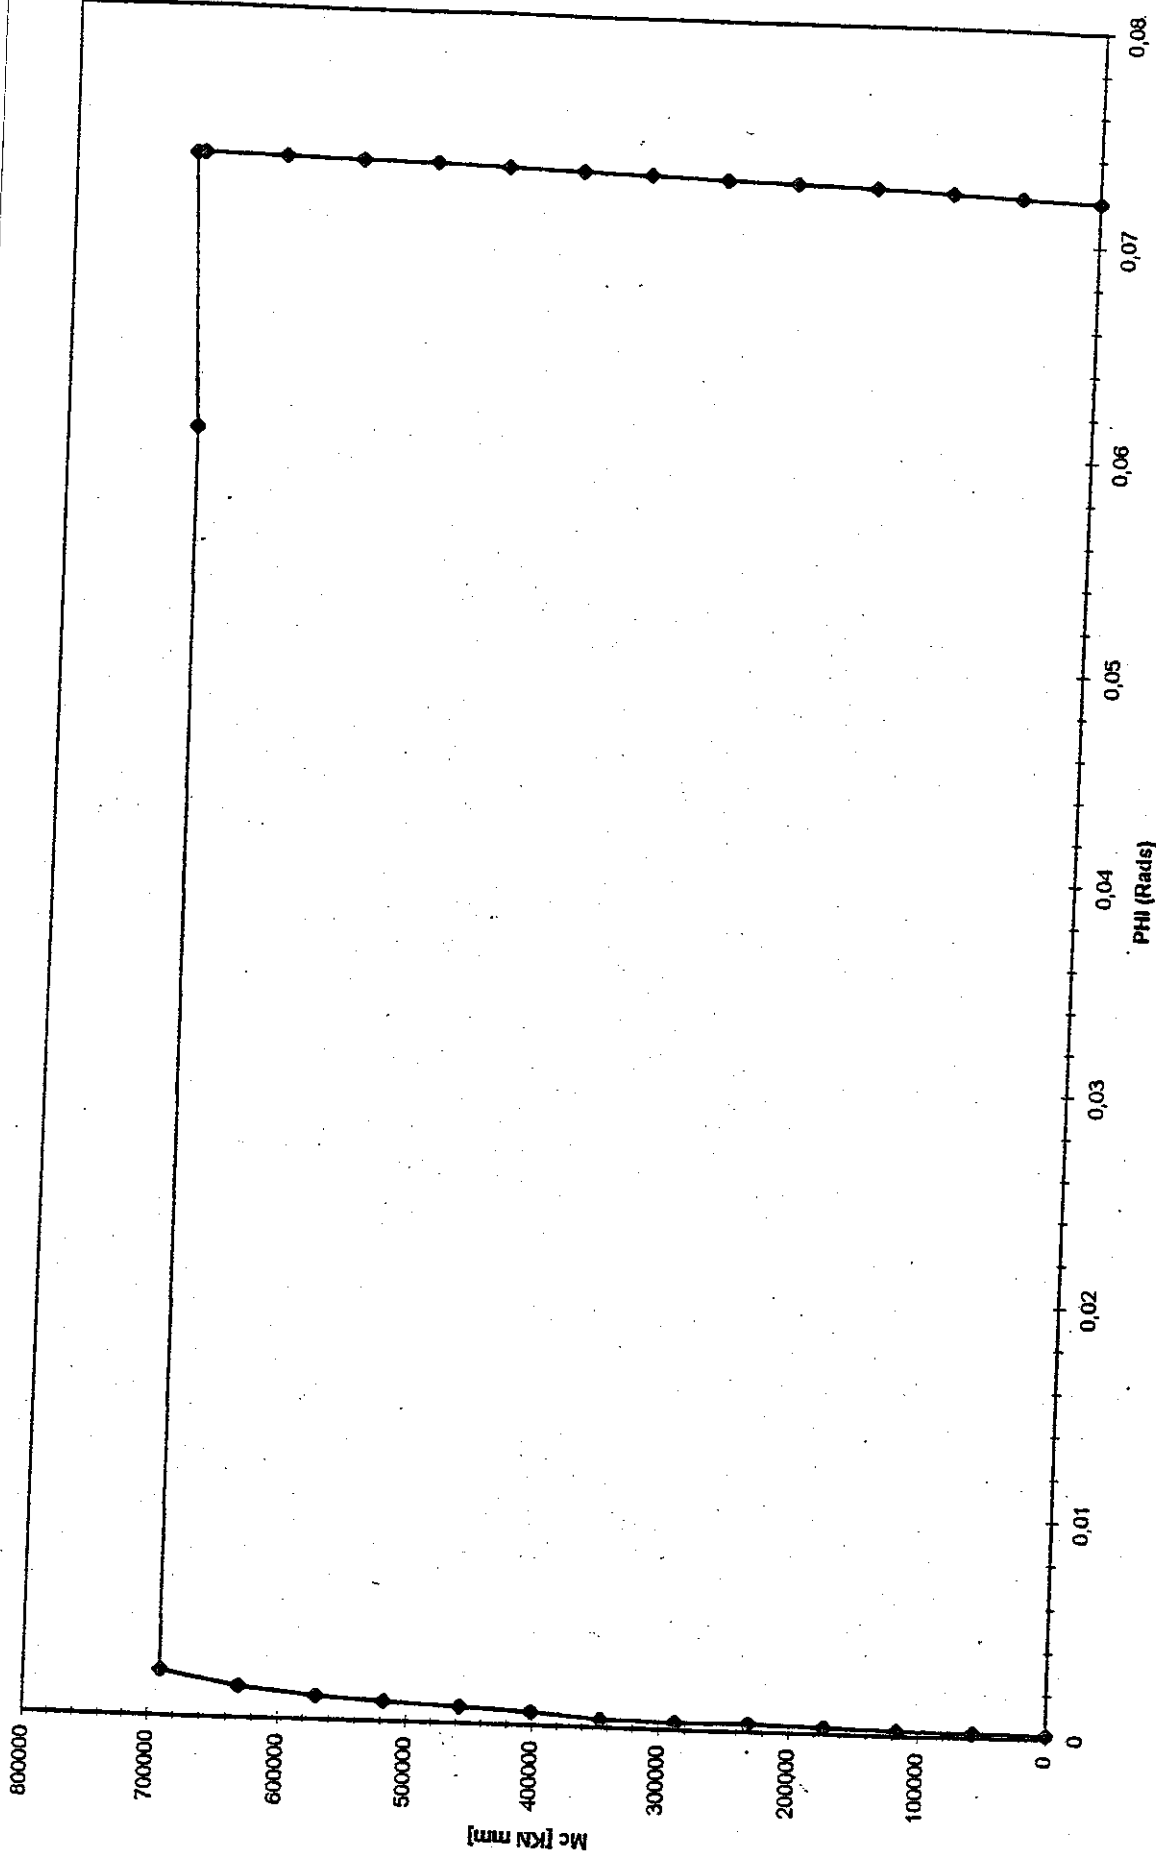
Figure 9.20: Torsional Moment versus Rotational Slip between Clamp and Chord Member
(Average Readings from Displacement Gauges W3, W4, W7, W8)

The eventual form of failure consisted of the clamp undergoing torsional slippage about the chord member. The torsional moment/rotational slip behaviour is illustrated in Figure 9.20. To give a handle on the magnitude of the slip, a rotation of 0.01 radians corresponds to a circumferential slip of about 3mm. The mode of slippage, as may be expected, is very ductile in nature.
