**Safety and Integrity of
Arctic Marine Pipelines**

**Progress Report #3
Centrifuge Test PR3d-2 Report**

**C-CORE
St. John's, Newfoundland**

C-CORE Publication: 98-C9

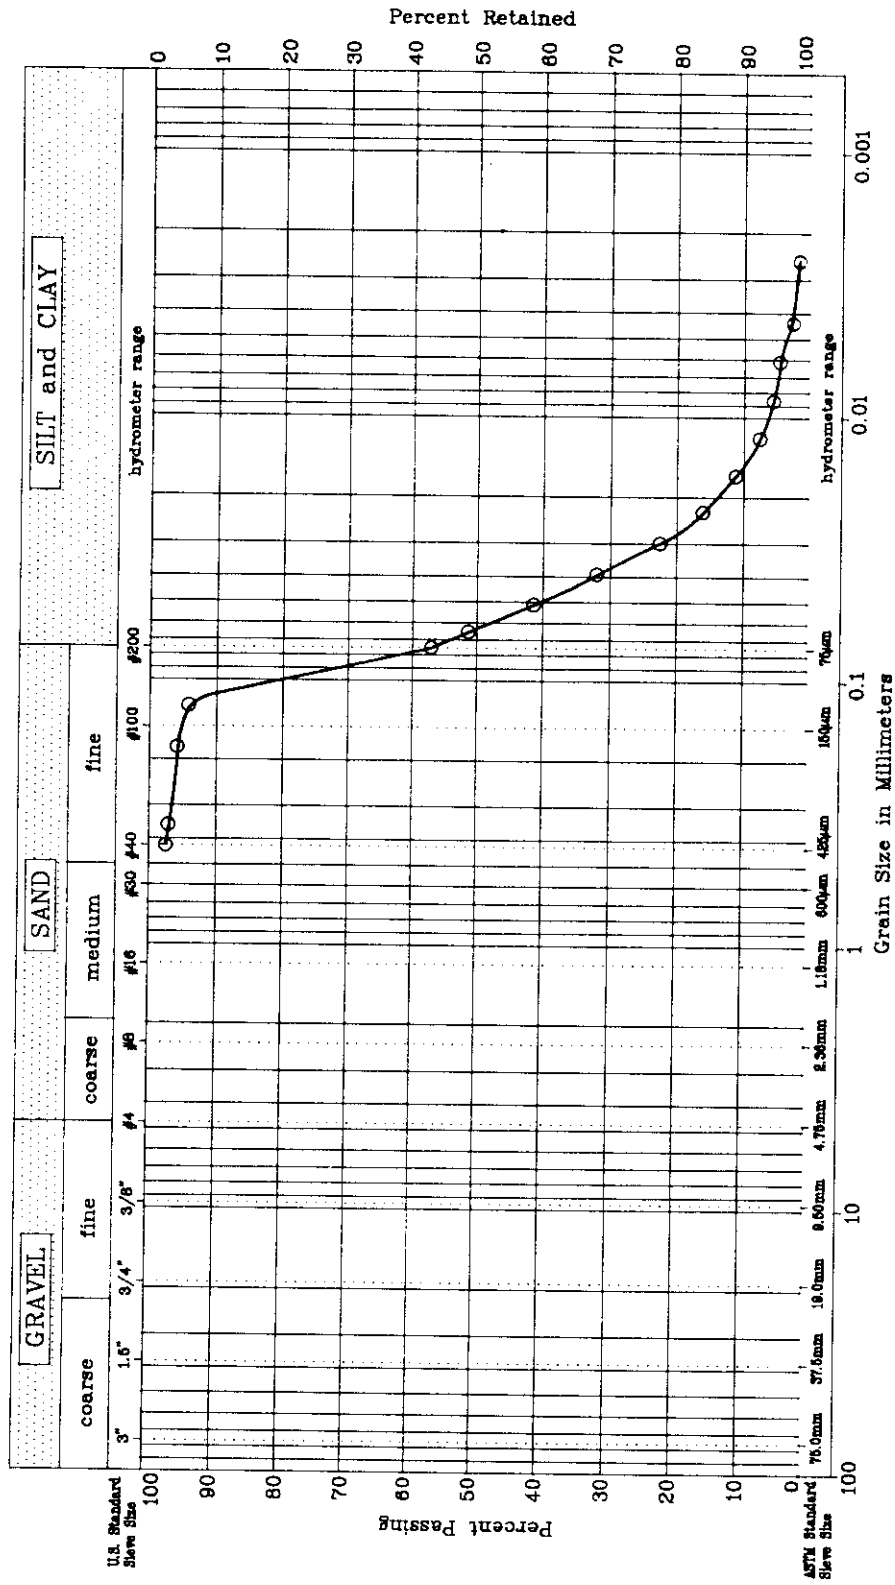
1

GRAIN SIZE DISTRIBUTION

Sample Description: Capital Silt

$D_{10} = 0.015\text{mm}$ $D_{30} = 0.037\text{mm}$ $D_{60} = 0.078\text{mm}$ $C_U = 5.2$ $C_C = 1.17$

Model preparation began Monday, April 13/1998. The model seabed was prepared from Capital Silt with the properties listed in Table 1. A grain size curve is shown in Figure 1.

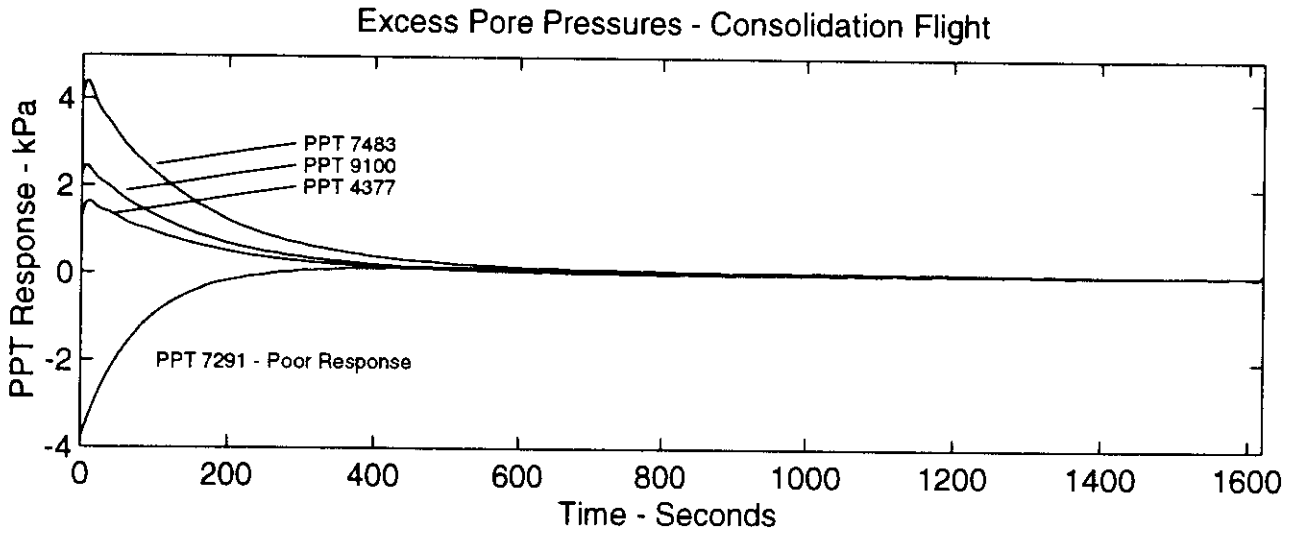
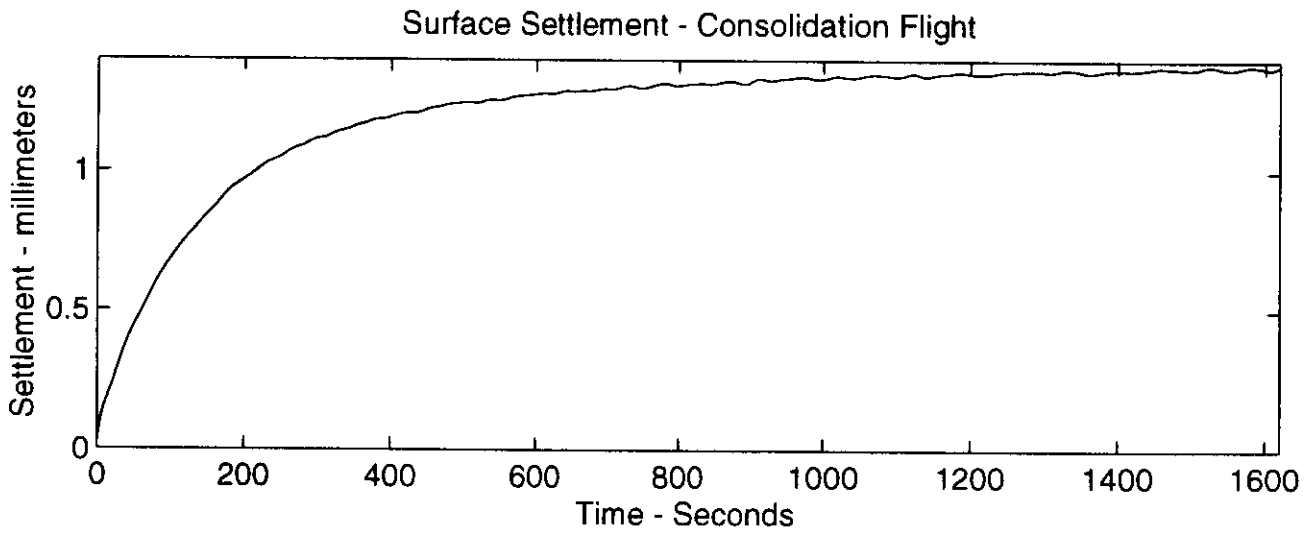
**FIGURE
3**

**Excess Pore Pressures and Settlement
During Consolidation Flight**

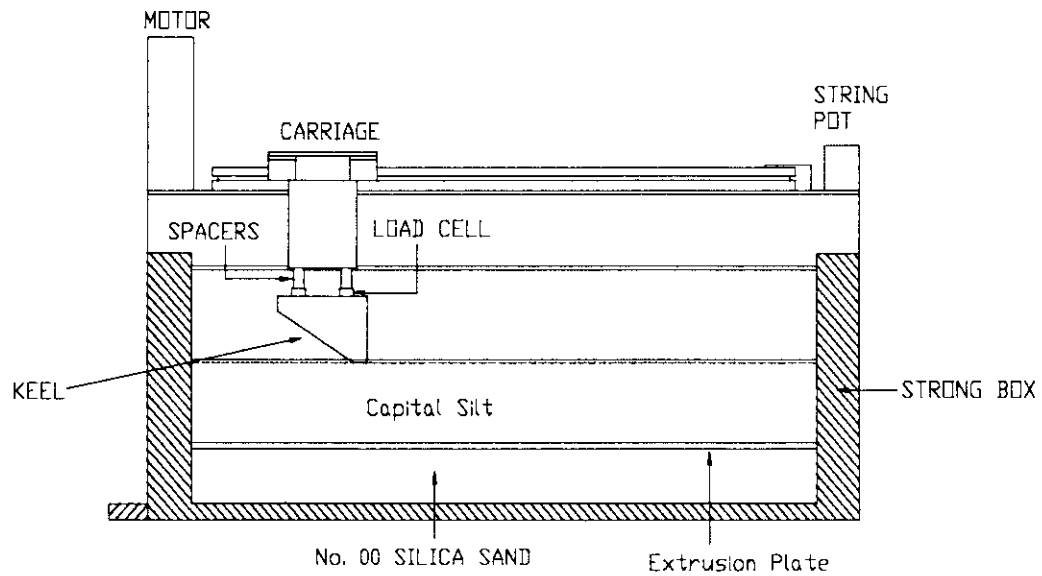
PRISE TEST PACKAGE CROSS-SECTION

Layout of Assembled Package

A 292 mm thick layer of No. 00 silica sand was first placed in the strongbox to serve as a drainage layer. Once this layer was compacted and levelled, an extrusion plate was placed on top of it to allow removal of the sample for post-test examination. This extrusion plate was covered with a layer of geotextile and the marker grids were put into position prior to placement of the Capital Silt. The marker grids were constructed by glueing together a grid of spaghetti strands. A total of 16 vertical strands were spaced at 15 mm and short pieces of lead solder, 4 mm long, were glued to these strands at spacings of 15 mm. Horizontal spaghetti strands with a spacing of 30 mm were employed to complete the grid. The grid was mounted on a plastic base which was, in turn, taped to the geotextile layer. Figure 2 shows the placement of the grids during the addition of the Capital Silt. A total thickness of 133 mm of capital silt was dumped in the strongbox. The spaghetti strands softened once they were in contact with the wet silt and might be considered to have no impact on the behaviour of the silt during the scouring events. Pore pressure transducers were positioned in the Capitol Silt under the scour paths. The surface of the silt was levelled and the package was loaded on the centrifuge and spun under 10-g to consolidate. The excess pore pressures and the settlement of the silt during the consolidation stage are shown in Figure 3. Once this step was complete, the horizontal drive and the keel were positioned for the scour. The layout of the assembled package is shown in Figure 4.

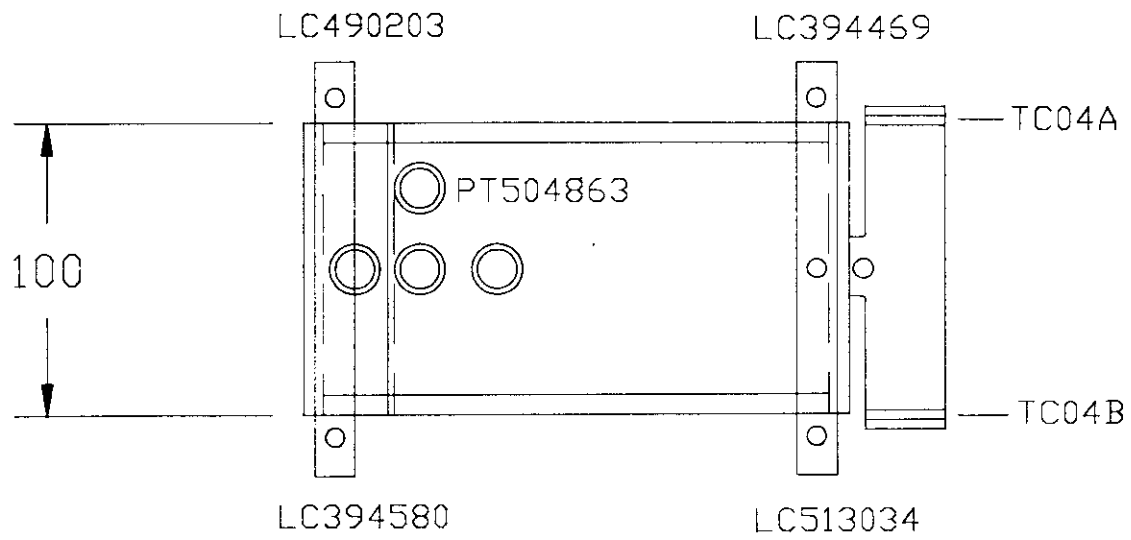
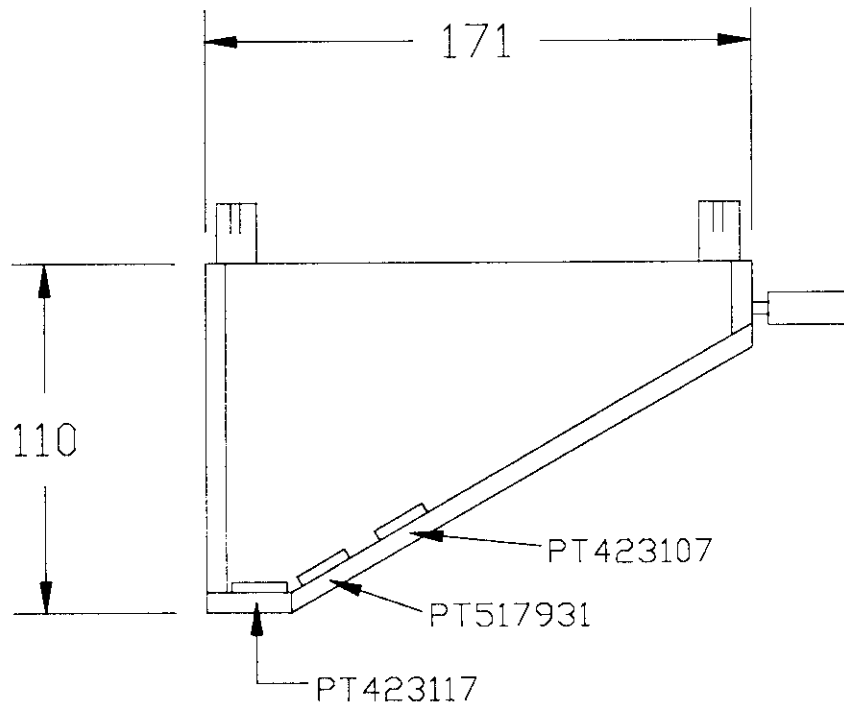
PLAN

PROFILE

Location of Transducers
on Model Keel

Table 2 provides a summary of the instrumentation used in centrifuge test PR3d-2. In total, 16 active transducers were employed, including instrumentation used to measure the vertical and horizontal loads acting on the keel, contact pressures acting on the model keel, keel displacement, and excess pore pressures generated during the scour events. Figure 5 shows the locations of the transducers which were attached to the model keel.

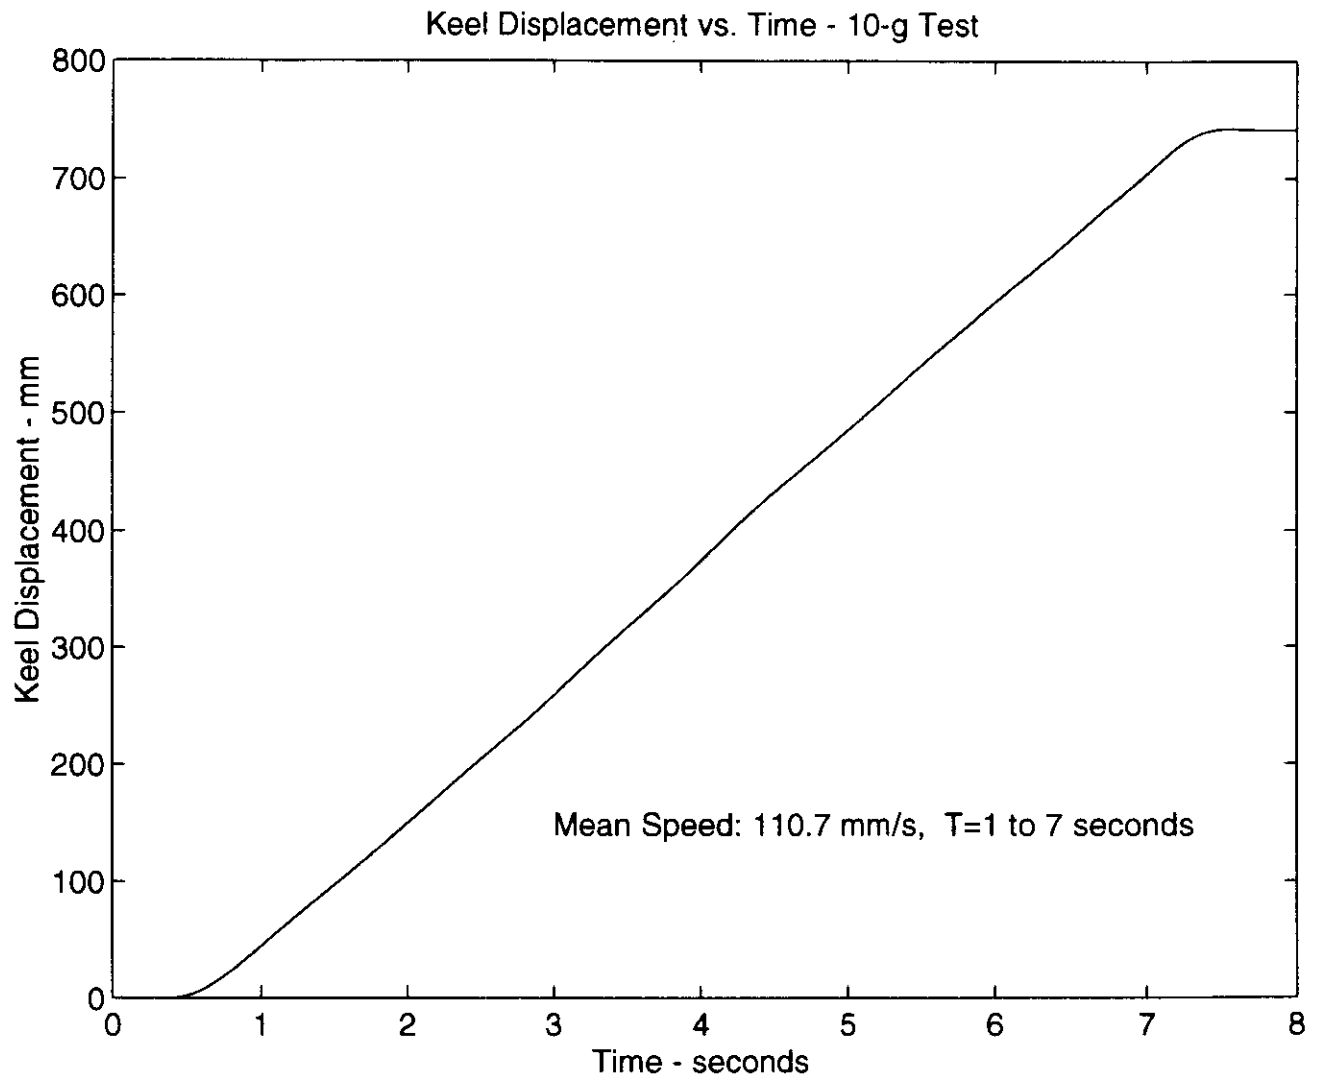
**FIGURE
6**

**Keel Displacement During
10-g Scour Event**

Figure 6 shows the keel displacement plotted versus time during the 10-g scouring event, as determined from measurements of the string potentiometer (SP02) which was attached to the carriage assembly. This data record was used to evaluate the horizontal position of the model keel in presentation of the results for each of the other transducers. The actual keel velocity or scour rate was 110.7 mm/s, equal to the slope of the displacement-time curve.

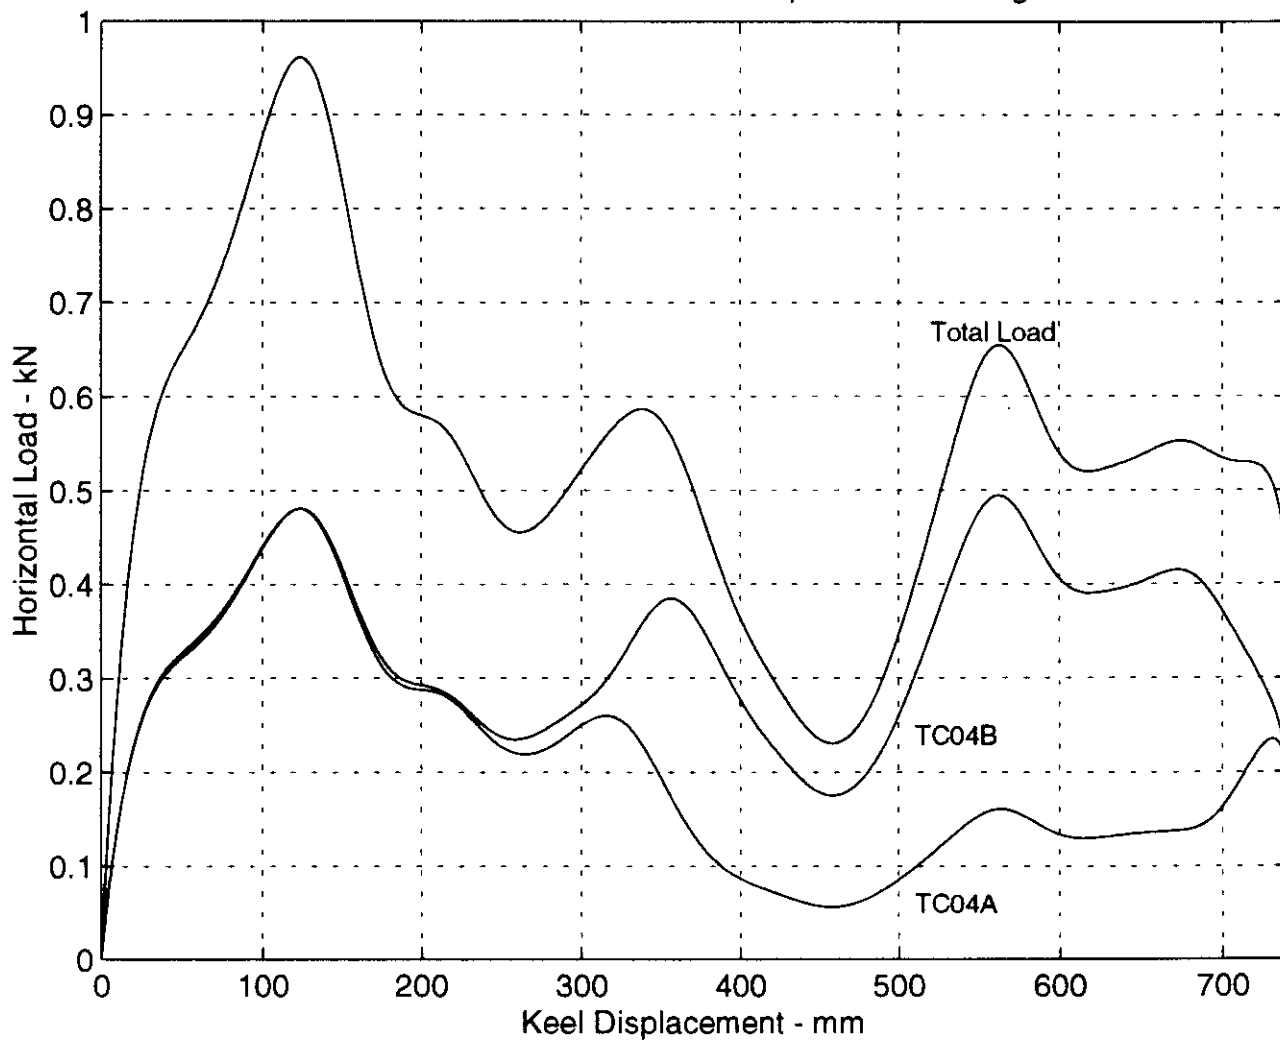
Model Horizontal Force vs. Keel Displacement - 10-g Test

Horizontal Forces During
10-g Scour Event

The total horizontal force was computed through summation of contributions from individual tension load cells (TC04A and TC04B) located at the connection between the drive system pulling cables and the model keel. Figure 7 shows the horizontal force for each tension cell and the total horizontal force plotted against keel displacement during the scour event. Steady state conditions were achieved after about 250 mm of keel displacement. The total average horizontal force imposed under steady state conditions was approximately 0.45 kN at model scale (or 45 kN at prototype scale). The oscillation in the forces after steady state is partly attributable to the unevenness of the mudline.

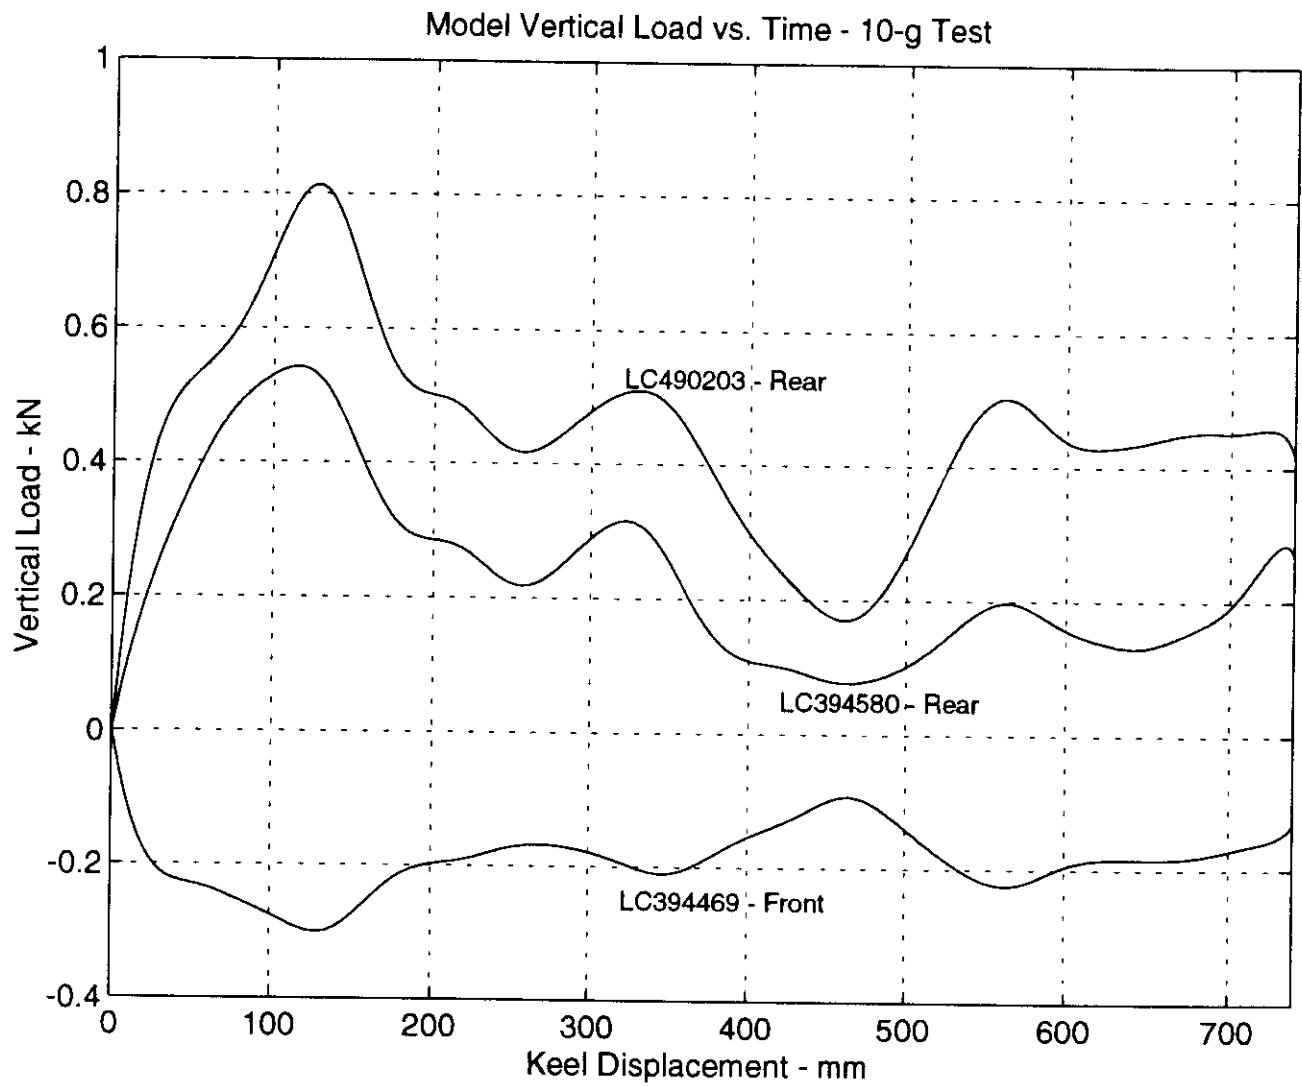
**FIGURE
8**

**Vertical Forces During
10-g Scour Event**

The total vertical force was evaluated through summation of the responses of the tension/compression load cells (LC394469, LC394580, and LC490203) which linked the model keel to the carriage assembly. Load cell LC513034 malfunctioned during this test and no data are available for plotting. Figure 8 shows the measured vertical force from the three functioning load cells, plotted against keel displacement during the scour event. It can be seen that the rear load cells are in compression while the front one is in tension. Steady state was achieved after approximately 250 mm. The relative magnitudes of the loads measured by the three functioning load cells are quite similar to those observed in test PR3d-1 (Hurley and Phillips, 1998). Since load cells LC513034 and LC394580 had very similar output levels during PR3d-1, the assumption was made that the same thing occurred during this test. This implies an average, steady state, vertical force of 0.58 kN (or 58 kN at prototype scale).

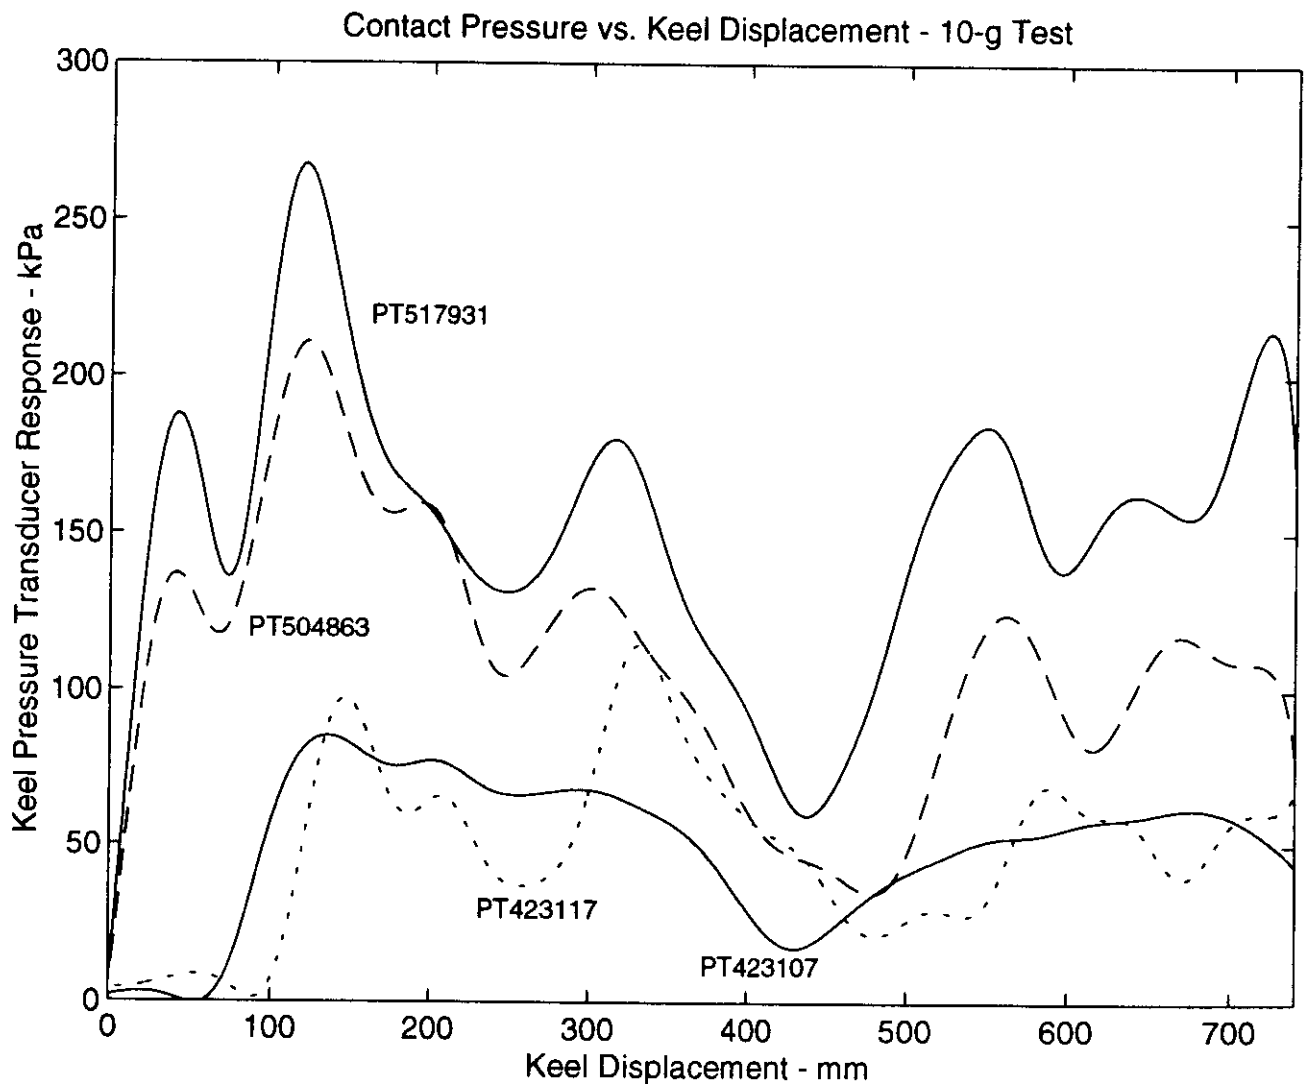
**FIGURE
9**

**Contact Pressures During
10-g Scour Event**

The contact pressures developed during the scouring event are displayed in Figure 9 which presents the data records for the four interface pressure transducers (PT423107, PT517931, PT423117, and PT504863) mounted on the model keel. The pressure record for the transducer located at the horizontal base of the keel (PT423117) indicated an average response over the duration of the event of approximately 44 kPa. The two pressure transducers located on the lower positions of the inclined face of the keel (PT517931 and PT504863) displayed average responses of 132 and 88 kPa. The transducer located on the upper position of the inclined face (PT423107) exhibited a response of approximately 44 kPa.

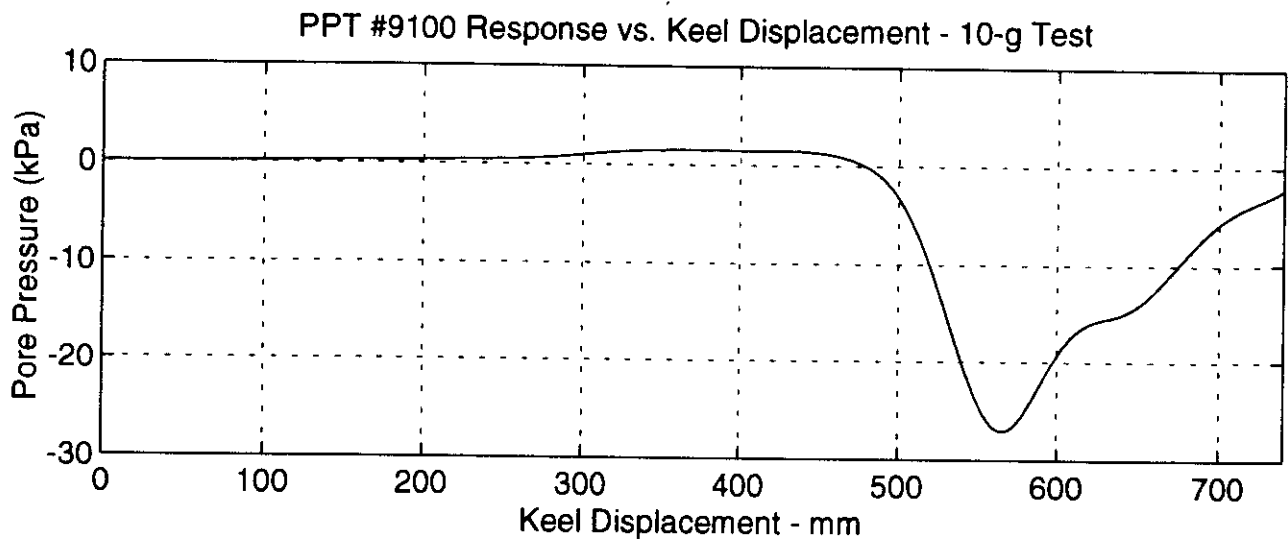
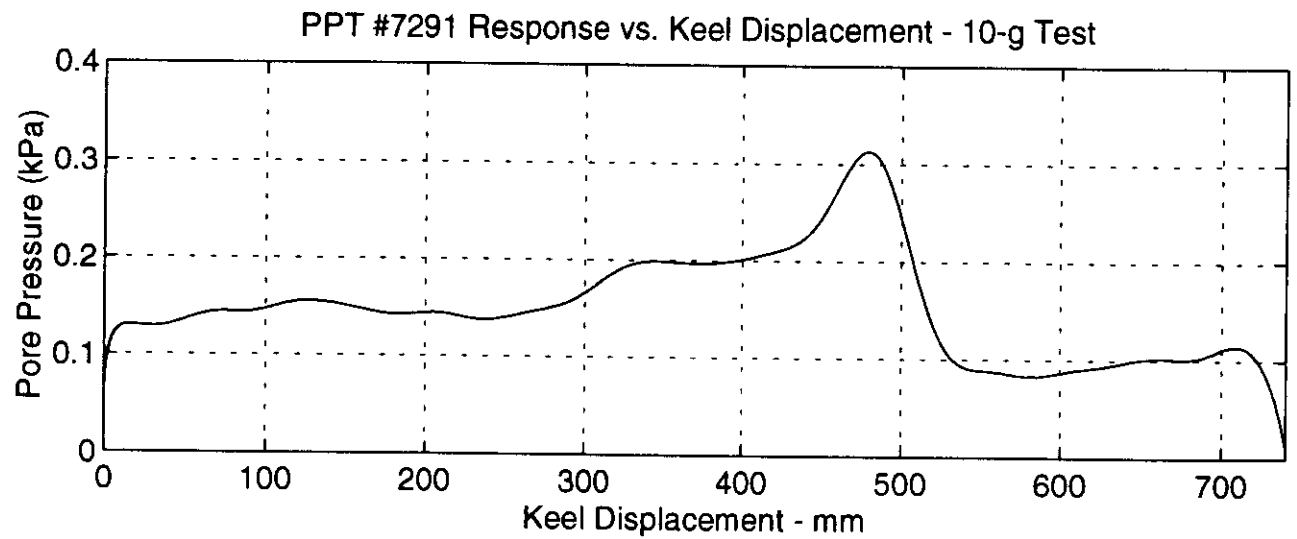
**FIGURE
10**

**Excess Pore Pressures During
10-g Scour Event**

Two pore pressure transducers (PPT 9100 and PPT 7291) were located under the 10-g scour and the response of these transducers is shown in Figure 10. PPT 9100 shows the development of a suction of approximately -27 kPa during the scour event. The weak response of PPT 7291, which also showed an anomalous response during the consolidation flight, is probably not indicative of the actual pore pressures experienced during the scour.

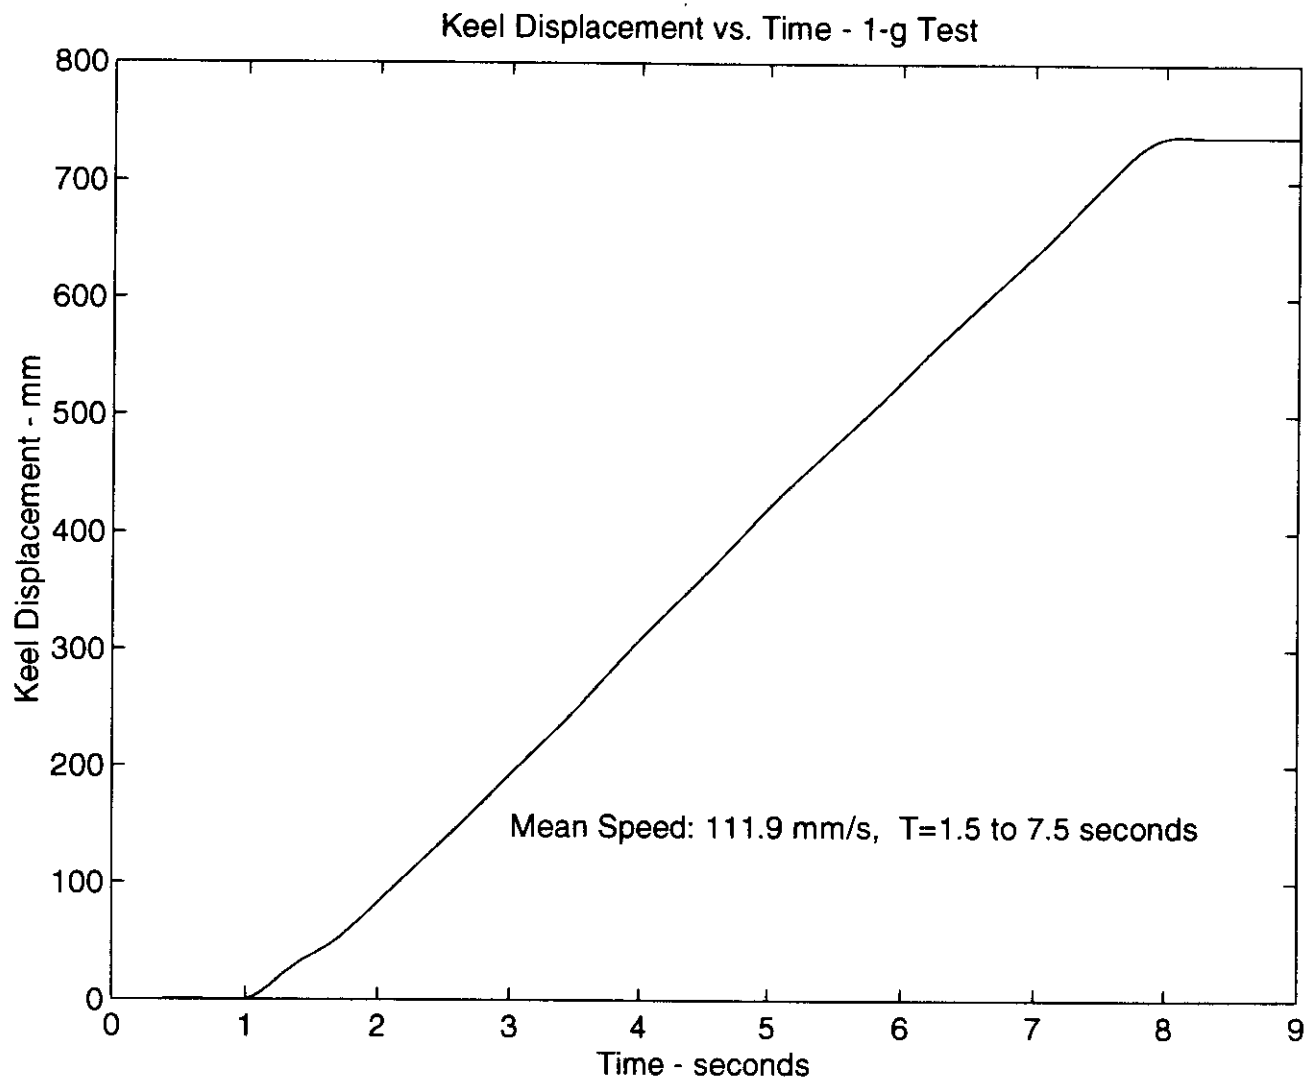
**FIGURE
11**

**Keel Displacement During
1-g Scour Event**

Figure 11 shows the keel displacement plotted versus time during the 1-g scouring event, as determined from measurements of the string potentiometer (SP02) which was attached to the carriage assembly. The actual keel velocity or scour rate was 111.9 mm/s, equal to the slope of the displacement-time curve.

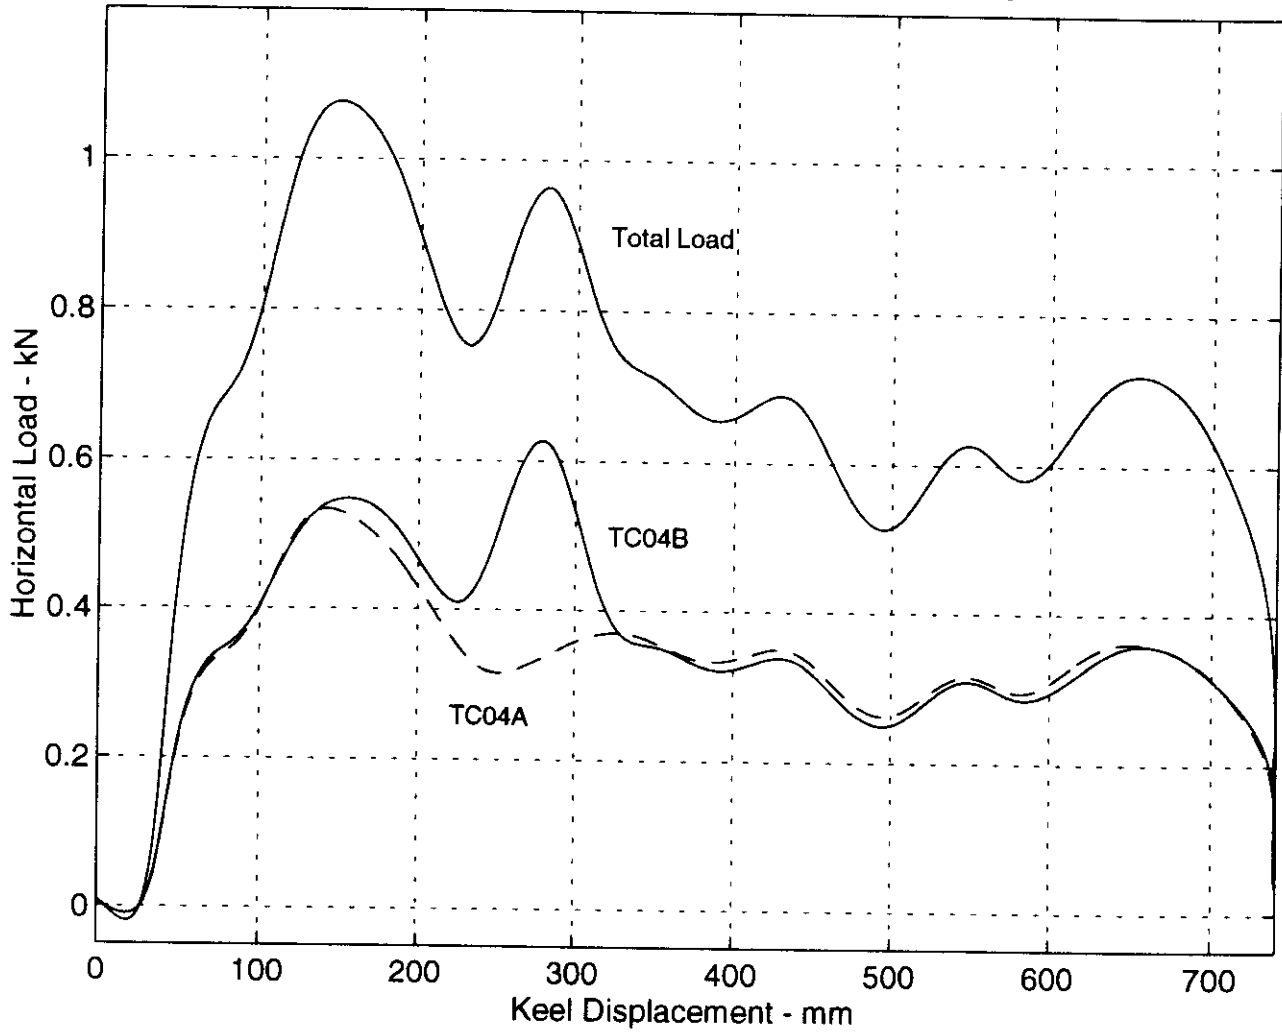
FIGURE
12

Model Horizontal Force vs. Keel Displacement - 1-g Test

Horizontal Forces During
1-g Scour Event

The total horizontal force was computed through summation of contributions from individual tension load cells (TC04A and TC04B) located at the connection between the drive system pulling cables and the model keel. Figure 12 shows the horizontal force for each tension cell and the total horizontal force plotted against keel displacement during the scour event. Steady state conditions were achieved after about 350 mm of keel displacement. The average horizontal force imposed under steady state conditions was approximately 0.68 kN.

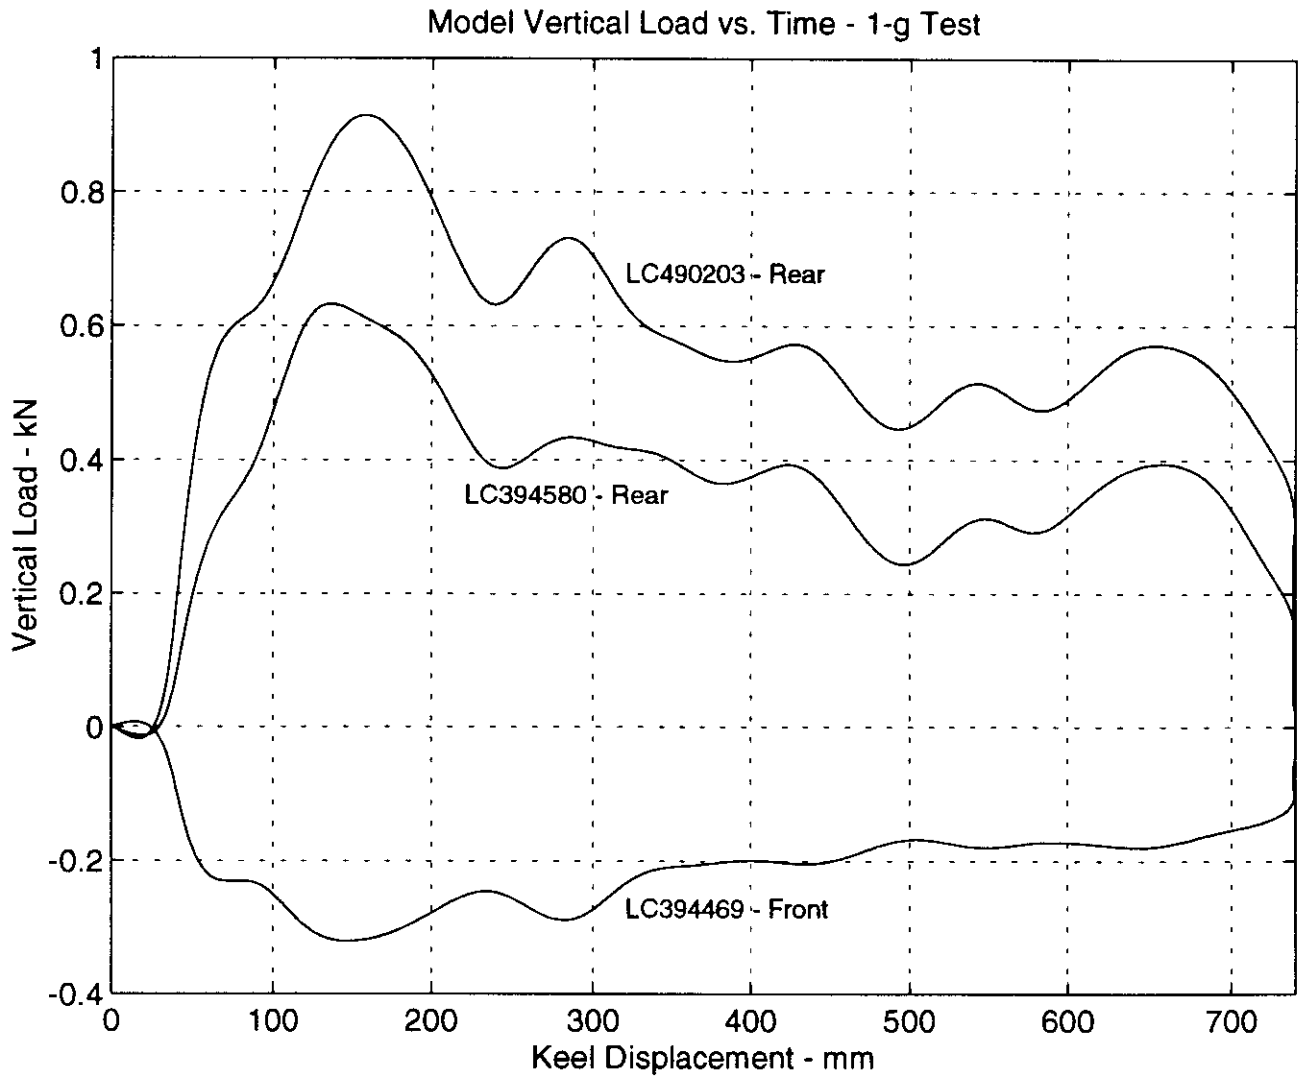
**FIGURE
13**

**Vertical Forces During
1-g Scour Event**

The total vertical force was evaluated through summation of the responses of the tension/compression load cells (LC394469, LC394580, and LC490203) which linked the model keel to the carriage assembly. Load cell LC513034 malfunctioned during this test and no data are available for plotting. Figure 13 shows the measured vertical force from the three functioning load cells, plotted against keel displacement during the scour event. It can be seen that the rear load cells are in compression while the front one is in tension. Steady state was achieved after approximately 350 mm. The relative magnitudes of the loads measured by the three functioning load cells is quite similar to that observed in test PR3d-1 (Hurley and Phillips, 1998). Since load cells LC513034 and LC394580 had very similar output levels during PR3d-1, the assumption was made that the same

thing occurred during this test. This implies an average, steady state, vertical force of 1.02 kN.

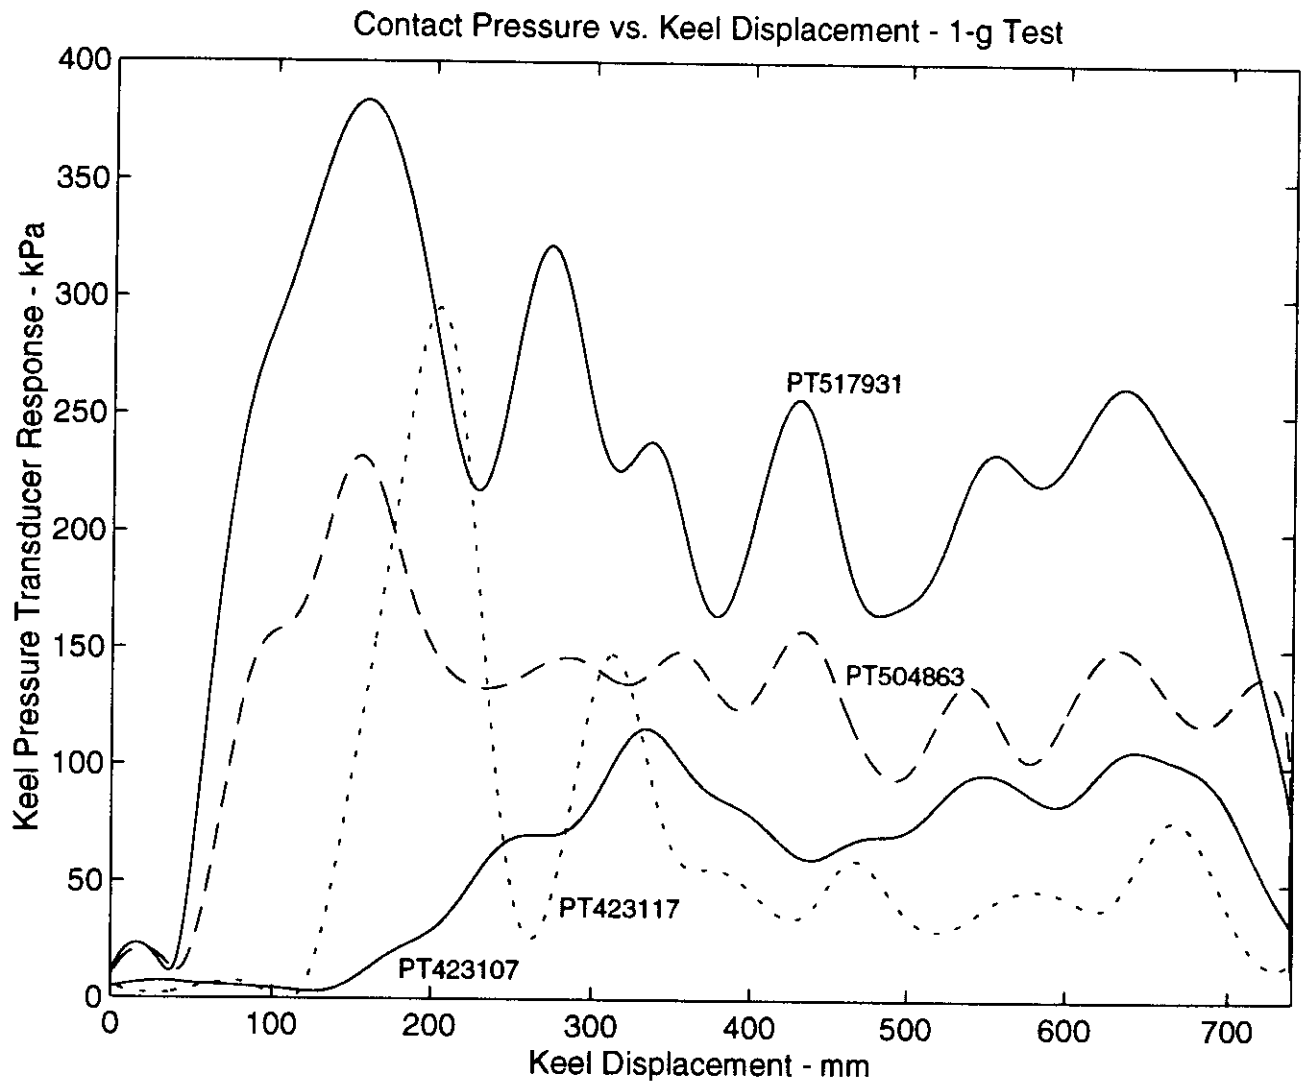
**FIGURE
14**

**Contact Pressures During
1-g Scour Event**

The contact pressures developed during the 1-g test are displayed in Figure 14 which presents the data records for the four interface pressure transducers (PT423107, PT517931, PT423117, and PT504863) mounted on the model keel. The pressure record for the transducer located at the horizontal base of the keel (PT423117) indicated an average response over the duration of the event of approximately 71 kPa. The two pressure transducers located on the lower positions of the inclined face of the keel (PT517931 and PT504863) displayed average responses of 239 and 140 kPa. The transducer located on the upper position of the inclined face (PT423107) exhibited a response of approximately 67 kPa.

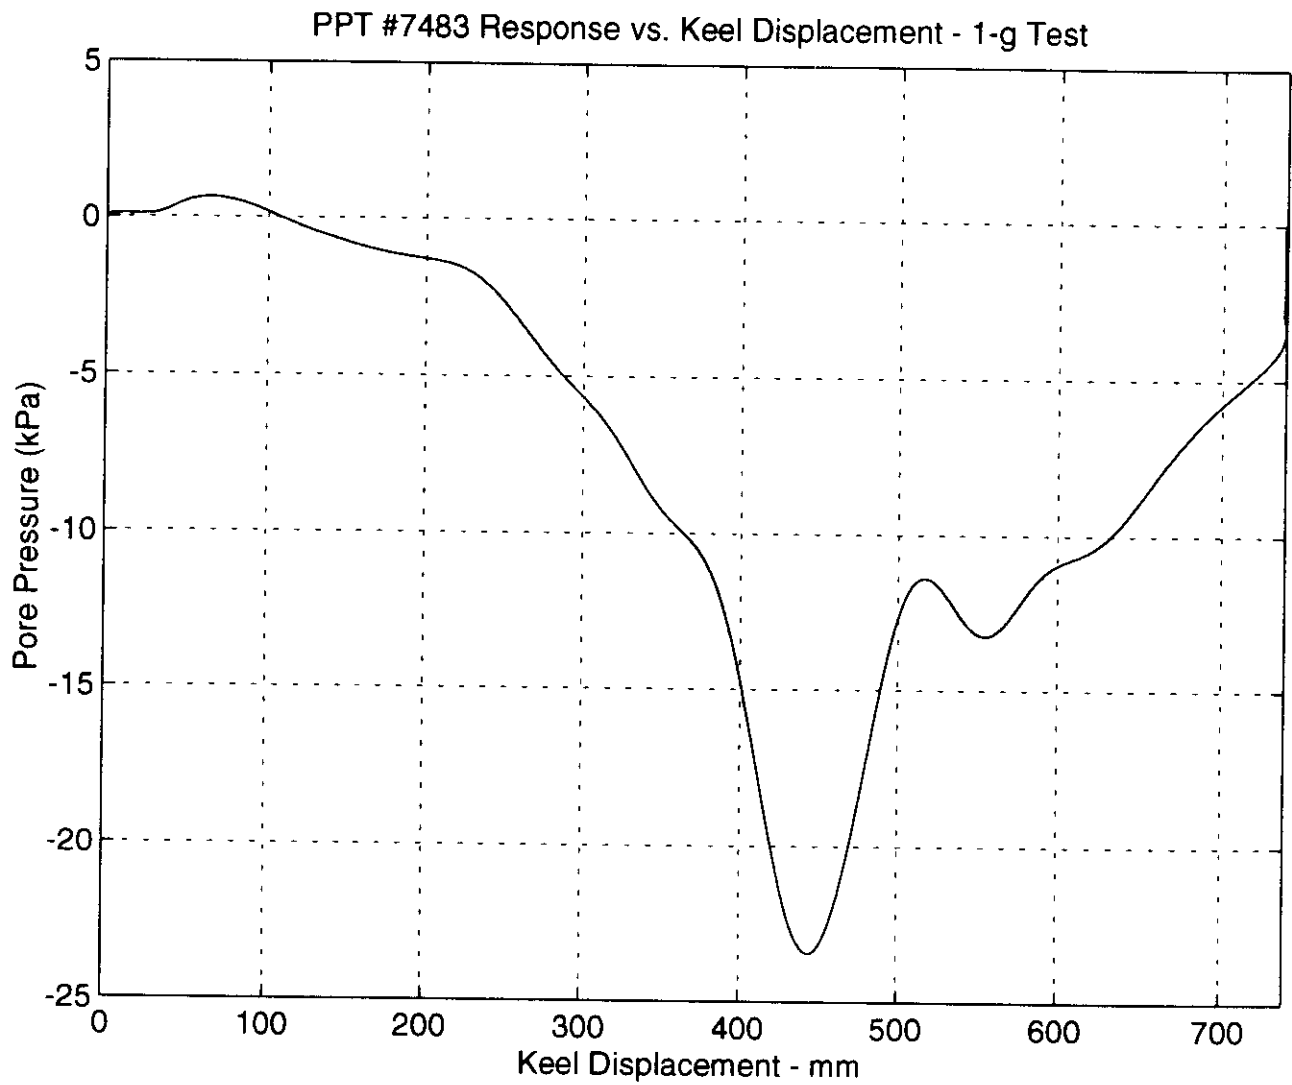
**FIGURE
15**

**Excess Pore Pressure During
1-g Scour Event**

Two pore pressure transducers (PPT 4377 and PPT 7483) were located under the 1-g scour and the response of these transducers is shown in Figure 15. PPT 7483 shows the development of a suction of approximately -23 kPa during the scour event. PPT 4377 over-ranged during this test, therefore the data obtained from this instrument have been omitted.

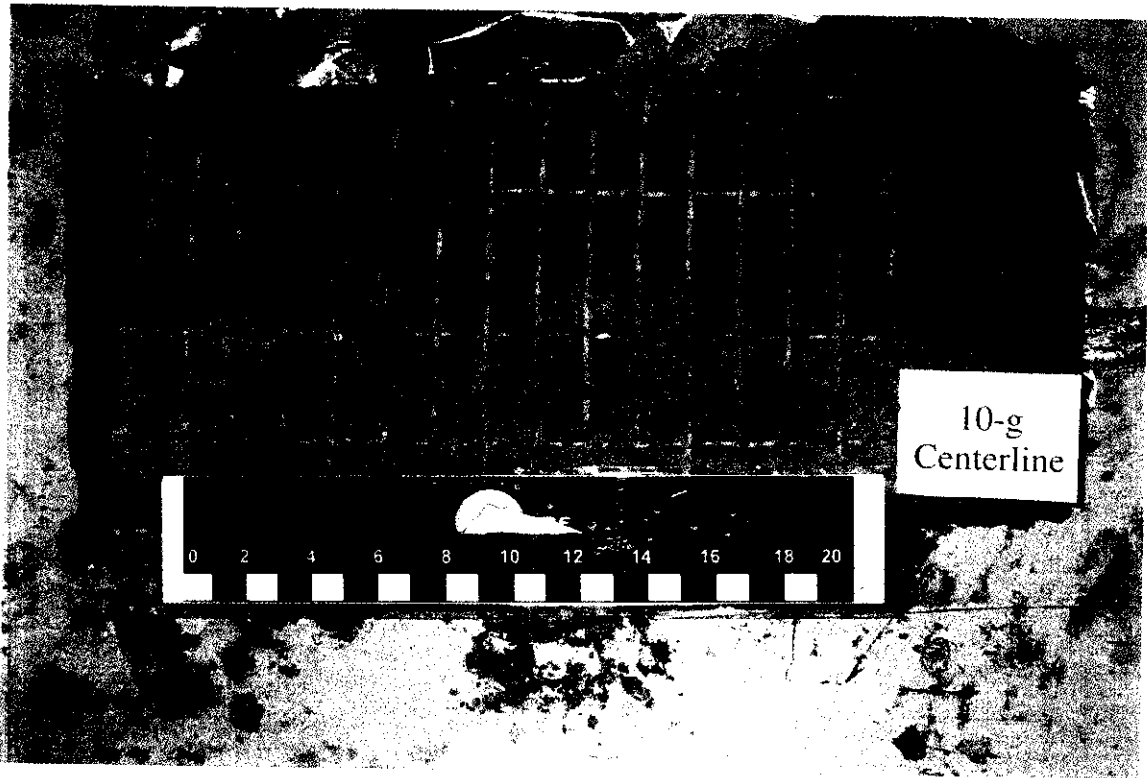
Grids from 10-g Scour

Post-test investigation of the silt testbed included photographic documentation and visual inspection of scour morphology, profiling of the scoured surface, and examination of sub-scour effects through excavation, measurement and photography of the buried displacement markers. Photographs which display two different views of each of the scours are presented in Figures 16 and 17. Profiles of the deformed sand surface were acquired using C-CORE's laser profiling system. Once the profiling was complete the sample was lifted from the strongbox using the extrusion plate. The sample was then excavated and the portions of the sample containing the marker grids were isolated and x-rayed, as shown in Figures 18 and 19. Once this process was complete, the spaghetti strands were exposed by carefully removing the silt. Photographs of the deformed grids are shown in Figures 20 and 21.
