**Safety and Integrity of
Arctic Marine Pipelines**

**Progress Report #3
Centrifuge Test PR3d-2 Report**

**C-CORE
St. John's, Newfoundland**

C-CORE Publication: 98-C9

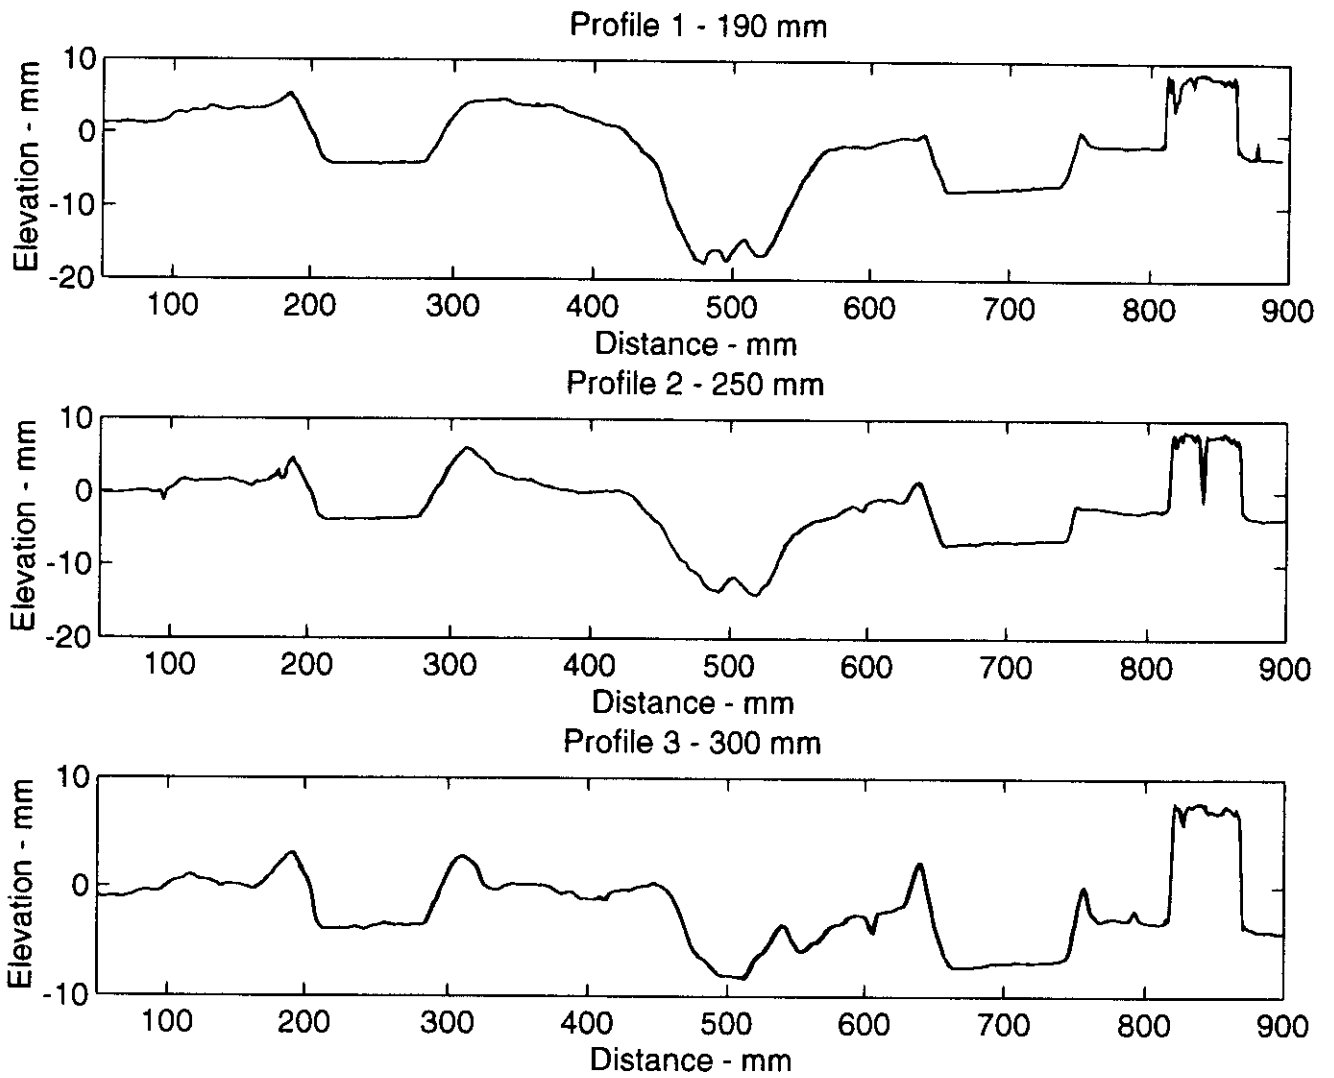
FIGURE
23

Profiles at Y=
190, 250 and 300 mm

The locations of the profiles are shown in Figure 22 and the cross-sectional profiles obtained along the scours are presented in Figures 23 through 29, beginning at y-coordinate equal to 190 mm from wall of the strongbox. The scour depths at each profile location are presented in Table 3.

It is immediately evident that the scour depths for the two tests were not the same. The average depth of the 10-g scour is 3.7 mm and the average depth of the 1-g scour is 5.9 mm. Since the elevation of the keel with respect to the strongbox is fixed, this can only be attributed to an uneven sample surface. The two lateral grids (normal to the scour direction) are at $y=450$ (10-g) and $y=447$ (1-g). The centerline marker grids, parallel to the direction of the scour and directly underneath them, range in position from $y=672$ to $y=912$ for the 10-g scour and $y=670$ to $y=910$ for the 1-g scour.

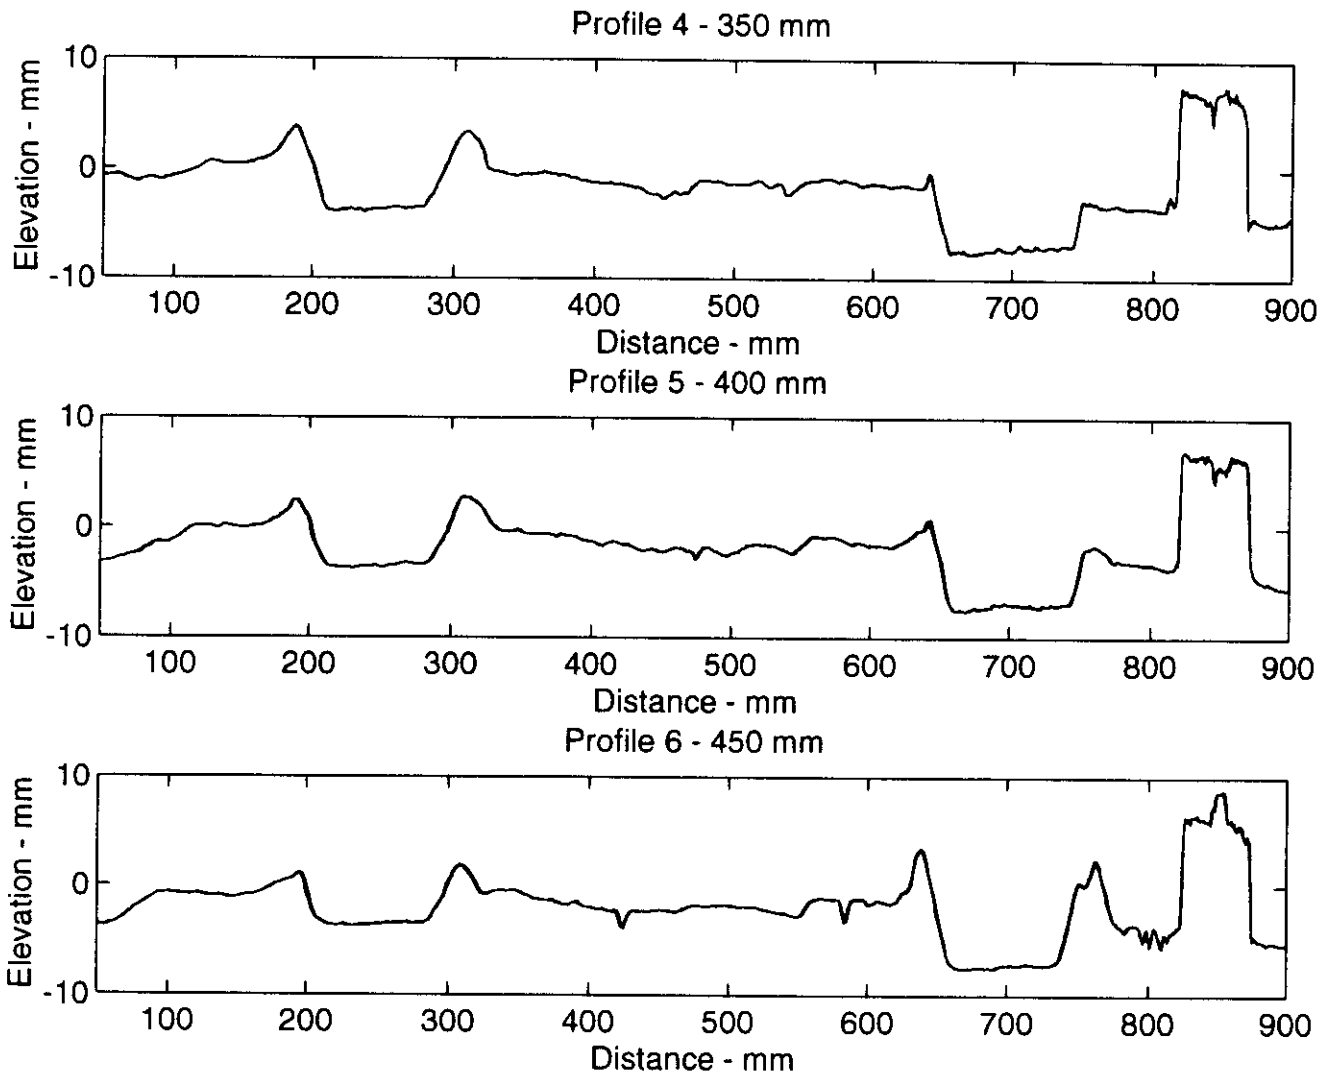
**FIGURE
24**

**Profiles at Y=
350, 400 and 450 mm**

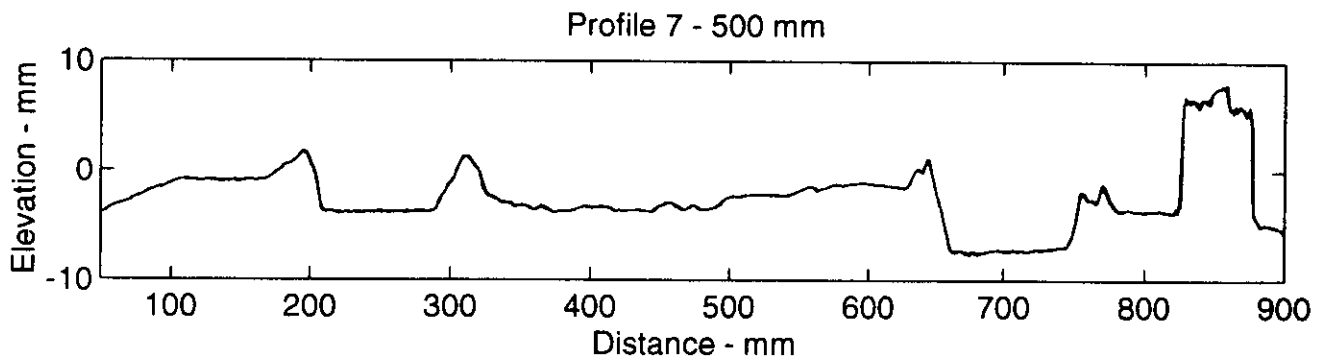
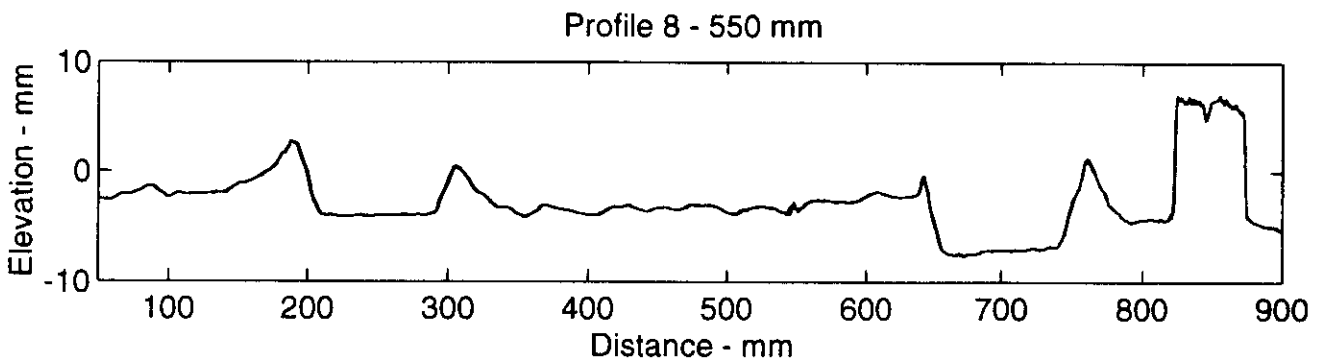
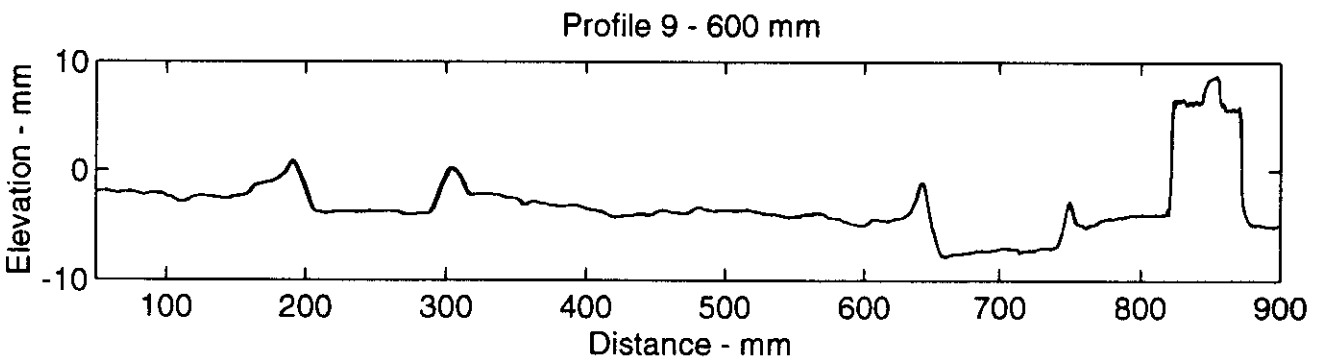
**FIGURE
25**

**Profiles at Y=
500, 550 and 600 mm**

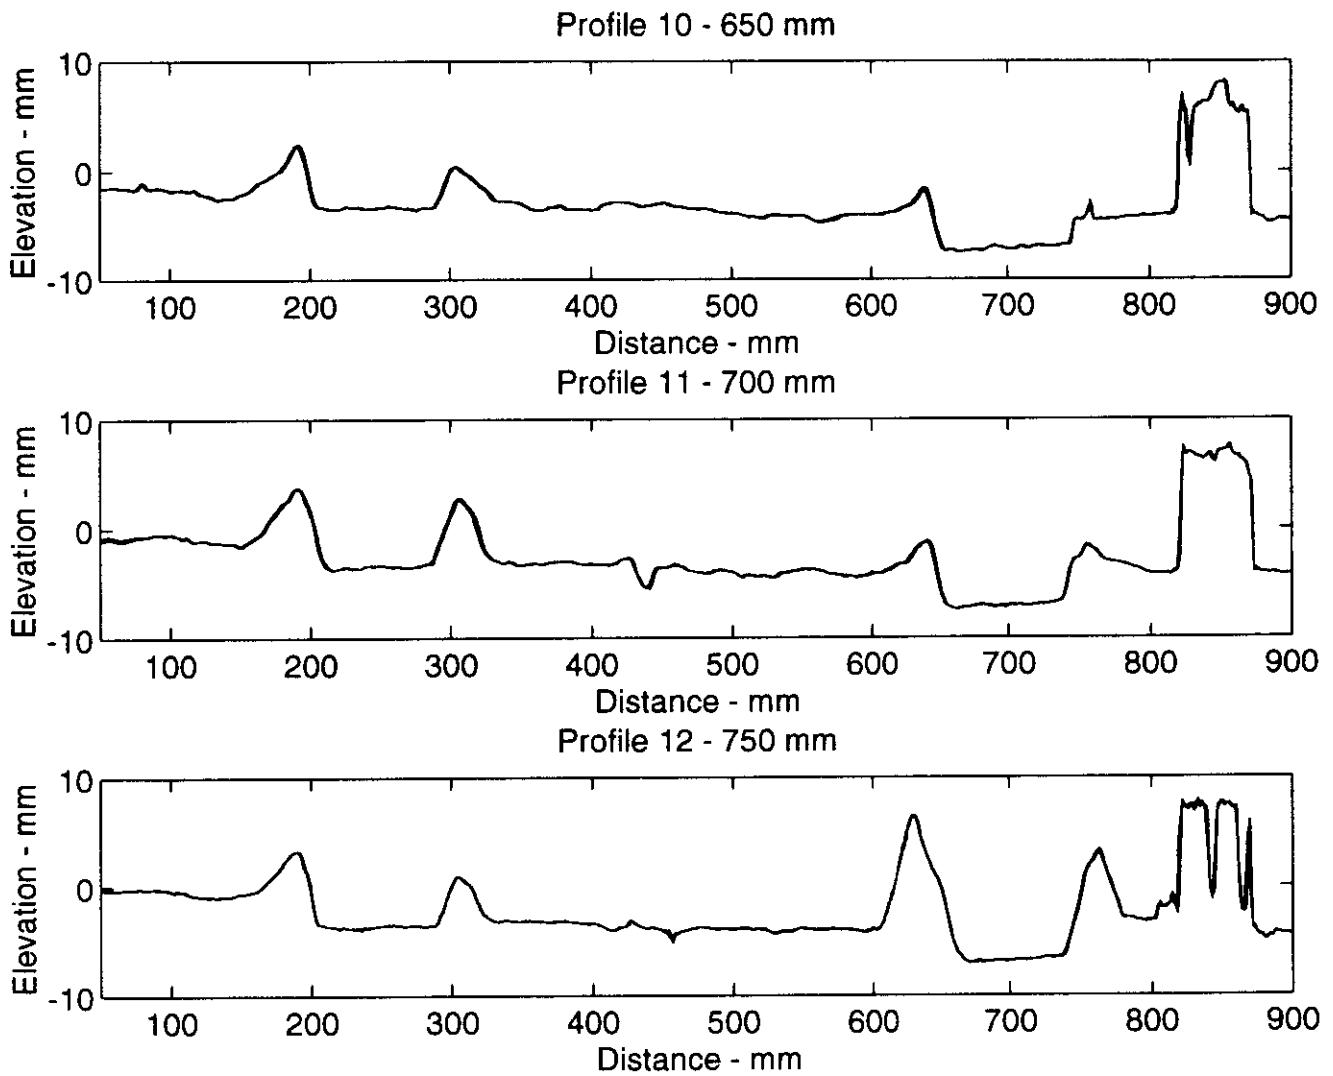
**FIGURE
26**

**Profiles at Y=
650, 700 and 750 mm**

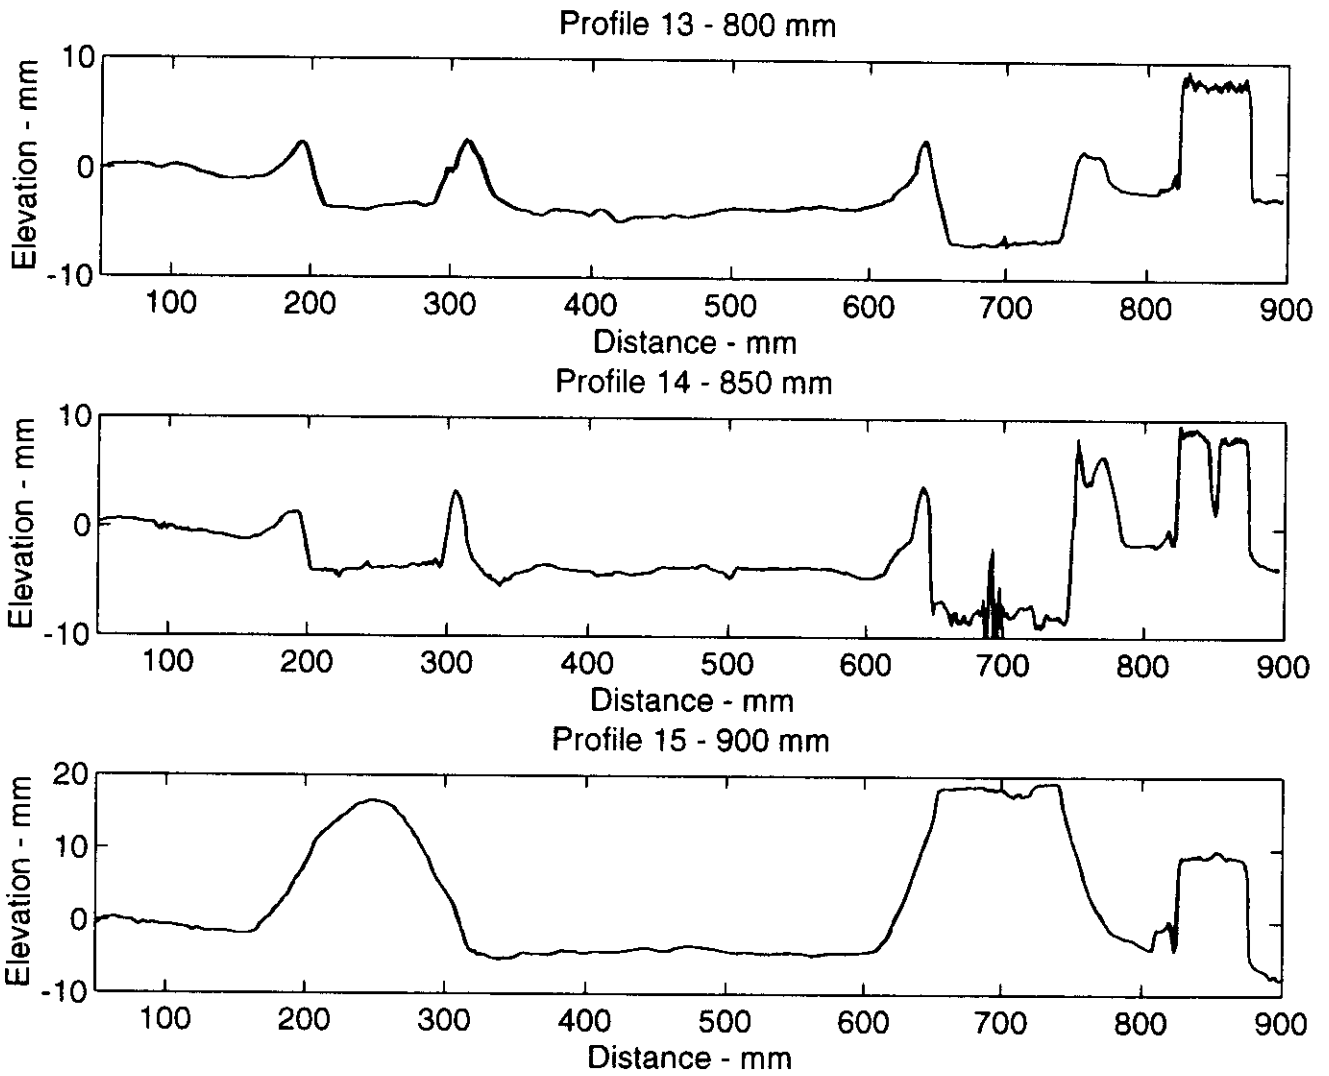
FIGURE
27

Profiles at Y=
800, 850 and 900 mm

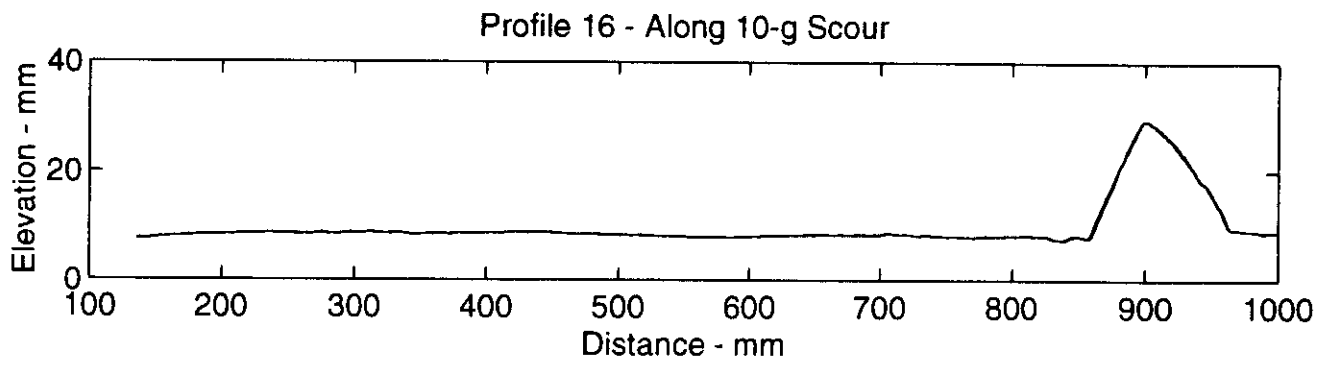
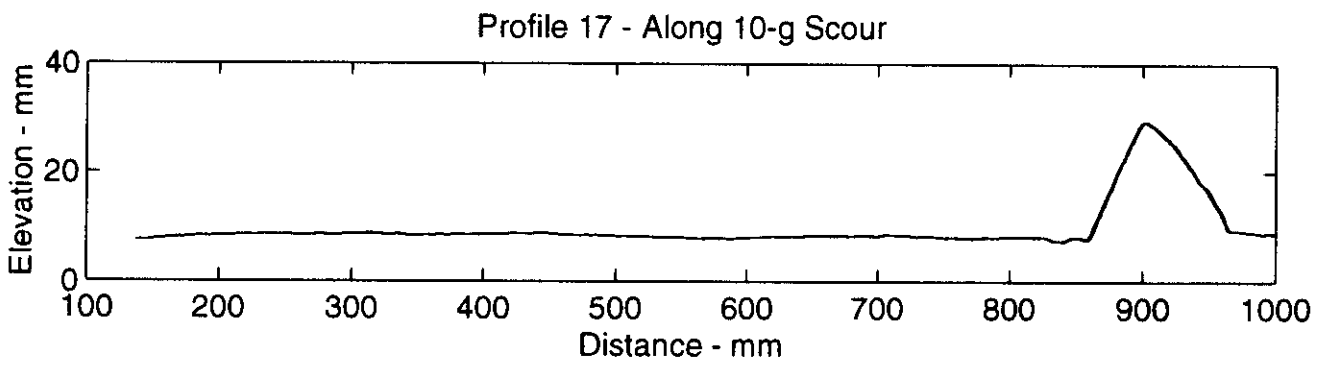
FIGURE
28

Profiles along 10-g Scour

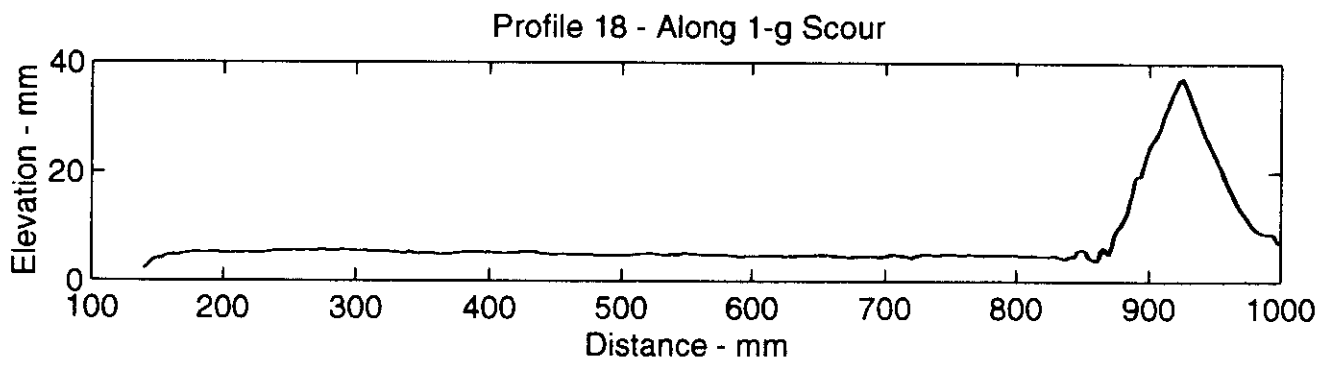
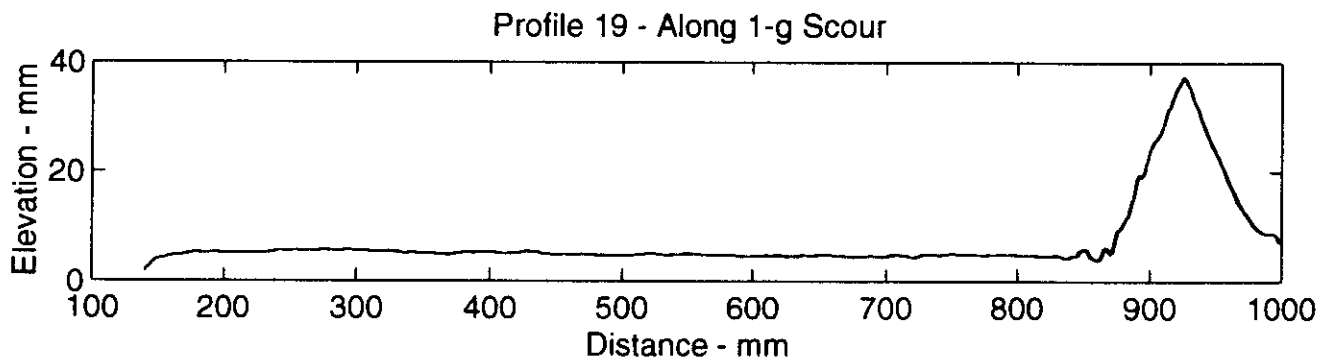
FIGURE
29

Profiles along 1-g Scour

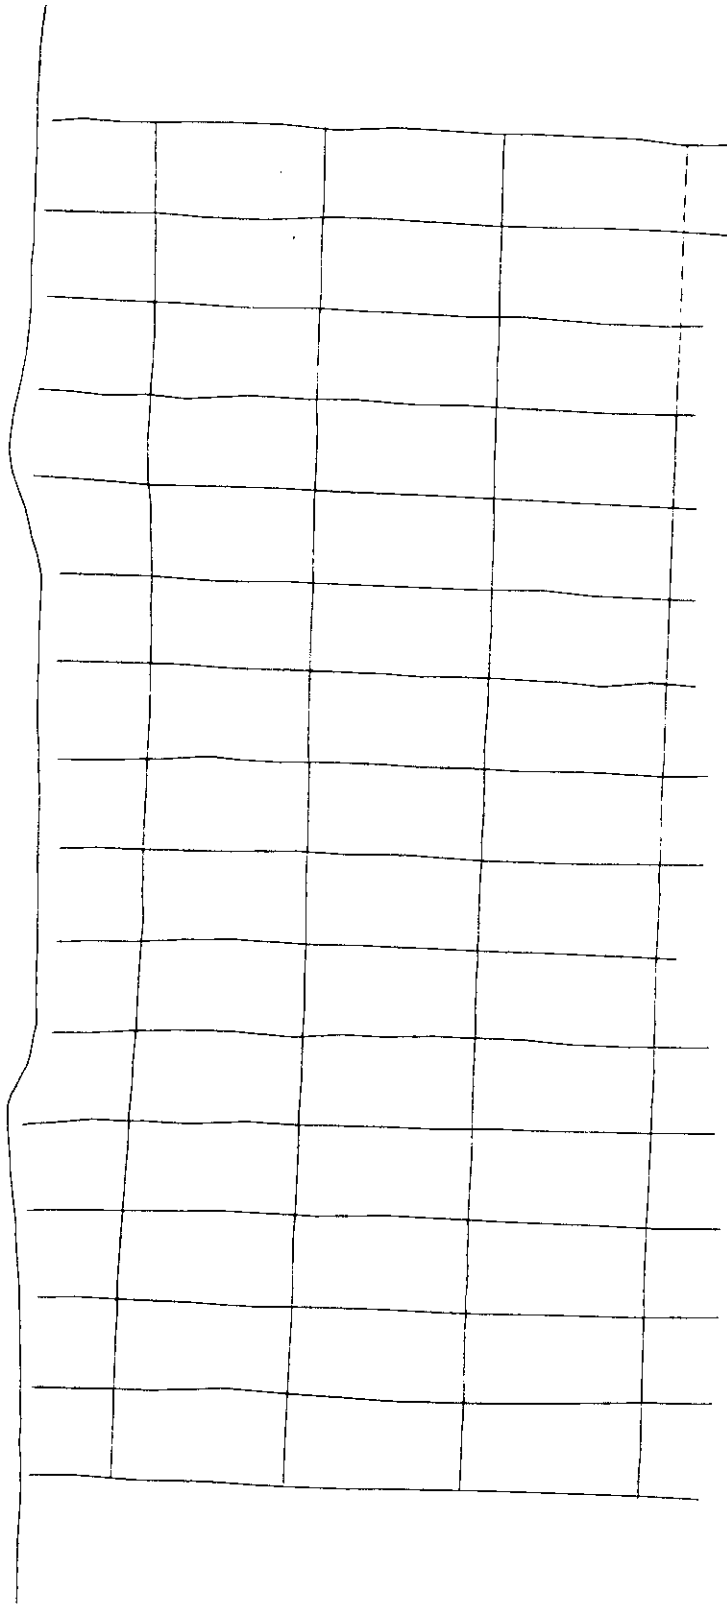
**FIGURE
30**

10-g SCOUR

Normal Marker Grid

**Grid Normal to 10-g Scour
Digitized from X-Ray**

Examination of the marker grids normal to the direction of scour revealed very little evidence of deformation, both for the 1-g and 10-g scours. These marker grids are shown in Figures 30 and 31. The centerline grids, parallel to the direction of the scours, revealed more information regarding the sub-scour soil deformation. Sub-scour deformation beneath the 10-g scour extends to approximately 36 mm beneath the bottom of the scour. Sub-scour deformation beneath the 1-g scour appears to extend approximately 38 mm below the bottom of the scour. Digitized marker grids are shown in Figures 32 and 33. Likewise, examination of lateral deformation at the base of the two scours indicates that the soil immediately under the 10-g scour deformed 4.5 mm laterally and the soil immediately under the 1-g scour deformed 4.6 mm laterally.

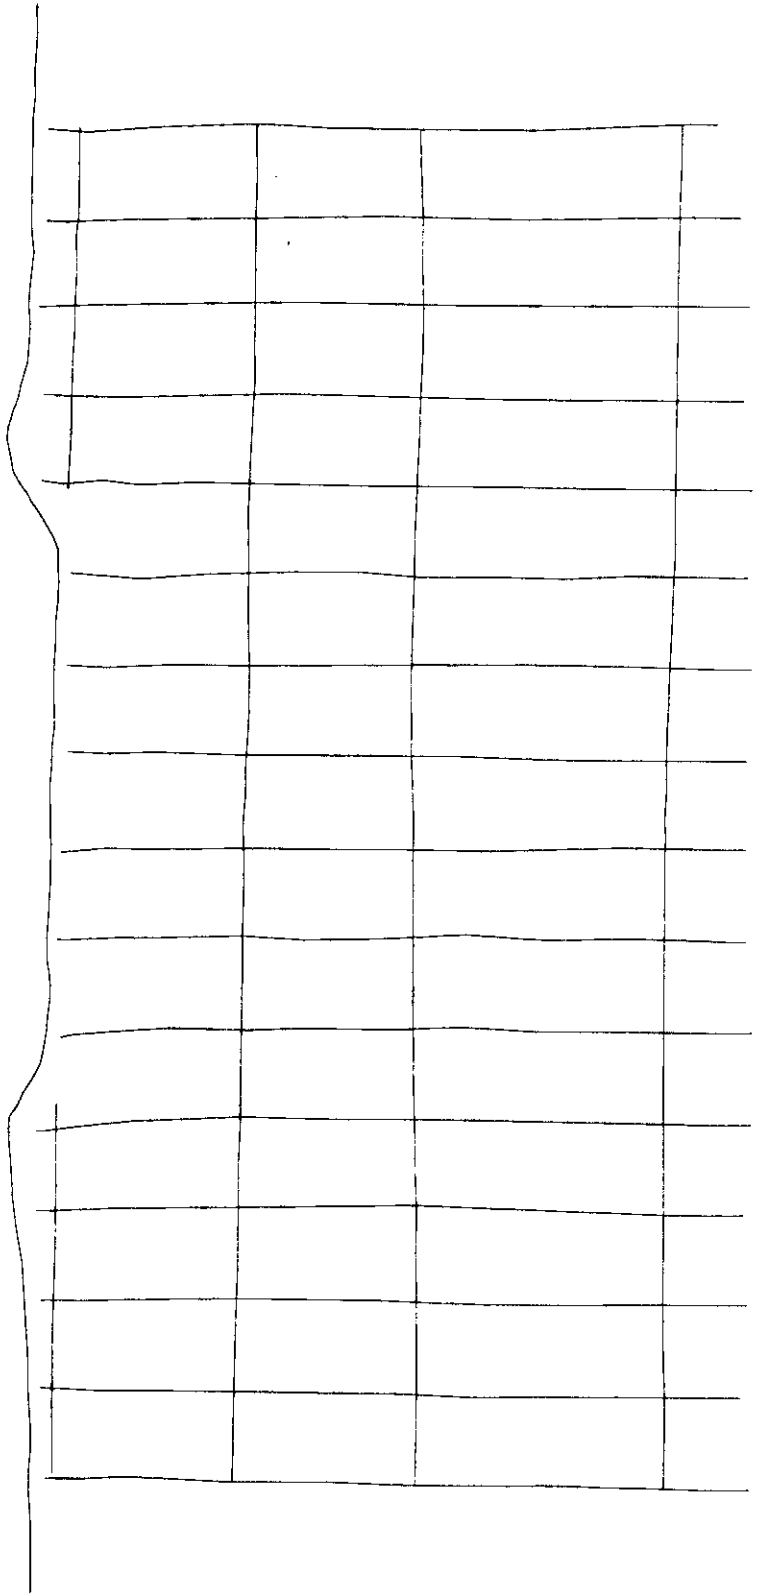
**FIGURE
31**

1-G SCOUR

Normal Marker Grid

**Grid Normal to 1-g Scour
Digitized from X-Ray**

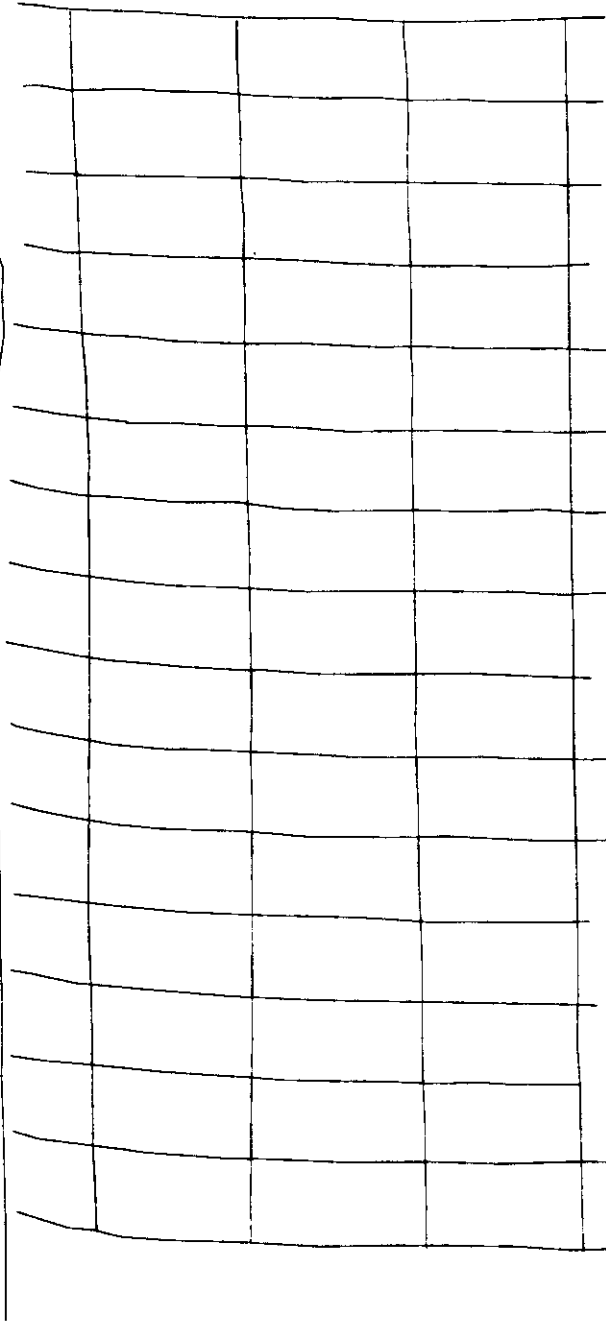
FIGURE
33

1-G SCOUR
Centerline Marker Grid

Centerline Grid From 1-g Scour
Digitized from X-Ray

The deformation depths were normalized with respect to the scour depths, to allow comparison between the two tests. The ratio of deformation depth to scour depth for the 10-g scour is $(36 \text{ mm})/(3.7 \text{ mm}) = 9.7$. The ratio of deformation depth to scour depth for the 1-g scour is $(38 \text{ mm})/(5.9 \text{ mm}) = 6.4$. Other scour tests conducted at 1-g in low-strength silts (Poorooshasb and Clark, 1990) have indicated deformation depth/scour depths ratio of up to seven.
