# NOAA Abandoned Vessel Program Removal Case Study: *F/V Hope*

*Dimensions:* 22' x 42'      *Hull:* Wood  
*Type:* Fishing      *Tonnage:* 14

# Removal Case Study: *F/V Hope*

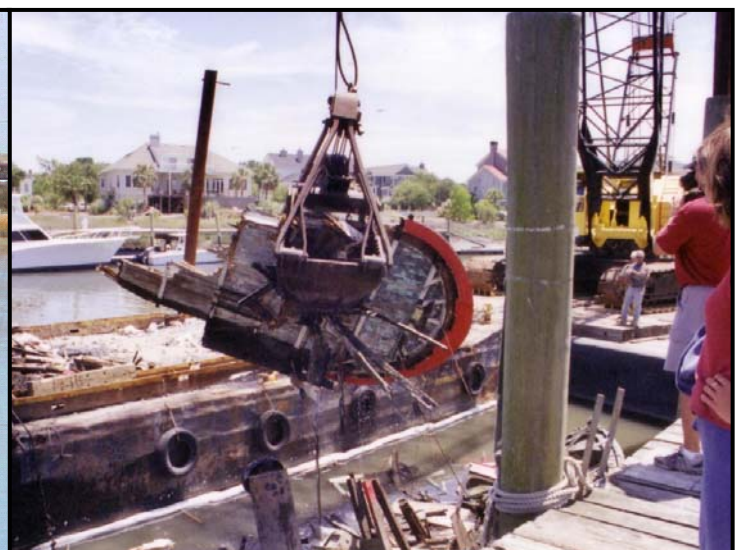
*Vessel Disposal*

Once the metals were scrapped, two 30' X 120' X 7' barges were used to transport the debris to the Cape Romain Contractors yard. The larger sections were then broken up and all the debris was loaded into dumpsters supplied by Carolina Waste. It was then hauled to the Bees Ferry landfill and disposed of appropriately. The disposal operation took approximately three days.
