# NOAA Abandoned Vessel Program Removal Case Study: *F/V Ivanhoe*

Contributing Agency: Washington Department of Natural Resources

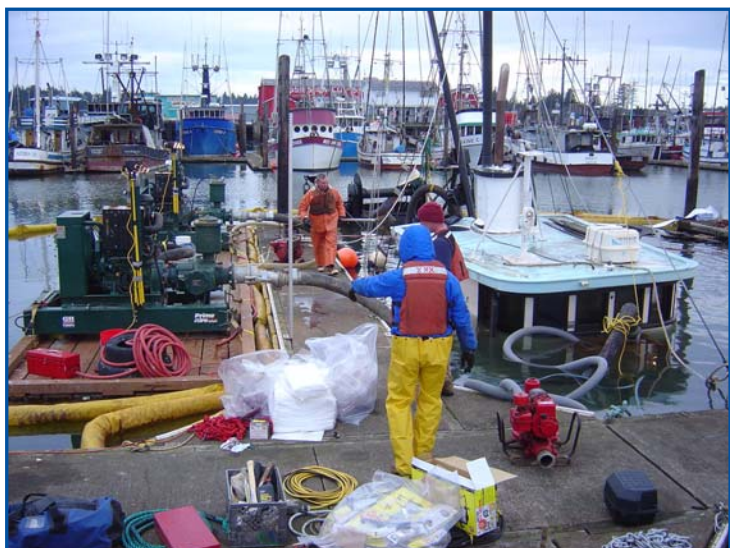
*Pumping out the vessel*

The USCG and Dept of Ecology mitigated the immediate diesel spill threat November 3rd 2003. The area was boomed and a local contractor was hired for clean-up. Once the immediate threat was mitigated, salvage contractor Global Diving & Salvage continued to monitor the environmental situation and conducted incidental spill response as salvage operations ensued. Salvage operations ran from November 4th to November 8th 2003. Air lift bags were placed under the stern, and a detailed diver inspection ensued. Cofferdams were built around all the vessel's hatches, then high pressure pumps removed water from inside the hull spaces. The vessel began to float as the internal water volume decreased. She was fully afloat on the morning of November 8<sup>th</sup>, and was towed to the Port of Ilwaco's travel lift, taken out of the water and placed on blocks in the boat storage yard.

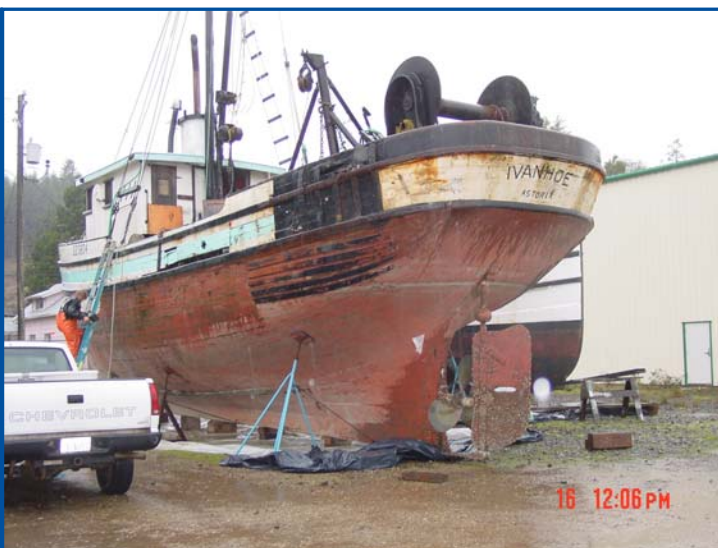
*F/V Ivanhoe in storage*

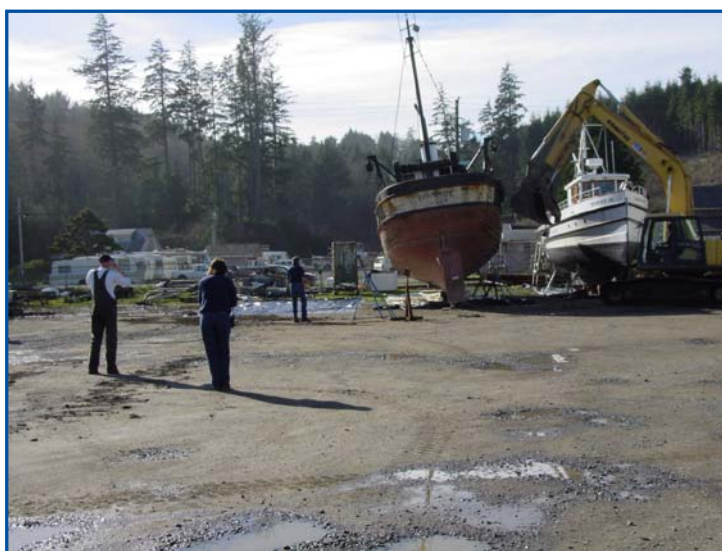
*Vessel Disposal 1*

A disposal contractor was selected through a competitive bidding process, and disposal operations were conducted between March 8th and 10th 2004. Dangerous wastes were removed from the vessel (remaining fuel, and fuel-contaminated bilgewater, hydraulic fluid, paints, solvents, batteries), and taken to appropriate recycling facilities. Metals were segregated and disposed of as scrap. The hull was crushed into small pieces by mechanical excavator and cutting tools, and the resulting debris was landfilled.

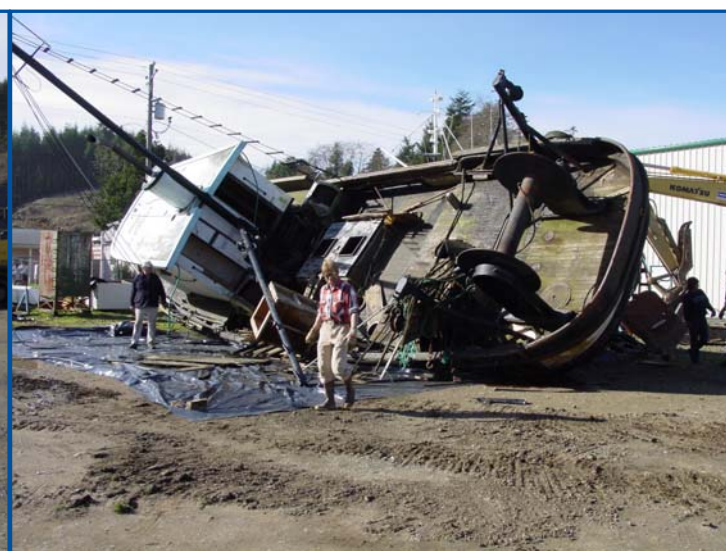
*Vessel Disposal 2*
