**PHASE I ENVIRONMENTAL SITE ASSESSMENT**

**POPLAR POINT SITE (SECTION ONE)**

**WASHINGTON, D.C.**

Prepared by  
Ridolfi Engineers Inc.

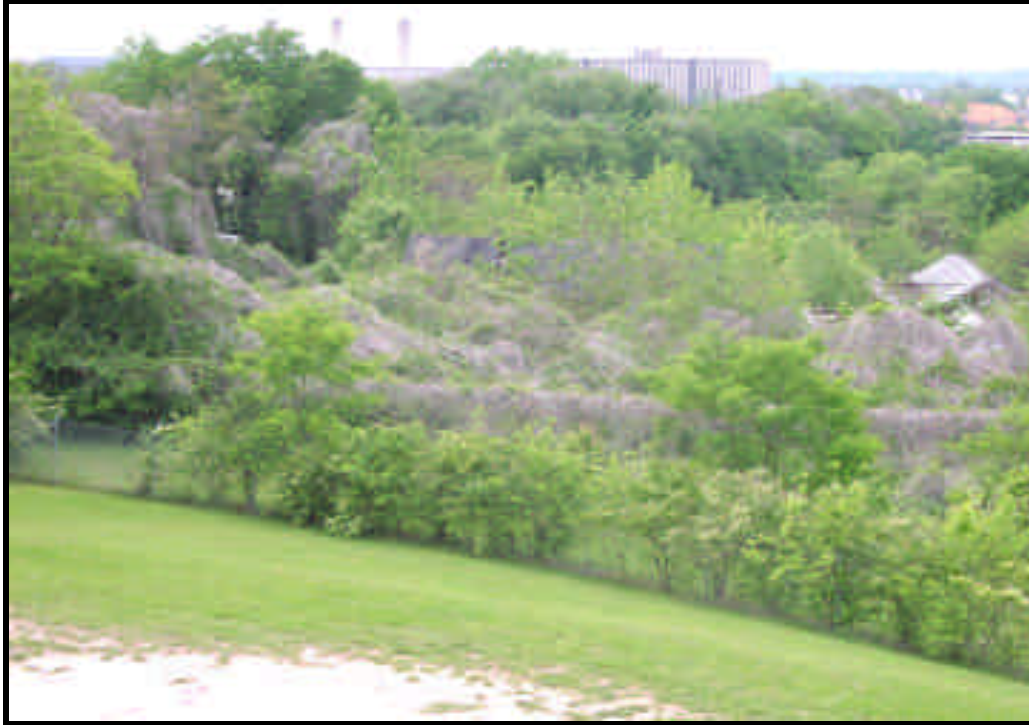
**Photo 1:** Overview of the southern portion of the former AOC and NRS areas of the Site, facing northwest (from the Anacostia Station parking structure photographed on May 6, 2002).

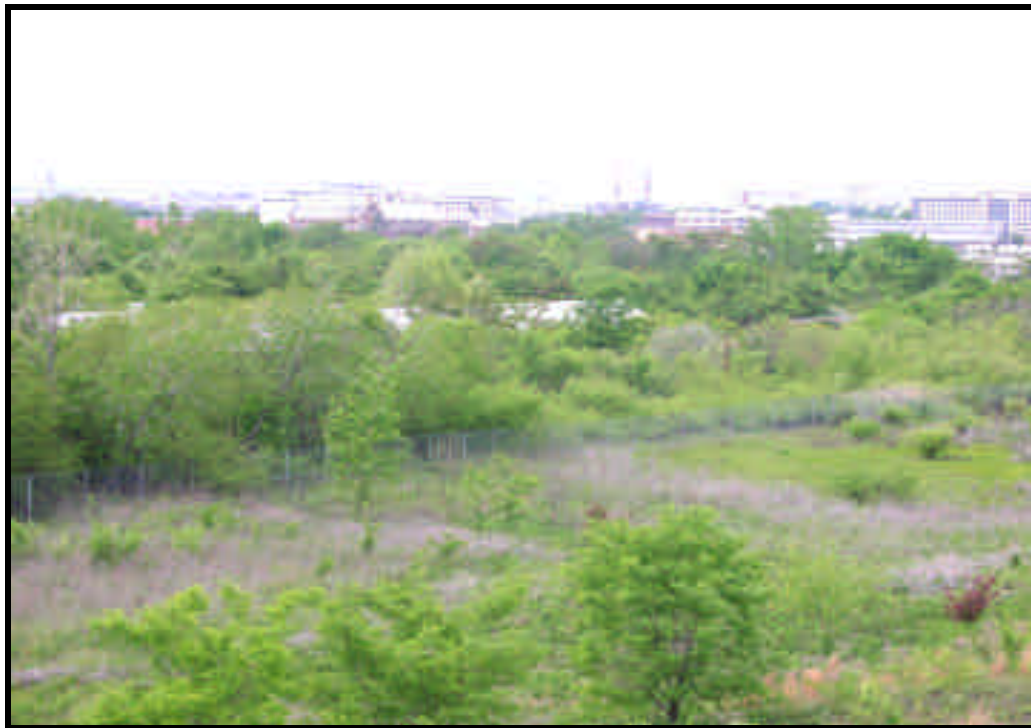
**Photo 2:** Overview of the northern portion of the former AOC and NRS areas of the Site, facing northwest (from the Anacostia Station parking structure photographed on May 6, 2002).

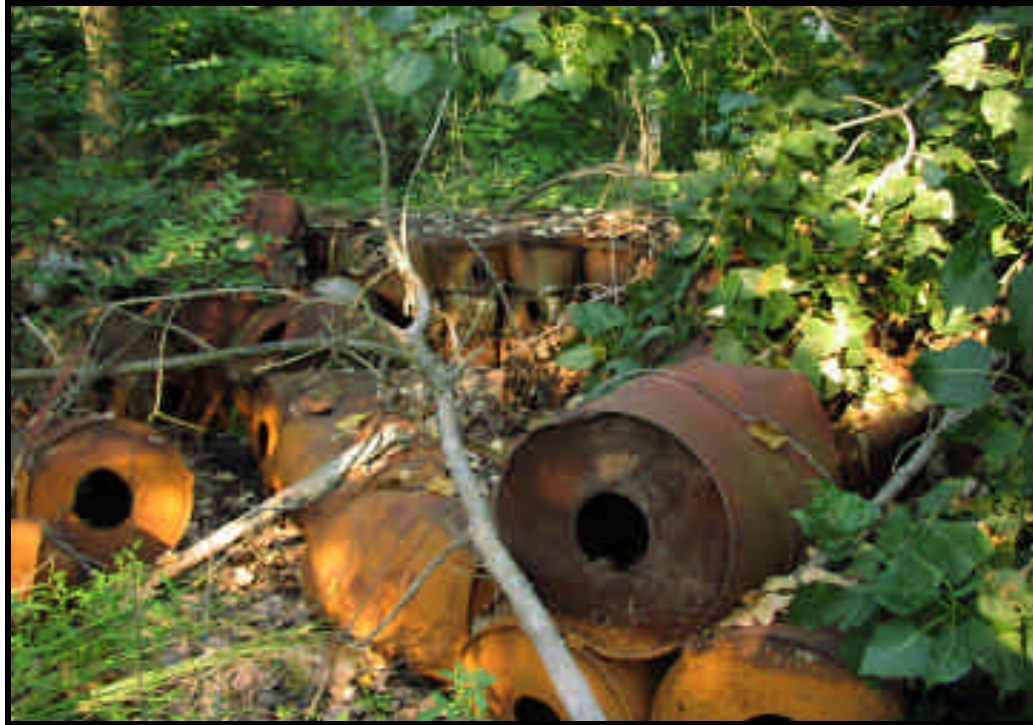
Approximately 128 drums bound together in groups of 12 to 14 with steel bands forming a large "drum cluster" were observed just west of the North-South Road, in the southern portion of Wetland 1. All of the visible drums had holes cut in each end, approximately 8 inches in diameter. The accessible drums were noted to be empty, and the outer surfaces of all the drums were rusted. There were also some isolated drums, somewhat removed from the main cluster, but in the same general vicinity.

**Photo 3:** A portion of the drum cluster found in Wetland 1, near the eastern boundary of the D.C. Lanham area of the Site (removed in November 2002 photographed on July 16, 2002).

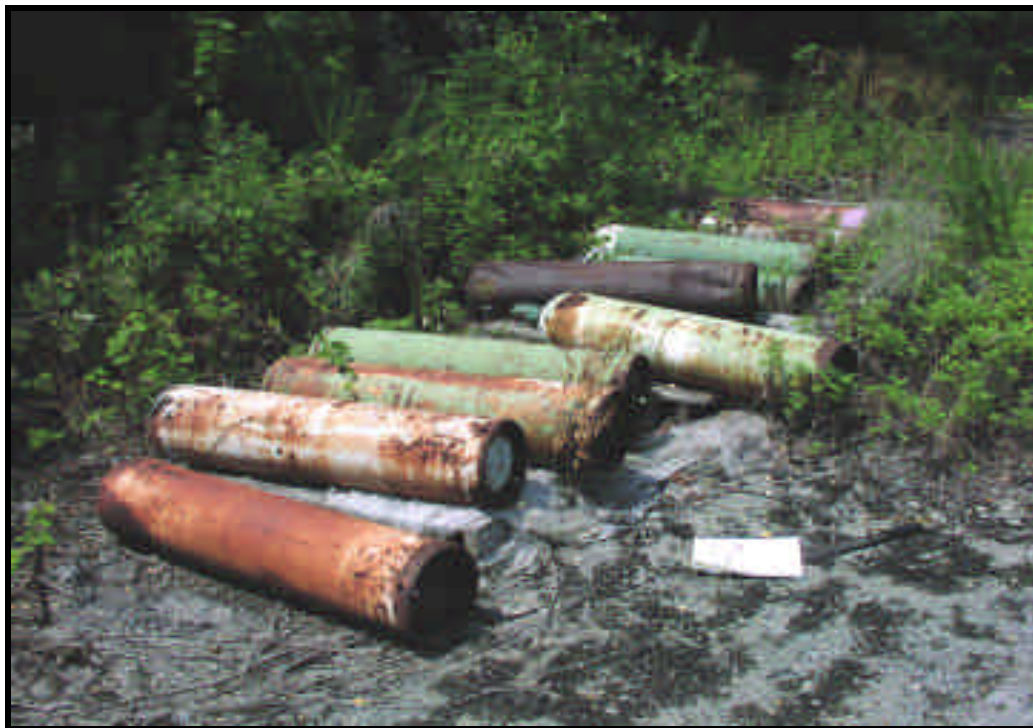
Ten gas cylinders were observed staged near the southeastern corner of the D.C. Lanham area, adjacent to the main access road on the Site. Five of these cylinders were green, three were white or silver, and one was pink or lavender. Six empty 55-gallon drums were also observed adjacent to the access road, near the southwestern corner of the D.C. Lanham area. In addition, four drums containing purge water from wells were also found in the southwestern corner of this area, near a monitoring well.

**Photo 4:** Gas cylinders in the southern portion of the D.C. Lanham area of the Site (removed in November 2002 photographed on August 27, 2002).

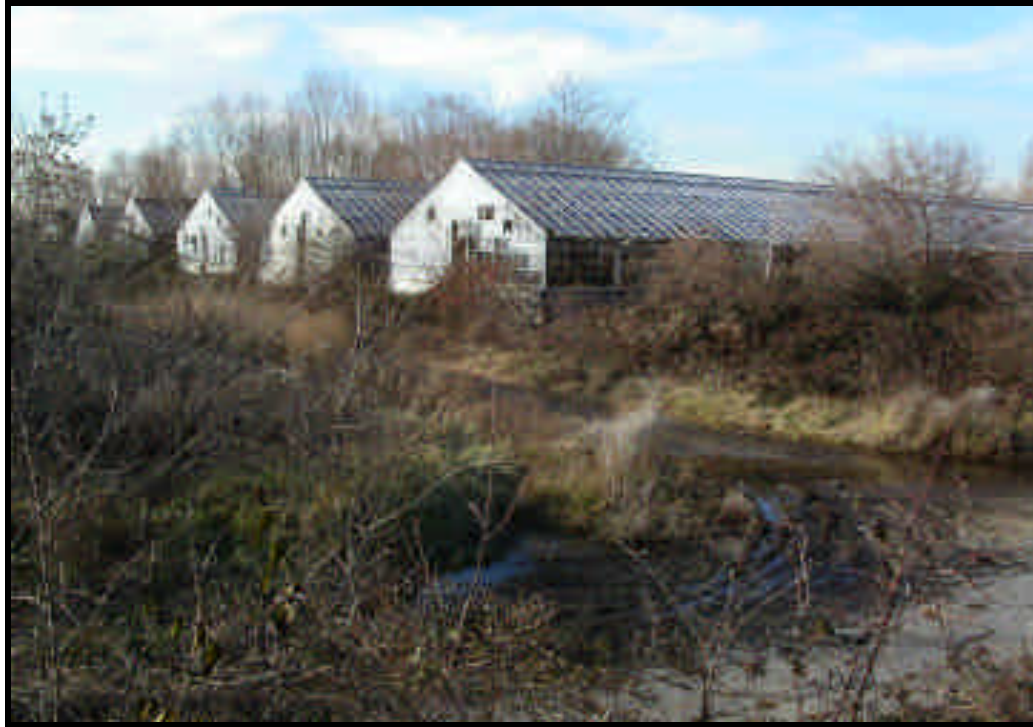
**Photo 5:** Southern portion of northern greenhouses, facing northwest (photographed on December 18, 2002).

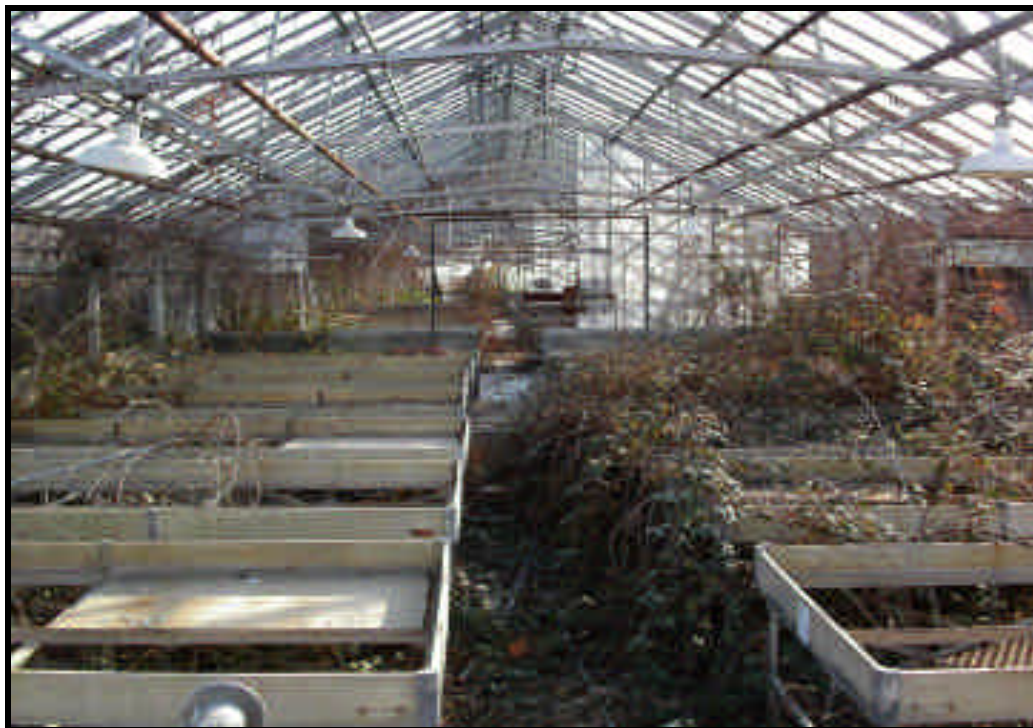
**Photo 6:** Interior of easternmost northern greenhouse (photographed on December 18, 2002).

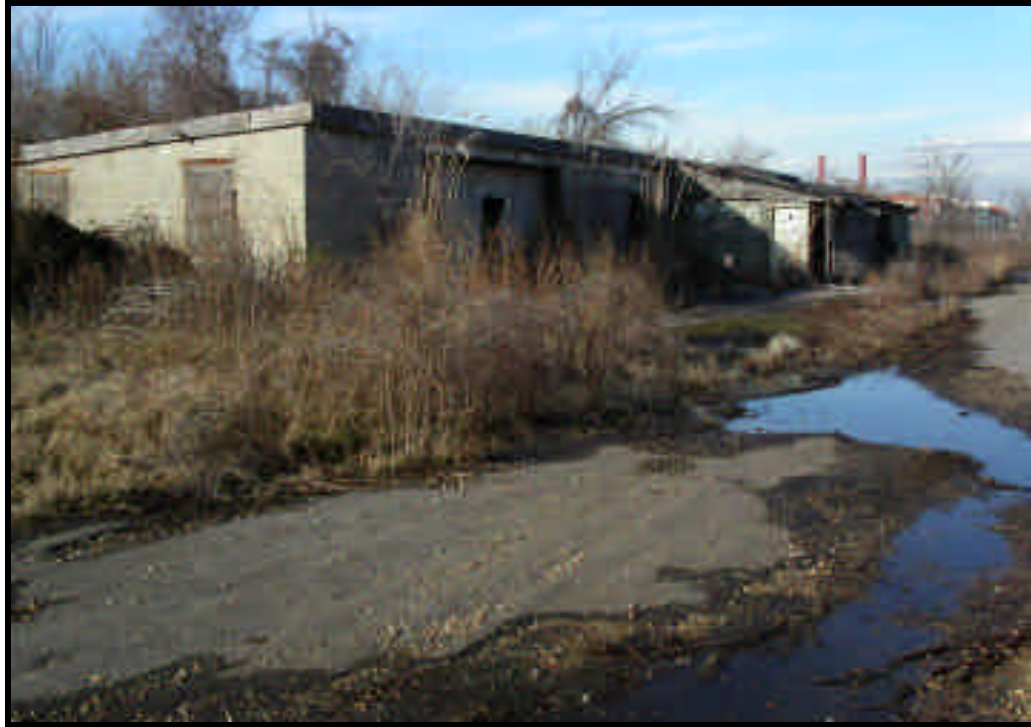
**Photo 7:** Former maintenance garage in AOC area facing northwest (photographed on December 18, 2002).

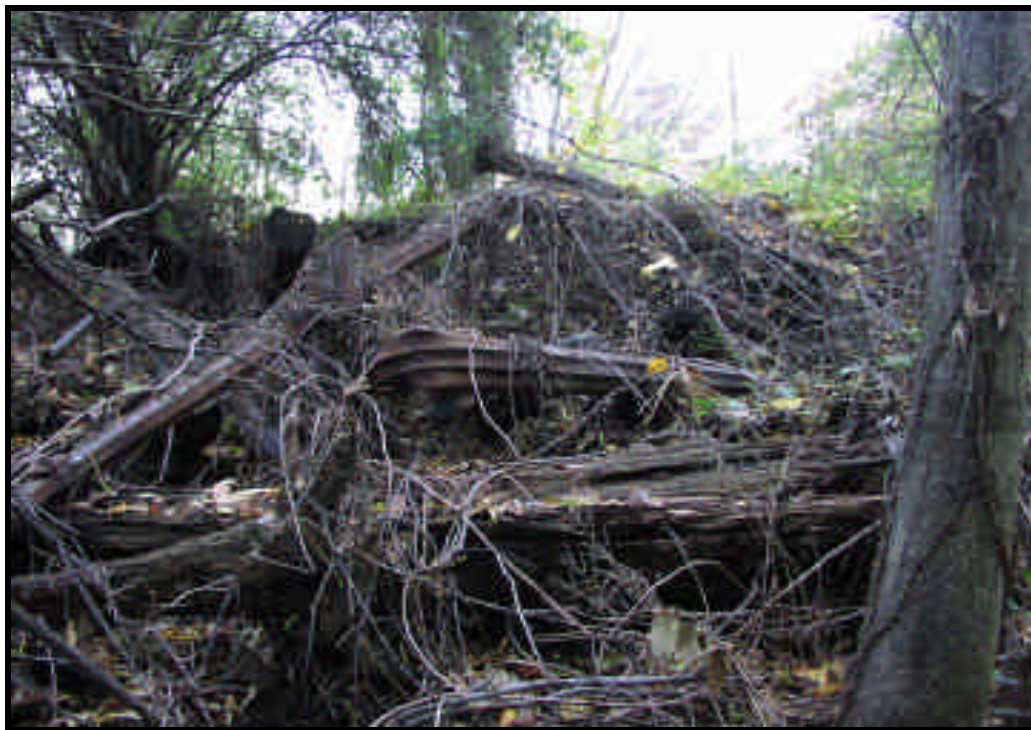
**Photo 8:** Large debris pile with lamp posts D.C. Lanham area of the Site (photographed on November 19, 2002).

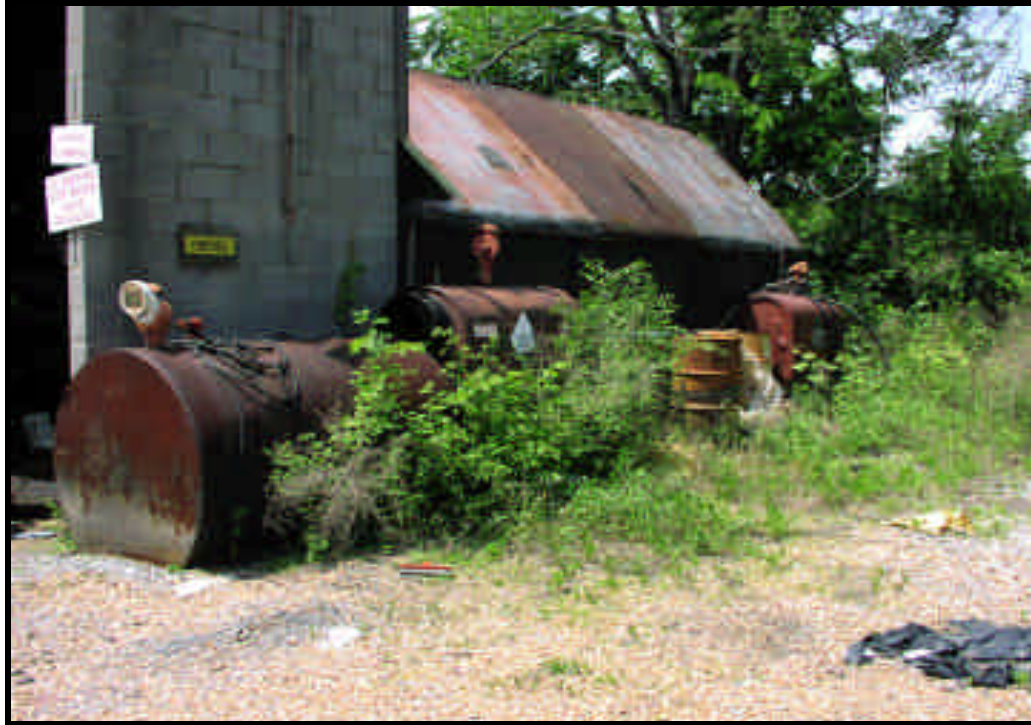
Green Fuel Oil Inc. is adjacent to southwestern corner of the D.C. Lanham area of the Site. Five above ground storage tanks (ASTs) and several fuel trucks were observed on the Green Fuel Oil Inc. property. Staining was observed on one of the ASTs and on the ground surface beneath the AST. The ASTs, staining, and fuel trucks observed on the Green Fuel Oil Inc. indicate that the property is a REC in connection with the Site.

**Photo 9:** ASTs located near the central portion of Green Fuel Oil Inc. property, facing southwest (photographed on May 8, 2002).

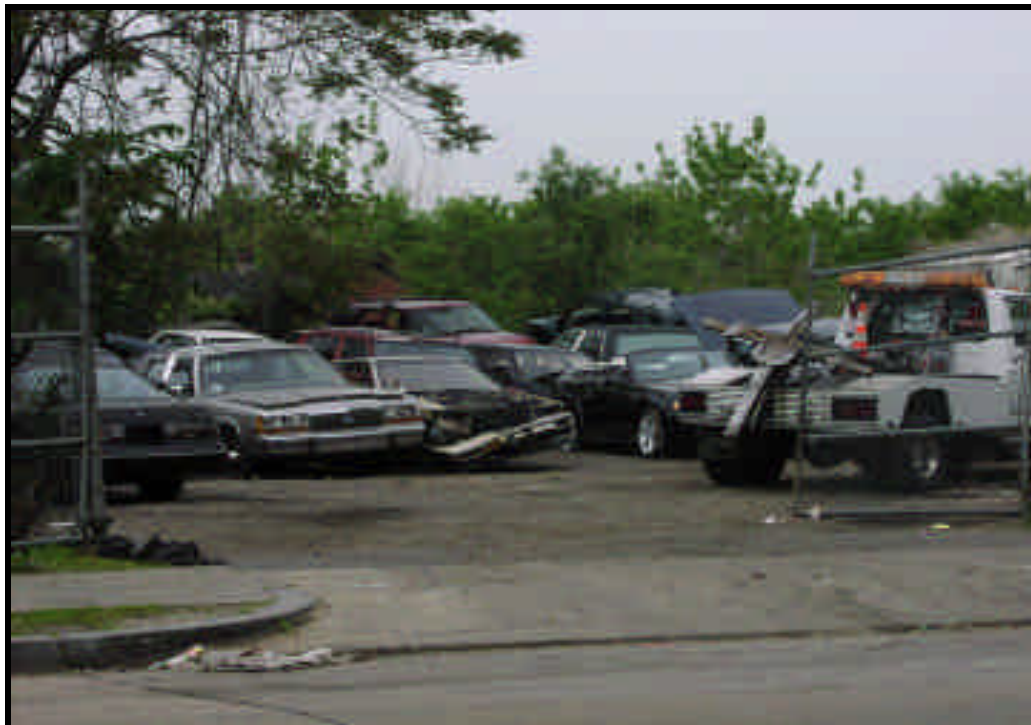
P & P Auto operates an automobile scrap yard and a trailer storage yard adjoining the southeastern corner of the D.C. Lanham area of the Site. Several scrap automobiles, automobile parts, and debris were observed on the automobile scrap yard property. Staining was observed on the ground surface near some of the debris in the scrap yard property. The staining and scrap automobiles represent a REC in connection with the Site.

**Photo 10:** Overview of the P&P Auto Body property adjacent to the southern portion of the D.C. Lanham area of the Property, along Howard Road (photographed on May 6, 2002).
