Color Plate 1

Fig. 3 (Chapter 3). Trends in Microcystin Occurrence in Midwestern Lakes. Taken from Graham et al. 2004. (See page 54).

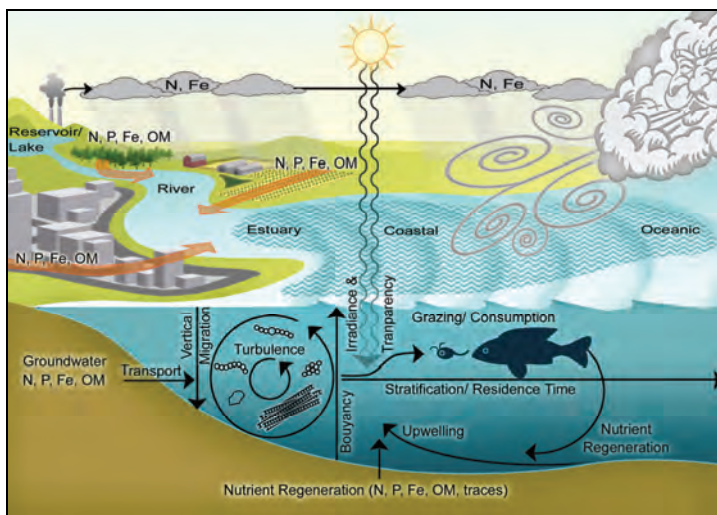
Fig. 4 (Chapter 10). Conceptual diagram, showing the interactive physical, chemical and biotic controls of cyanobacterial blooms along the freshwater-marine continuum. (See page 221).

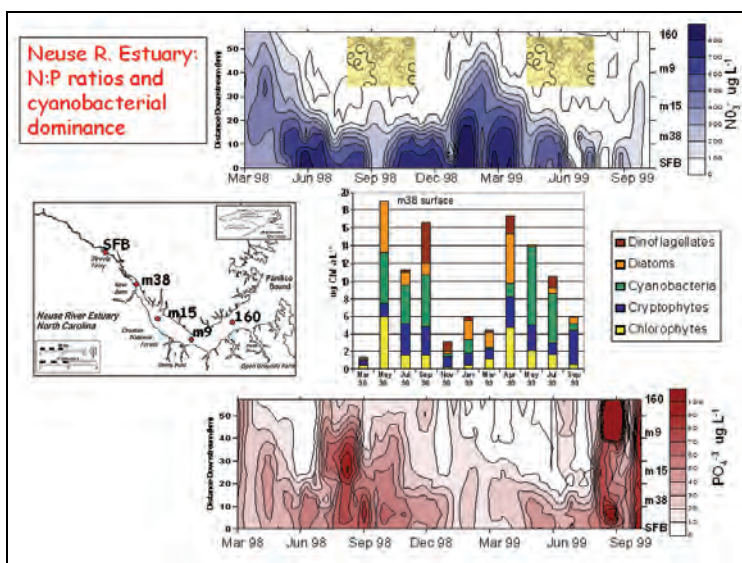
Fig. 5 (Chapter 10). Relationship, in space and time, of nitrate and phosphate concentrations, and relative dominance by cyanobacteria in the Neuse River Estuary, NC. Phytoplankton composition along a transect of 5 locations ranging from the upper oligohaline to lower mesohaline segments of the estuary was determined using high performance liquid chromatographic (HPLC) analysis of diagnostic (for major algal groups) photopigments (see Paerl et al. 2003). The period during which N_2 fixing cyanobacteria were present is indicated by the photomicrograph in the upper frame. (See page 223).
