MONITORING REVIEW
FOR
HUSSEY UPLAND RESTORATION
PROJECT

**OWEB Effectiveness Monitoring Report – Fence,
Water Development, Grazing Management**

OWEB Grant #: 205243

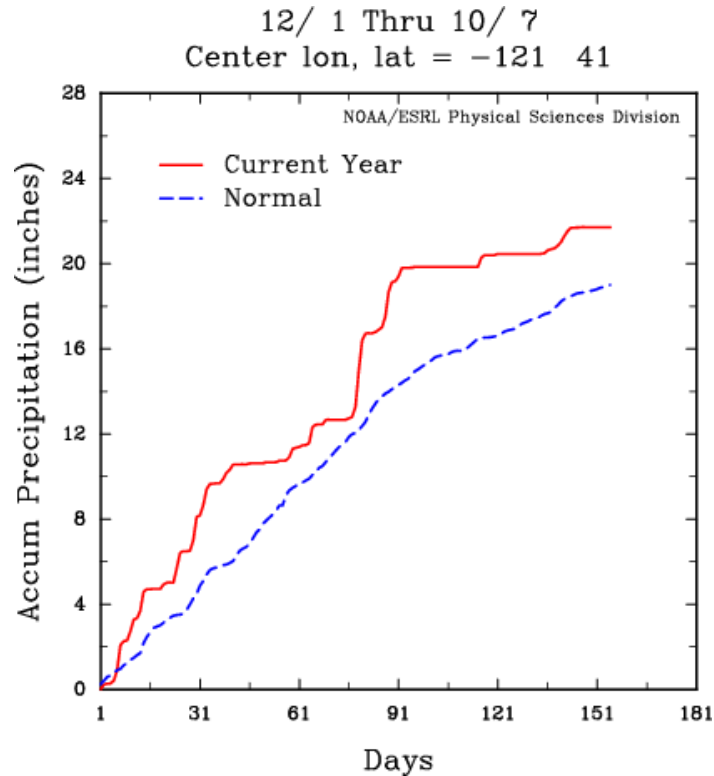
I ran a report from NOAA/ESRL Physical Sciences Division on precipitation amounts in the project area and felt that because the annual precipitation was significantly lower than normal that vegetative production was lower than normal and in the future maybe an adjustment in AUM's harvested would be appropriate.

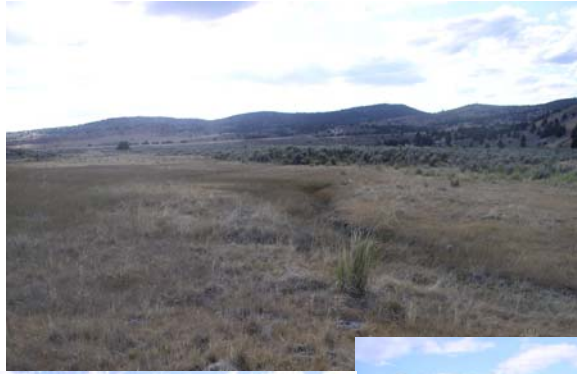
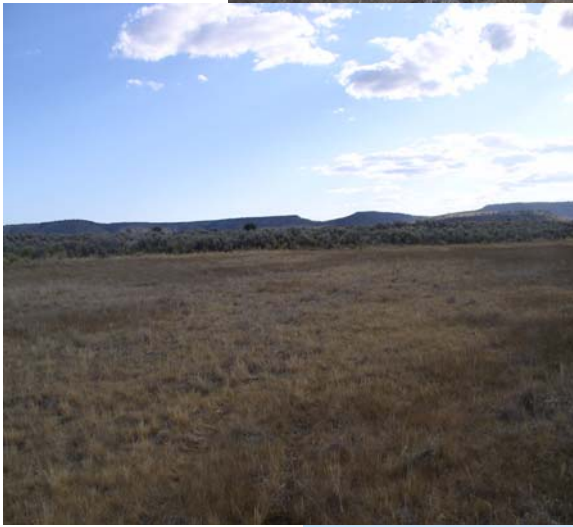
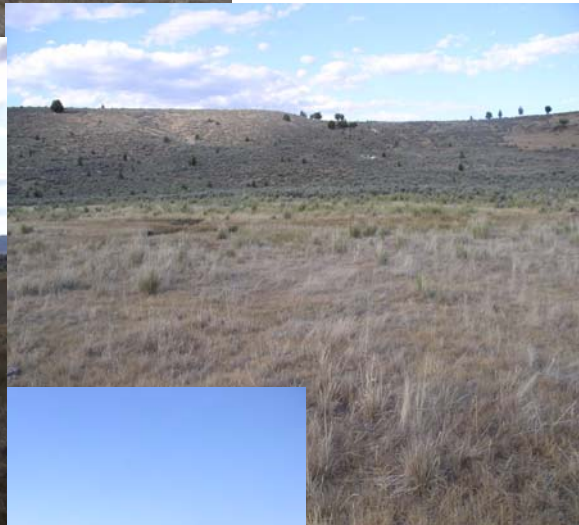
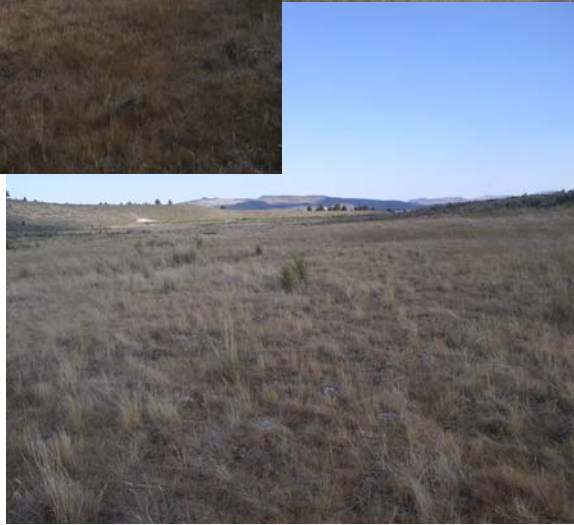
Conclusion: This is a meadow site that has had rotated grazing for 3 years now. Notice how dry the meadow is. The spring and summer of 2007 has been one of the driest years in history.

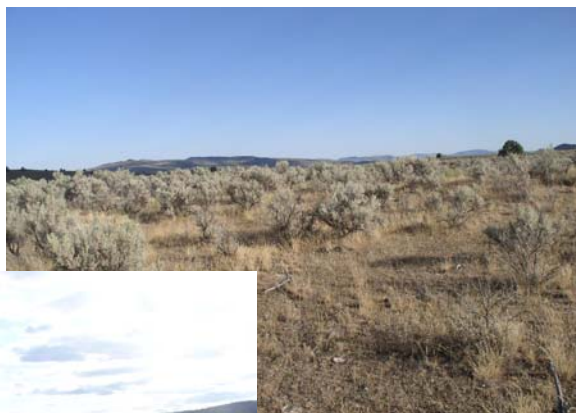
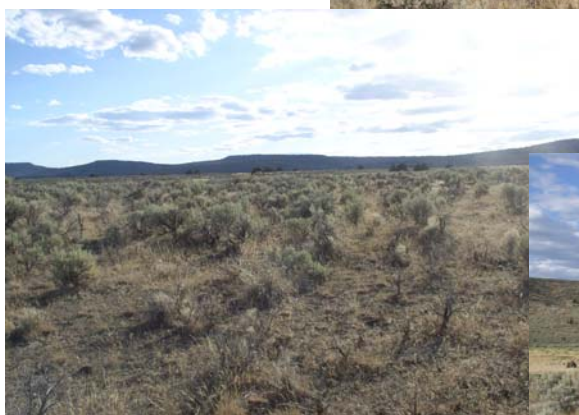
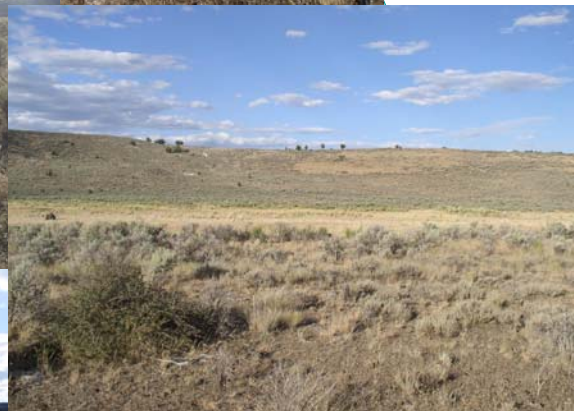
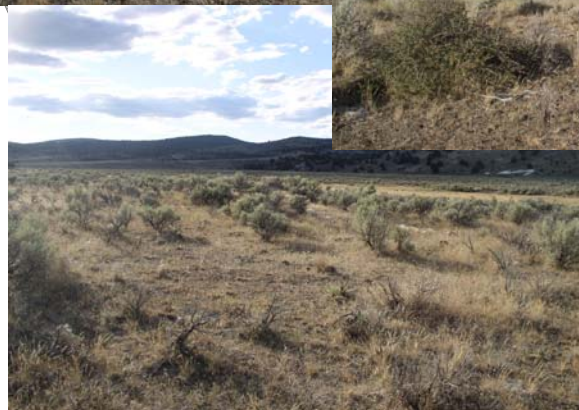
Evidence of Overland Flow: Slight

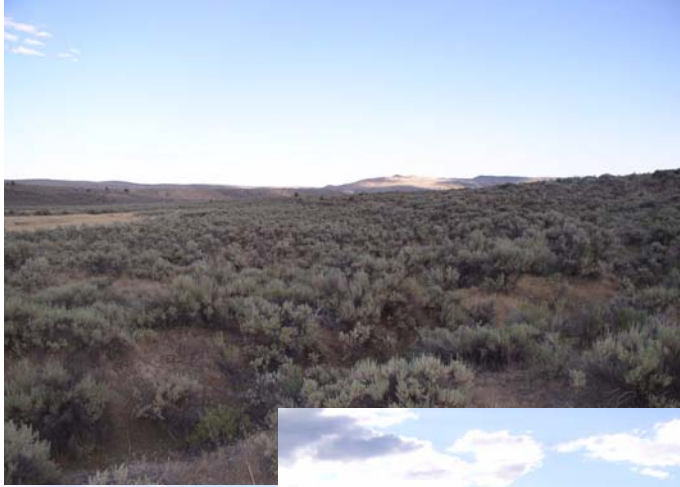
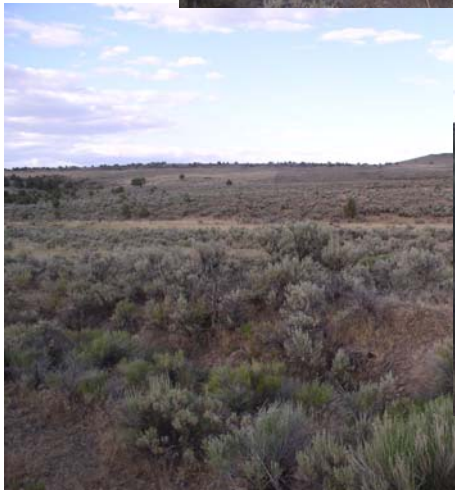
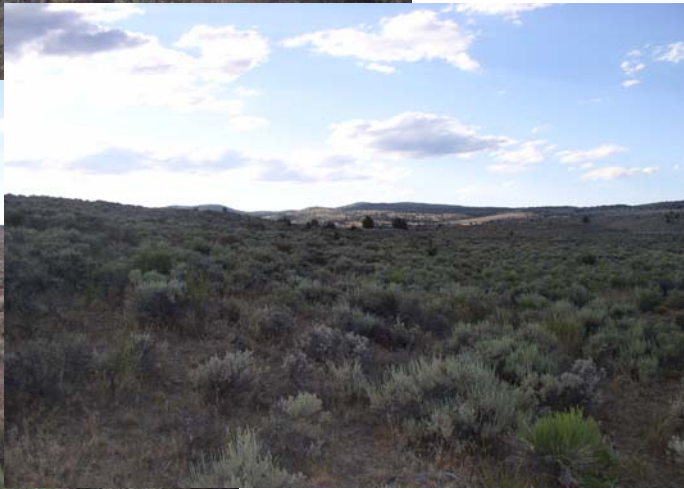
Conclusion: Upland site.
