In May of 2003, the Tenmile Lakes Basin Partnership (TLBP) passed a motion initiating the development of Tenmile Lakes Watershed Monitoring Program as a part of implementing the Watershed Council's Action Plan and recommended activities that were recommended within the draft Tenmile Lakes TMDL.

This report is to fulfill the TLBP's final report requirements of this monitoring project, grant 204-282. Work within this contract completed an approved QAPP, over 600 volunteer hours, in addition to our individual monitoring components as well as development of the Watershed Council's web page. All of these monitoring activities were specifically designed to provide information on the apparent decline of water quality and native fish habitat within the basin.

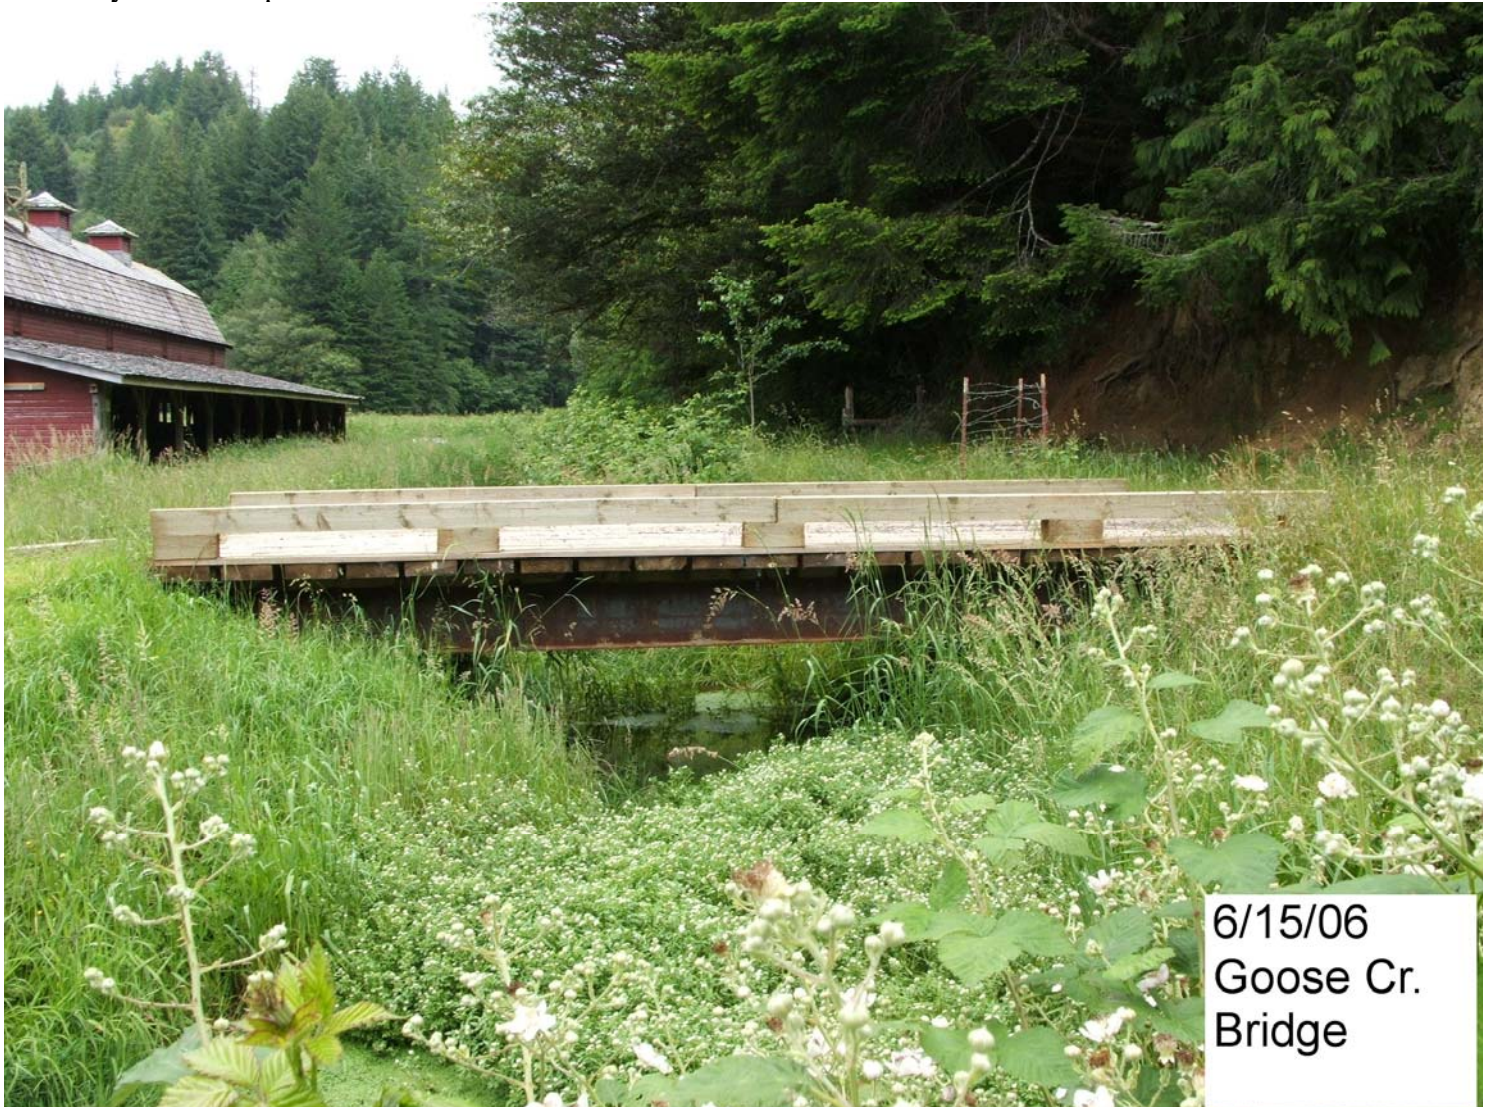
Thirty stream crossing upgrades, culverts replaced with bridges, were monitored for effectiveness of improving fish passage and reduction of sediment inputs from these sites. The monitoring question for project type number 1 is; Are storm related turbidity responses reduced? The results of our monitoring of these sites revealed that after an initial flushing of "stored" sediment behind these crossings, storm related turbidity is dramatically reduced when improperly placed and sized culverts are replaced with bridges. In addition, stream channels were observed to function more like the "natural" stream conditions and Coho fry were commonly observed using bridges as sanctuary from bird predations.

Photo 1. Summer monitoring photo of Goose Creek Bridge site.

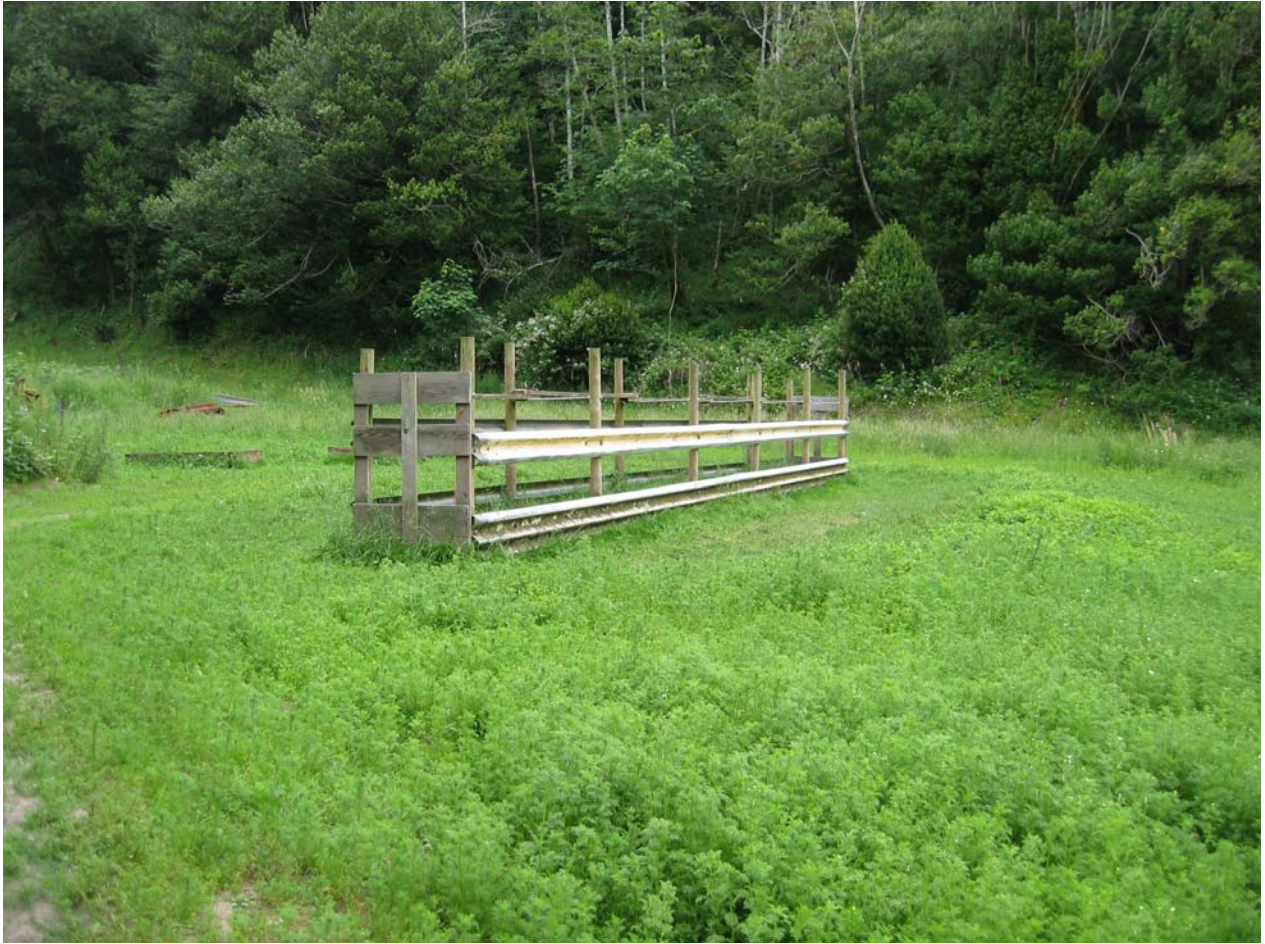
Two Nutrient Management projects, located in the Big and Noble Creek subbasins were monitored to determine if project type reduced nutrient loading into the Lakes from these sites. Monitoring of these sites which included Nitrogen and Phosphorus grab samples and use of a turbidity meter. Monitoring revealed that actions within the Nutrient Management projects, bioswales and gutters to feed buildings have little impact on nutrients entering adjacent tributaries and Lakes from these livestock operations.

Photo 2. Big Creek Nutrient Management site.

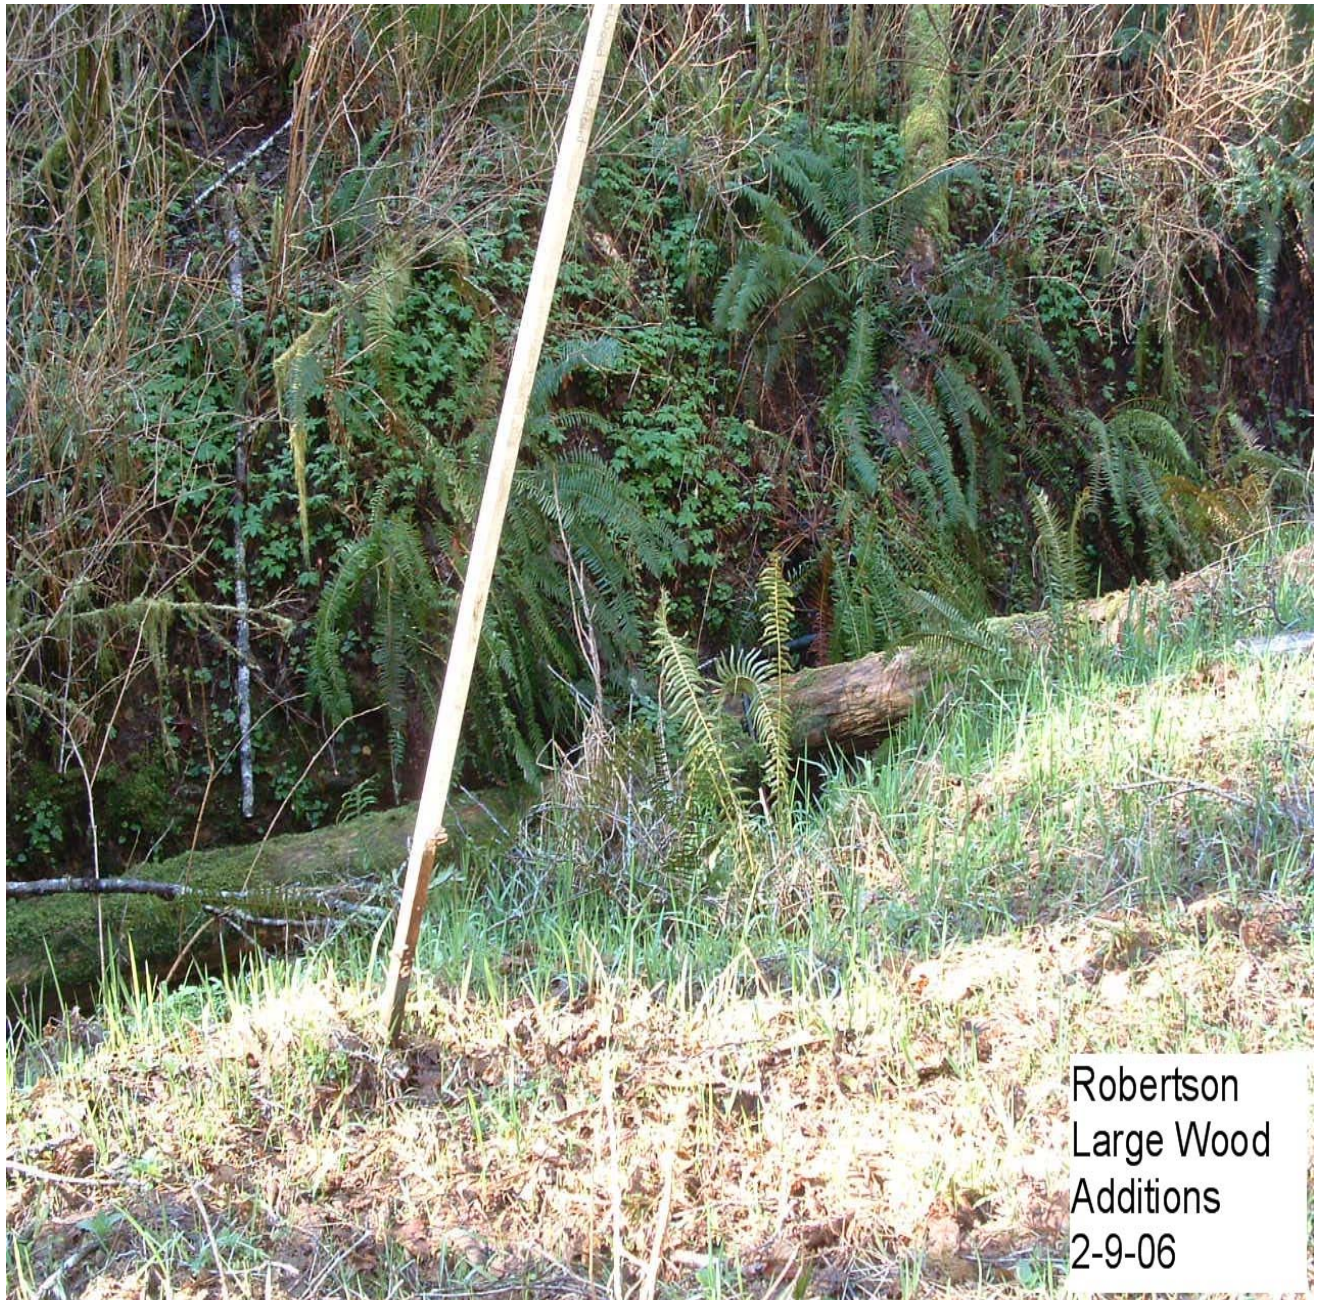
Four Large Woody Debris projects located in the Big Creek and Robertson Creek were monitored over the period of this monitoring project. Monitoring during low and high flow events was implemented to determine effectiveness of structures improving stream habitat conditions. Monitoring revealed mixed results from this project type. For the Sunlake Tributaries of Big Creek, both LWD sites revealed that they added very little to channel complexity. With the amount of upslope erosion and soil movement through this system, both structures were completely buried by sediment during the first high flow event. Visual observations through winter reveal that the structures were unburied and buried under sediment through out the winter but did not create the rearing pools as designed and planned. The thirteen Red Cedar logs placed in Robertson Creek did not achieve any better results than those on Sunlake. None of these structures were cabled in and all moved significantly from one high water year to the next so did not improve stream habitat conditions on Robertson Creek. Visual observations of the Robertson LWD structures will be increased due to close proximity of structures to the Upper Robertson Bridge and Fence.

Photo 3. Robertson LWD monitoring site.

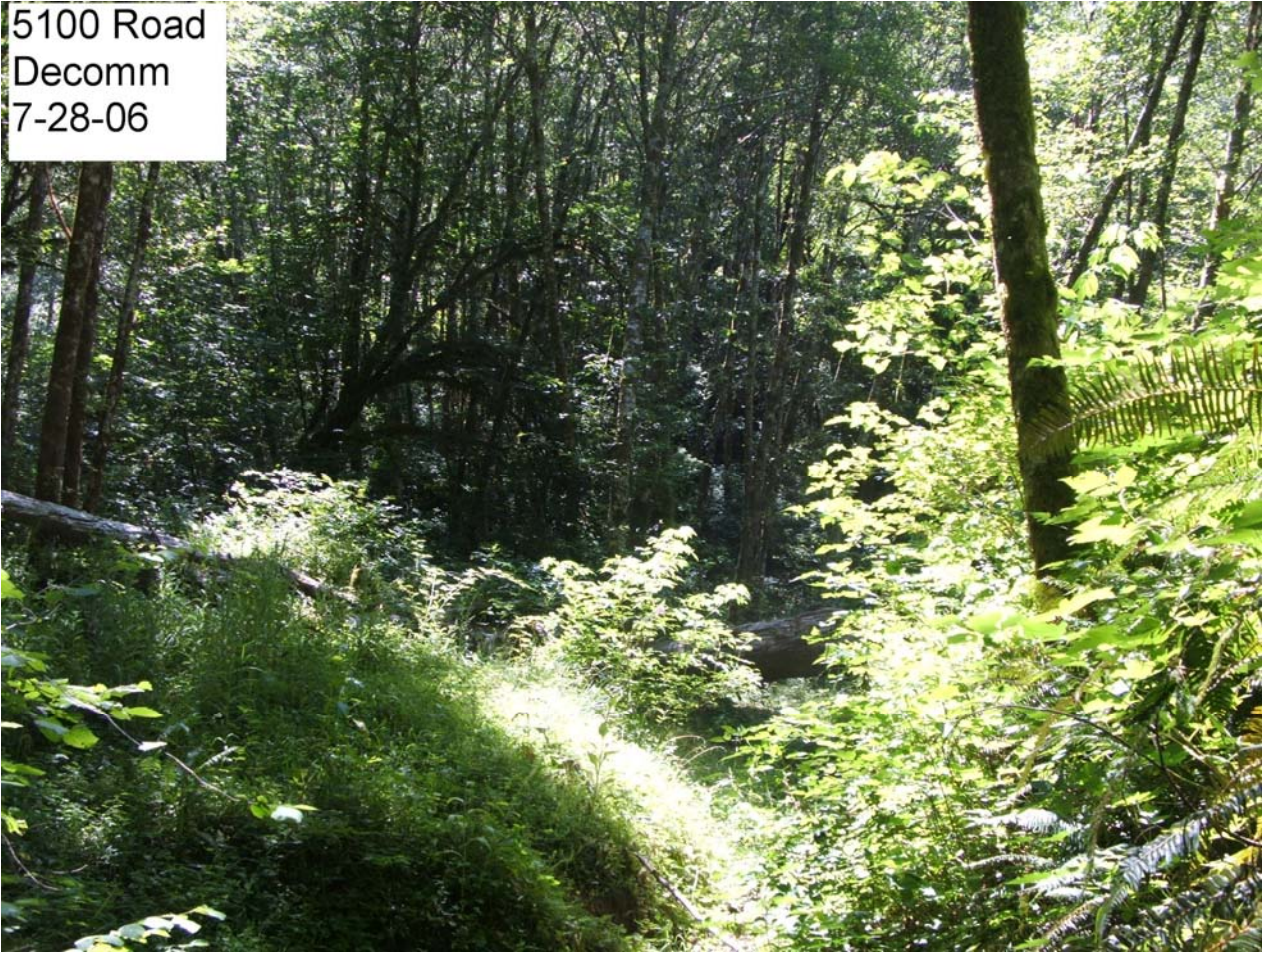
5100 Road
Decomm
7-28-06

This project supported effectiveness monitoring of two completed Road Decommissioning projects, the ESF 5100 road and 2100 road. The question that our monitoring sought to answer was did our activities reduce turbidity from these sites. With no Premonitoring of these sites it is very difficult to quantify results but our visual observations of these sites reveal that this type of project implemented correctly results in reduced sediment inputs from these Legacy roads. Its important to note that applying erosion control grass seed will most likely have to be reapplied due to shading from overhanging sources.

Photo 4. 2100rd monitoring site.

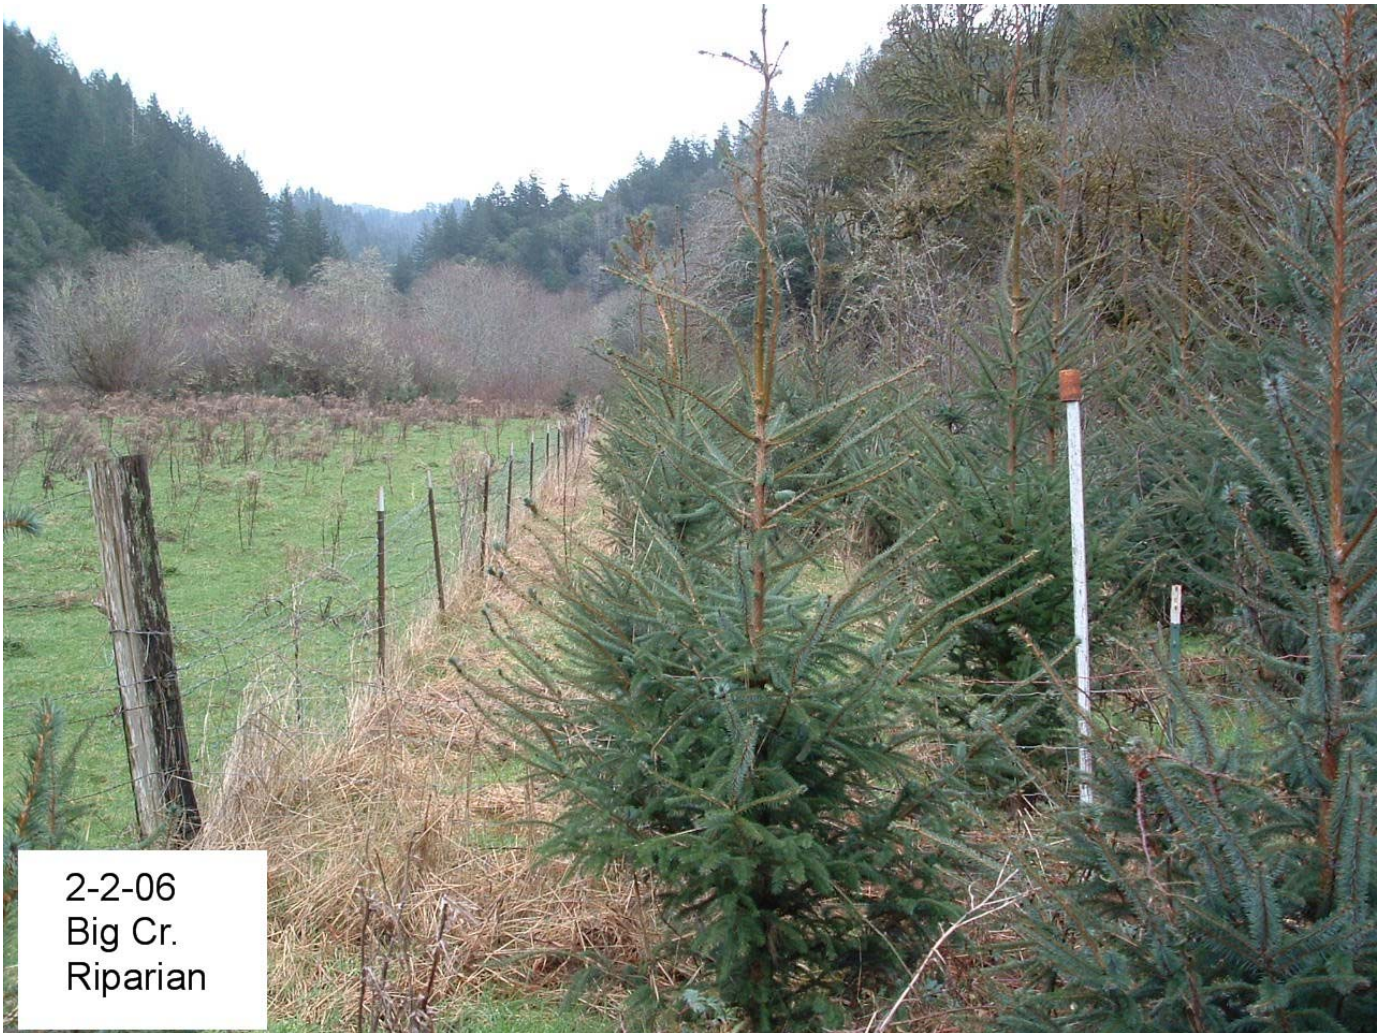
Riparian planting along eleven stream reaches was monitored for effectiveness of improving shade conditions and decreasing stream temperatures. Our results are inconclusive at this time on how our riparian plantings are impacting shade conditions on these tributary reaches. Even at those “microsites” that were planted with 7-14 foot tall transplants our monitoring was unable to determine impacts on shade. Monitoring results did reveal several interesting facts. First, transplants supplemented with BH hormone have equal survival rates as nursery stock. Growth of transplants is slower in first year after planting than nursery stock. Second, Sitka Spruce seedlings, either nursery or transplants, have the highest rate of survival for conifer plantings. Third, once free to grow, at least six feet for all species, within these agricultural reaches these riparian plants grow at incredible rates. Sitka spruce planted on Big Creek four years ago grew on average 12-14 feet in height.

Photo 5. Big Creek riparian monitoring site.

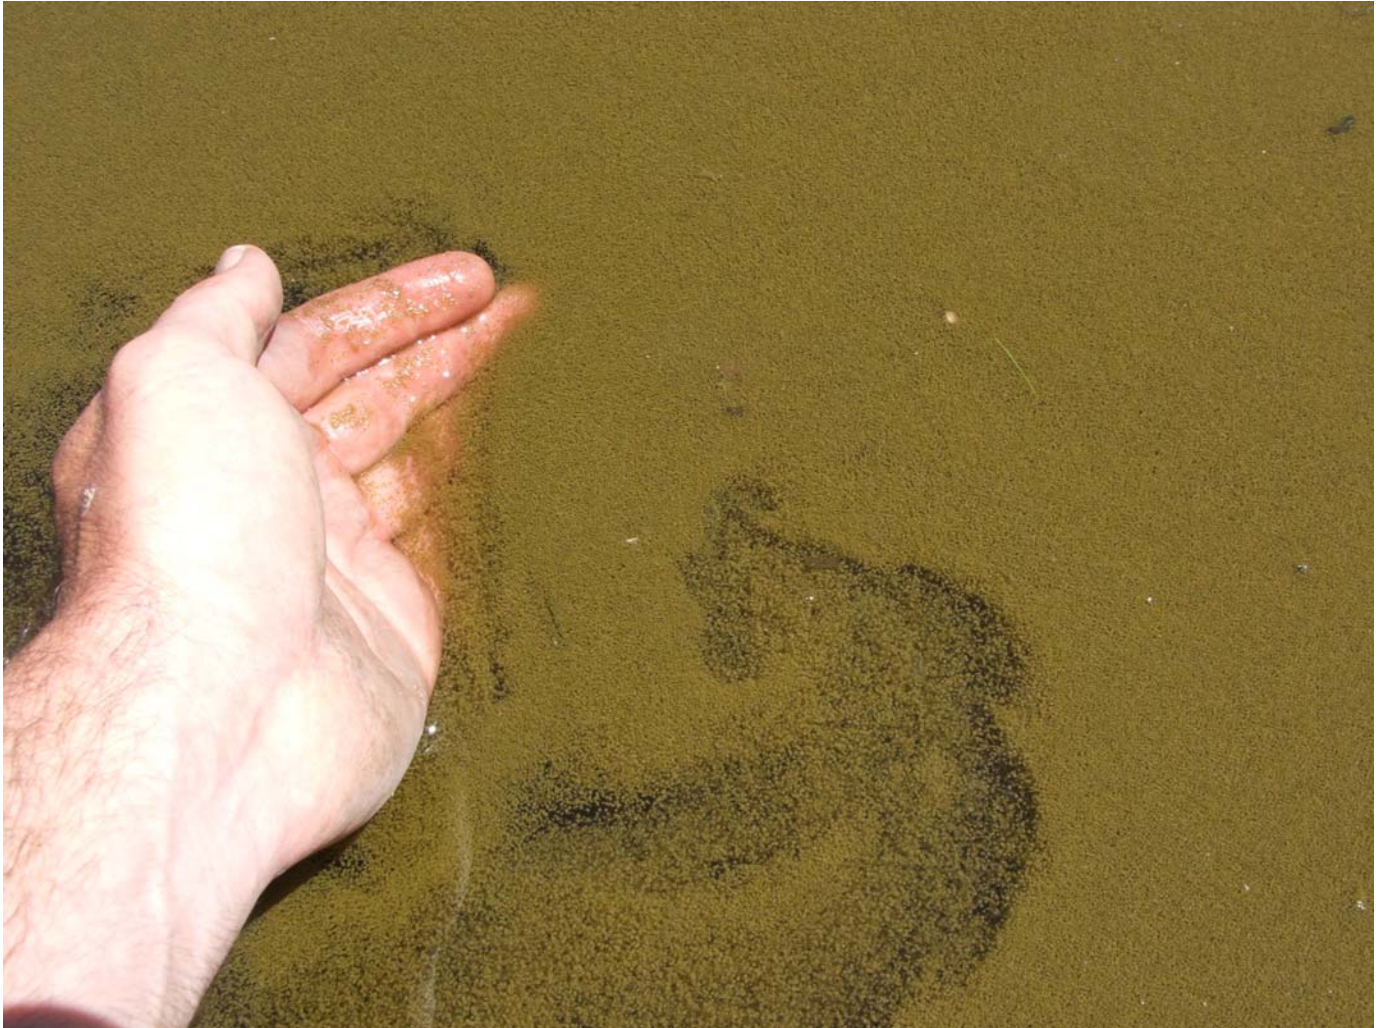
Algae composition monitoring was conducted during the months of June through October at four standard lake sites, 2 in North Tennile and 2 in South Lake. This baseline monitoring was conducted to determine what algae species are present in the Lakes and what Lake conditions results in blooms. This monitoring was successful identified 16 different species within the Lakes. Of which two, *Microcystis aeruginosa* and *Anabaena flos-aquae* can when conditions in the Lakes are right produce harmful toxic blooms. Monitoring reveals that harmful blooms can occur in both Lakes when Lake temperatures remain stable at 68-70 degrees during August through September.

Photo 6. Algal bloom on Templeton arm.

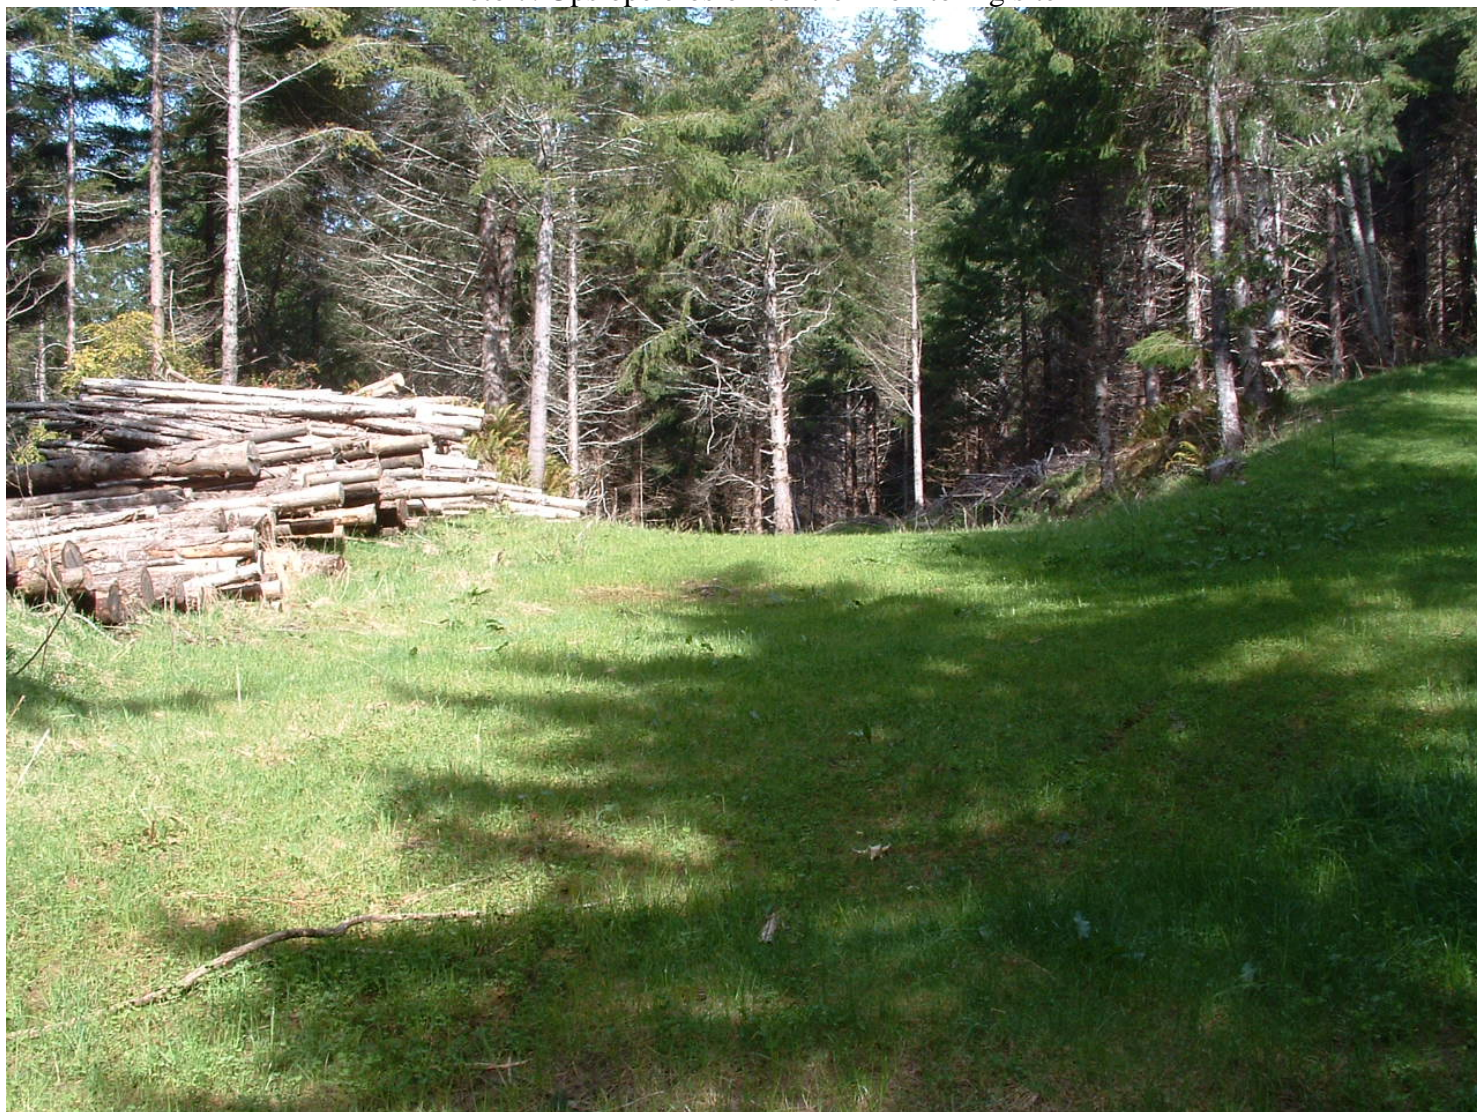
Seven Upslope Erosion Control sites where erosion mix grass seed was applied to disturbed sites were monitored for effectiveness of reducing storm related turbidity responses. Results reveal that where erosion mix has been adequately applied, it is successful in reducing chronic sediment inputs from these small upland sources. Again, it is impossible to quantify results due the lack of Premonitoring at sites. Seeding exposed soils is very effective along roadsides, landings, and impacted riparian areas around Lakeshore. Sites must be exposed to direct sunlight to ensure adequate growth of erosion mix. As shown with Road decommissioning, applying grass seed to heavily shaded areas is not effective.

Photo 7. Upslope erosion control monitoring site

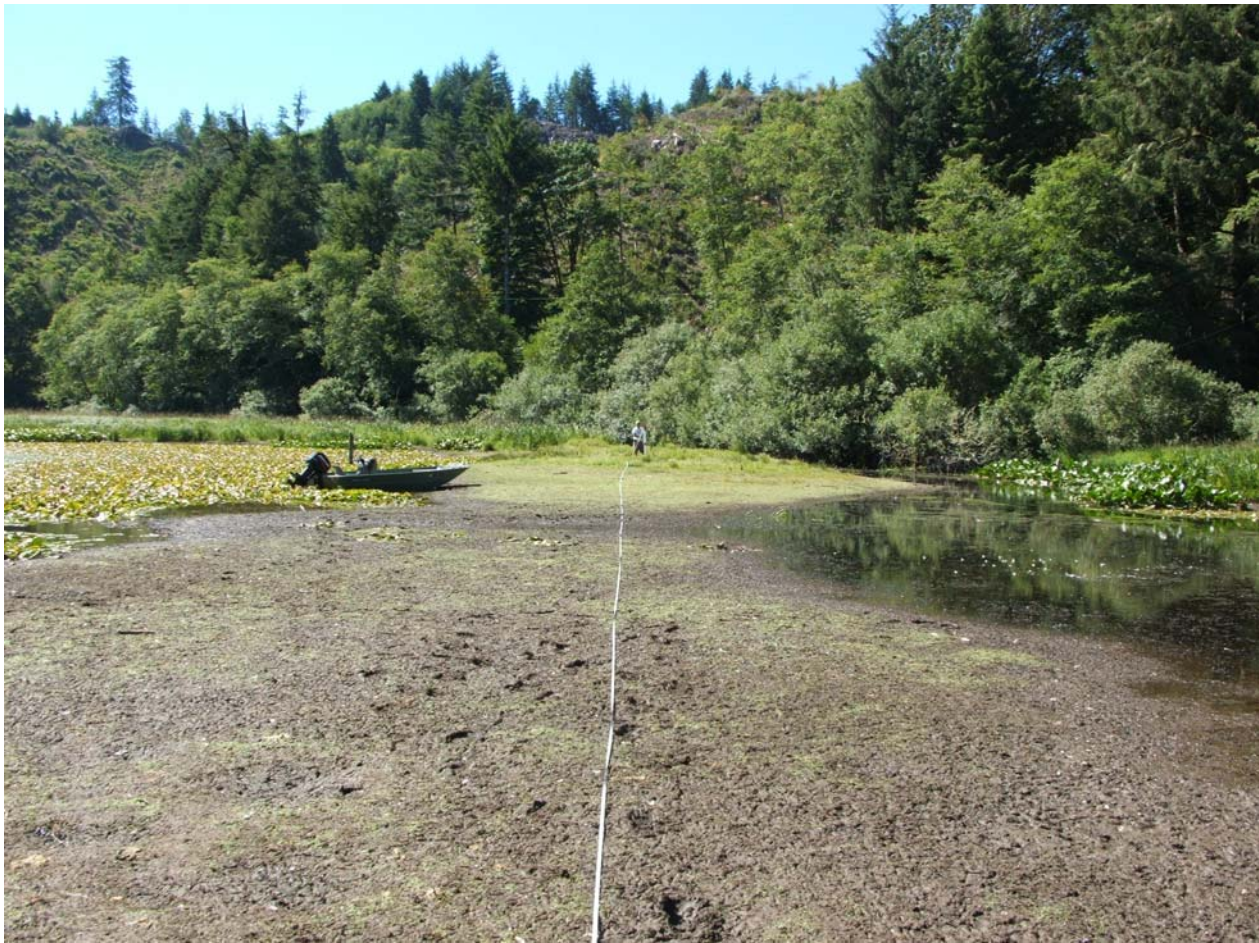
Through the process of developing the QAPP and what should be the monitoring priorities for the watershed it became very evident that tracking sediment accumulation into the Lakes from all sources was a priority for the Monitoring Committee. The Delta Building Study involves surveying four tributary mouths when the Lakes are at their lowest elevations. Transects were established and data collected included length and width at each point. The final product is a 3-dimensional map of each delta survey to provide information on sediment inputs. Every succeeding year, a survey team will survey at same Lake height and re-survey deltas.

Photo 10. Johnson Creek Delta monitoring.

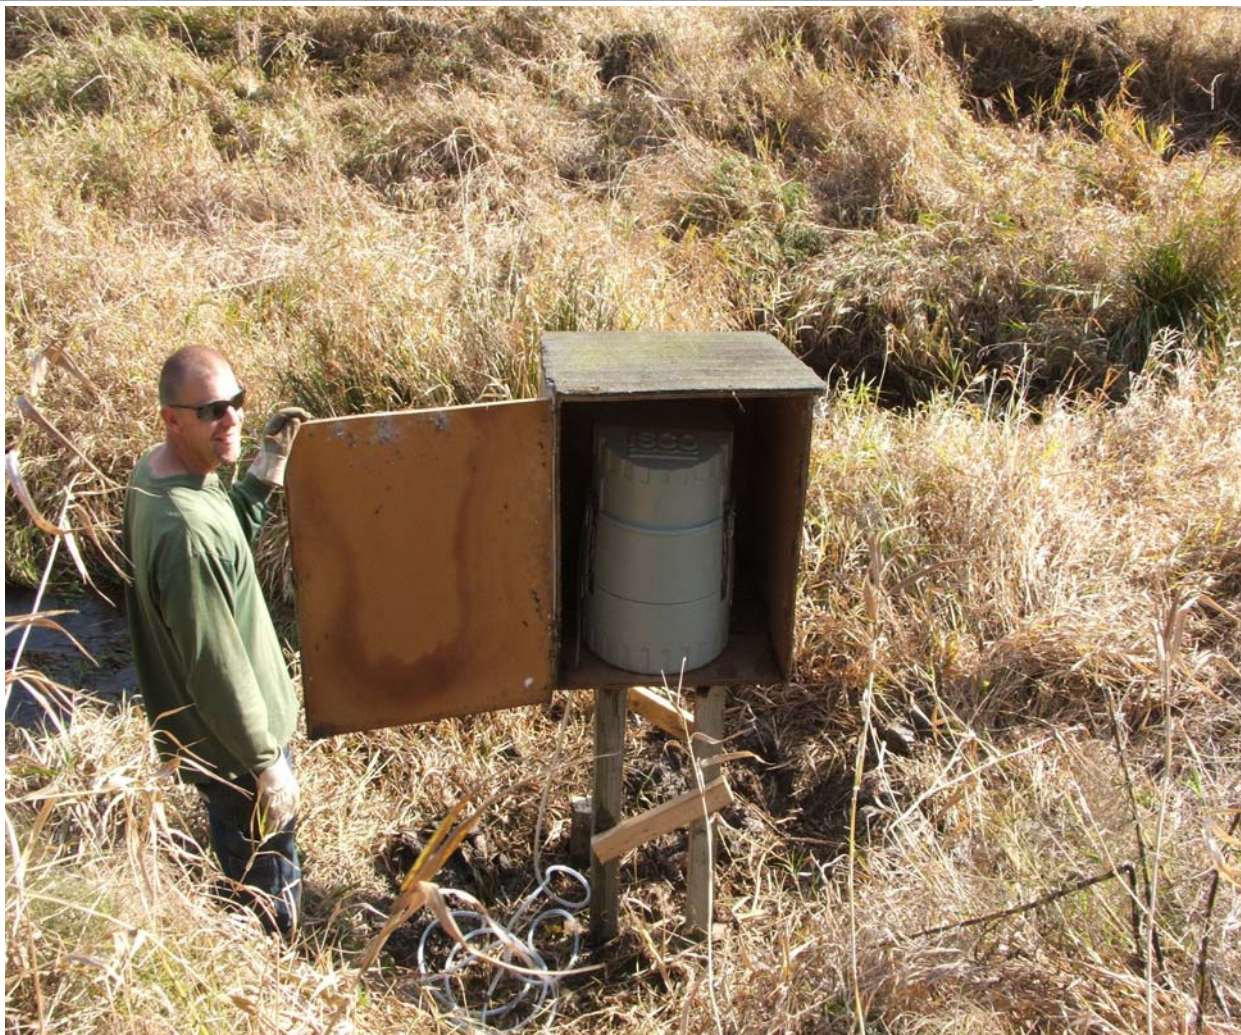
Photo 11. Blacks Creek VEMCO monitoring station.
