EPA CHEMICAL ACCIDENT INVESTIGATION REPORT

**Accra Pac Group, Inc.
North Plant
Elkhart, Indiana**

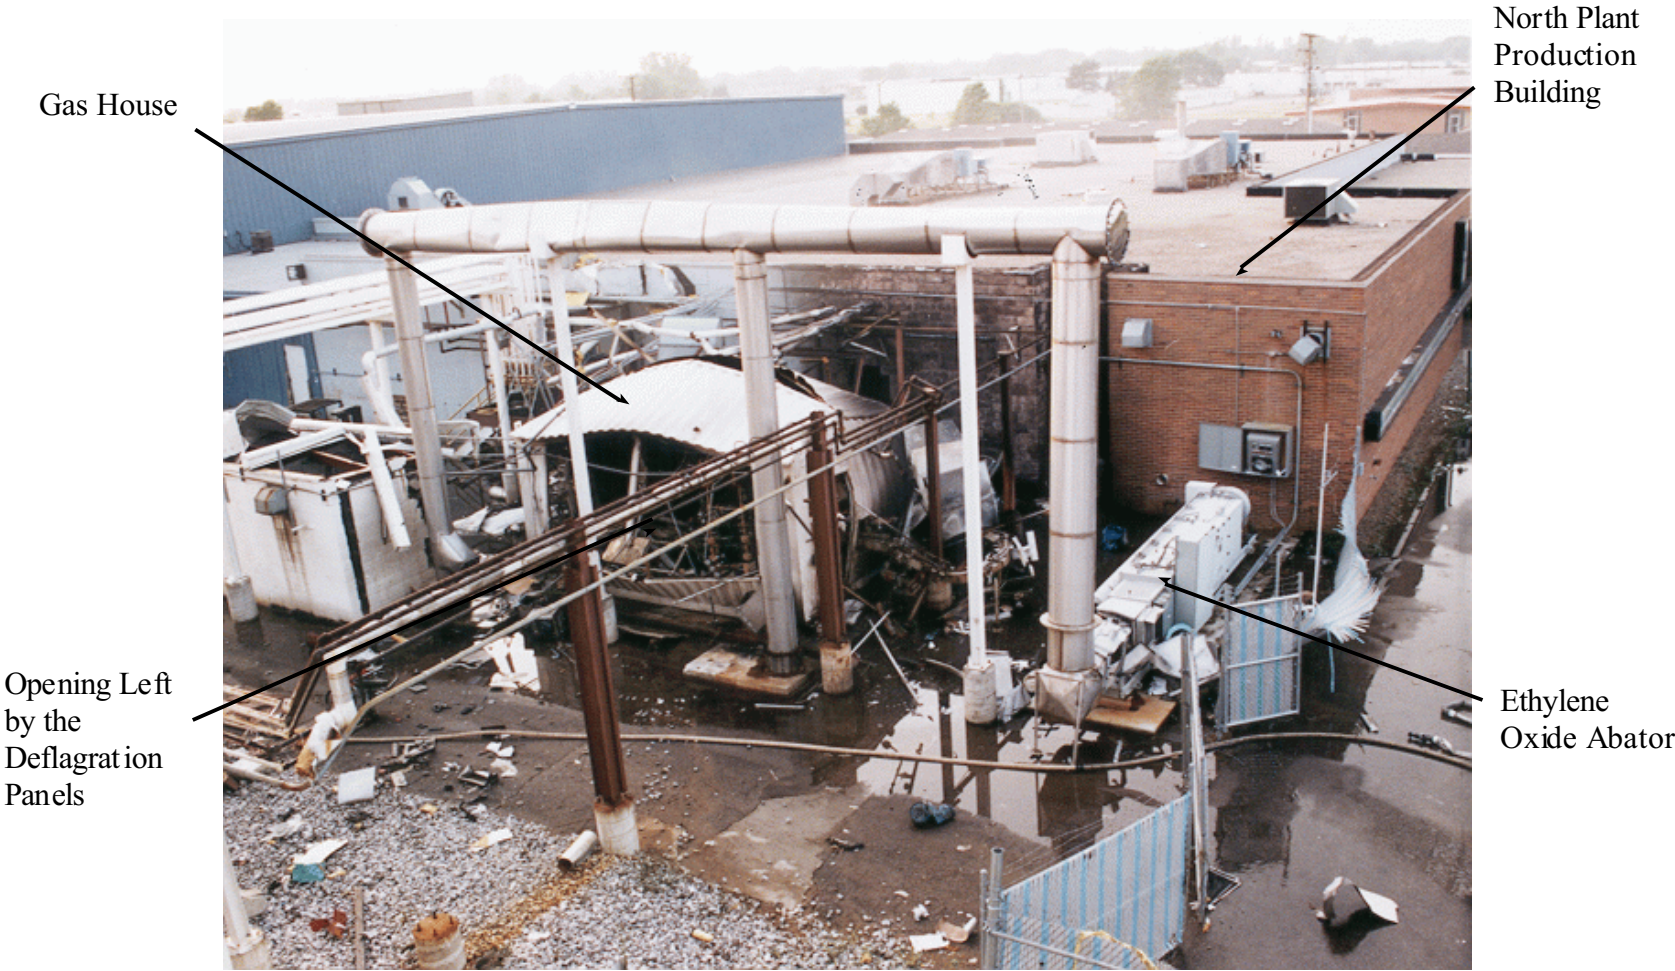
An Accra Pac employee working in the Production Building across from the Gas House was killed as a result of the explosion. When the Gas House doors were blown off, the door facing the Production Building impacted the Production Building door and caused that door and its frame to be dislodged and blown into the Production Building where it struck and killed the employee.

A-1: The Gas House and the Production Building after the explosion and fire.

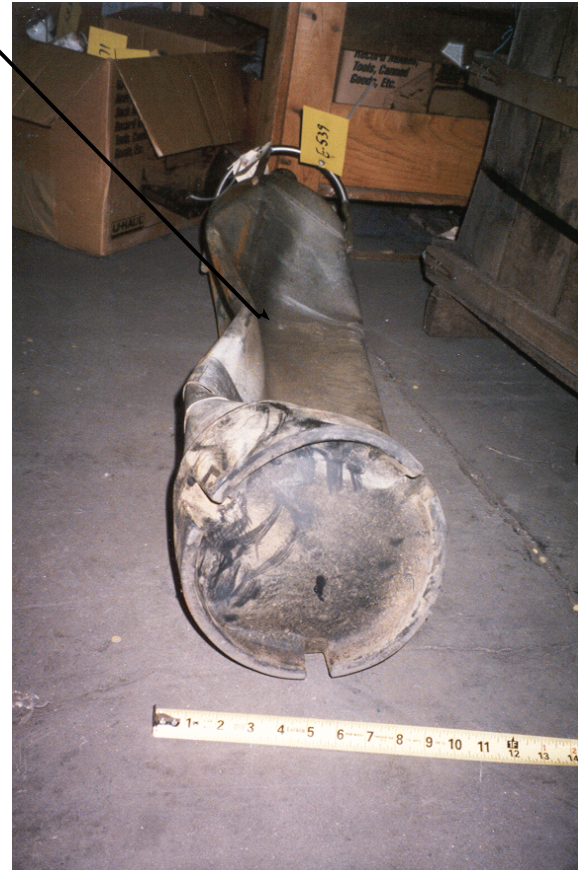
Ethylene Oxide Reclamation Tank

- The ethylene oxide reclamation tank in the Gas House was found to have been crushed by the force of the explosion. (See Appendix A-3) The tank collapsed from three sides leaving almost no void volume. Had the reclamation tank been substantially full of liquid, which is not compressible, the reclamation tank would not have become crushed in the explosion. The reclamation tank showed no signs of puncture or rupture. Thus, any release of ethylene oxide would have had to have occurred in the connectors, valves, or tubing associated with the reclamation tank.

A-3: Side and bottom view of the ethylene oxide reclamation tank after the explosion and fire.

- **Relocate the reclamation tank to a location outside the Gas House to reduce the amount of hazardous material inside the occupied building.** In the event of a tank leak, this would reduce the likelihood of injury to the occupant of the Gas House. Also, **develop a way to monitor the quantity of material in the reclamation tank.** This capability is necessary to avoid overfilling which can lead to an accidental release. Finally, **install a non-return check valve on the reclamation tank.** This would minimize any release should the feed line or any connectors leading to the reclamation tank fail.
