NOAA Technical Memorandum NMFS-AFSC-147

# **Electronic Monitoring of Seabird Interactions with Trawl Third-wire Cables on Trawl Vessels - A Pilot Study**

H. McElderry, J. Schrader, D. McCullough, J. Illingworth,  
S. Fitzgerald, and S. Davis

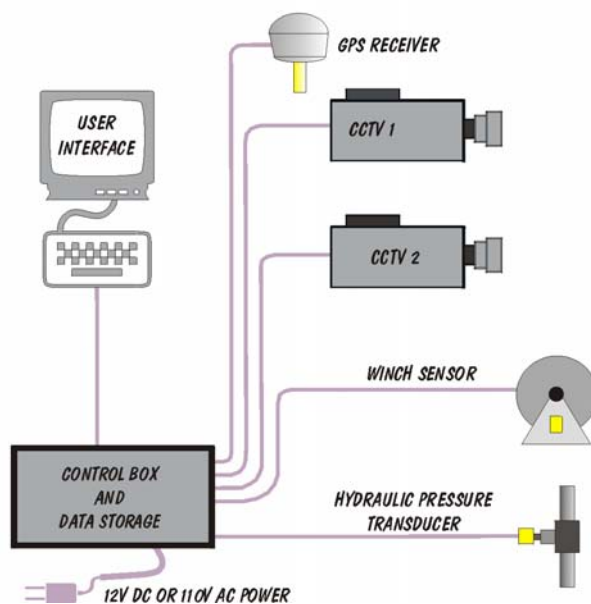
**Figure 1.** Schematic of electronic monitoring system.

The control box contains the operating system, data storage components, and power supplies for the video cameras and peripheral vessel sensors. The control box is a robust aluminum container approximately the size of a briefcase. It is spill-and-splash resistant but not adequately weatherproof for on-deck deployment. The box has about 0.5 cubic feet of dry and ventilated interior space for storage. The space must also be reasonably accessible to service technicians. On larger fishing vessels the monitoring system is usually powered by the onboard 120-volt AC supply although it can also be powered by a 12-volt DC source. Video camera and sensor cables are routed from the external devices to the internal control box through cable glands or compression fittings to maintain the hermetic integrity of the deckhouse structures.

The two core components in the control box are the data-logging and video computers. The data-logging computer captures and records sensor data to provide a digital time series record of the vessel activities. Post-processed sensor information can be used to detect specific actions on the vessel, such as setting or hauling fishing gear. The chronology of fishing activity derived from the time series is used to identify time-matched video segments for review. The data-logging computer can also activate the video computer whenever fishing activity is evident in the sensor data stream. In pilot programs, software control of the video computer is generally not used.

The video computer digitizes the incoming analog camera signal and stores the video imagery on removable computer hard disks. The video computer can be set to collect imagery at a wide selection of timelapse frame rates and digital compression ratios. Video frame rate and compression settings are optimized to deliver the highest quality image with the lowest storage space requirement.

The EM system integrates an assortment of available digital video and computer components with a proprietary software operating system to create a unique and powerful data collection tool. The system can operate on either DC or AC voltage to log video and vessel sensor data during the fishing trip. The EM system automatically restarts and resumes program functions following power interruption. The instrumentation can be configured to start recording video at power up or the software can be set to automatically activate video collection whenever fishing activities are recognized in the sensor data. The system components are graphically depicted in Figure 1 and described in the following text.

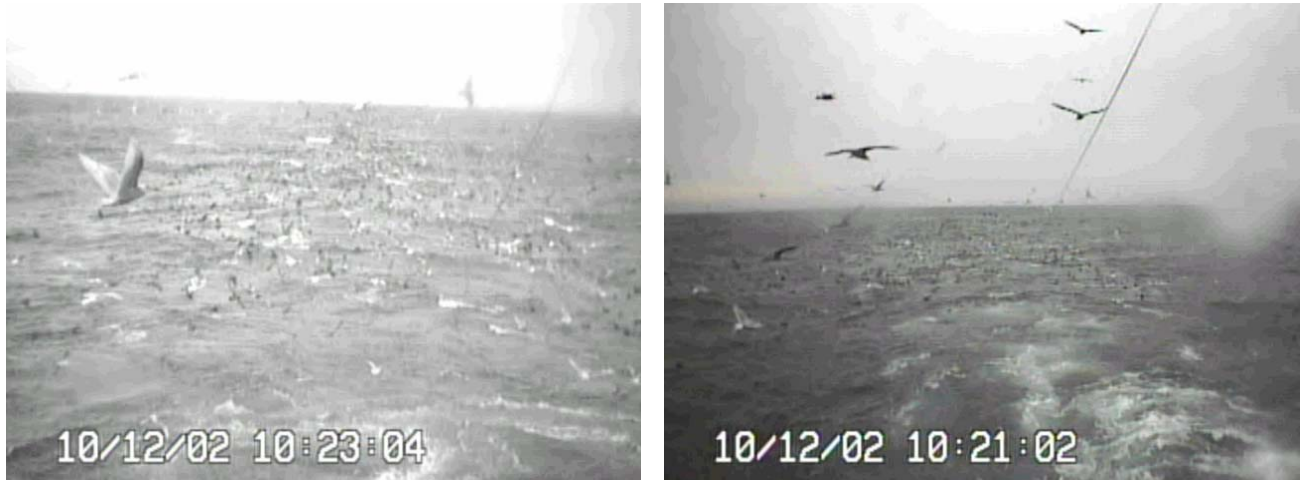
**Figure 2.** An example view from the twin camera system mounted on each vessel. The left view is a black-and-white image and the right is in color.

Two types of cameras were selected for deployments: a high resolution (570 TV lines), black-and-white camera and a standard resolution (350 TV lines) color camera. The black-and-white camera is considerably more sensitive to light (0.16 Lux @ f/2) than the color camera (1.0 Lux @ f/2) and thus has enhanced image resolution during low light conditions.

Initially, camera positions were targeted for the trawl deck where the trailing third-wire and flying seabirds could be viewed in greater contrast against the lighter background of the sky. However, most mounting locations on the net deck are exposed to heavy equipment and were thus deemed unsuitable for camera placement. To avoid damage to cameras and possible obstruction to net and line handling activities, cameras were placed near the third-wire winches, one deck level above the trawl deck. At this level, there were several safe mounting locations, either on the third-wire tow davit or nearby handrails; however, the higher camera position compromised image quality with the trailing third-wire and airborne seabirds appearing against the darker background of the sea. Figure 2, shown above, displays the two views provided by the cameras. It is important to note that a reduction in image quality occurs when taking still images from video imagery (image grabbing).

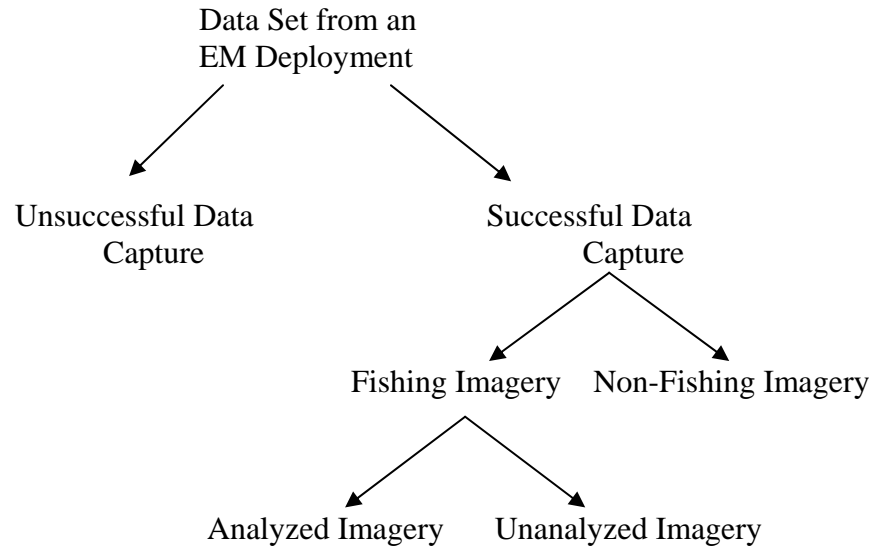
**Figure 3.** Flowchart showing the data set inventory categories.

Data sets from EM deployments were inventoried to assess the overall success of data capture and to identify elements of the fishing trip for more detailed analysis of the imagery. The inventory process is outlined in a flowchart in Figure 3, showing the categories used to separate the EM data set. The first tier in the process was to distinguish successful EM trips from those that were unsuccessful. Within the successful EM trips, the data set was further subdivided into fishing and non-fishing components. Lastly, within the fishing component of the data set, the data were divided between what could and could not be analyzed. The reasons for and the criteria used to create these separations are described in more detail in the following sections.

The initial viewing of the imagery also served to help conserve storage space. Selective portions of video were archived so that hard drives could be reused on subsequent trips. If the imagery for a trip was not saved in its entirety, portions that were useful for further analysis were saved. The criteria used to select imagery to be saved included, but were not limited to: imagery that occurred during fishing operations, imagery with sufficient light available for viewing, and imagery with seabirds present. Other portions of imagery may also have been saved, but would not be included in the analyzed imagery (Fig. 3).
