Riparian Areas: Conditions, Implementation and Effectiveness

Oregon Plan Habitat Team

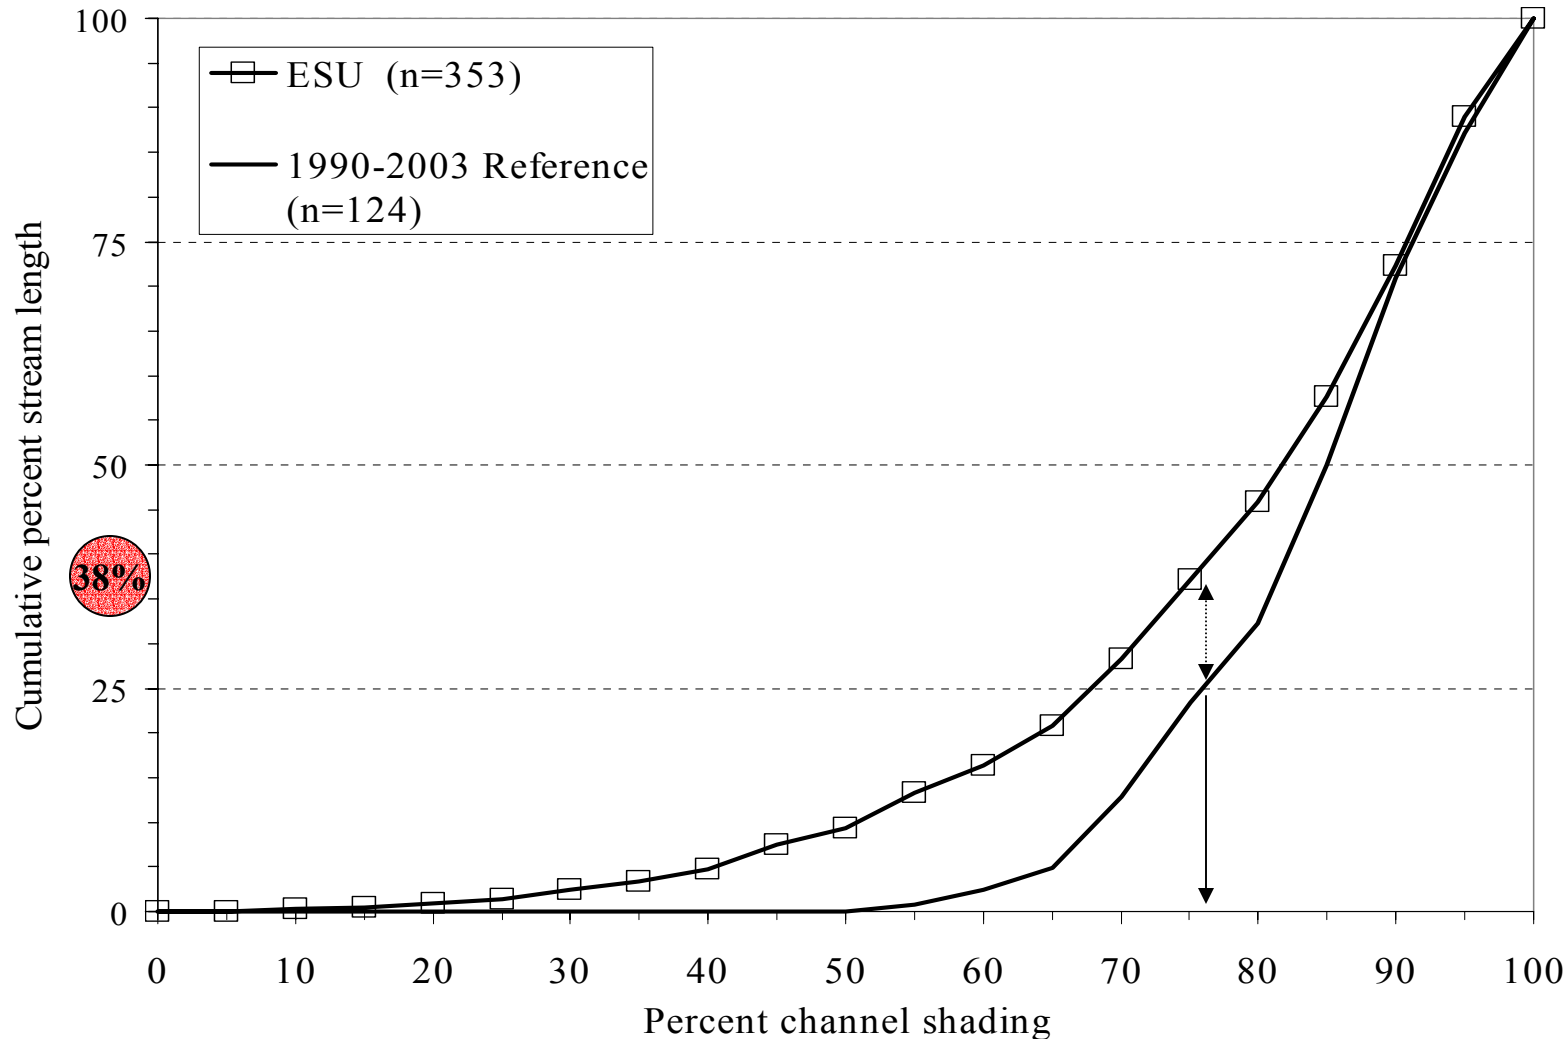
Shade Conditions: Random And Reference

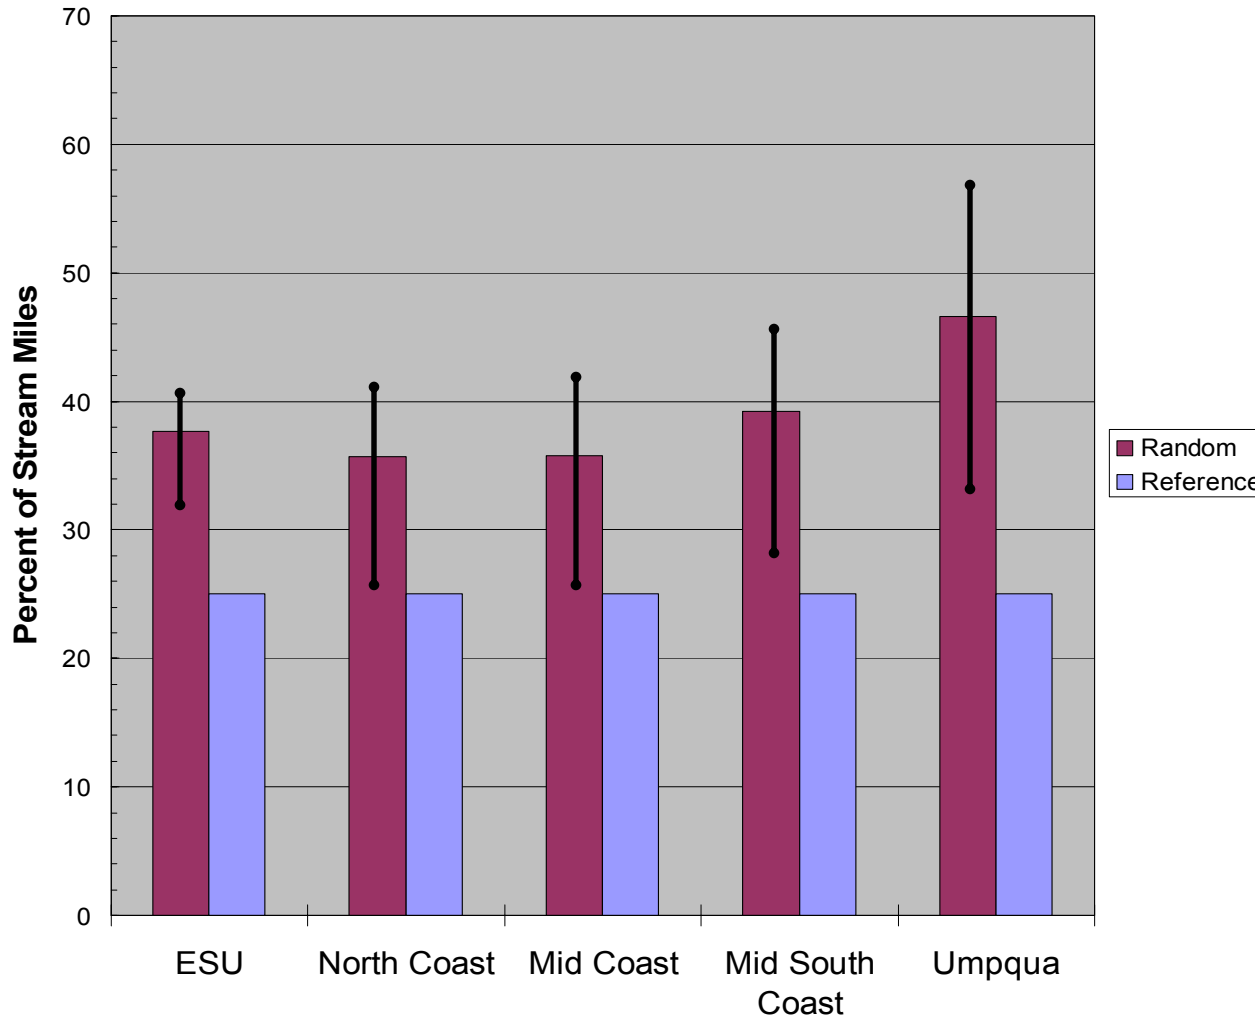
Percent of Streams in “Lower” Shade Conditions: Monitoring Unit

- The lower shade trend is strongest in the Umpqua monitoring unit and on agricultural, shrublands, and urban lands.
- State and Federal forested lands have shade levels better than or equal to reference sites.
- Lack of large conifers is consistent throughout the ESU and across land uses.

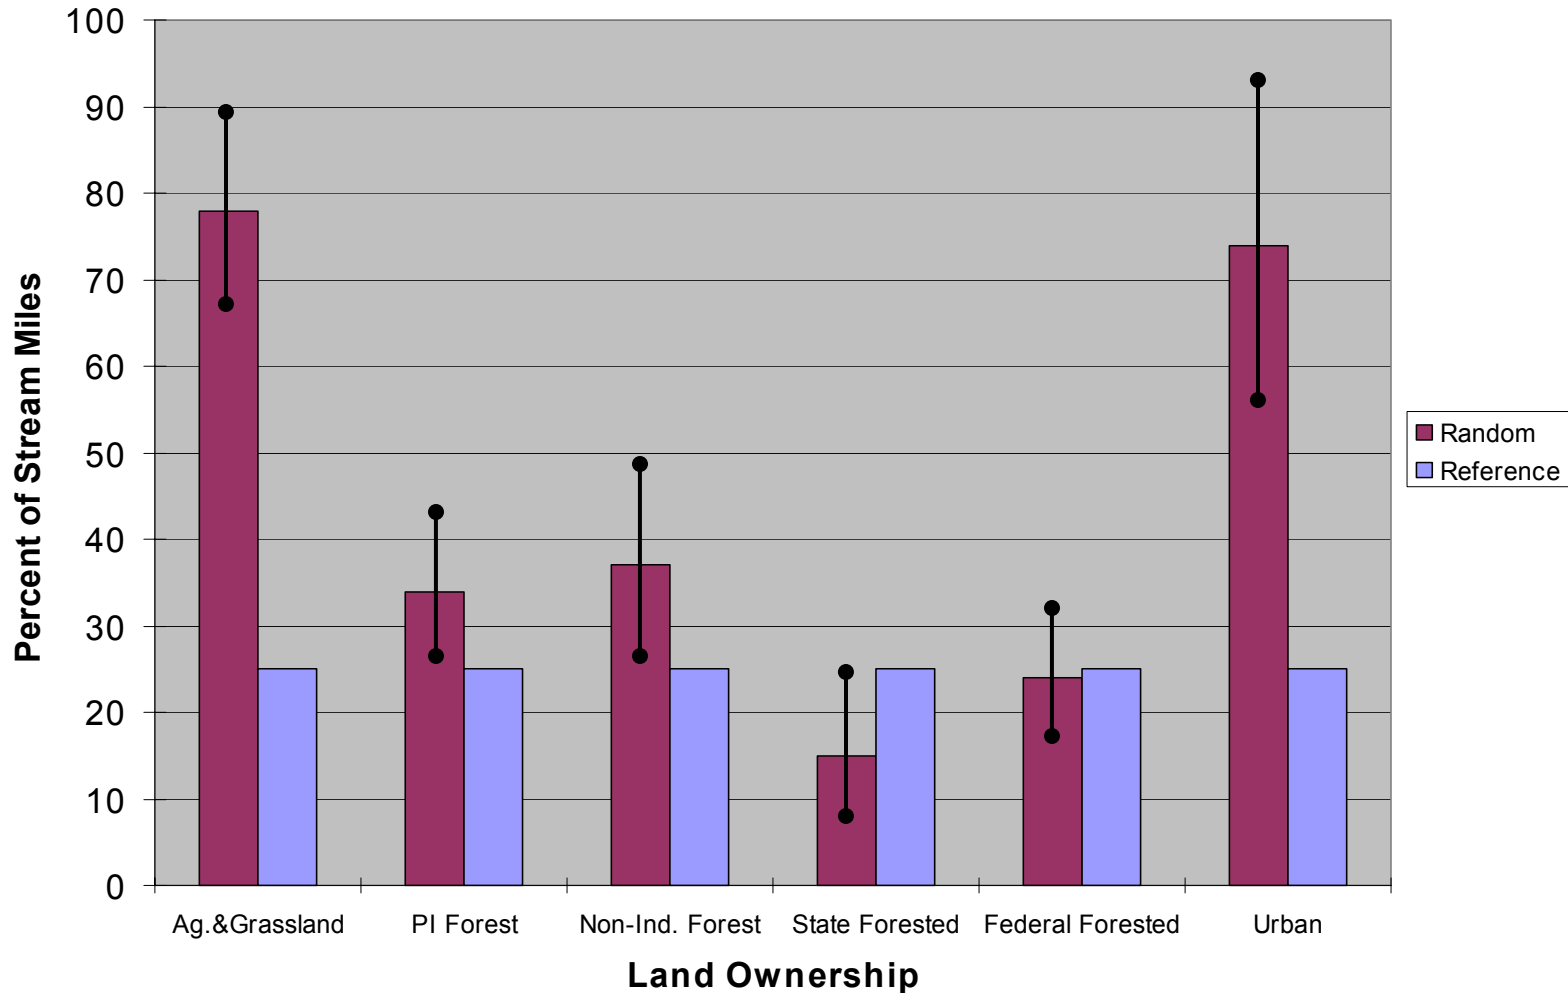
Percent of Coho Stream Miles in “Lower” Shade Conditions: Land Ownership

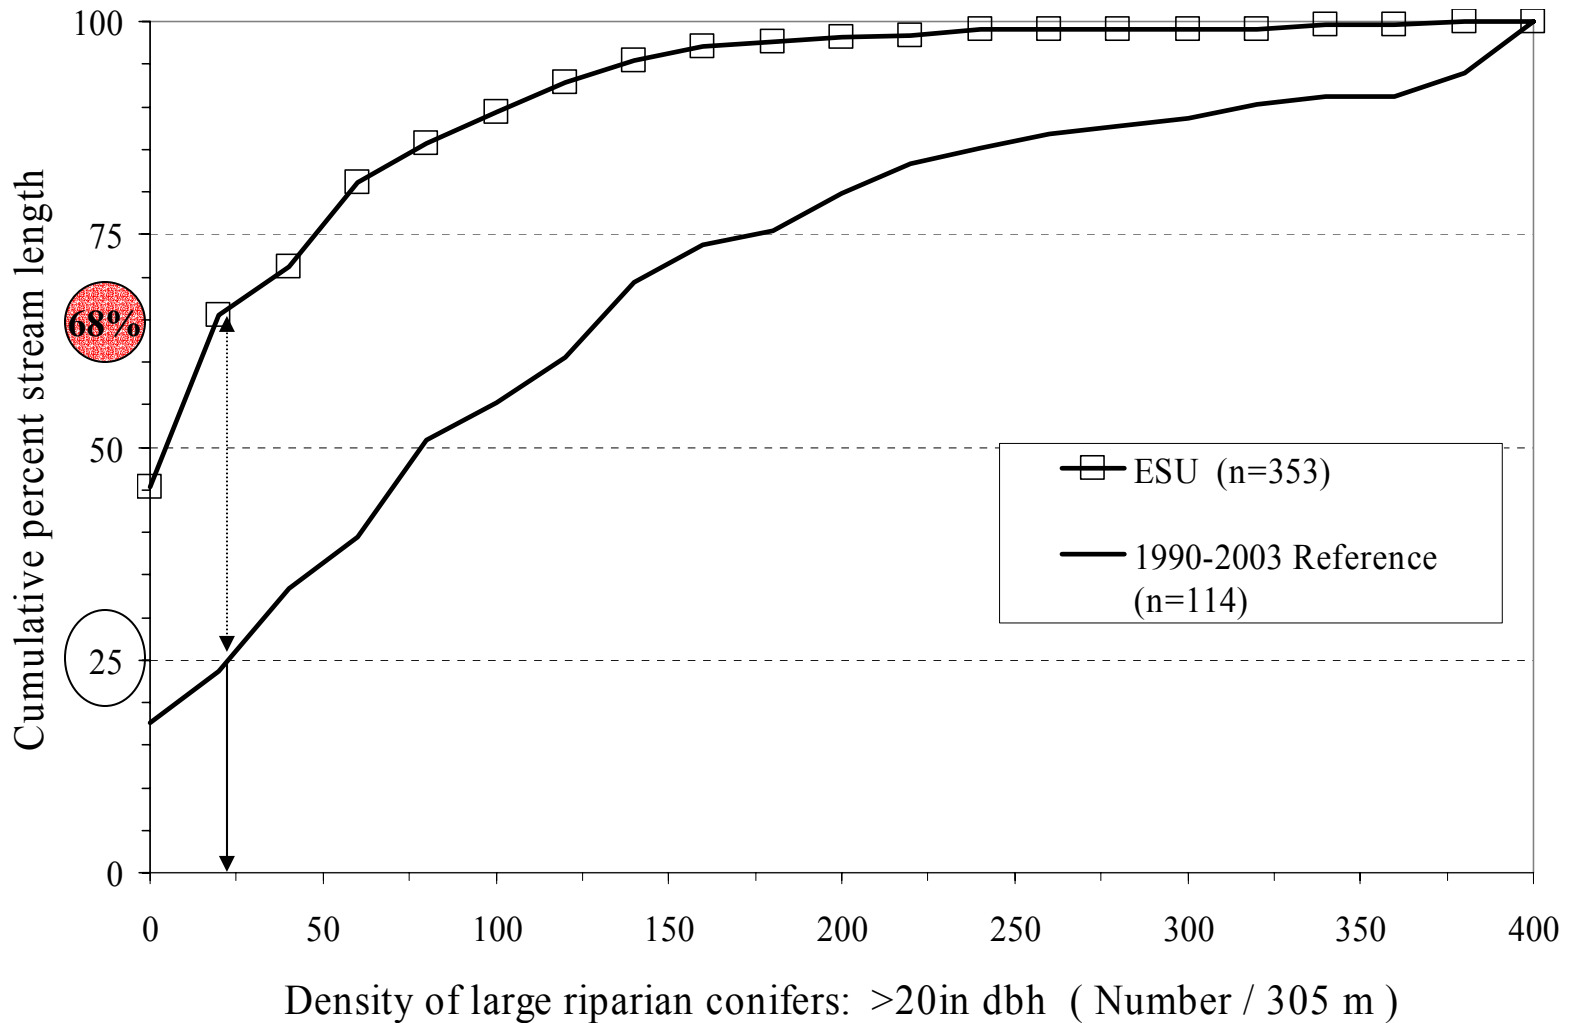
Density of Large Riparian Conifers

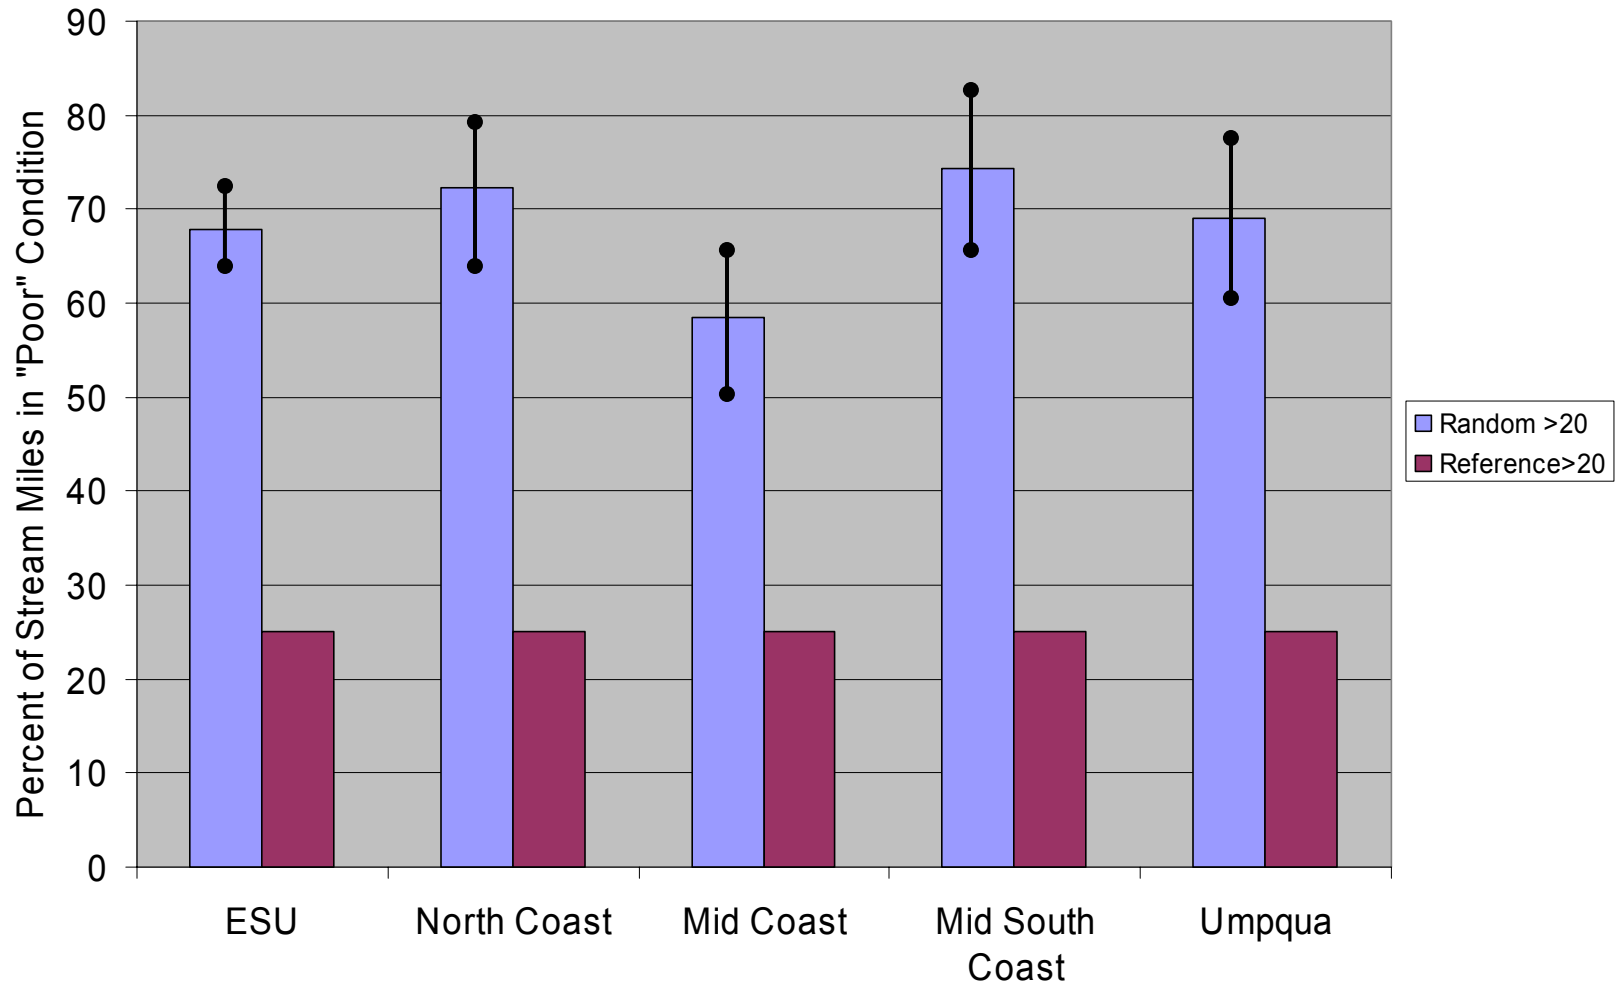
Percent of Streams with “Low” levels of Large Conifers (>20”) By Monitoring Unit

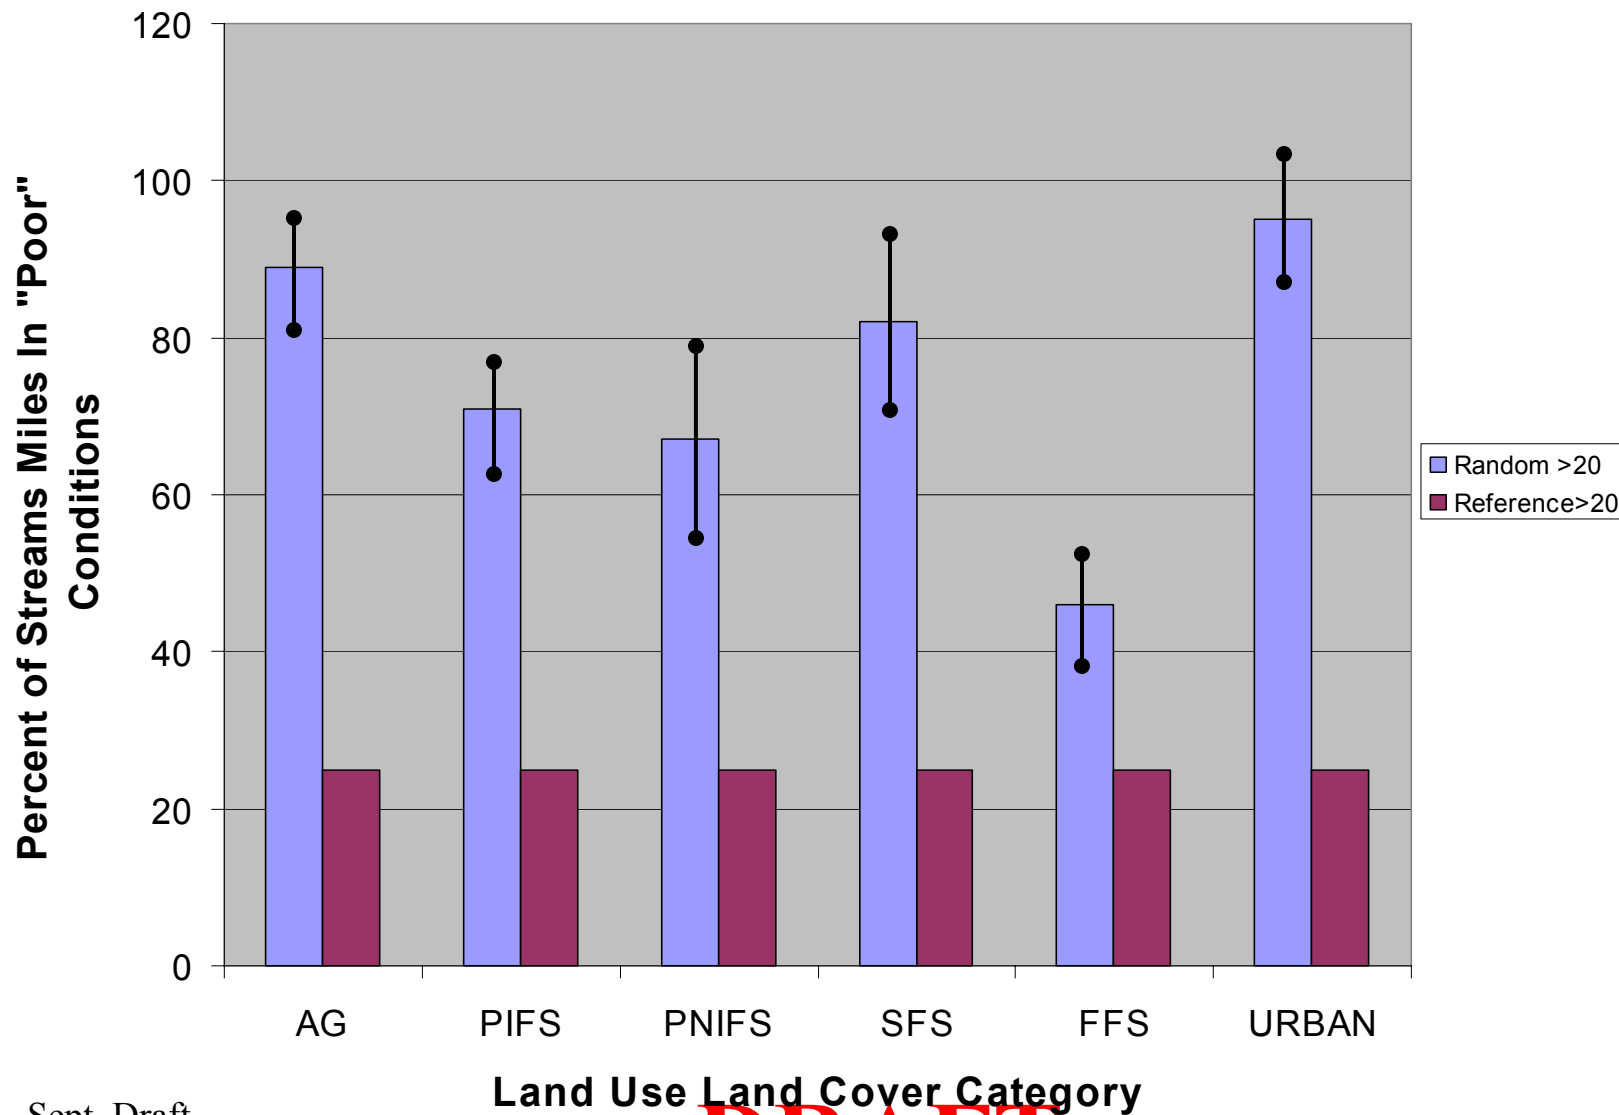
Percent of Streams with Low Levels of Large (>20") Conifer Trees: By Land Ownership

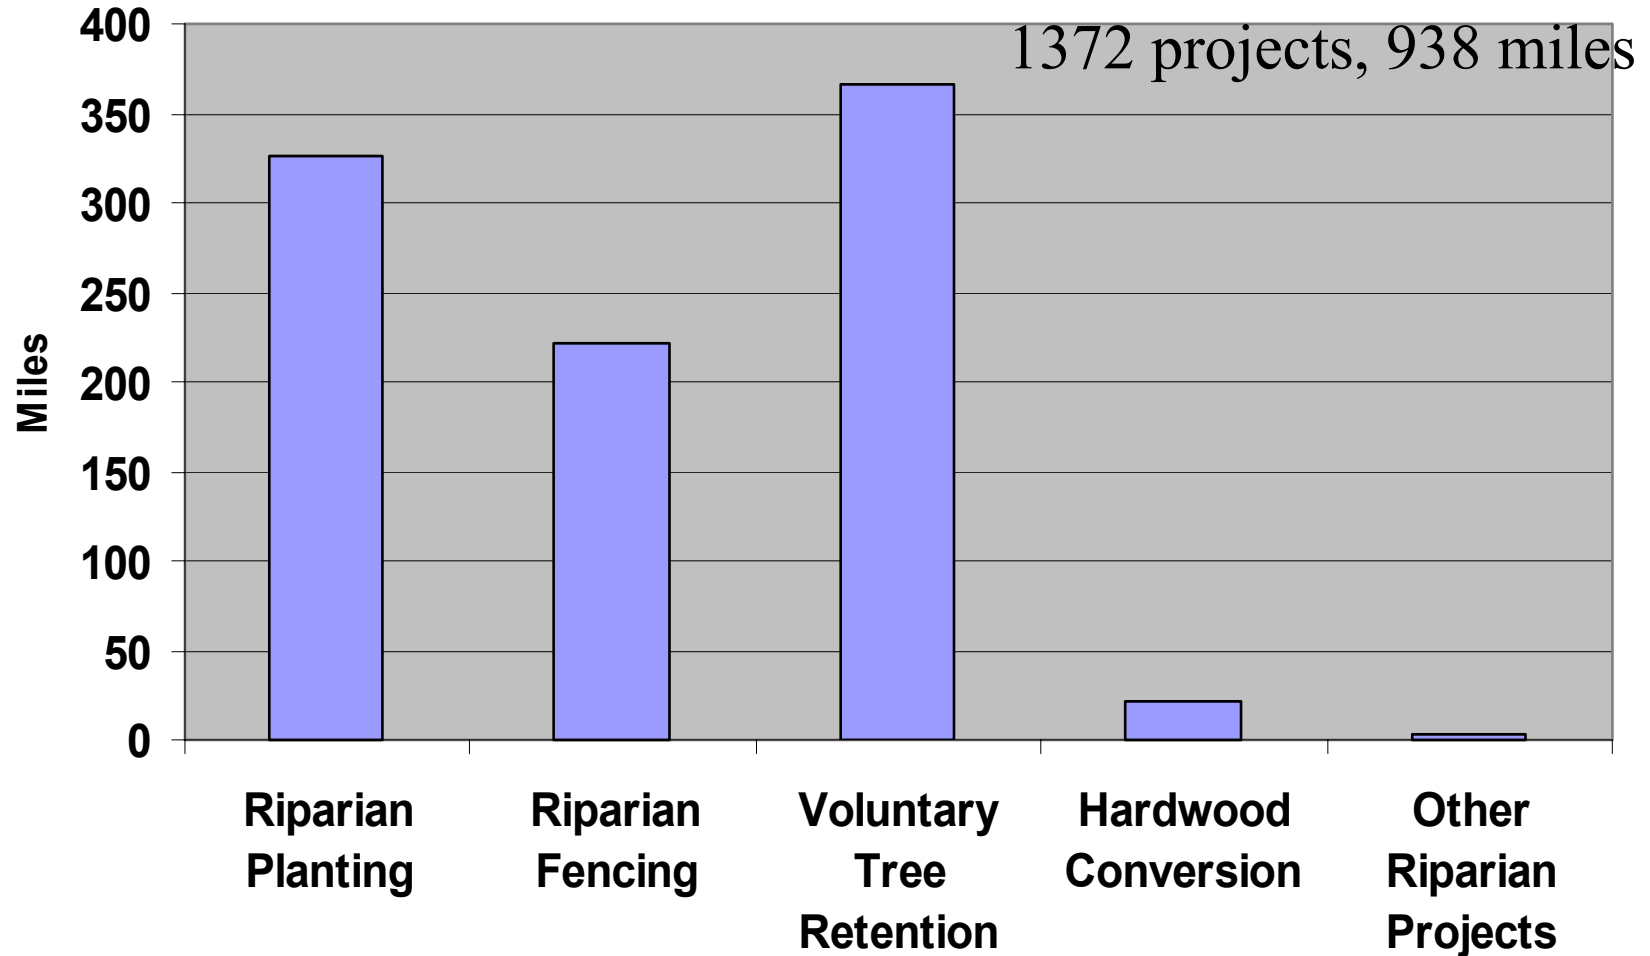
Riparian Restoration Projects

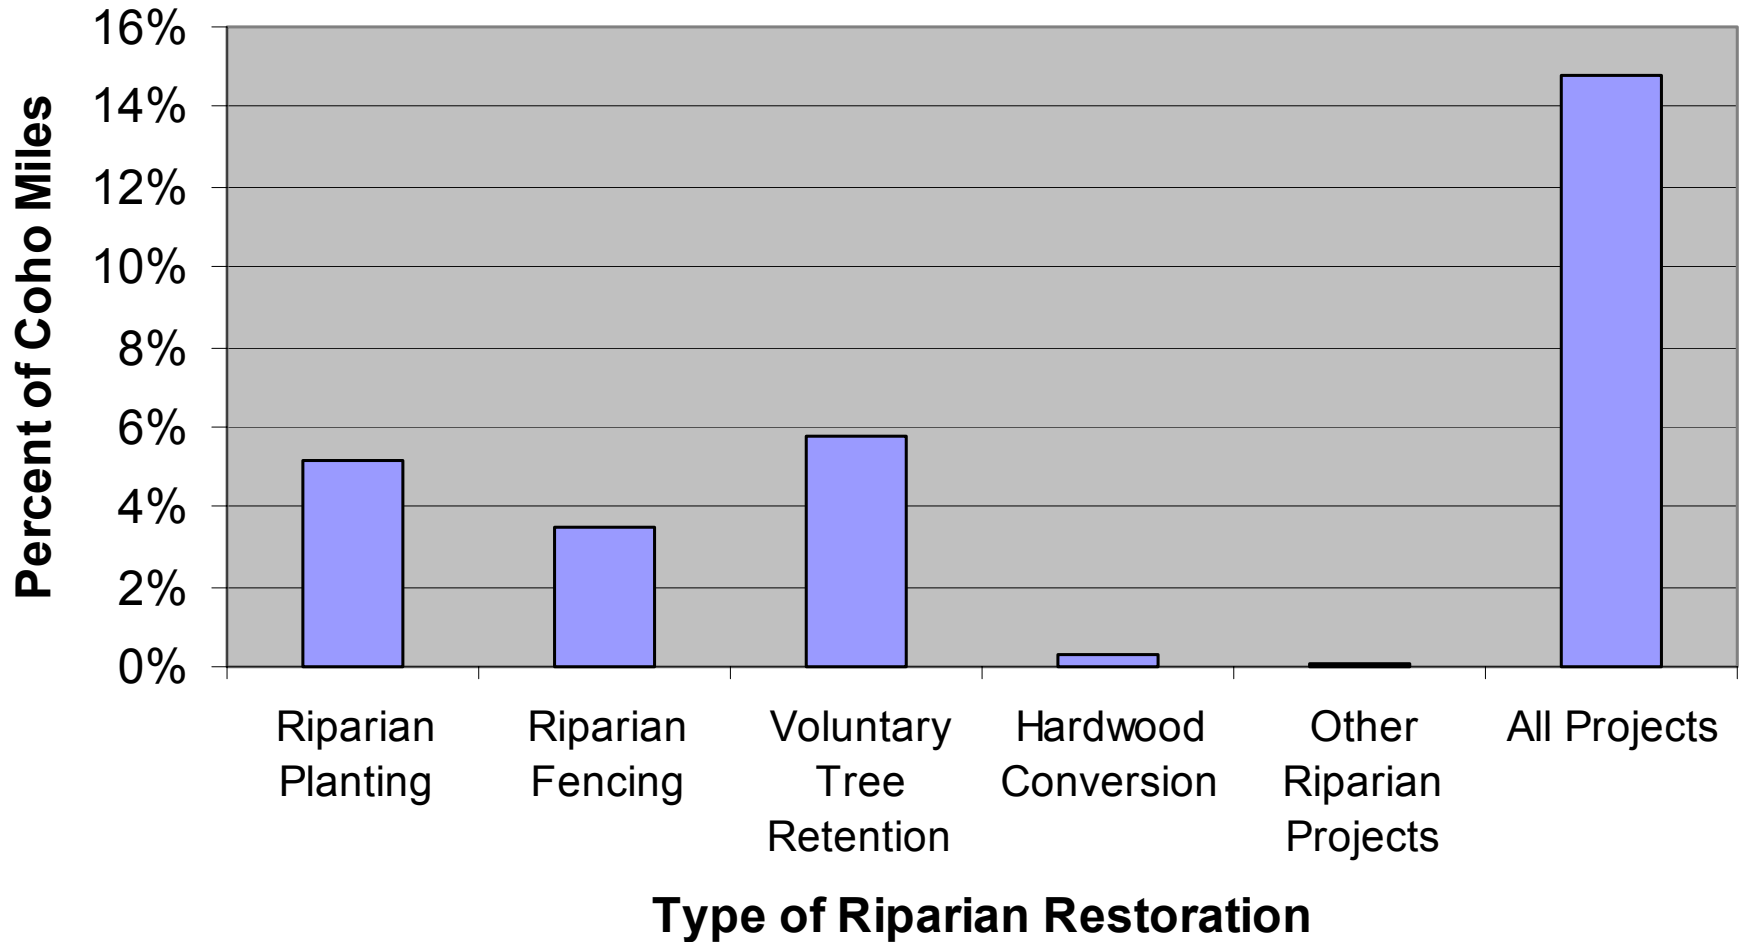
Riparian Restoration as a Percent of Coho Miles

- Miles treated equate to 14% of coho miles
- Mostly
 - Planting
 - Fencing
 - Voluntary Retention

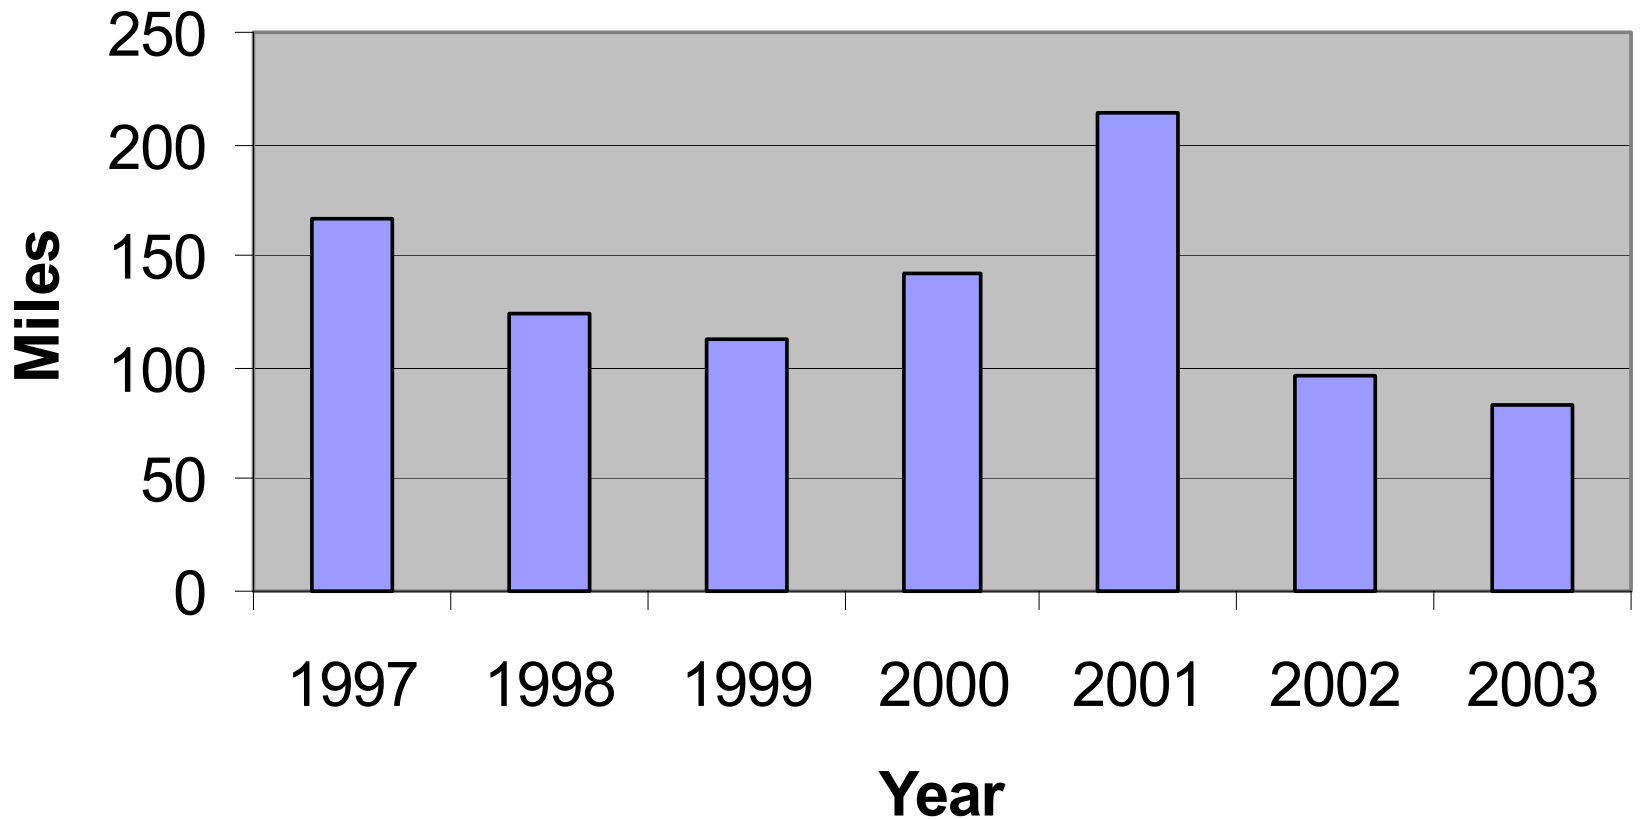
Riparian Restoration Actions By Year

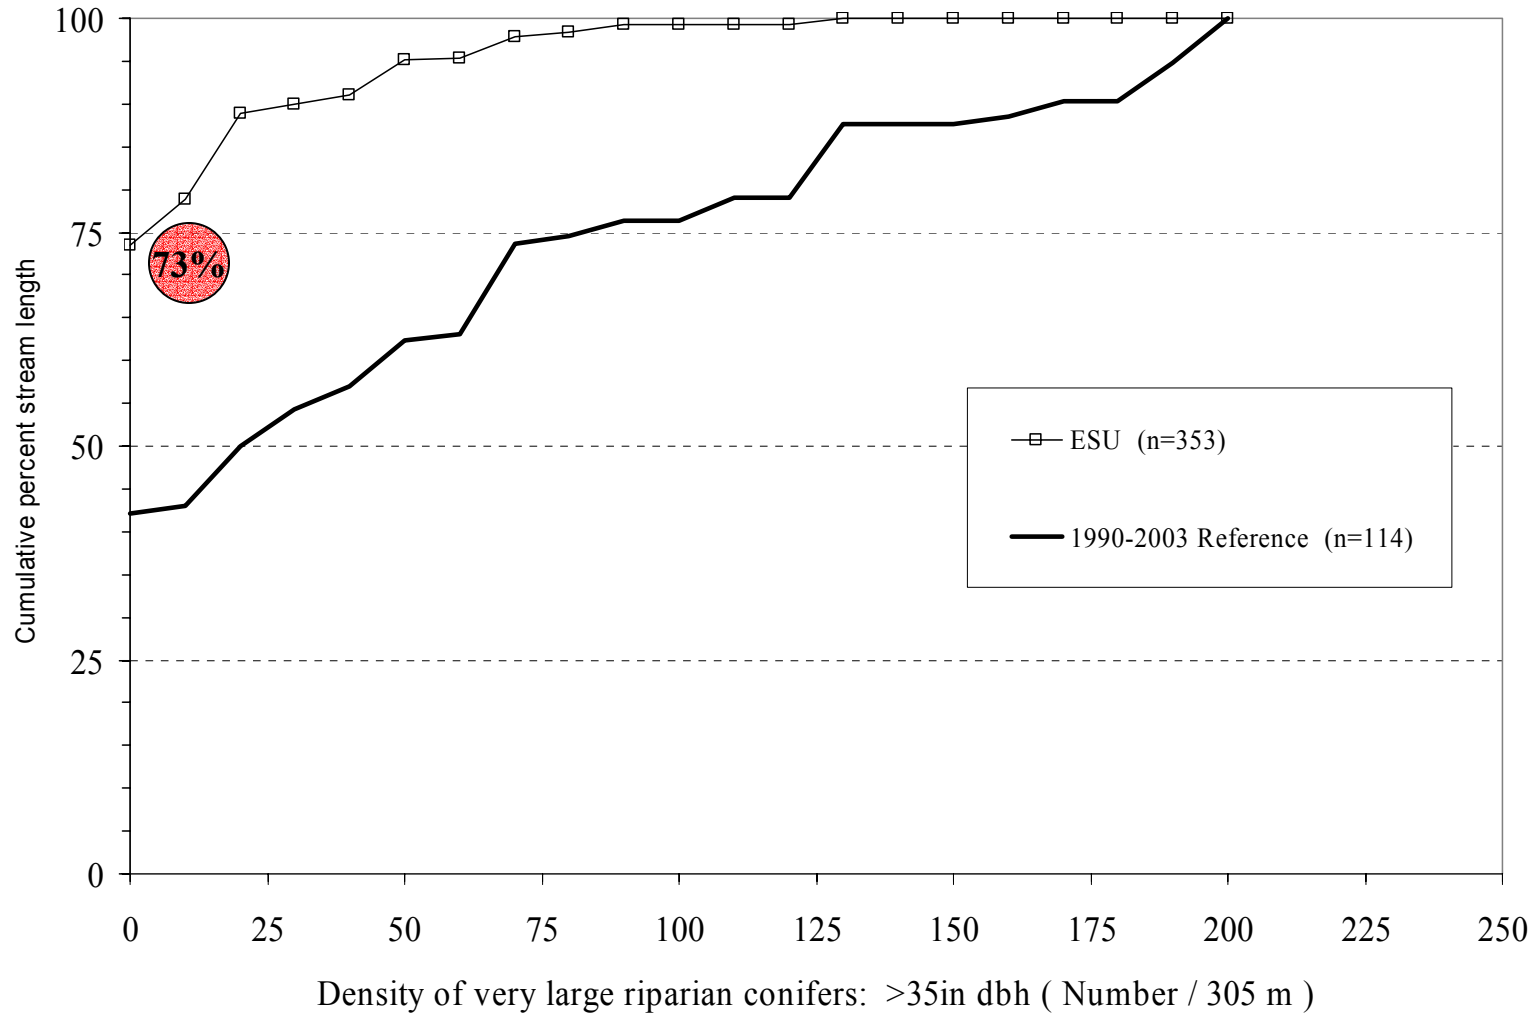
Density of Very Large Conifers

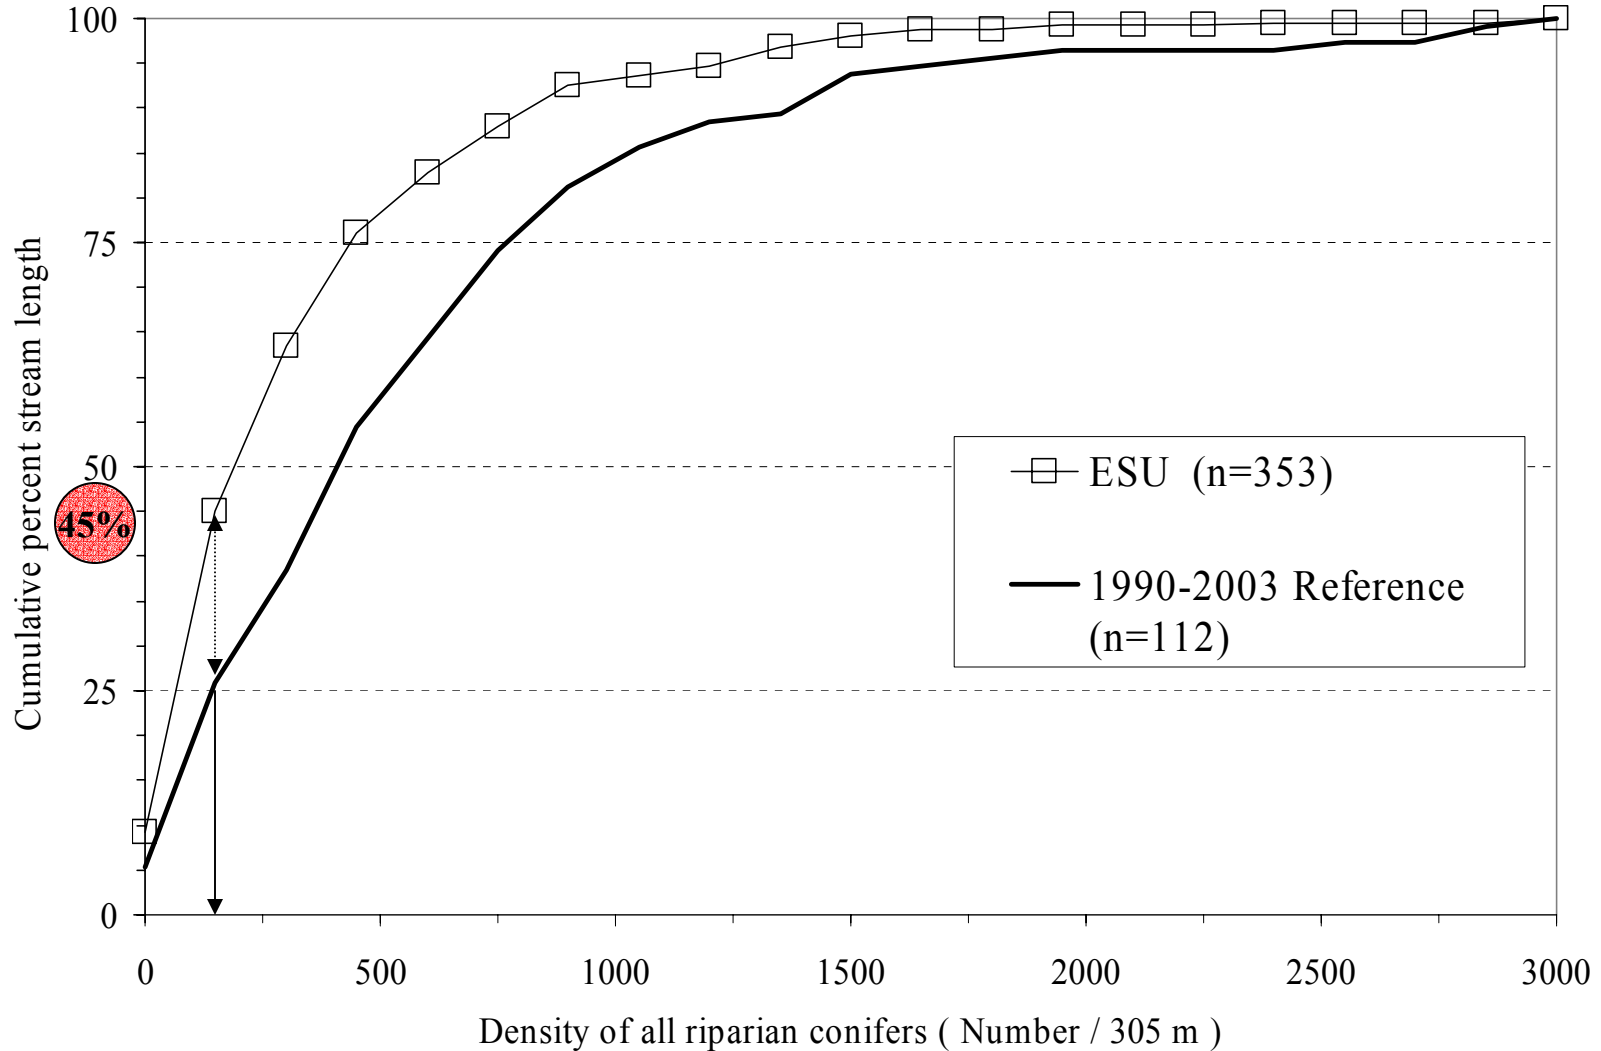
Density of All Riparian Conifers
