Marone Point, Louisiana  
Comparison of Marsh Shears Before and After Hurricane Lili (Oct. 3, 2002)  
(Landsat 7 Thematic Mapper Satellite Imagery)

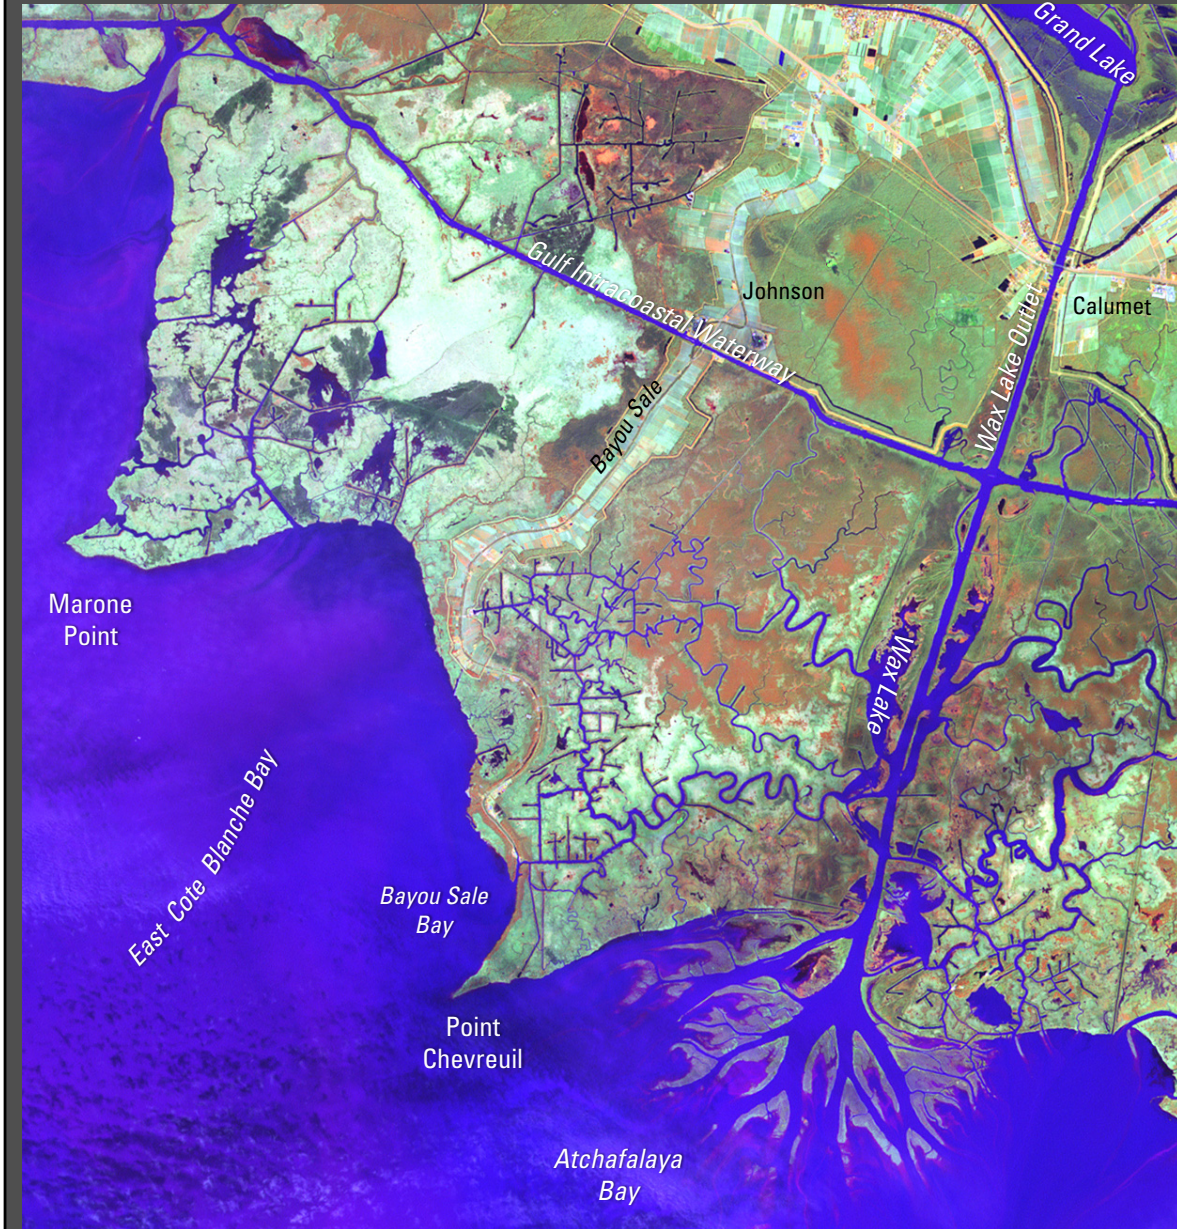
February 2, 2002

Image Source:  
Landsat 5 Thematic Mapper Satellite  
Imagery is provided by the USGS Center for  
Earth Resources Observation and Science.  
Bands 4 (near-ir), 5 (mid-ir), and 3 (visible  
red) are displayed.
