Delacroix, Louisiana: Photo C
Examples of Shearing After Hurricanes Katrina and Rita
Intermediate Marsh Community Type

Data Series 281

U.S. Department of the Interior
U.S. Geological Survey

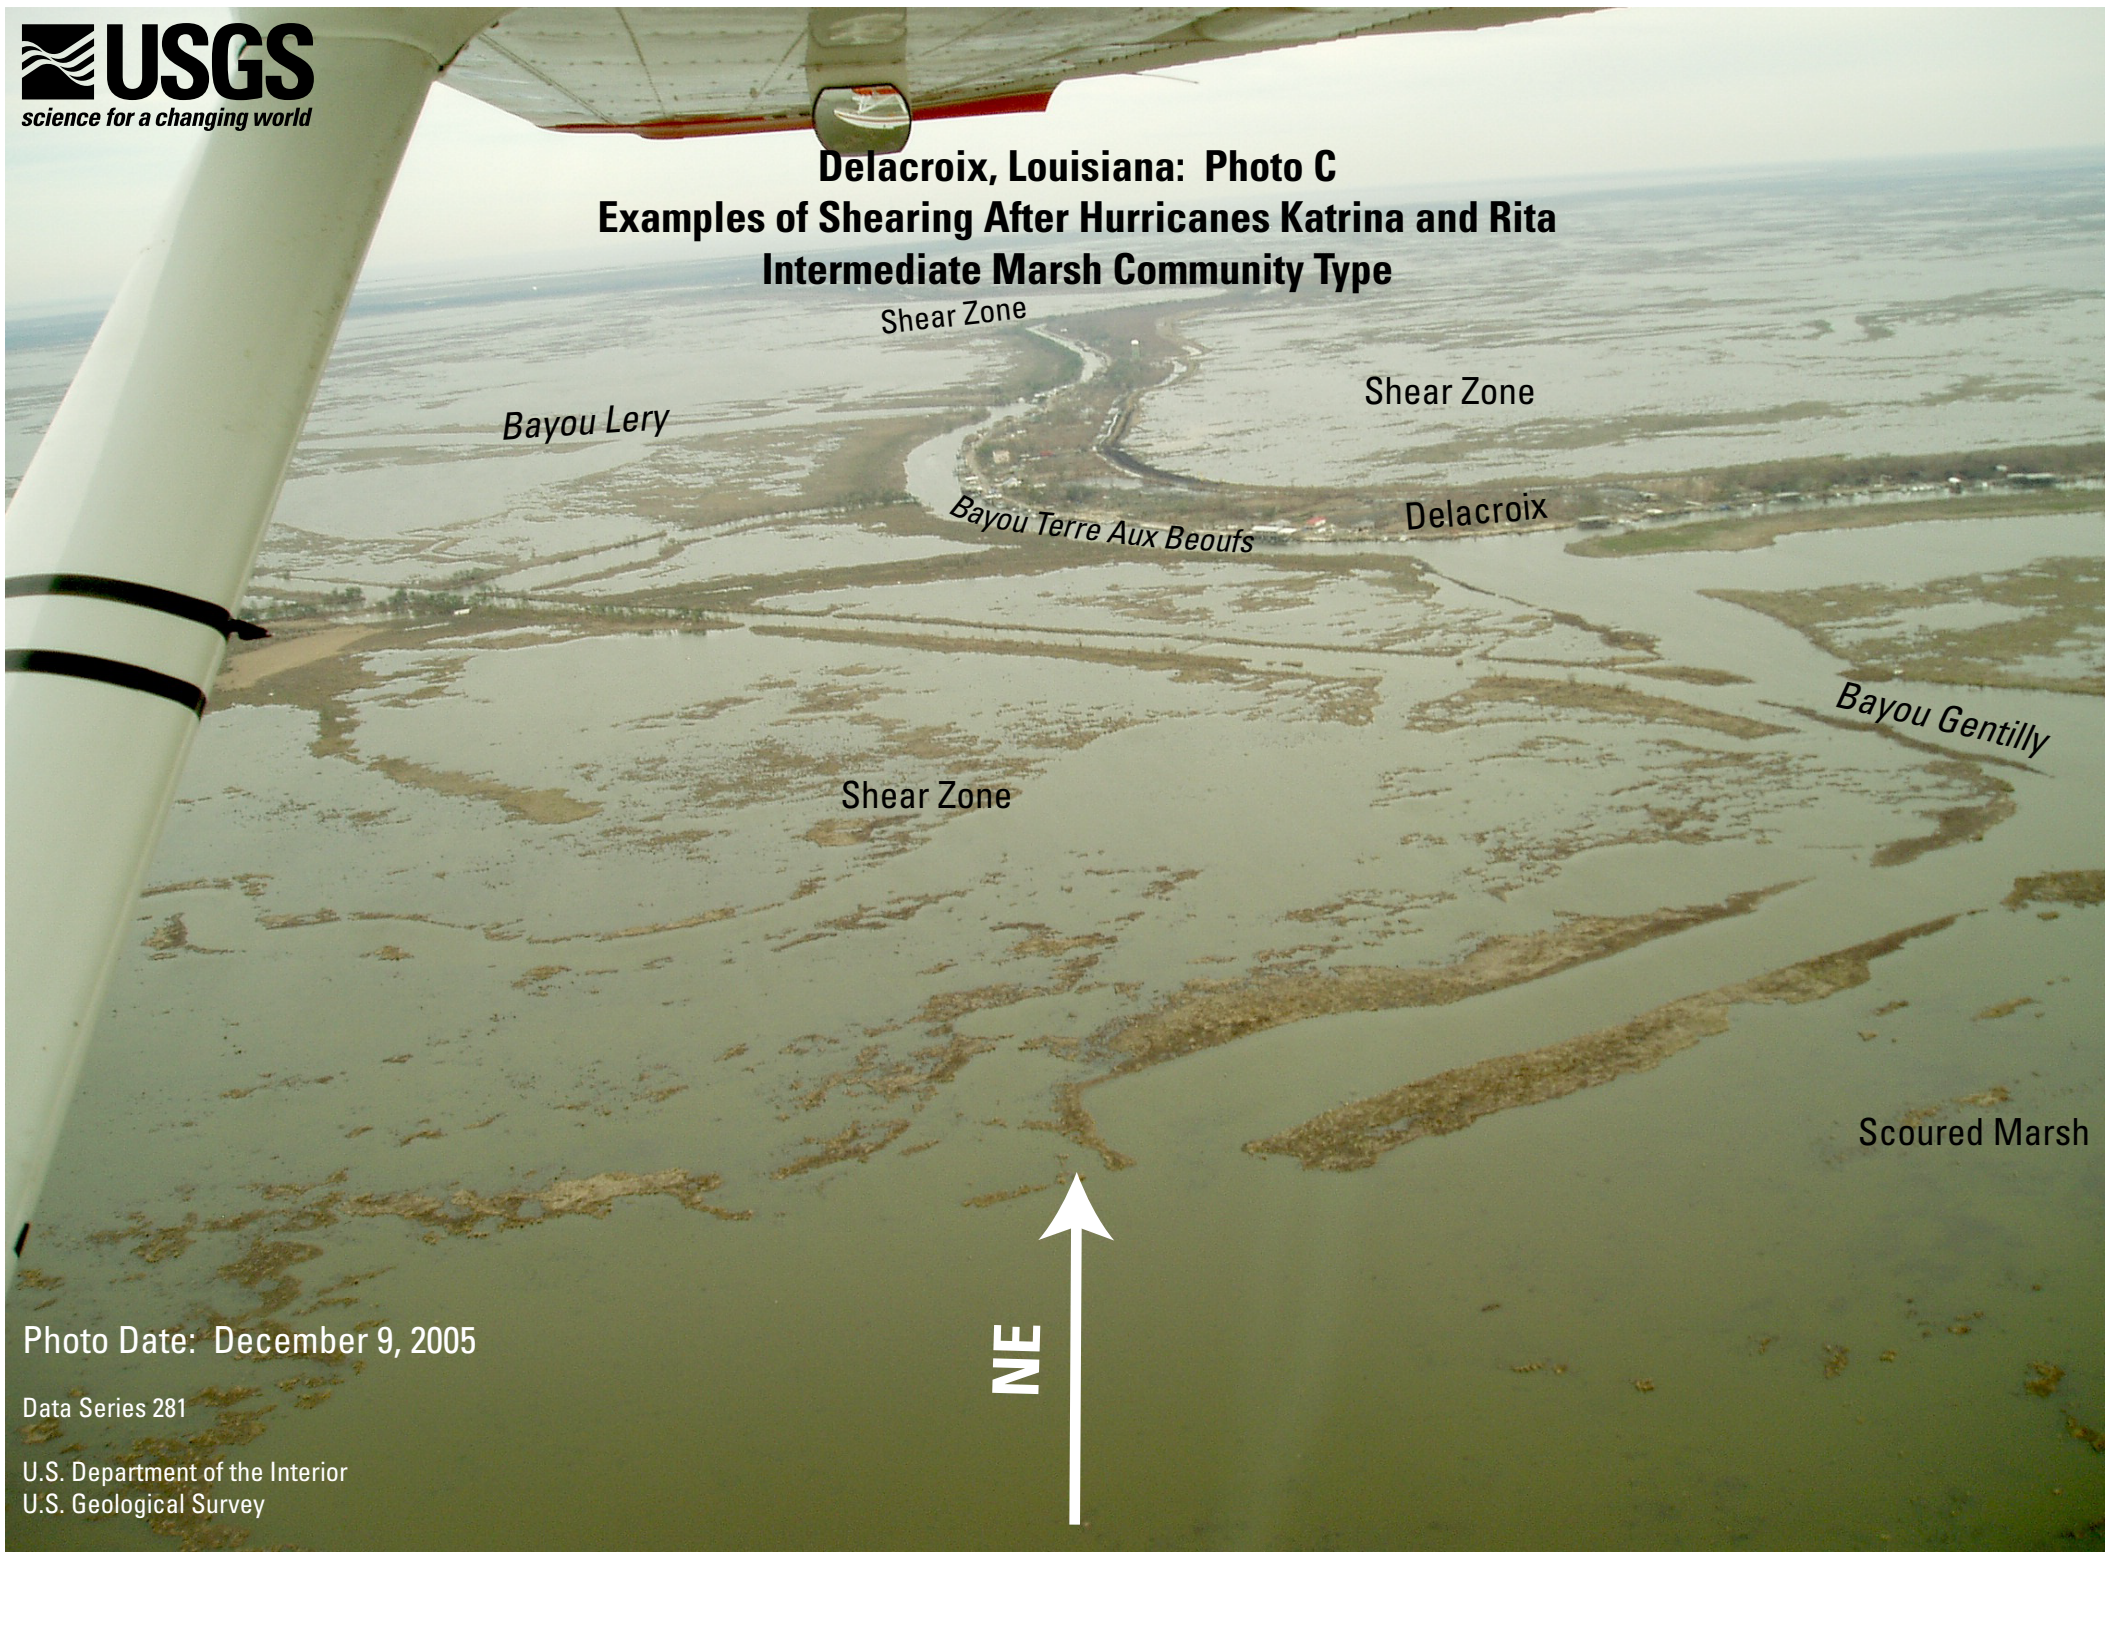
Shear Zone

Scoured Marsh
