Delacroix, Louisiana: Photo I
Examples of Shearing After Hurricanes Katrina and Rita

Data Series 281

U.S. Department of the Interior
U.S. Geological Survey

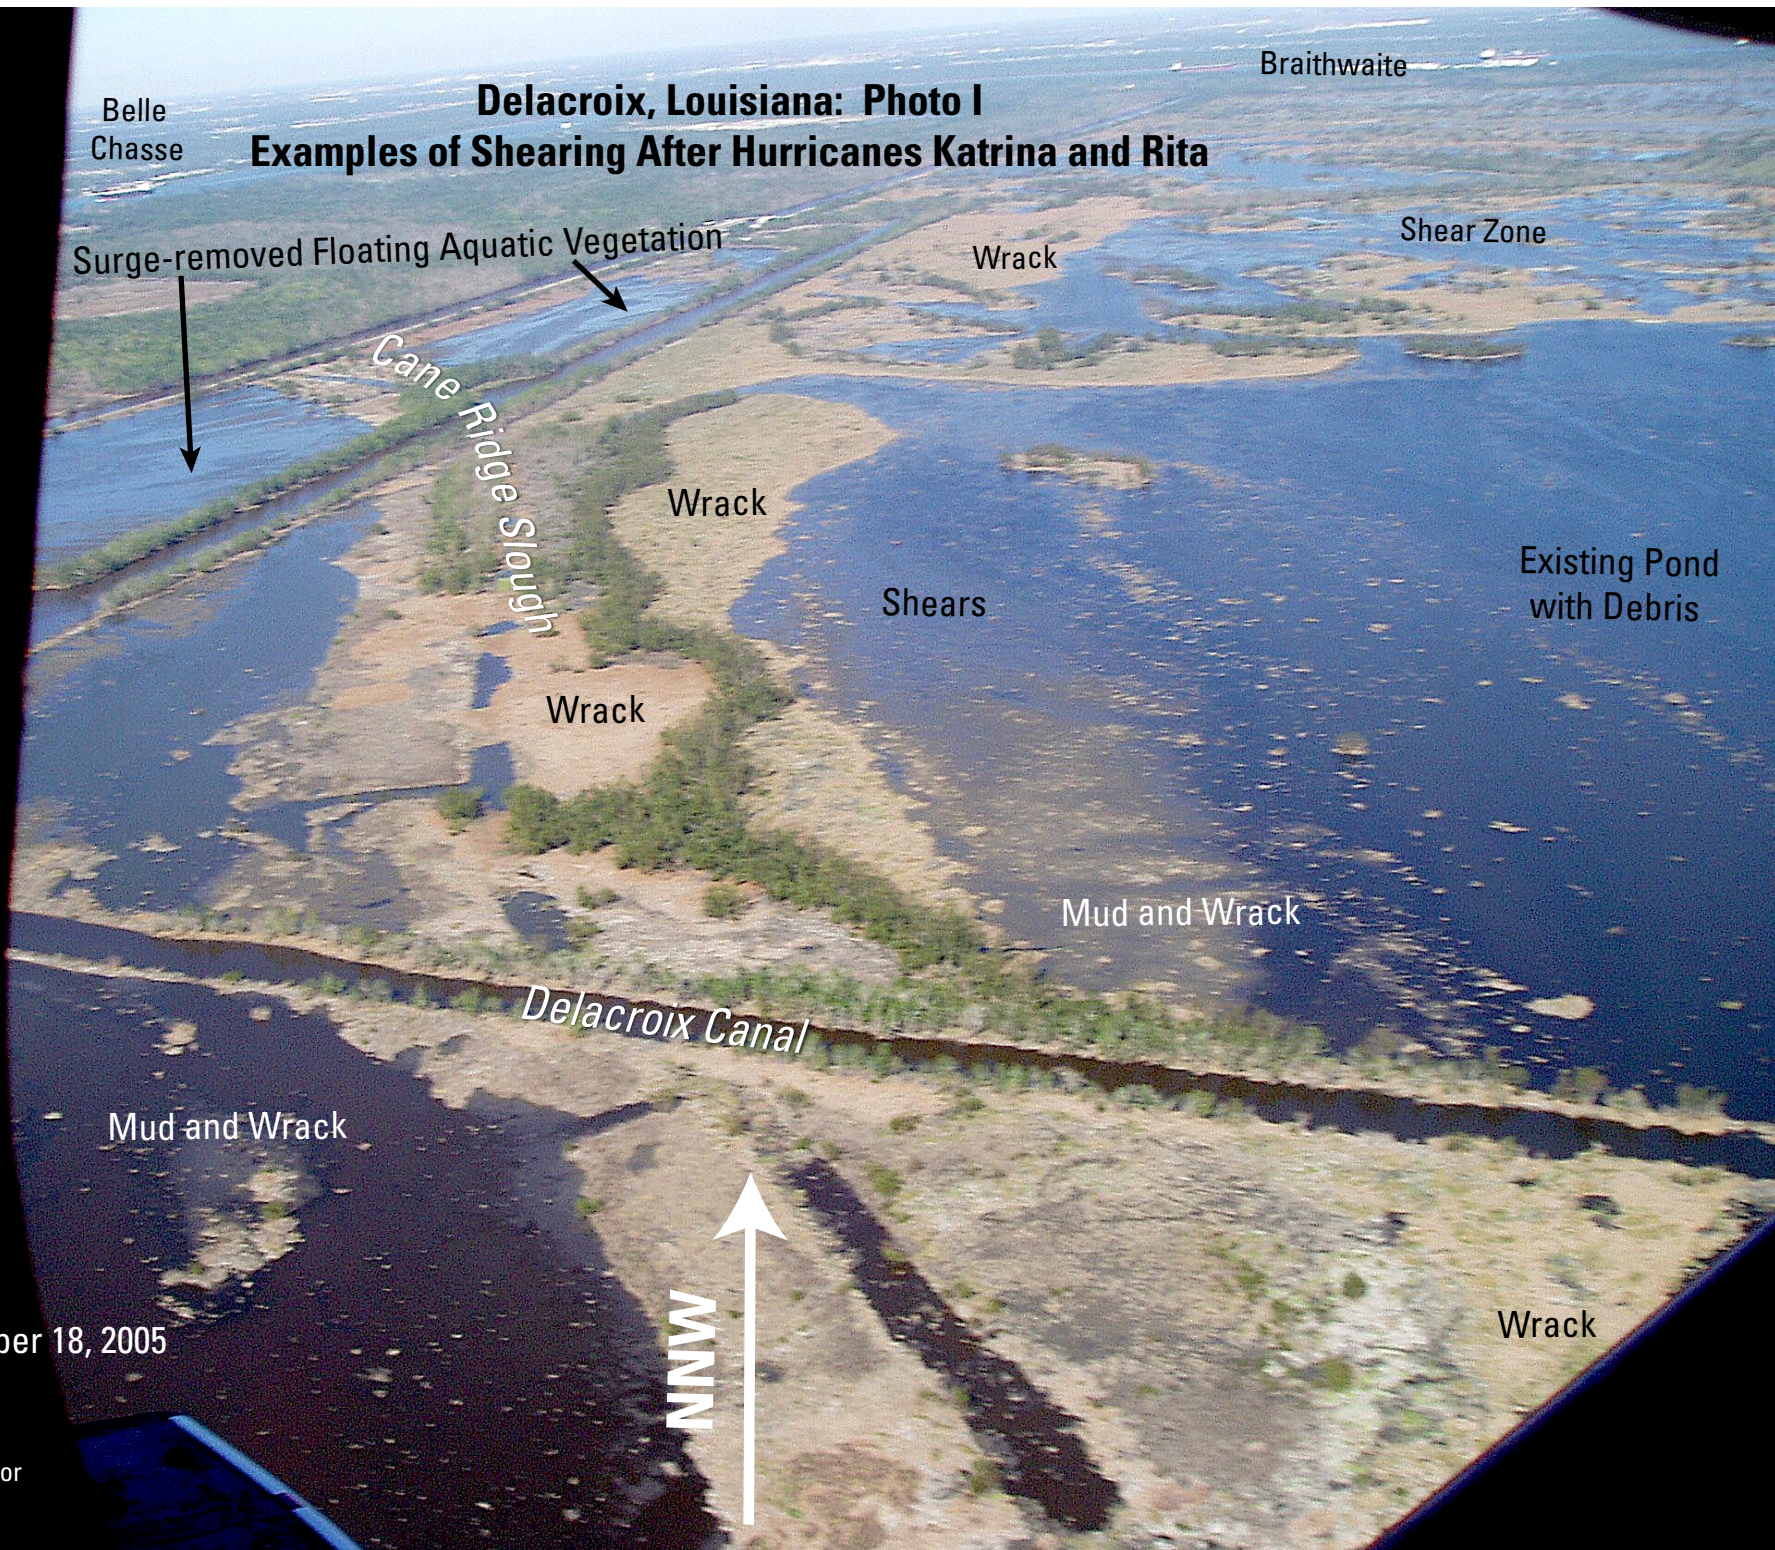
Surge-removed Floating Aquatic Vegetation

Wrack

Shear Zone

Shears

Existing Pond with Debris

Mud and Wrack

Photo Date: November 18, 2005
