Delacroix, Louisiana: Photo Q
Examples of Shearing After Hurricanes Katrina and Rita

Data Series 281

U.S. Department of the Interior
U.S. Geological Survey

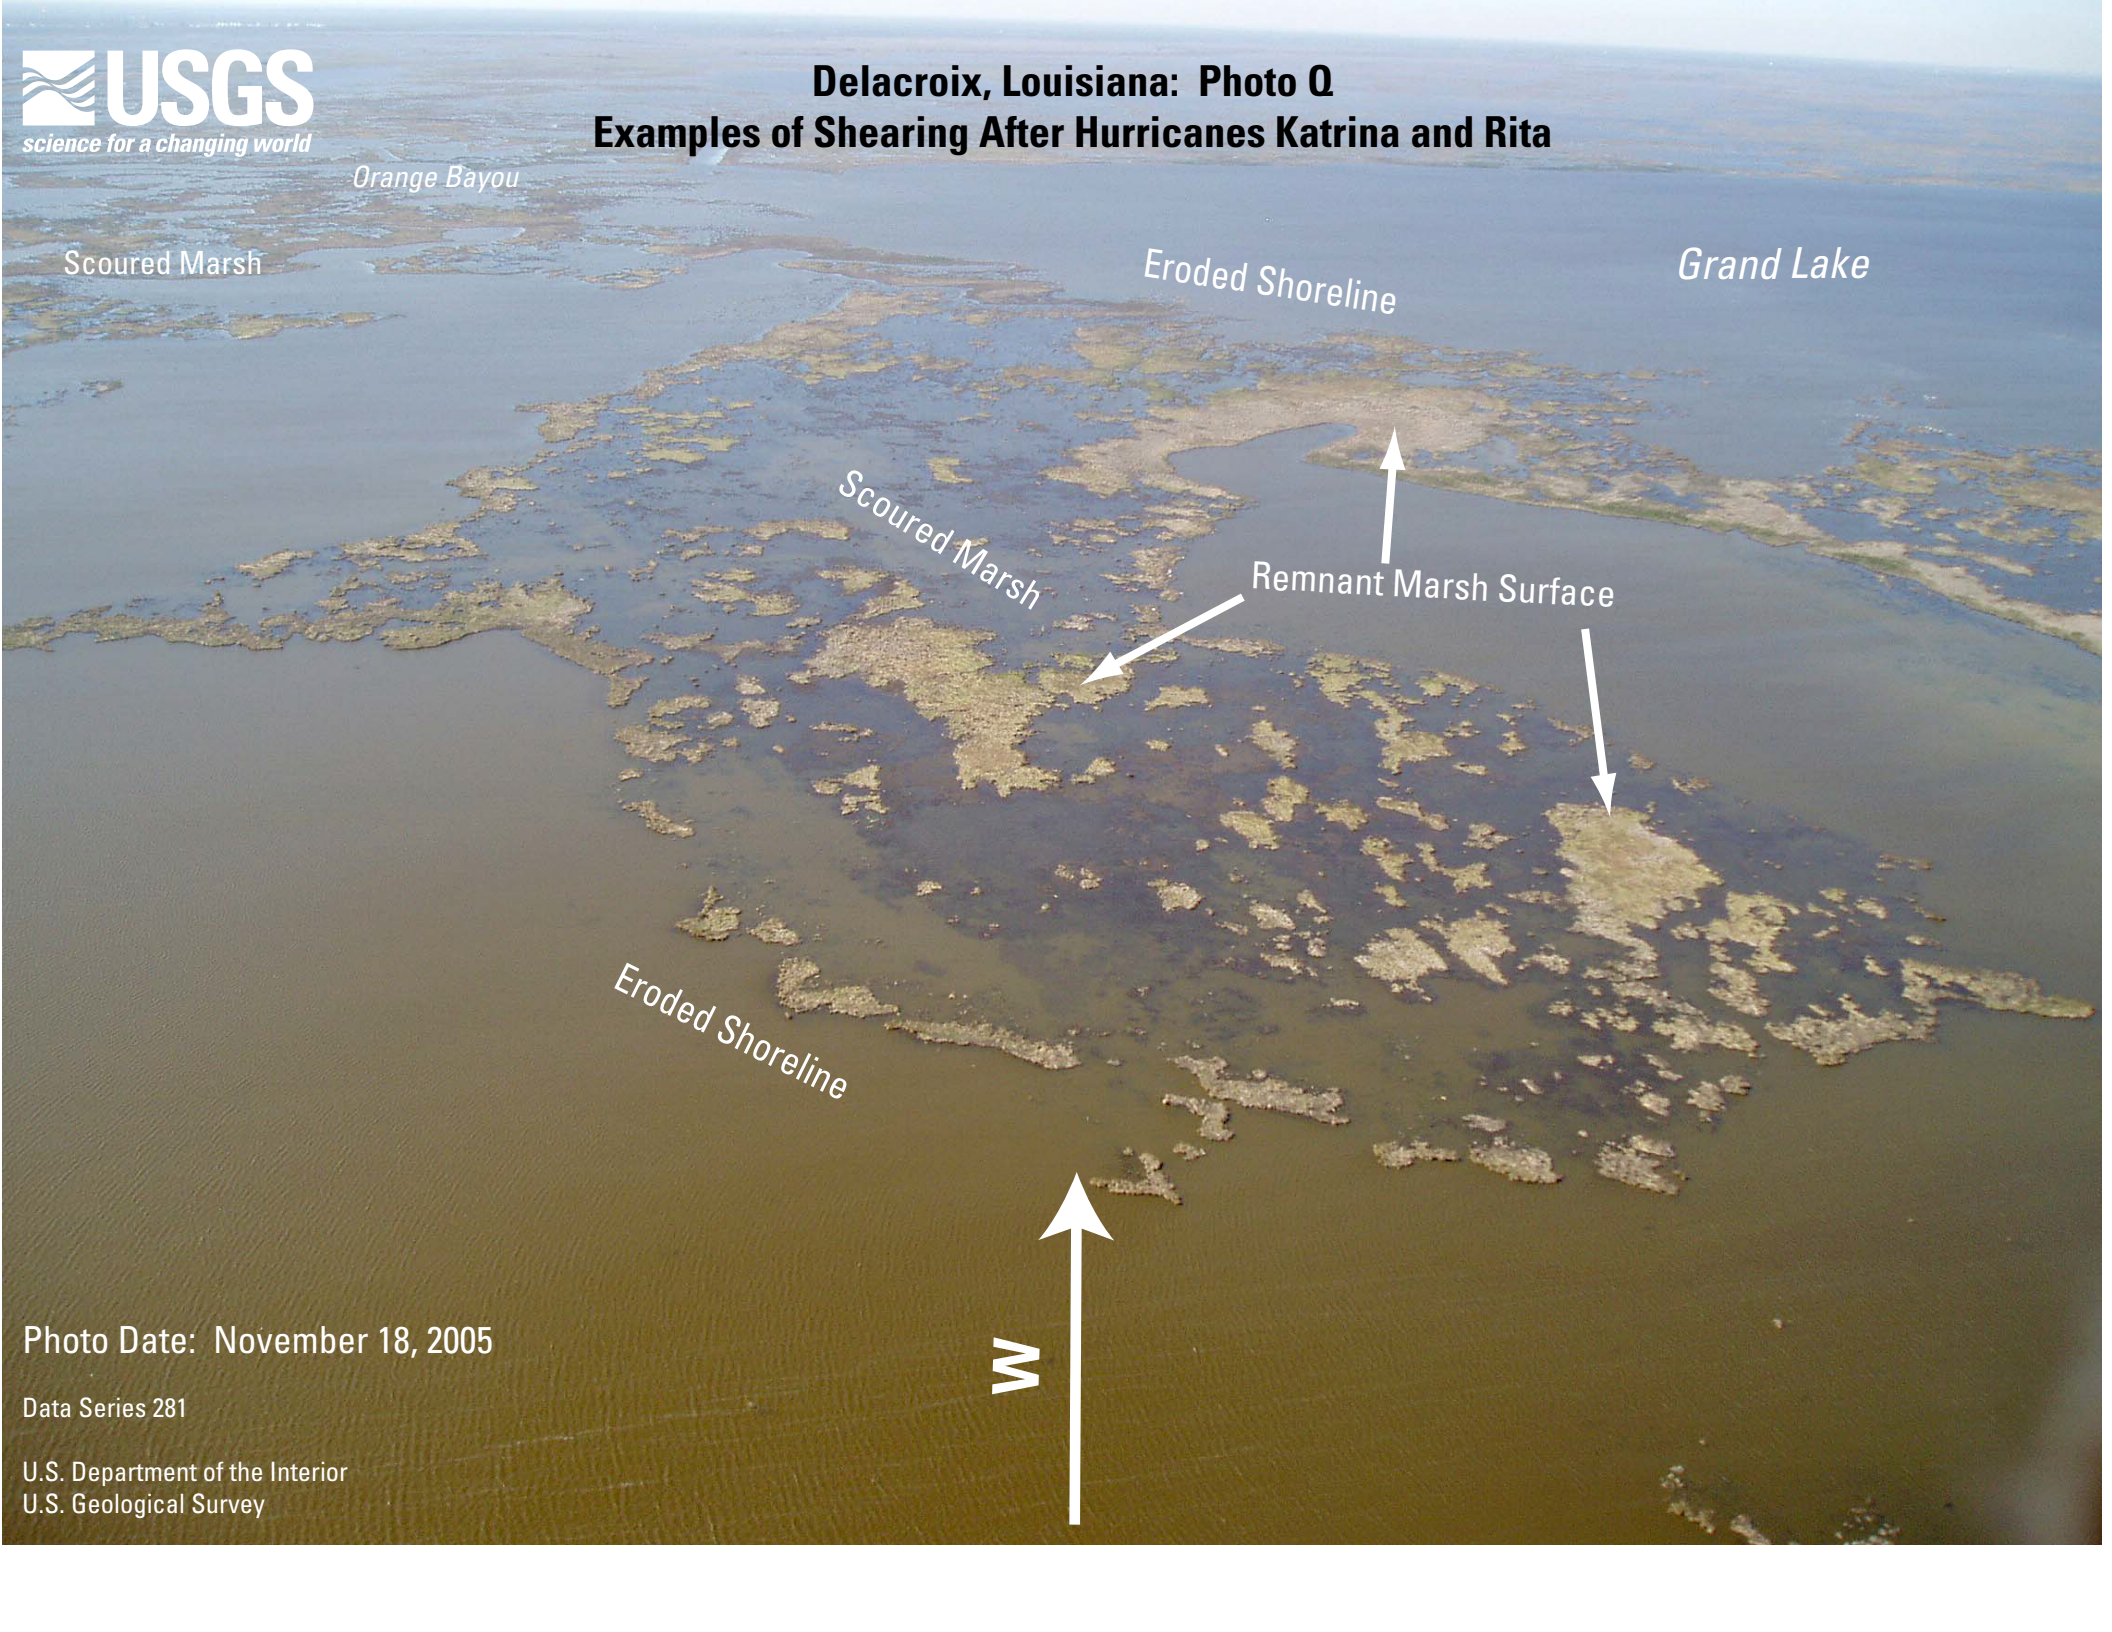
Orange Bayou

Scoured Marsh

Eroded Shoreline

Grand Lake

Remnant Marsh Surface

Photo Date: November 18, 2005
