Formation, Evolution, and Stability of Coastal Cliffs—Status and Trends

Professional Paper 1693

Monty A. Hampton and Gary B. Griggs, Editors

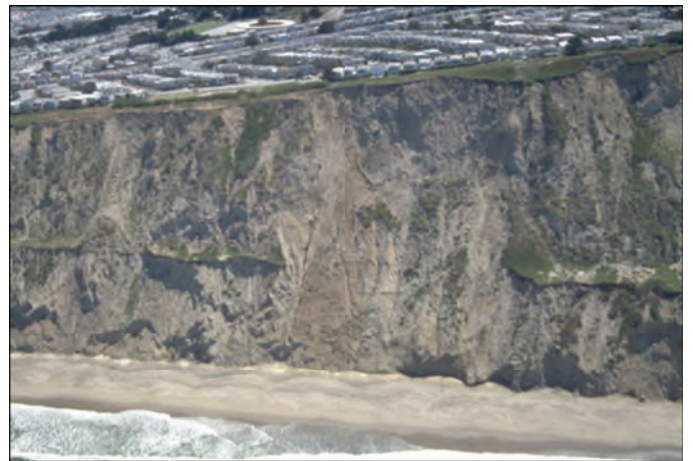
Figure 1. This coastal cliff in Daly City, California, is about 150 m high. As evidenced by the large landslide near the center of the photograph, the cliff is unstable, posing a threat to the nearby densely developed area. The San Andreas Fault is a short distance offshore.

coast of central California, or relatively flat as is common along much of the urban coasts of California, New England, and along the Great Lakes. Problems related to coastal-cliff retreat exist within both types of terrain. The flat terraces and gently sloping plains in urbanized coastal areas in particular have attracted development, because the flat surfaces provide nearly ready-made building sites, and the elevated position can provide magnificent coastal vistas (fig. 1). Cliff retreat

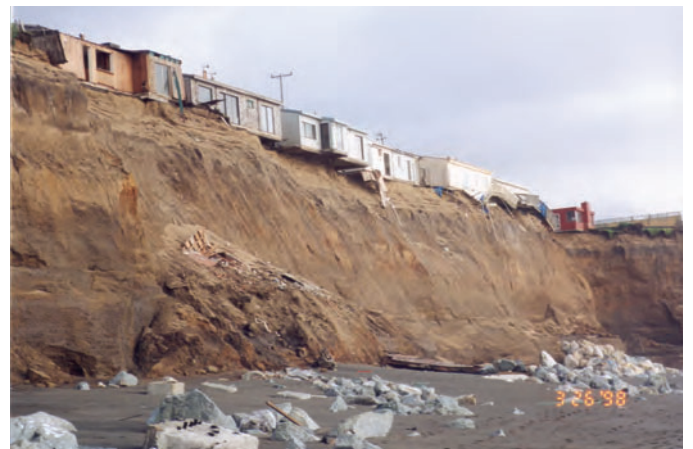
Figure 2. Rapid retreat of this sea cliff in Pacifica, California, caused damage to these houses, which later were declared unsafe and demolished. Compare with the cover photo of the same area, taken about 2-1/2 months previously, before the arrival of the 1997-98 El Niño storms.

has caused damage to structures in many of these places (fig. 2). A common problem along mountain-backed coastal cliffs, which typically are sparsely developed, is damage to or loss of coastal roadways as the coastal cliff retreats (fig. 3).

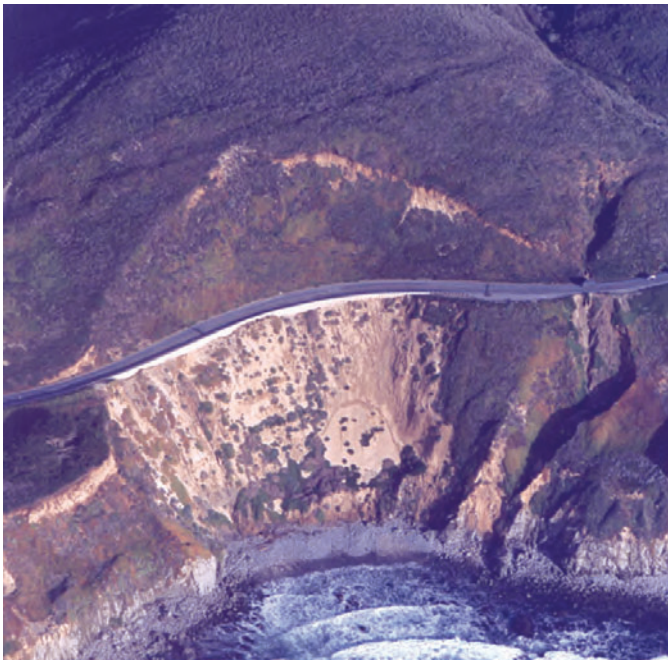
Figure 3. Movement of this large landslide on the Big Sur coast of central California is related to erosion of the coastal cliff at its base, plus other factors such as ground water. Occasional movement of large slides such as this one results in frequent damage to and associated closure of California state Highway 1, which generally follows the coast, as shown here.

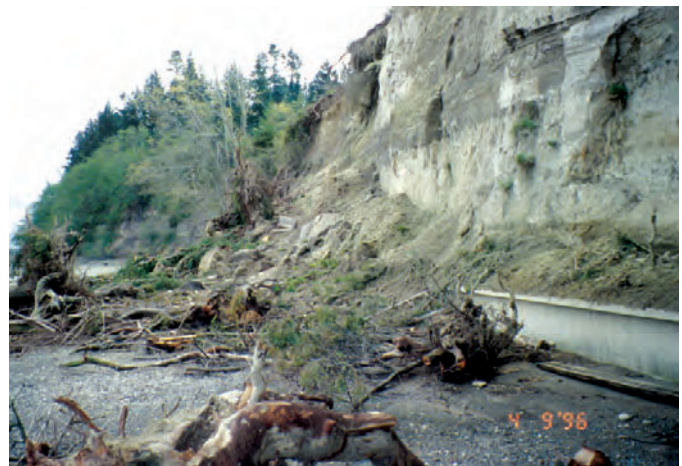
Figure 4. Failure of this steep bluff in glaciofluvial and glacial sediment in Puget Sound, Washington, occurred despite a stabilization attempt. The seawall was built to prevent toe erosion the year prior to failure of the slope.

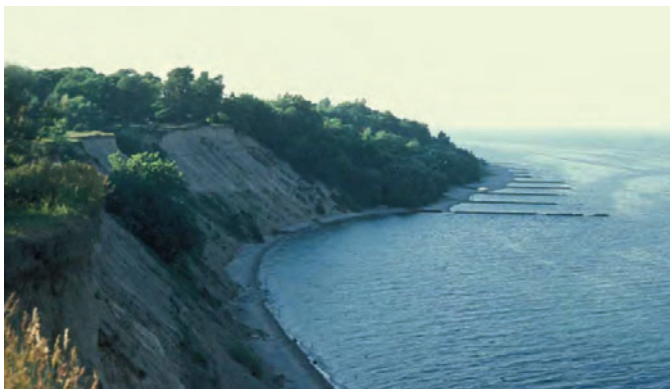
Figure 5. South of Milwaukee, Wisconsin, on Lake Michigan, groins protect the bluff in the distance, but serve to enhance erosion of the bluff in the foreground.

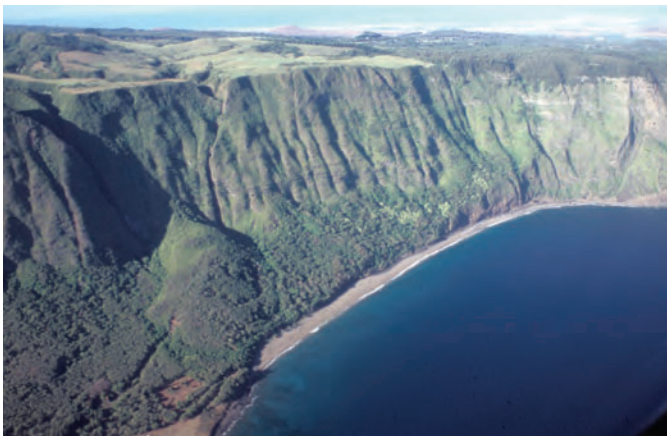
Figure 1. Steep cliff in basalt, more than 300 m high, on the northern coast of Molokai, Hawaii.

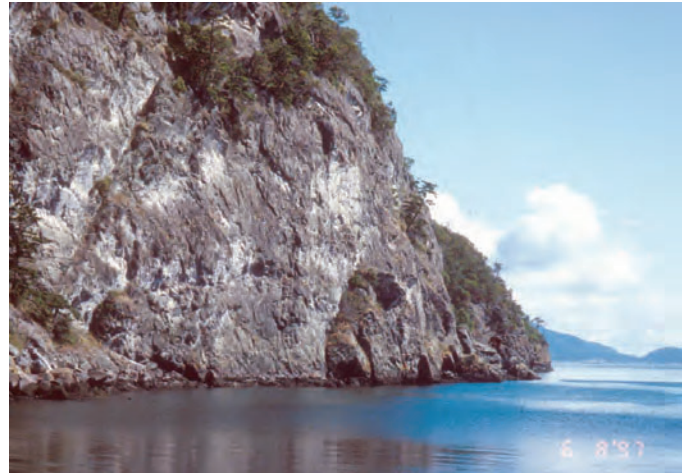
Figure 2. This vertical coastal cliff of basalt in the San Juan Islands of northern Puget Sound, Washington, has a narrow erosional ramp at the base, but no beach. Because of the strength of the rock and low wave energy, the erosion rate is negligible, with the exception of rare block falls.

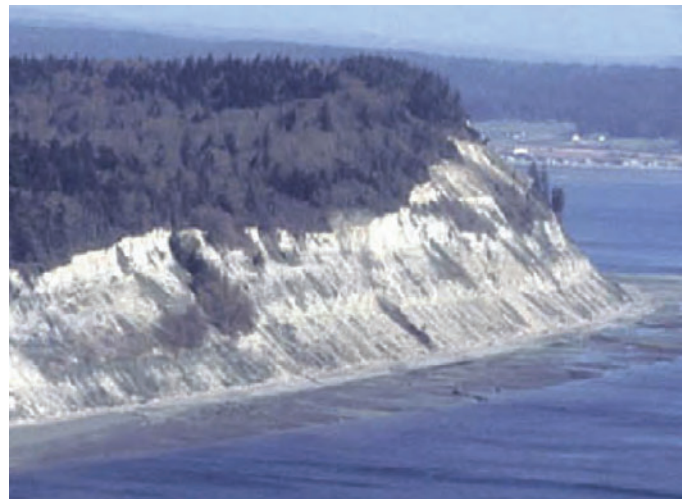
Figure 3. A moderately inclined, high bluff of sandy sediment in Puget Sound, Washington. Erosion rates are consistently at a relatively high rate here because the sediment is weak and because the exposure and orientation result in rapid longshore redistribution of sand, preventing buildup of a wide, protective beach.

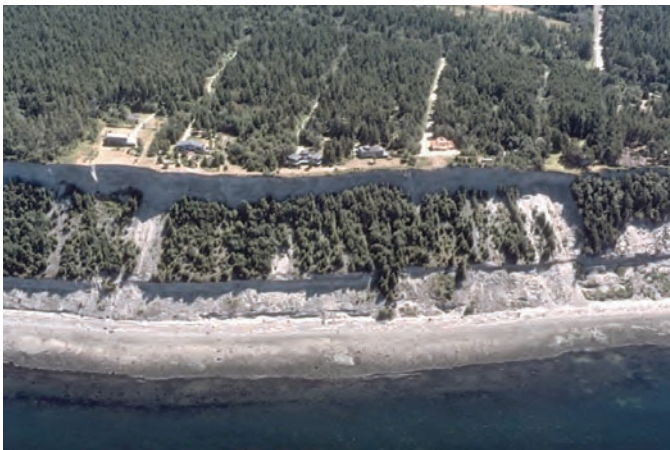
Figure 4. This 60-m-high bluff in Washington in glacial sediment shows the role of material composition in defining bluff shape. The upper till unit (in shade) fails in vertical slabs and does not support vegetation, whereas the central sandier outwash unit rests near the angle of repose, with substantial revegetation between erosional events. The lower, steep and unvegetated glacial unit is subject to wave action when storms and high tides coincide and when beach volume is reduced.

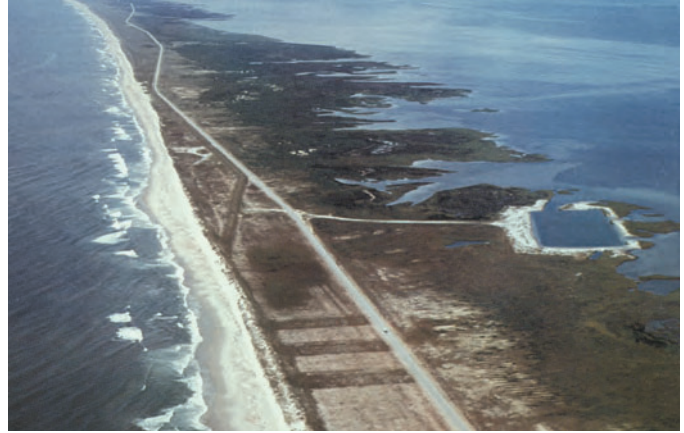
Figure 5. Depositional coastal landforms along the Outer Banks of North Carolina.

depositional landforms such as wide sandy beaches and dunes, as well as offshore barrier islands or bars (fig. 5). Extensive reaches of eroding bluffs occur only along the inland shores of estuaries, such as the Calvert Cliffs of Chesapeake Bay (Wilcox and others, 1998; Ward and others, 1989).

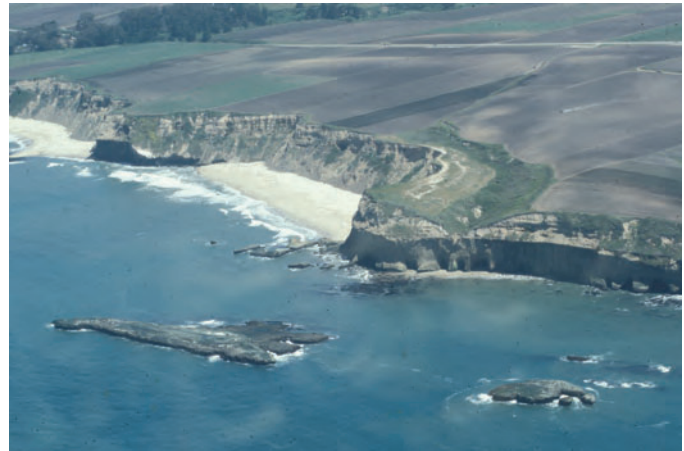
Figure 6. Steep coastal cliff with rocky headlands, sea caves, and sea stacks with a pocket beach, San Mateo County, California.

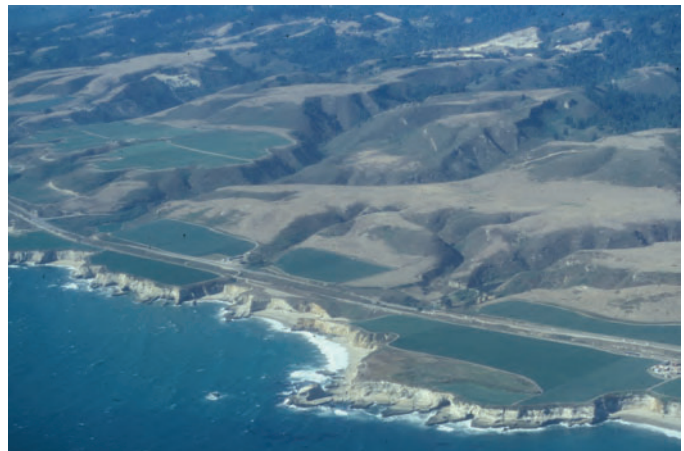
Figure 7. A series of uplifted marine terraces along the San Mateo County coast, central California.

Along parts of the U.S. west coast, resistant coastal cliffs are carved into uplifted bedrock such as crystalline granite or lithified sedimentary rock. Tectonic uplift along the coasts of California and Oregon has preserved older, degraded wave-cut platforms (uplifted or emergent marine terraces) with their abandoned coastal cliffs, at present elevations of up to several hundred meters above sea level (Bradley and Griggs, 1976) (fig. 7).

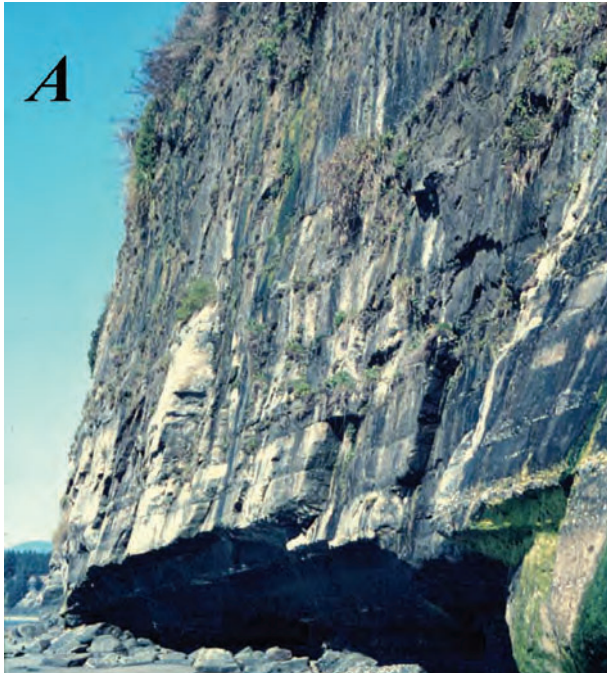
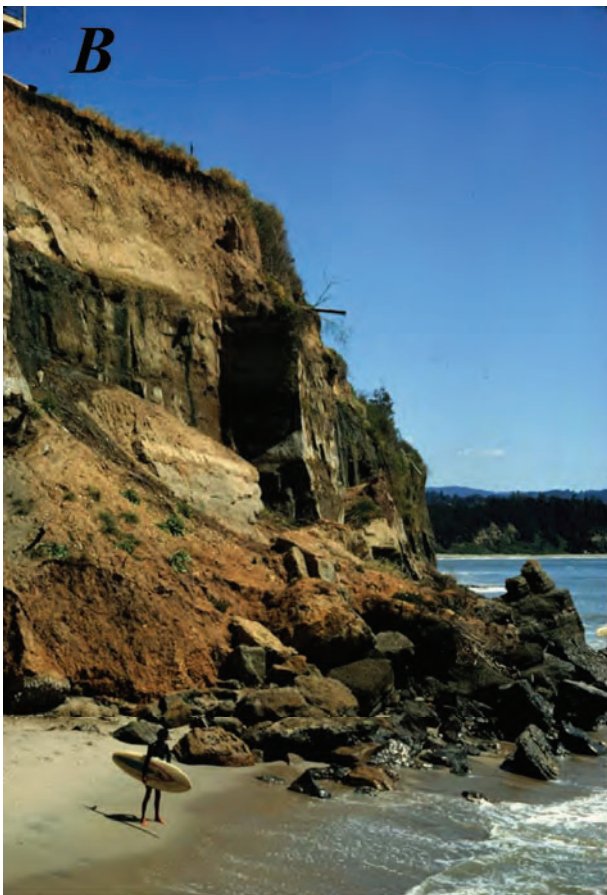
Figure 8. Undercut cliff (*A*) and adjacent cliff failure caused by undercutting (*B*) at Capitola, California. Note that the cliff-face morphology is determined by near-vertical jointing.

Figure 30. Rock falls along a seaward dipping joint set in Tertiary sedimentary rocks at Capitola, California. Another example is shown in figure 8.

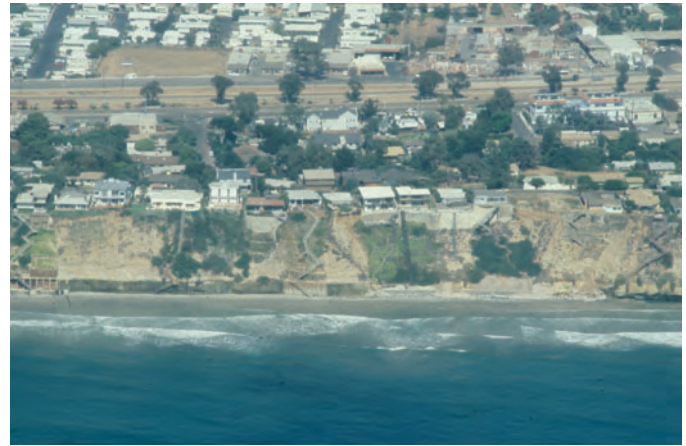
Figure 9. This nearly vertical coastal cliff in the Solana Beach area of southern California is fronted by a narrow beach and is under frequent attack by waves, which remove talus and erode the cliff base.

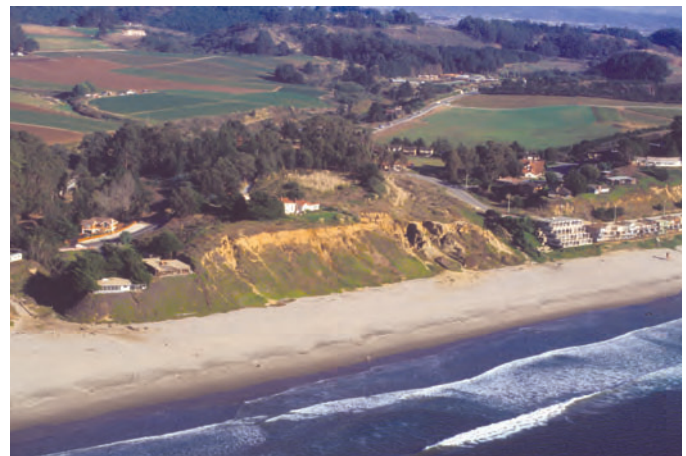
Figure 10. Coastal bluff with a convex profile in the northern Monterey Bay area of California, fronted by a wide protective beach. The convex profile exists because of a large talus build-up on the cliffs and reflects a dominance of terrestrial processes over wave erosion.

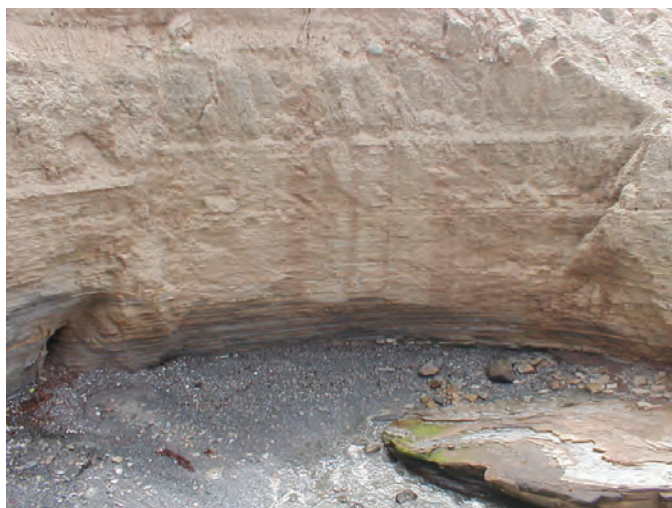
Figure 15. Wave-cut notch, approximately 3 m high, at the base of a sea cliff eroded into interbedded sandstone and shale at Cabrillo National Monument, San Diego County, California. The erosion is enhanced by the abrasive effect of the coarse beach sediment that is entrained within the waves. Notice the sea cave at the left side, where a steep fault cuts the strata.

The primary evidence that waves have eroded a cliff is the presence of an undercut notch along the cliff's base (fig. 15), which can initiate the collapse of the overlying rock or unlithified sediment because of oversteepening and removal of support (Wilcox and others, 1998; Carter and Guy, 1988; Vallejo and Degroot, 1988; Edil and Vallejo, 1980; Edil and Haas, 1980). However, as discussed elsewhere, not all notches are wave-cut.

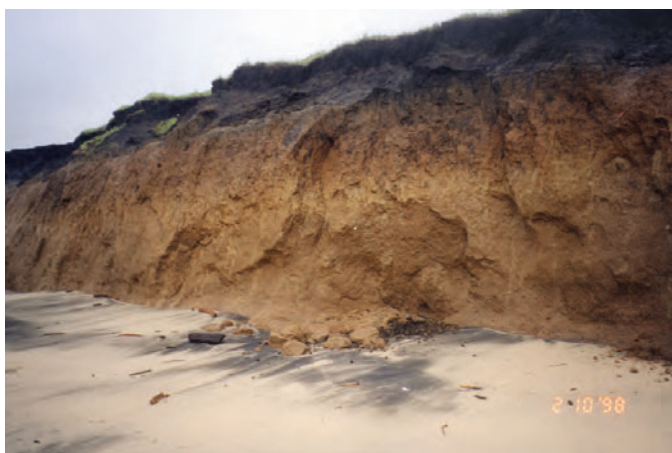
Figure 16. This photo, taken after large El Niño storm waves battered the sea cliff at Vallejo Beach in central California, shows irregularly bounded depressions that are typical when waves quarry blocks from a sea cliff. Cliff is about 2 meters tall.

Further evidence of wave impact is in the form of irregularly bounded recesses in the cliff face (fig. 16) from which blocks have been quarried by pounding waves. An erosional scarp at the seaward edge of cliff-base talus accumulations implies that waves have approached the cliff, and that erosion

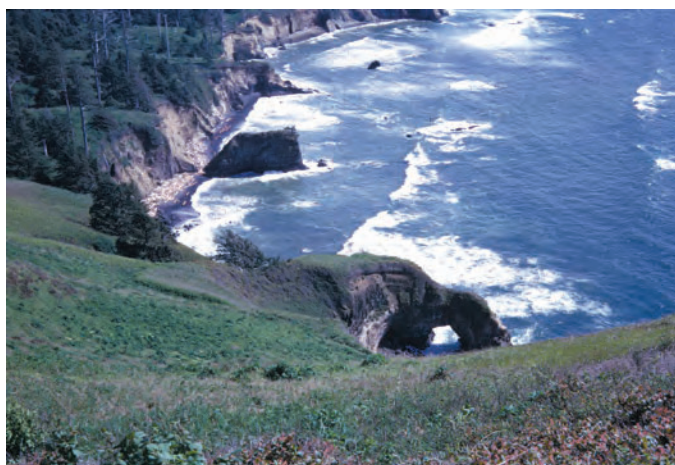
Figure 17. Wave-eroded arch along the Oregon coast.

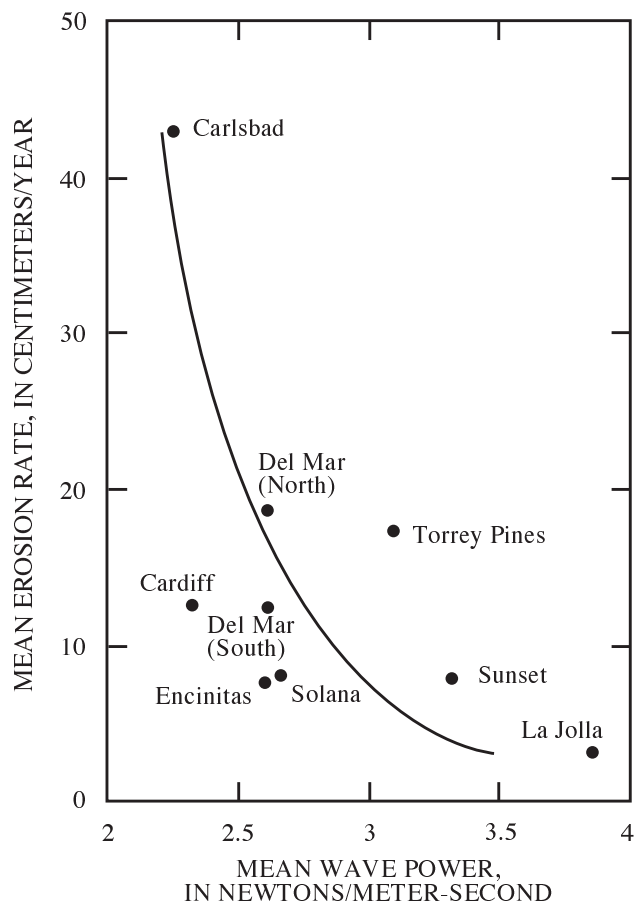
Figure 21. Relation between sea-cliff erosion rate and mean wave power at sites in San Diego County, California. Note that the exponential decay curve is strongly leveraged by the Carlsbad site. Modified from Benumof and others (2000).

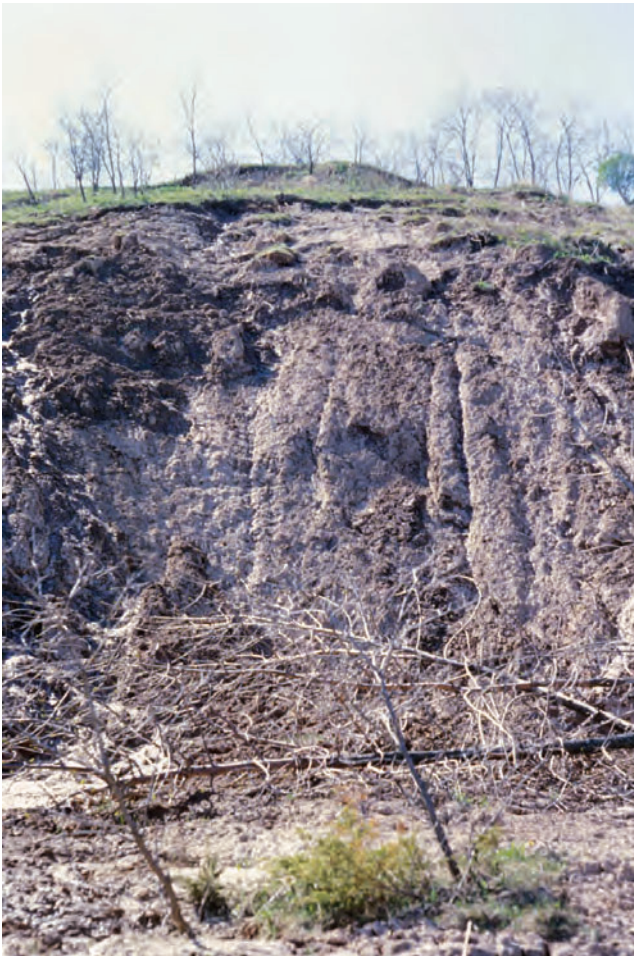
Figure 22. Western Lake Michigan bluff face in mid summer shows the effects of sheetwash and the development of gullies. These shallow gullies form every year on clayey till where solifluction and shallow slides occur in winter. From Sterrett (1980).

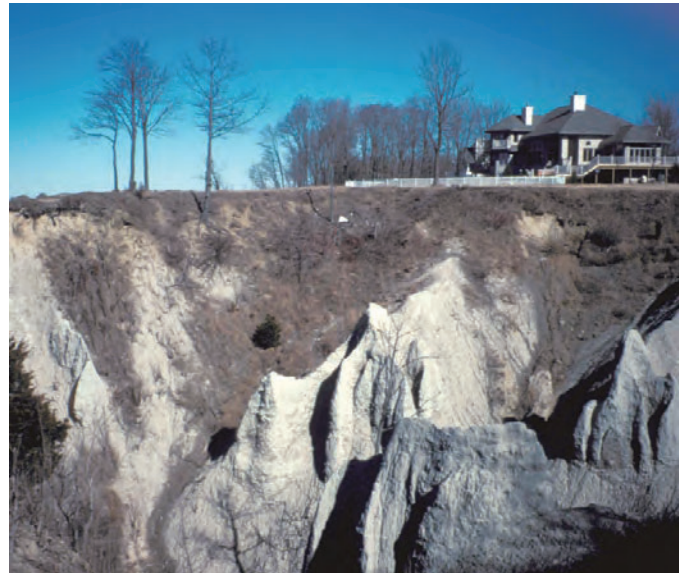
Figure 23. Deep gullies on the eastern Lake Michigan shoreline are primarily initiated by sapping of ground water or capture of surface runoff. In this case surface runoff diverted by development rapidly caused substantial incision.

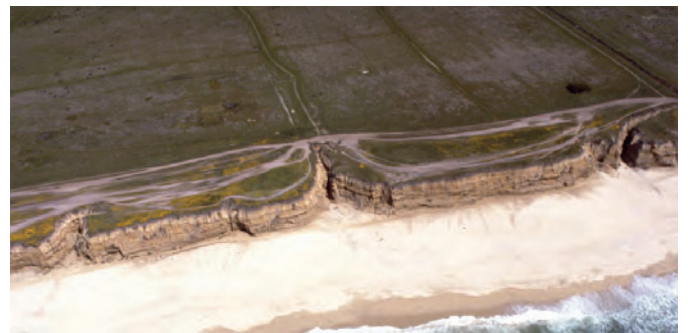
Figure 24. These large gullies at County Beach in San Mateo County, California, were carved by a combination of seepage erosion and concentrated surface runoff. Cliff is ~15 m high.

Gullies form where surface water is concentrated in channelized flow; point-source ground-water seepage high on a coastal cliff can have a similar effect. Gullies can be deep and wide, seriously interrupting the continuity of a coastal cliff, if the source flow is sustained or of high discharge (fig. 24).

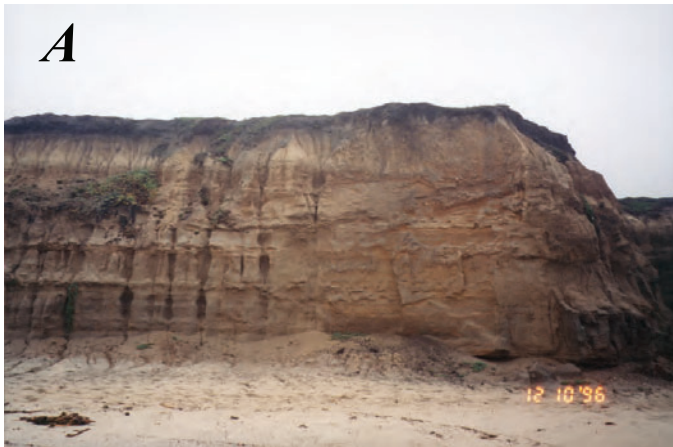
Figure 25. Signs of recent sea-cliff failures in northern San Mateo County, California. Cliffs are about 10 m high. *A*, The relatively smooth section of cliff face (right side of photo) adjacent to a roughened section (left side of photo) implies recent slope failure, although other evidence such as fallen blocks has been removed. *B*, An unambiguous example of recent failure.

sion of cliff faces emphasizes the details of bedding structures in sedimentary deposits, and it can erode vertical flutes and impart a badlands topography (see, for example, Norris, 1990) (figs. 22 and 23). Fresh-water sheet flow generally causes only a small amount of coastal-cliff retreat, but concentrated runoff can carve gullies that deeply indent the cliff (fig. 24). The amount of cliff erosion caused by sheet wash typically is overshadowed by other processes such as slumping, landsliding, or rock falls, but the magnitude of cliff-face relief can reach meters between episodes of gravitational slope failure (see, for example, Sterrett, 1980). Smooth unvegetated sections of cliff face adjacent to sculpted or vegetated ones can signify locations of recent slope failure (fig. 25).

Moderate-scale landslides encompass a large percentage of the height of a coastal cliff but have relatively restricted inland and lateral extent. Many of these occur as topples at local promontories, points of land, or cliff-gully intersections (fig. 25). These places seem to fail because the slope is not supported at its sides, but we do not know of an analytical treatment of this situation. Moderate-scale landslides are typical on Great Lakes shorelines with cliff heights greater than about 20 m.

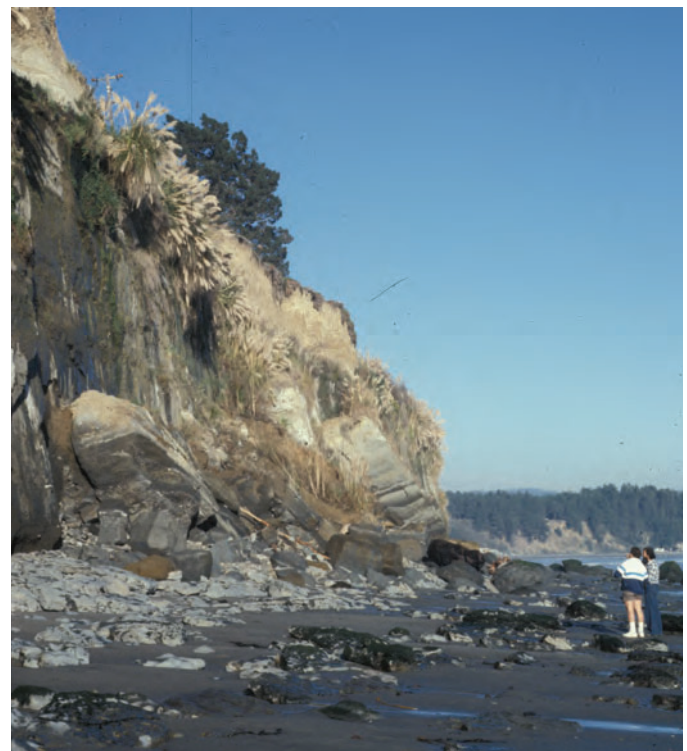
Figure 26. Block failure along joint sets accelerated by seepage in sedimentary rocks of northern Monterey Bay, California. Seepage imparts a dark shade to the cliff, visible at the left side of the photo.

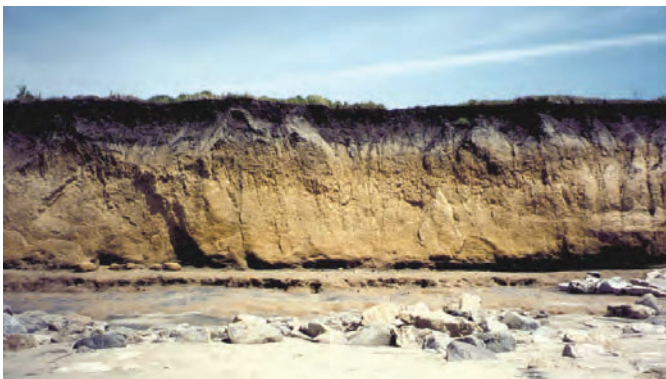
Figure 27. Ground-water discharge at the base of a coastal cliff in northern San Mateo County, California, that is underlain by impermeable rock has eroded a low notch, which undercuts and potentially destabilizes the cliff. Cliff is about 3 m high.

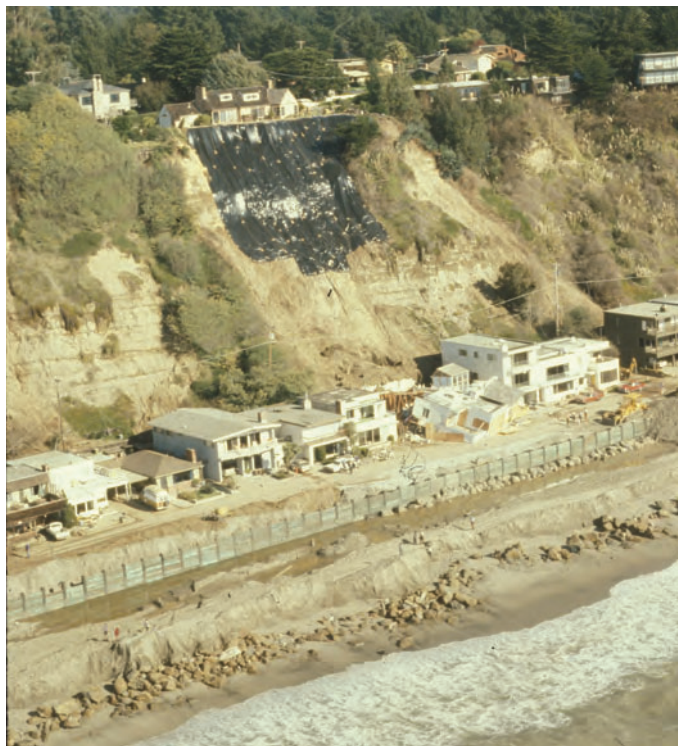
Figure 28. Shallow debris flows on this coastal cliff in Rio del Mar, California were initiated by sustained high intensity rainfall. Note the damaged houses.

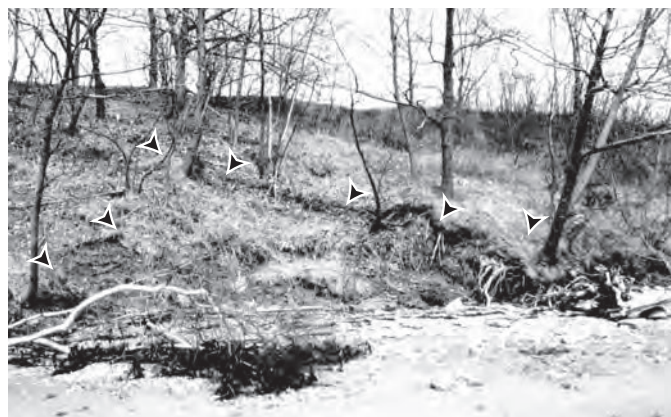
Figure 29. An eroding bluff of glacial-marine sediment, Rockland, Maine. The bluff is about 13 m high and composed of muddy marine sediment deposited about 13,000 years ago. As a large, detached block of material in the left and center of the photo (beneath arrows) creeps downslope, trees on its surface are bent and twisted by the movement.

bent trunks of trees that attempt to maintain a vertical attitude as the block they rest on slowly descends a slope (fig. 29).

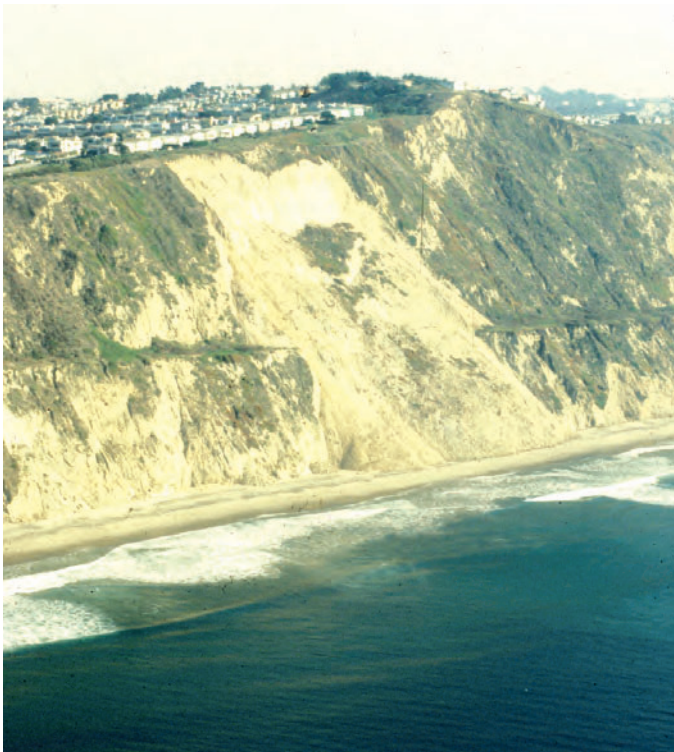
Figure 31. Large-scale coastal cliff landslide south of San Francisco, California.

Large coastal landslides have been studied extensively along the coast of the British Isles, California, Oregon, and the Great Lakes. By “large” (relative to the size of the coastal cliff) we mean landslides that encompass the entire height of a coastal cliff; some extend inland a considerable distance (fig. 31). They also typically extend tens to hundreds of meters along-shore. Activity of large landslides can be separated into pre-failure movements (small precursory displacement and offset), failure (the main phase of movement, usually abrupt and with maximum displacement), and reactivation (renewed movement after a period of quiescence and typically a result of degradation of material properties or exposure to more hostile environmental conditions) (Lee, 1997). Wave-induced steepening (that is, coastal-cliff formation and retreat) at the toe of the landslide and high ground-water levels commonly are invoked as the principal triggering mechanisms of large landslides (Moore and others, 1998; Hutchinson and others, 1985; Edil and Vallejo, 1980; Quigley and Zeman, 1980; Hutchinson, 1969).

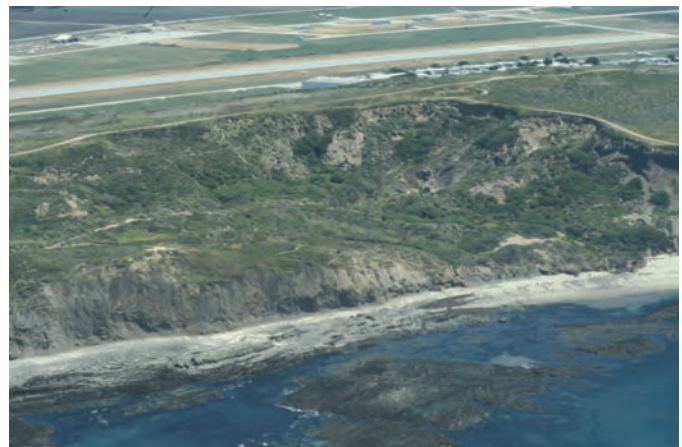
Figure 32. A large rotational slump in sedimentary rocks in the Half Moon Bay area of central California, showing a clearly developed rear scarp and undercliff (displaced landslide mass) with a cliff eroded at the seaward edge.

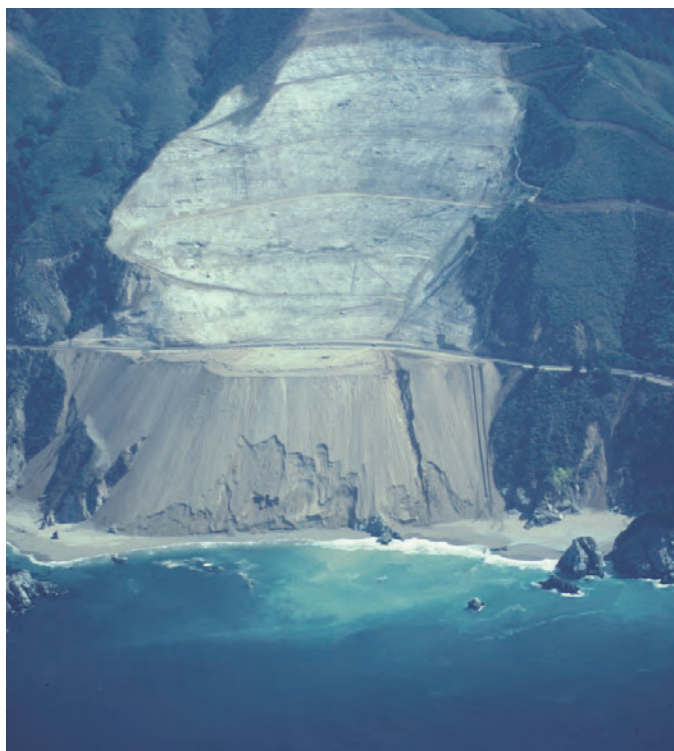
Figure 33. Reconstruction of California State Highway 1 along the Big Sur coast after a major coastal landslide in 1983. Total cost: \$7,500,000.

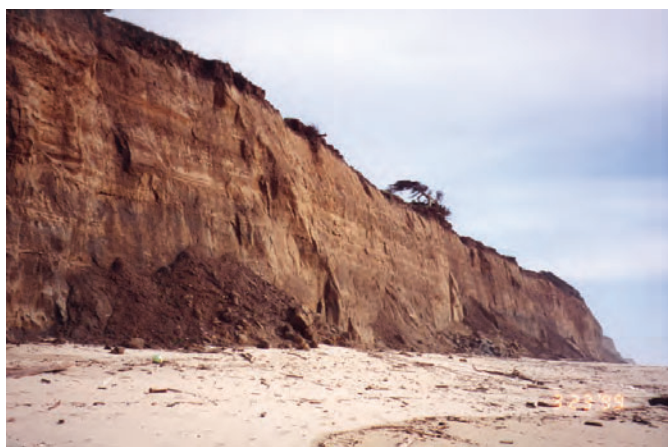
Figure 34. The relatively large failure scar on this coastal cliff (left foreground), rather than being formed by a single landslide, developed gradually as a consequence of many small block falls, the remains of which constitute the debris apron. The other debris aprons in the background formed similarly. This sea cliff in northern San Mateo County, California, retreats mainly as a consequence of small block falls.

Small failures, less than the total cliff height, are common. They occur in the form of small rotational slumps, block falls, or topples that typically involve a few cubic meters of material, or less (fig. 34) (Hampton, 2002; Hampton and Dinger, 1998). Some small rotational slumps occur in stratigraphically inhomogeneous cliffs at levels of perched ground water (Chase and others, 1999). Many small failures occur at places where erosion or previous slides have oversteepened the slope and thereby decreased the resistance to failure. Intersecting joints

can bound prismatic blocks that fall from a cliff (wedge failures, fig. 8B), as can shrinkage fractures (Hampton and Dinger, 1998; Benumof and Griggs, 1999). Small slides typically are not isolated; instead, multiple slides tend to affect broad areas of a cliff face with similar properties (fig. 34).

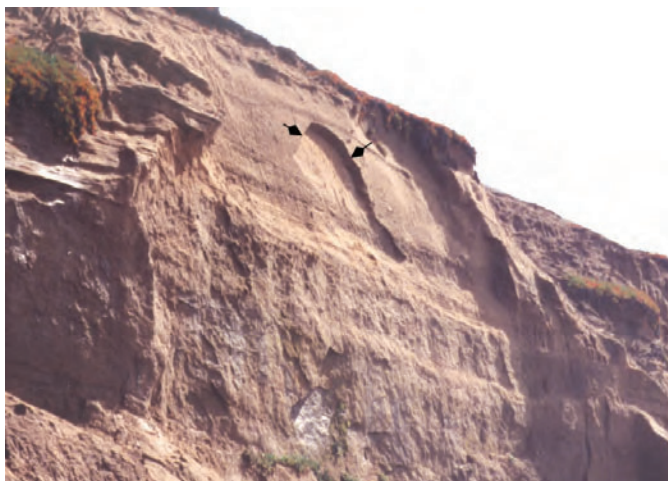
Figure 35. Stress-release jointing (beneath arrows) can occur on nearly vertical coastal cliffs. It is a consequence of the release of confining pressure in a horizontal direction as a coastal cliff retreats, with consequent expansion of the rock near the cliff face.

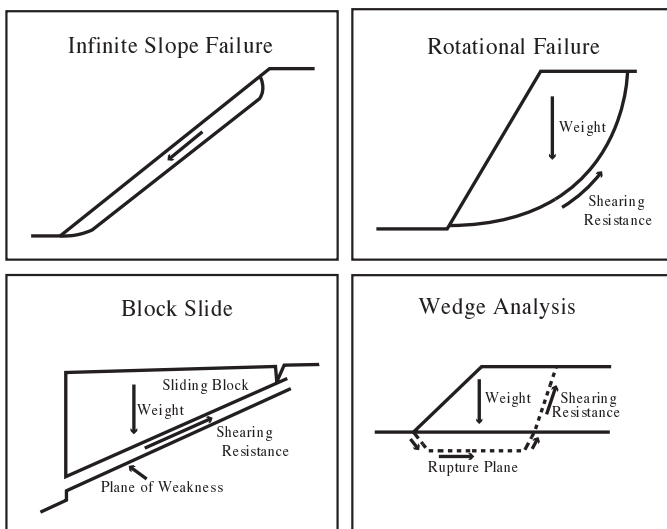
Figure 36. Various idealized failure modes for analyzing landslides.

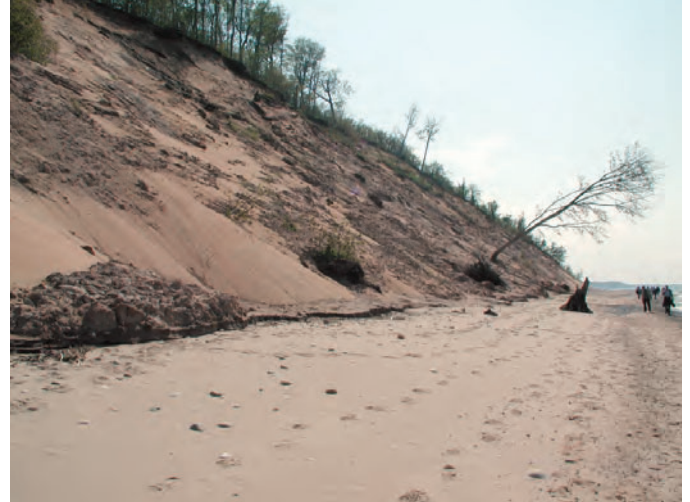
Figure 37. Failing bluff on the south shore of Lake Superior in Michigan, showing shallow slide of tree-and-root mat down sand slope that is at the angle of repose.

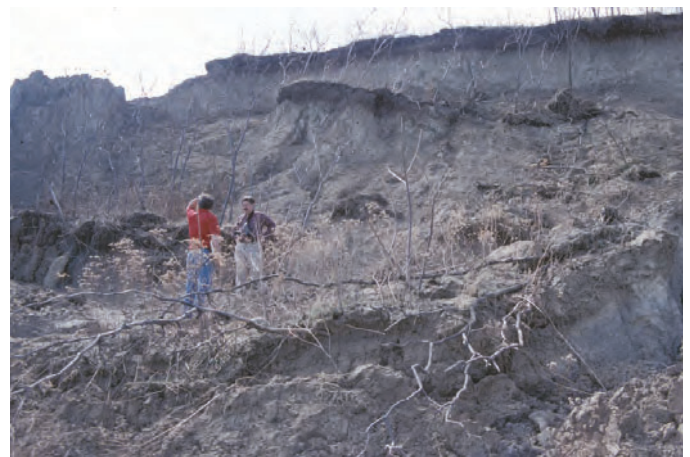
Figure 38. Slump on west shore of Lake Michigan, showing characteristic backward rotation of surface of block (above and to right of people).

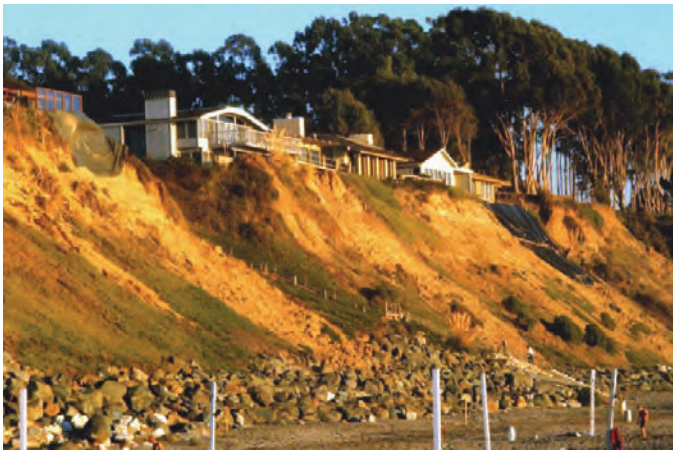
Figure 39. Shallow bluff failures that originated near the top of a moderately sloped sea cliff in northern Monterey Bay following the 1989, magnitude 6.9 Loma Prieta earthquake.

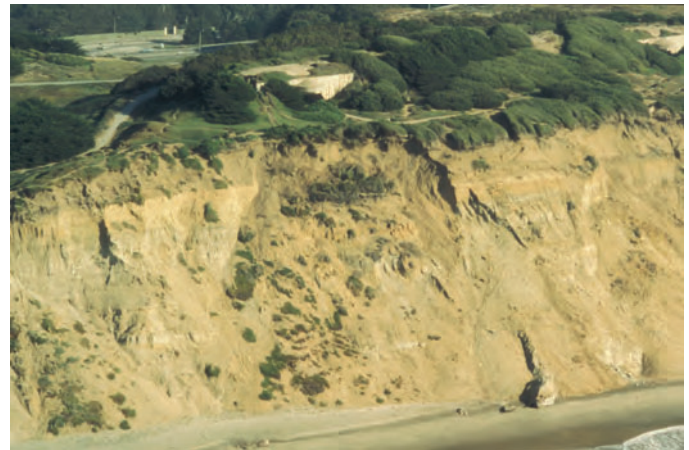
Figure 40. A shallow cliff failure on the upper part of a steep sea cliff in the San Francisco area of California, caused by seismic shaking during the 1989 Loma Prieta earthquake.

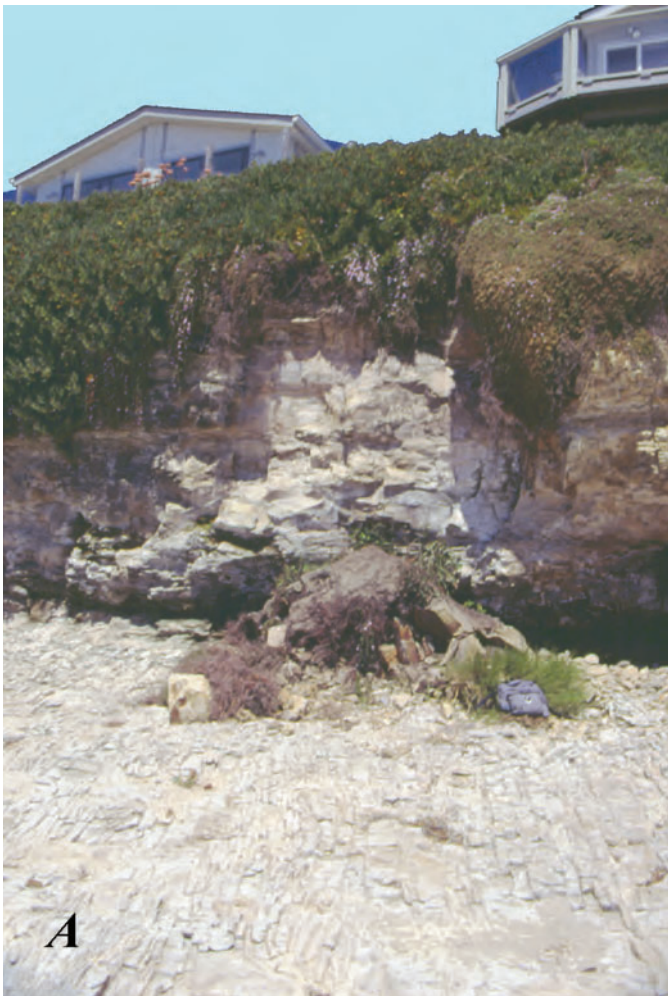
Figure 3. Photographs of vegetated coastal cliffs. *A*, Thick vegetation growing well over the top edge of a coastal cliff near Natural Bridges State Beach, California; if the cliff edge were being digitized in two dimensions on an aerial photograph, it would be very difficult to pick out the edge. *B*, Heavy vegetation covers most of this slope at Seacliff State Beach, California. Although adjacent areas have been recently active, the cliff edge on this slope would be difficult to isolate on a two-dimensional aerial photograph.

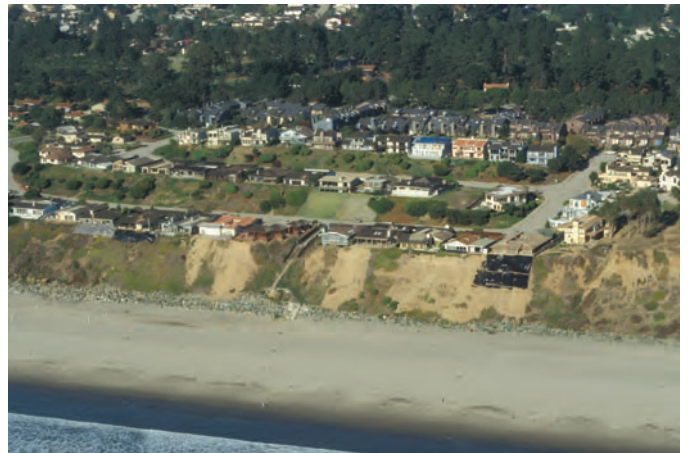
Figure 1. Developed sea cliffs in Northern Monterey Bay showing "riprap" at base of cliff and landslides from the 1989 Loma Prieta earthquake.

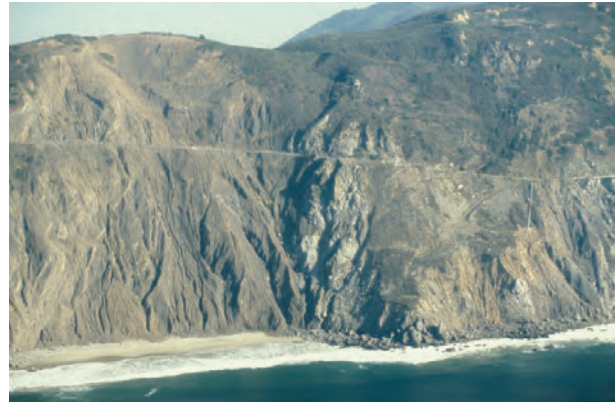
Figure 3. Steep, high cliffs south of San Francisco.

Los Angeles County. One logical breakdown is to categorize the coastline as consisting either of (1) steep coastal mountains and sea cliffs with hundreds of meters of relief (fig. 3), (2) uplifted marine terraces and sea cliffs a few meters to perhaps 100 meters in height (fig. 4), and (3) coastal lowlands with beaches and sand dunes (fig. 5). The great majority (1,267 km or 72 percent) of the California coast consists of actively erod-

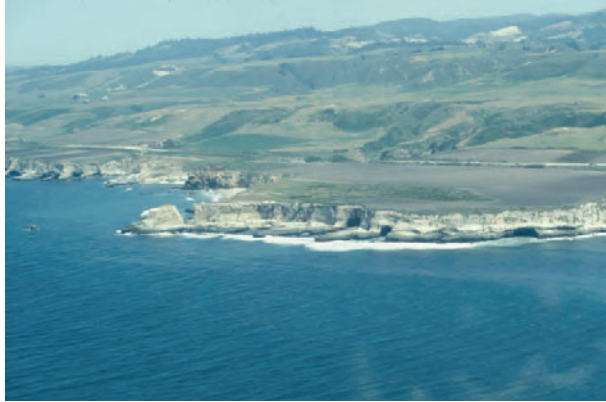
Figure 4. Cliffs eroded into uplifted marine terraces in Santa Cruz County.

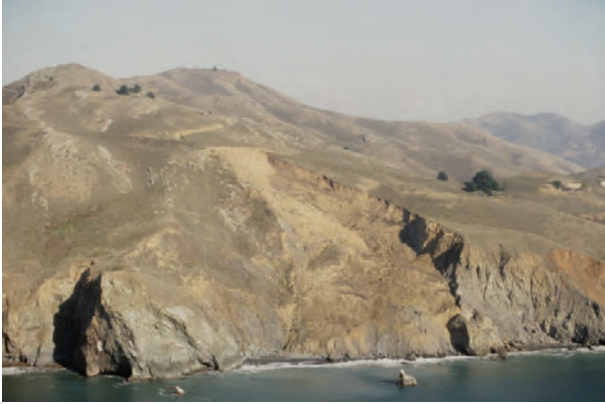
Figure 7. Large-scale slump and coastal cliffs in the Franciscan Formation of the Marin Headlands, north of the Golden Gate.

The high relief, steep cliffs or coastal mountains are located predominantly in northern California from Del Norte County to Mendocino County (fig. 2), at the Marin Headlands just north of the Golden Gate (fig. 7), in the Pacifica to Montara area of San Mateo County (figs. 2, 3), and along

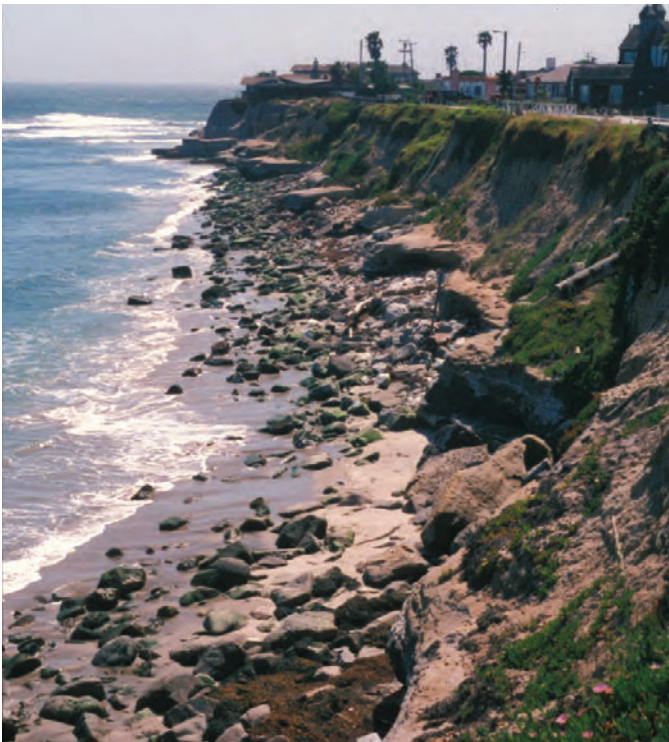
Figure 10. Eroding coastal bluffs in northern Monterey Bay exposing both mudstone bedrock at beach level and overlying sandy terrace deposits.

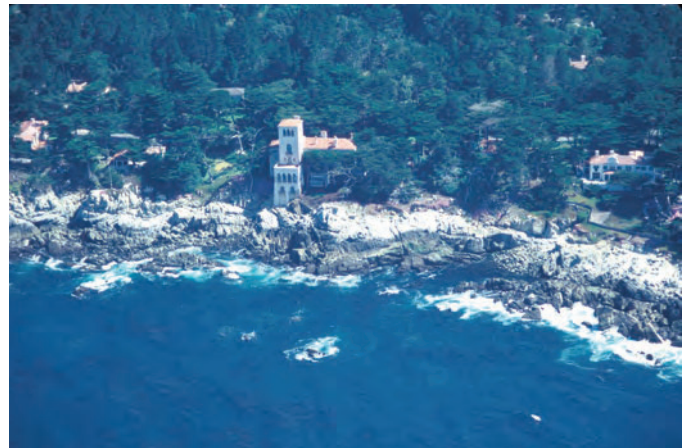
Figure 11. The irregular, granitic sea cliffs of the Monterey Peninsula.

Sections of coast consisting of unweathered crystalline rock, such as the granite of the Monterey Peninsula, usually erode at very slow rates. At some locations on the Monterey Peninsula, for example, virtually no change was detected between photos taken over a 60- to 70-year span (Griggs and Savoy, 1985). Between these generally resistant areas, however, erosion rates can vary considerably. Waves attack the weaker zones over time, the fractures and joints for example, to form inlets and coves (fig. 11). The more resistant rock is left behind as points, headlands, and sea stacks.

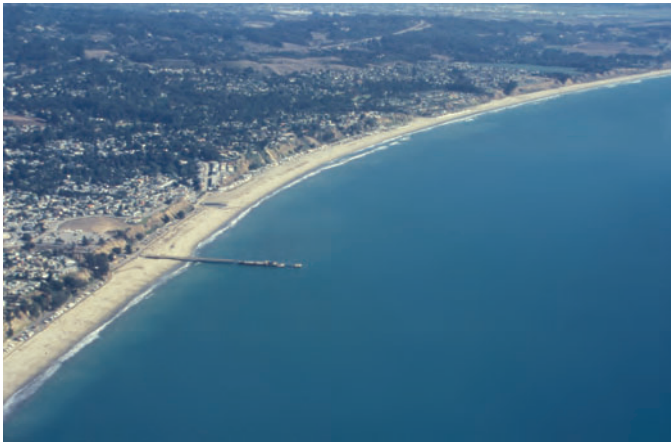
Figure 12. Linear cliffed coastline along northern Monterey Bay.

or sandstone, or unconsolidated materials, such as alluvium, dune sand, or marine-terrace deposits. In these areas, which are characteristic of much of Santa Barbara, Santa Cruz, and San Mateo Counties, for example, the cliffs often retreat in a more linear fashion, producing relatively straight coastlines (fig. 12). Lithologic, stratigraphic, and structural weaknesses or differences are the key factors affecting erosion rates in sedimentary rocks. Where the coastal bluff consists of relatively homogeneous sedimentary rocks, the shape of the coastline, the sea-cliff morphology and the average rates of erosion are often similar alongshore.

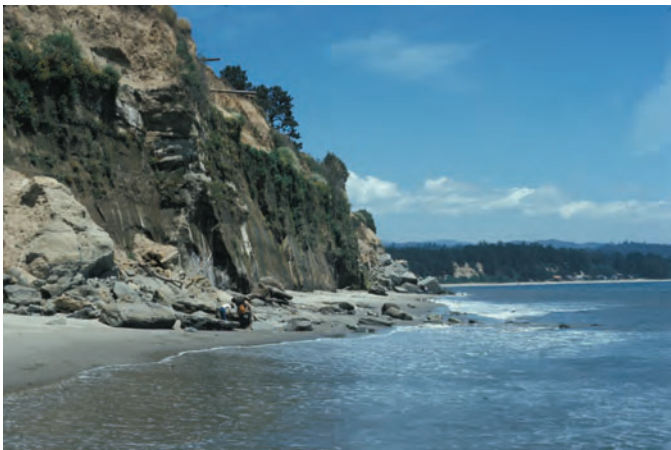
Figure 13. Episodic coastal bluff failure in Capitola, Santa Cruz County.

Cliff erosion, as mentioned earlier, is due not only to waves undercutting the base of the cliff, but also to rockfalls, landsliding, and slumping higher on the cliff face. The orientation and spacing of joints in the sandstones, siltstones, and mudstones that make up the cliffs surrounding northern Monterey Bay are the dominant factors affecting cliff retreat in this area (fig. 13; Griggs and Johnson, 1979).

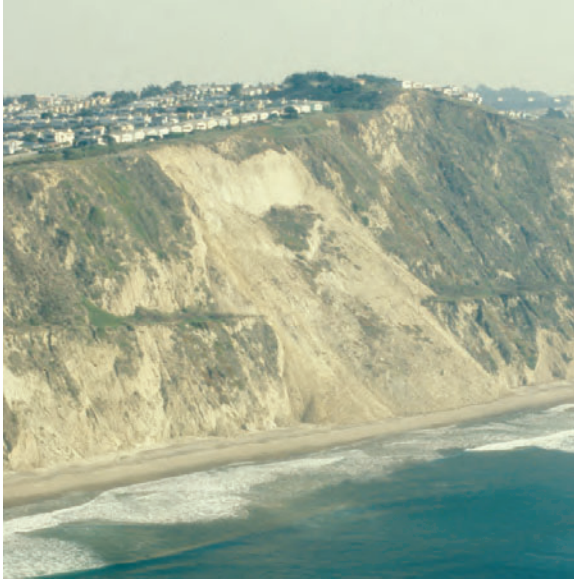
Figure 14. Seismically induced bluff failure north of Pacifica in Daly City, 1989.

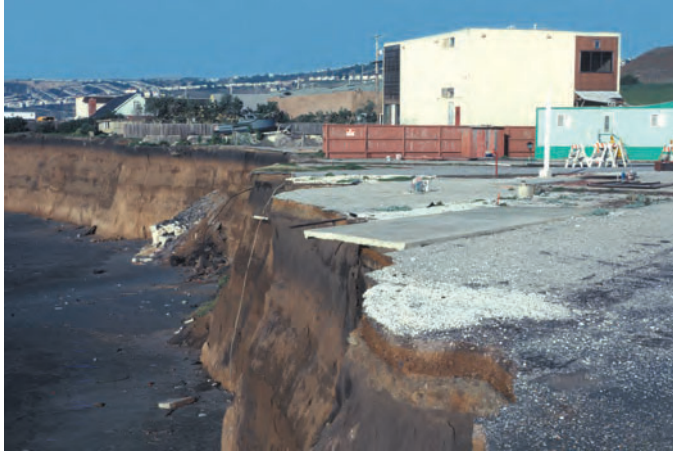
Figure 16. Erodible bluffs consisting of unconsolidated marine terrace deposits and soil in Pacifica; the site of previous mobile home pads that had to be abandoned because of sea-cliff retreat during the 1983 El Niño.
