Formation, Evolution, and Stability of Coastal Cliffs—Status and Trends

Professional Paper 1693

Monty A. Hampton and Gary B. Griggs, Editors

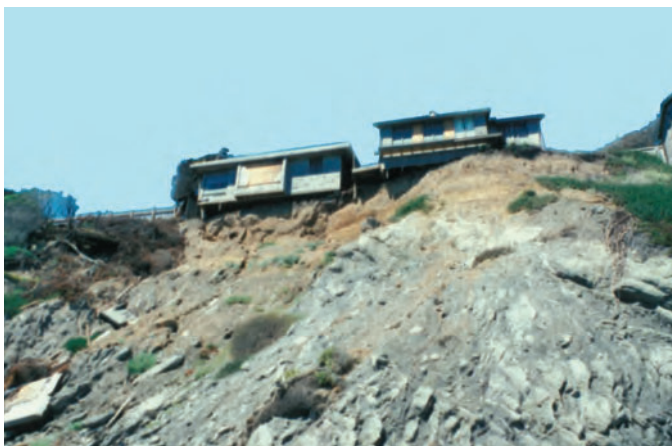
Figure 19. Ongoing cliff erosion in the Franciscan Formation of Northern California threatens cliff-top development.

Each area of California's coastline has its problem areas or erosional hot spots that have been repeatedly damaged and which regularly are featured in news stories (Moore and others, 1998). Gleason Beach, along the Sonoma County coast, is an area where a group of cliff-top homes was built in an otherwise very rural and undeveloped area. The underlying geology consists of the heterogeneous Franciscan Formation, which forms both resistant headlands and very erodible, slide prone slopes. Houses have been undermined, collapsed, and destroyed, and many others have been left in precarious positions 25 m above the waves (fig. 19).

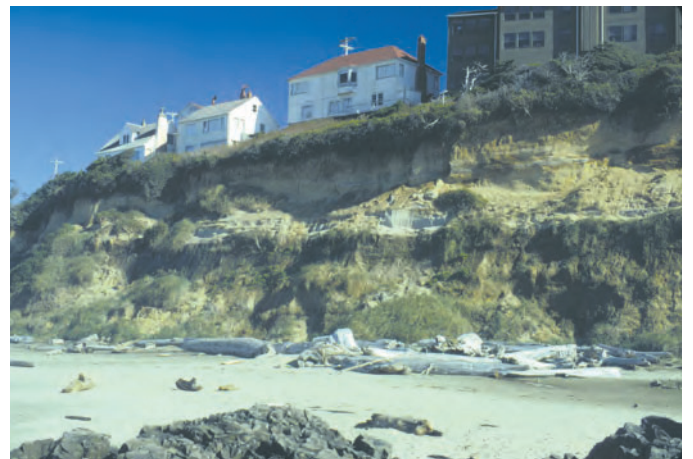
Figure 2. Sea-cliff erosion into the marine terrace at Lincoln City, threatening homes that had been constructed close to the cliff edge.

Many of Oregon's coastal communities are situated on the nearly level marine terraces (fig. 2), where their seaward edges are being cut away by sea-cliff erosion and landsliding (fig. 3). Communities, such as Cannon Beach, Lincoln City, Gleneden Beach just south of Lincoln City, and Newport, have suffered as sea cliffs retreated when attacked by the waves of winter storms. A number of State parks have been affected, with the loss of picnic grounds and camping facilities. Stretches of Highway 101 have similarly suffered from cliff erosion and landsliding, costing taxpayers millions of dollars in repairs. In

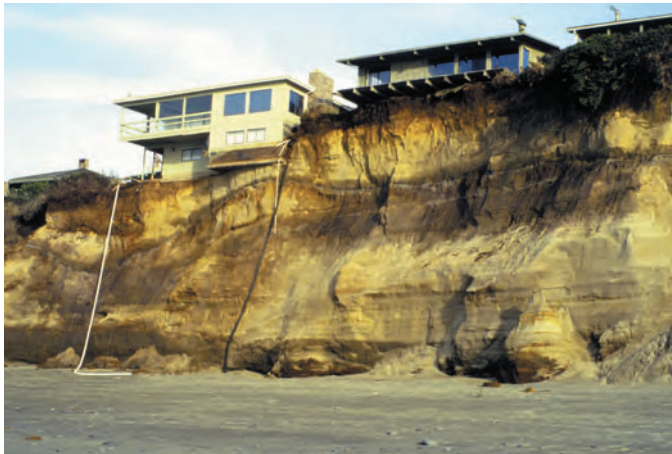
Figure 3. Erosion of the sea cliff at Gleneden Beach south of Lincoln City. Waves were able to attack the cliff because a rip current had locally cut an embayment into the beach.

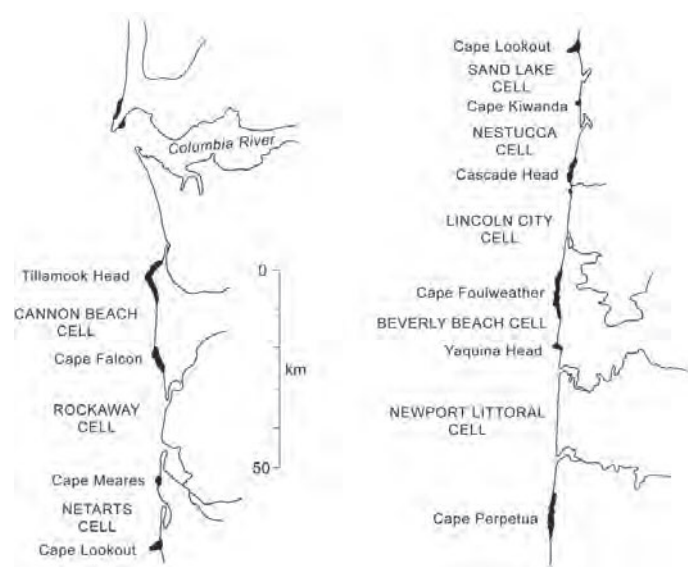
Figure 5. The division of the northern Oregon coast into a series of littoral cells that contain stretches of sandy beaches, isolated by large rocky headlands. The left of the figure shows the northernmost coast, continuing southward on the right. (From Komar, 1997.)

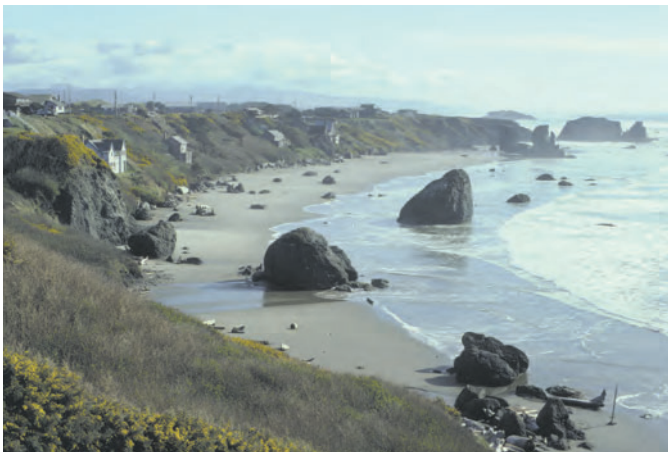
Figure 7. The sea cliff at Bandon on the southern Oregon coast, where the high rate of land elevation increase exceeds the global rise in sea level, reducing the wave attack of the cliff.

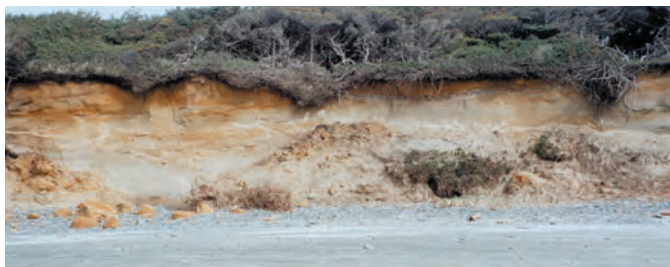
A

Figure 12. A, The sea cliff at Lost Creek in the Newport Littoral Cell, where wave erosion has cut back the Tertiary mudstone. **B,** The rate of sea-cliff retreat along the Newport Littoral Cell versus the average hours of wave impact per year assessed from the graph in figure 11, depending on the local elevation of the cliff toe. (From Ruggiero and others, 2001.)

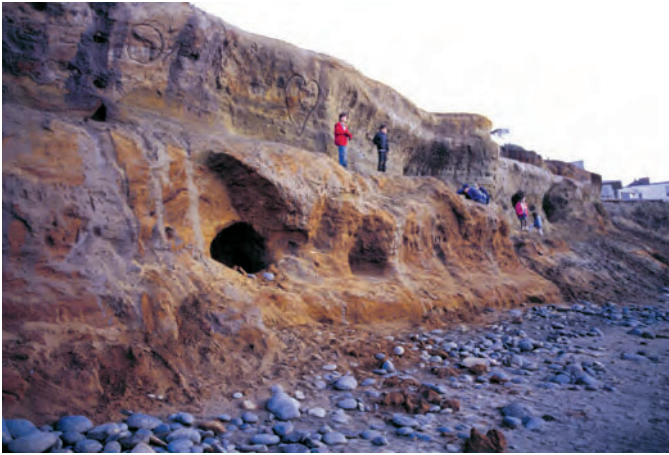
Figure 16. Graffiti and caves carved into the sea cliff at Roads End State Park in north Lincoln City.

One unusual form of subaerial sea-cliff erosion results from people carving graffiti or even caves into the exposed cliff (fig. 16). Although this may seem insignificant, on the Oregon coast where natural cliff recession rates are generally small, such human impacts can be the primary cause of cliff erosion. A general observation is that rates of sea-cliff retreat are enhanced in parks such as Roads End State Park shown in figure 16, the park providing greater access to the public, and with the human-induced erosion gradually diminishing with along-shore distance from the park.

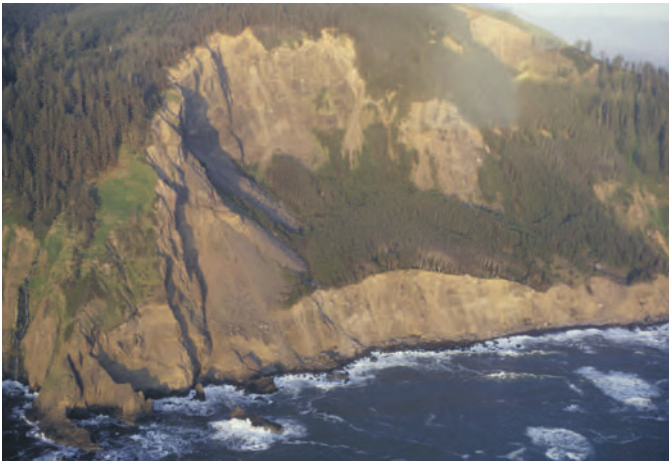
Figure 17. A large landslide on Cascade Head north of Lincoln City, which initially moved in 1934. (Photo by John V. Byrne.)

Large-scale landslides are common along the Oregon coast, and their occurrence has damaged homes, parks, and highways. The largest are found on headlands, or more precisely, within the loose debris shed from the basaltic headlands that has accumulated along their flanks. An example is the huge landslide on Cascade Head (fig. 17), that abruptly gave way in 1934 (North and Byrne, 1965). Wave action has cut away its toe, forming a high cliff in the debris. Such massive landslides associated with headlands have affected a few private homes, but in particular park lands such as Ecola State Park on Tillamook Head immediately north of Cannon Beach.

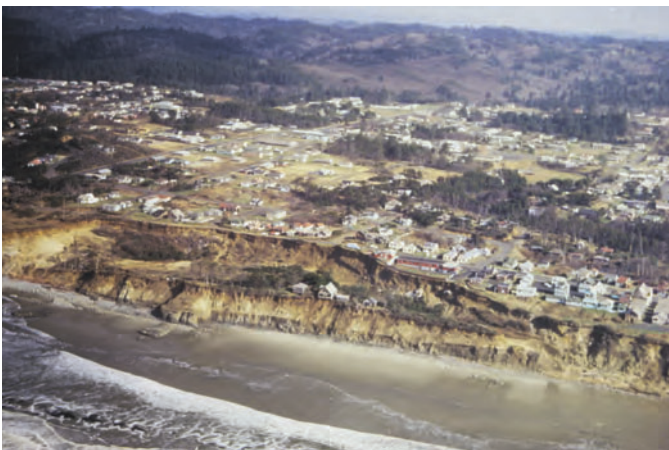
Figure 18. The 1942-43 landslide at Jump-Off Joe in Newport as photographed in 1961, with surviving houses on the slide block still inhabited. (Photo from the Lincoln County Historical Society, Newport.)

The importance of the cliff composition and slope of its layers to the inception of landslides is illustrated by occurrences of mass movement in the Newport and Beverly Beach Littoral Cells. The sea cliffs there consist mainly of Tertiary mudstones that locally dip seaward at 30° in the Nye Beach area of Newport. This is the site of the infamous Jump-Off Joe landslide that has been destructive to coastal properties (Sayre and Komar, 1988; Komar, 1997). Its initial movement began during the winter of 1942-43, affecting about 15 acres and 15 houses. Several houses were immediately destroyed by the ground movement, but a few remained intact on the down-drop block of the landslide as seen in the photograph of figure 18 taken in 1961; they eventually succumbed to toe erosion produced by waves. Jump-Off Joe was recognized as the best example on the Oregon coast of instabilities leading to landsliding, and it also had the highest rate of cliff recession found anywhere on the coast, so it was a surprise when an attempt was made to develop the site in 1980. Initially the developer planned to build condominiums on the down-drop landslide block, but was prevented from doing so when the State rejected their request to construct a sea wall along the toe of the slide to prevent its further erosion. Instead, the developer constructed the condos on the small remnant of marine terrace to the immediate north of the Jump-Off Joe landslide (fig. 19), beyond which was a second and older landslide of comparable size. As the condominiums approached completion, slippage in this remnant terrace undermined the condo's foundation, leading to its destruction (Sayre and Komar, 1988; Komar, 1997).

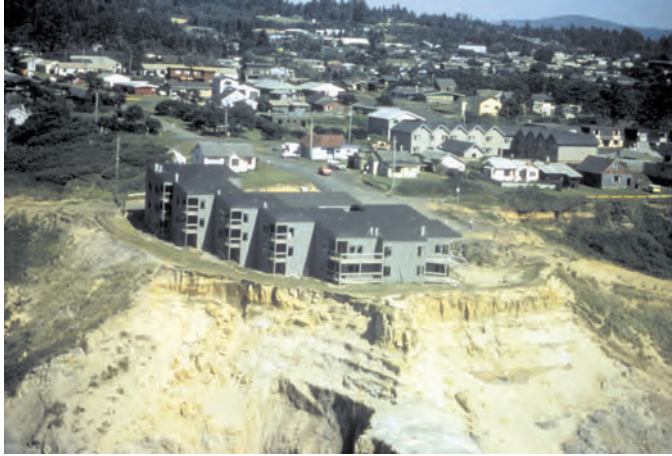
Figure 19. The condominiums built in 1981 on the remnant terrace immediately north of the Jump-Off Joe landslide in Newport. (From Sayre and Komar, 1988.)

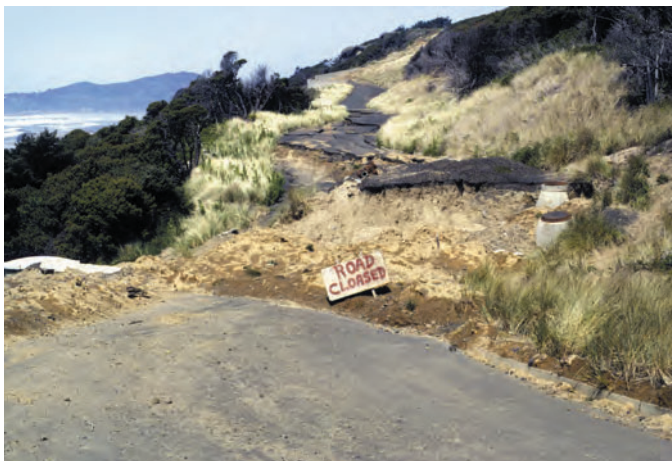
Figure 20. The disruption of streets and sewers in the Stratford Estates development north of Yaquina Head (fig. 5), resulting from a slowly moving landslide. (From Komar, 1997.)

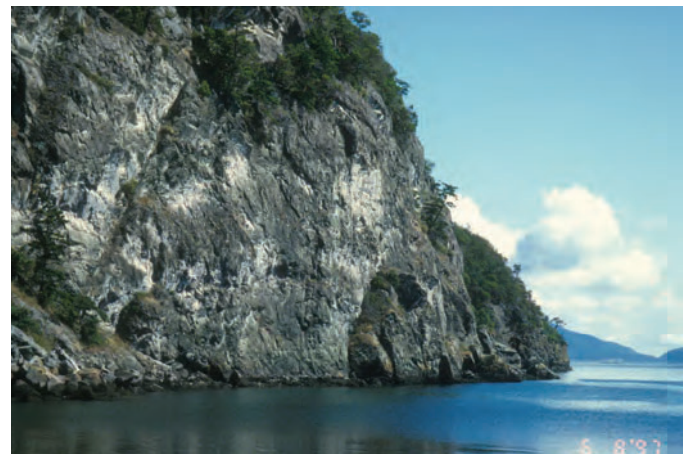
Figure 2. Basalt sea cliff in the San Juan Islands of northern Puget Sound. The base of the cliff is marked by a narrow erosional ramp. Erosion rates here are negligible, with the exception of rare block falls.

Rocky shorelines are common in many portions of the northern sound where bedrock is exposed at the coast. Steep cliffs are not unusual, but these features are rarely actively eroding sea cliffs (fig. 2). Rather, they represent glacially scoured knobs and hills of moderate relief that have experienced little marine erosion due to their resistant lithologies and the modest wave energy of the sound. Marine erosion may have removed a veneer of glacial sediment, but the resis-

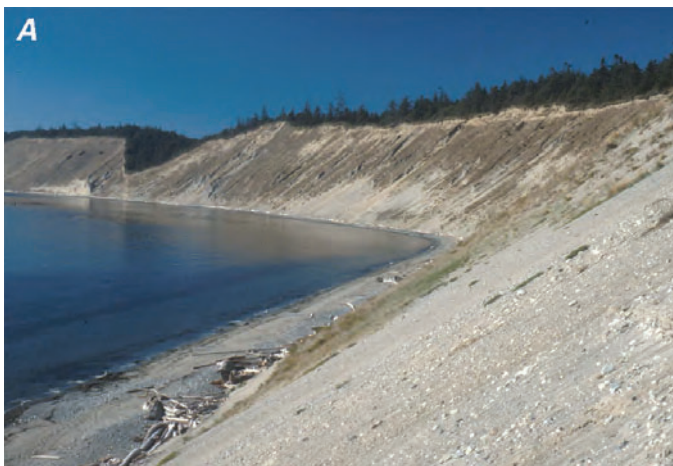
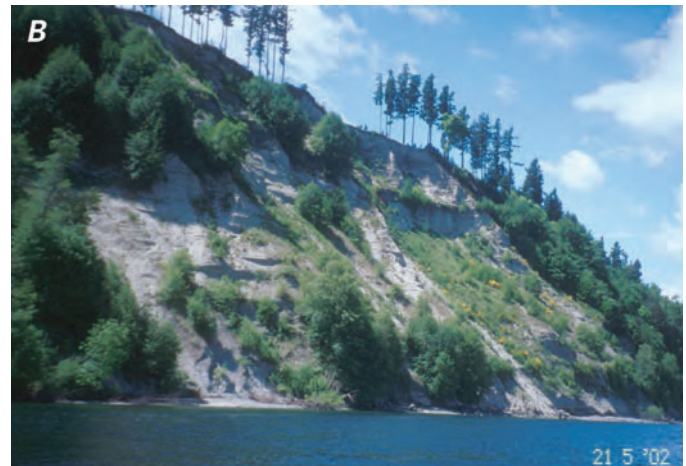
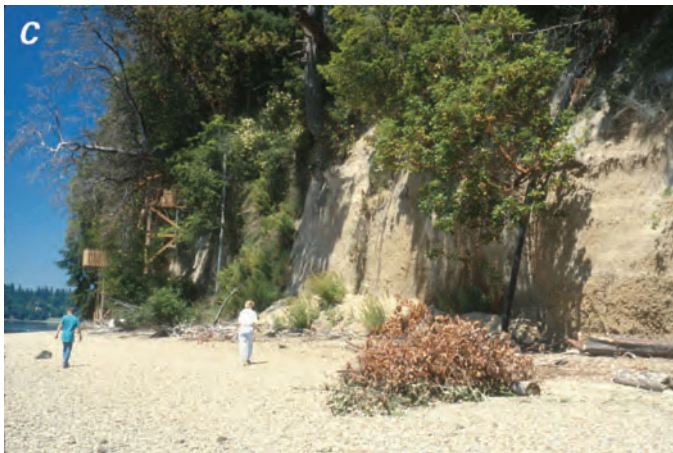
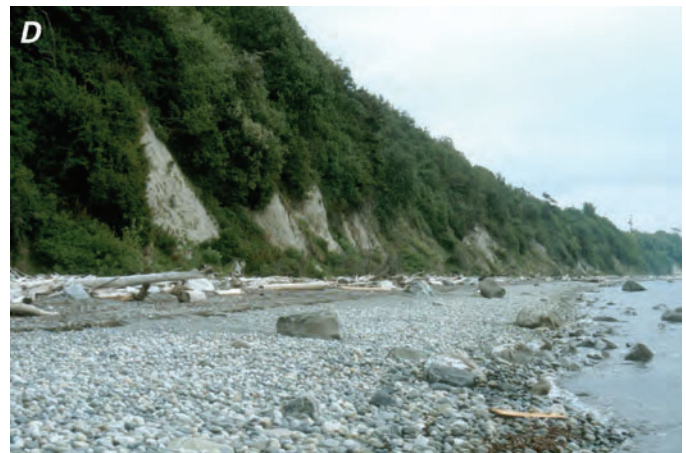
Figure 3. Examples of coastal bluffs from different parts of Puget Sound. *A*, High bluffs composed entirely of poorly consolidated recessional outwash gravels. *B*, 100-m high bluff in Tacoma consisting primarily of advance glacial outwash. Vegetation establishes rapidly after periodic failures. *C*, 15-m bluff in southern Puget Sound. Compact glacial sediments form near-vertical face; vegetation occurs along top of bluff and on colluvial material at toe of slope. *D*, Upper portion of these 40-m bluffs in northern Puget Sound are gradually sloped and heavily vegetated, whereas lower slopes are steeper and more exposed.

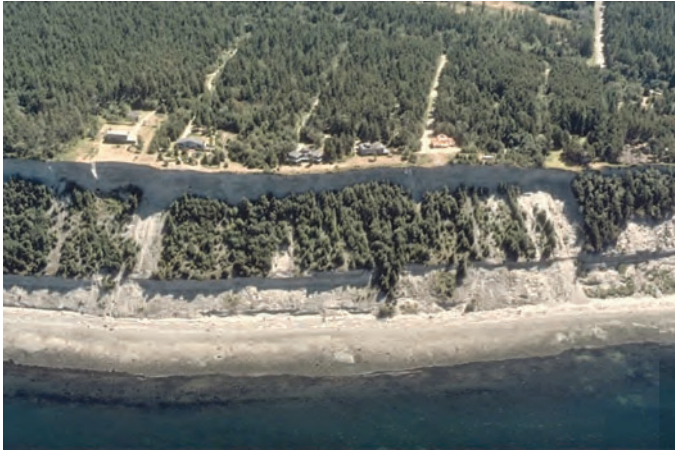
Figure 4. High bluffs near Port Townsend illustrate role of distinct stratigraphic units in defining bluff profile. Upper unit of glacial till fails in vertical slabs and does not support vegetation. Central sandier outwash unit is at angle of repose, with substantial revegetation between erosional events. Lower glacial unit is subject to wave action when storms and high tides coincide and when beach volume is reduced.

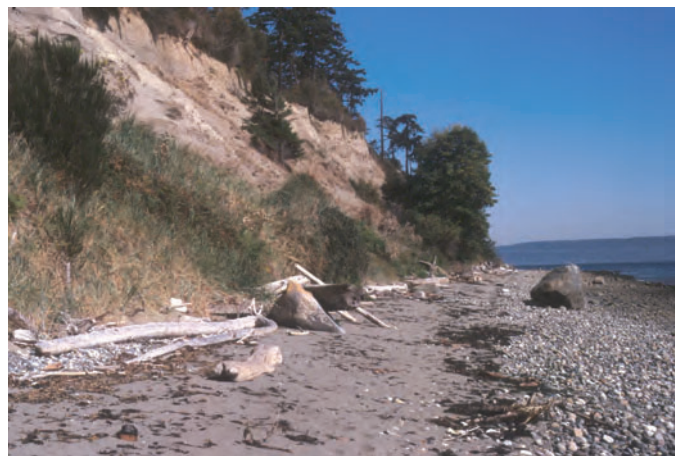
Figure 6. Typical mixed sand and gravel beach at base of high coastal bluff on Puget Sound. Berm, which consists of sandy material overlying a coarse gravel core, protects slope toe from wave action except when storm waves coincide with unusually high tides.

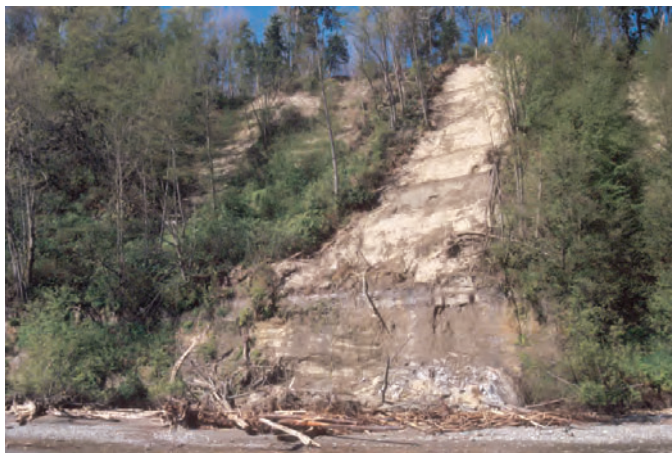
Figure 7. Shallow landslide extending entire height of bluff on Puget Sound. Landslide was likely triggered by saturated conditions at contact between lakebed clays and overlying outwash sand (note dark band above bottom portion of bluff).

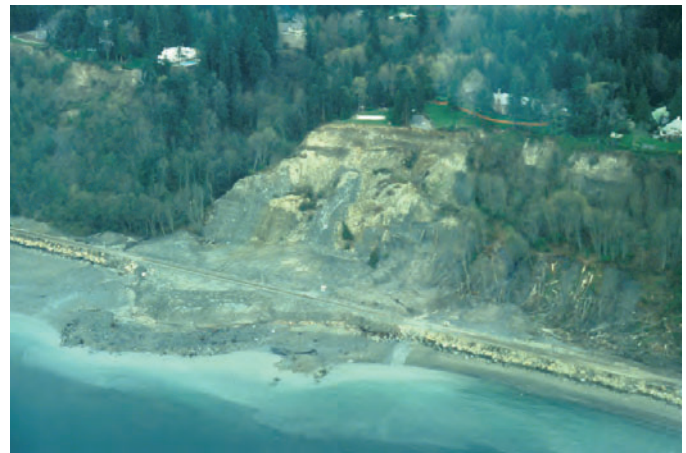
Figure 8. Large landslide north of Seattle that occurred in January 1997, following heavy rains. Note distinct mid-slope bench to the right of the landslide, marking the contact at the base of the glacial outwash. The landslide, which pushed a train into the Sound, involved a deeper failure in the underlying clay units. The toe of slope had been protected by the railroad grade at beach level for approximately 100 years and was not involved in the slide.

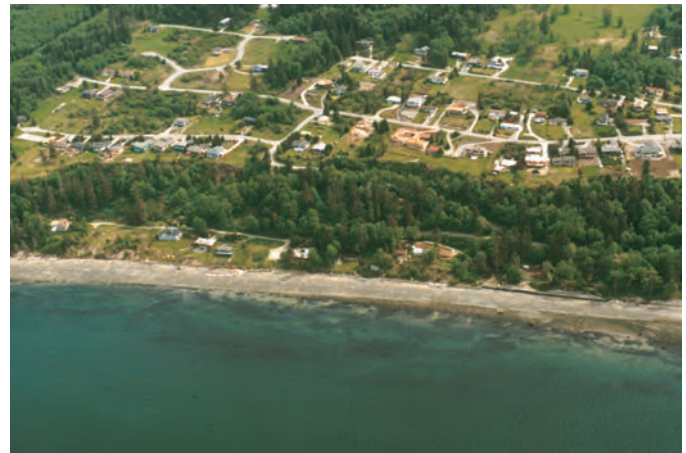
Figure 9. Large, prehistoric landslide on Whidbey Island. Portions of this slide periodically reactivate during wet weather. The toe of this landslide occurs slightly below beach level in this area. The landslide extends almost 2 km along the shoreline.

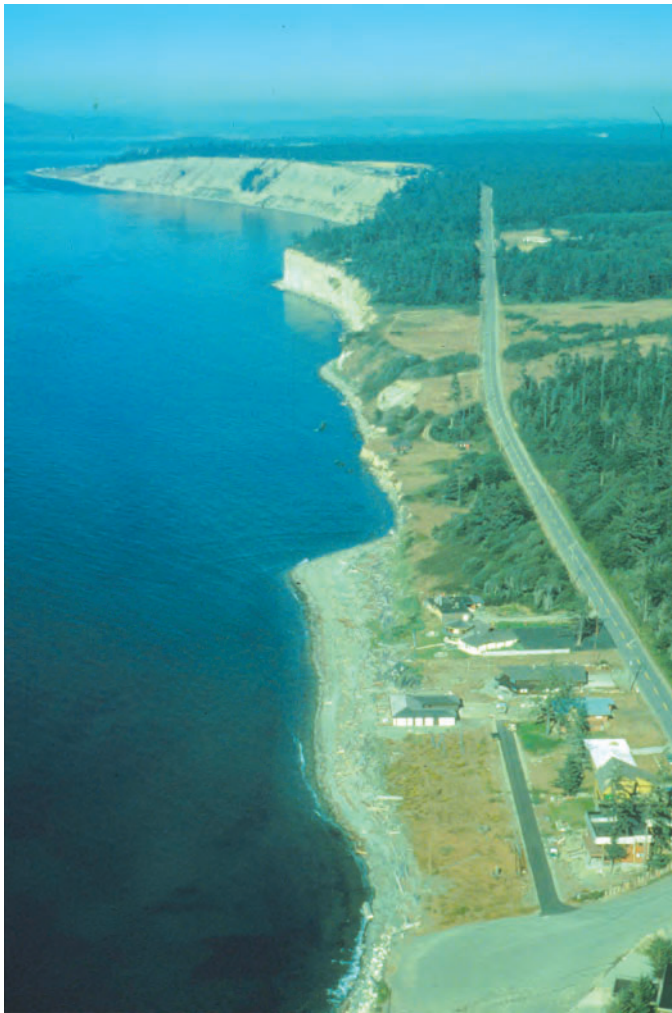
Figure 10. Irregular shoreline along western shore of Whidbey Island. Wave exposure is relatively uniform along this reach, and shape of shoreline is related to lithology and longshore redistribution of sediment by littoral processes. Beach in foreground is a barrier. Sharp point in mid-distance occurs where a resistant glacial till unit emerges at the toe of the bluff. (Photo by Gerald Thorsen).

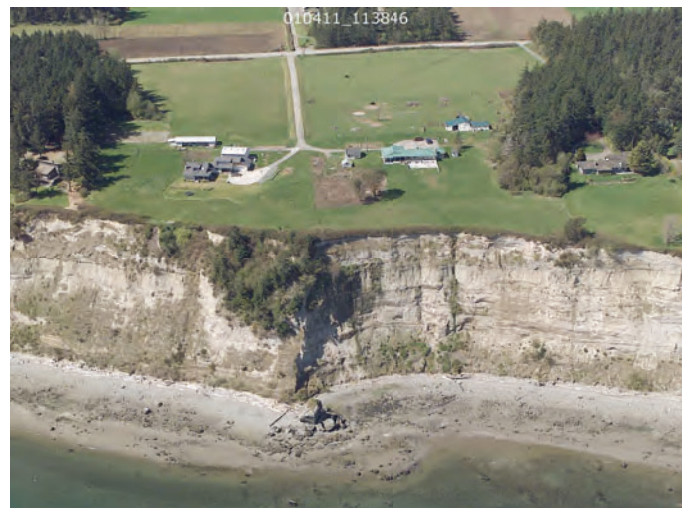
Figure 11. Offset in bluffs resulting from the presence of large glacial erratic in the nearshore. Wave action and longshore drift are from left to right. The boulder acts as a groin—on the left side the beach is relative stable, but erosion has been exacerbated on its downdrift side.

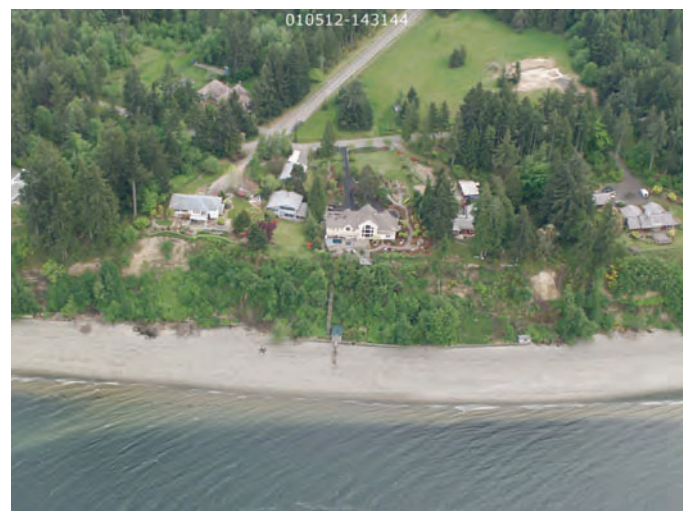
Figure 12. Homes built along the top edge of a bluff in southern Puget Sound. Setback requirements vary among jurisdictions. The desire for views typically leads property owners to build as close to the bluff as regulations allow.

Development along bluffs most commonly occurs at the top of the bluff (fig. 12). The distance a building is set back from the bluff edge depends on local regulations, the history and age of the structure, the topography of the site, lot lines, and the original property owner's concept of risk and their desire for views. Property owners often build as close to the

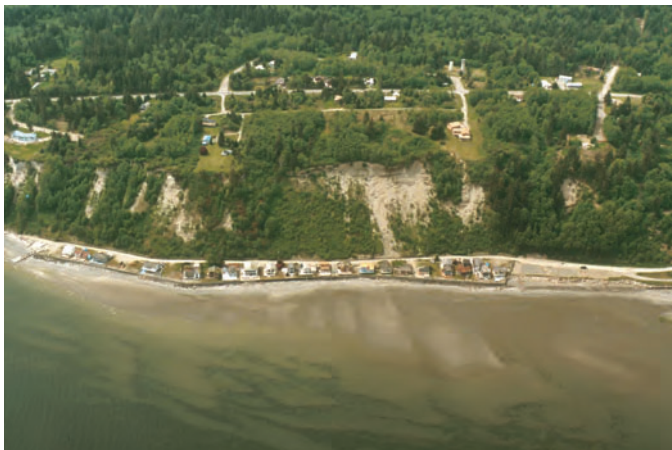
Figure 13. Residential development on artificial fill below high bluffs on eastern Whidbey Island.

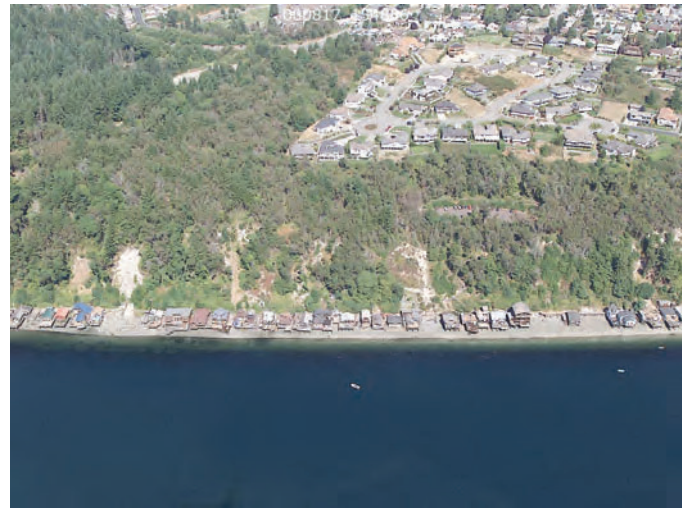
Figure 14. Salmon Beach community in Tacoma. Homes built over beach on piles at base of high bluff are periodically damaged or destroyed by landslides.

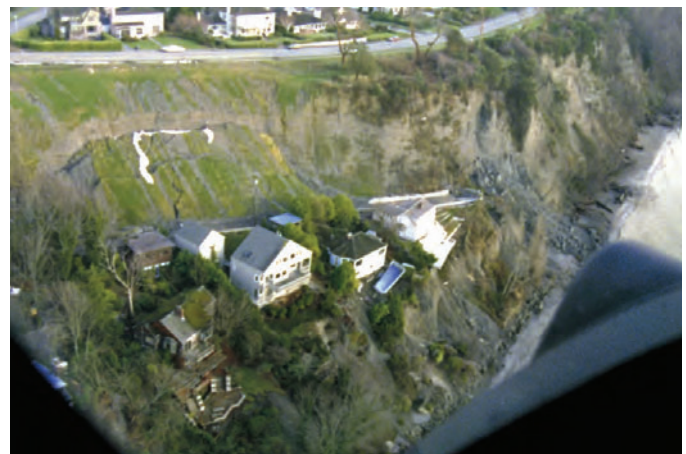
Figure 15. Homes destroyed by landsliding along Magnolia Bluff in Seattle during the winter of 1996-97. Homes had been built on a mid-slope bench formed by past erosion and landsliding.

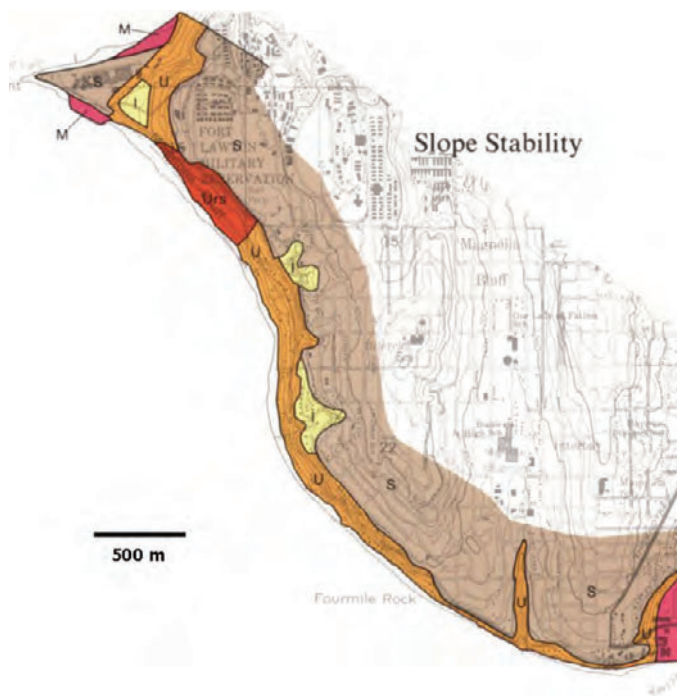
Figure 16. Map of coastal slope stability for residential portion of Seattle, from Coastal Zone Atlas of Washington (Washington Department of Ecology, 1978-1980). U indicates Unstable; Urs indicates recent landslides (as of late 1970s). Such maps exist for most of Puget Sound.

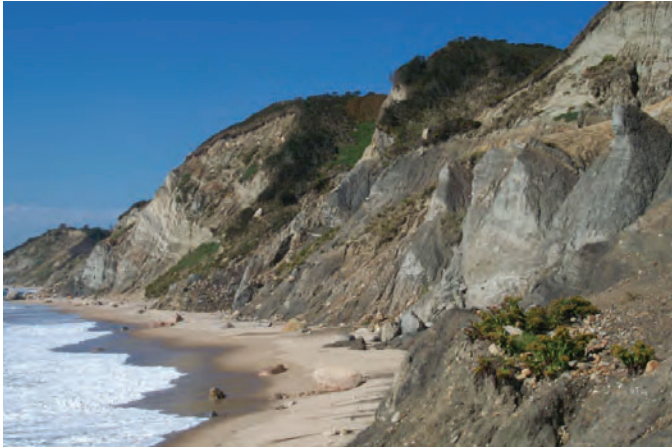
Figure 4. Bluff cut into a glacial moraine on Block Island, Rhode Island (photograph by Jon Boothroyd, University of Rhode Island).

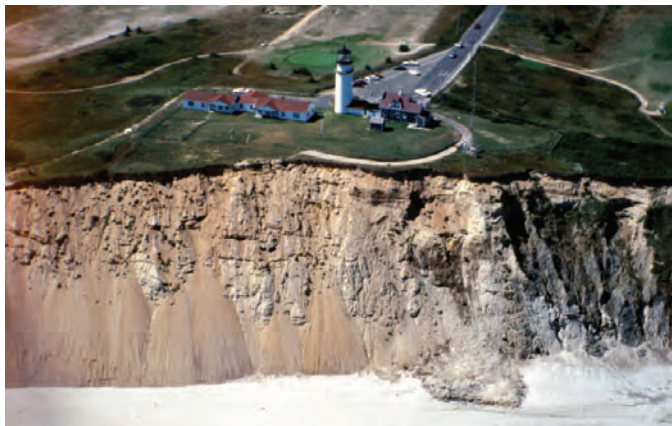
Figure 5. Highland Light on outer Cape Cod. Eroding bluff is mostly composed of outwash sand and gravel. The lighthouse was moved back from the bluff shortly after this photo was taken (photograph from James Allen, U. S. Geological Survey).

Landslides occur in all glacial materials (figs. 5, 11), but are most common in bluffs of glacial-marine sediment (fig. 16; Kelley and Dickson, 2000). Gravity is the force causing landslides, and they occur largely in materials with at least 5 m of relief (Berry and others, 1996). Gravity is resisted only by friction within the sediment of bluffs. Water reduces the shear strength of sediment and allows gravity to overcome sediment friction, and snow melt during spring or winter thaws has often been implicated as a cause of landslides in Maine's glacial-marine sediment. This material is generally muddy and relatively impermeable, but fractures or sandy beds must exist to allow water to enter the muddy sediment (Berry and others, 1996).

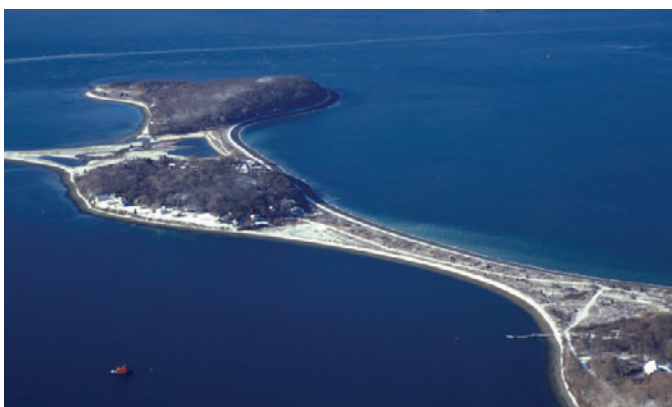
Figure 6. Drumlin islands in Boston harbor. Erosion of these till deposits leads to the formation of the associated spits and tombolos.

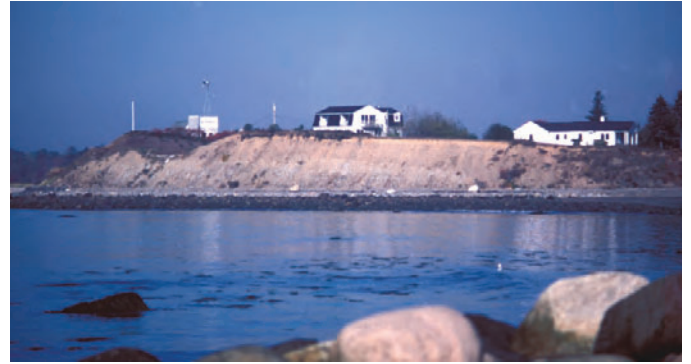
Figure 7. Stratified coastal moraine in Kennebunk, Maine.

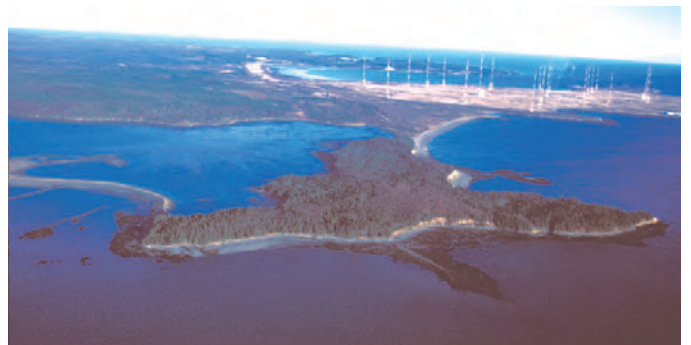
Figure 8. Sprague Neck moraine has eroded for a long time, but still blocks a large part of the entrance of Machias Bay, Maine. Note the 2-km-long beach (left) derived from erosion of the till.

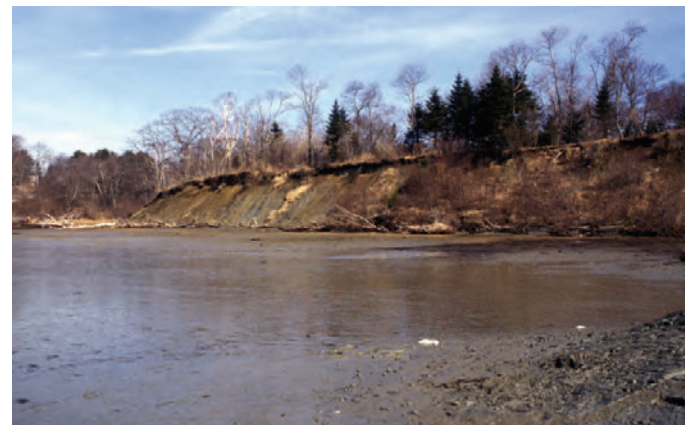
Figure 9. Eroding bluff of glacial-marine sediment, Brunswick, Maine.

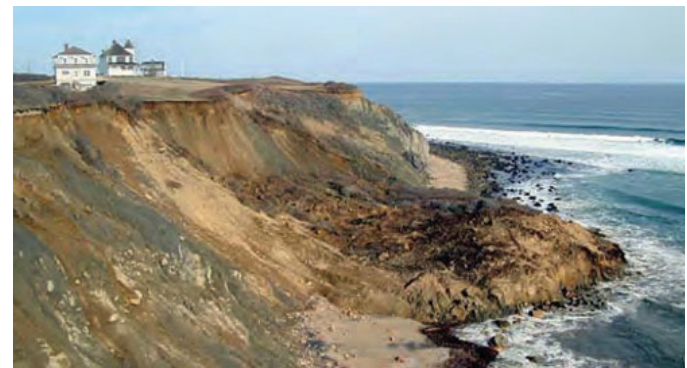
Figure 11. Landslide on Block Island, Rhode Island. The large volume of eroded material disappeared soon after the bluff collapse (photograph from Jon Boothroyd, Univ. Rhode Island).

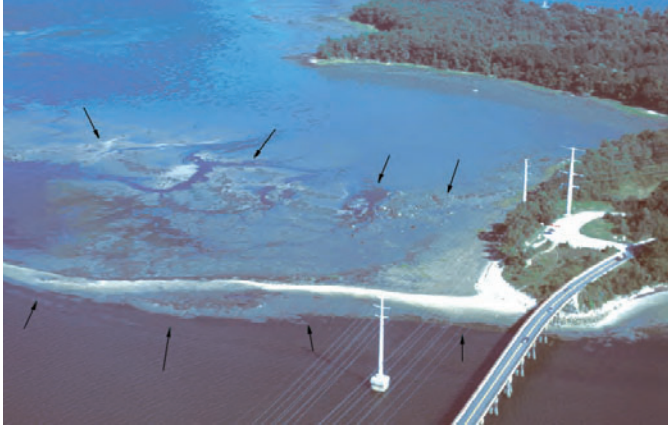
Figure 12. Aerial photo of eroded moraine (surrounded by arrows) in Casco Bay, Maine.

Wave erosion of till deposits is usually a slower process because boulders eroded from the till remain nearby, acting as a seawall and inhibiting further wave impact. Finer constituents of the till are winnowed away, however, and a lag deposit of gravel often marks the retreat of till bluffs (fig. 12). Where sand and fine gravel is abundant within till deposits, large beaches may grow and protect the coast. This is the case in Boston Harbor, where drumlin till is the source of sediment (fig. 6). During thousands of years of sea-level rise, the coast retreats in a stepwise fashion from one glacial sediment source to another (Boyd and others, 1987). For a time, beaches may protect bluffs from wave attack, but when one source of beach material is gone, the next bluff begins to erode.

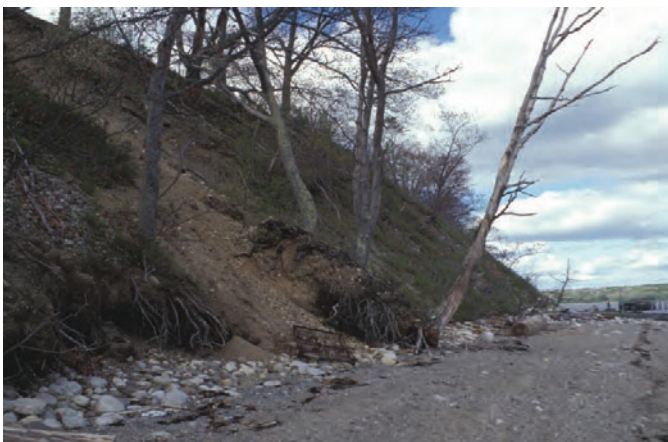
Figure 13. Large block of glacial sand and gravel creeping down the slope of an esker in Prospect, Maine.

and creep of bluff materials leads to slow bluff erosion (fig. 13). Creep is a complex process aided by wetting and drying, as well as freezing and thawing of ground water, in coastal bluffs. Creep is too slow to be observed directly, but the bending of tree trunks as they slide down a slope is a distinct symptom of creep (fig. 13).

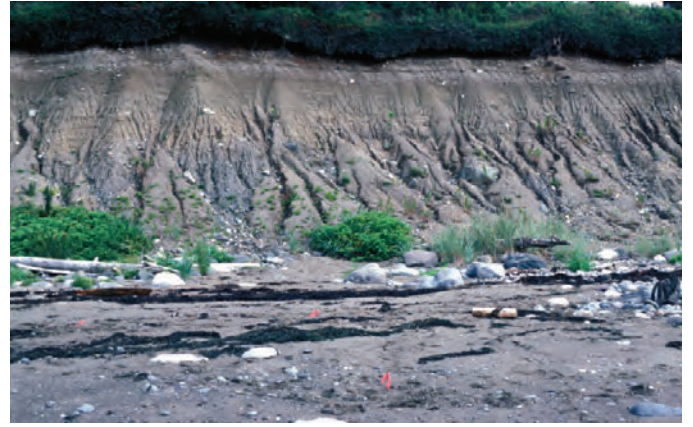
Figure 14. Small gullies on bluff of moraine in Cutler, Maine. This moraine is protected from direct wave attack by a beach of gravel eroded from the till.

Erosion of surface materials by rain or snowmelt is another mechanism causing bluff retreat. When it is the dominant process, rill marks cover a slope (fig. 14). Runoff-induced erosion is abetted by a lack of vegetation. Plants impede downslope water movement and help to dry soils by removing water from the ground. People cut trees and brush to improve views, however, and hiking and bike trails on bluff slopes also aid in the erosion of bluffs by inhibiting plant growth and loosening soil materials.

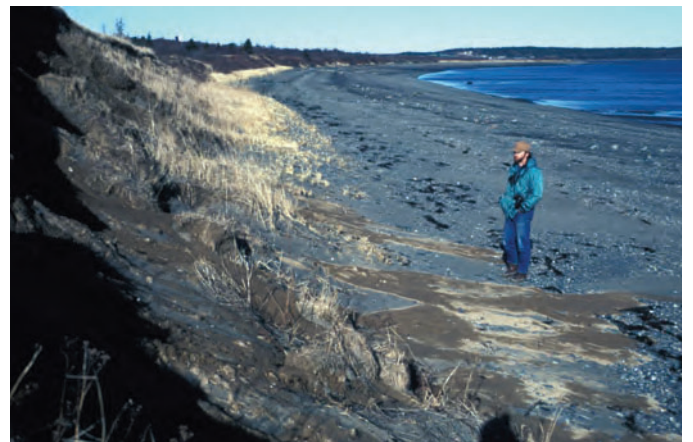
Figure 15. Frozen ground water in bluff of glacial-marine mud is thawing and flowing down the face of the bluff in Lubec, Maine.

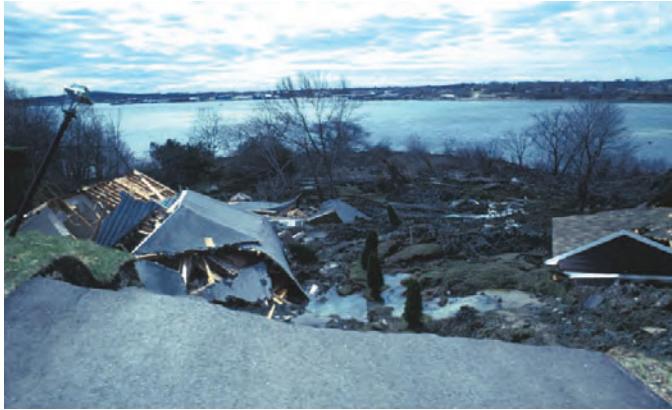
Figure 16. Landslide in glacial-marine sediment, Rockland, Maine. Two houses were lost when erosion due to the event reached more than 100 m landward from the edge of the bluff in April 1996.

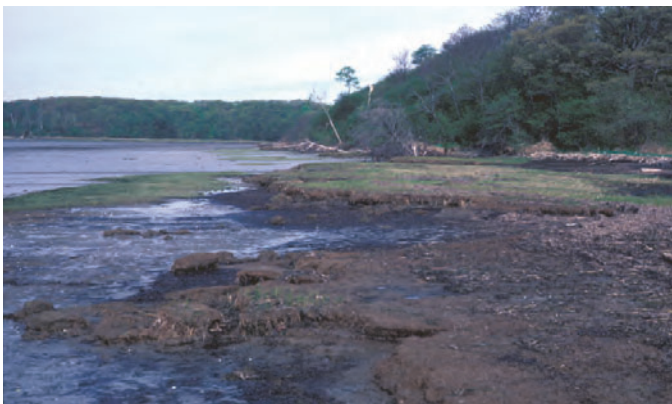
Figure 17. Salt marsh deposit protecting a bluff from erosion in Brunswick, Maine.

The rate of erosion of bluffs in New England is controlled to a large degree by the rate of removal of eroded materials (Sunamura, 1983). These materials may be slump blocks from a large mass movement or sand formed by waves onto a beach. In sheltered areas, salt marshes colonize intertidal mud deposits and landslide debris above mean tide level and inhibit further erosion (fig. 17; Kelley and others, 1989). Thus, the long-term rate of bluff retreat is often the average of short bursts of erosion and long intervals of stability (Sunamura, 1983). Although there are no published studies that have evaluated bluff retreat and storm occurrence, it is reasonable to believe that once a bluff has lost the protection of a salt marsh or beach, retreat occurs during a large storm event.

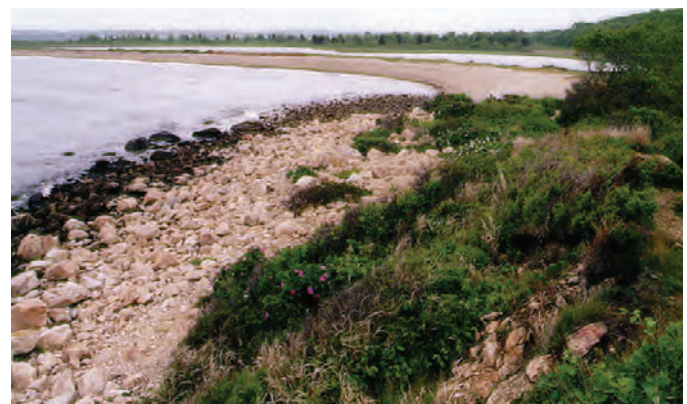
Figure 18. Eroding bluff of till, Pine Island, Conn. (photograph by Nate Gardner, University of Maine).

There are no published descriptions of bluff erosion in New Hampshire, Rhode Island, or Connecticut. New Hampshire's outer coast is largely composed of bedrock and beaches, but small bluffs of glacial sediment similar to those in Maine probably exist in the few estuaries of the State. Eroding till bluffs were probably common in Rhode Island and Connecticut (fig. 18), but human development has protected most bluffs from erosion with seawalls.

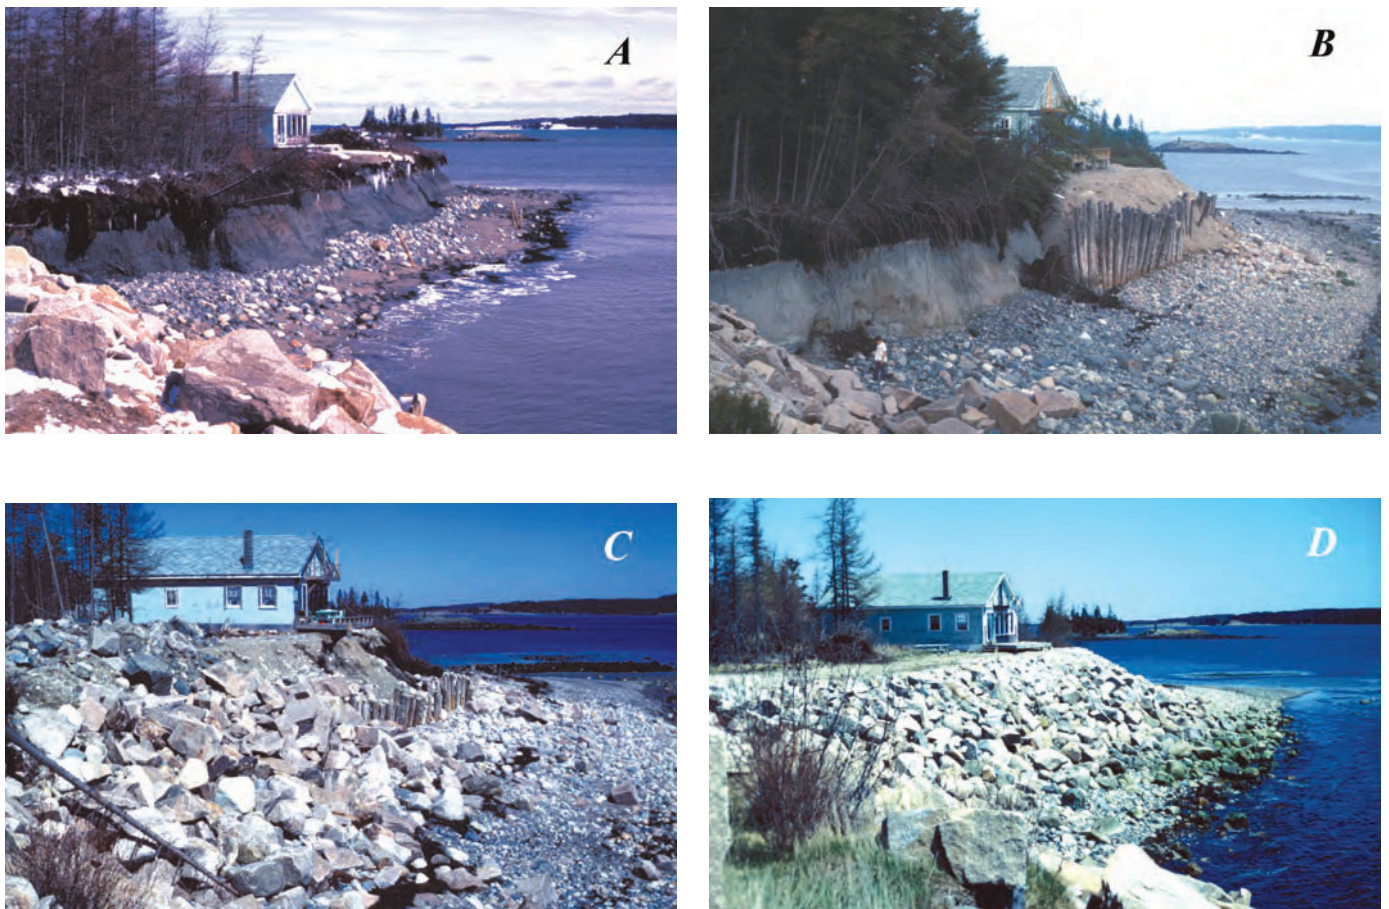
Figure 19. Typical response of homeowner to bluff erosion in Jonesport, Maine. *A*, 1983. *B*, 1985. *C*, 1989. *D*, 1993.

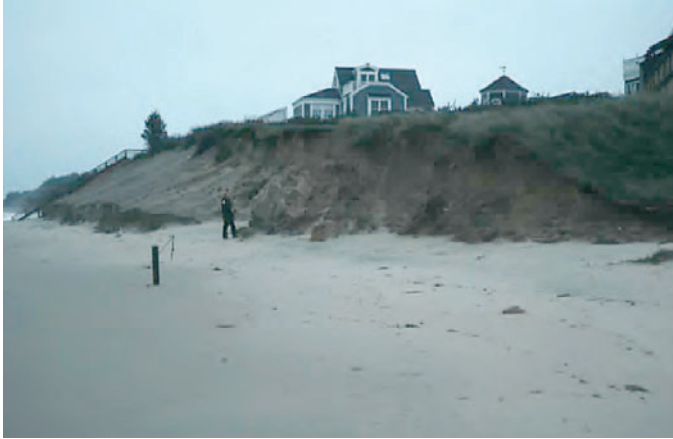
Figure 20. Bluff erosion on the south shore of Cape Cod, Mass. threatened condominiums during the “Halloween Storm” of 1991. The bluff retreated at least a meter at the beginning of the storm, and sand was dumped onto the beach to protect the buildings.

rates on the order of a meter per year are common, and measurements of erosion have led to the movement of several lighthouses prior to their collapse. Highland Light, constructed in 1797, for example, was recently moved 150 m to lengthen its lifetime (fig. 5). Short-term rates of retreat are even more extreme, and greater than 10 m of retreat has been observed during individual storms (fig. 20; Sunamura, 1983).

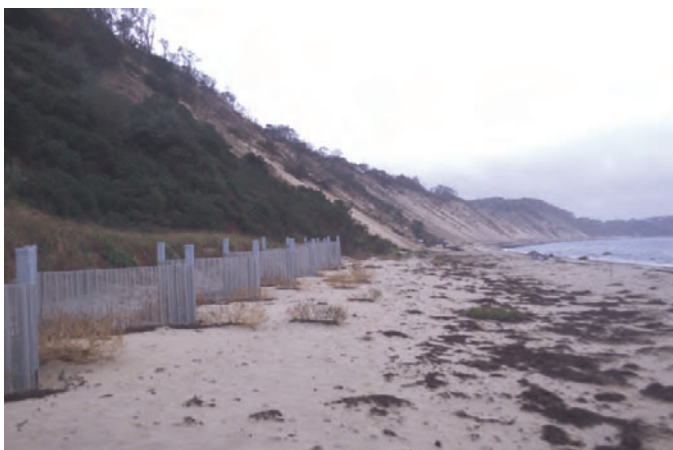
Figure 21. Bluff of outwash sand and gravel at the White Cliffs area of Plymouth, Mass., have historically eroded at rates between 1m/yr and 2 m/yr (James O’Connell, Woods Hole Sea Grant, oral commun., 2002). The gabion wall was built prior to laws prohibiting such structures to slow shoreline retreat.

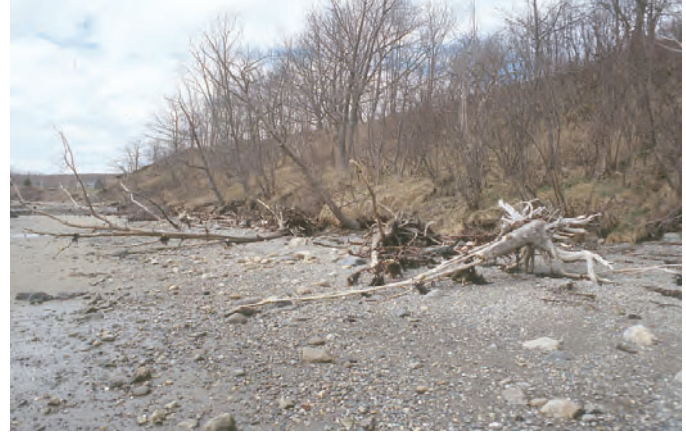
Figure 22. Erosion of glacial-marine mud bluffs in Rockland, Maine, proceeds relentlessly between large landslide events.

16). Even without landslides, the bluffs are retreating through creep (fig. 22). Similar bluffs comprise extensive stretches of the Maine coast. In undeveloped areas there is little concern about bluff retreat. In the suburban areas near Portland, Maine, however, more than 25 km of bluff shoreline is deemed “highly unstable” by the State (Kelley and Dickson, 2000), and valuable properties are now at risk (fig. 23).

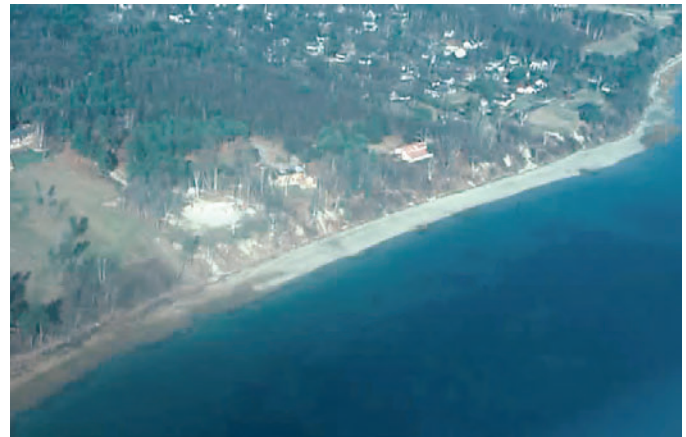
Figure 23. Aerial photo of Cumberland Foreside, Maine, with slowly retreating bluffs and valuable nearby houses.

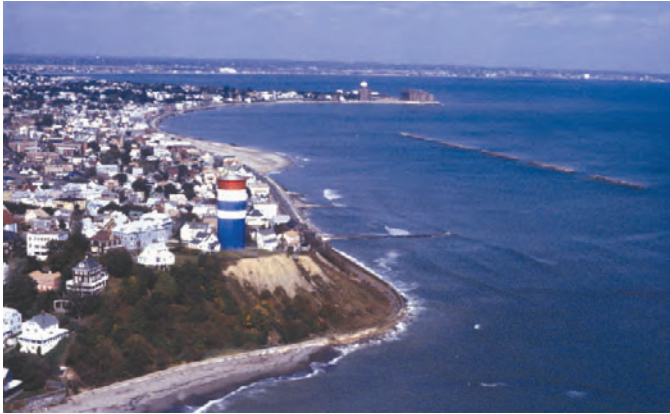
Figure 24. Stabilization of the eroding drumlins in Winthrop, Mass., cut off the supply of sediment to adjacent beaches. Seawalls, groins, and offshore detached segmented breakwaters are needed, along with occasional beach replenishment, to maintain the shoreline position.

of sand to its beaches by the early 20th century and has used seawalls, groins, breakwaters, and replenishment to hold the beach shoreline in place (fig. 24). Because so many beaches in New England are associated with eroding bluffs (Duffy and others, 1989), bluff stabilization may be a major cause of chronic beach erosion and the growing need to replenish beaches (Haddad and Pilkey, 1998). In many residential coastal areas, all of the original eroding bluffs of glacial sediment are armored. In Maine, 20 percent of the 1,250 km of Casco Bay’s shoreline is armored (Kelley and Dickson, 2000); an additional 20 percent is bedrock.

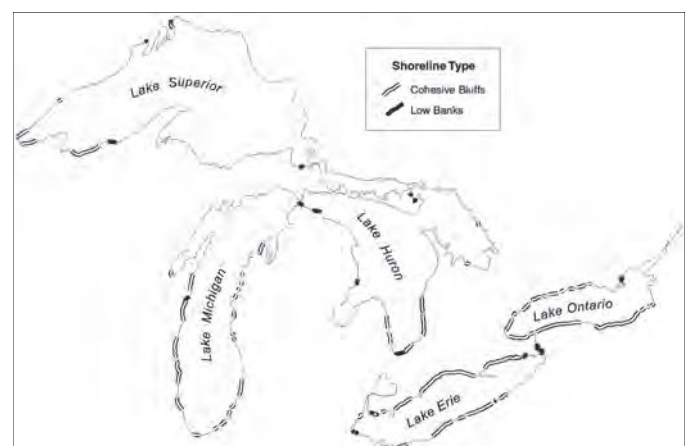
Figure 1. Map of Great Lakes showing the distribution of cohesive bluffs and banks (from Pope and others, 2001).

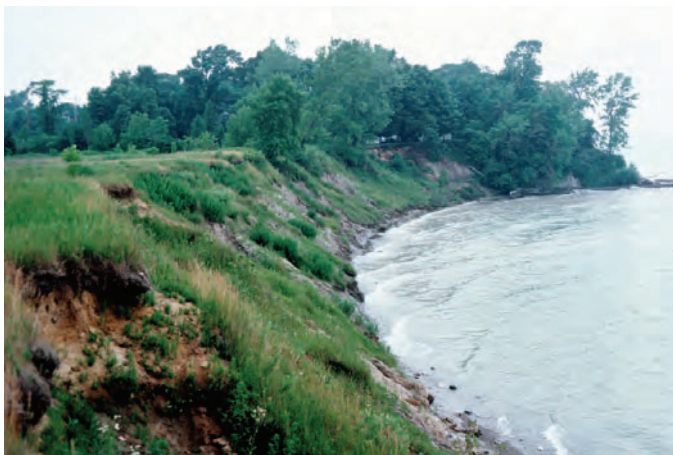
Figure 4. Low cohesive bluff (10 m) with simple profile and parallel retreat on the southeastern shore of Lake Michigan in Kenosha County, Wisconsin.

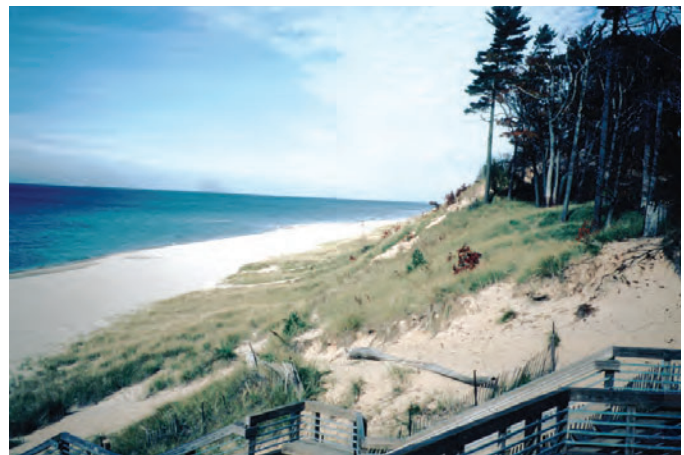
Figure 5. Low (8 m) bluff composed mostly of sand on the eastern shore of Lake Michigan near Luddington, Michigan.
