Formation, Evolution, and Stability of Coastal Cliffs—Status and Trends

Professional Paper 1693

Monty A. Hampton and Gary B. Griggs, Editors

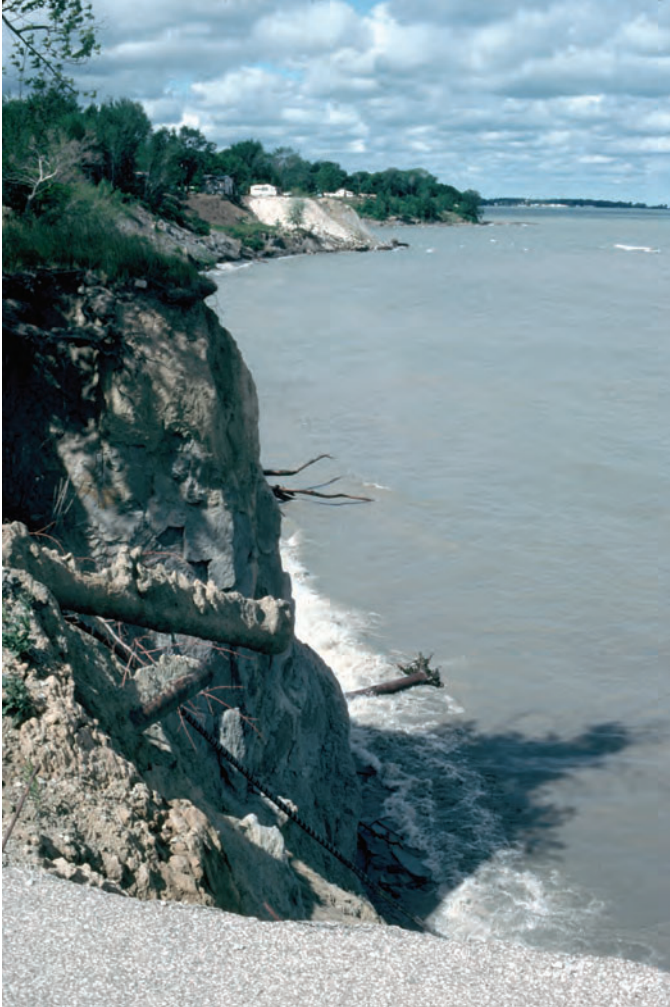
Figure 6. Low (12 m), rapidly receding bluff with complex profile that fails by slump, falls, and flows on the south shore of Lake Erie, near Cleveland, Ohio.

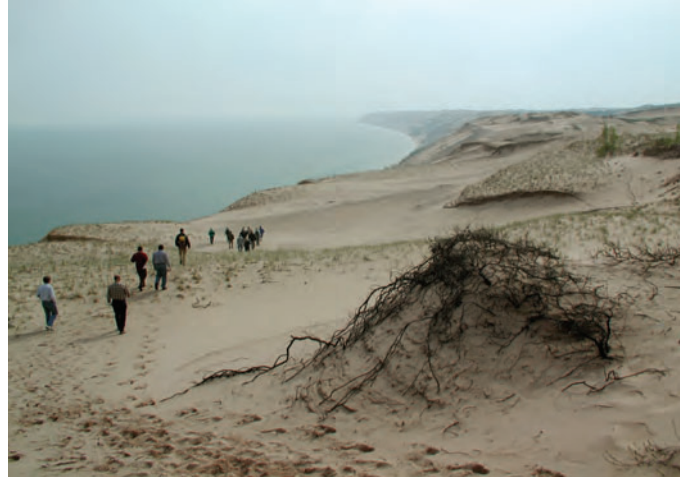
Figure 8. High (> 40 m) bluff of sand and gravel capped by sand on the south shore of Lake Superior near Munising, Michigan.

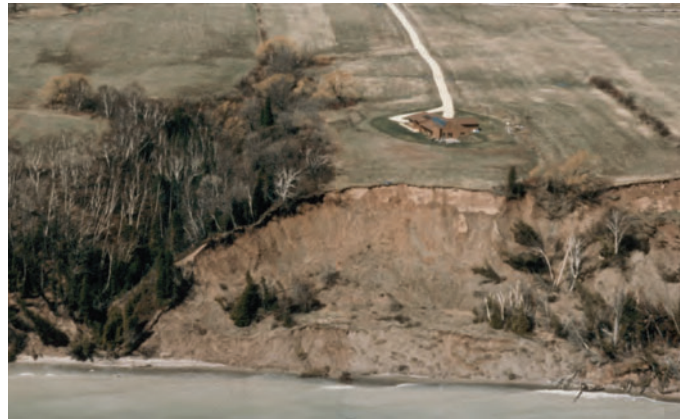
Figure 9. High (>30 m), complex bluff that failed in the early 1990s by a large deep-seated slump north of Milwaukee, Wisconsin, on the western shore of Lake Michigan.

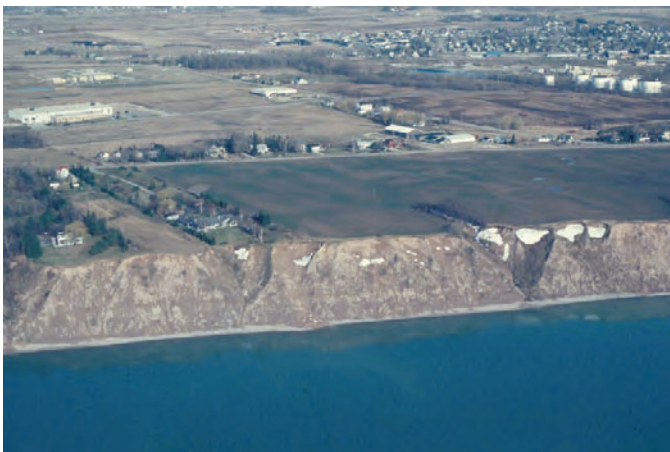
Figure 7. High (35 m) bluff of cohesive till and lake sediment on the western shore of Lake Michigan north of Milwaukee, Wisconsin.

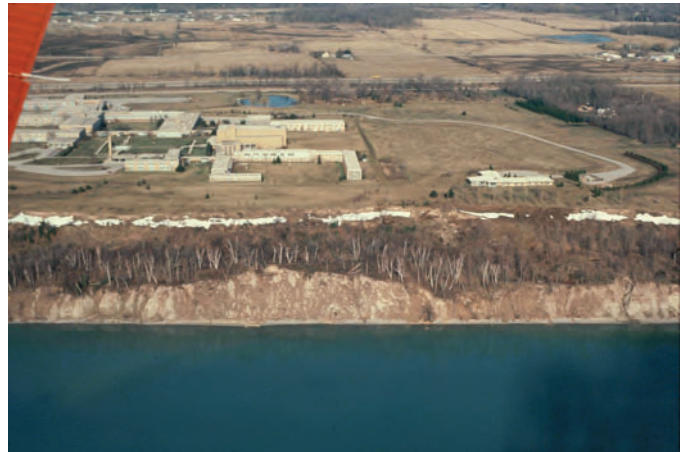
Figure 10. High (>30 m), complex bluff protected by large, deep-seated slump block that failed more than 50 years ago. Note that top of bluff is above white snow patch; slump block is below.

event, the slump block begins to be affected by wave erosion. As waves erode the base of the slump block, the actively eroding face of the slump block increases in height as the lakeward part of the slump block is removed. At the same time, the actual bluff top, now isolated from wave action, makes minor adjustments and becomes stable. Continued wave erosion eventually removes the slump block over what can be a long period (probably 50 to 100 years near Milwaukee; Chapman and others, 1997), eventually producing an unstable slope, which fails again.
