Energy Design and Performance Analysis of the BigHorn Home Improvement Center

M. Deru, P. Torcellini, and S. Pless

NREL

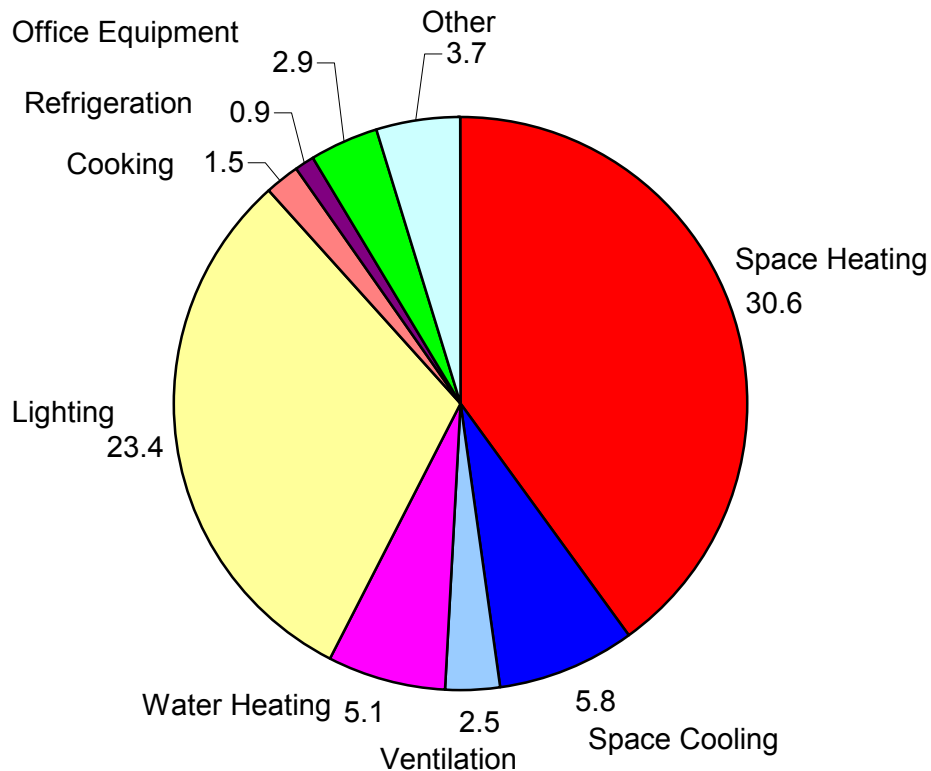
Figure 2-1 Typical site EUIs by end use for retail buildings (kBtu/ft²·yr) (DOE 2003)

Average site energy consumption by end use for mercantile and service (retail) buildings in the U.S. is shown in Figure 2-1 and for warehouse and storage buildings in Figure 2-2 (DOE 2003). The building site energy use intensity (EUI) is 76.4 kBtu/ft²·yr and 38.3 kBtu/ft²·yr for the two building types. These numbers are based on 1995 data collected by the Energy Information Administration. Most of the space heating, water heating, and cooking are by natural gas; the rest of the energy consumption is electricity. The primary energy consumed to generate and distribute the electricity is approximately three times the energy used on site. Lighting is the largest primary energy end use for both building types; therefore, reduction in the lighting of loads is a primary objective in this project.

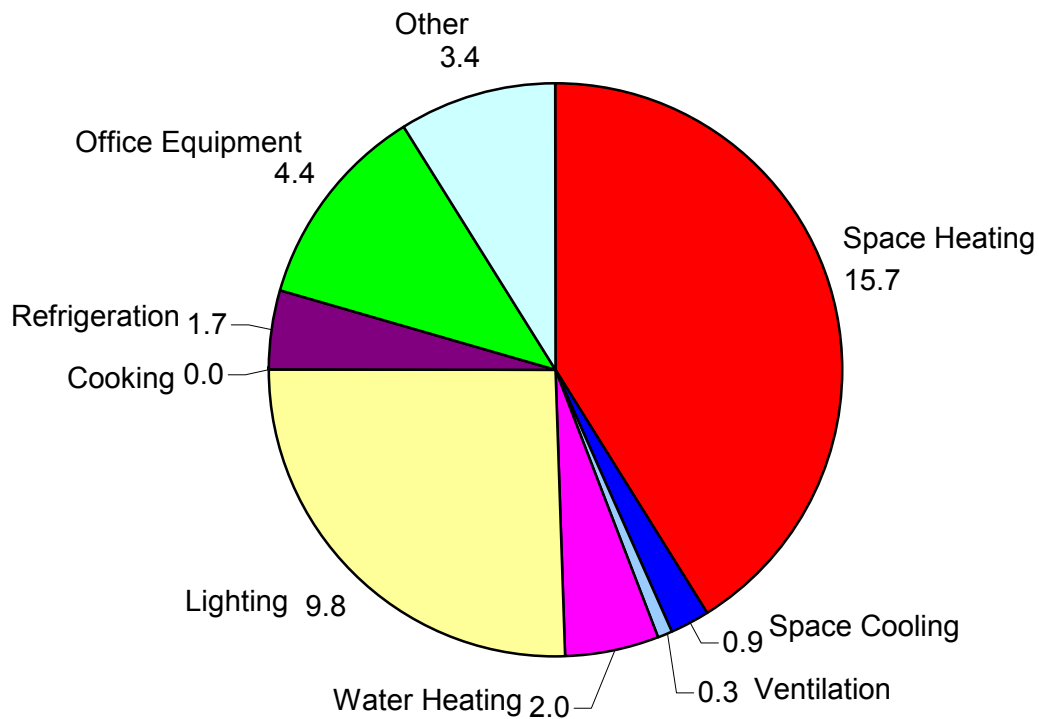
Figure 2-2 Typical site EUIs by end use for warehouse buildings (kBtu/ft²·yr) (DOE 2003)

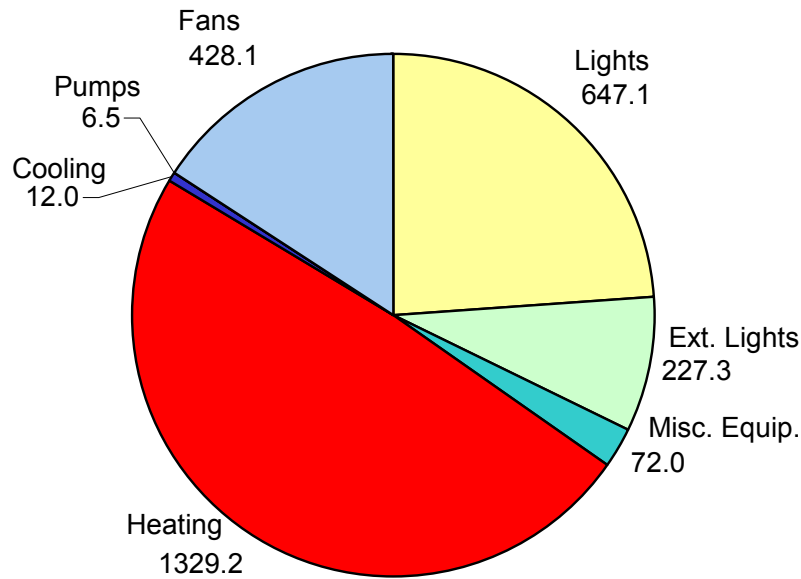
Figure 3-1 Design Baseline Model annual site energy consumption (MMBtu)

Figure 3-1 shows a breakdown of the Design Baseline Model annual energy consumption by category. The building is obviously dominated by the heating load, which is almost half the total building energy. The cooling load for this building can be almost entirely met by outside air economizers, which suggests that natural ventilation may meet the cooling loads. For this building with this system, the fans use a significant amount of energy to meet the ventilation needs. The high light levels in the retail area make the lighting almost one-quarter of the total. This analysis shows that reductions in the heating, fan, and lighting loads have the most energy saving potential.

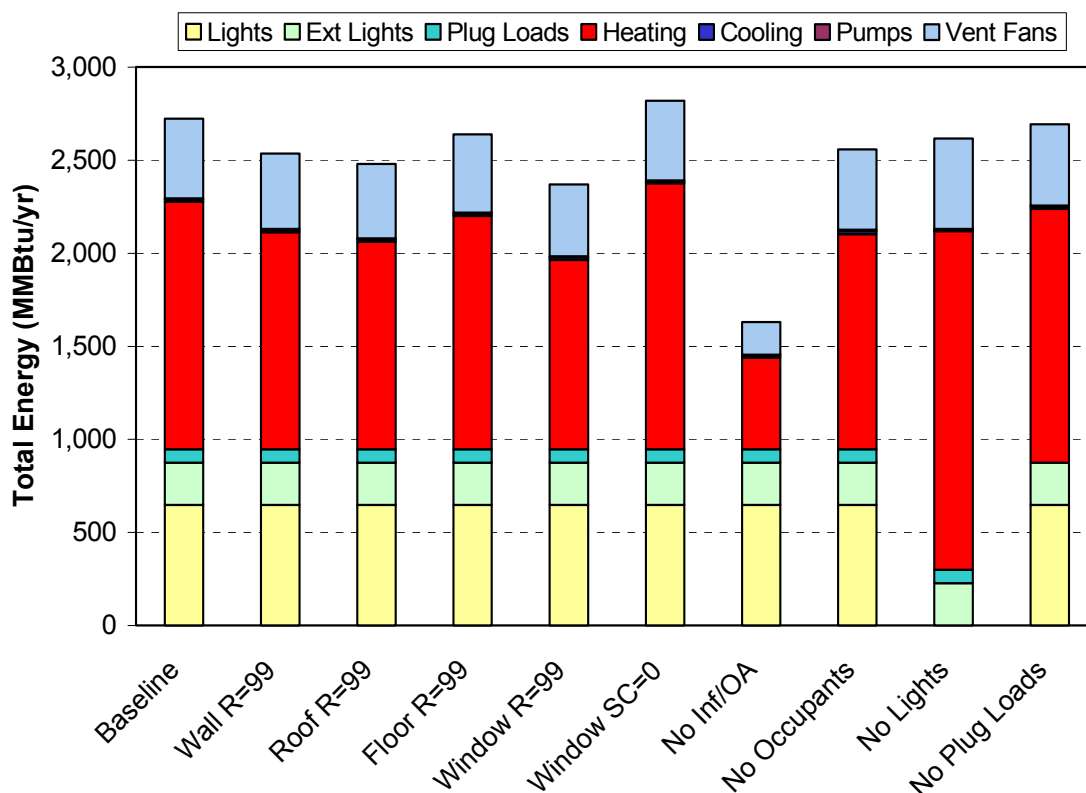
Figure 3-2 Baseline parametric study results for total energy consumption

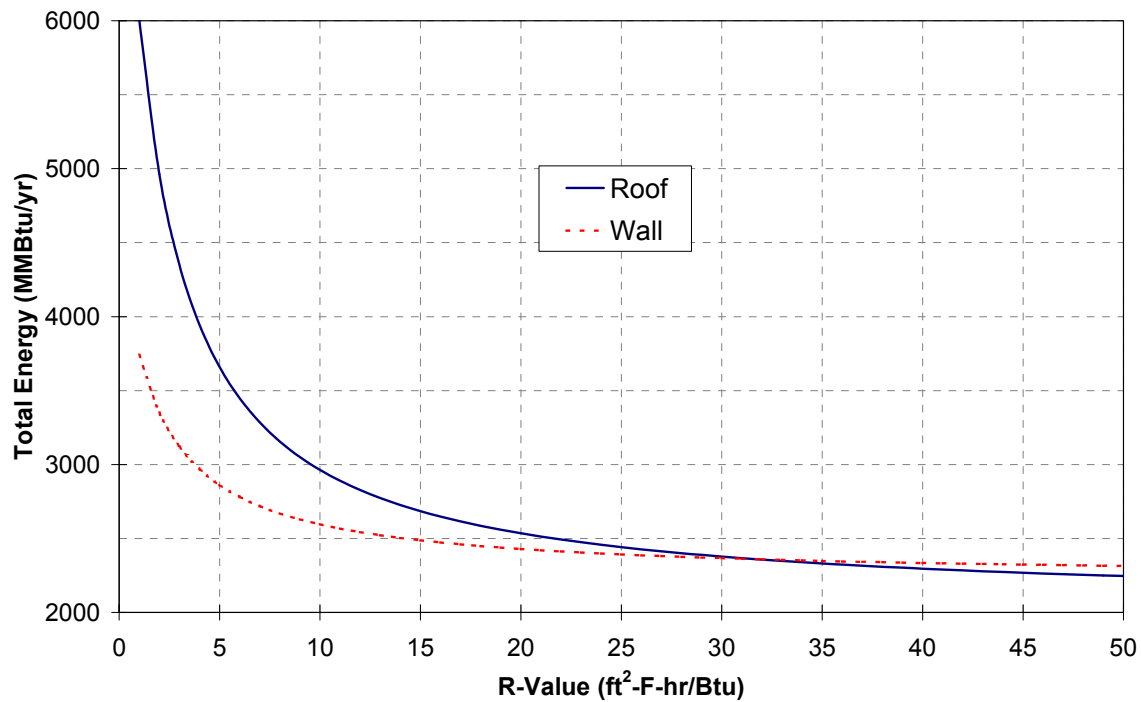
Figure 3-3 Total energy consumption versus wall and roof insulation values

Additional parametric simulations were completed with the Design Baseline Model to investigate the effects of wall and roof insulation on heating energy. The insulation levels in the wall and the roof were varied in separate runs from R-1 to R-50 $\text{ft}^2 \cdot \text{°F} \cdot \text{hr} / \text{Btu}$ (RSI-0.2 to $8.8 \text{ m}^2 \cdot \text{K} / \text{W}$). The effect on the total energy consumption in the building is shown in Figure 3-3. From these runs, it was recommended that the wall insulation should be at least R-20 (RSI-3.5) and the roof insulation should be at least R-30 (RSI-5.3), which is the same as the Design Baseline Model.

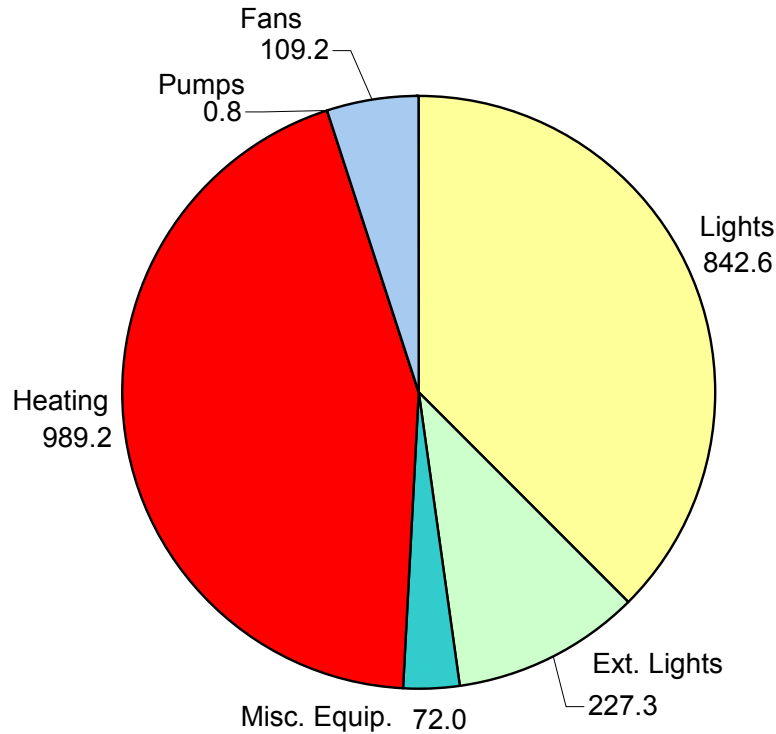
Figure 3-4 Original Model annual site energy consumption (MMBtu)

An annual energy simulation was completed with weather file A, which represents the “average” weather year based on long-term weather data. The energy consumption of the Original Model is illustrated in Figure 3-4. The energy loads in this building are dominated by the heating and lighting loads. The heating energy use is lower than that of the Design Baseline Model because of improved insulation levels, less outside air intake in the retail/office area, and increased heat gain from the lights. The lighting energy has increased because the Original Model assumes a lighting power density (LPD) of 1.5 W/ft² (16 W/m²) in the warehouse and the Design Baseline Model is limited to 0.42 W/ft² (4.5 W/m²) by the 10 CFR 435 energy code. These lighting levels are high for this space because it is a retail lumberyard that requires more lighting than a warehouse devoted strictly to storage.

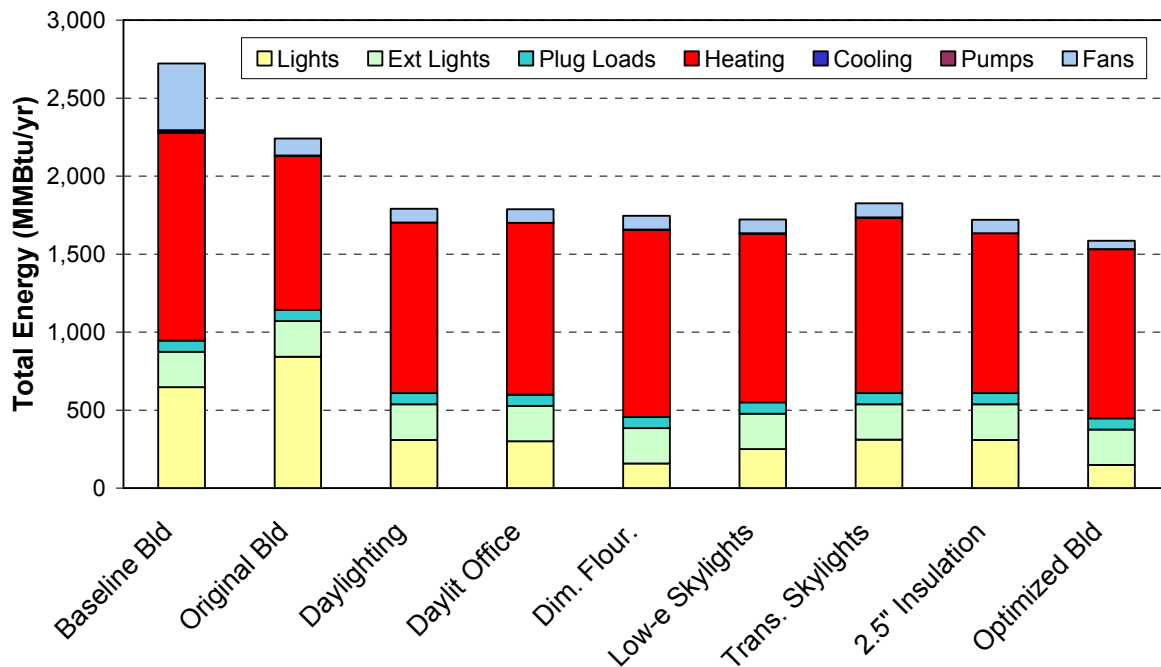
Figure 3-5 Total energy consumption for the Design Baseline, Original, design variations, and Optimized Models

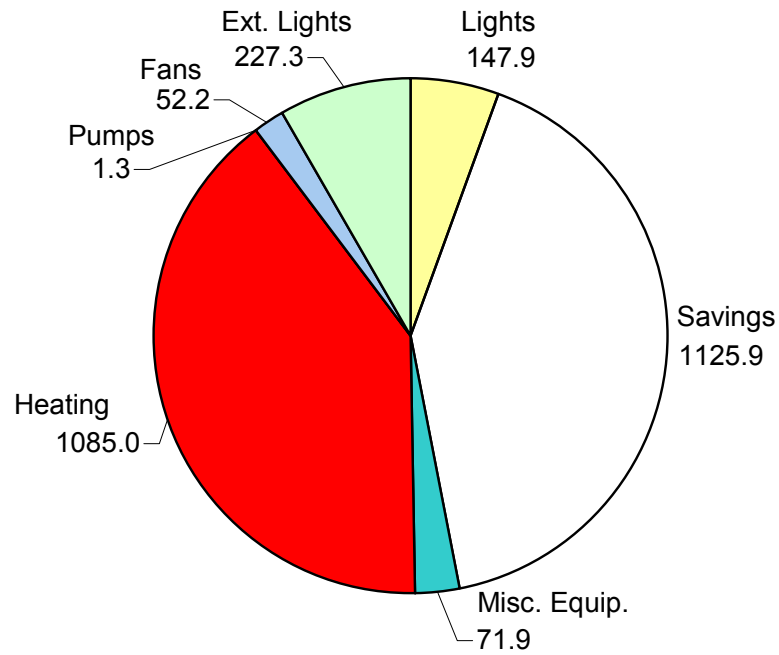
Figure 3-6 Optimized Model annual site energy consumption (MMBtu) (savings relative to the Design Baseline Model)

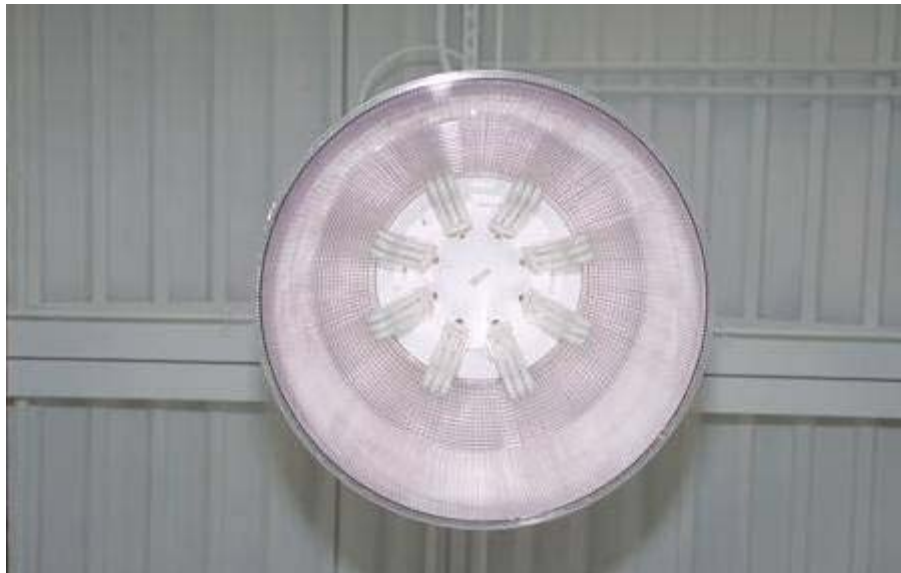
Figure 5-7 Pendant luminaire with eight 42-Watt CFL bulbs used in the retail and warehouse areas

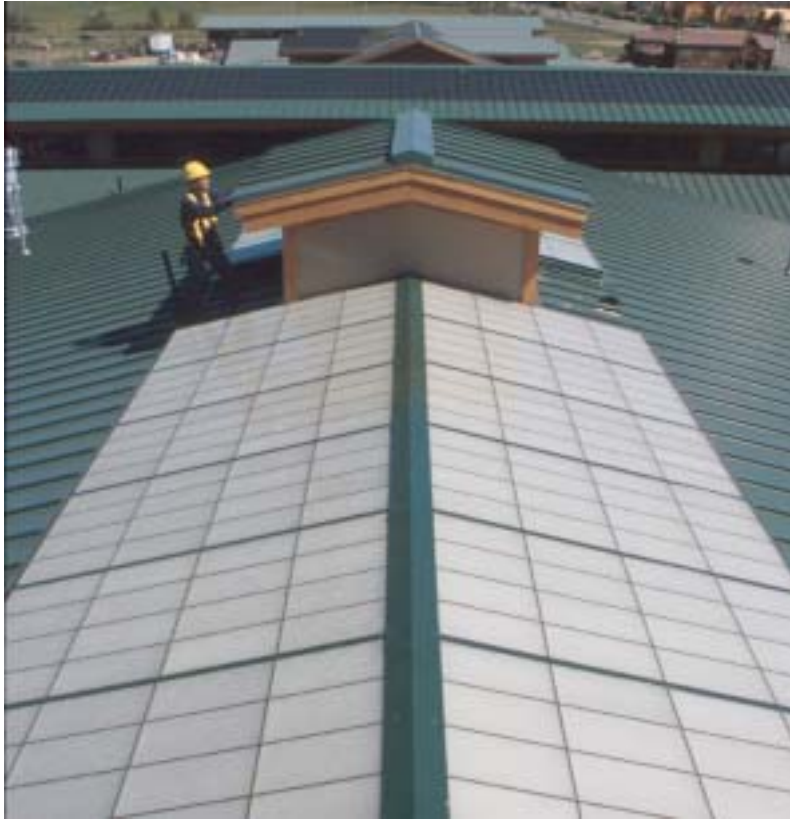
Figure 5-8 Translucent skylights in the warehouse

Daylighting is provided in the warehouse primarily through skylights along the ridgeline (Figures 5-1 and 5-8). The skylights are insulated translucent glazing panels with the thermal and optical properties listed in Table 5-2. One large dormer, two smaller dormers, and small windows on the south and east walls provide additional natural lighting. The bright white interior ceiling and wall surfaces improve daylight distribution. An analysis of the lighting systems, including illuminance measurements, is presented in Section 7.2.

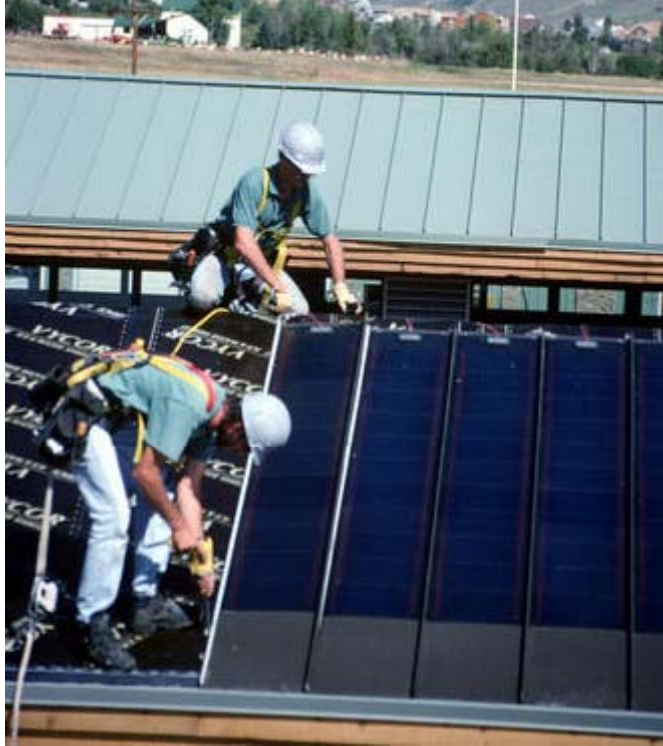
Figure 5-9 Installation of the roof-integrated PV panels

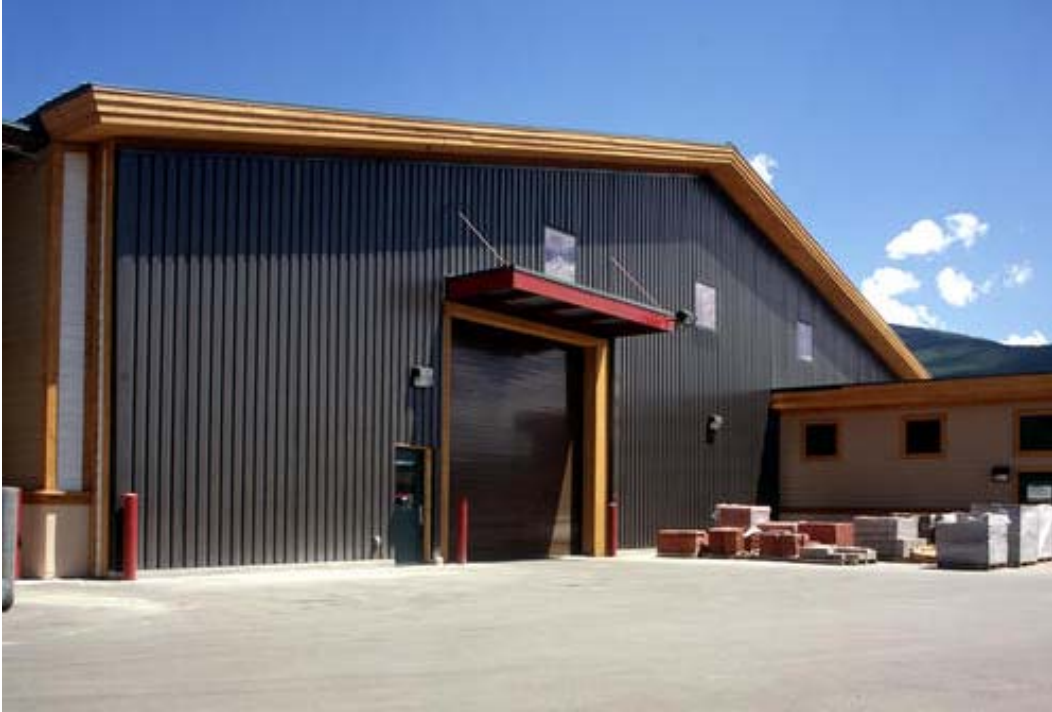
Figure 5-12 Transpired solar collector on the south wall of the warehouse

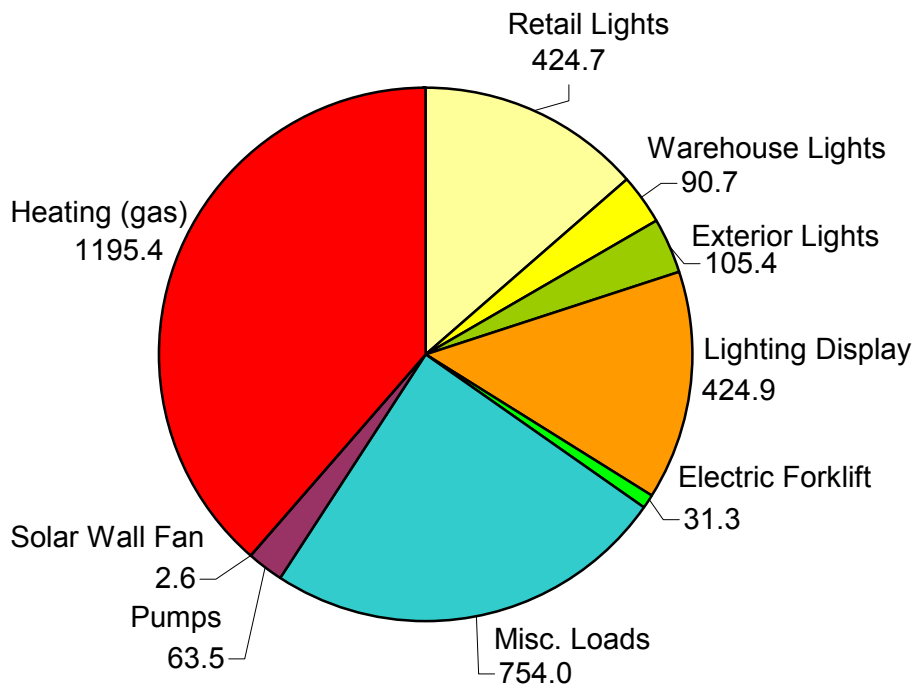
Figure 6-2 Measured source energy use from September 1, 2002 to August 31, 2003 (MMBtu)

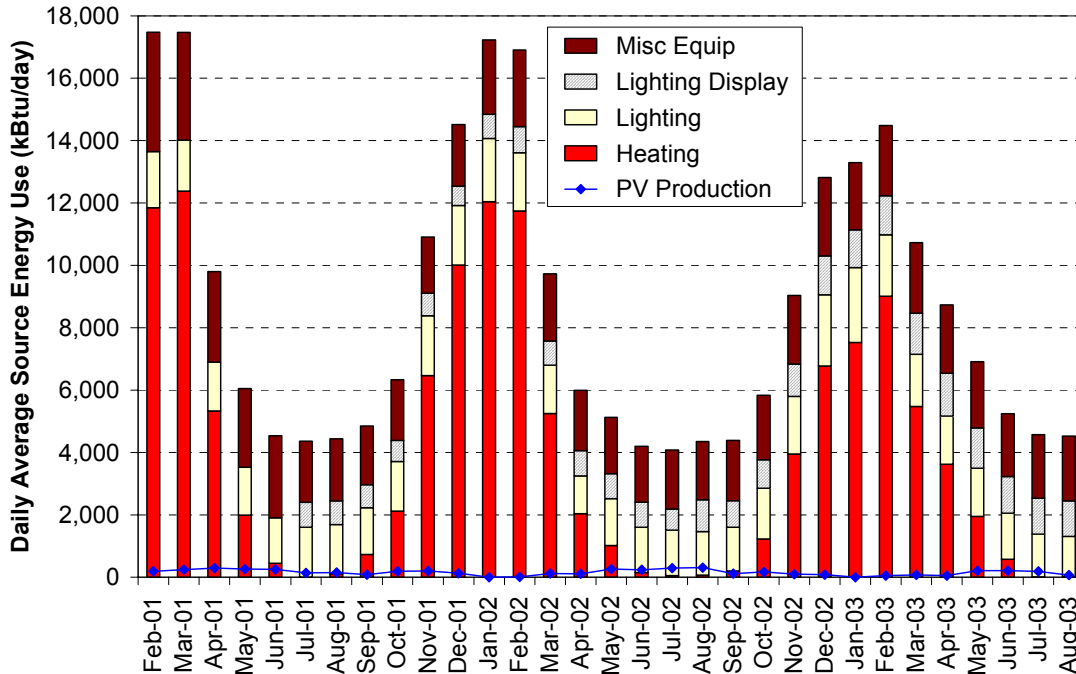
Figure 6-3 Daily average source energy consumption by end use for the BigHorn Center (monitoring of the lighting display began in July 2001)

A monthly view of the data is presented in Figure 6-3, which shows the daily average source energy consumption by major end use from February 2001 to August 2003. The energy produced by the PV system is also shown as a line graph. The PV energy production was adjusted to reflect the amount of source energy that was offset by producing and using the PV energy onsite.

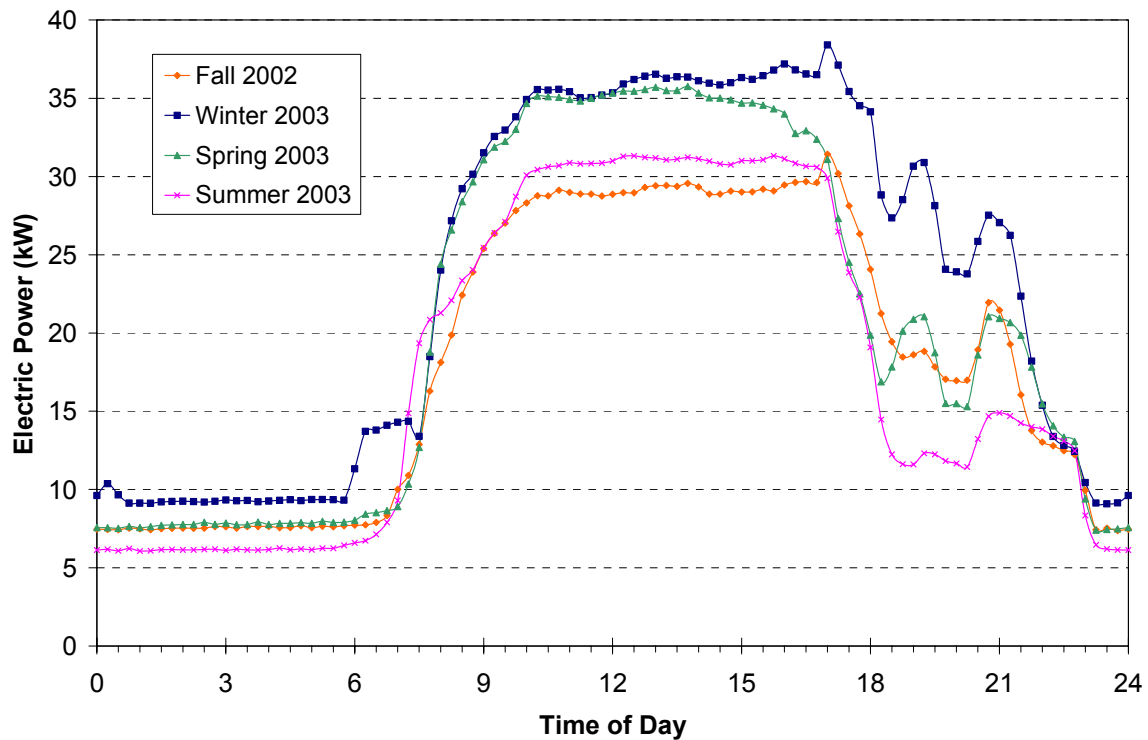
Figure 6-4 Average daily electrical energy load profiles by season

Another useful method of viewing the electrical energy consumption data is to look at the average daily energy use profiles by season (see Figure 6-4). The winter profile is the largest because the shorter days require more lighting and the cold weather requires increased use of the heating system pumps and the roof ice melt. The relative magnitude of the load profile between the other seasons varies with the operation of the building. The lighting display area is altered every few months to add or remove lights. The operation of the warehouse and retail/office lights varies slightly with the personnel working in these spaces and how much light they desire for working conditions. The evening profile reflects the effects of the cleaning crew, who work two to three nights a week and turn on most of the interior and exterior lights while they clean.

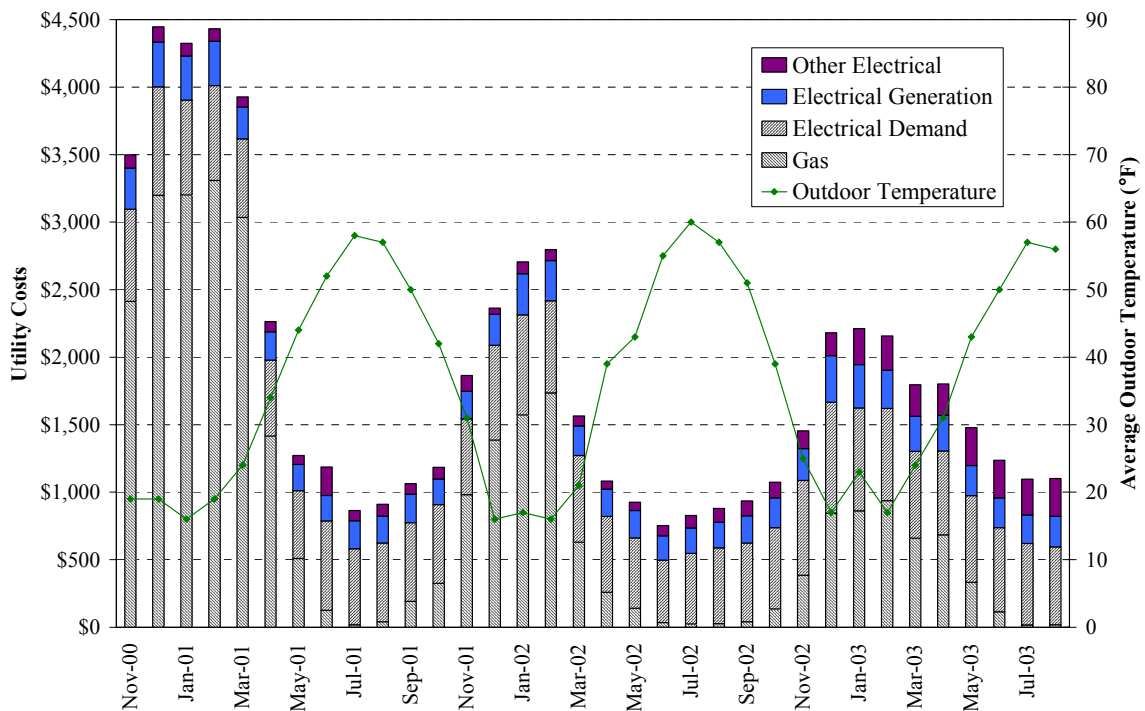
Figure 6-5 BigHorn Center monthly utility costs

The monthly energy costs from the utility bills from November 2000 to August 2003 are shown in Figure 6-5. This graph shows the breakout of the energy charges and the average monthly outdoor temperature. The gas costs were very high during the first winter because consumption and prices were high. The cost of electricity was dominated by the demand charge, which was more than half the electrical utility bill. The “Other Electrical” category includes the fixed monthly charge, energy rate adjustments, fees, and taxes. The increase in this value over the last nine months was due to increases in the energy rate adjustments.

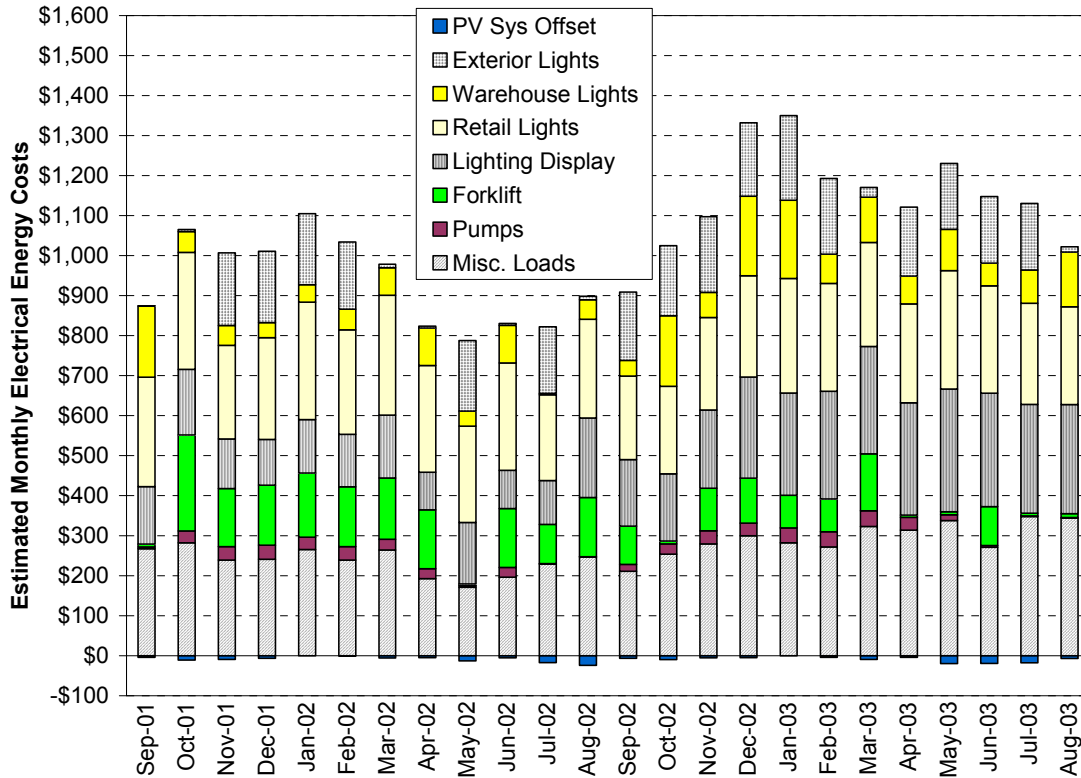
Figure 6-6 Estimated monthly electrical energy costs by end use

The monthly electricity costs by end use were estimated for the two-year monitoring period (see Figure 6-6). The energy costs are estimated by calendar month, and do not align with the utility bills. The utility bills are not billed on the same day every month, but typically run from the 25th to the 25th of each month. For most months, the measured peak demand was within 2% of the billed demand value. For some months, the time of the measured peak demand did not align with the billing periods, which resulted in a difference in the billed and measured demand values. For two months, there was an unexplained larger measured demand value than the billed value.

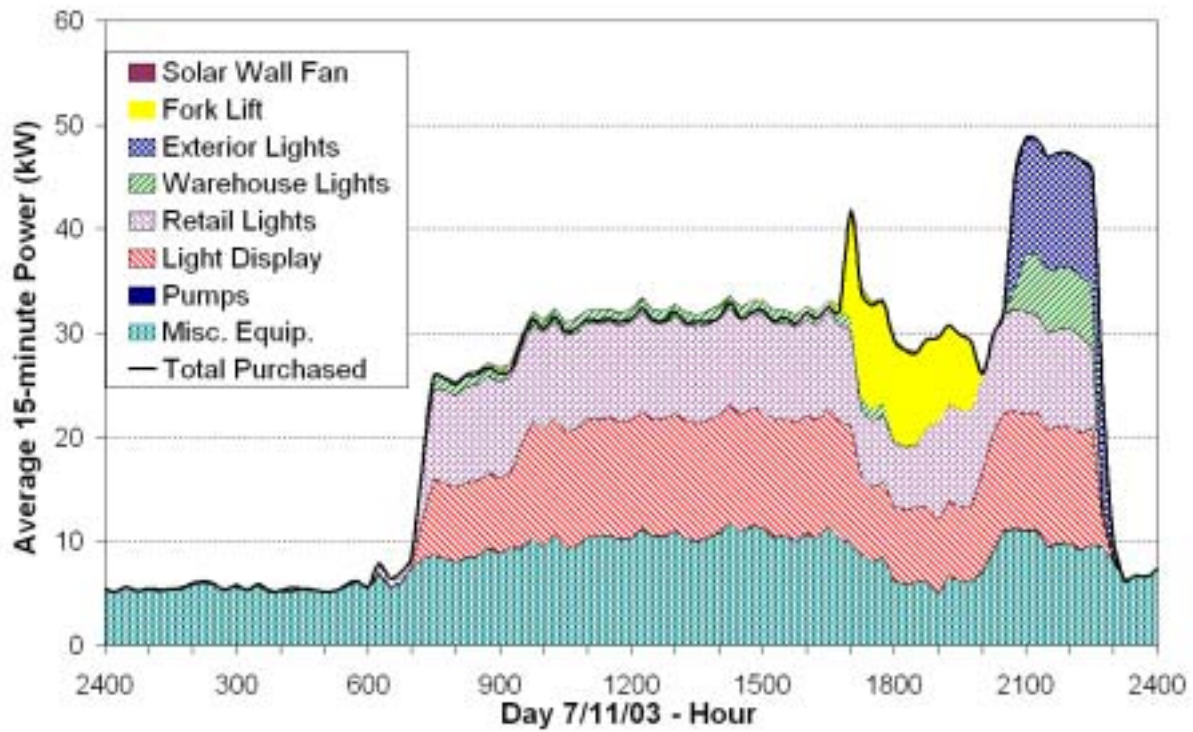
Figure 6-7 Electrical power profile on the peak demand day in July 2003

The electrical power profiles for typical peak demand days during the summer and winter are shown in Figures 6-7 and 6-8. These figures show the average power drawn every 15 minutes. The heavy black line is the purchased electrical power. When this line is below the top of the graph, the PV system provided some of the building electrical load. In Figure 6-7, the PV system provides some power during the day; however, the PV system was only operating on one of three inverters on this day. In Figure 6-8, the PV system was down and did not produce any power.

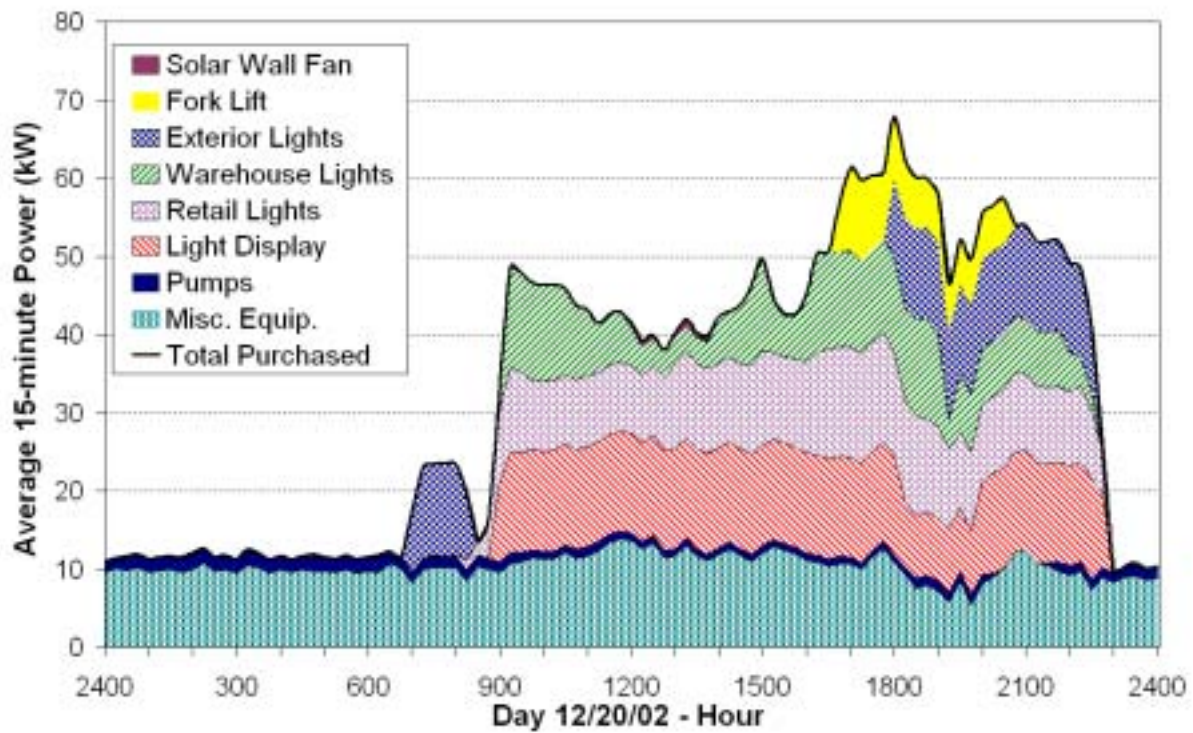
Figure 6-8 Electrical power profile on the peak demand day in December 2002

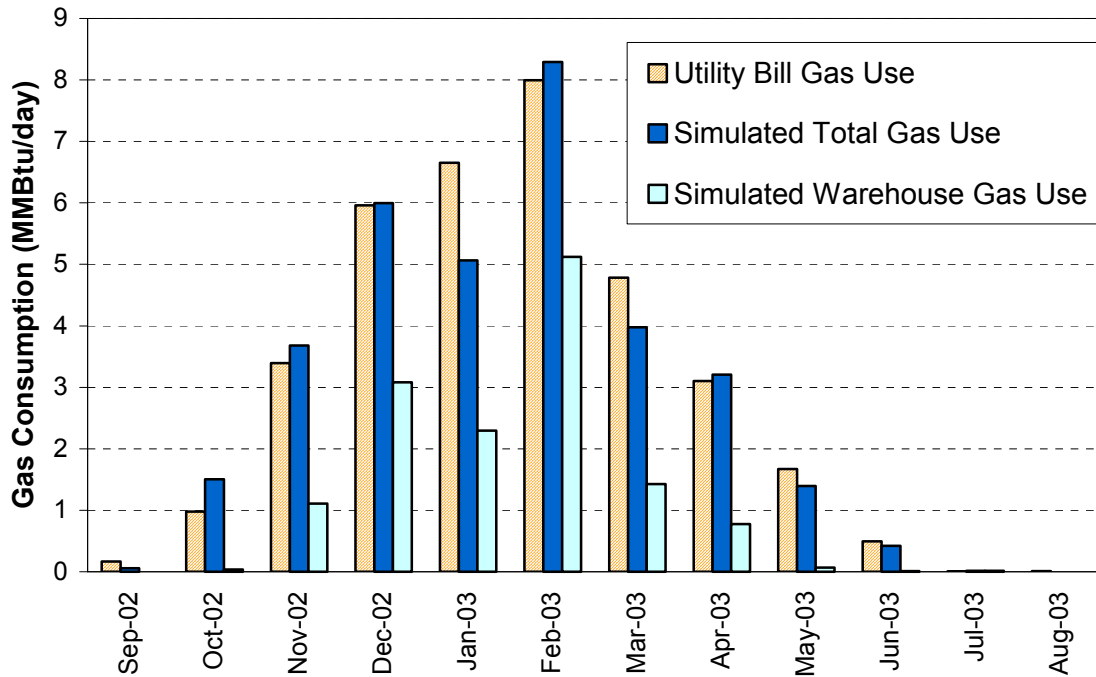
Figure 6-9 Calibration of simulated gas consumption with utility bills

Next, the gas consumption was calibrated with the monthly totals from the utility bills. This was difficult because only the monthly total natural gas for the building is known, and the split between the warehouse and the retail/office area is not known. In addition, the operating conditions and thermostat schedules change occasionally depending on the needs and desires of the building occupants. The warehouse is operated as a drive-in loading space, and at least one overhead door is always open during store operating hours. The radiant gas heaters are operated to keep the space warmer than 37°F (3°C). This operation is difficult to model because the air exchange with the outdoors is unknown. However, the low temperature set point in the warehouse makes it possible to find months where the heating load in the warehouse is small. The largest unknown in the model of the retail/office space heating system is the Panel Loss Ratio; therefore, this value was altered to best match the measured data. The Panel Loss Ratios that best matched the monthly data were 0.05 for the retail and office space and 0.1 for the break room. Next, the maximum infiltration for the warehouse was changed to find the best match for every month of the year. The best fit of the data was found with the maximum warehouse infiltration set to 5.25 ACH. Because of the high flow rates from open doors, it was not feasible to measure the ACH. The annual total gas use from the As-Built Model was 4.8% lower than the total from the utility bills. A look at the month-by-month comparison in Figure 6-9 shows a good match for most months. Excluding January, the simulated results are only 0.03% lower than the utility bills. January had some operational differences that were unknown and we were unable to account for them in the model.

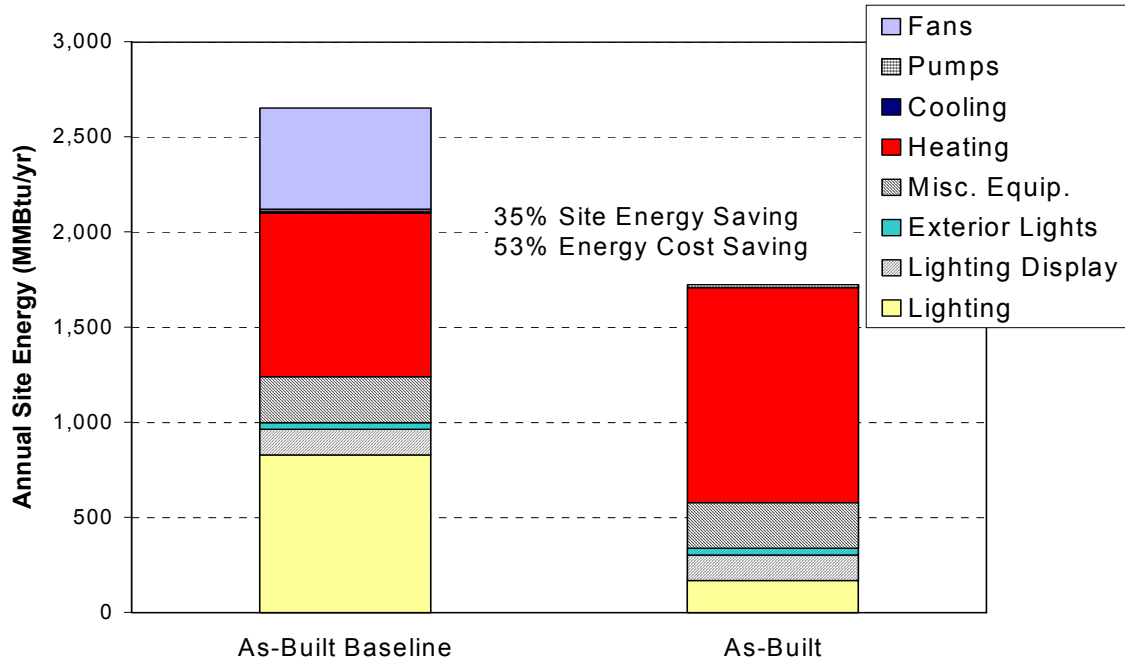
Figure 6-10 Simulated annual site energy consumption for the As-Built Baseline Model and As-Built Model with an average year weather file

The source energy savings are much greater than the site energy savings because the mix of electrical and gas energy consumption is different in the two building models. The As-Built Baseline Model has much higher energy consumption due to the lights and fans than the As-Built Model, and the As-Built Model has much higher gas consumption. In the As-Built Baseline Model, 68% of the site energy consumption is electricity; in the As-Built Model, the electricity consumption is only 34% of the total.

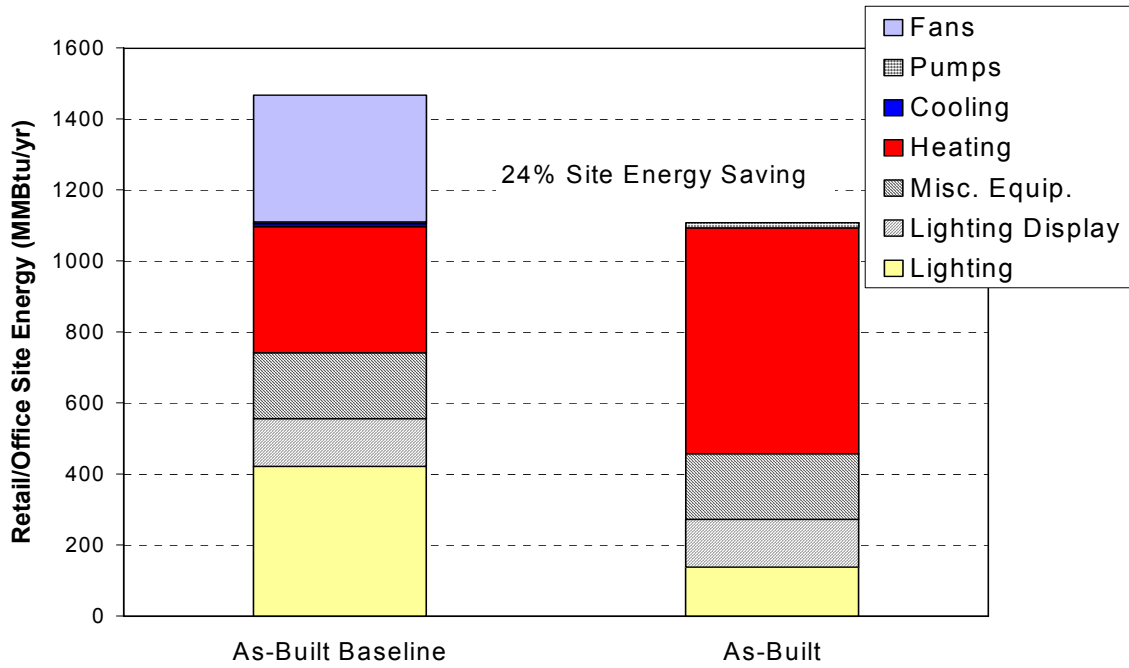
Figure 6-11 Simulated annual site energy consumption for the retail/office space using an average year weather file

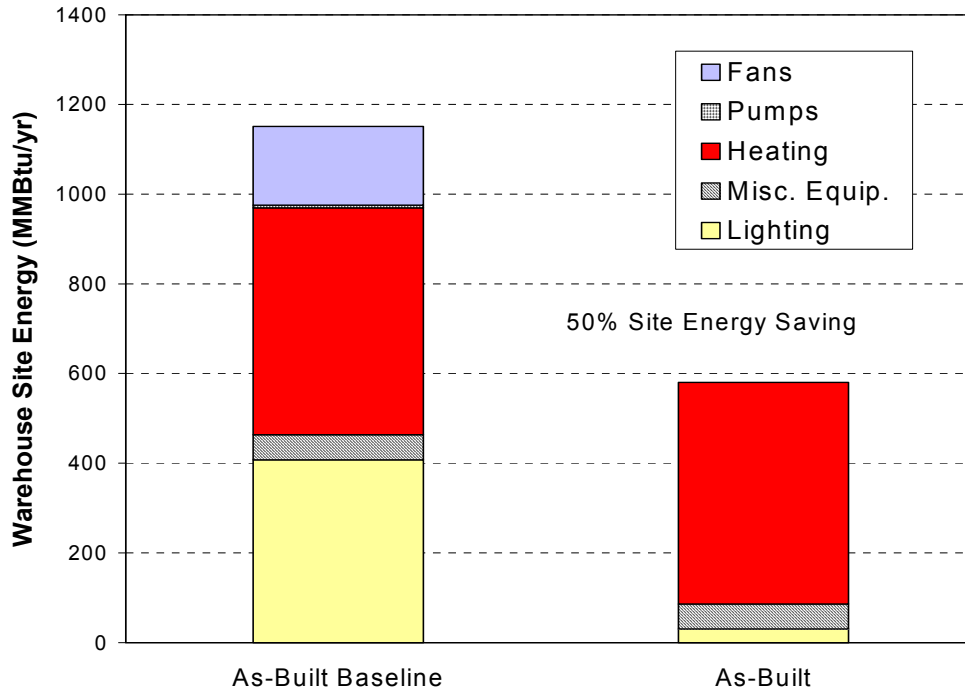
Figure 6-12 Simulated annual site energy consumption for the warehouse using an average year weather file

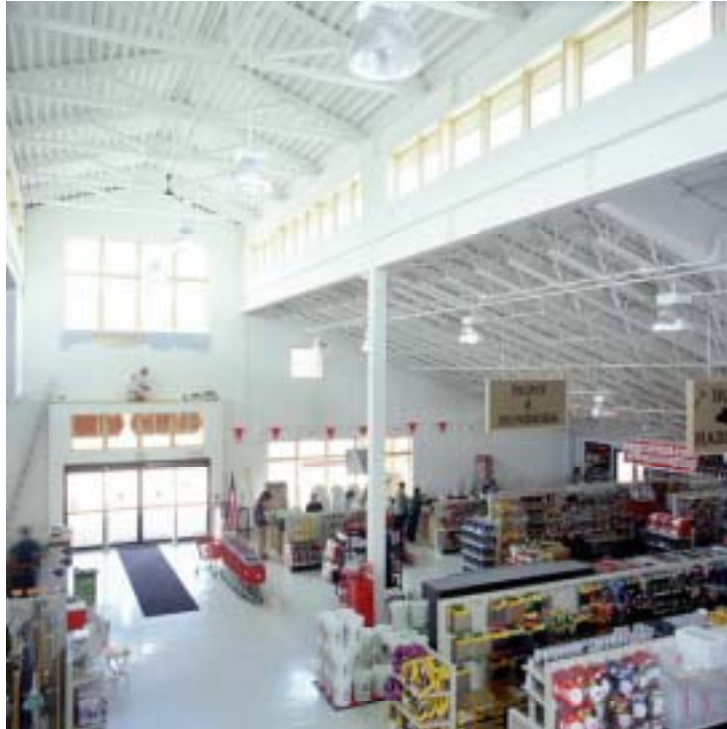
Figure 7-2 Retail area lighting with daylight only for clear sky conditions on June 5, 2000

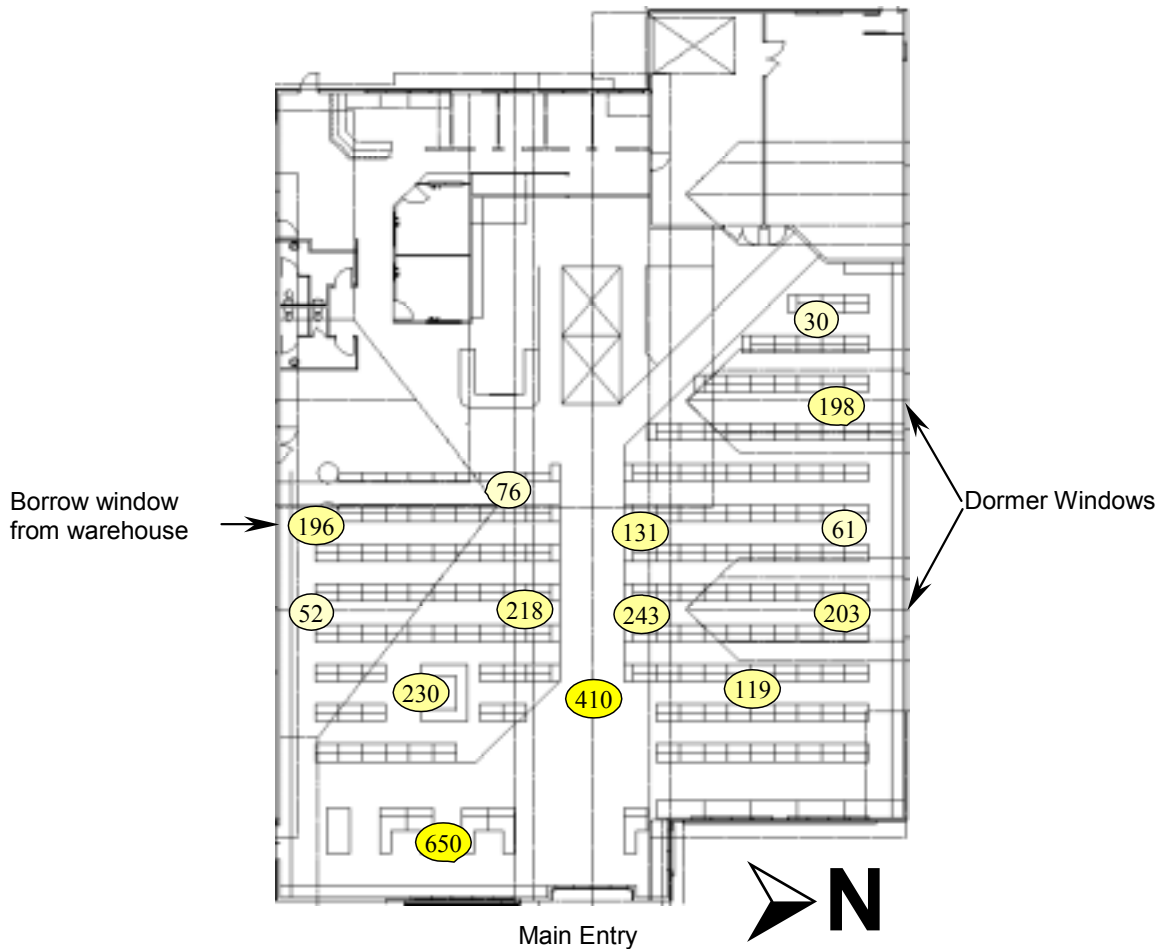
Figure 7-3 Illuminance levels in lux from daylight only on June 5, 2000, at 11:00 MDT

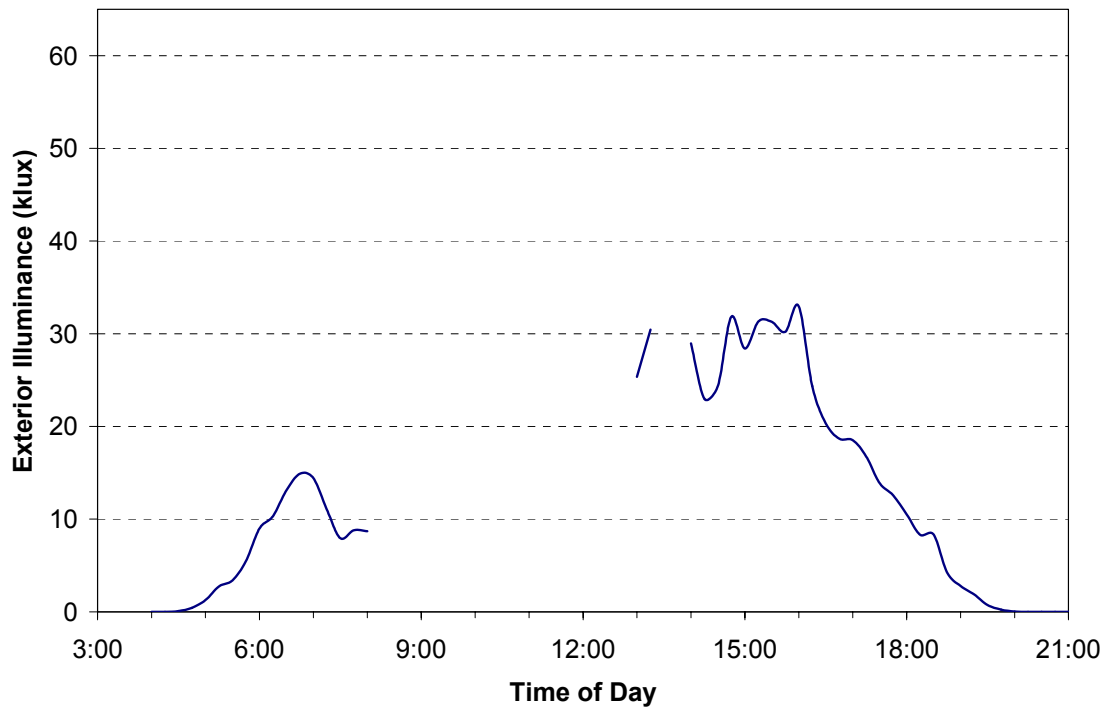
Figure 7-5 Exterior illuminance for June 23, 2001

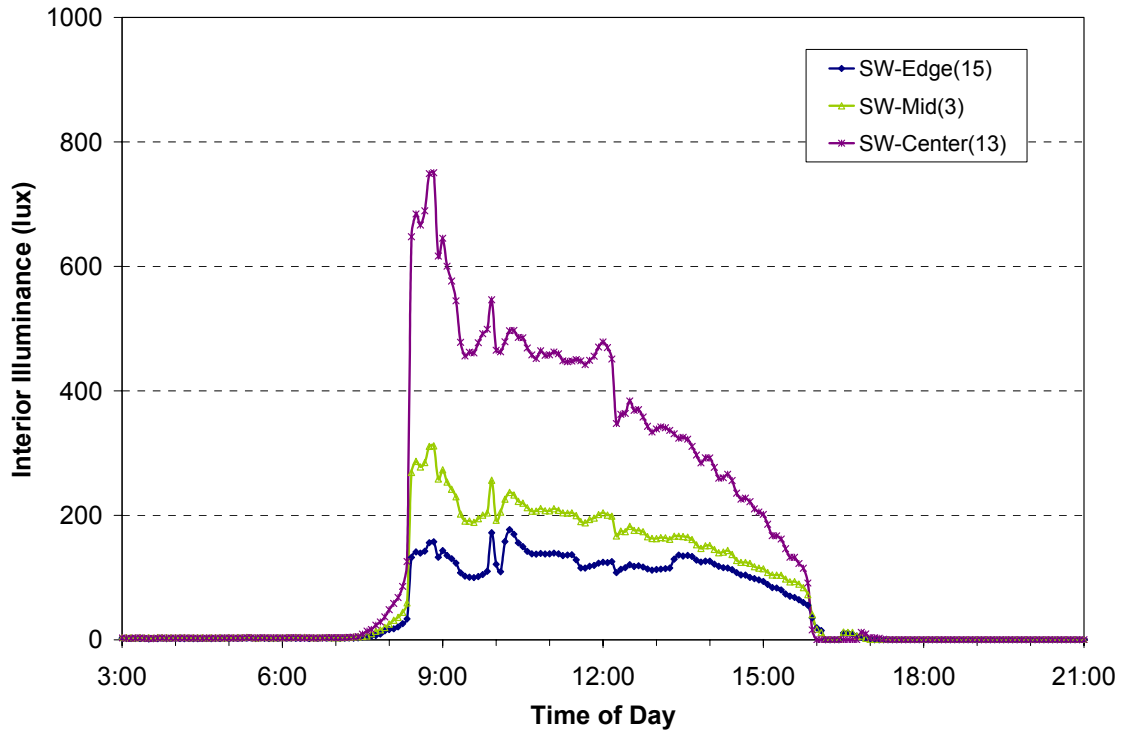
Figure 7-7 Daylight levels on the south side of the retail area for a clear winter day (December 31, 2000)
