Energy Design and Performance Analysis of the BigHorn Home Improvement Center

M. Deru, P. Torcellini, and S. Pless

NREL

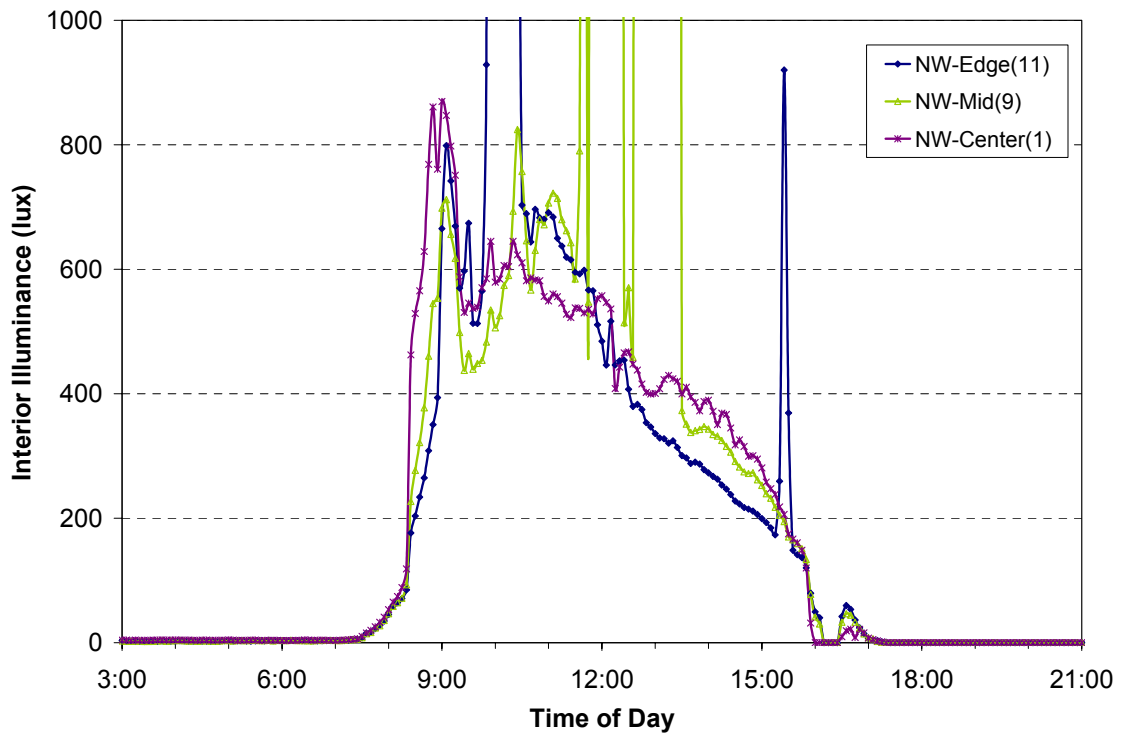
Figure 7-8 Daylight levels on the north side of the retail area for a clear winter day (December 31, 2000)

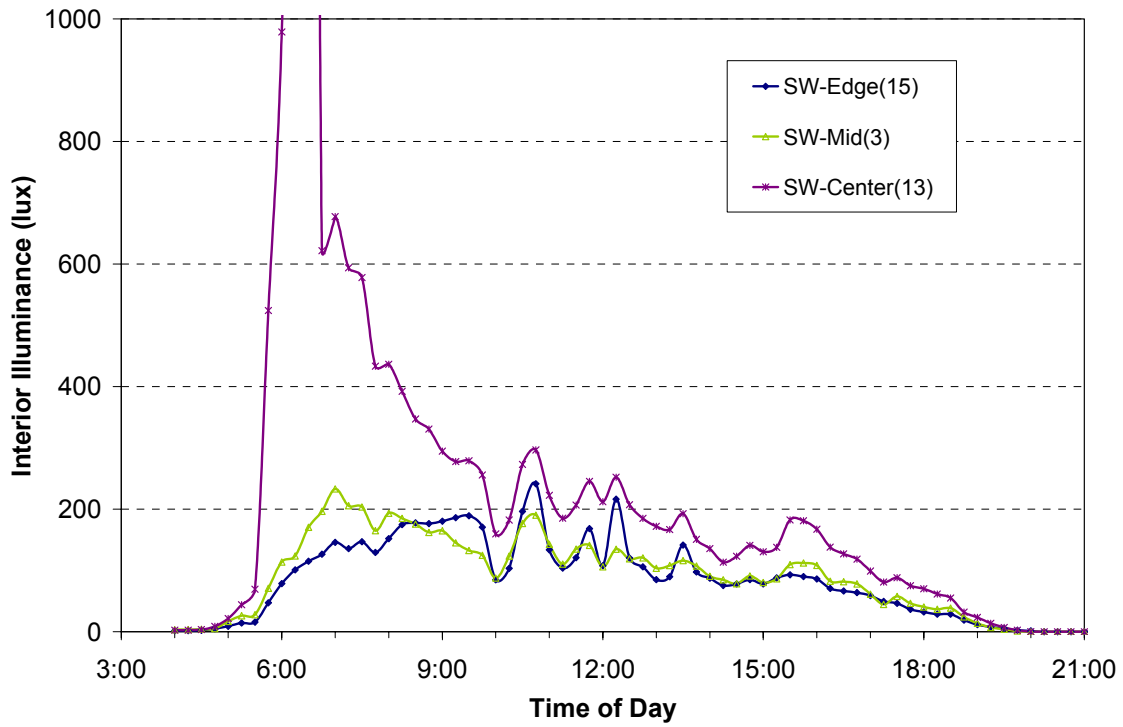
Figure 7-9 Daylight levels on the south side of the retail area for a partly cloudy summer day (June 23, 2001)

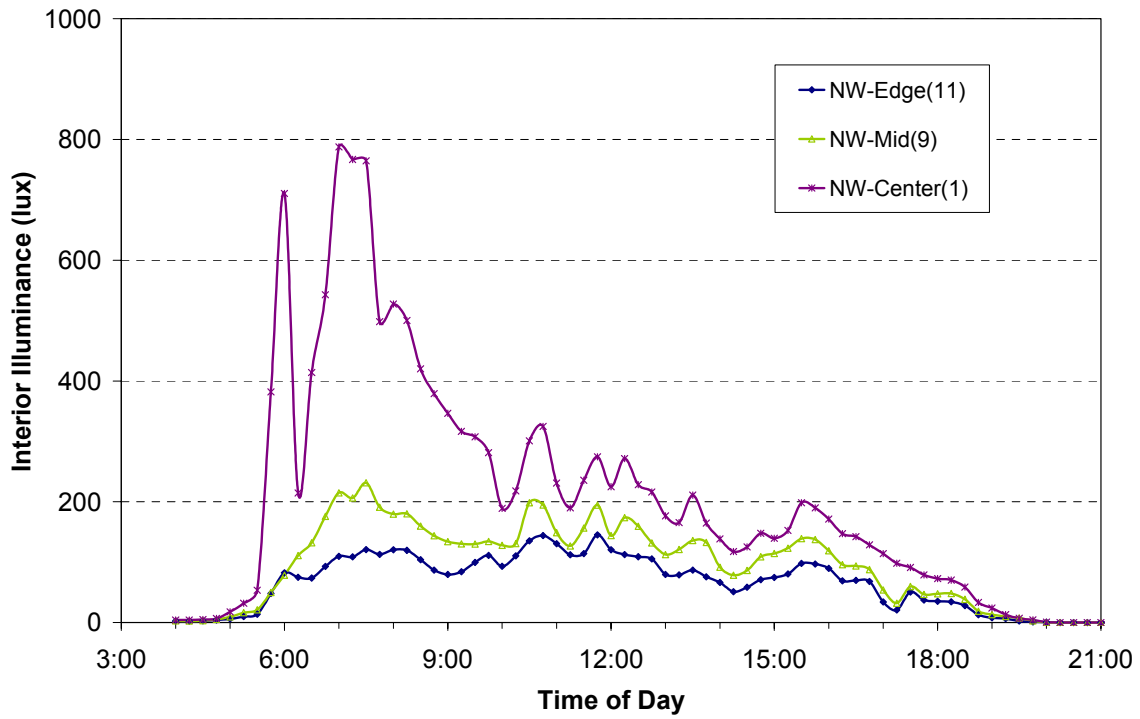
Figure 7-10 Daylight levels on the north side of the retail area for a partly cloudy summer day (June 23, 2001)

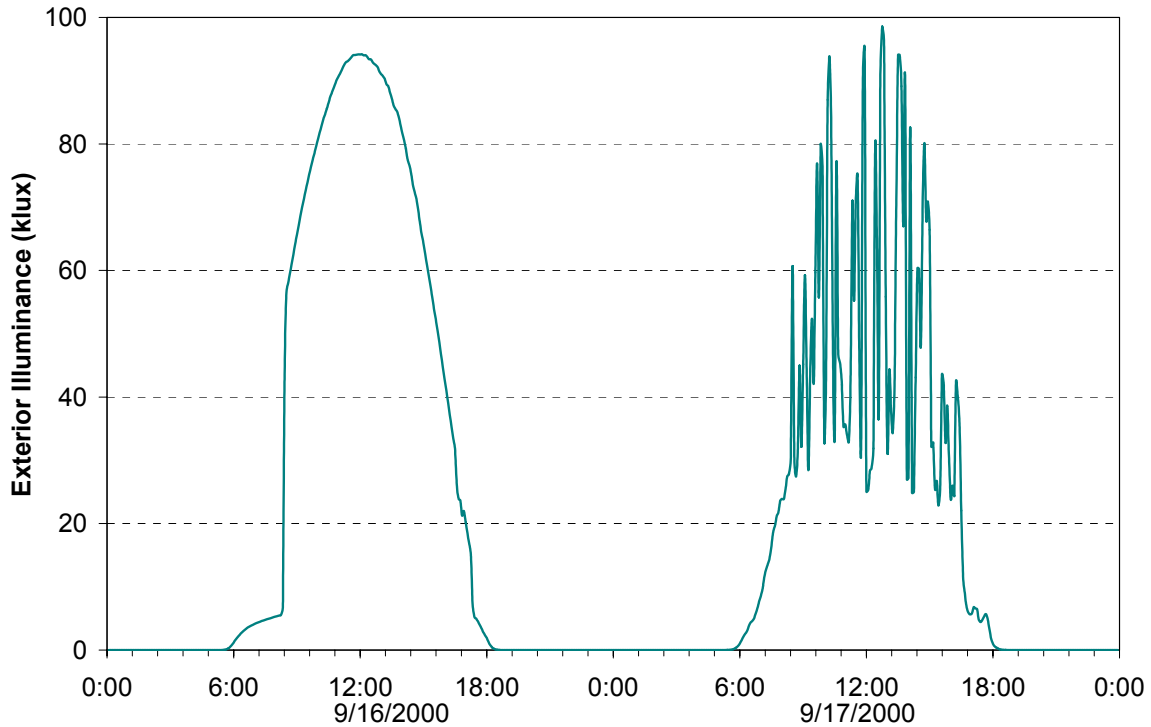
Figure 7-11 Exterior illuminance for September 16 and 17, 2000

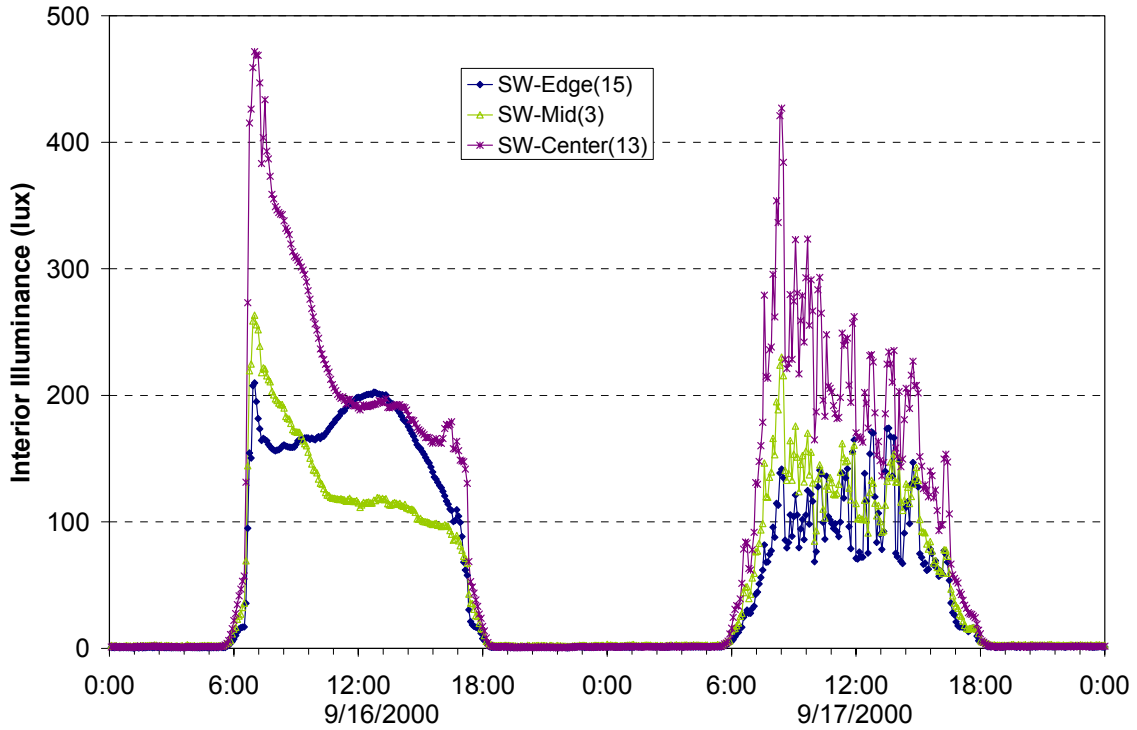
Figure 7-12 Daylight levels on the south side of the retail area for clear and partly cloudy autumn days (September 16 and 17, 2000)

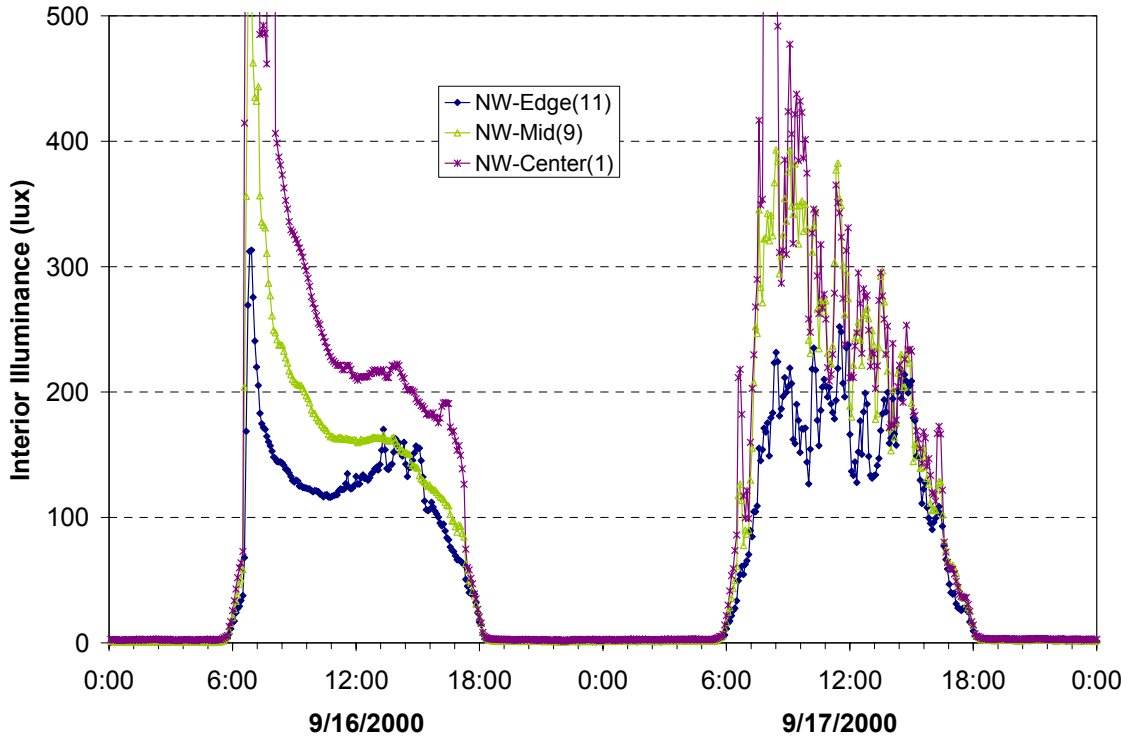
Figure 7-13 Daylight levels on the north side of the retail area for clear and partly cloudy autumn days (September 16 and 17, 2000)

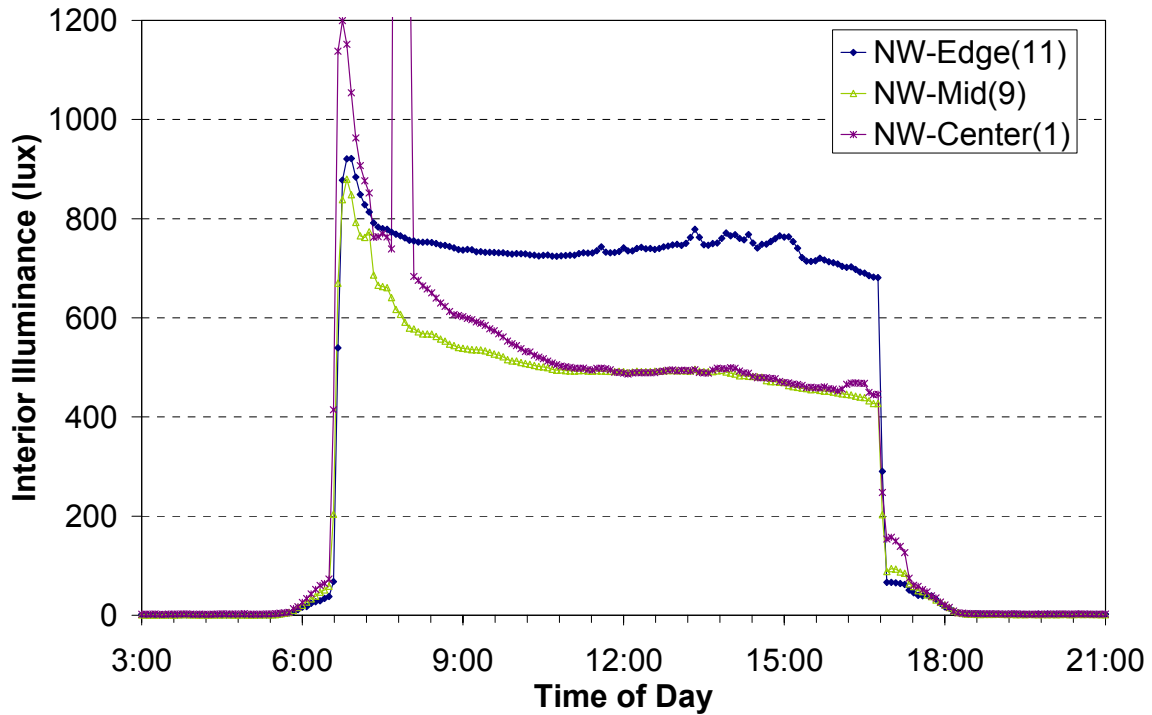
Figure 7-15 Light levels from daylight and electric lights on the north side of the retail area on September 16, 2000

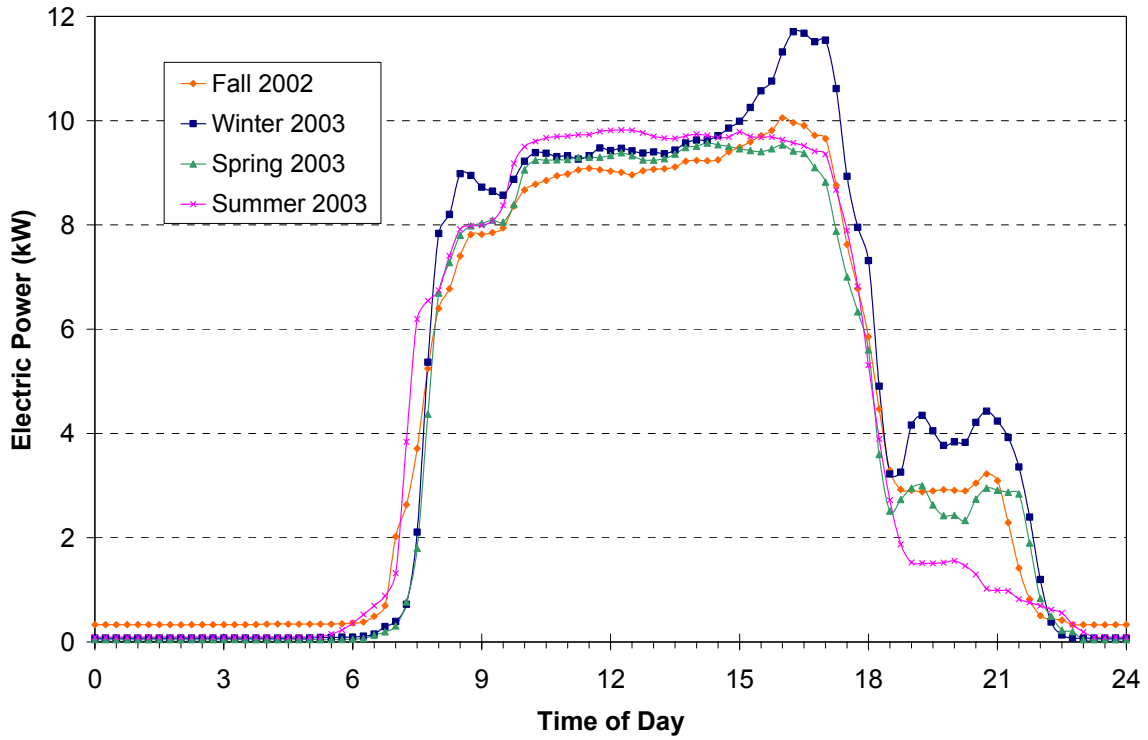
Figure 7-16 Seasonal average daily profile for the retail lighting power

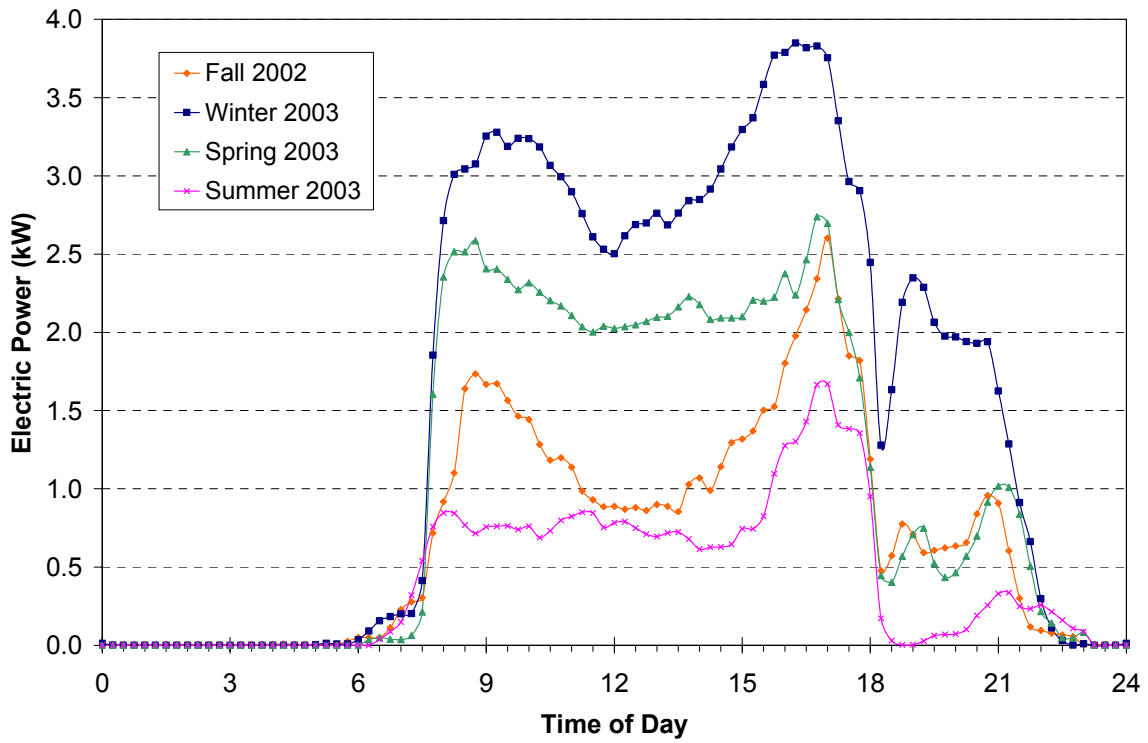
Figure 7-17 Seasonal average daily profile for the warehouse lighting power

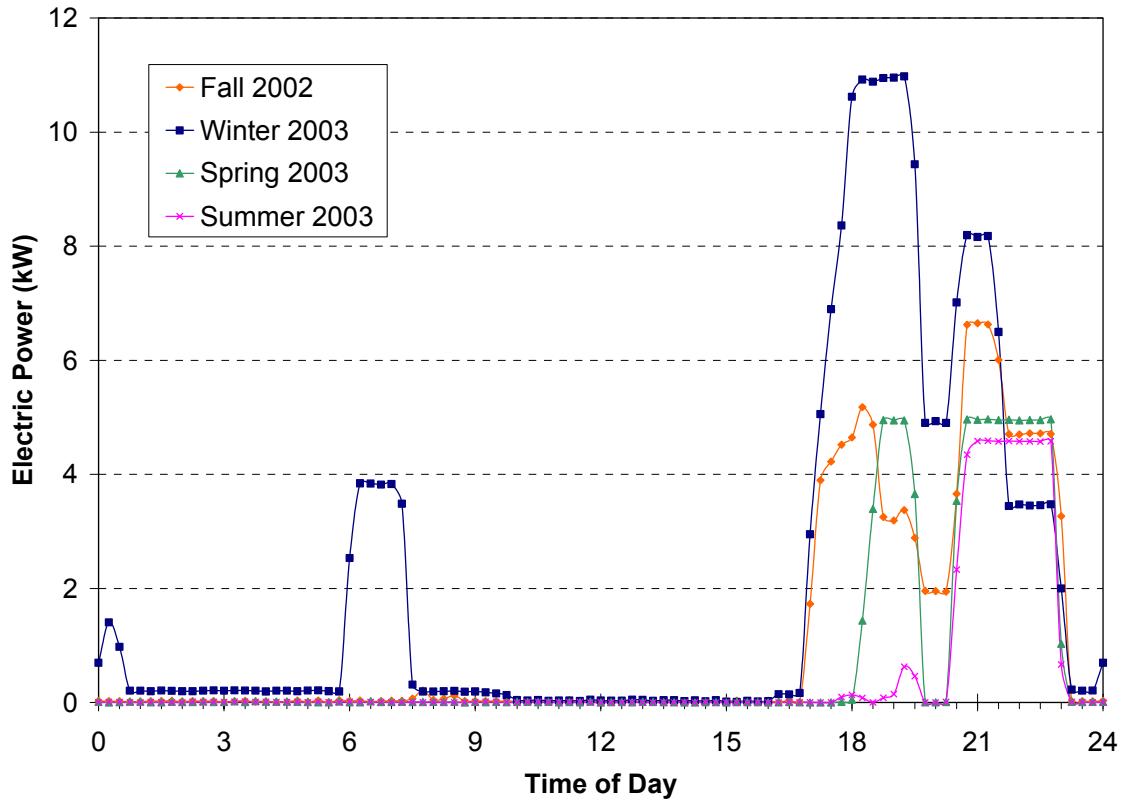
Figure 7-18 Seasonal average daily profile for the exterior lighting power

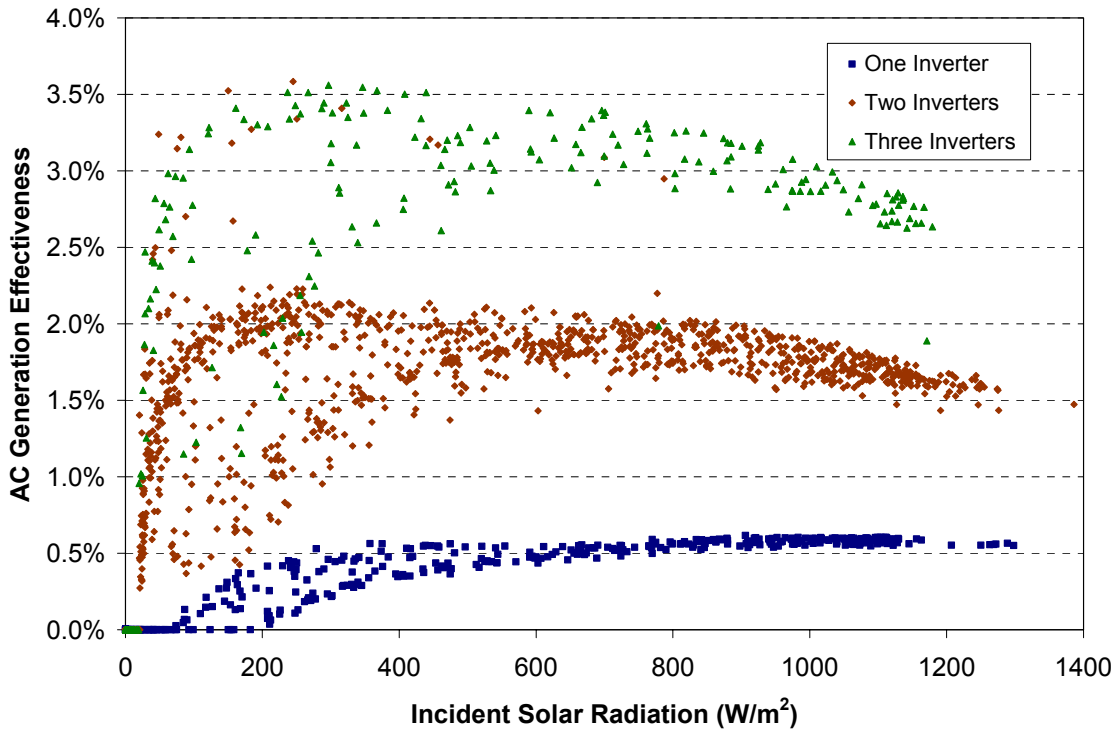
Figure 7-22 AC Generation Effectiveness for June 2003 with 1, 2, or 3 inverters operating

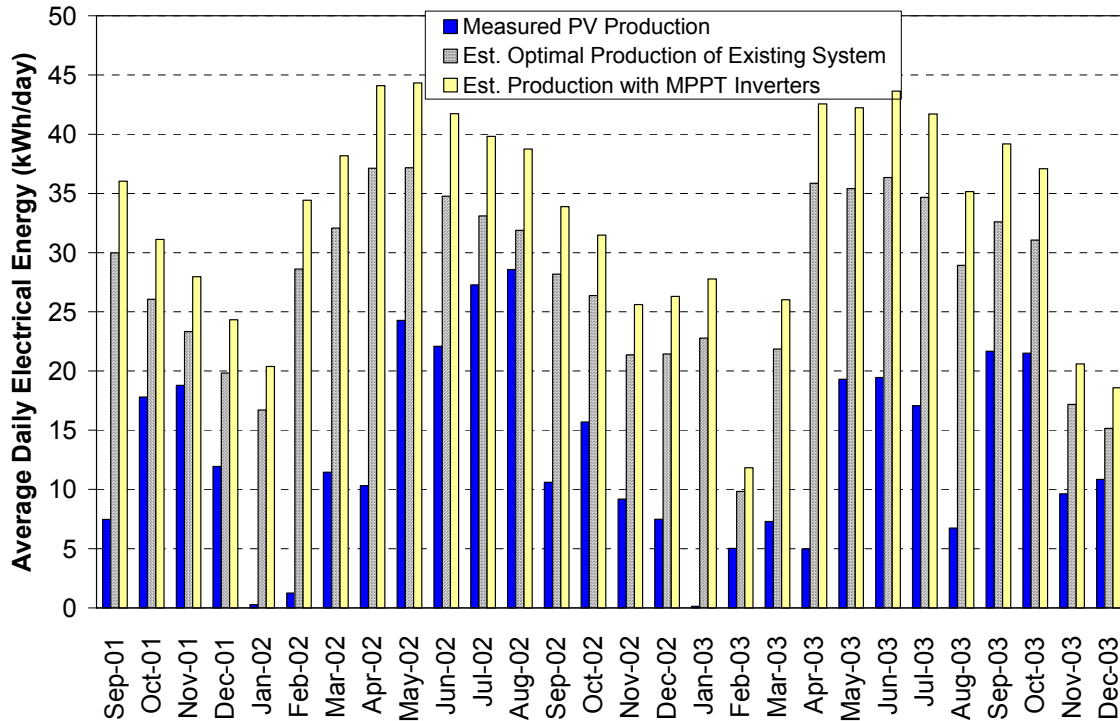
Figure 7-24 Estimated and measured PV system production
