Assessment of Eddy Current Testing for the Detection of Cracks in Cast Stainless Steel Reactor Piping Components

Pacific Northwest National Laboratory

NUREG/CR-6929
PNNL-16253

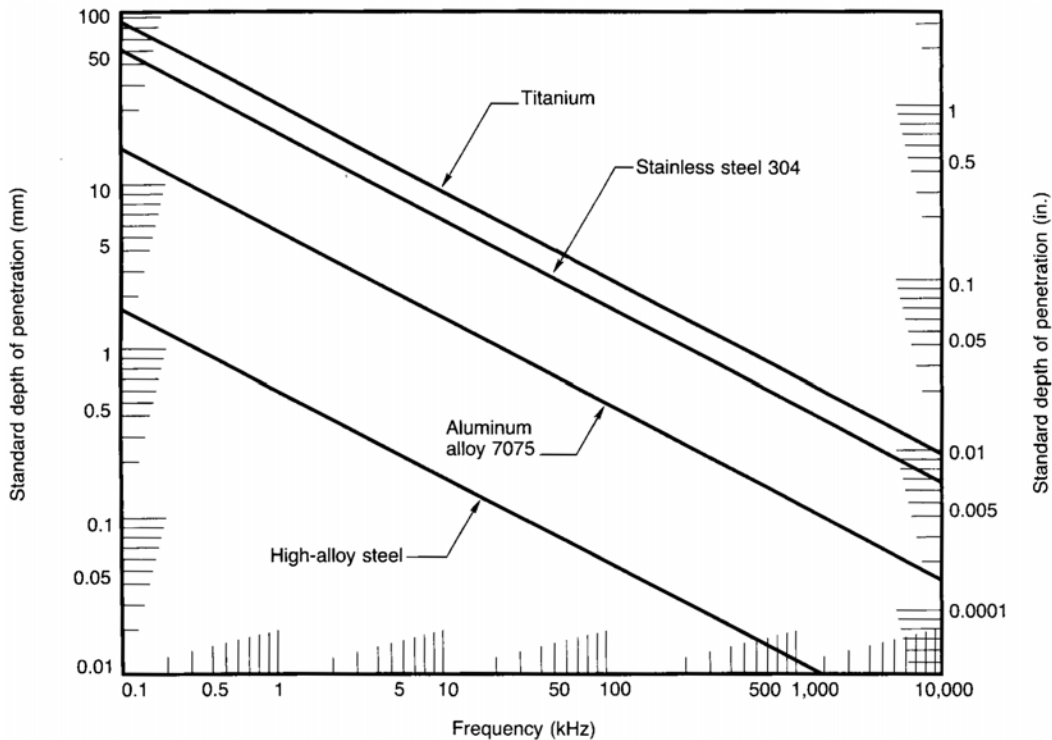
Figure 3.2 Eddy Current Testing Standard Depth of Penetration for Assorted Materials of Varying Conductivity as a Function of Frequency (from Hagemaiier 1990)

Figure 3.1 illustrates the relationship between frequency, conductivity, and permeability on the depth of penetration for an eddy current field. Therefore, the depth of penetration decreases with increasing frequency, conductivity, and permeability. In the work reported here, with the given operational frequency of 250 kHz using type 304 stainless steel as the base material, our standard depth of penetration is 0.9 mm. This is the distance down from the surface of the material where the eddy current energy density has decreased by 37%. This can be significant to an ET examination, as penetration into ferrous materials at practical frequencies is quite small. Figure 3.2 depicts the standard depth of penetration for an eddy current field for materials of varying conductivity as a function of frequency.

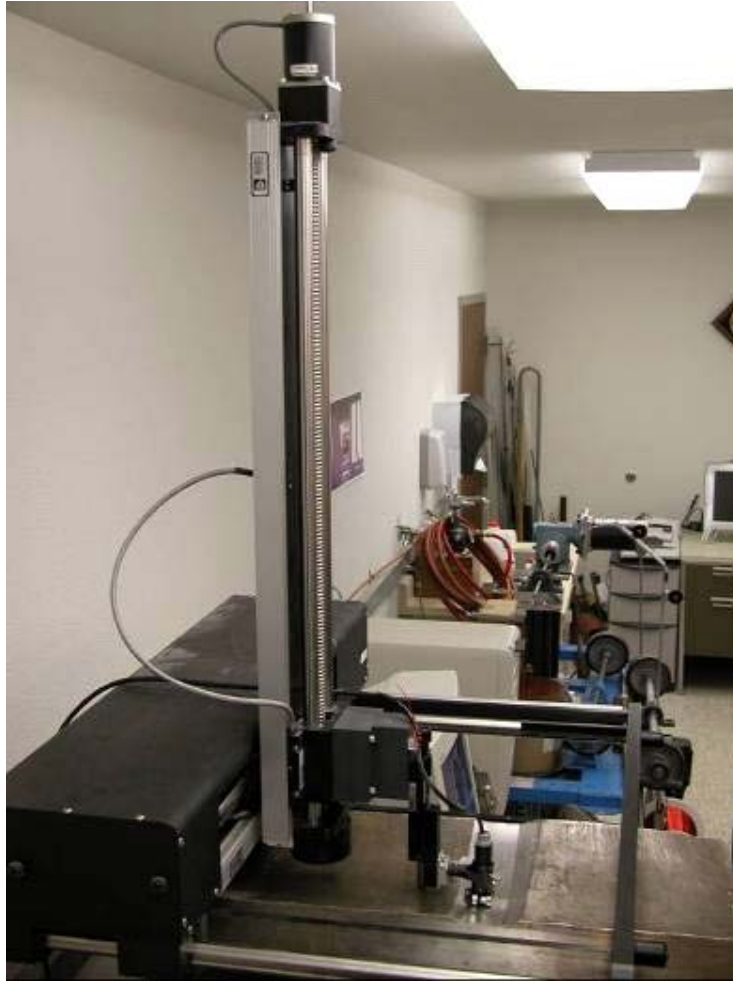
Figure 4.1 Automated x-y Eddy Current Testing Scanning System

The CSS examinations in this study were implemented using a PC-controlled x-y scanning system connected to a Zetec MIZ27-SI eddy current instrument. A digital photograph of the ET scanning system configuration is shown in Figure 4.1. A Zetec plus-point probe (Model Z0000857-1) configured with two small coils oriented 90° from each other was chosen. This probe configuration (sometimes referred to as a plus-point probe) consists of a differential pair of coils that interrogate the same spatial area on the material under test. These types of probes are generally insensitive to extraneous factors and most effective for detection of cracks and other surface material discontinuities. These operational characteristics permit the suppression of localized geometry variations (curved surfaces, corners, weld splatter) and variations in material composition (filler metals, heat-affected zone). Plus-point probes are

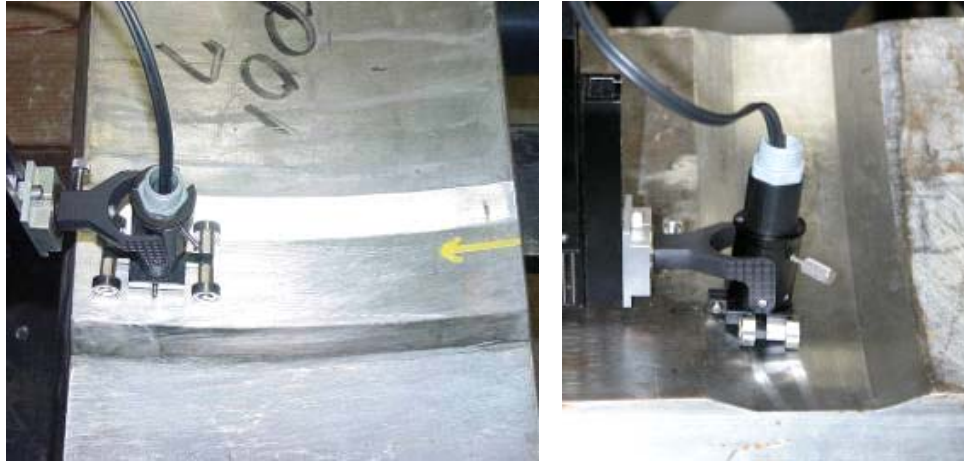
Figure 4.3 Top and Side Views of Inner Diameter Scan Configuration Using Eddy Current Testing Probe and Spring-Loaded Probe Sled for Translation over the Inner-Diameter Surface

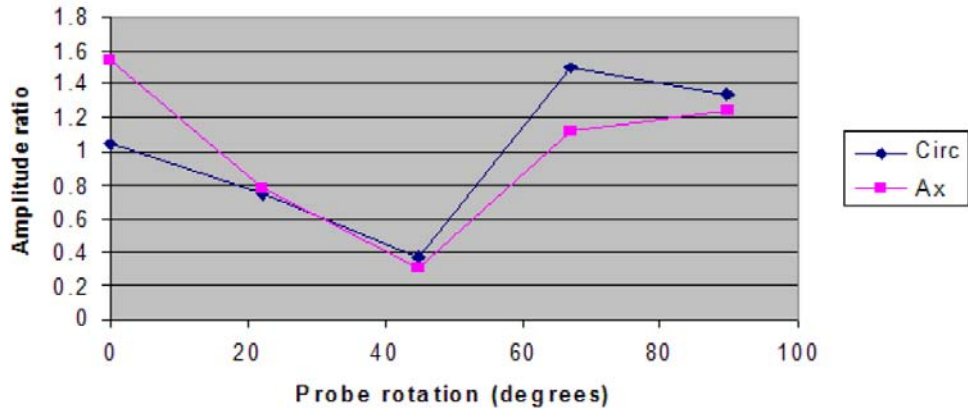
Figure 4.4 Relative Sensitivity of the Plus-Point Probe to a Calibration Block Reflector

PNNL chose to use existing EDM notch reflectors to aid in evaluating and understanding probe sensitivity issues and noise levels. These tests demonstrated that the reduction in probe sensitivity to off-angle cracking, crazing, and branching can be significant and is on the order of 14 dB, or a factor of 5.

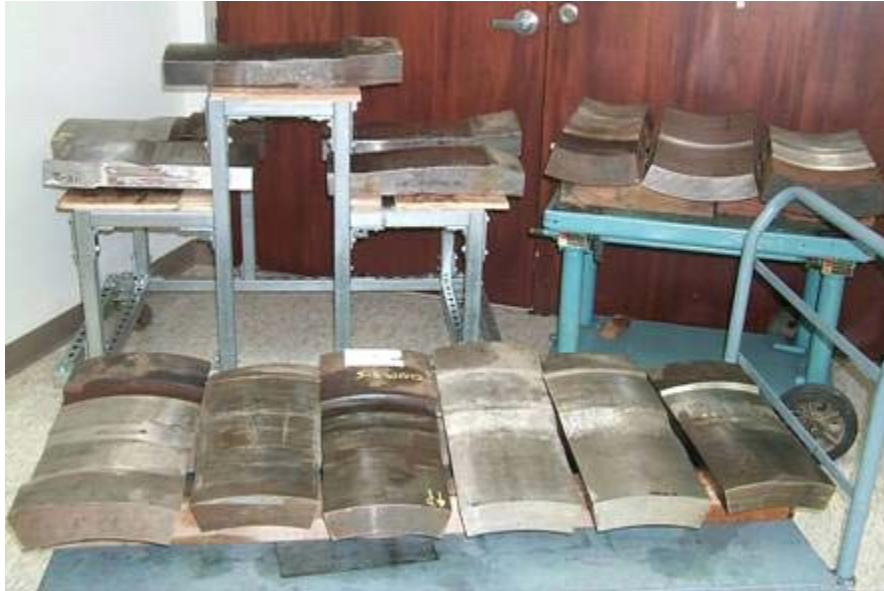
Figure 5.3 Westinghouse Owners Group Set of Cast Stainless Steel Specimens Used in This Study

The represented microstructures were described as coarse and coarse-mixed microstructures, consisting of combined dendritic (columnar) and equiaxed grains. Figure 5.3 shows the WOG specimens in the laboratory prior to data acquisition.

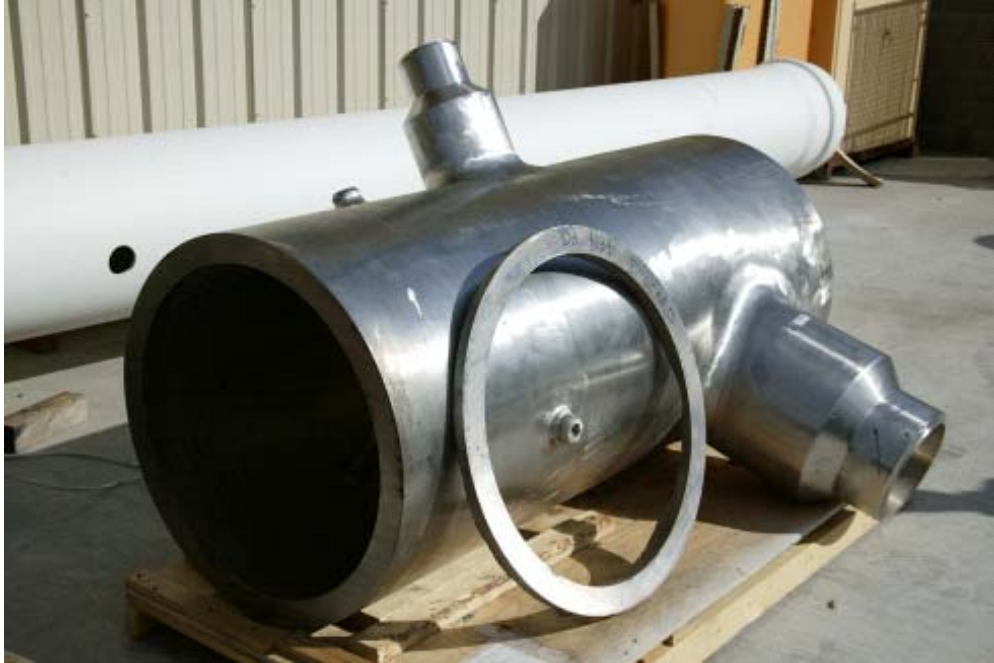
Figure 5.5 Large Blank Cast Spool Piece, Extracted from a Cancelled Spanish Nuclear Power Plant, Acquired by the EPRI NDE Center, and Loaned to PNNL for Advanced NDE Assessment Work
