Optimizing Maintenance Activities
Fourth Report

REPAIR OF CONTINUOUSLY
REINFORCED CONCRETE PAVEMENT

*Combined State Studies
Of Selected Maintenance Activities
A Cooperative Analysis By Teams From
Arkansas, Louisiana, Mississippi, Texas*

Report FHWA-TS-78-215

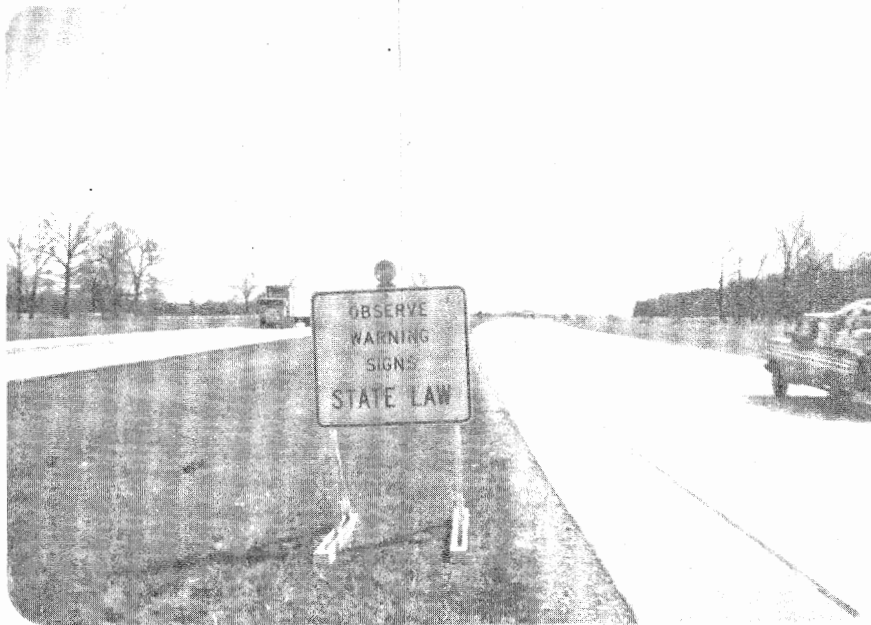
Figure 1. Advance warning sign (on both sides of the road).

1. Provide for detouring traffic. Many suggestions for improving current practices were investigated but any procedure used will have to comply with State and Federal standards for controlling and handling traffic through construction or maintenance zones. Much additional consideration must be given to detouring procedures on projects where patching is an almost continuous or recurring operation. Figures 1 through 5 show typical detour signing.

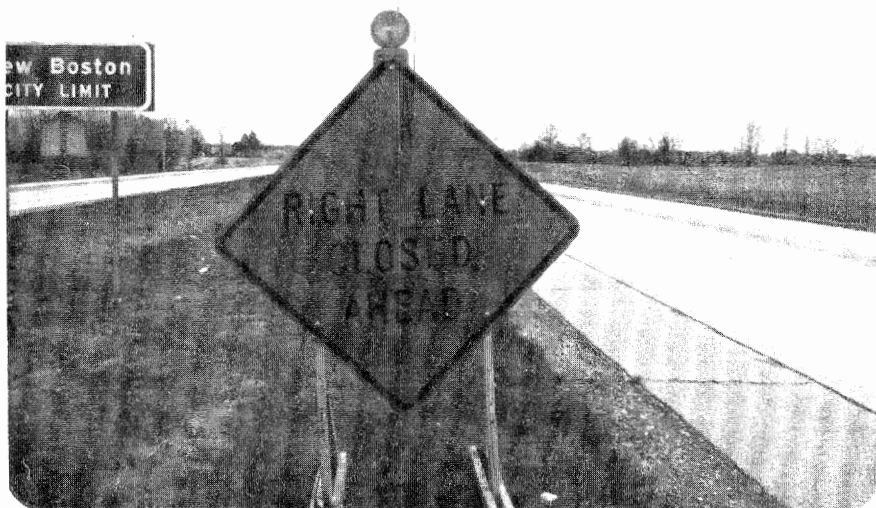
Figure 3. Right lane closed ahead (on both sides of the road).

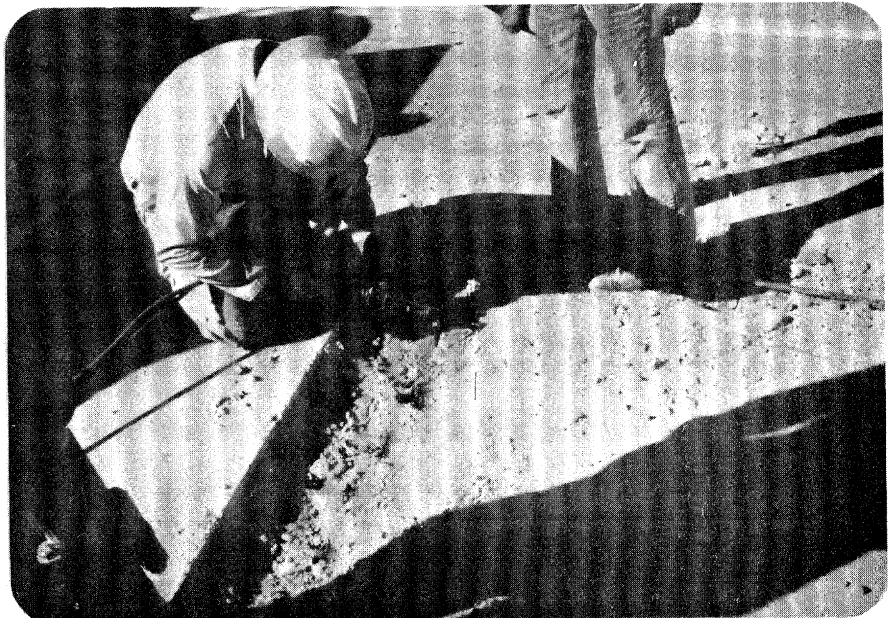
Figure 8. Cutting the steel.

4. Cut steel to provide sufficient length for lap splicing or welding. Some of the States preferred welding while others preferred tying. The

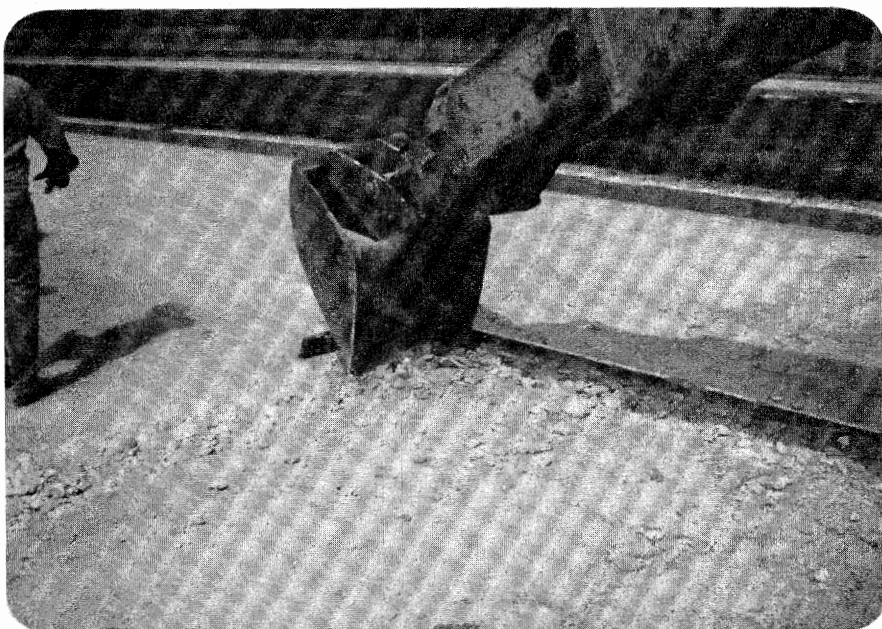
Figure 9. Preparing to lift out the slab in one piece.

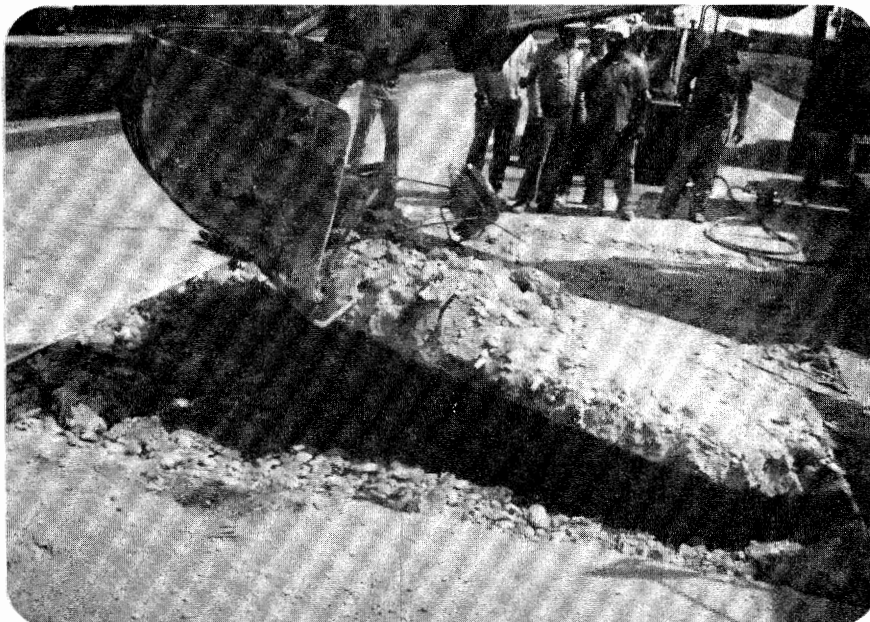
Figure 10. Raising the slab.

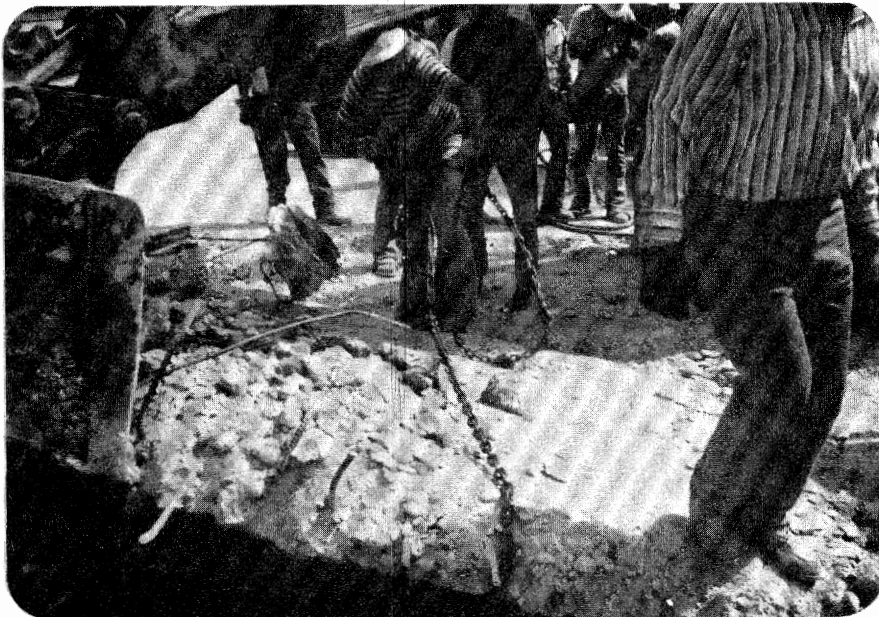
Figure 11. Putting a chain around the slab.

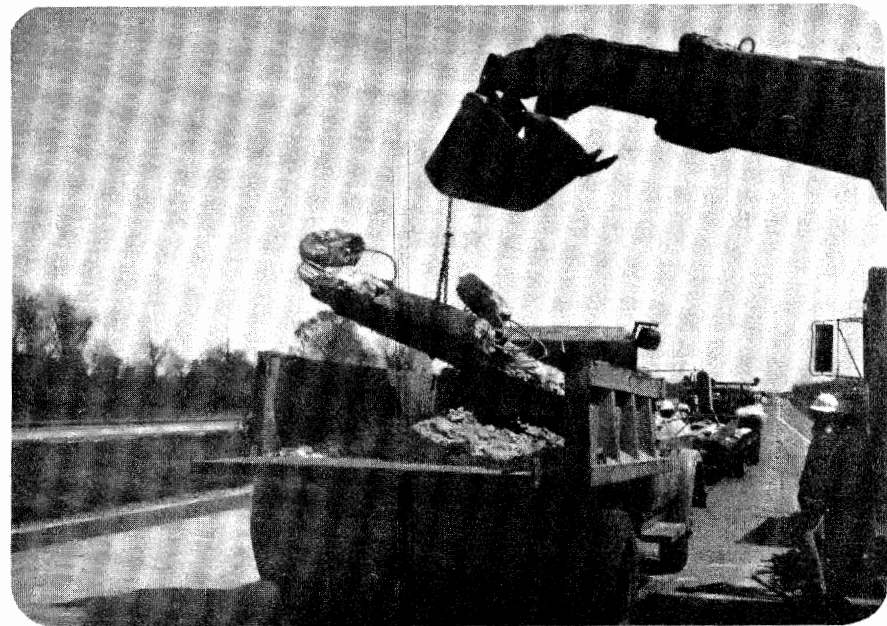
Figure 13. Loading the slab for disposal.

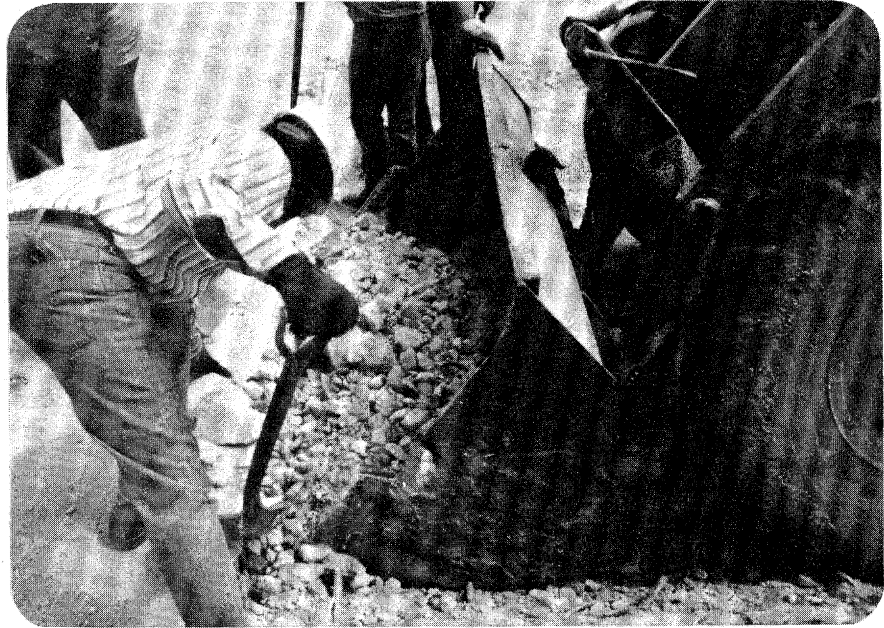
Figure 15. Loading debris.

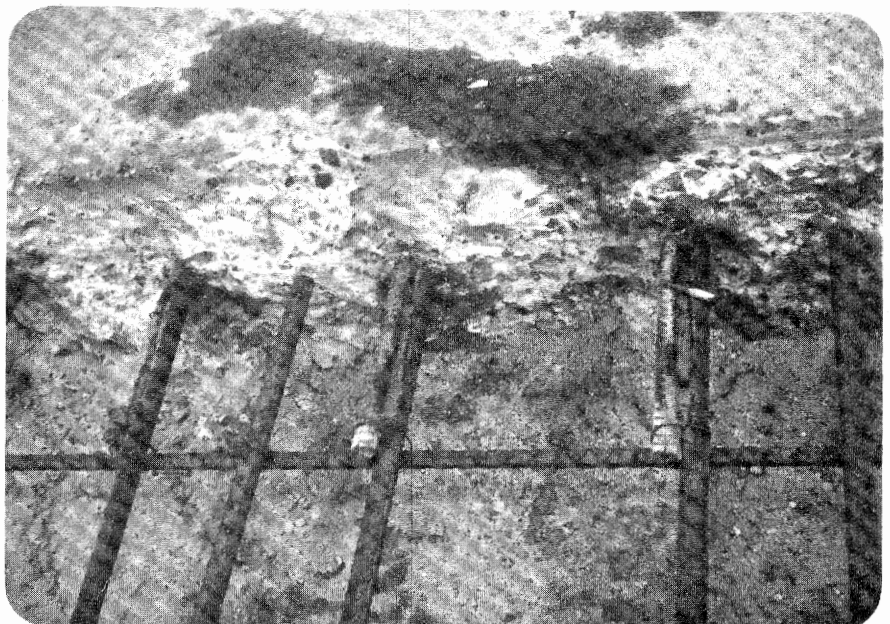
Figure 18. Typical welded steel splice.

advantages of welding to maintain positive continuity of the steel were acknowledged. Tying the steel eliminates the need for a welder on the job thus reducing the cost of the patch. The existing steel could be left in place if the unsound concrete can be removed without breaking the steel. The practice of cutting the steel in the middle, bending it up to remove the concrete, then bending it back down for reuse is considered unsatisfactory. Figures 8 and 17 through 20 show examples of steel being cut and spliced by welding and tying.

6. Replace the steel to match the existing bars and either splice in accordance with usual specifications or weld at least six inches. The need for placing any additional steel in the patch has not been demonstrated.

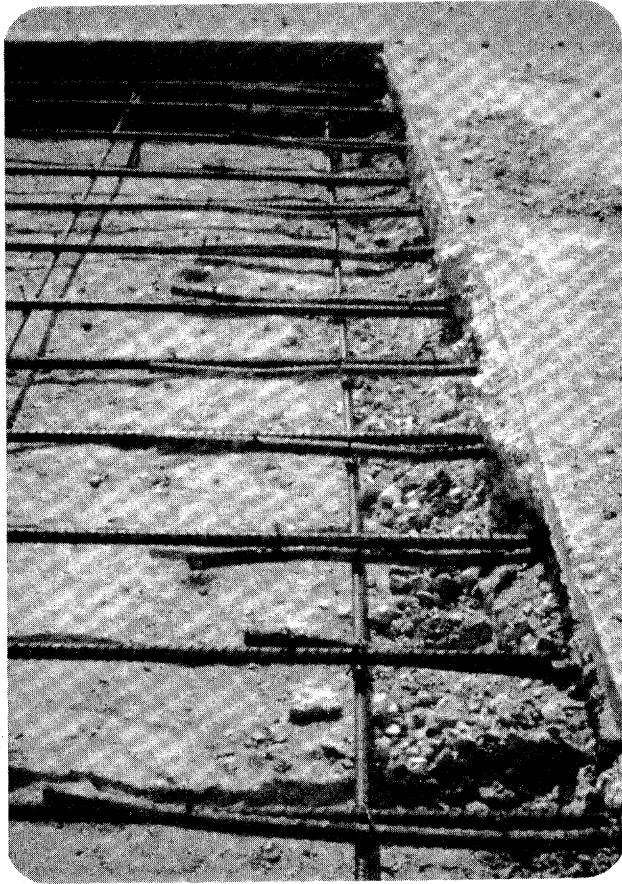
Figure 19. Typical tied steel splice.

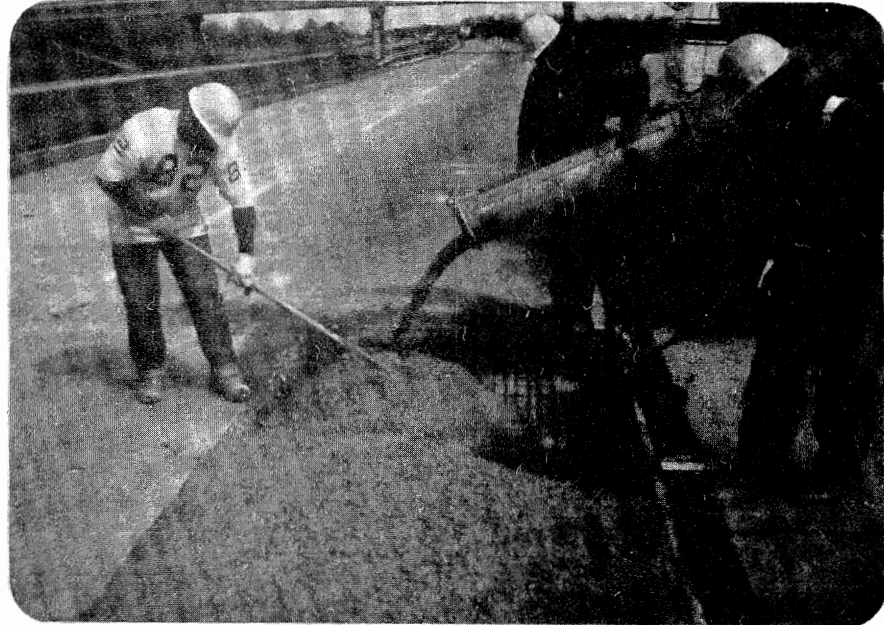
Figure 24. Placing concrete from a ready-mix truck.

9. Fill the excavated area with concrete using a design to provide for quick setting where needed. Figure 24 shows the concrete being placed from a ready-mix truck. In most cases, it is desirable to return the road to traffic service as soon as possible for the convenience and safety of

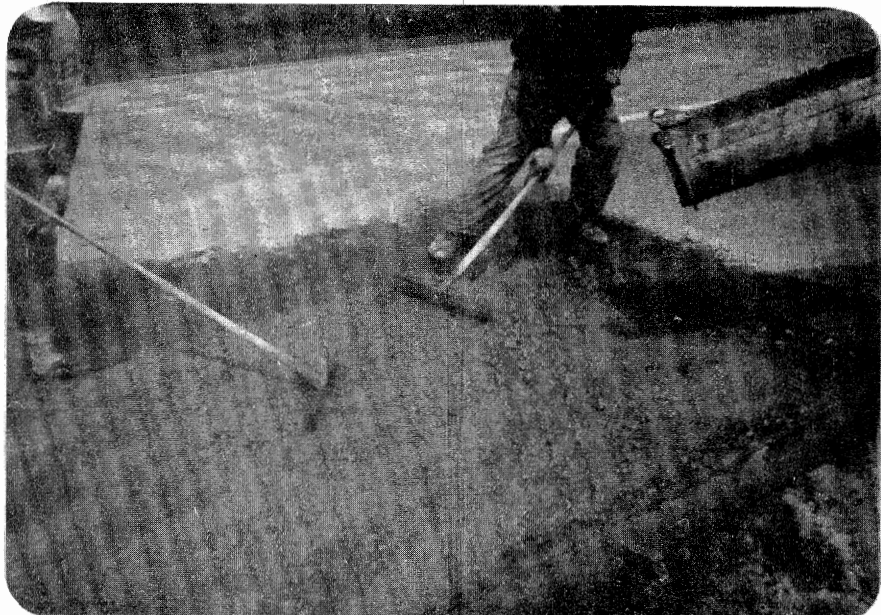
Figure 25. Spreading concrete.

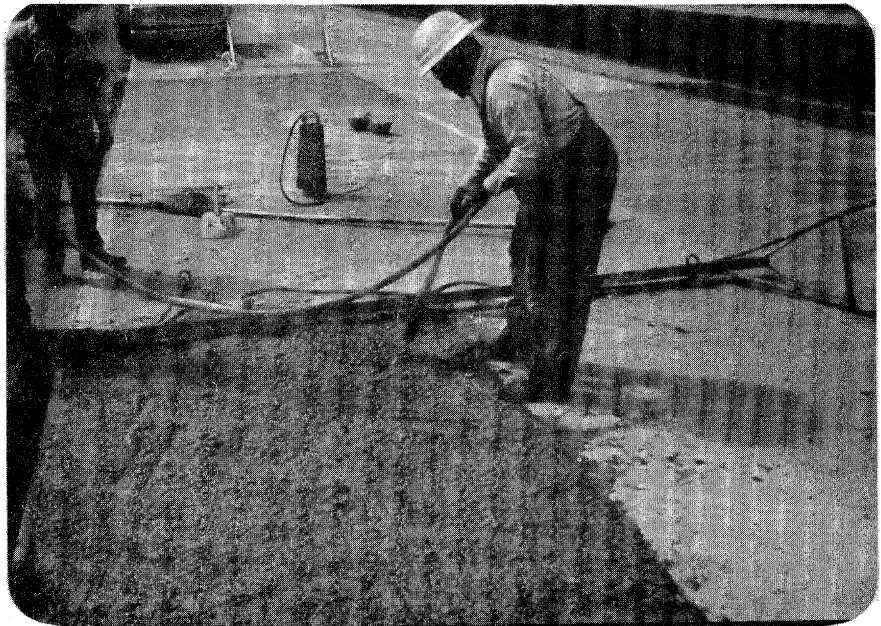
Figure 27. Vibrating the concrete.

10. Consolidate the concrete by mechanical vibration and screed the surface for riding quality. Adequate consolidation of the concrete is imperative and this can best be assured by mechanical vibration. Also, it is unnecessary to provide for a surface finish in excess of the condition of the existing concrete. Figures 25 through 27 show the concrete being spread, struck off and consolidated.
11. Use a sprayed membrane curing compound to cure the concrete patch. Other curing methods provide for a satisfactory patch but the use of a curing compound is the most practical. Figures 28 and 29 show the patch being finished and cured.

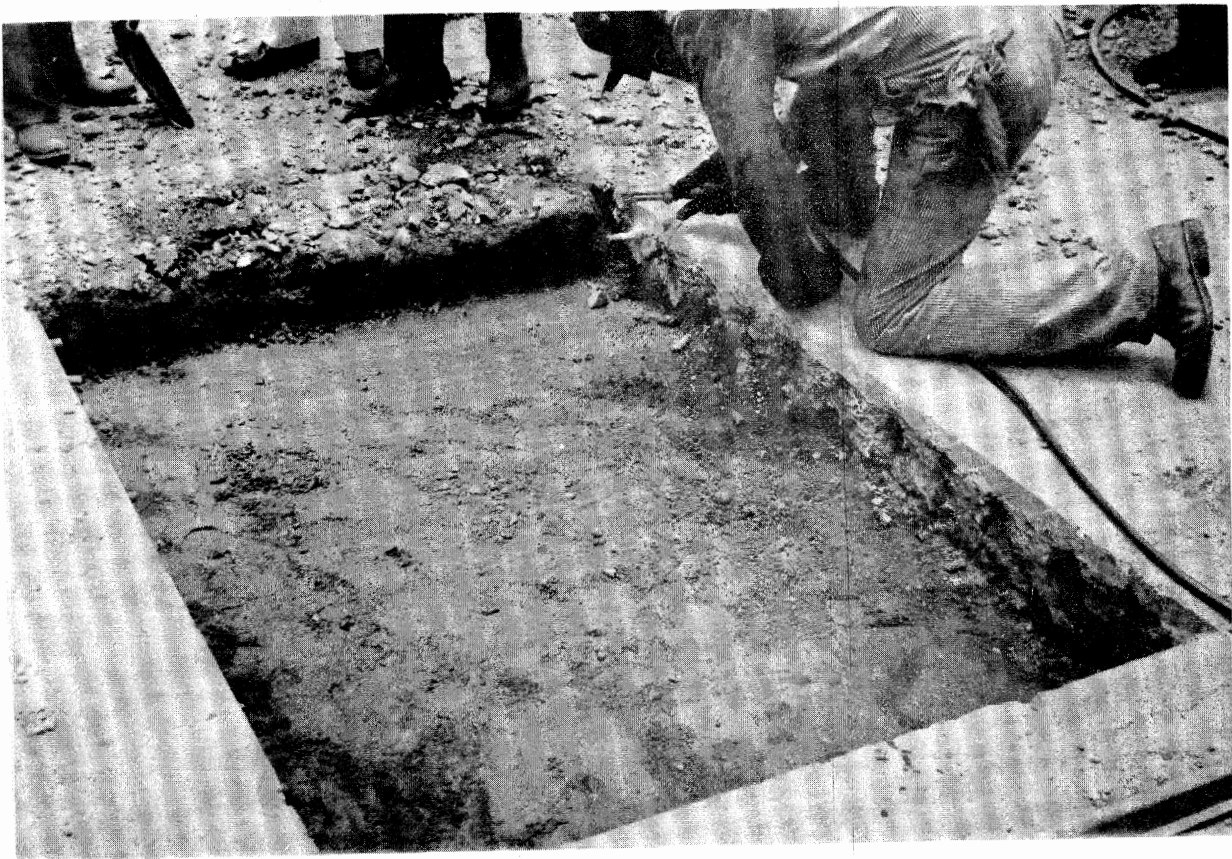
Figure 30. Preparing hole for precast patch.

with CRCP is more difficult due to the absence of joints and the need to retain continuity of the steel. However, the advantage of being able to complete a repair within one day makes precast patching an attractive possible alternative for CRCP repair. Such patches have been placed experimentally by the State of Mississippi. More time will be required to fully develop and evaluate this method of repair. The monetary saving for this type of patch is not expected to be great when compared with conventional patching methods. However, full development and utilization of this technique should permit much more rapid repairs. Figures 30 through 37 demonstrate some of the operations involved and the appearance of the finished patch. In this case, no attempt was made to maintain the continuity of the steel.

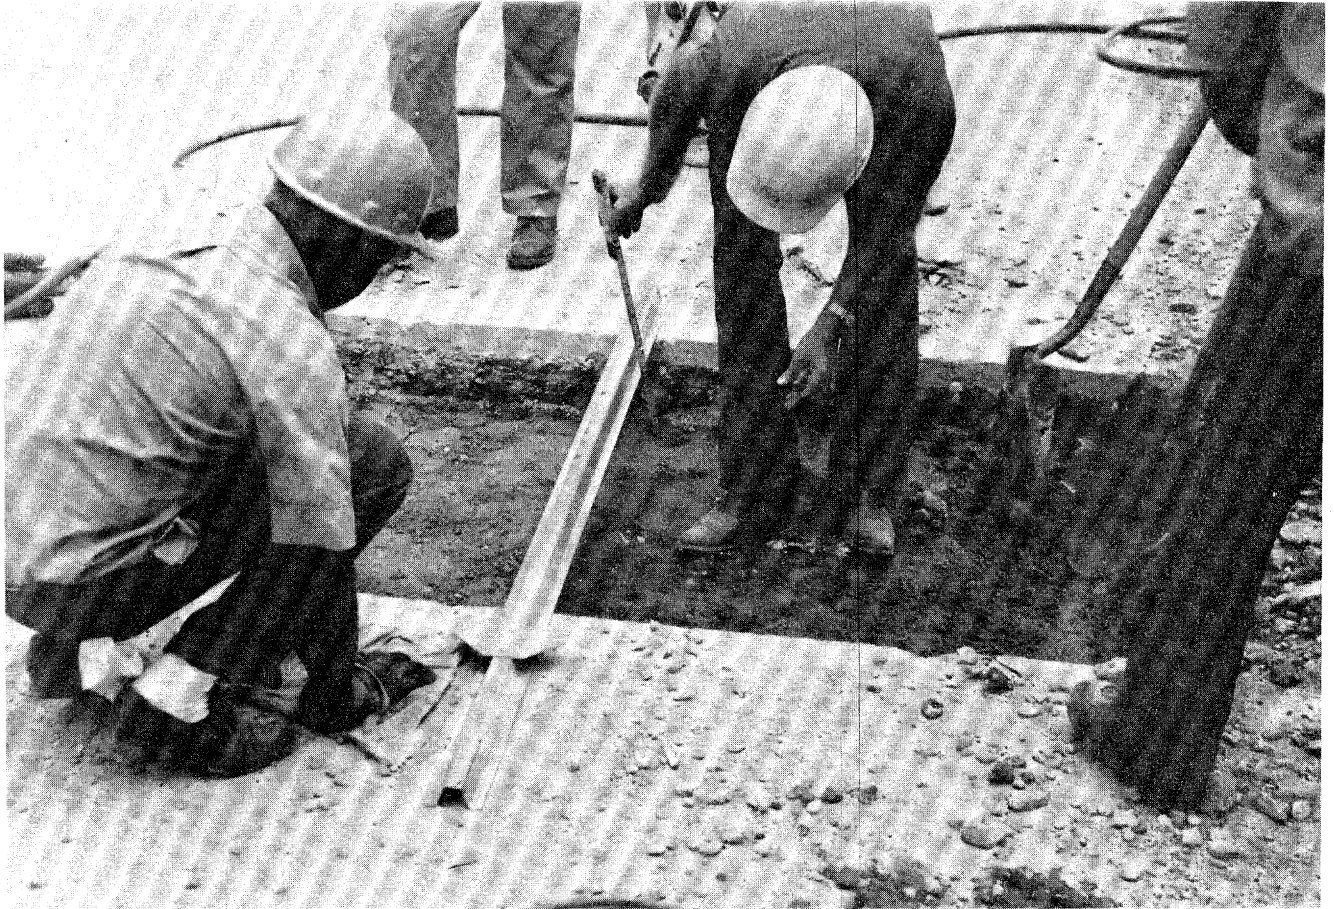
Figure 31. Checking for proper depth.

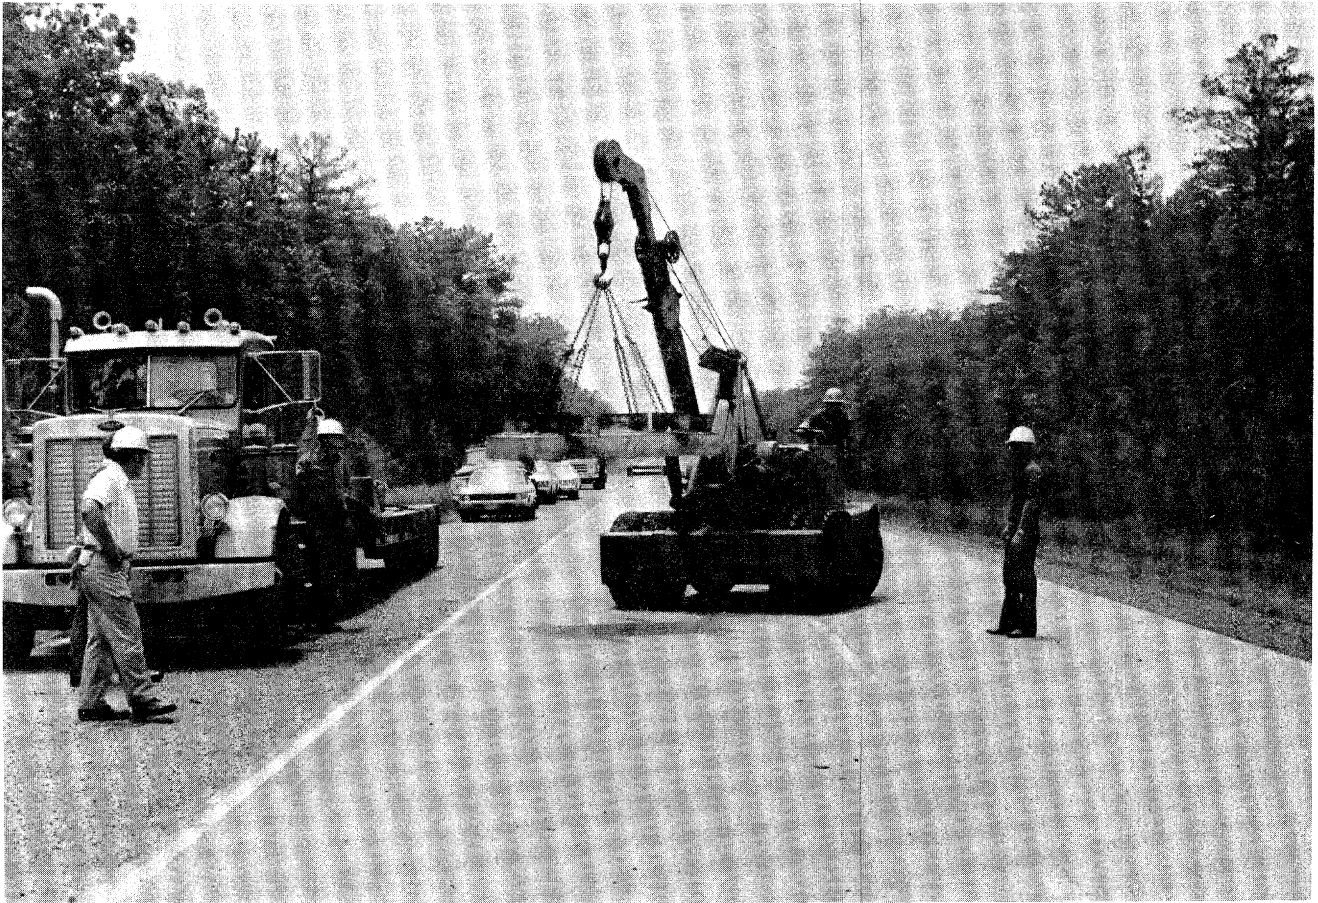
Figure 33. Taking the precast slab from truck to the hole.

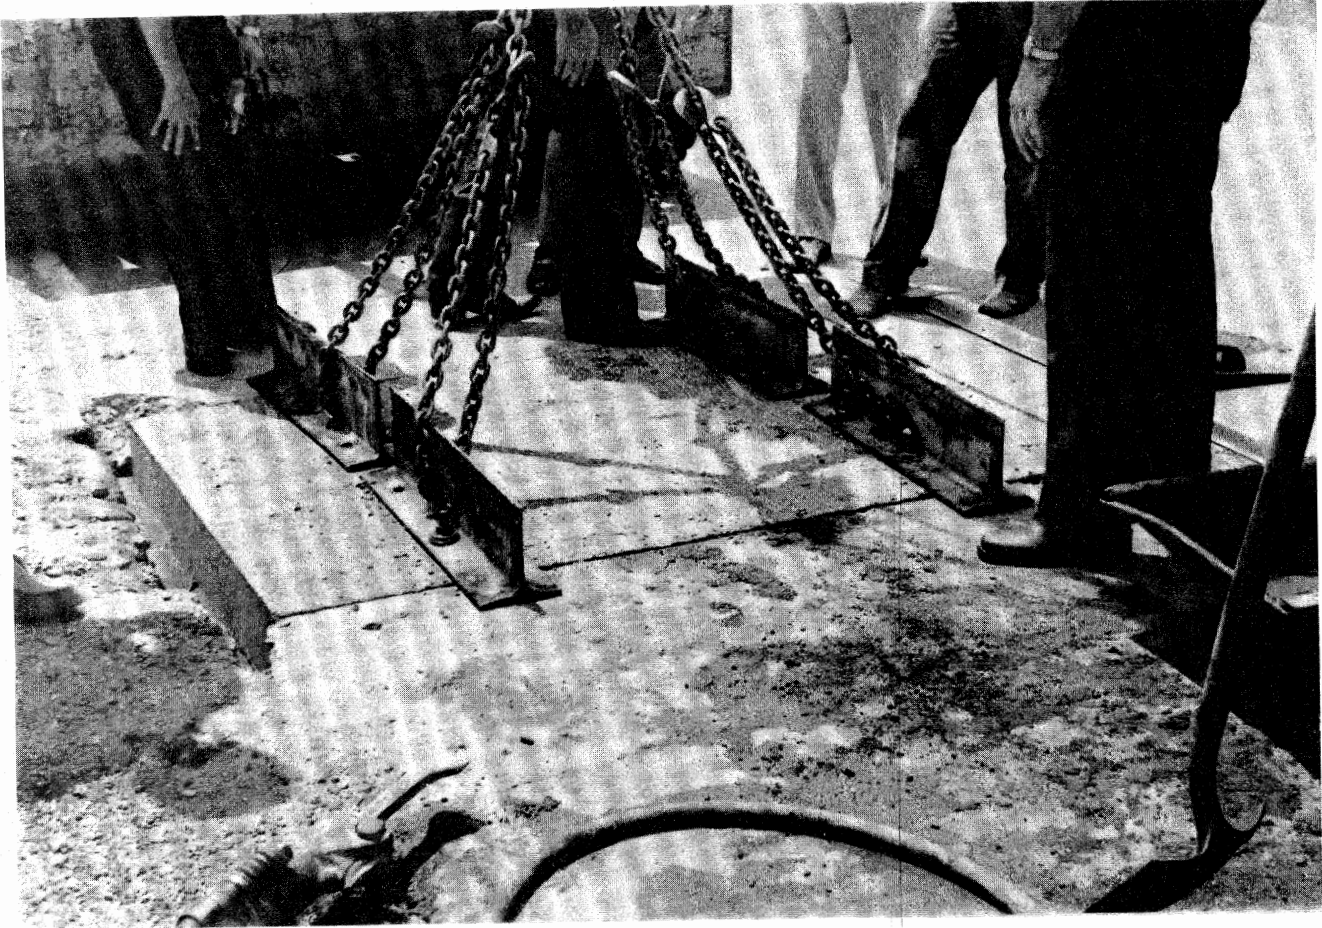
Figure 35. The slab in place.

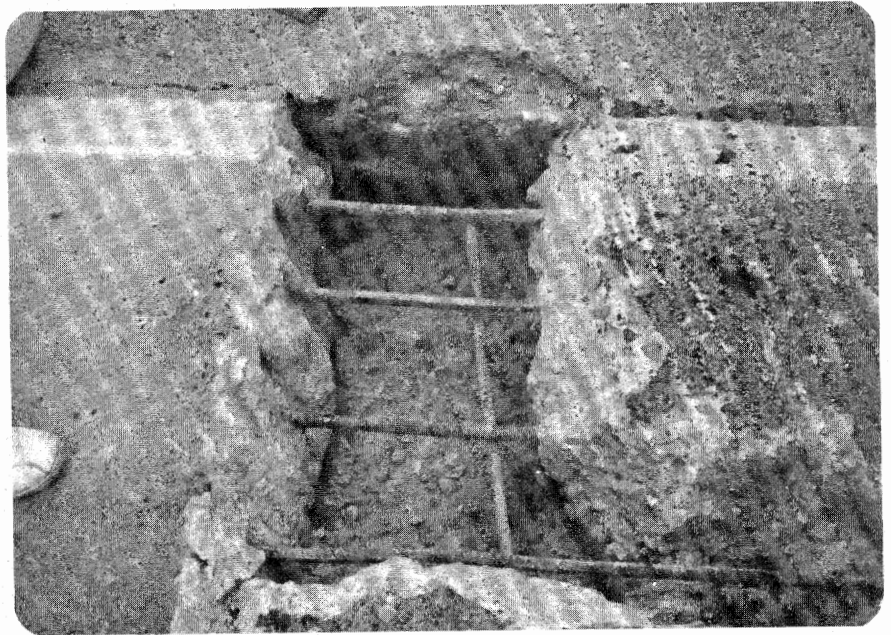
Figure 38. Hole prepared for polymer patch.

12. Polymer Concrete Patch. Polymer concrete offers the possibility of fast setting with higher strength and better bonding than normal concrete. Research in Texas has demonstrated the practicality of the use of polymer concrete for bridge deck repair. Experimental patches have also been made on CRCP. The high cost of this material combined with the specialized equipment and knowledge required for handling precludes it from being readily adopted for CRCP repair. Experimentation and further development and evaluation of this technique is being pursued in Texas. Figures 38 through 44 show the installation and results of polymer patching.

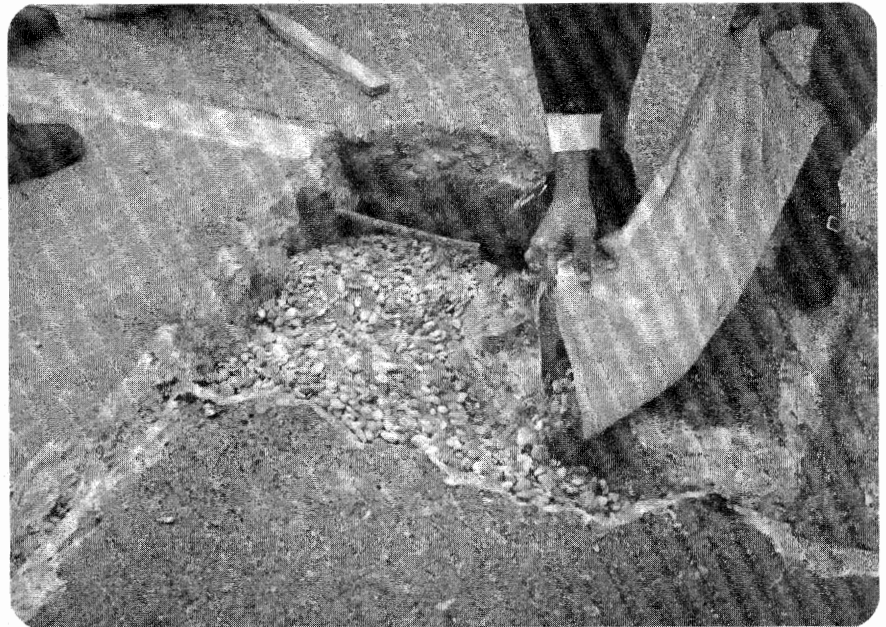
Figure 39. Placing coarse aggregate in the hole.

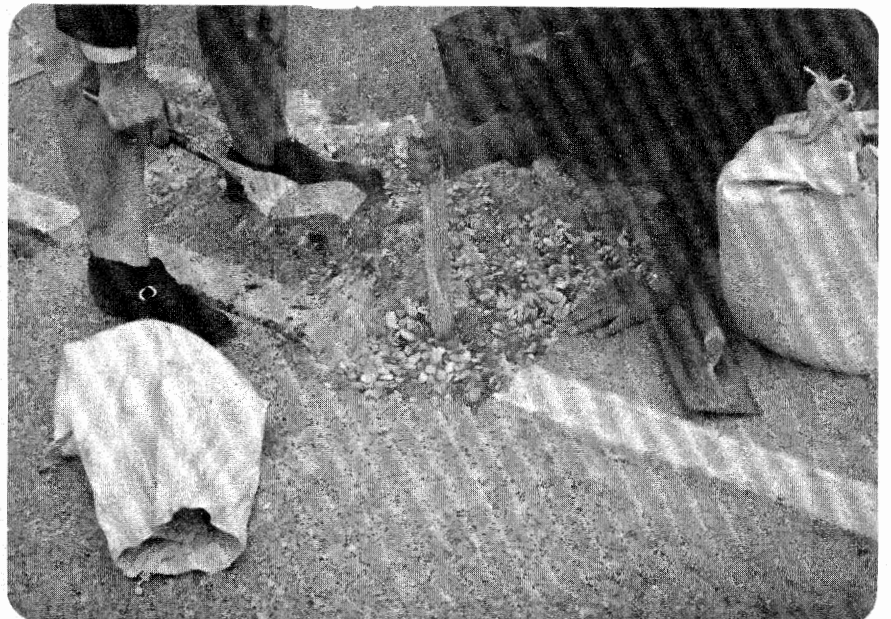
Figure 40. Placing fine aggregate.

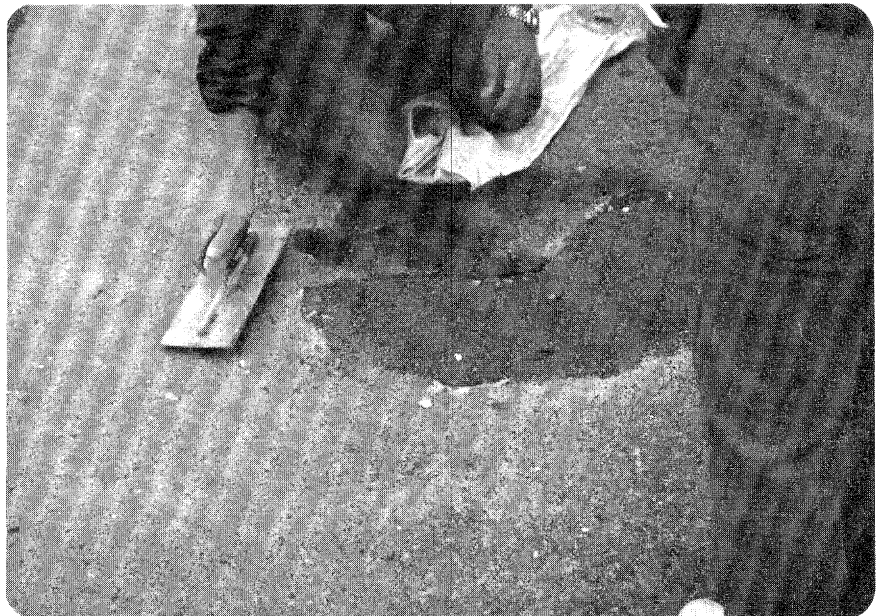
Figure 43. Finishing a polymer patch.
