**Data Report for the Scoping Study on Metal Contaminant  
Levels in Sediment and Concurrent Aquatic Habitat  
Evaluation for the Palmerton Zinc Natural Resource Damage  
Assessment, Palmerton, Pennsylvania**

**The Palmerton Natural Resource Trustee Council**

**January 30, 2007**

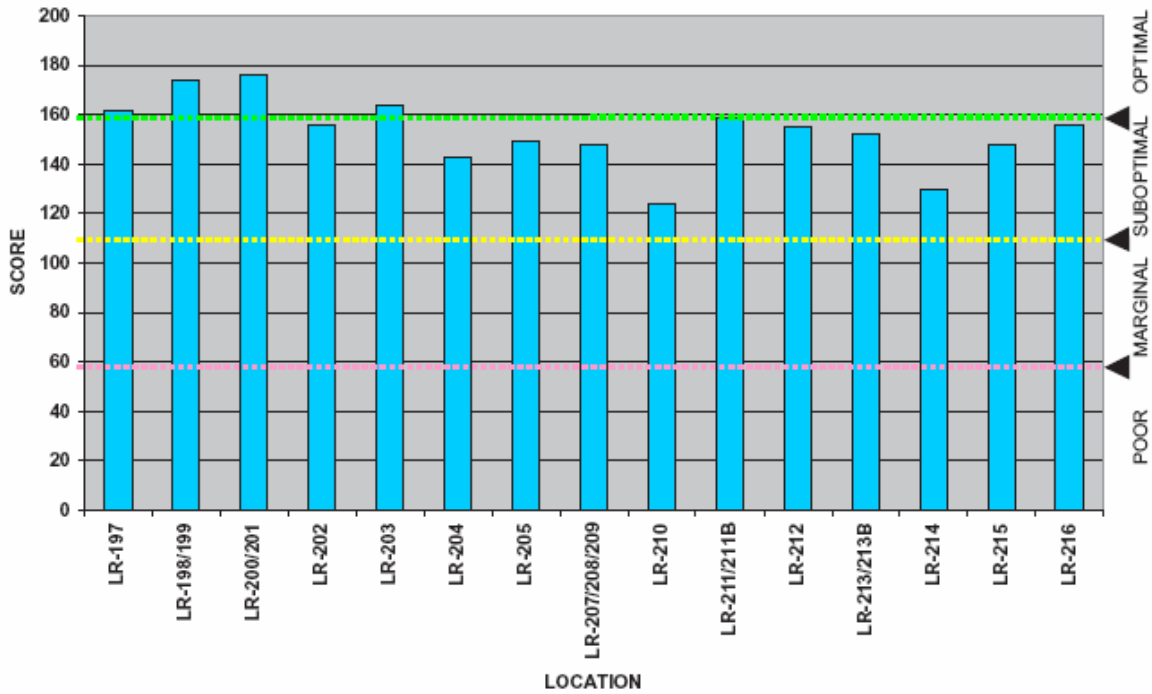
Figure 2. Lehigh River Rapid Bioassessment Protocol Habitat Scores, October 2004.

Habitat scores are summarized in Table 2 and Figure 2 for the Lehigh River and Table 3 and Figure 3 for Aquashicola Creek, Mill Creek and Buckwha Creek. Habitat scores in the Lehigh River reaches ranged from suboptimal to low optimal (Figure 2), which indicates good habitat. Scores in the Bowmanstown to Palmerton area were slightly lower than up- or downstream, but differences were minimal. Scores in Aquashicola Creek and tributaries were primarily in the suboptimal range (Figure 3), which indicates good habitat. Notable exceptions occurred where marginal scores showed poorer habitat in a disrupted area at AC-185/186 between the Site Cinder Bank and Stony Ridge Materials Aggregate Sales and BC-194 on Buckwha Creek at a disturbed area downstream of the new bridge at Kunkletown.
