Palmerton Zinc Pile Superfund Site Natural Resource Damage Assessment Plan

The Palmerton Natural Resource Trustee Council

February 2006

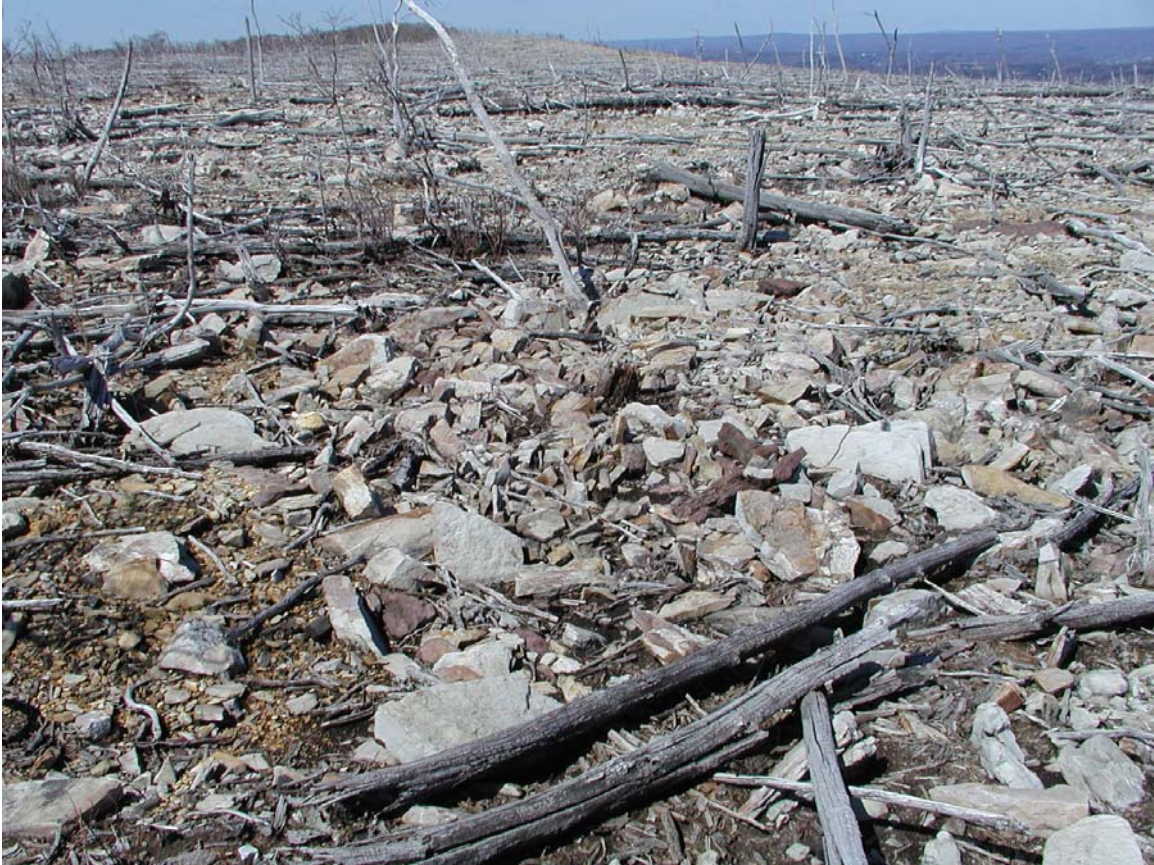
Exhibit 3-3 Denuded area on top of Blue Mountain

These data indicate that injury to vegetation in the assessment area has occurred (43 CFR Section 11.62 (f)(1)(i)).
