Ceramic vs. Polymer (Non-Ceramic) Insulators

March 2002
Andrew Phillips
EPRI

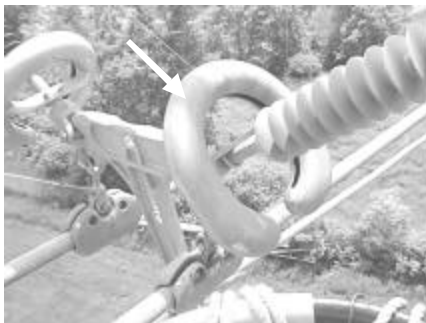
Energized End Grading Ring

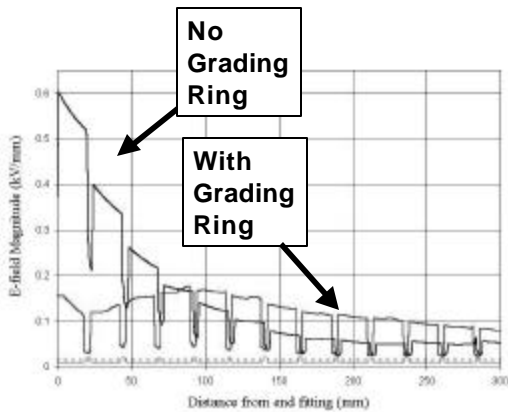
Grading Rings

- Reduce E-field magnitudes at live and ground end fittings

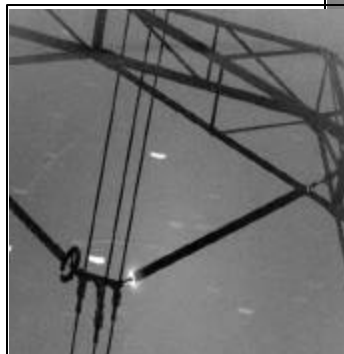
Why Grading Rings?

- Prevent corona under dry conditions
 - Radio interference, audio noise
- Prevent internal discharge
 - Voids & defects in rubber
- Reduce wetting corona activity
 - Ages rubber & end fitting seal

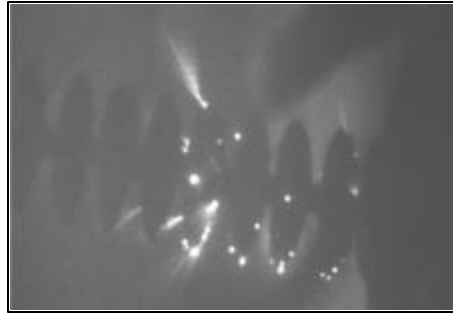
Wetting Corona Activity

- **Result of:**
 - Non-uniform wetting
 - High E-field
- **Occurs mainly at live and ground ends**
- **Lower hydrophobicity makes discharge activity more likely**

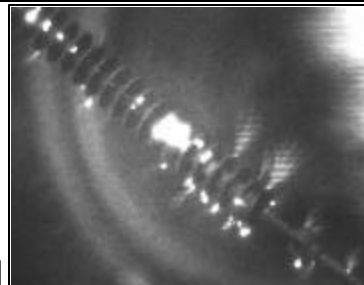
Wetting Corona Activity

- **Is a function of:**
 - Type & magnitude of wetting
 - Hydrophobic/hydrophilic
 - Rain/mist/fog/condensation
 - Magnitude of surface E-field
 - Grading ring dimension and position
 - End fitting design
 - Configuration and live end hardware

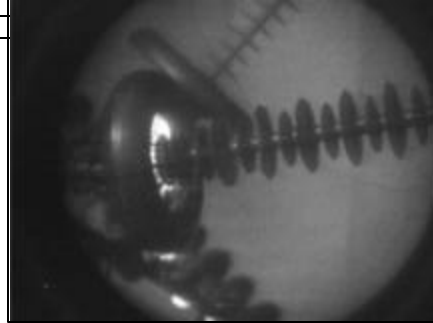
Wetting Corona Aging Mechanism

- Corona generates
 - UV light
 - Heat
 - Gaseous by-products
 - O₃ (Ozone), NO₂

EPRI tests: Wetting on NCI lowers pH to 3.4 after 15 min. of wetting corona activity

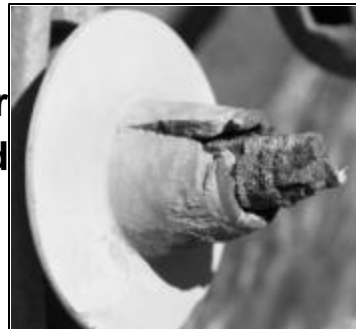
Water Reaches Rod

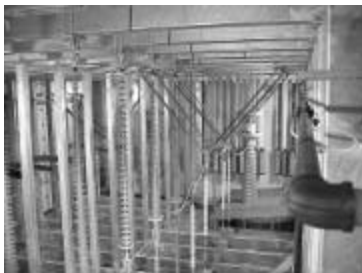
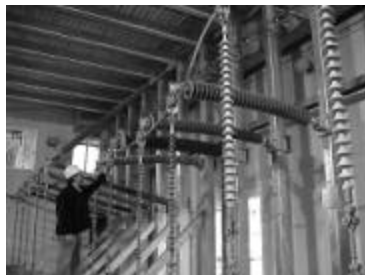
- **Aging of Polymer Insulators**
 - 500 kV Full Scale Aging Test
 - Report Prod ID# 100719
 - 230 kV Full Scale Aging Test
