# The 1972 Black Hills-Rapid City Flood Revisited

—by Janet M. Carter, Joyce E. Williamson, and Ralph W. Teller

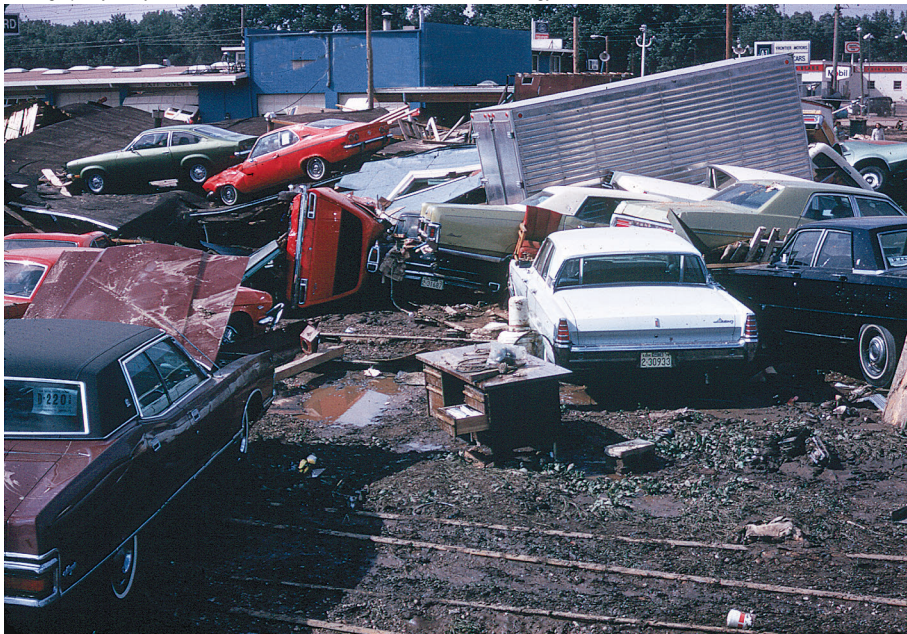
**Figure 1.** The 1972 flood destroyed 5,000 automobiles, including these cars that were parked at a dealership on East Boulevard.

On June 9-10, 1972, extremely heavy rains over the eastern Black Hills of South Dakota produced record floods on Rapid Creek and other streams in the area. Nearly 15 inches of rain fell in about 6 hours near Nemo, and more than 10 inches of rain fell over an area of 60 square miles (Schwartz and others, 1975). According to the Red Cross, the resulting floods left 238 people dead and 3,057 people injured. In addition to the human tragedy, total damage was estimated in excess of \$160 million (about \$664 million in 2002 dollars), which included 1,335 homes and 5,000 automobiles that were destroyed (Schwartz and others, 1975) (fig. 1).

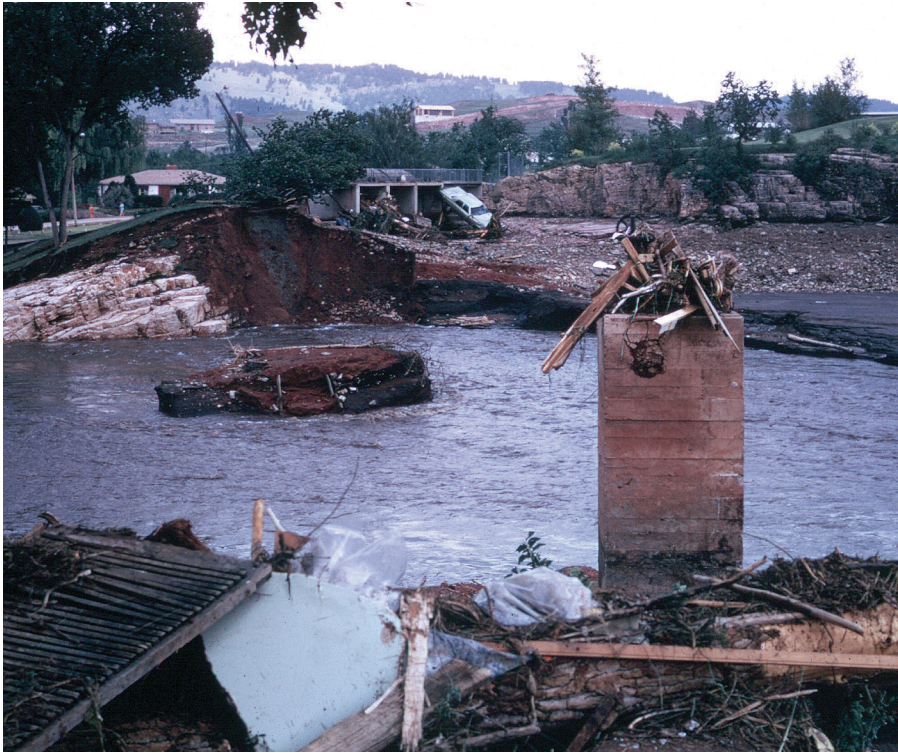
**Figure 3.** Photograph of the remains of the Canyon Lake Dam the morning after it failed. During the flood, the spillway of the dam clogged with floating debris. When the dam failed at about 10:45 p.m. on June 9, 1972, a surge of water was sent into urban Rapid City.

amounts of debris that clogged the spillway of the Canyon Lake Dam. The dam at Canyon Lake failed at about 10:45 p.m. However, the effect of this dam failure (fig. 3) on the subsequent flood wave into urban Rapid City has been difficult to assess because the amount of water coming down Rapid Creek and several tributaries (accounting for 86 percent of the peak flow) far overshadowed the amount of water in the small lake (Schwartz and others, 1975). The peak flow of 50,000 cubic feet per second ( $\text{ft}^3/\text{s}$ ) was carried through Rapid City via Rapid Creek at about midnight on June 9, while many people were asleep and unaware of the impending flood. The stage of Rapid Creek (measured above Canyon Lake) rose more than 13 feet in 5 hours during the flood.

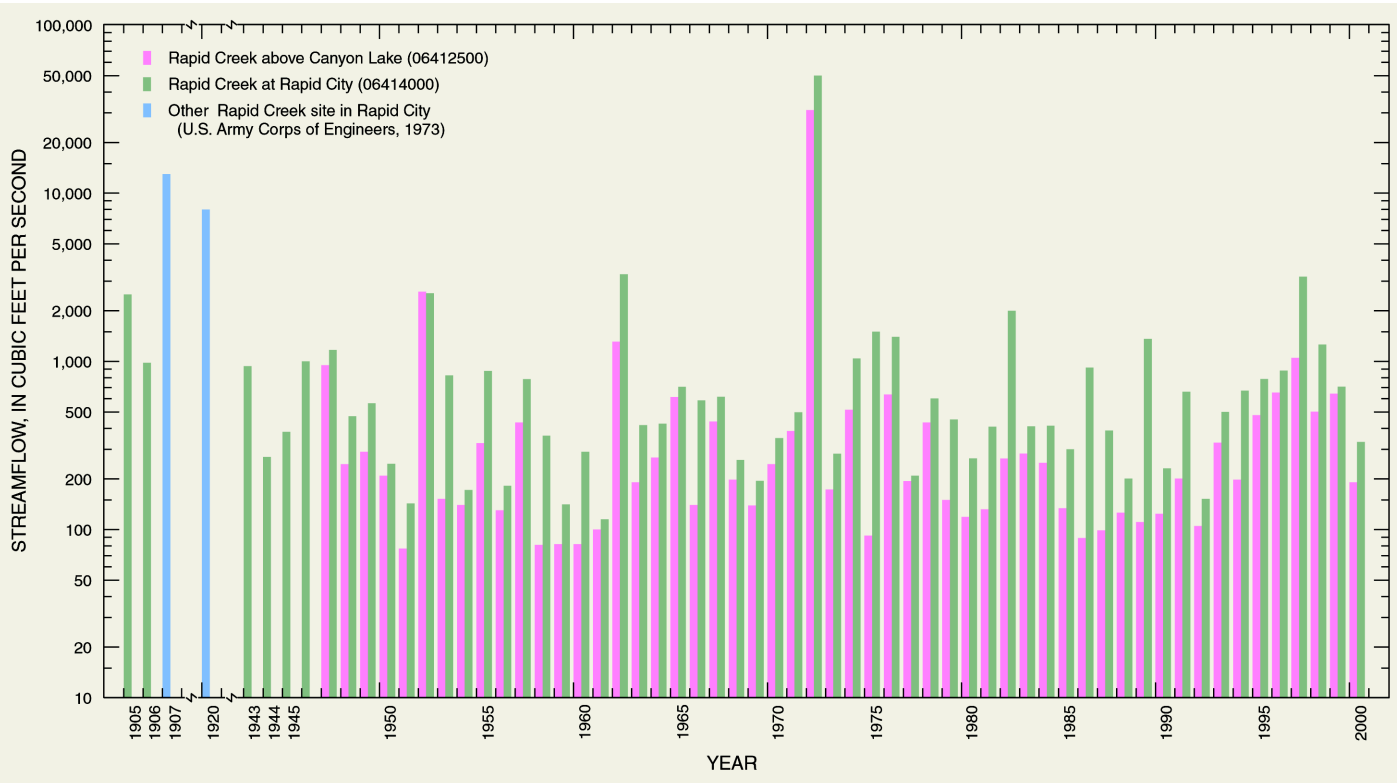
**Figure 4.** Annual maximum peak flows since 1900 for selected gaging stations on Rapid Creek.

Annual maximum peak flows recorded since 1900 for two gaging stations on Rapid Creek—above Canyon Lake and at Rapid City—are shown in figure 4. The second largest flood recorded along Rapid Creek occurred in May-June 1907 with an estimated peak flow of 13,000 ft<sup>3</sup>/s (U.S. Army Corps of Engineers, 1973). During the 1907 flood, Canyon Lake Dam was overtopped

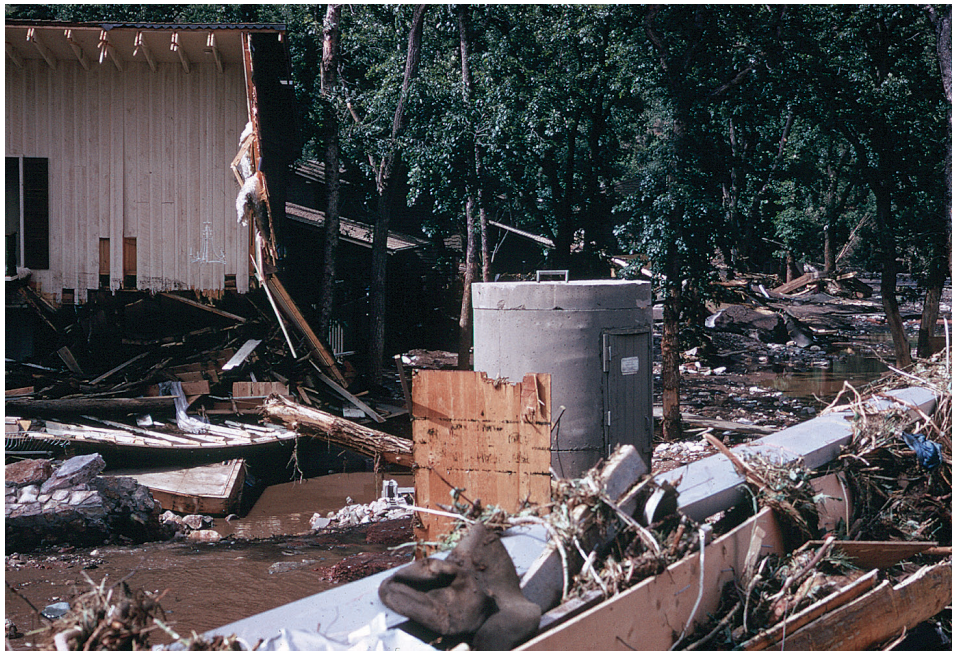
**Figure 5.** Photograph of U.S. Geological Survey streamflow-gaging station Rapid Creek above Canyon Lake near Rapid City (06412500) the day after the flood. A peak discharge of 31,200 cubic feet per second occurred at this site just before midnight on June 9, 1972. In the background are the remains of new houses that people were moving into the night of the flood.

A peak flow of 31,200 ft<sup>3</sup>/s occurred at the gaging station above Canyon Lake (fig. 5) during the 1972 flood and was 12 times the previous maximum of 2,600 ft<sup>3</sup>/s recorded in 1952. The peak flow of 50,000 ft<sup>3</sup>/s at the gaging station at Rapid City during the 1972 flood was more than four times the previous estimated maximum of 13,000 ft<sup>3</sup>/s during May-June 1907. The 1972 peak flow at this station was more than 15 times the previous recorded maximum (3,300 ft<sup>3</sup>/s on July 13, 1962) since construction of Pactola Dam in 1956.

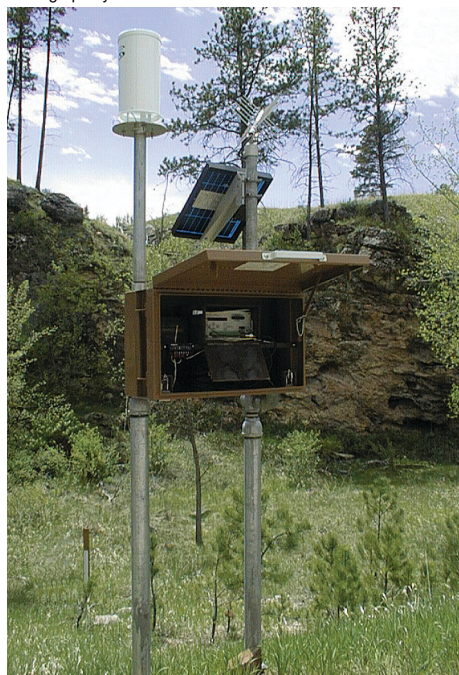
**Figure 6.** Photograph of a current flood-warning system gaging station. Real-time data from the gaging station are relayed via a satellite network to the National Weather Service and Rapid City-Pennington County Emergency Management.

In 1997, a flood-warning system was implemented by the USGS in cooperation with the Rapid City-Pennington County Emergency Management and National Weather Service (NWS) (Teller and others, 2000). Combination precipitation/streamflow-gaging stations (fig. 6) monitor rainfall and subsequent rises in stream stage on a continuous basis

during the flood season (April-October). This real-time information is relayed via a satellite network to the NWS, where forecasters can send warning to the public when streams rise to threatening levels. Rapid City-Pennington County Emergency
