National Transportation Safety Board

Safety Recommendation

In reply refer to: H-06-13

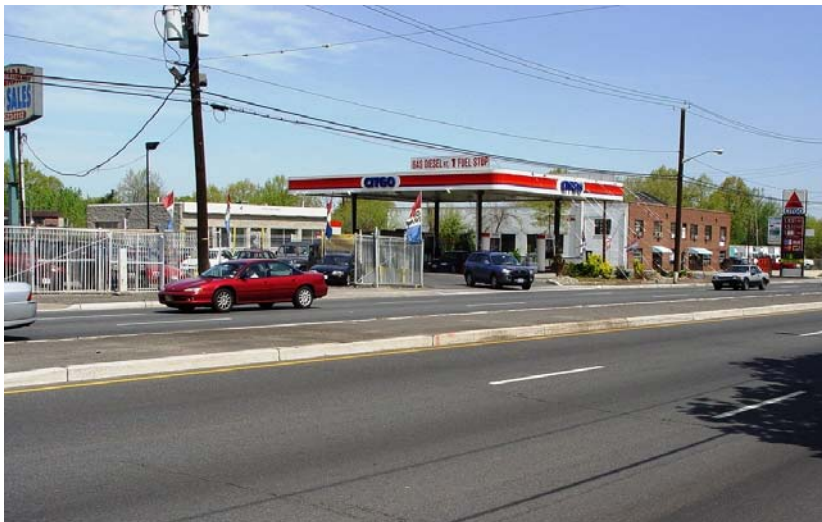
The accident occurred on U.S. 1 near MP 41.4 in the city of Linden, Union County, New Jersey. This section of U.S. 1 is a divided, two-way, six-lane asphalt-paved roadway (three lanes designated for northbound traffic and three lanes designated for southbound traffic), extending in a northeast/southwest direction. Slightly north of the accident site, the southbound lanes transitioned from four lanes to three. The northbound and southbound lanes are divided by an 11.5-foot-wide raised median with 6-inch-high Portland cement concrete curbing. (See photograph that follows.)

Raised curbed median near accident location.

The Safety Board concludes that a raised curb median, such as the one on U.S. 1 in the vicinity of the accident, is not sufficient to prevent crossover median accidents and can cause a vehicle to become out of control or airborne at the speeds at which vehicles travel on that segment of roadway. The Safety Board further concludes that had a median barrier been present at the accident site, the Mercedes probably would not have crossed from the southbound lanes into the northbound lanes and collided with the Ford.
