**Lessons Learned:
Incomplete FEL Lab Sweep
LL2007-TJNAF-0001**

Presented at the DOE Accelerator Safety
Workshop

August 7, 2007

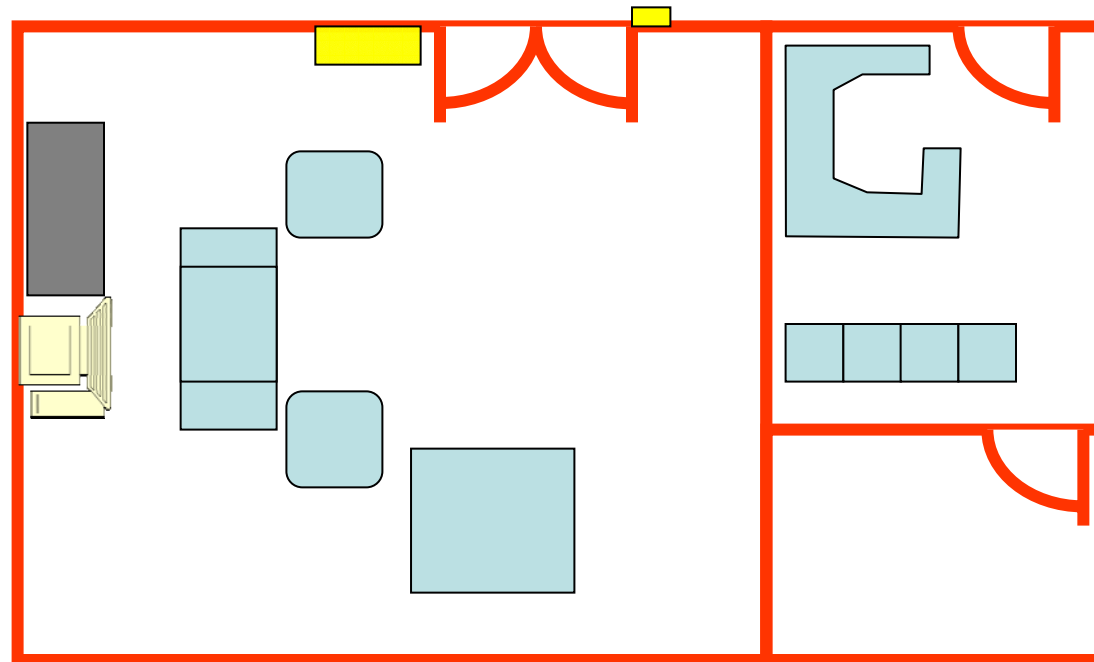
Lab 1 and Control Room

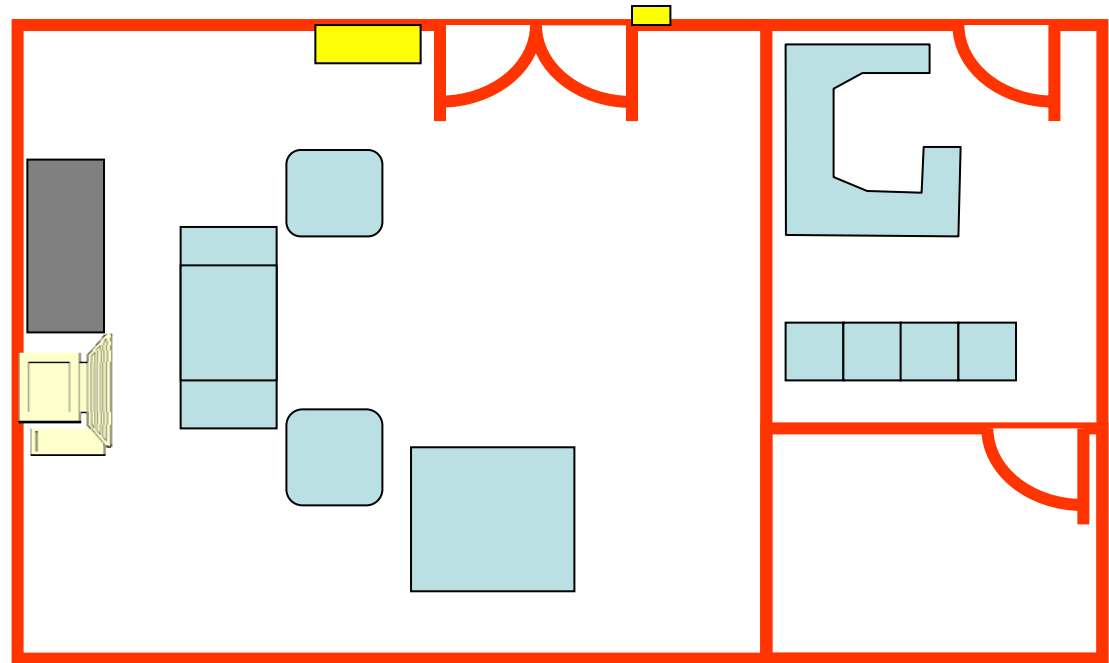
View from door

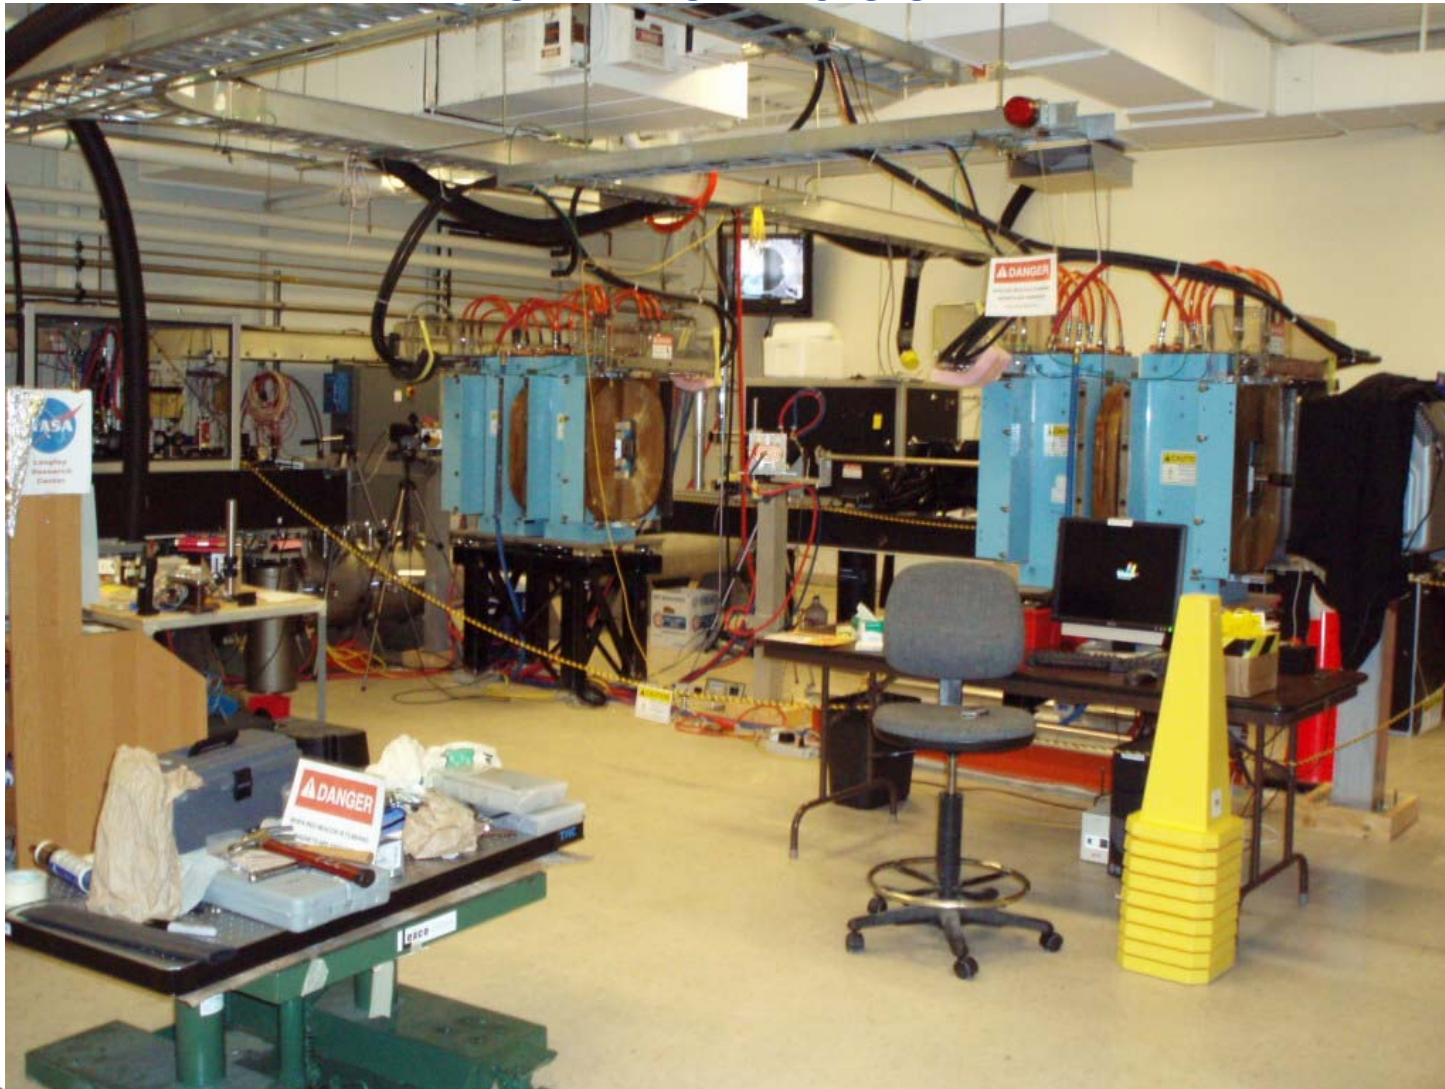
View from workspace

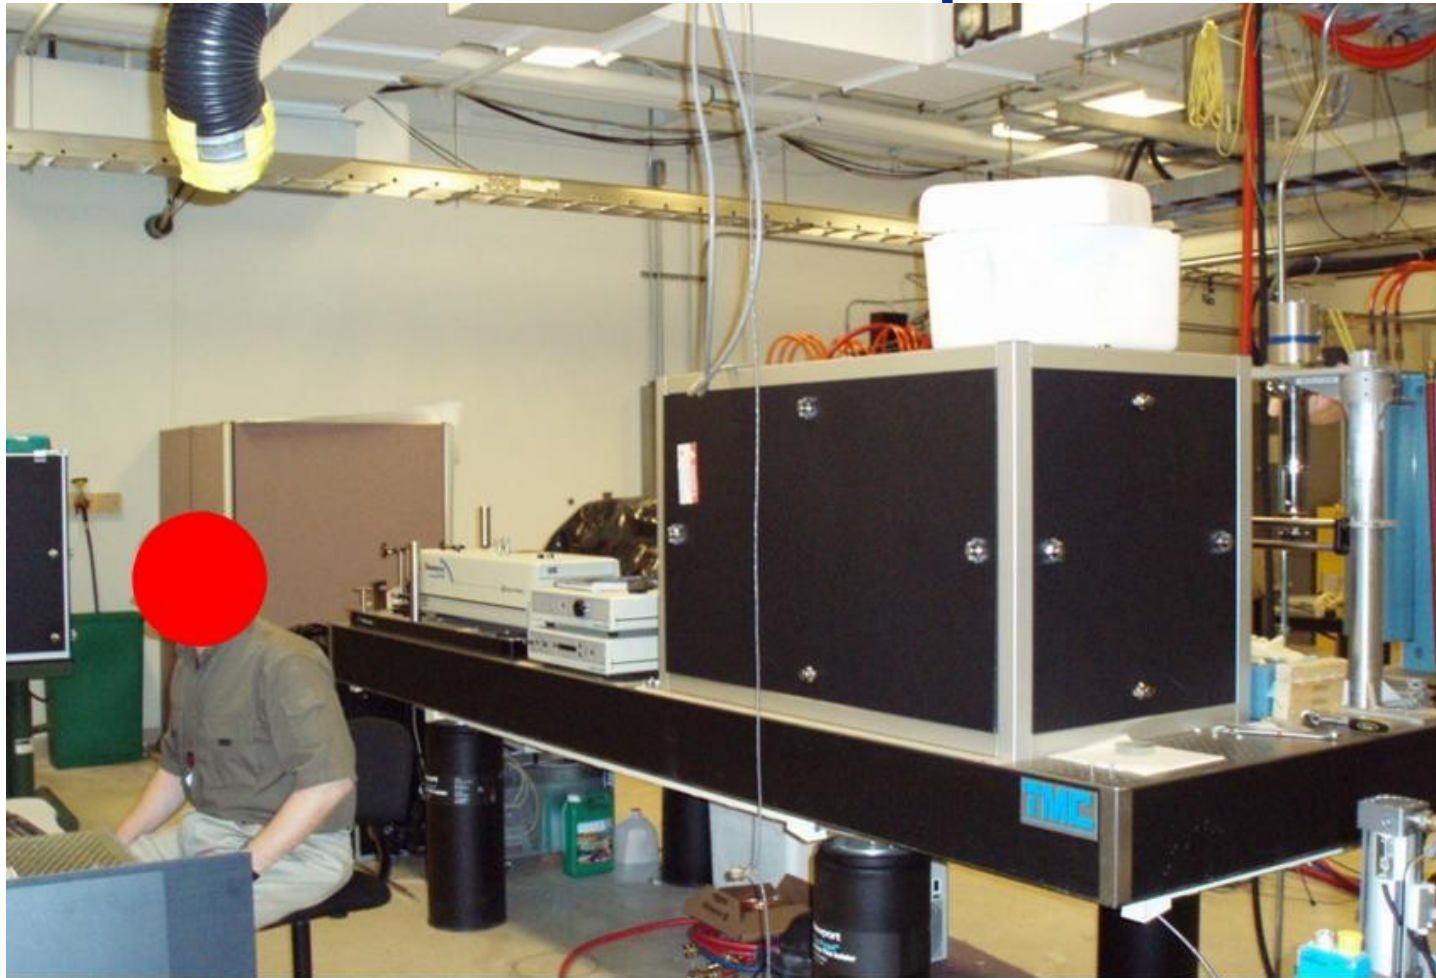
Position of user at computer workstation in Lab 1. This view is from the right-rear corner of the lab.
