# **Channel Stability and Water Quality of the Alagnak River, Southwestern Alaska**

**Water-Resources Investigations Report 02-4184**

**Prepared in cooperation with the  
NATIONAL PARK SERVICE**

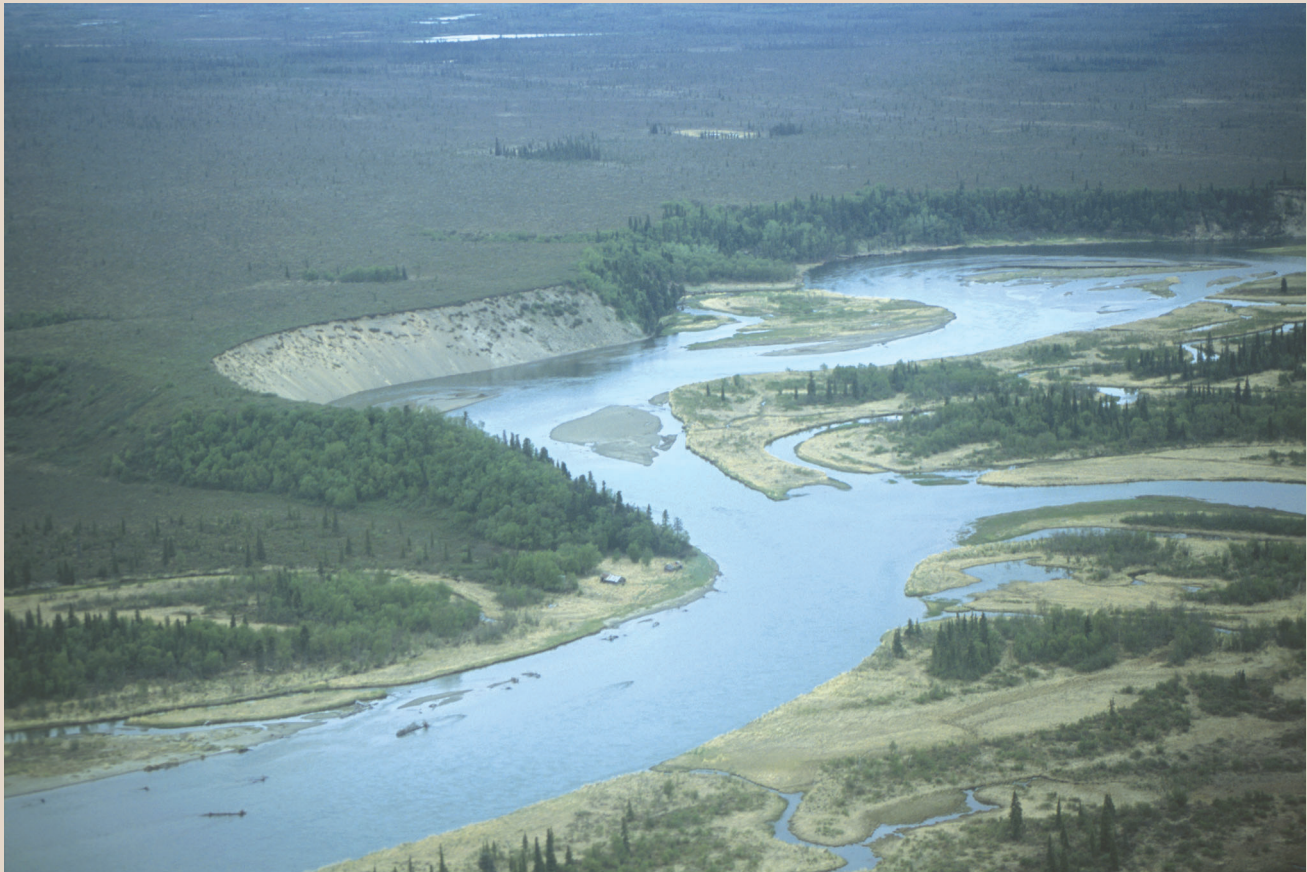
**Cover photograph:**

Agnes Estrada's historic cabins at river kilometer 51 stand just downstream of the Alagnak River's most extensive actively eroding bank and the location of the most substantial channel changes in the past 50 years (oblique aerial photograph by Janet H. Curran, U.S. Geological Survey, June 4, 2001).

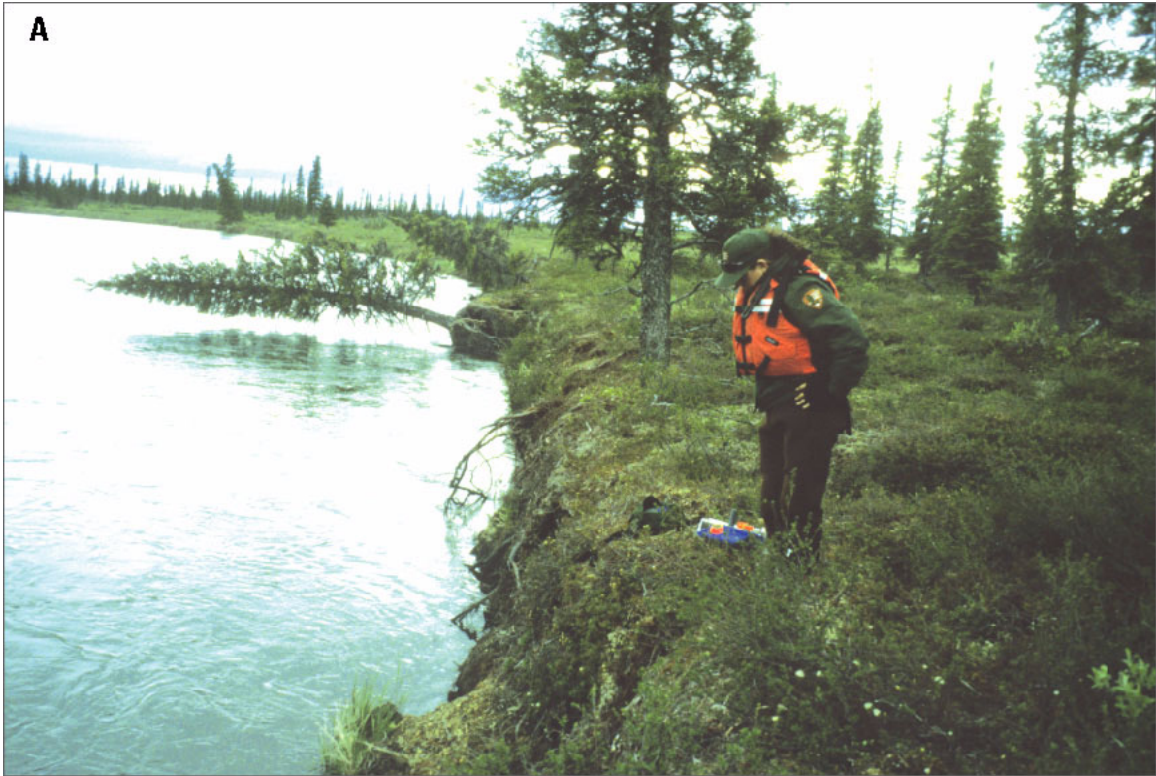
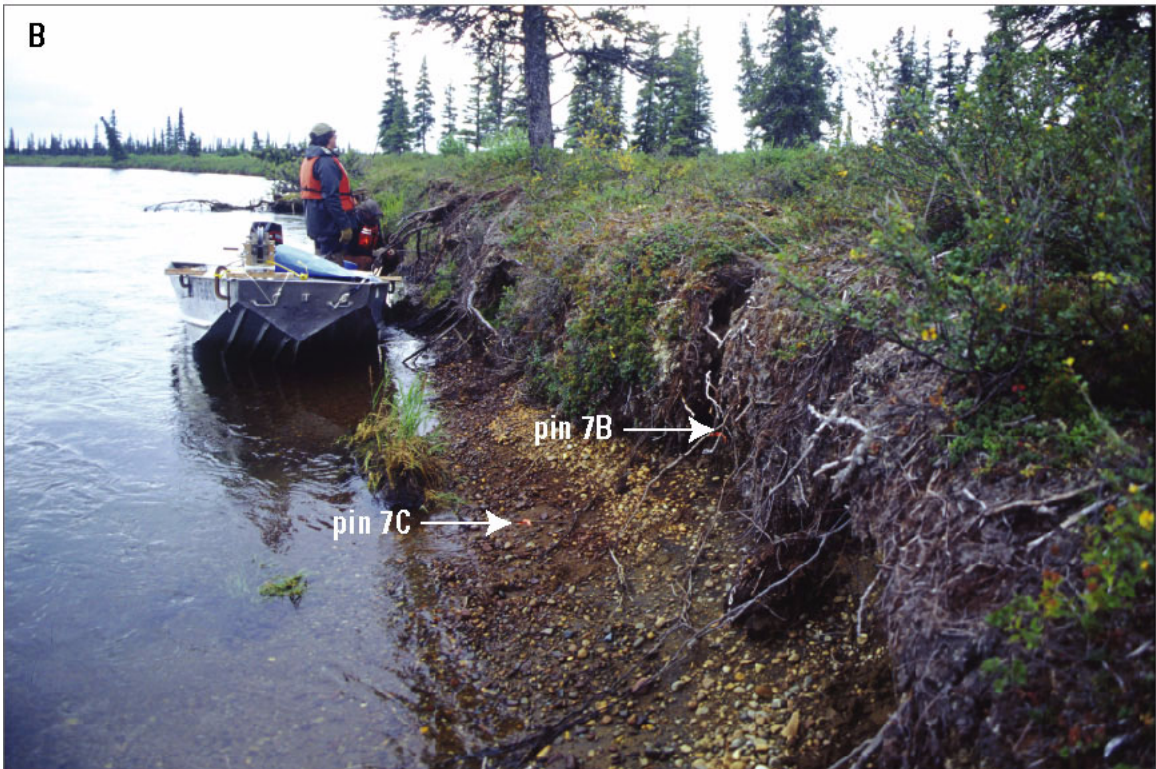
**Figure 6.** Vegetation mat draped over bank at erosion monitoring site 7 on the Alagnak River.  
(A) High stage. Person is standing in line with erosion pins. Photograph by author, June 12, 2000.  
(B) Low stage. Leaning tree visible in (A) has fallen into river and is collecting debris. Photograph by author, August 8, 2000.

Vegetation on terraces and other higher flood plain surfaces along the Alagnak River forms an interwoven mat that retains its integrity for weeks to years as it drapes over eroding banks. The strength of this root mat is typically sufficient to support trees in a leaning position (fig. 6) for several years, even as erosion removes the underlying bank. The mat is not attached to the bank face, such that the bank face is unvegetated. Eroding banks where a draped mat is not present are also unvegetated. High eroded banks with exposed faces revegetate once the bank toe is no longer subjected to active erosion.

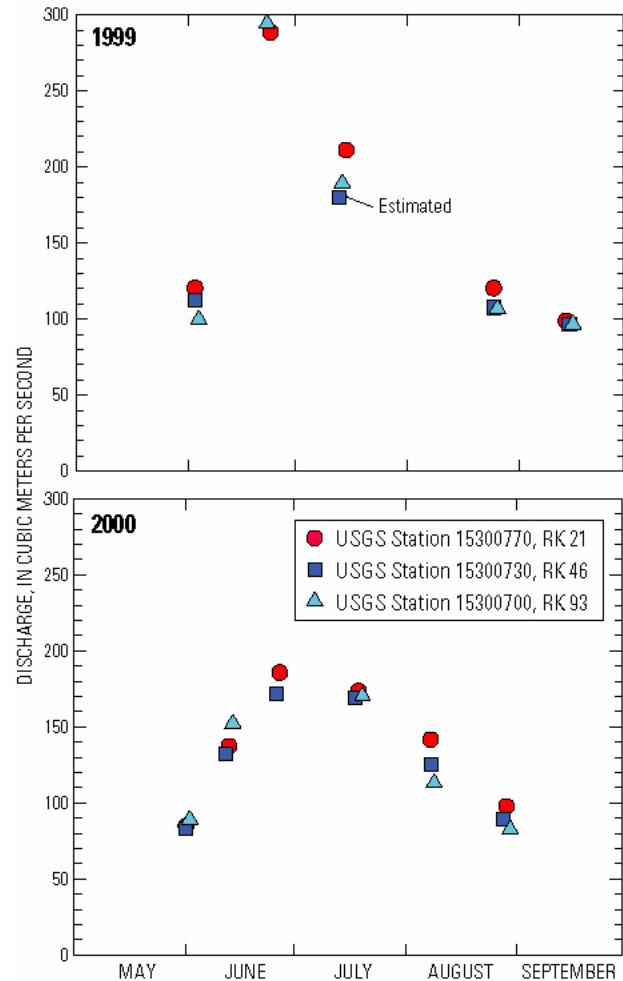
**Figure 8.** Measured discharge at Alagnak River river kilometer 21, 46, and 93 in 1999 and 2000.

Detailed comparisons of measured discharge between sites would require adjustment for river stage, which fluctuated by as much as 0.1 m over the 3-day periods of measurement. In addition, each discharge measurement is considered accurate to within 5 to 8 percent of actual discharge. In spite of these uncertainties, comparisons of the unadjusted measured discharge

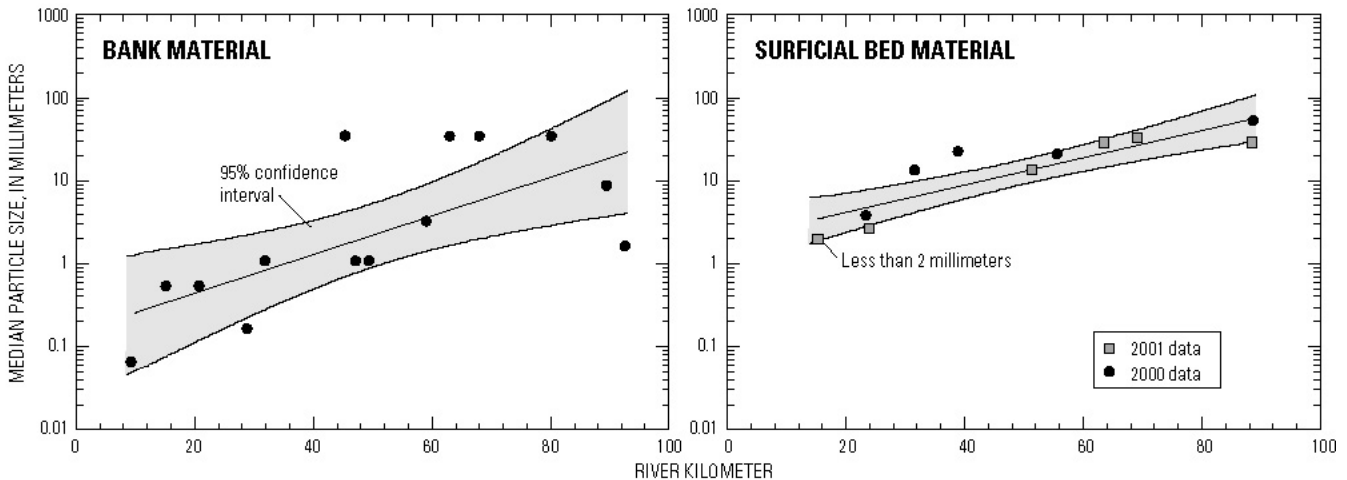
**Figure 10.** Downstream distribution of median particle size of bank material and surficial bed material in the Alagnak River. Regressions are significant at  $\alpha = 0.05$ .  $R^2$  is 0.49 for bank material and 0.68 for bed material.

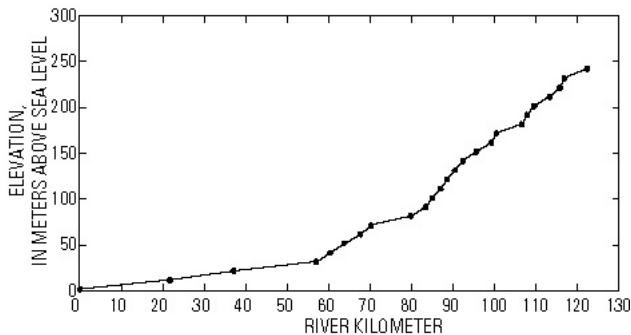
**Figure 12.** Longitudinal profile of the Alagnak River.

Meanders become more pronounced downstream from The Braids, corresponding roughly to a decrease in valley gradient (fig. 12). Downstream from RK 35, the

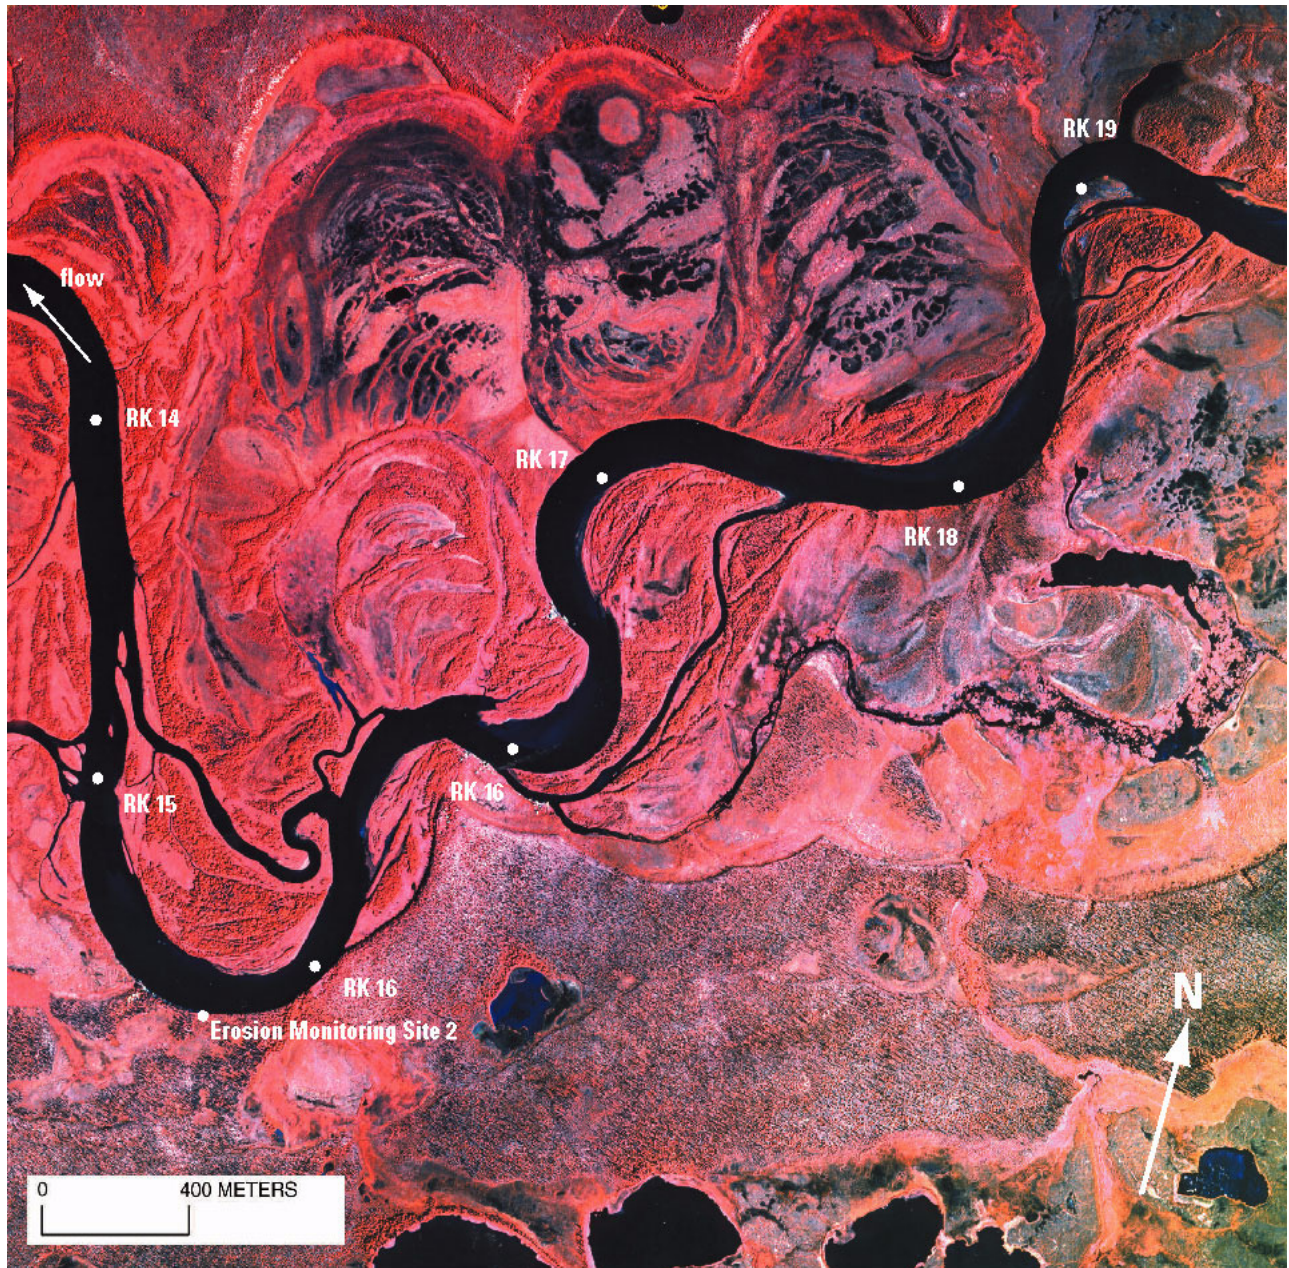
**Figure 13.** The Alagnak River from river kilometer 13.6 to 19.6. Aerial photography by Aeromap U.S. for the National Park Service, July 26, 2000.

Alagnak River is a single-thread meandering river having a few midchannel islands and the meander-cutoff scars, point bar-cutbank topography, and meander scrolls typical of a meandering river (fig. 13).

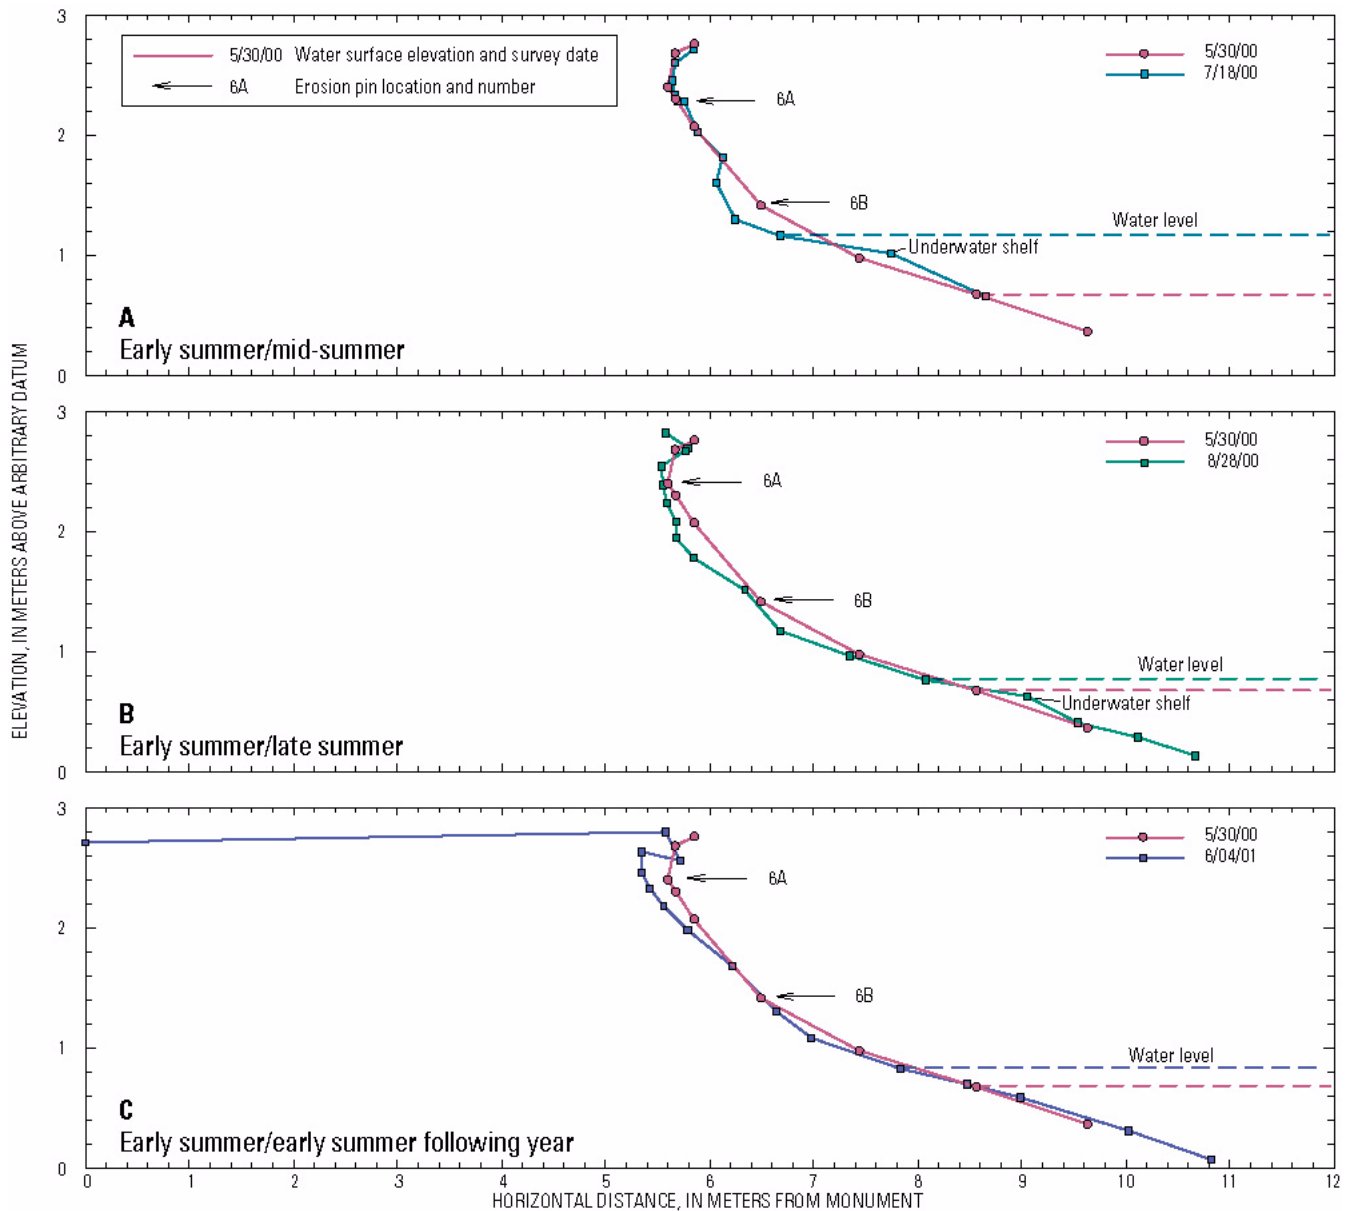
**Figure 20.** Bank profiles at erosion monitoring site 6 at river kilometer 45.9 on the Alagnak River, 2000–2001. Initial early summer conditions are plotted together with subsequent conditions in (A) mid-summer, (B) late summer, and (C) early summer the following year.

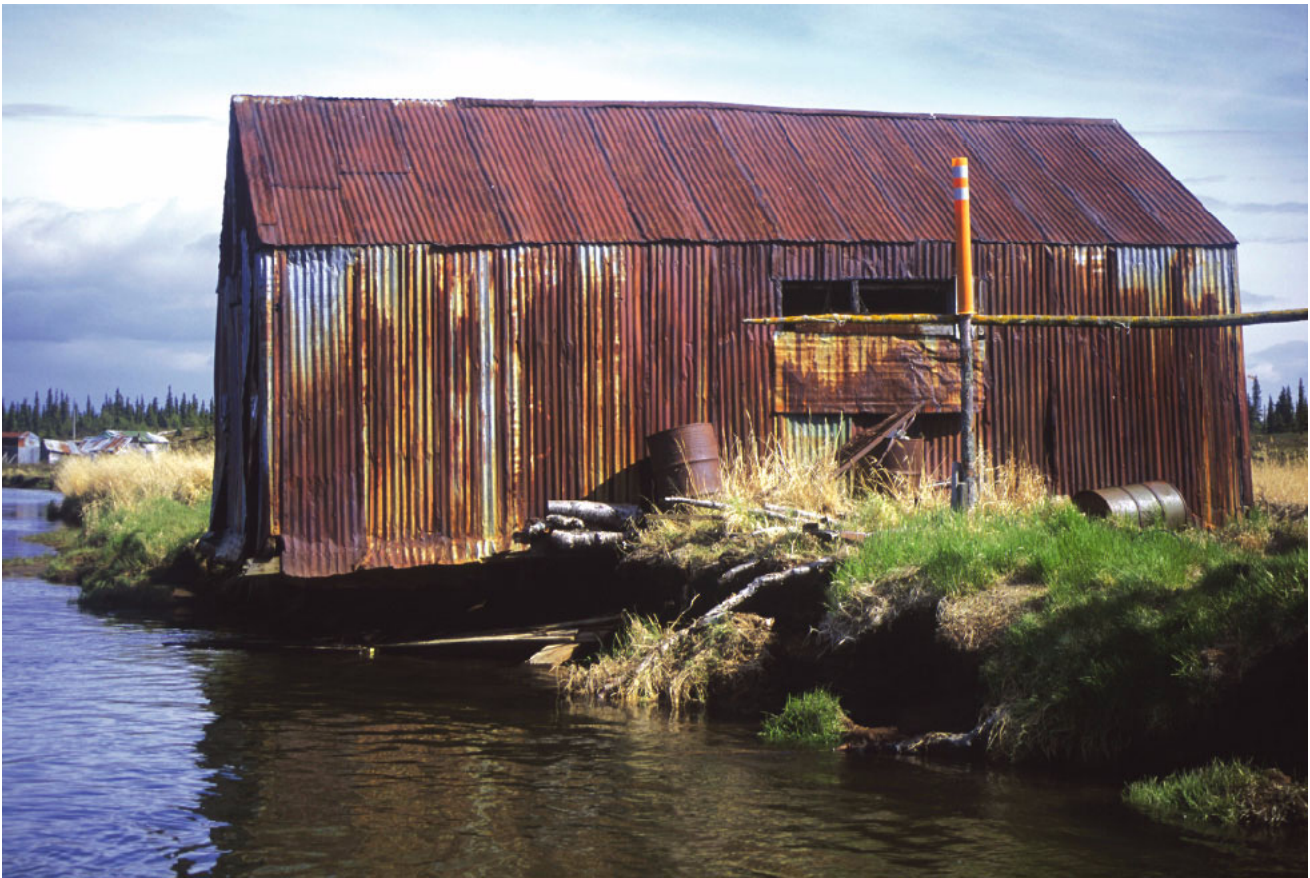
**Figure 21.** Bank erosion beneath bankside structure, Alagnak River river kilometer 17. Photograph by author, June 5, 2001.

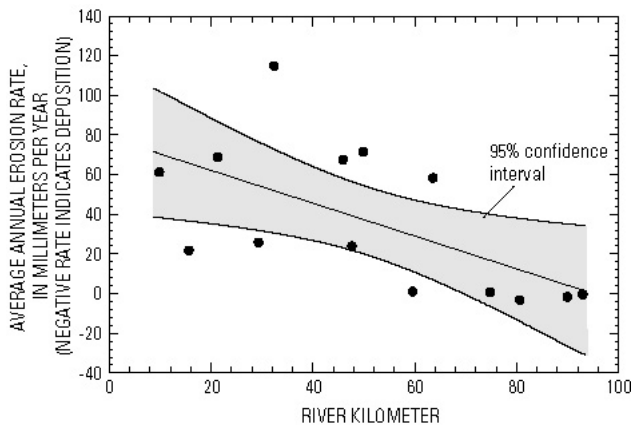
**Figure 22.** Downstream distribution of measured erosion rates along the Alagnak River. Regression is significant at  $p = 0.02$  with  $r^2 = 0.37$ . the erosion monitoring sites may reflect growth of moss and other vegetation over the pin, or soil creep.

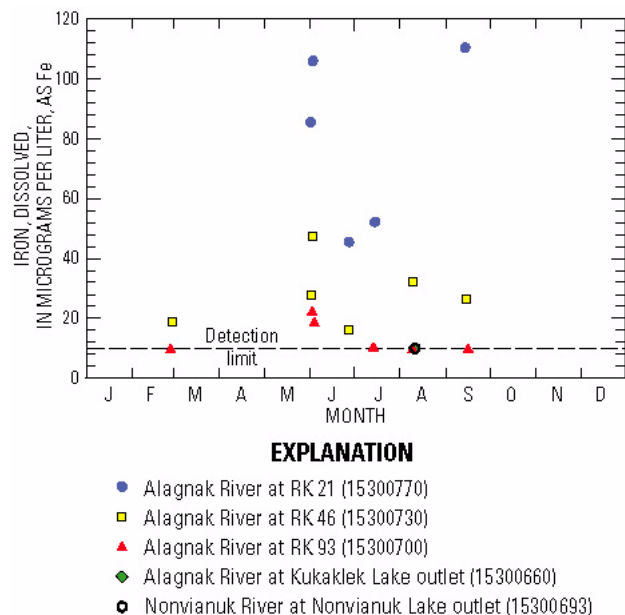
**Figure 26.** Dissolved iron concentrations in the Alagnak and Nonvianuk Rivers, 1999–2001

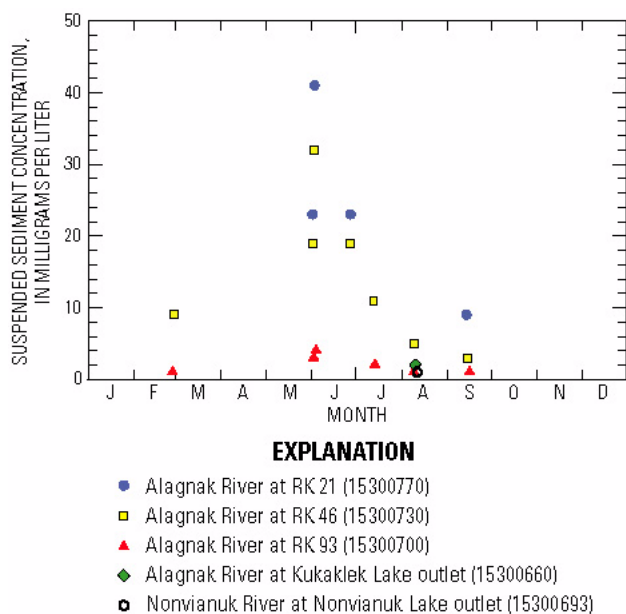
**Figure 27.** Suspended-sediment concentrations in the Alagnak and Nonvianuk Rivers, 1999–2001

Occasional, brief periods of high suspended-sediment concentration were observed at RK 51, where a sediment plume originating at actively eroding bluffs was visible from the air and at river level. A large section

of bank had failed shortly before the time this sediment plume was visible. Periodic pulses of high suspended-sediment concentrations that persist several hours also have been noted by Katmai Lodge staff (Tony Sarp, Katmai Lodge owner, oral commun., 2001).

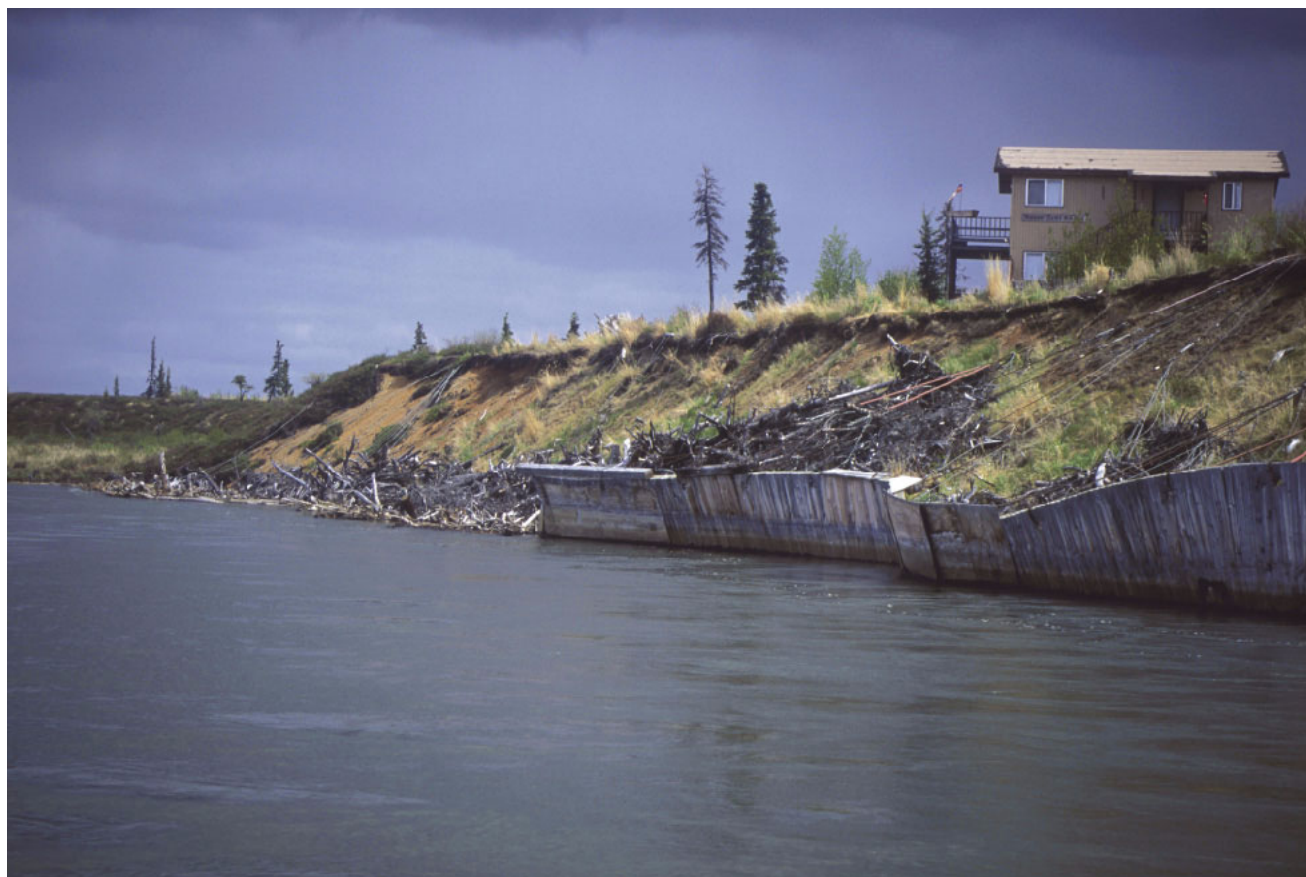
**Figure 28.** Trees and a revetment as erosion control, Alagnak River river kilometer 38. Photograph by author, June 7, 2001.

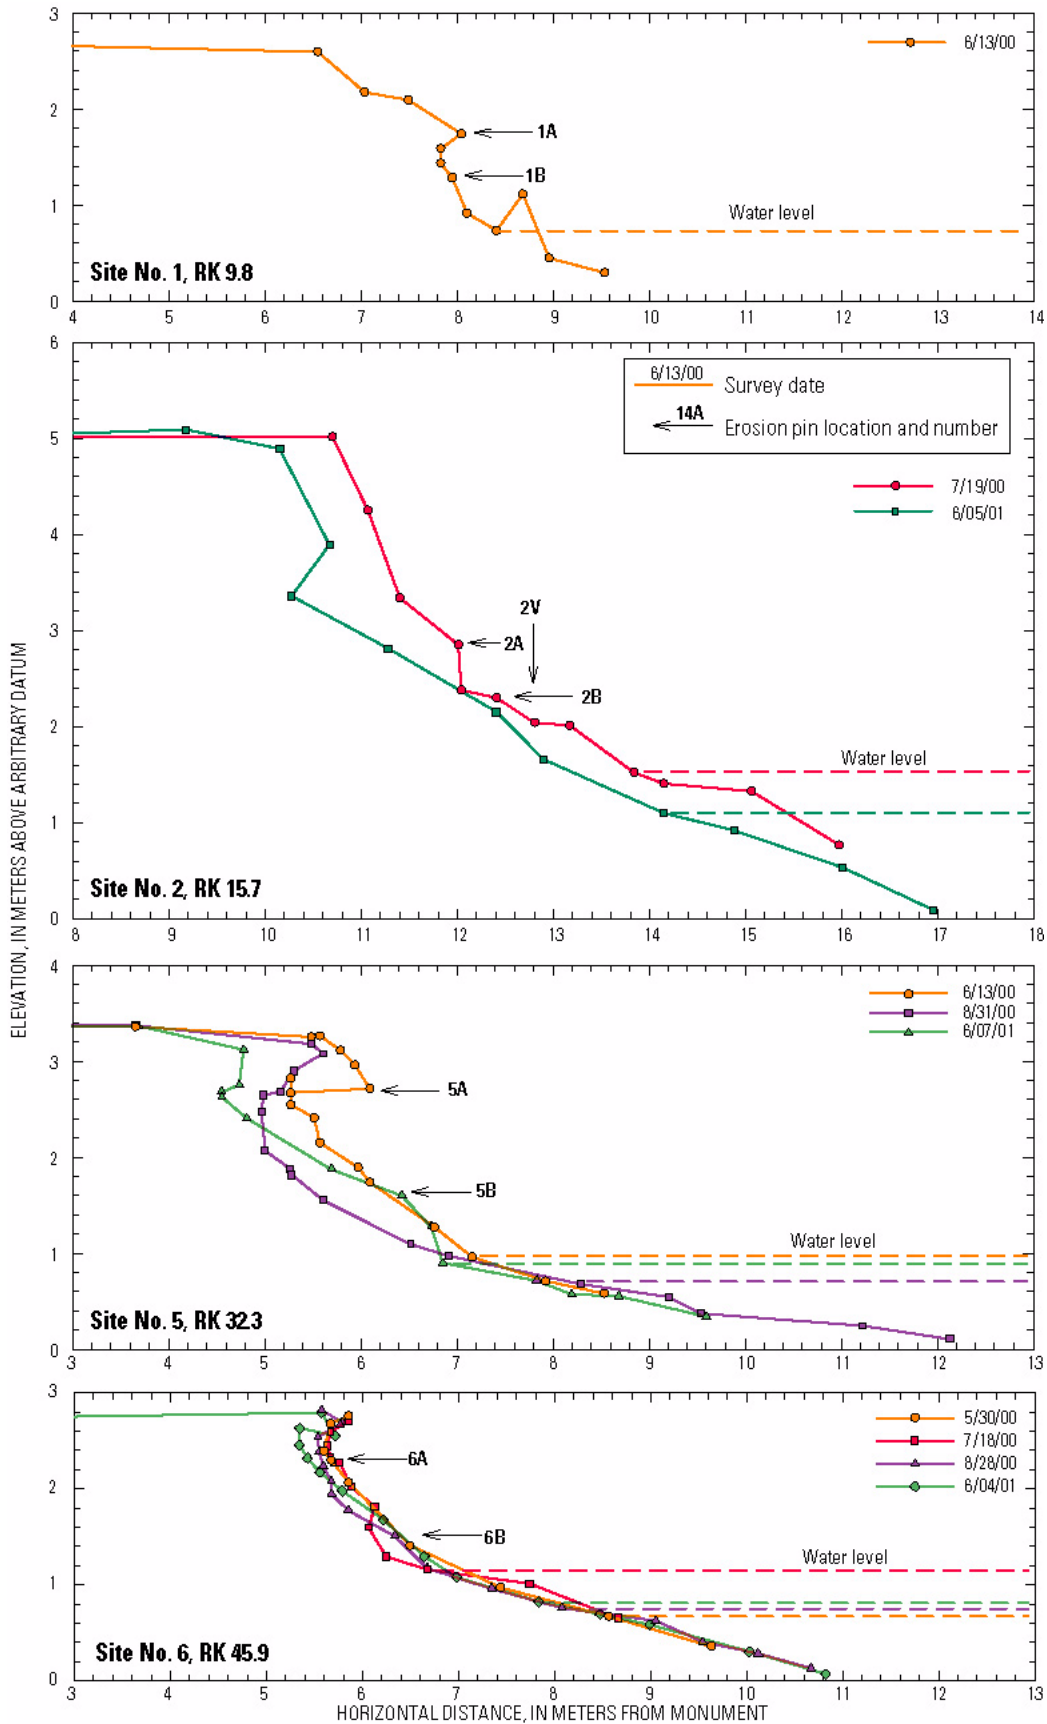
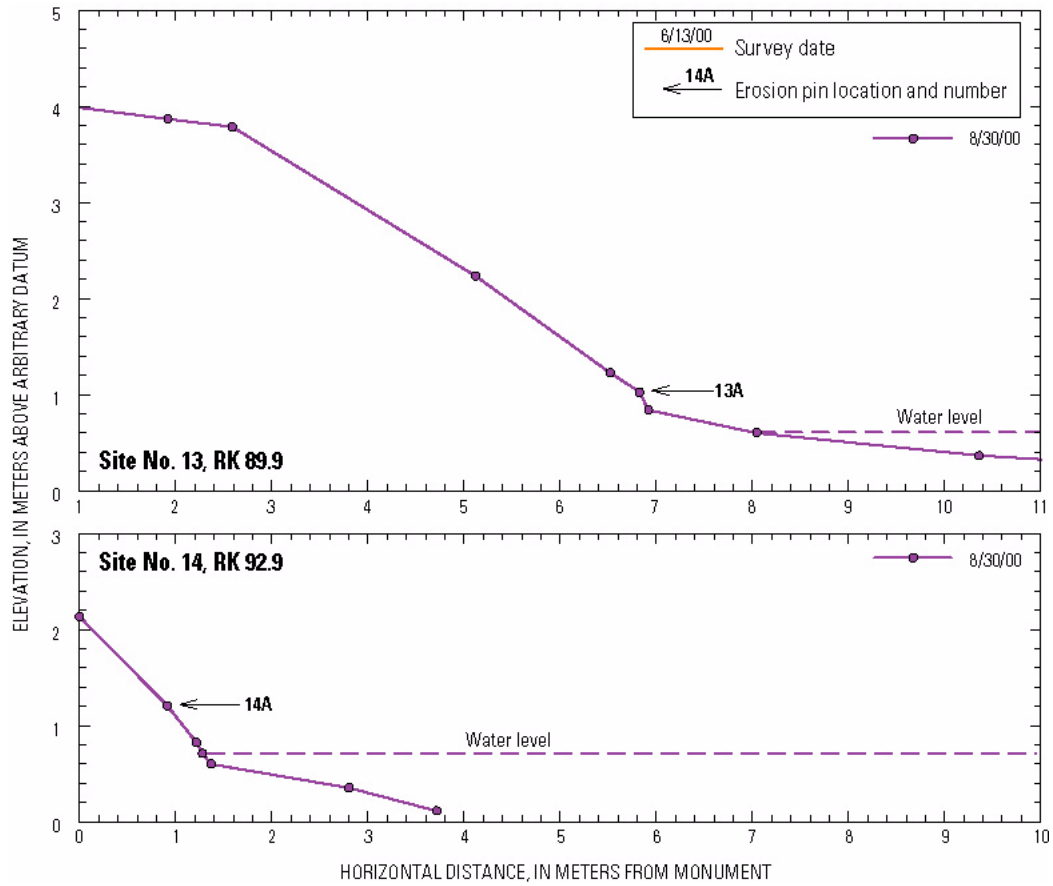
**Appendix 5.** Bank profile surveys at erosion monitoring sites, 2000 and 2001. Erosion monitoring locations shown in figure 9.
