Final Report on Electric Clothes Dryers and Lint Ignition Characteristics May 2003

DIRECTORATE FOR ENGINEERING SCIENCES

**ELECTRIC CLOTHES DRYERS
AND LINT IGNITION CHARACTERISTICS**

May 2003

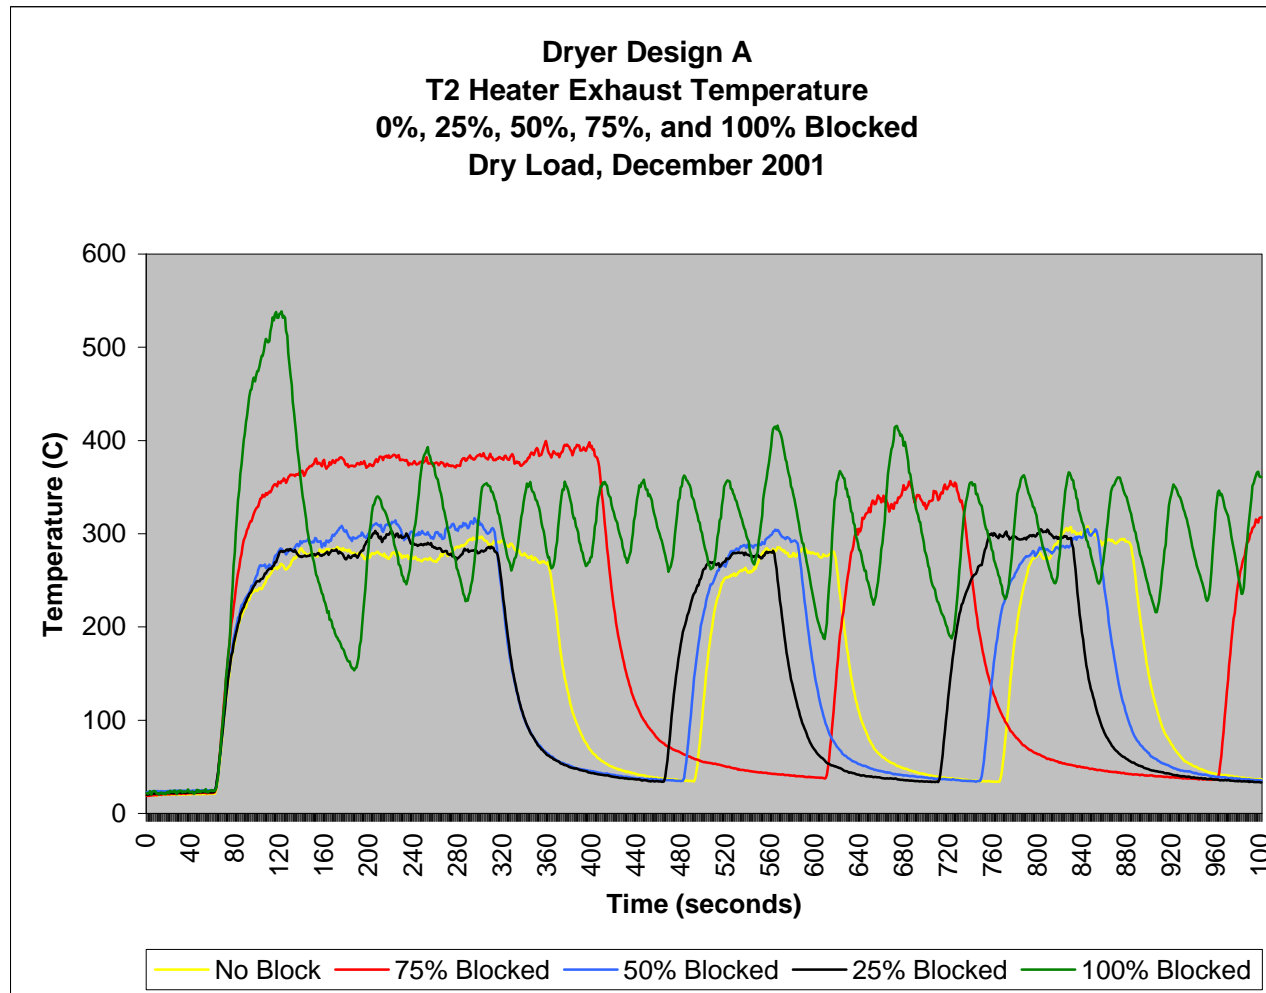
Figure 12. Dryer Design A – T2 Heater Exhaust Comparison

At exhaust vent blockages of 100% and 75%, the peak heater exhaust temperatures were similar – around 325°C to 375°C – as shown in Figure 12. However, the period during which the heater exhaust operated near the peak temperature differed for the two conditions. At 100% blockage, the temperature was not maintained at the peak temperature very long because the high limit thermostat cycled the heating element more rapidly. At 75% blockage, the duration the heater exhaust stayed near the peak temperature was approximately 100 to 300 seconds – until the primary thermostat switched the heating element off

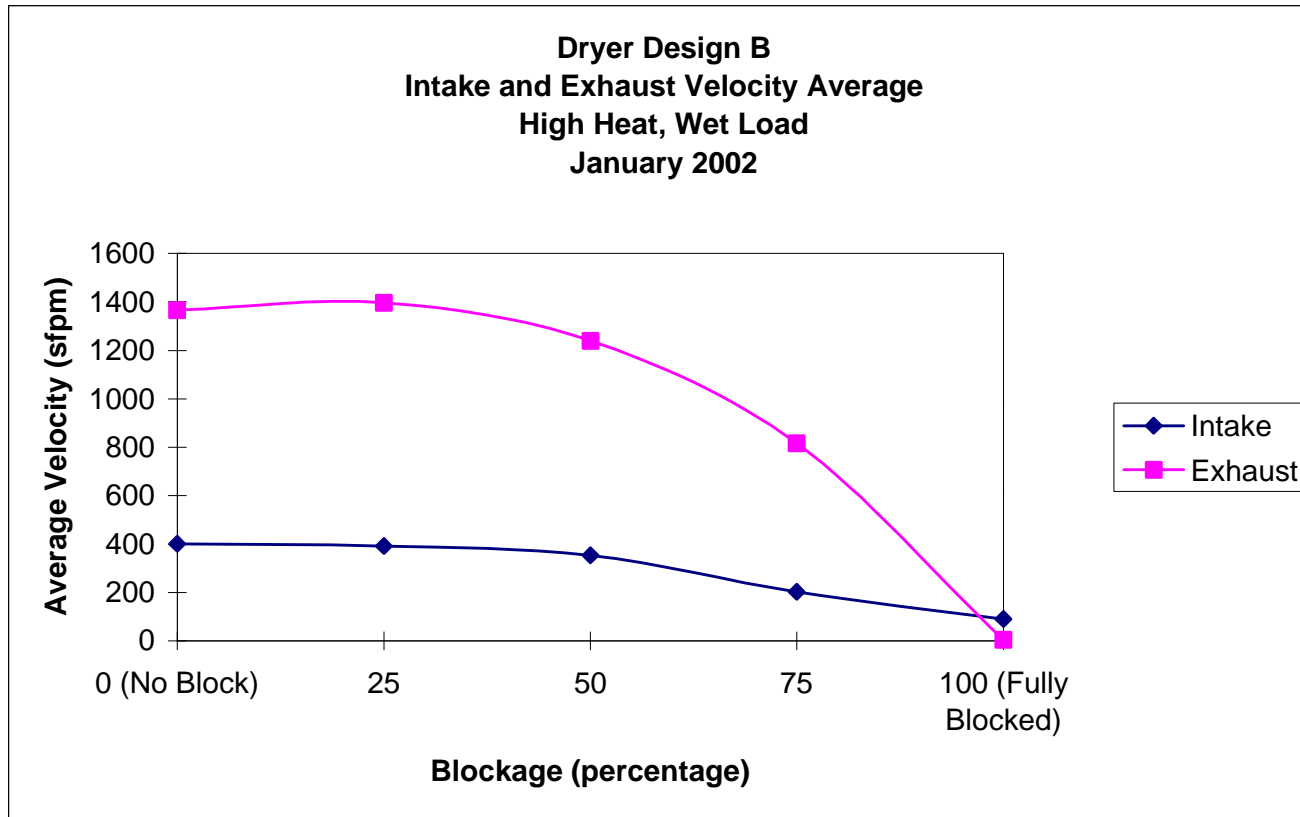
Figure 25. Dryer Design B – Average Airflow Velocities (High Heat and Wet Load)

Figure 25 shows the average intake and exhaust air velocities for the different blockage conditions. The data from 120 seconds to 1000 seconds were averaged. This avoided the initial overshoot when the blower was first powered. The intake velocity stayed steady until the exhaust vent was 25% blocked, and it began to decrease more rapidly between 25% and 50% blockage. When the exhaust vent was 100% blocked, the exhaust velocity was near zero, as expected, and the average intake air velocity was 90 sfpm.

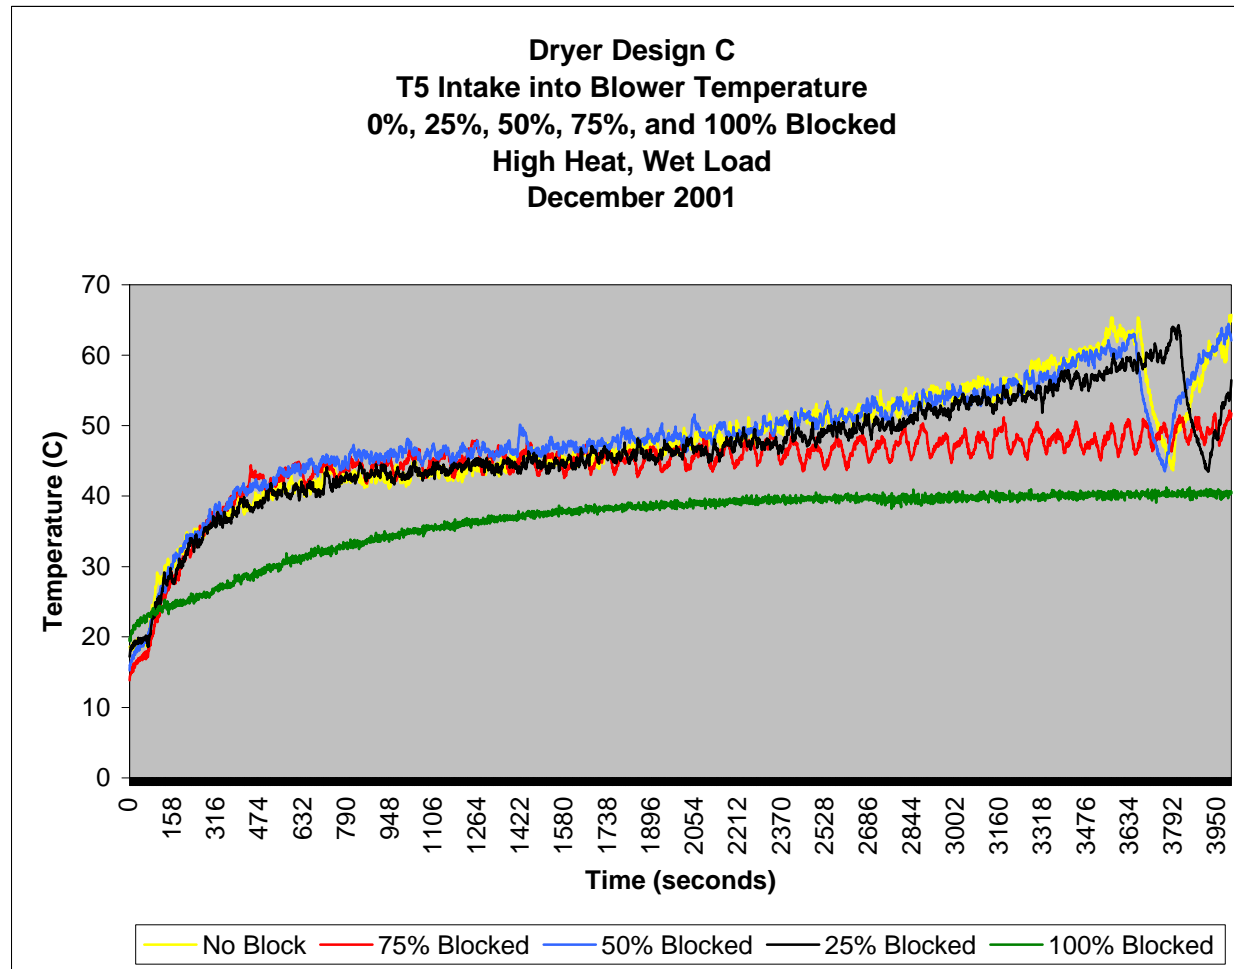
Figure 31. Dryer Design C – T5 Intake into the Blower Comparison

Figure 31 shows the air temperature at the intake to the blower reached around 50°C in the unblocked and partially-blocked conditions, until around 2100 seconds. For the unblocked, 25% and 50% blocked conditions, the temperature continued to increase to over 60°C. With the exhaust vent 75% blocked, switching of the high-limit thermostat prevented the temperature of the air entering the blower from increasing to the set point at which the primary thermostat would open.
