# Home Destruction Within the Hayman Fire Perimeter

Jack Cohen and Rick Stratton

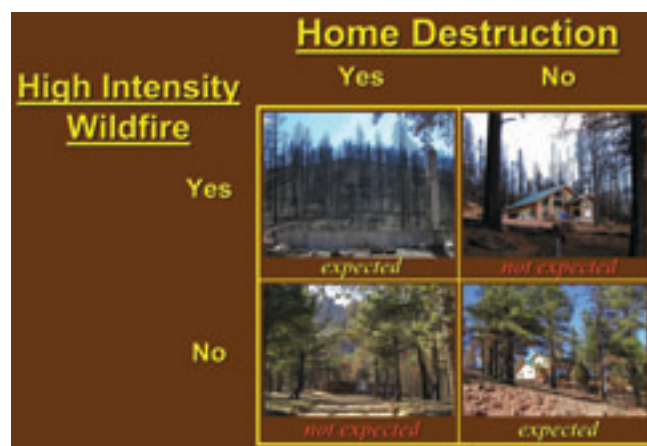
**Figure 1**—A 2x2 matrix of home destruction associated with the nearby wildland fire intensity. Expectations correspond to fire intensities, for example, home survival is expected if low fire intensities occur (lower right cell) and unexpected if the home is destroyed (lower left cell).

A wide array of wildland fire intensities were evidenced with respect to home destruction and survivability. Figure 1 shows the range of wildland fire intensities associated with homes destroyed and a similar range with those that survived.

surroundings (within 100 to 200 feet) principally determine home ignitions during intense wildland fires. This area that includes the home characteristics and its immediate surroundings is called the *home ignition zone*. Figure 1 shows expected cases and unexpected cases based on an association of fire intensities and the resulting home destruction or survival. The home ignition zone provides the means for understanding the unexpected situations—homes destroyed associated with low fire intensity and surviving homes associated with high intensities. The wildland fire intensity in the general area does not necessarily cause home destruction or survival. This distinguishes the difference between the exposures (flames and firebrands) produced by the surrounding wildland fire from the actual potential for home destruction (home ignition zone) given those exposures. Recognizing that the home ignition zone principally determines home ignition potential provides an important context for interpreting the home destruction information. The home ignition zone implies that the issue of home destruction can be considered in a home site-specific context rather than in the general context of the Hayman Fire.

Seventy homes were destroyed in association with the occurrence of torching or crown fire in the home ignition zone. Sixty-two homes were destroyed by surface fire and/or firebrand(s). The homes destroyed correspond to the two left cases in figure 1. A destroyed home was counted in the high intensity fire category if any high intensity burning occurred in the area surrounding the home. Significant site disturbance in the time lapsed between the fire occurrence and our assessment prohibited any further analysis as to whether these high intensities could have directly caused home ignition. That is, loss of evidence and the limited time for assessment disallowed a postburn analysis of the home ignition zone.

period (for example, home debris removal, tree removal, rebuilding activities) eliminated much of the evidence important for highly reliable determinations of the categorical ignition cause. The occurrence of high intensity burning adjacent to a home site does not necessarily cause direct home ignition (fig. 1, upper right cell), and this can usually be determined immediately after the fire. For this assessment, the lack of adequate evidence and the assessment's time constraints dictated our assumption that any high intensity burning adjacent to the home site categorically designated the cause to be tree torching/crown fire.

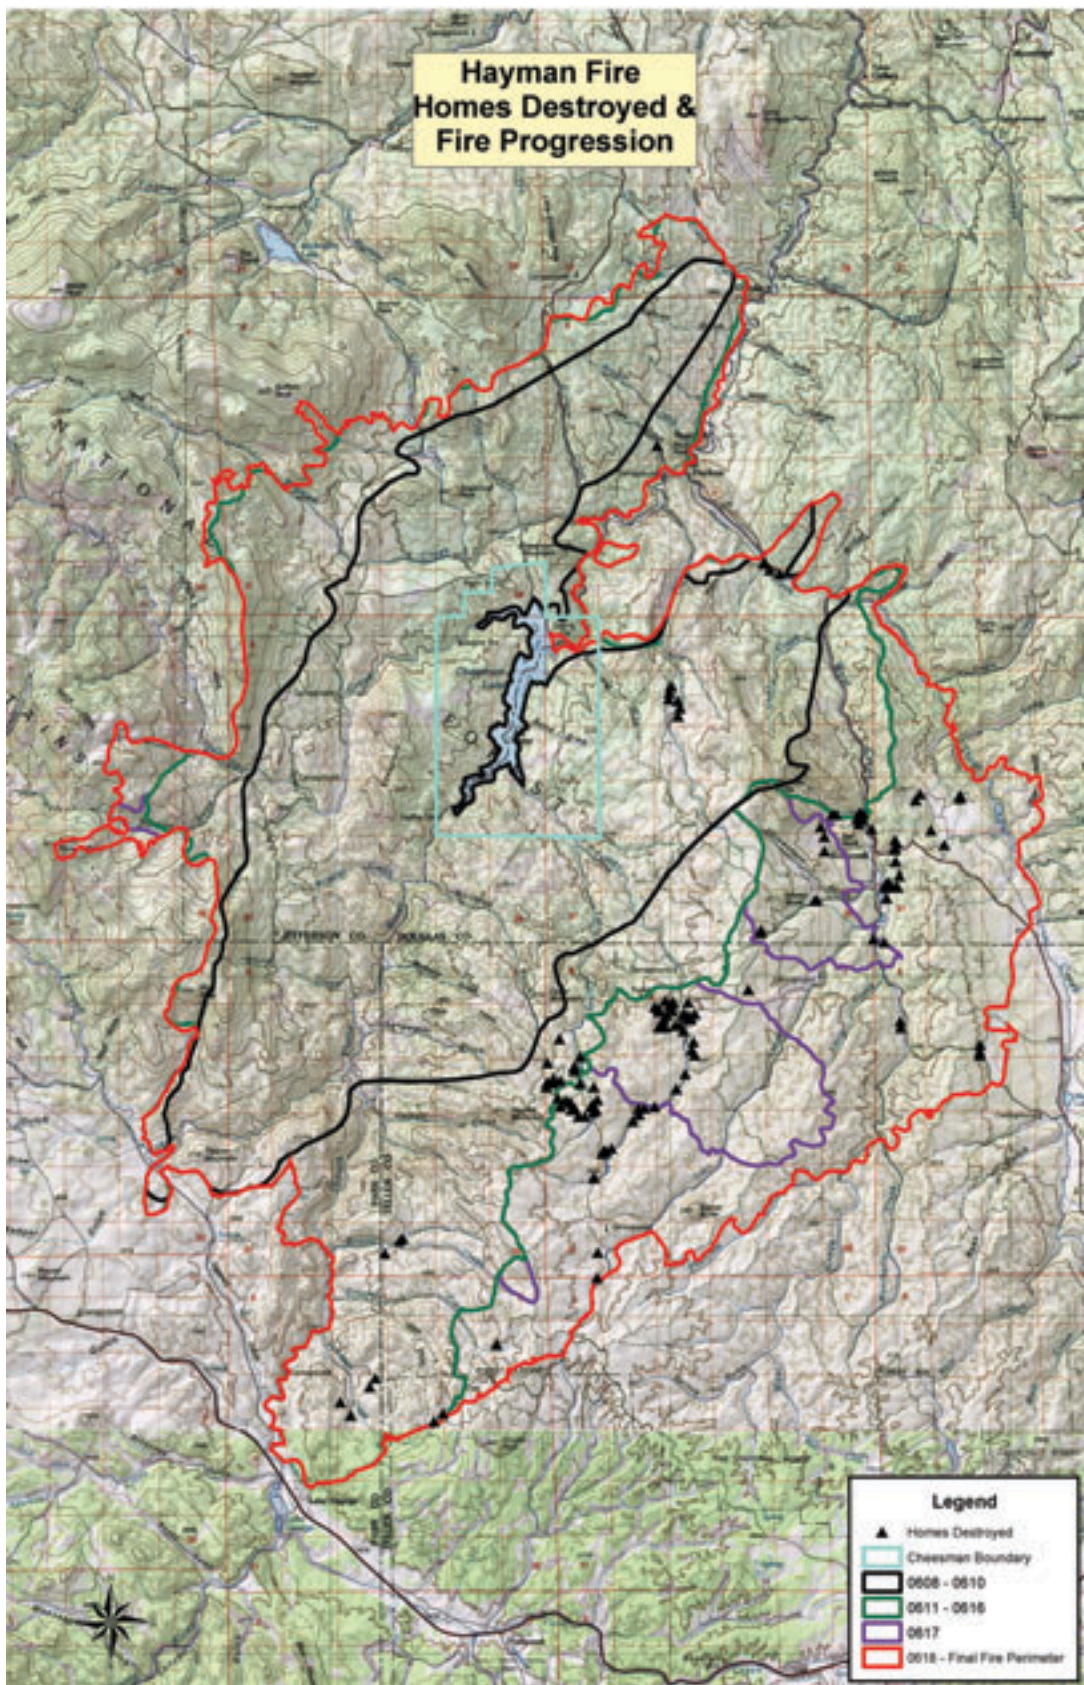
**Figure 2**—Locations of destroyed homes in relation to the Hayman Fire progression. The lines correspond to the estimated position of the perimeters at the end of June 10, 16, 17, and the final fire perimeter.

The following timeline is based on the fire chronology presented in the fire behavior section but focuses on the progression of the fire in relation to homes destroyed (fig. 2). The exact time individual homes were destroyed is largely unknown. Furthermore, the progression of the fire may not coincide with the actual date a home burned. This is largely a function of an estimate of the fire's perimeter at a specific time and unburned areas within the perimeter that can later burn.

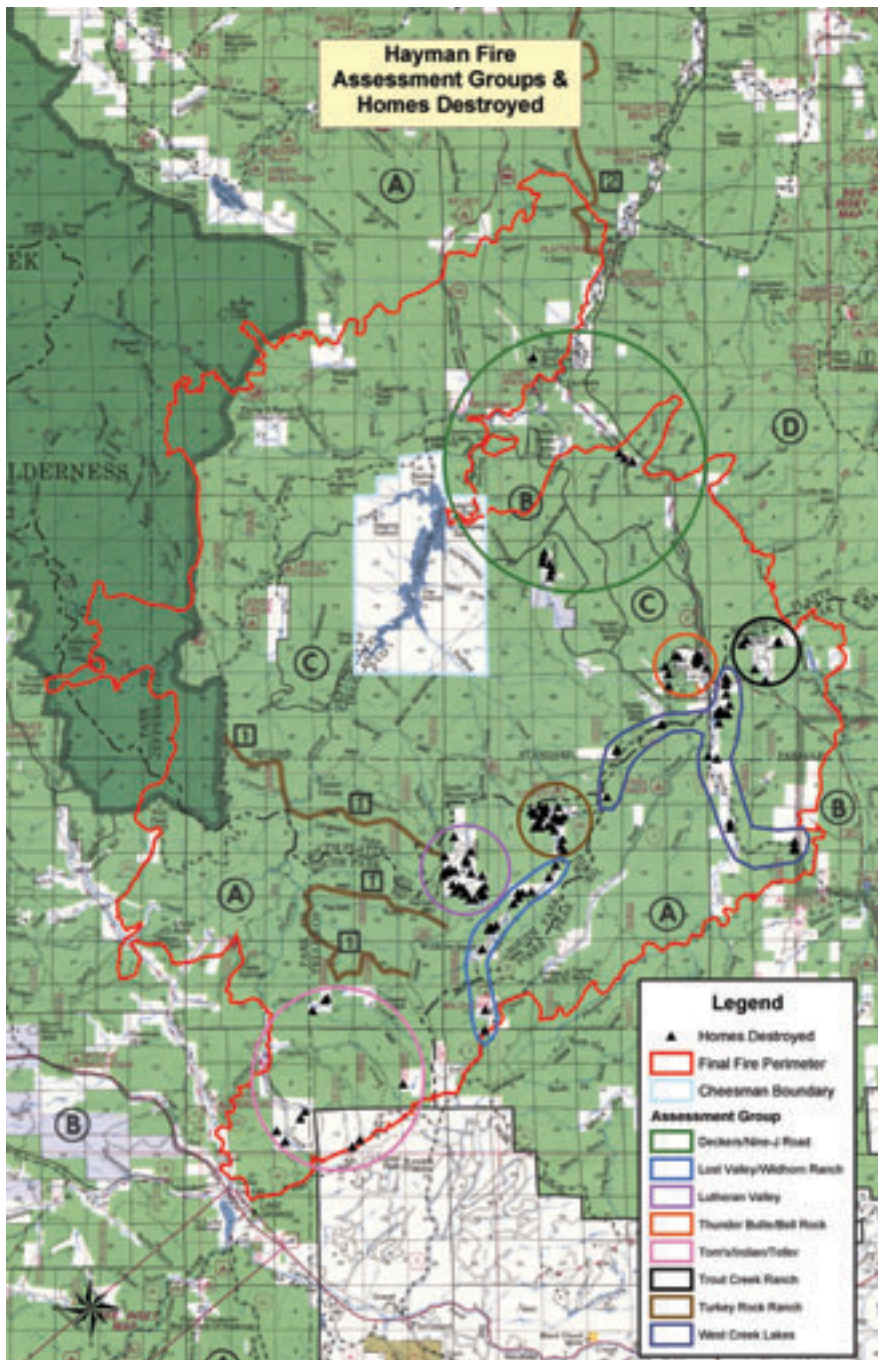
**Figure 3**—The 132 destroyed homes were clustered into eight assessment groups according to area proximity and the fire progression.

The 132 homes burned on the Hayman Fire were clustered into groups based on location and time of destruction. Eight assessment groups were delineated (fig. 3) and are listed below in relative order of occurrence (table 2). Each of the assessment groups is specifically examined. The destroyed homes are displayed on maps delineating fire severity. Corresponding photos provide a clearer understanding of the nonuniform burn patterns associated with homes destroyed and those that survived. The photos show burned homes as well as unburned homes in the same area. Many of the photos show trees with dead needles remaining that were unconsumed during the fire. This indicates that the intensities at those locations were not sufficient to initiate combustion in tree canopies.

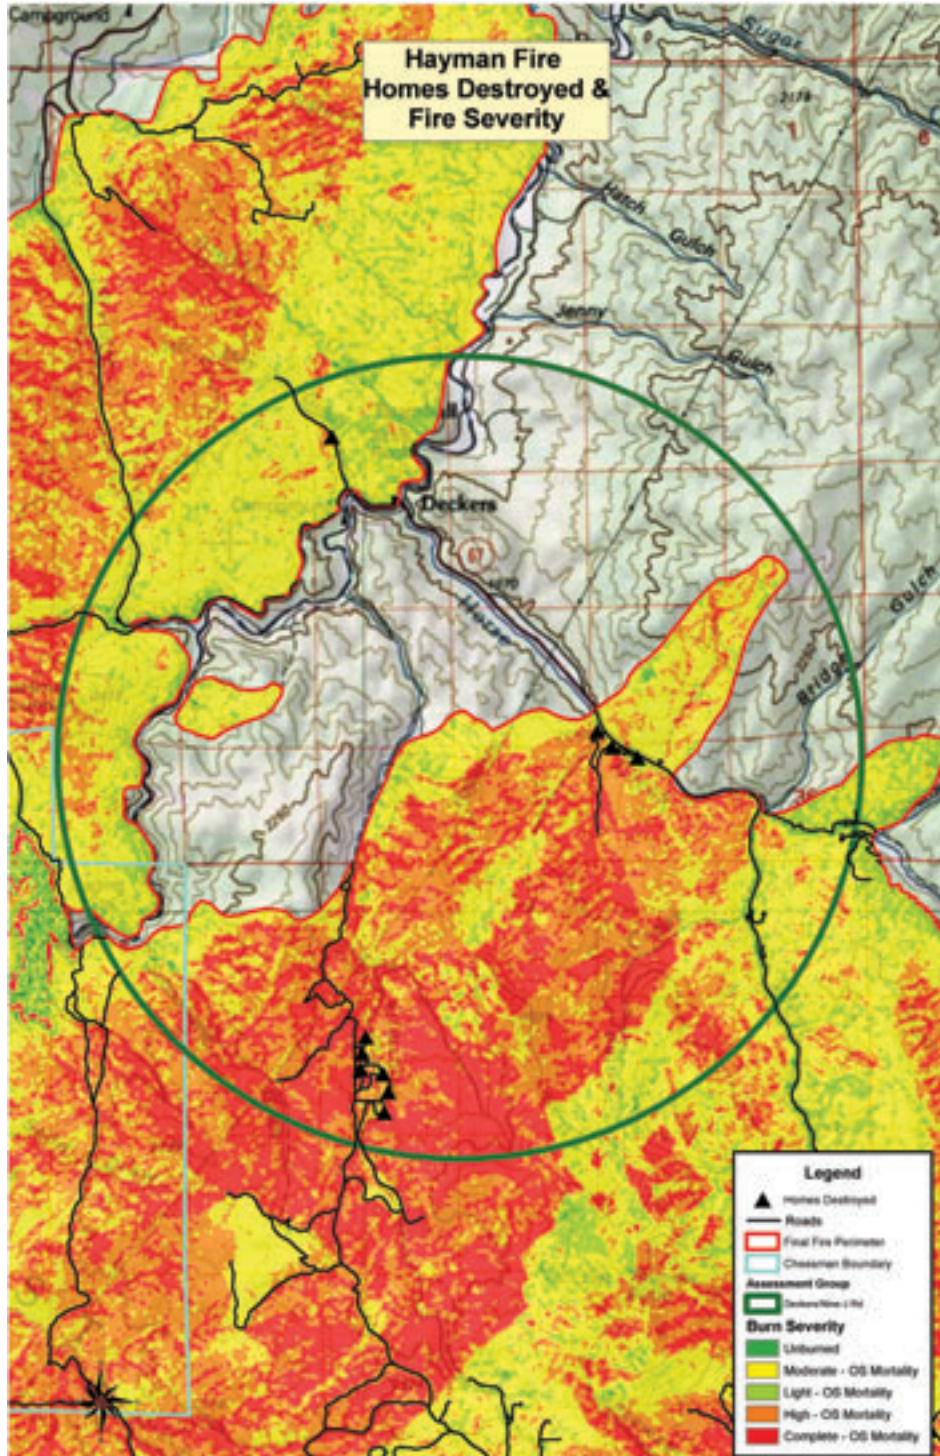
Figure 4—The Deckers/Nine-J Road assessment group with the associated fire severity.

This assessment group consists of home(s) north-west and southeast of Deckers and the Nine-J Road area (County Road 59) (fig. 4). One summer cabin was destroyed in Lazy Gulch (Jefferson County), just northwest of Deckers along State Highway 126 (fig. 5, 6). Three additional structures—two primary residence

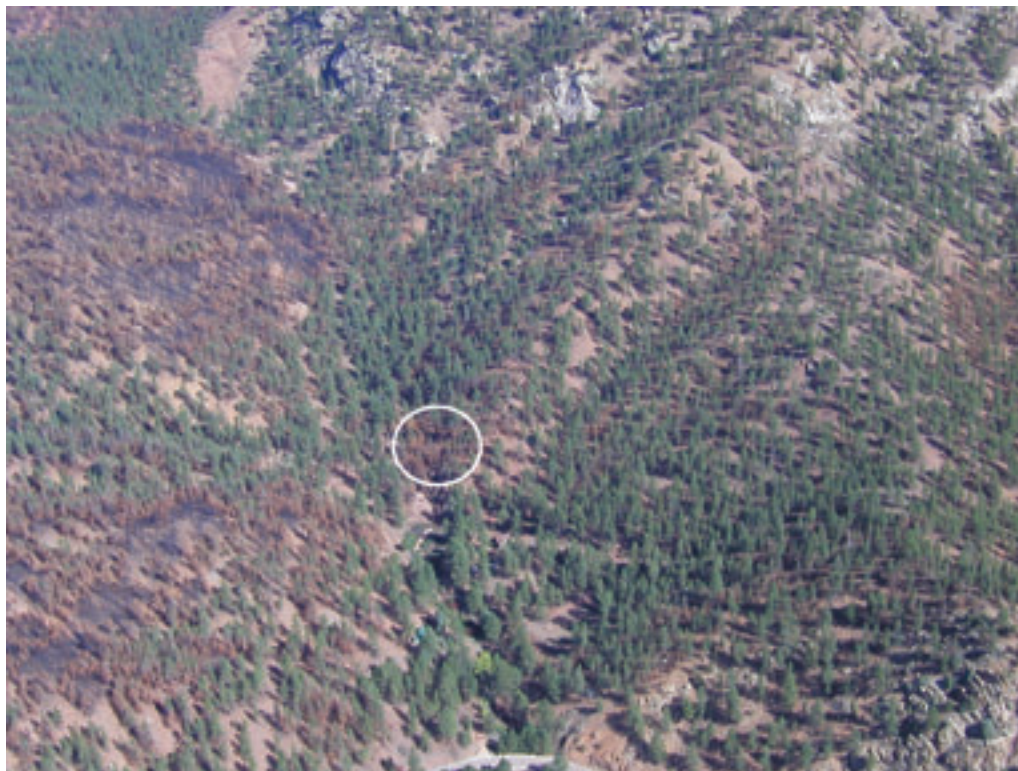
**Figure 5**—Aerial view looking north at Lazy Gulch (State Highway 67, northwest of Deckers). The circle indicates where the summer home was destroyed. Note the unburned homes below the circle.

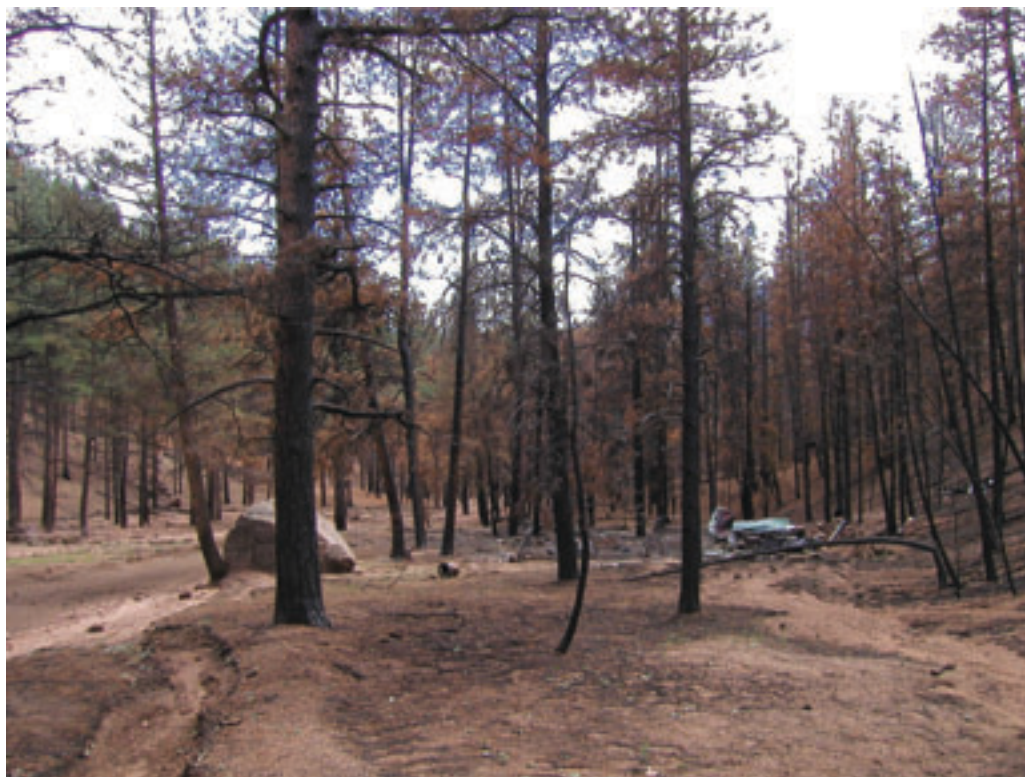
**Figure 6**—Site view of the summer home destroyed in Lazy Gulch (State Highway 67, northwest of Deckers). The remaining needle kill indicates a surface fire next to the home without tree torching and crowning.

and the Horse Creek Cafe and Saloon (fig. 7)—were destroyed southeast of Deckers (State Highway 67). General area intensity (GAI) was high, where as the site-specific intensity (SSI) was moderate to low in Lazy Gulch and high to moderate along State Highway 67. In the Nine-J Road area, six homes were destroyed; GAI and SSI were high (fig. 8).

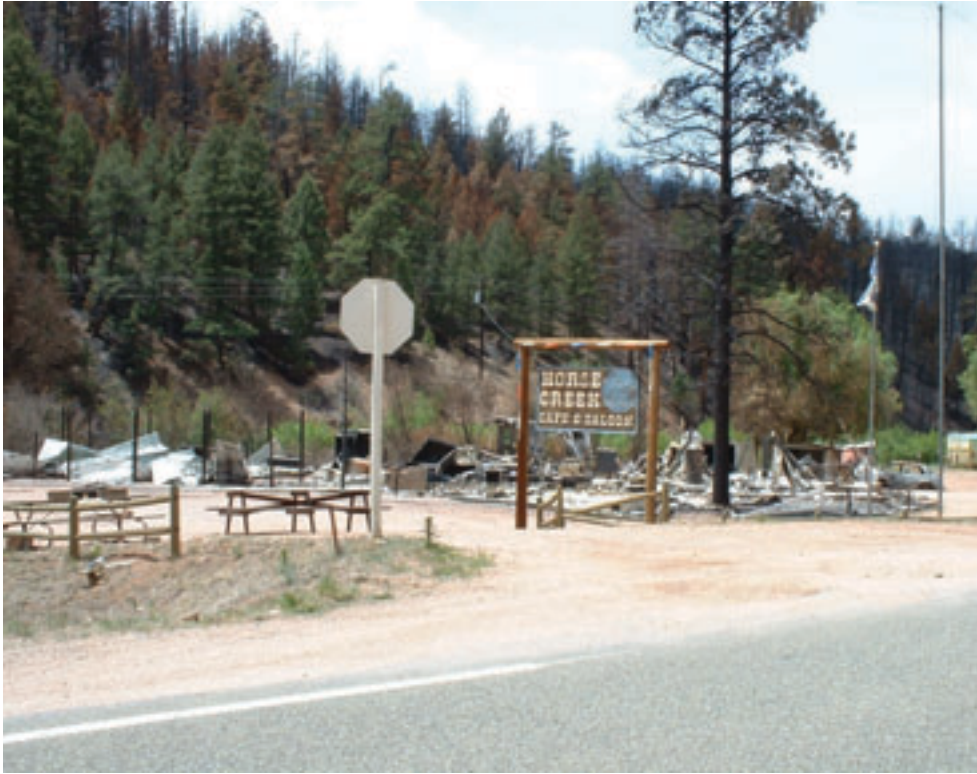
**Figure 7**—The destroyed remains of the Horse Creek Cafe and Saloon on State Highway 67, southeast of Deckers. Note the unburned vegetation. (Photo by R. Moraga)

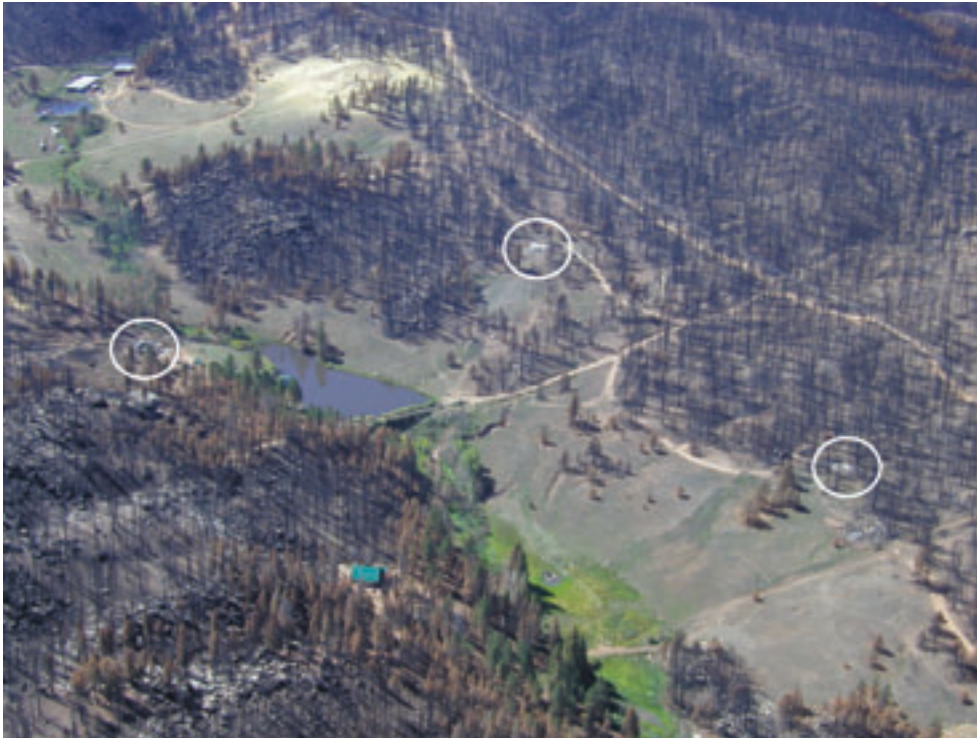
**Figure 8**—Aerial view looking to the south-southwest of Nine-J Road (County Road 59). Circled areas indicate where a home was destroyed. Note the unburned home with the green roof.

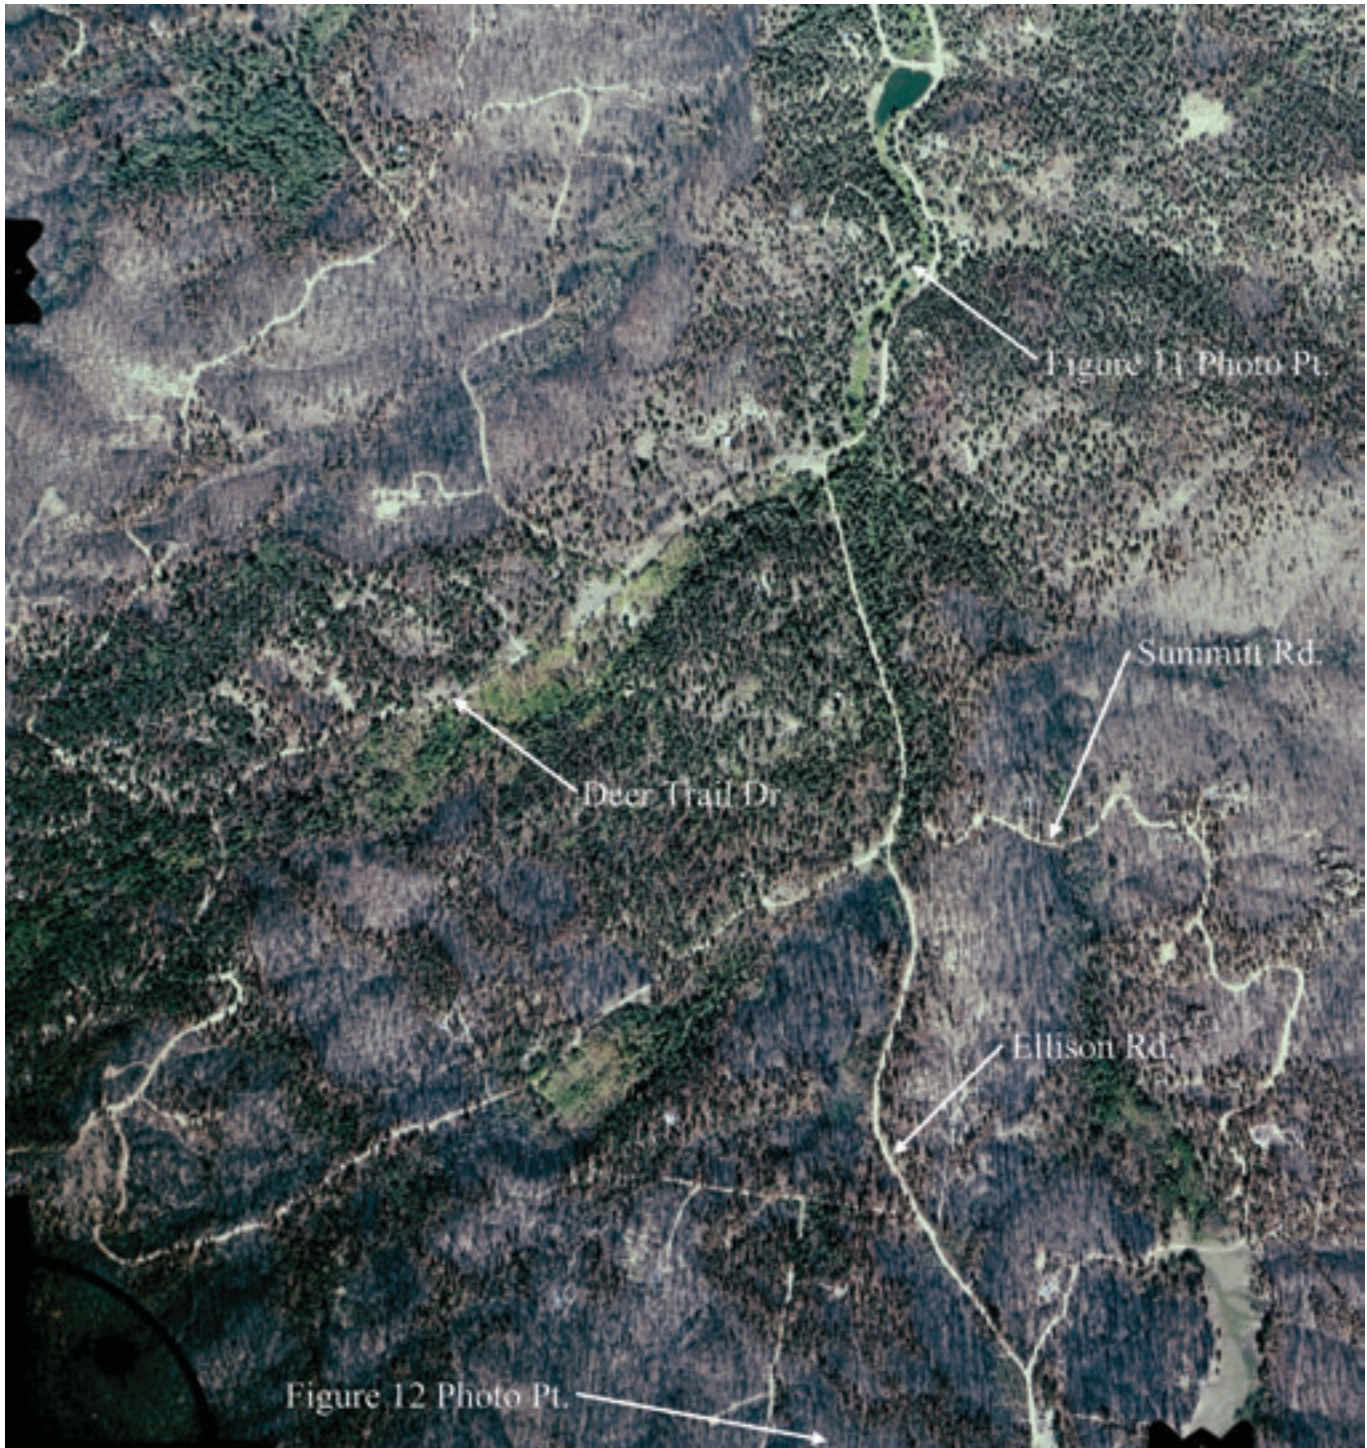
**Figure 10**—Aerial photograph of Lutheran Valley Ranch. (Photo produced by Jim Ellenwood)

Twenty-six homes were destroyed in Lutheran Valley Ranch (fig. 9, 10) as well as several outbuildings and

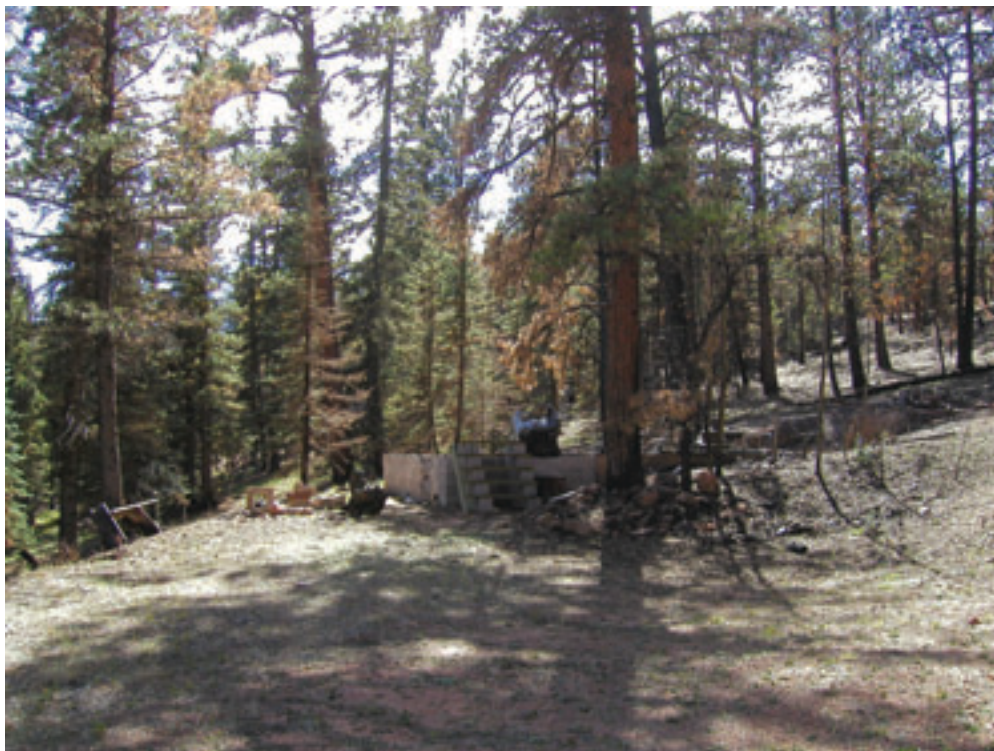
**Figure 11**—Home destroyed in Lutheran Valley Ranch; ignition cause was designated as surface fire and/or firebrand.

bunkhouses at the Lutheran Valley Retreat. To the northeast the GAI was moderate to high and the SSI was moderate to low (fig. 11); all other areas experienced high GAI and high to moderate SSI (fig. 12).

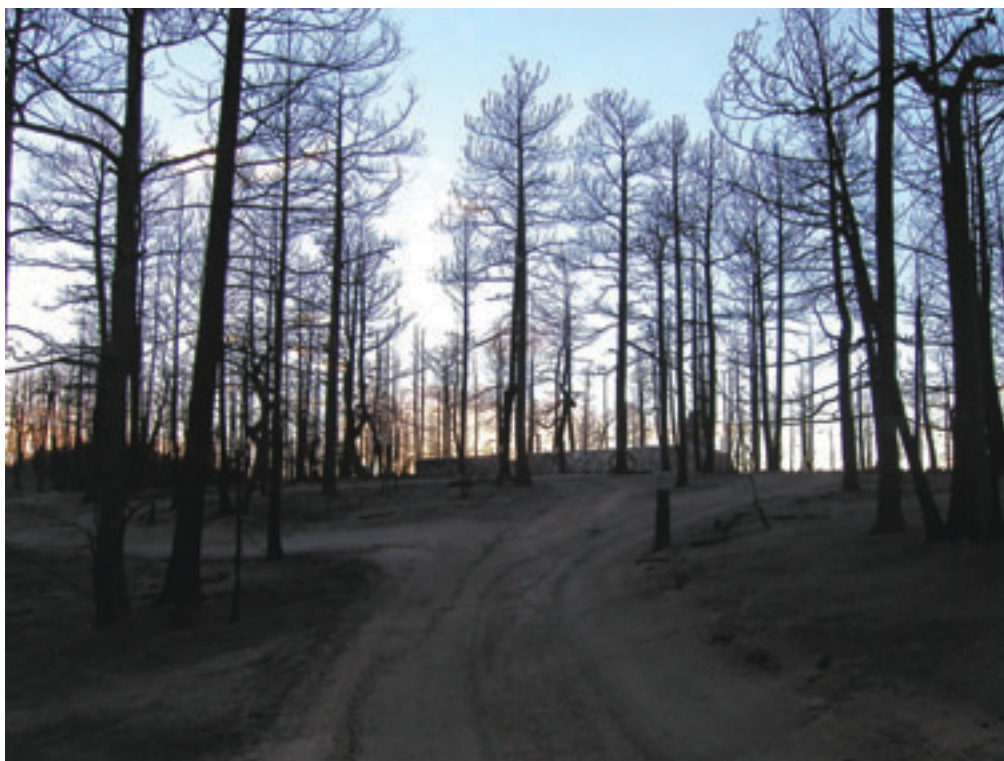
**Figure 12**—Another example home destroyed in Lutheran Valley Ranch. The ignition cause was designated as torching/crown fire.

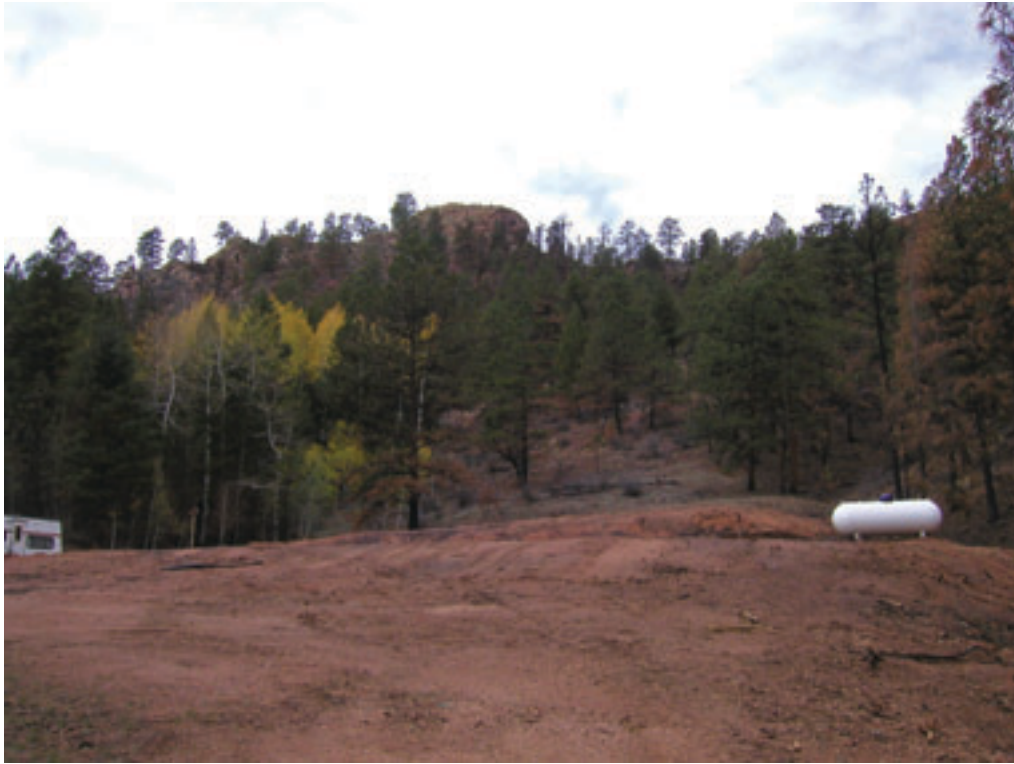
**Figure 14**—Home site where a structure was destroyed in Tom's Ranch (Forest Road 200). The ignition cause was designated as surface fire and/or firebrand.

(Forest Road 200) experienced a range of intensities (both GAI and SSI) (fig. 14, 15). The GAI of the Indian Creek area was moderate and the SSI was moderate to low. Homes in west Teller County experienced high to moderate GAI and moderate to high SSI.

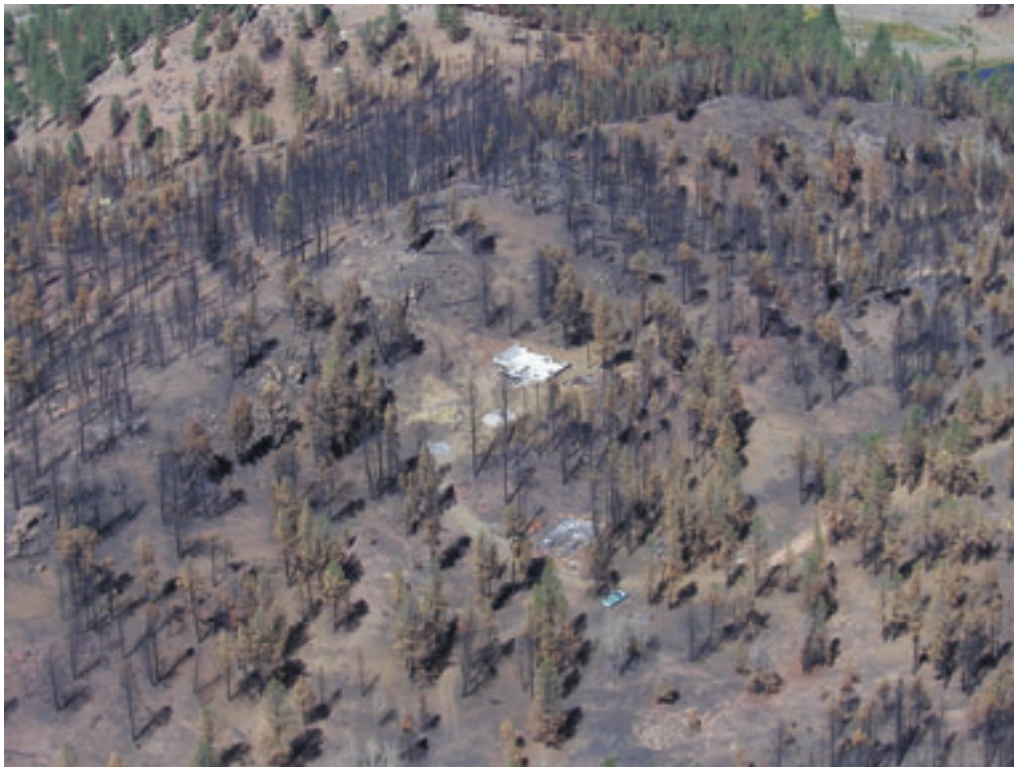
**Figure 15**—Home destroyed in Tom's Ranch (Forest Road 200); ignition cause was designated as torching/crown fire. Note the unburned tree canopies scattered throughout the area.

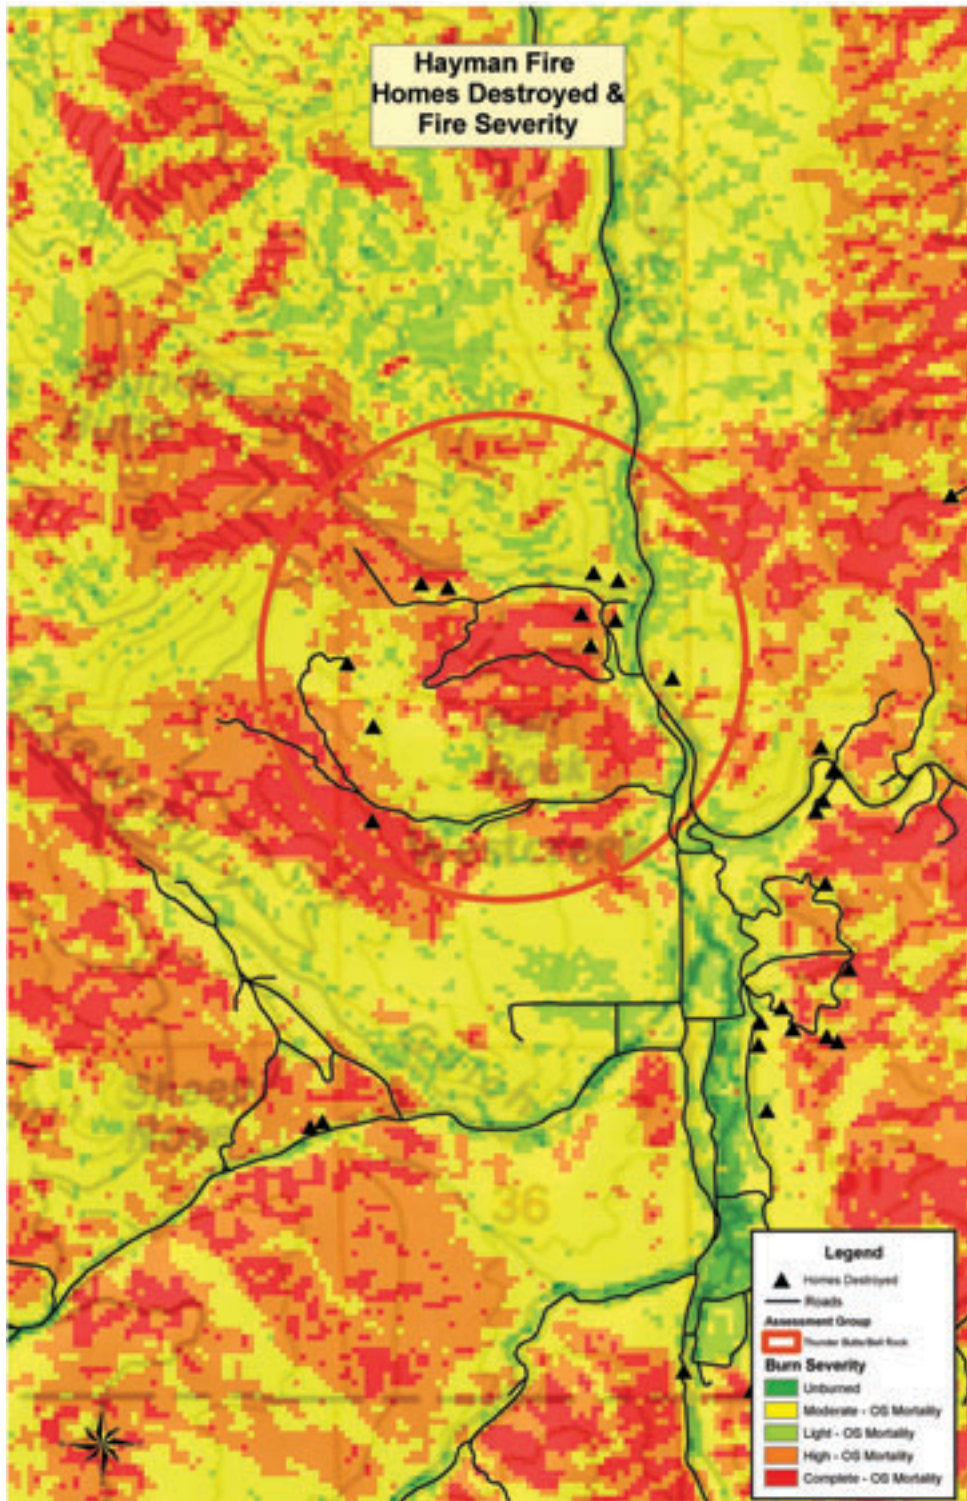
**Figure 16**—Thunder Butte Subdivision/Bell Rock assessment group with the associated fire severity.

of Bell Rock along Bell Rock Road (fig. 16). The GAI was high and the SSI was high to moderate in the Thunder Butte area (fig. 17, 18). The GAI was high to moderate and the SSI was moderate to low in the Bell Rock Area (fig. 19).

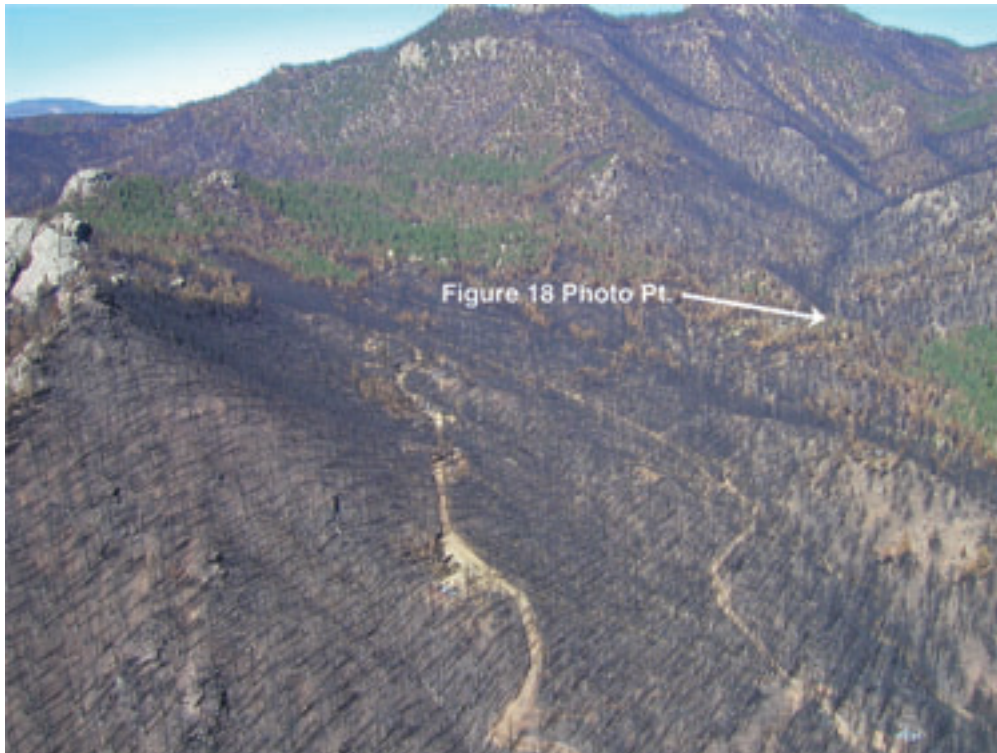
**Figure 17**—Aerial photograph looking west through the Thunder Butte Subdivision with Bell Rock (top left) and the east face of the Thunder Butte bowl (top right).

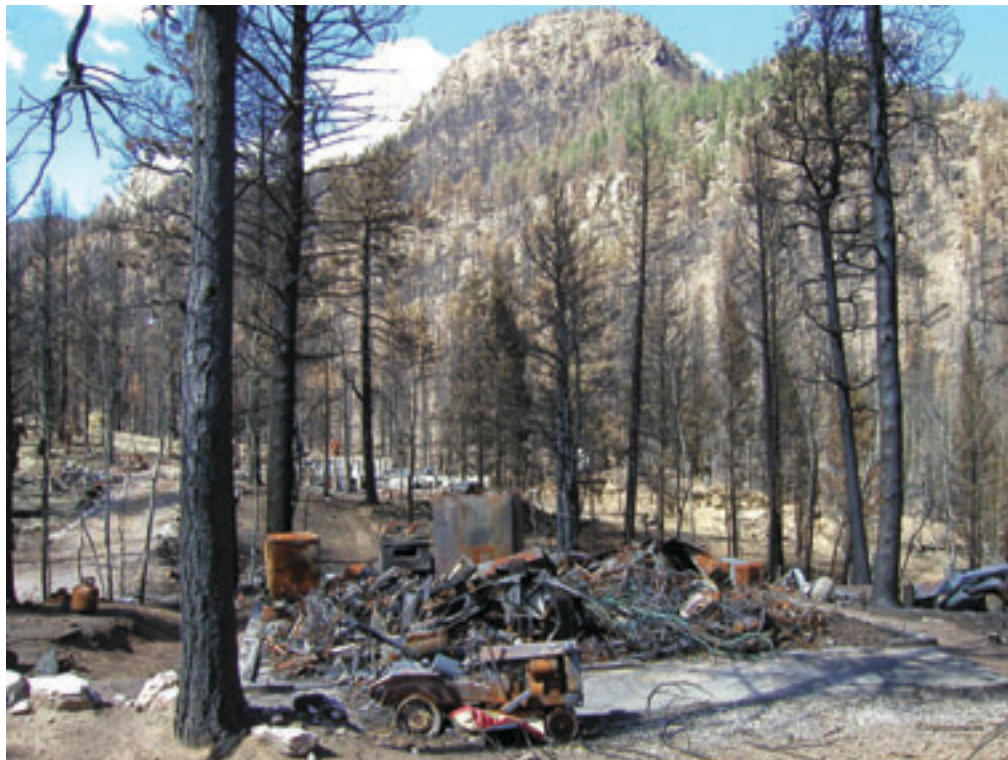
**Figure 18**—Destroyed home in the Thunder Butte Subdivision designated as torching/crown fire cause. The garage is in the foreground and the home is in the background. The trees in the immediate vicinity were severely burned by the structure fire.

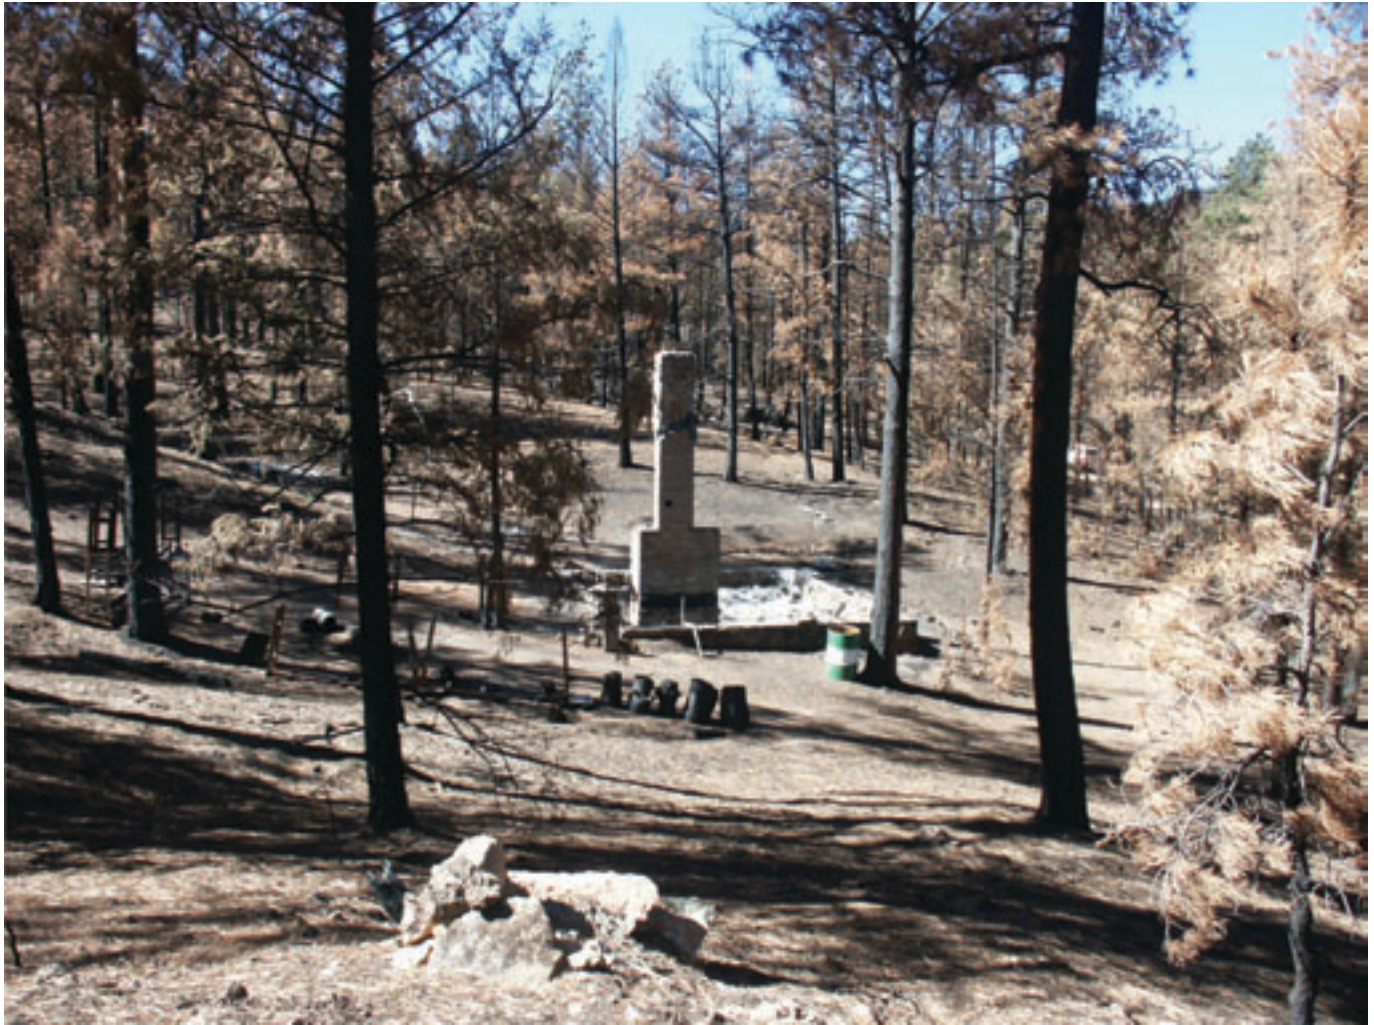
**Figure 19**— This home, southwest of Bell Rock, was designated as destroyed by surface fire and/or firebrand.  
(Photograph by Jeff DePooter)

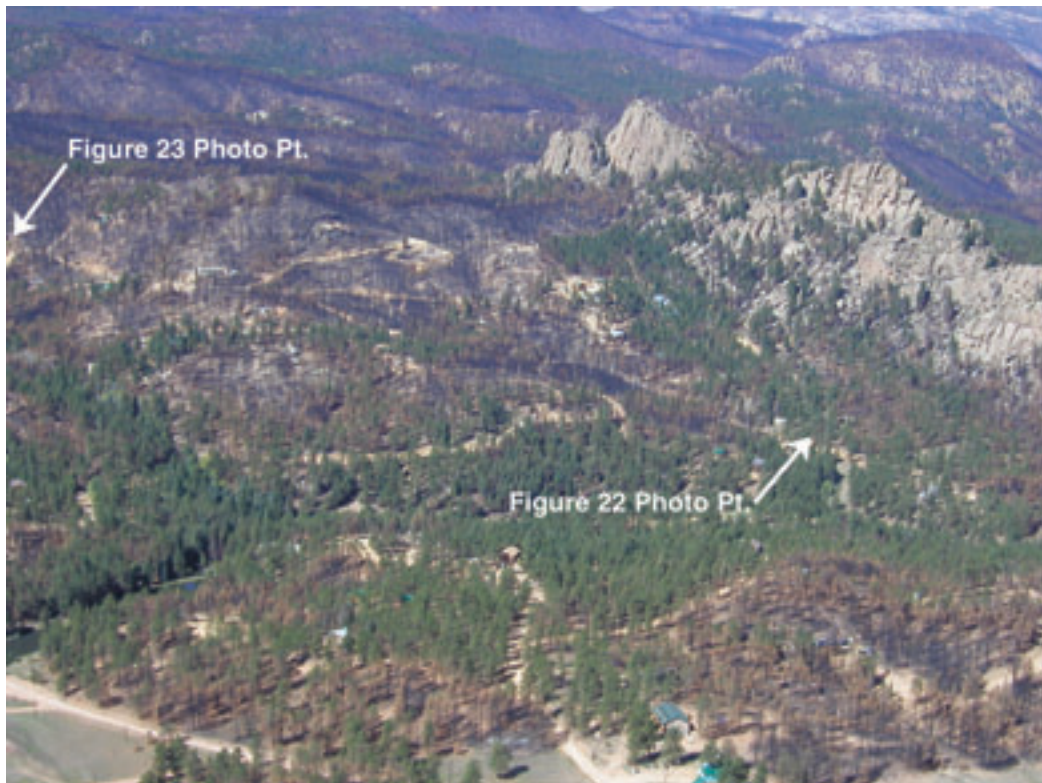
**Figure 21**—Aerial photograph showing the Turkey Rock Ranch area looking west-northwest. Note the unburned homes scattered throughout the lower two-thirds of the photo.

Twenty-eight homes in Turkey Rock Ranch were destroyed (fig. 20, 21). Homes on the north and east

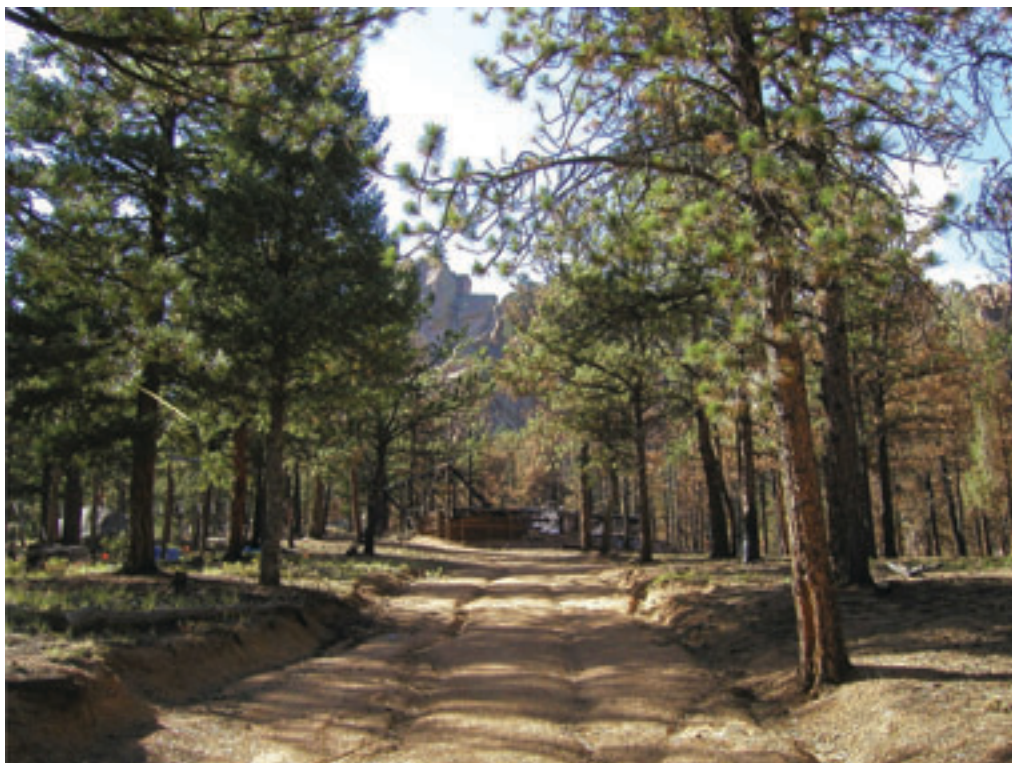
**Figure 22**—Home in Turkey Rock Ranch designated as destroyed by surface fire and/or firebrand.

side of the subdivision experienced moderate to low GAI and SSI (fig. 22); however, the GAI on the south and west sides were high with the SSI high to moderate (fig. 23).

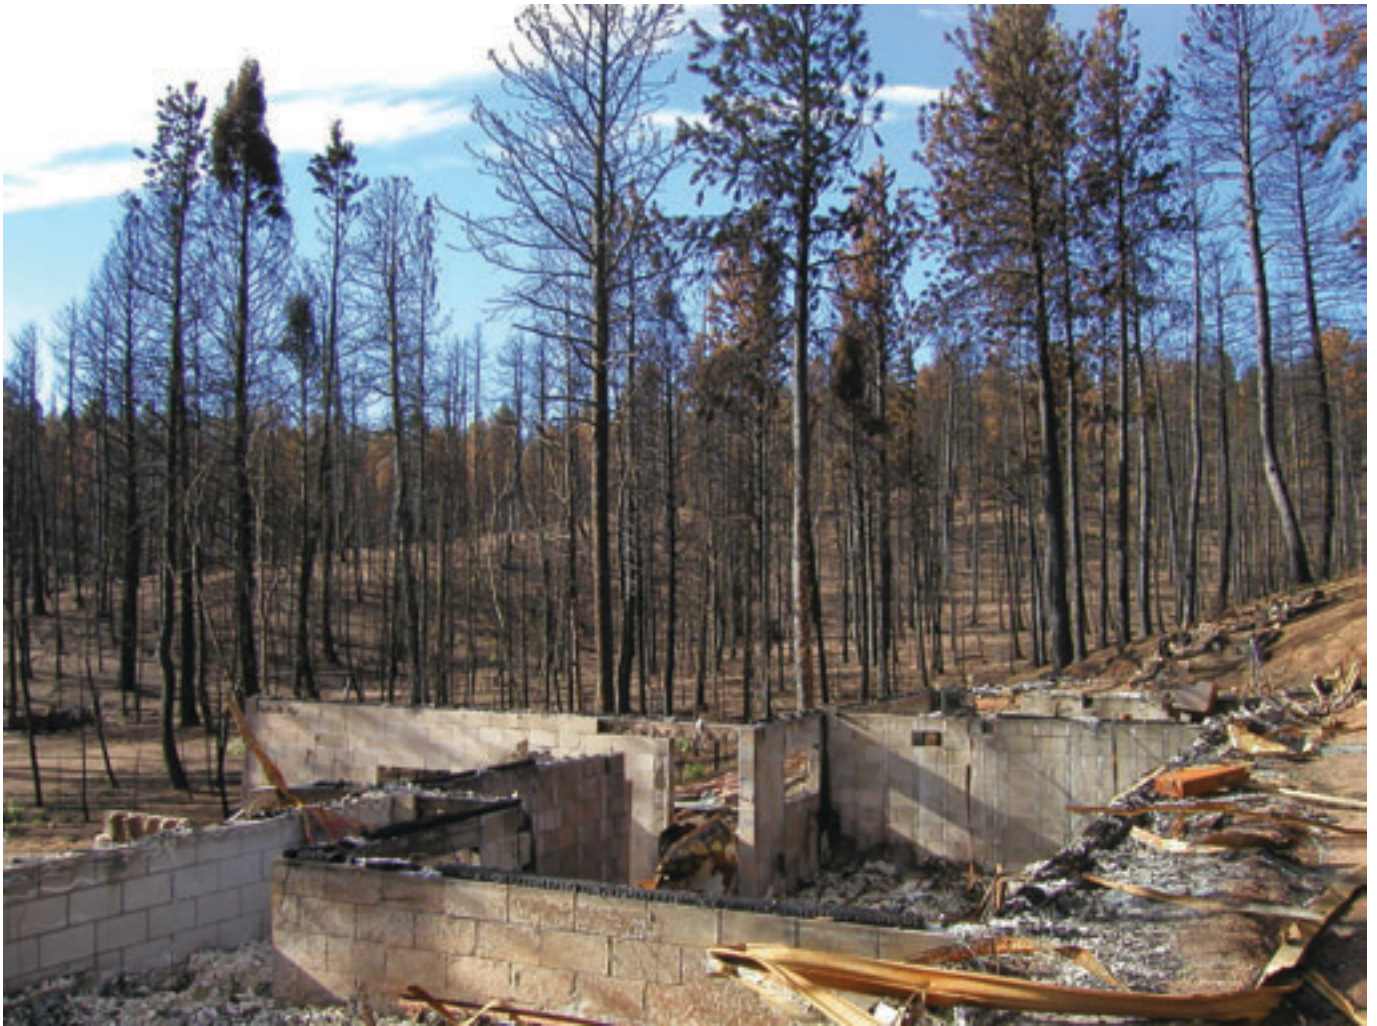
**Figure 23**—This home in Turkey Rock Ranch was designated as destroyed by torching/crown fire.
