# Home Destruction Within the Hayman Fire Perimeter

Jack Cohen and Rick Stratton

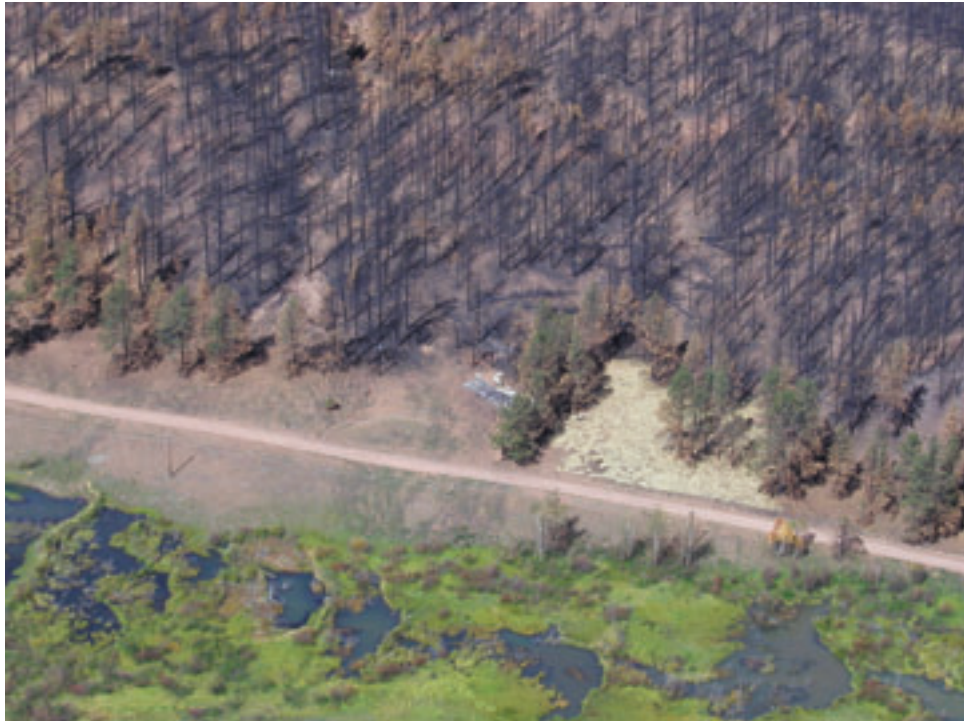
**Figure 25**—Aerial photograph of a home in Lost Valley Ranch designated as destroyed by torching/crown fire. Note the unburned vegetation immediately adjacent to the home on the right as well as other unburned vegetation.

The GAI and the SSI in Lost Valley was high to moderate (fig. 25). The Wildhorn Ranch Subdivision (fig. 26) and Wildhorn Lodge (fig. 27) experienced high GAI and high to moderate SSI.

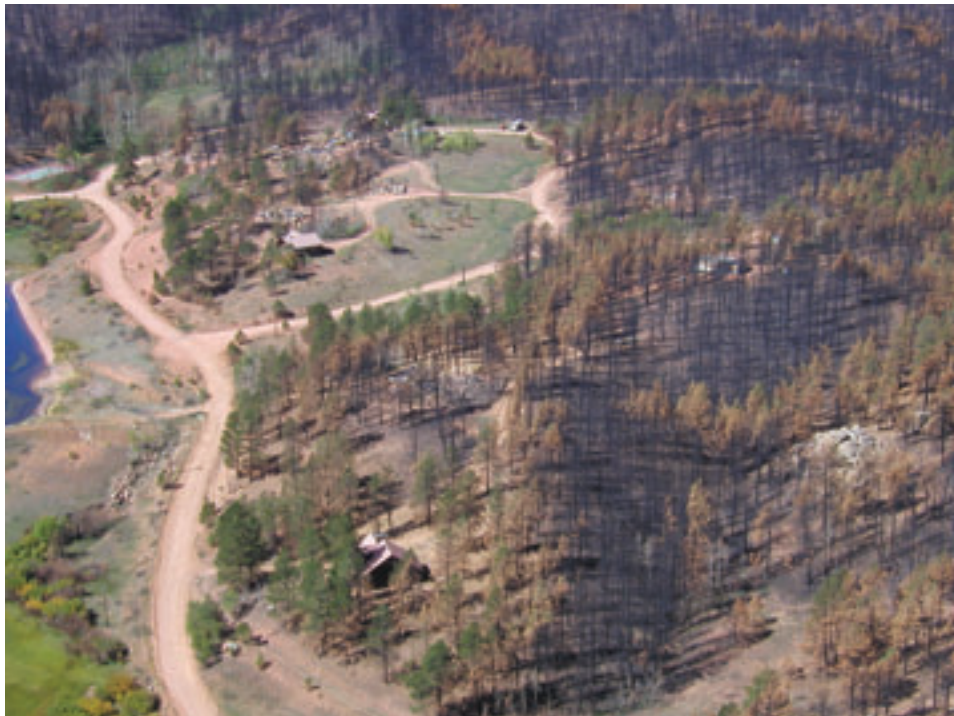
**Figure 26**—Aerial photograph looking southwest at the Wildhorn Ranch Subdivision.

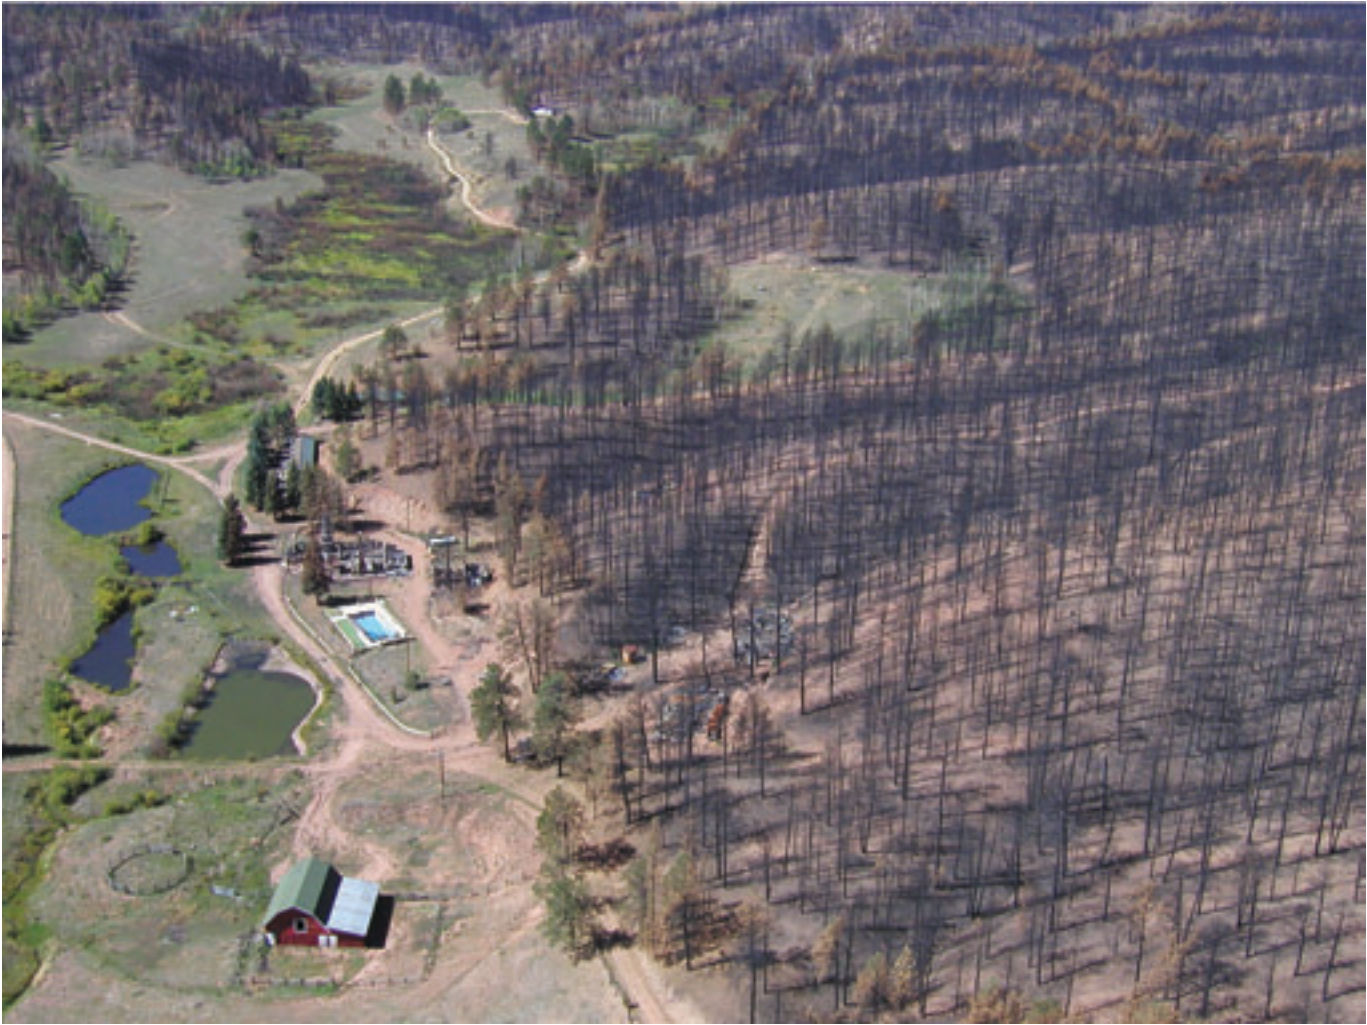
**Figure 27**—This aerial photo shows the Wildhorn Lodge and guest home. These structures were designated as destroyed by torching/crown fire.

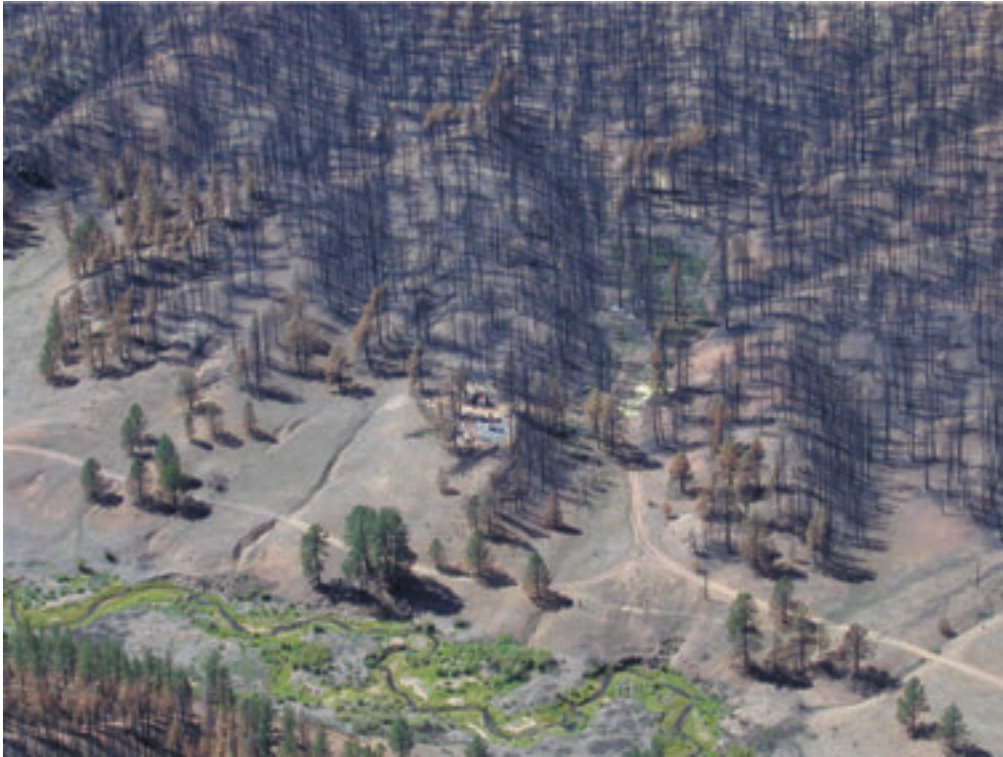
**Figure 29**—Aerial photograph looking west-southwest showing a home destroyed along County Road 78. The ignition cause was designated as torching/crown fire.

Lakes community (fig. 28). Homes along County Road 78 (fig. 29, 30) and State Highway 67 (fig. 31) experienced high GAI but moderate and low SSI. The four homes along Stump Road experienced high to moderate GAI and SSI (fig. 32). Homes in West Creek Lakes experienced high to moderate GAI and moderate to low SSI (fig. 33 through 35).

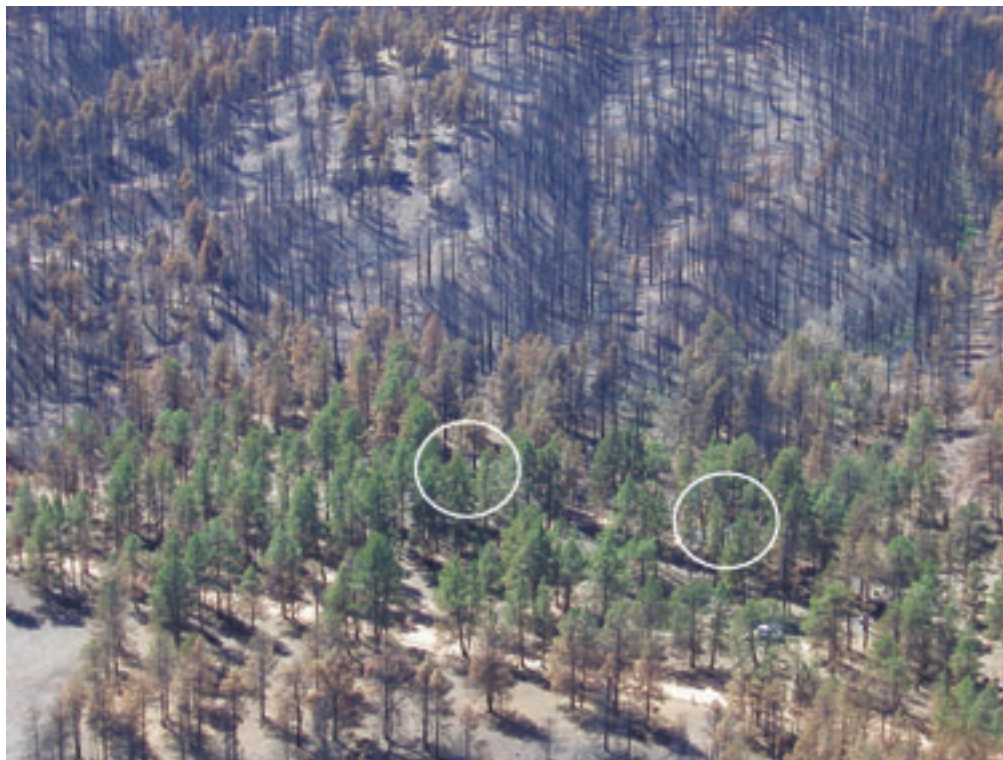
**Figure 30**—Aerial photograph showing two homes (circled areas) destroyed along County Road 78 (Painted Rocks area). The ignition cause was designated as surface fire and/or firebrand.

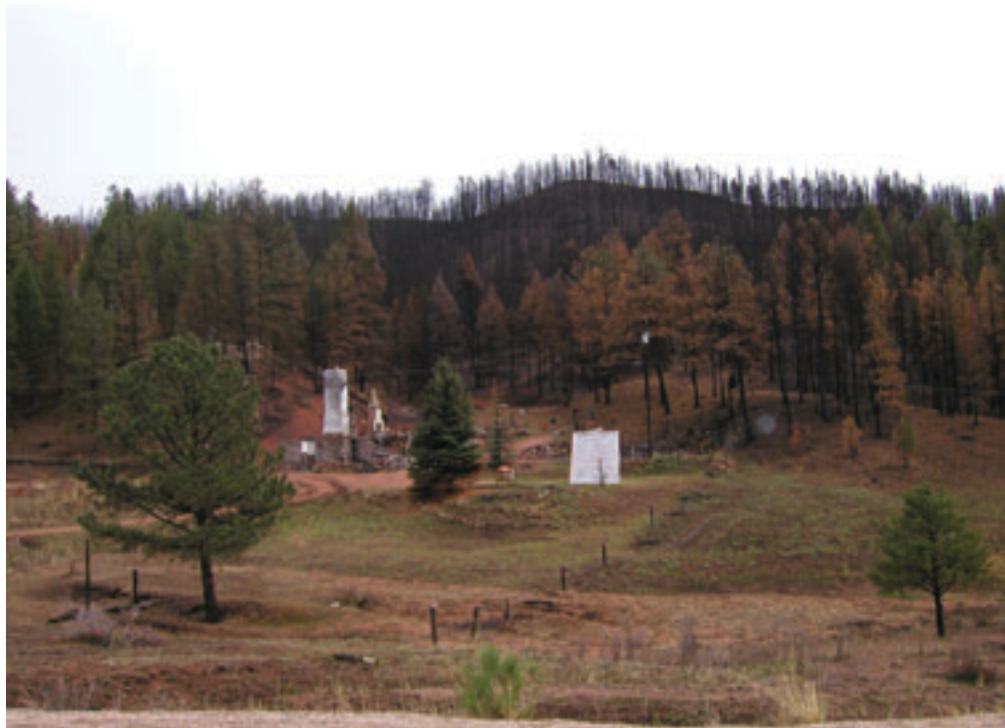
**Figure 31**—This view looking to the south shows a destroyed home along State Highway 67. Although the crown fire crested the ridge, the home is surrounded by unconsumed vegetation (albeit killed), indicating that the crown fire did not directly ignite this home.

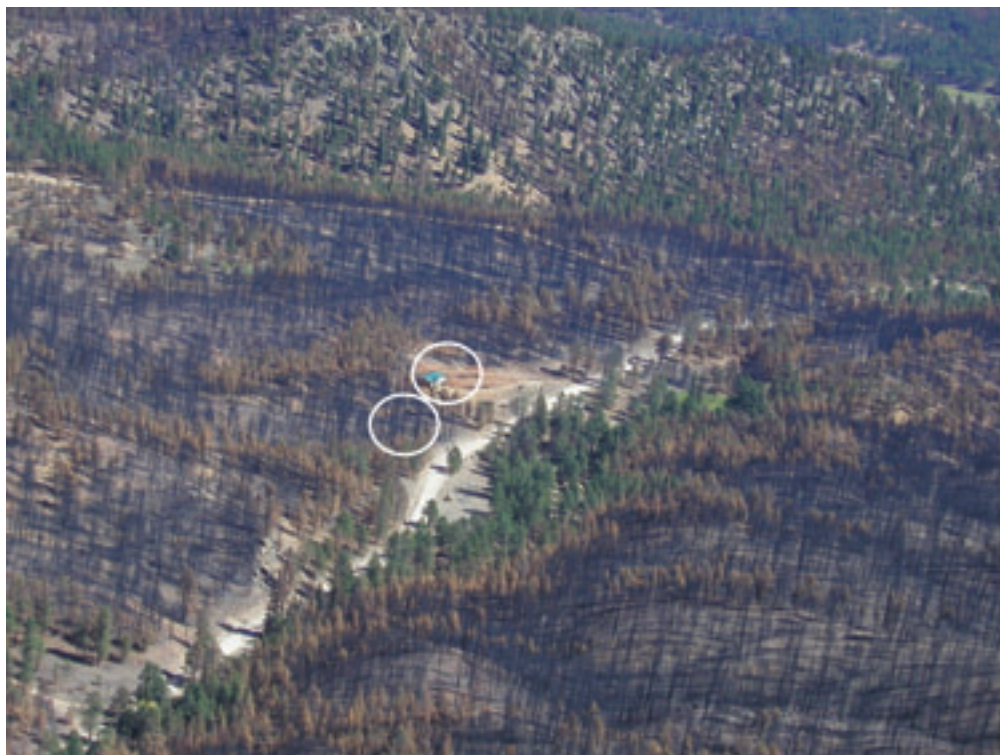
**Figure 32**—The homes in this scene (circled) along County Road 68 (Stump Road) were designated as destroyed by torching/crown fire. The home farthest away in the view is being rebuilt.

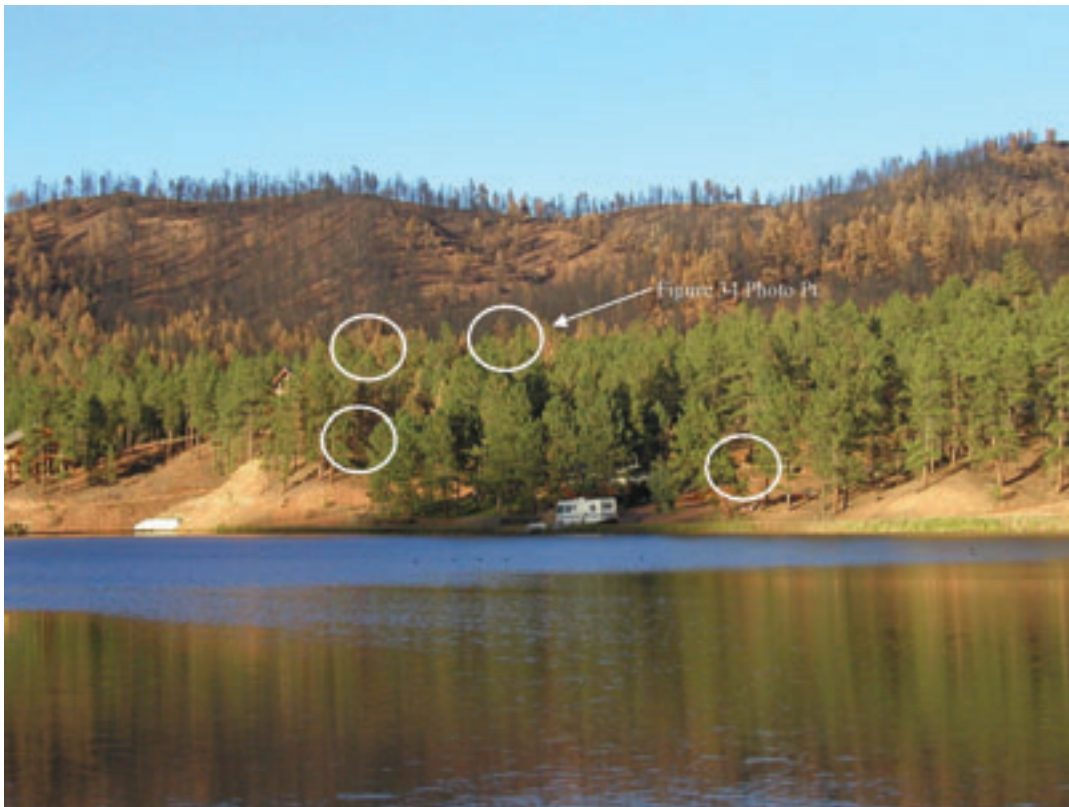
**Figure 33**—This view looking east in West Creek Lakes shows homes (circled) destroyed by surface fire and/or firebrands.

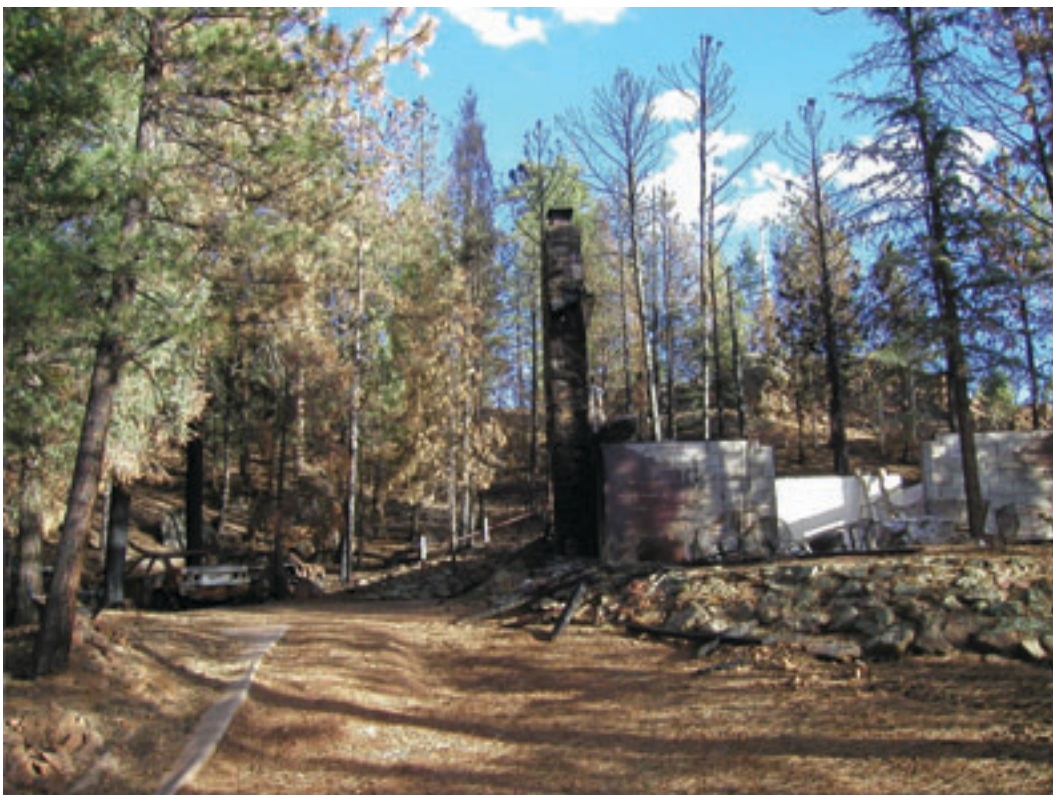
**Figure 34**—Surface fire and/or firebrands destroyed this home in West Creek Lakes.

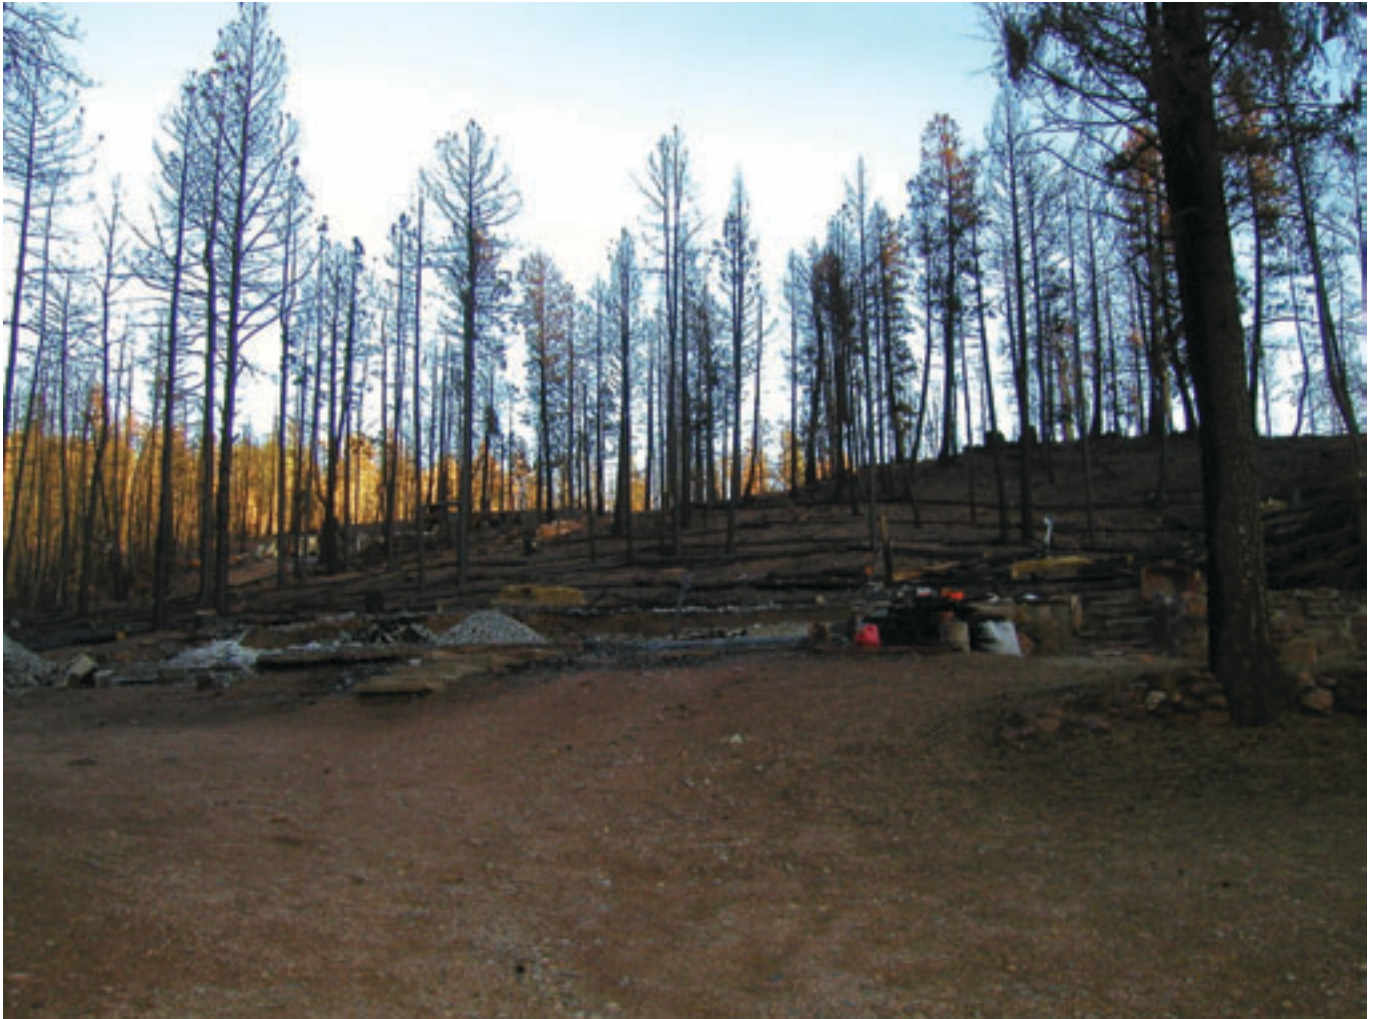
**Figure 35**—This home in West Creek Lakes was designated as destroyed by torching/crown fire.

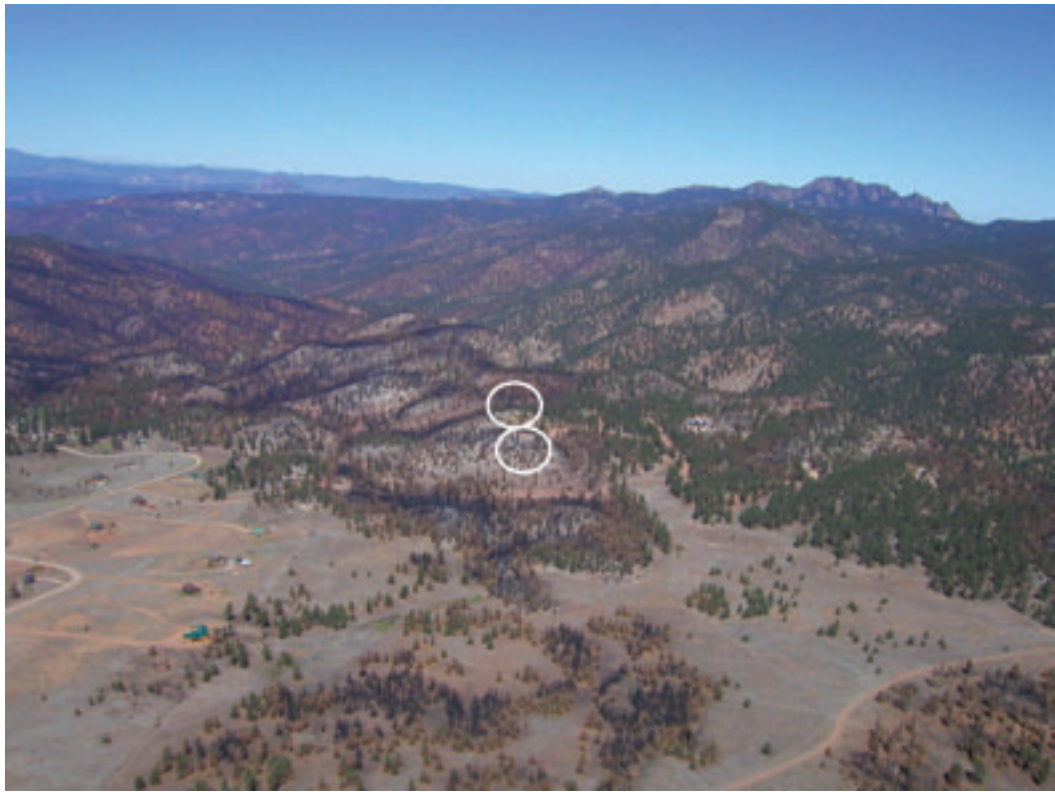
**Figure 37**—View of the west side of Trout Creek Ranch looking northwest toward two homes destroyed on a cul-de-sac.

experienced moderate to high GAI and high to moderate SSI (fig. 37, 38). The one exception was a home on Trout Creek that experienced moderate to low GAI and SSI (fig. 39).

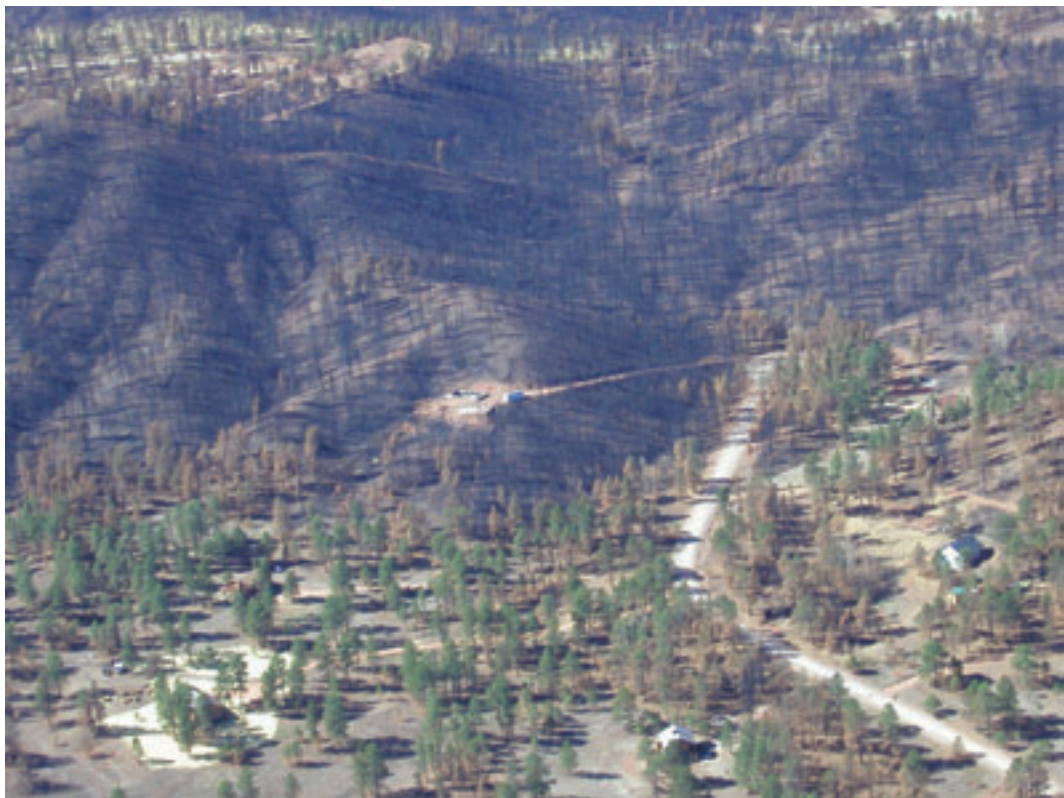
**Figure 38**—These homes on the east side of Trout Creek Ranch were designated as destroyed by torching/crown fire.

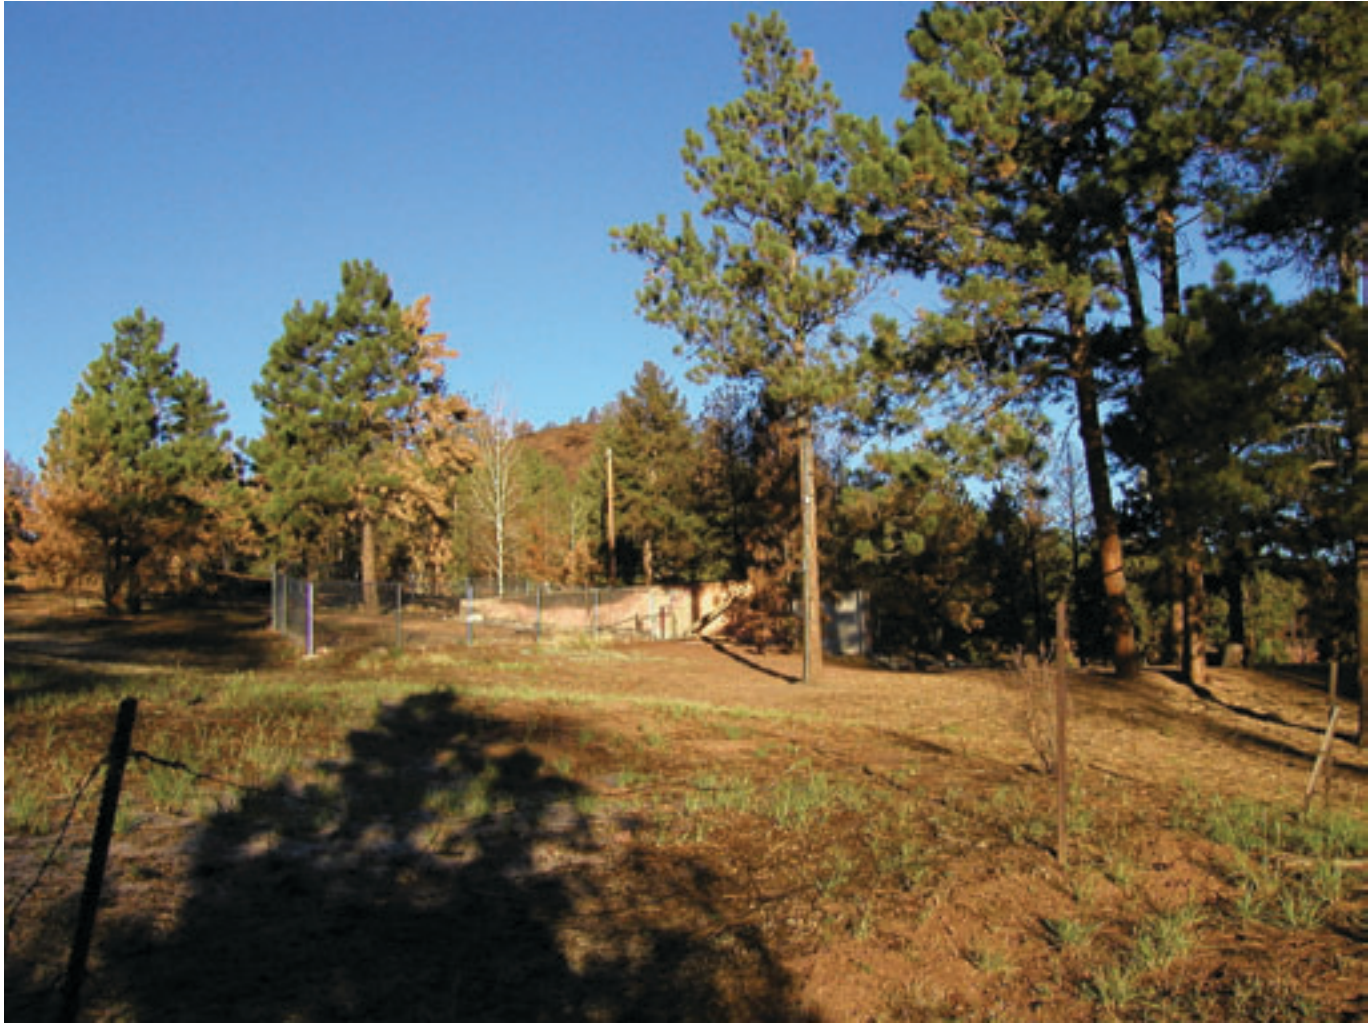
**Figure 39**—This home, on the south side of Trout Creek Ranch, was designated as destroyed by surface fire and/or firebrand.
