# IMPROVEMENTS IN TECHNICAL EXCELLENCE, COMMUNICATIONS AND DECISION-MAKING

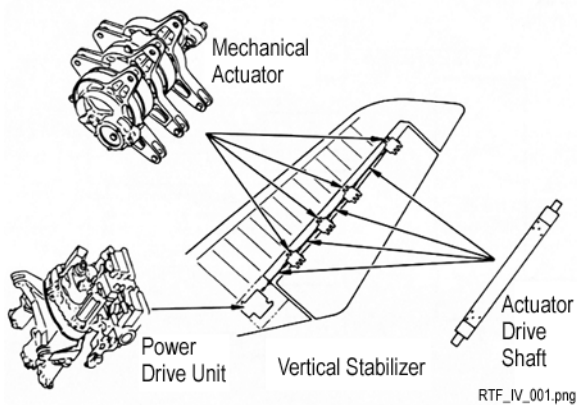
**The Rudder Speed Brake consists of two panels, four actuators and a drive shaft**

The Rudder Speed Brake (RSB) is part of the Shuttle's tail assembly. Located on the trailing edge of the vertical stabilizer, the RSB provides directional and speed control of an Orbiter. The RSB is driven by four actuators powered by a drive shaft. Like a traditional aircraft, the rudder swings from side to side to steer the Orbiter as it descends through the atmosphere. It also functions as a speed brake to slow the Orbiter down. When braking is needed, the sides of the rudder vertically split into two separate surfaces and flare out to provide air resistance.

In late 2002, internal corrosion was discovered in the body flap actuators of Atlantis (OV-104). Following the finding, the body flap actuators onboard Discovery (OV-103) were inspected and also found to be corroded and in need of refurbishment. Space Shuttles also use the same type of actuator in their RSB assembly. Because of the component commonality, NASA elected to inspect and refurbish the RSB actuators. The RSB actuators became an issue because corrosion inside the units could result in jamming of the RSB.

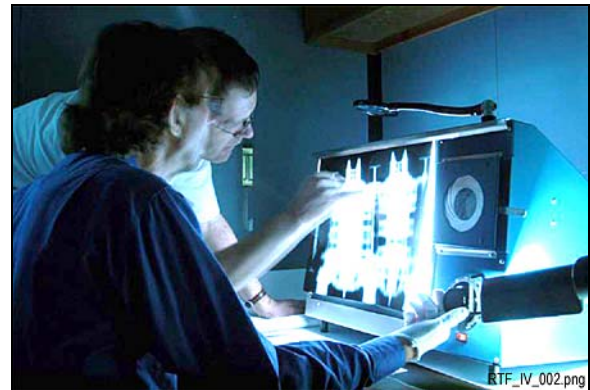
**Actuator inspection using X-ray analysis**

During the refurbishment of Discovery's RSB actuators, it was discovered that planetary gears in actuator No. 4 had been installed inverted. Gears in Discovery's other actuators also showed pitting and wear. Furthermore, X-ray analysis of replacement stock actuators revealed actuator No. 2 to have its planetary gear improperly installed, as well.

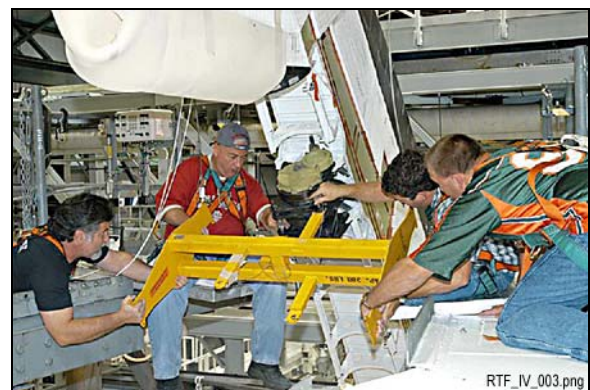
**Actuator installation on Discovery**

Upon the return of replacement actuator No. 2, the entire set of replacement actuators was installed on Discovery. This was the first time in Space Shuttle Program history that complete installation of the RSB components was performed entirely at Kennedy Space Center.

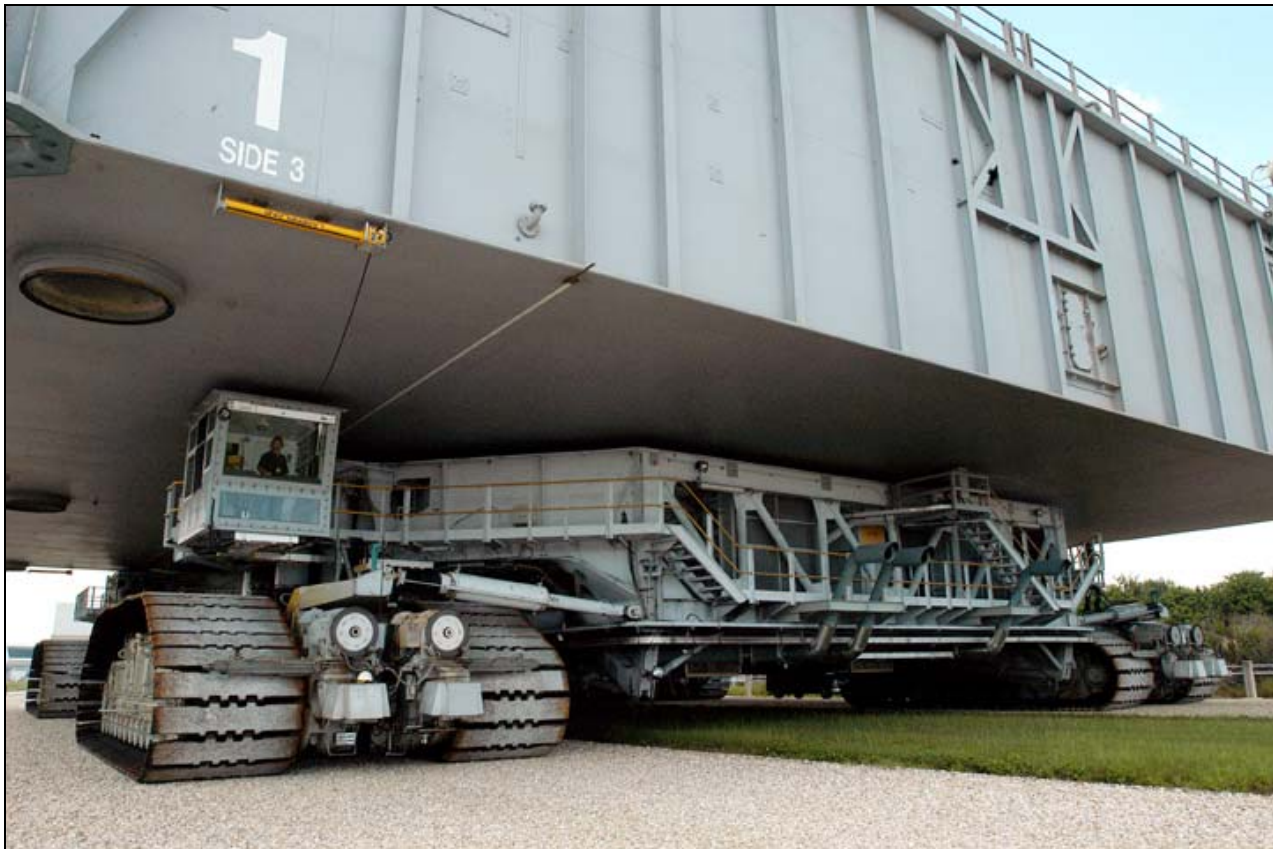
**Crawler Transporter vehicle**

Before Return to Flight, NASA's two Crawler Transporter vehicles underwent replacement of the 456 tread belt "shoes" on each vehicle. Each of the vehicles has eight belts, and each belt has 57 shoes. Each shoe is 7½ feet long and 1½ feet wide and weighs approximately 2,100 pounds.

KSC system engineers and technicians worked on the sprockets and rollers on each belt before the new shoes were installed. Welding repair and inspection of some of the sprockets and manufacture of some of the rollers were performed in the Launch Equipment Support Facility.

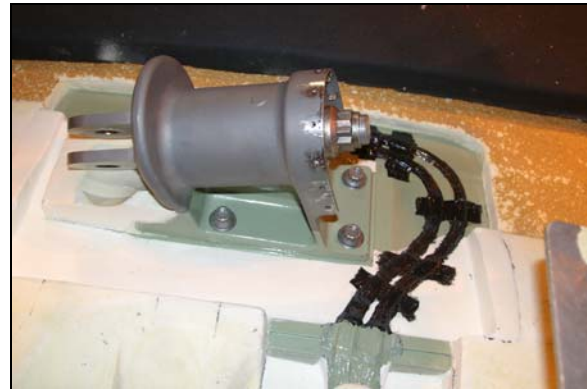
The External Tank's forward Shuttle attach fitting - called the bipod - was redesigned to eliminate the large insulating foam ramps as a debris source and replace them with electric heaters.

The ramps were in place to prevent ice buildup - another potential debris source - on the two

bipod fittings, which connect the tank to the Orbiter through the Shuttle's forward attach strut.

Development of this redesign concept actually began after some insulating foam from the left bipod ramp area came off during the October 2002 launch of Space Shuttle Atlantis on the STS-112 mission. During launch of Columbia on its STS-107 mission in January 2003, a similar loss prompted NASA's Office of Space Operations (then Office of Space Flight) to mandate a redesign of the bipod ramp.

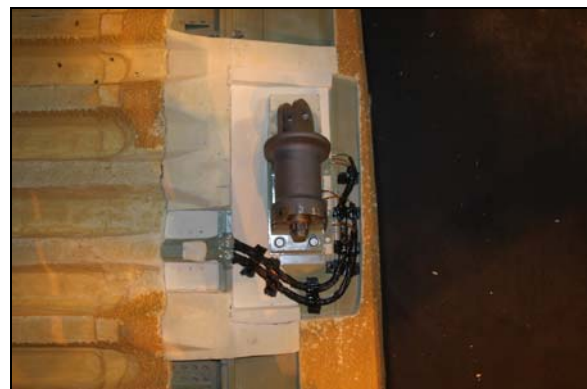
The foam ramps were wedge-shaped blocks hand sprayed and hand carved to the desired dimensions of about 30 inches by 14 inches by 12 inches to fit over the bipod fittings during the tank's final stages of preparation.

After the Columbia accident, engineering analysis and dissection of existing bipod ramps indicated that hand-spraying over the complex geometry of the fittings was prone to producing

voids and defects that contribute to foam loss during ascent.

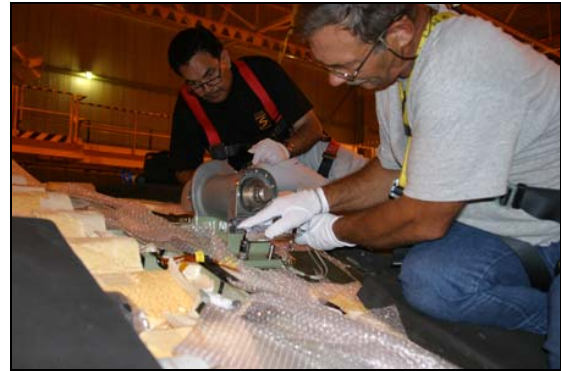
**Bipod installation**

Control of the heaters will be through ground-based Programmable Logic Controllers that will vary the heater power based on temperature sensors co-located with the heaters at the copper plates. Additional temperature sensors on the bipod fittings will monitor the fitting temperatures to ensure they stay above freezing. To minimize the potential for a launch scrub, the heaters and temperature sensors have built-in redundancy to permit operation even in the presence of certain hardware failures.

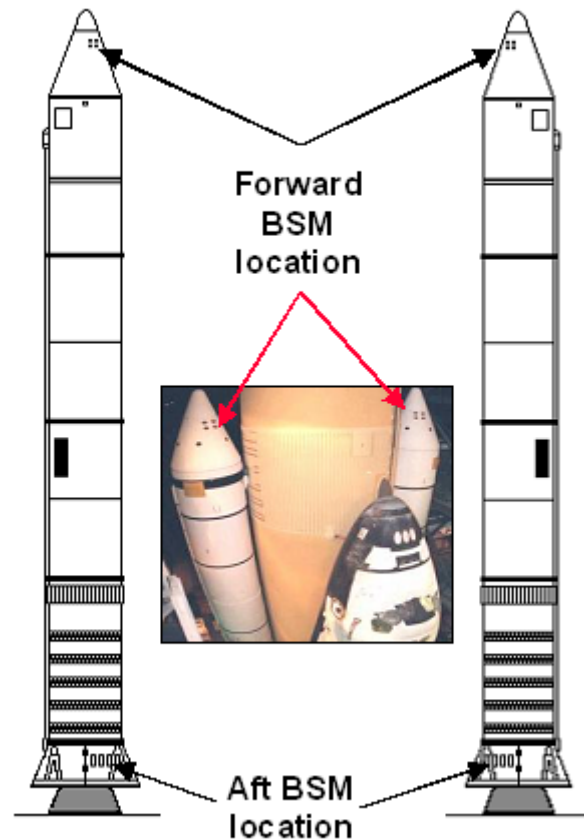
**Solid Rocket Booster separation motors ignite two minutes after launch pushing the boosters away from the Shuttle**

Design changes include beveling the solid propellant grain configuration; modifying the retainer design; and, modifying the adapter to direct loads to the center of the retainer plate. These efforts were undertaken with a parallel activity to tighten controls on propellant and material suppliers.

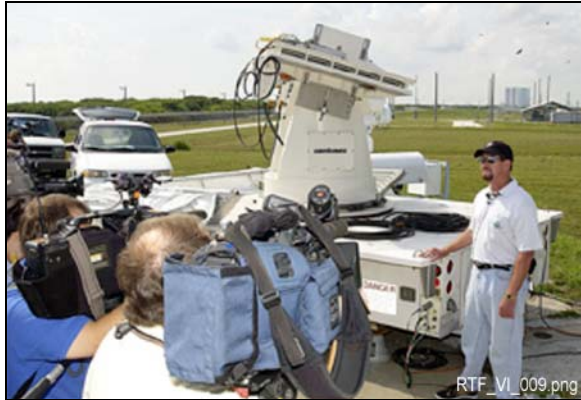
For Return to Flight, there are three camera sites designated one, two and six. Two new cameras have been added for camera site one, located northeast of the launch pad. The addition of this tracker ensures a view of the underside of the right wing as well as the area between the External Tank and the Orbiter to track any debris during its roll maneuver just after launch. All camera sites have two film and one HDTV video cameras.

The short-range tracking cameras have 200-mm focal length lenses and are loaded with 400 feet of film, running 100 frames per second. In addition to the film cameras around the launch pads, there are 42 fixed cameras with 16-mm motion picture film.

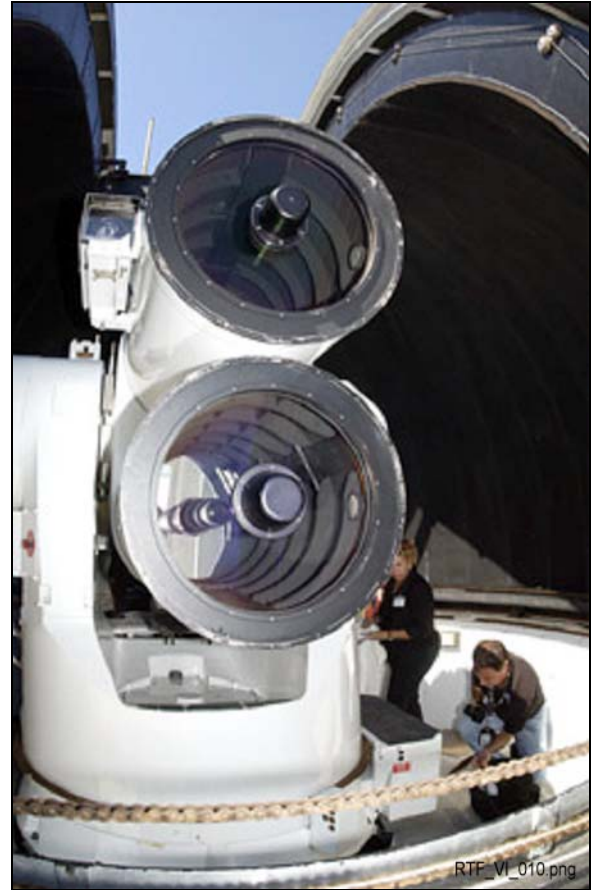
Medium-range trackers are located at six sites: Three along the coast and three near the Launch Complex 39 area. Placement at these sites provides three views for triangulation, to better characterize any suspect area. These cameras have 800-mm and greater lenses, running 100 frames per second. Three of the cameras have 400 feet of film and two have 1,000 feet. The additional tracking cameras have 150-inch lenses, with 1,000 feet of film. Five of six sites also have HDTV video cameras.

Five long-range trackers have existed north and south of the pads, from Shiloh and Playalinda to Cocoa Beach, ranging from 14 miles north to 20 miles south. These additions will reach as far north as Ponce de Leon Inlet, 38 miles from the launch pads, and south to Pigor, 11 miles from the pads. One of the cameras previously located at Patrick Air Force Base has been converted to be transportable and moved to a location north of the pad.

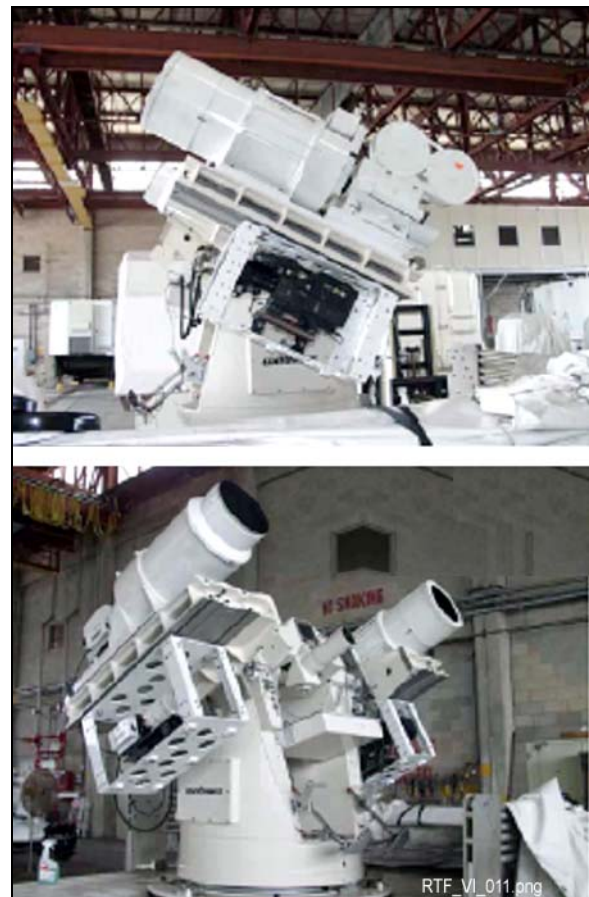
**Kineto Tracking Mount tracker**

Cameras are either fixed or mounted on a tracker. A variety of trackers are used at the different camera sites, the predominant tracker being a Kineto Tracking Mount (KTM) tracker. All of the trackers within close proximity to the launch pads are remotely controlled. The remaining trackers are remotely or manually controlled on-site.

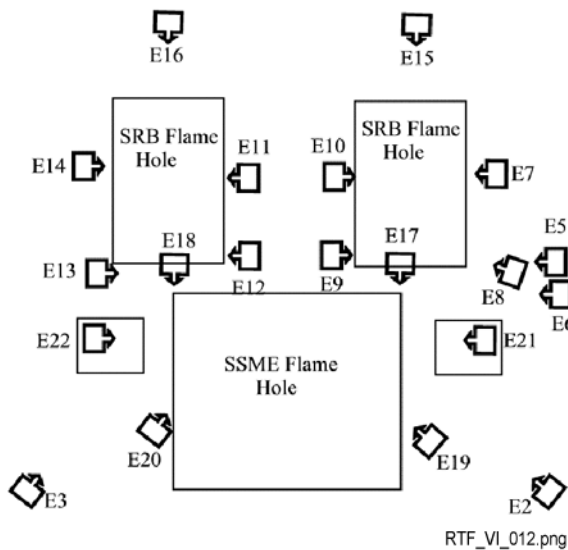
Twenty-two 16mm cameras are on the Mobile Launch Platform...

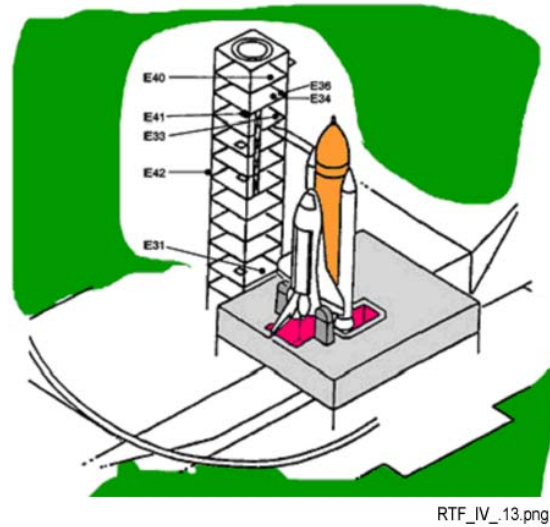
...and eight 16mm cameras are on the launch tower (Fixed Service Structure).

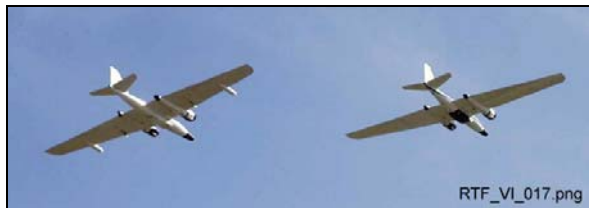
NASA has implemented use of an aircraft-based imaging system taking advantage of agency WB-57 aircraft based near the Johnson Space Center in Houston. The WB-57 Ascent Video Experiment (WAVE) will be used on an experimental basis during the first two post-Columbia Space Shuttle flights and provide both ascent and entry imagery to enable better observation of the Shuttle on days of heavier cloud cover and areas obscured from ground cameras by the launch exhaust plume. WAVE was initiated to develop the technical and operational capabilities of obtaining video of the Shuttle during launch from an aircraft, which will supplement ground cameras to obtain three useful views.

WAVE includes a 32-inch ball turret system mounted on the nose of each WB-57 aircraft. The turret houses an optical bench providing installation for both High Definition Television and infrared cameras. Optics consists of an 11-inch-diameter, 4.2 meter fixed focal length lens. The system can be operated in both auto track and manual modes from a command and control system in the cockpit, which includes monitors for all three cameras, switch panels and joysticks. All footage will be recorded on board and returned for processing and evaluation shortly after the Shuttle launch.

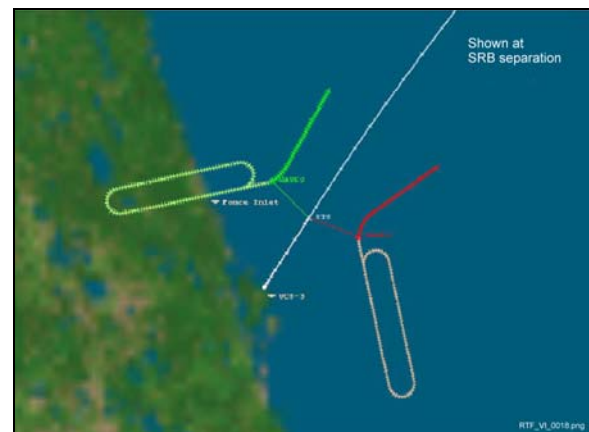
Two and a half hours before launch, the aircraft will take off from Patrick and enter a holding pattern. One will be positioned north of the Shuttle's flight path and one will be positioned south. The aircraft will be in communication with a WAVE Operations Officer in the Range Operations Control Center who in turn will be in communication with the chairperson of the imagery team in the Launch Control Center.

Twenty minutes before launch the aircraft will enter their final circuit, and about five minutes before launch will begin recording video. The WAVE requirement is for imagery acquisition from 60 seconds after liftoff to 15 seconds after booster separation. However, plans are for the aircraft to track the vehicle from liftoff through Main Engine Cut Off (MECO), which occurs 8 1/2 minutes later. The two aircraft should be about 23 miles (37 kilometers) from the Shuttle at booster separation.

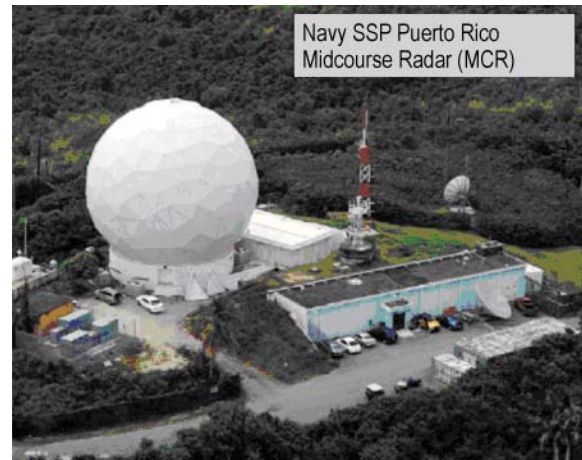
**Wideband, Coherent C-Band Radar**  
 3MW peak transmit power  
 0.5 M range resolution @ 500 Mhz WB LFM  
 15.24 M dish diameter

The Wideband Coherent C-band Radar provides high spatial resolution of debris events, and can detect debris events within the Shuttle vehicle stack. This radar – called the Navy Midcourse Radar – formerly was located at Roosevelt Roads Naval Station in Puerto Rico. It now resides at the site formerly occupied by the National Center for Atmospheric Research, north of Kennedy.

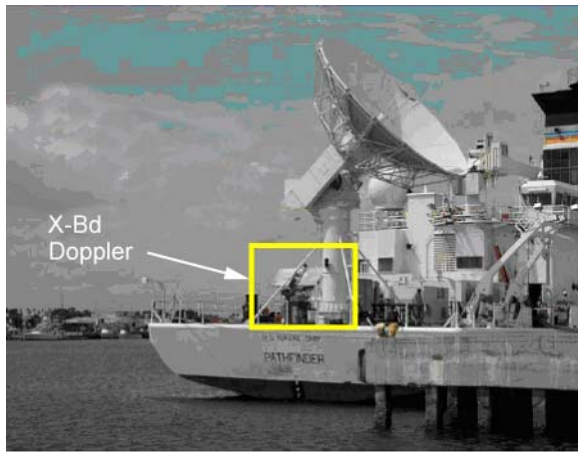
**Continuous Pulse Doppler X-Band Radar**  
 1.6 KW peak transmit power  
 0.14 M/S Doppler velocity resolution  
 4 x 4 M reflector size

The radars are capable of resolving debris at or greater than observed signal strength of minus 50 decibels per square meter (dBsm). Shuttle debris sources have been characterized as typically falling within in the minus 30 dBsm to minus 45 dBsm range. The X-band and the C-band radars were tested in August 2004 during the launch of the Delta II/Messenger spacecraft from the National Center for Atmospheric Research (NCAR) site intended to permanently house the systems.

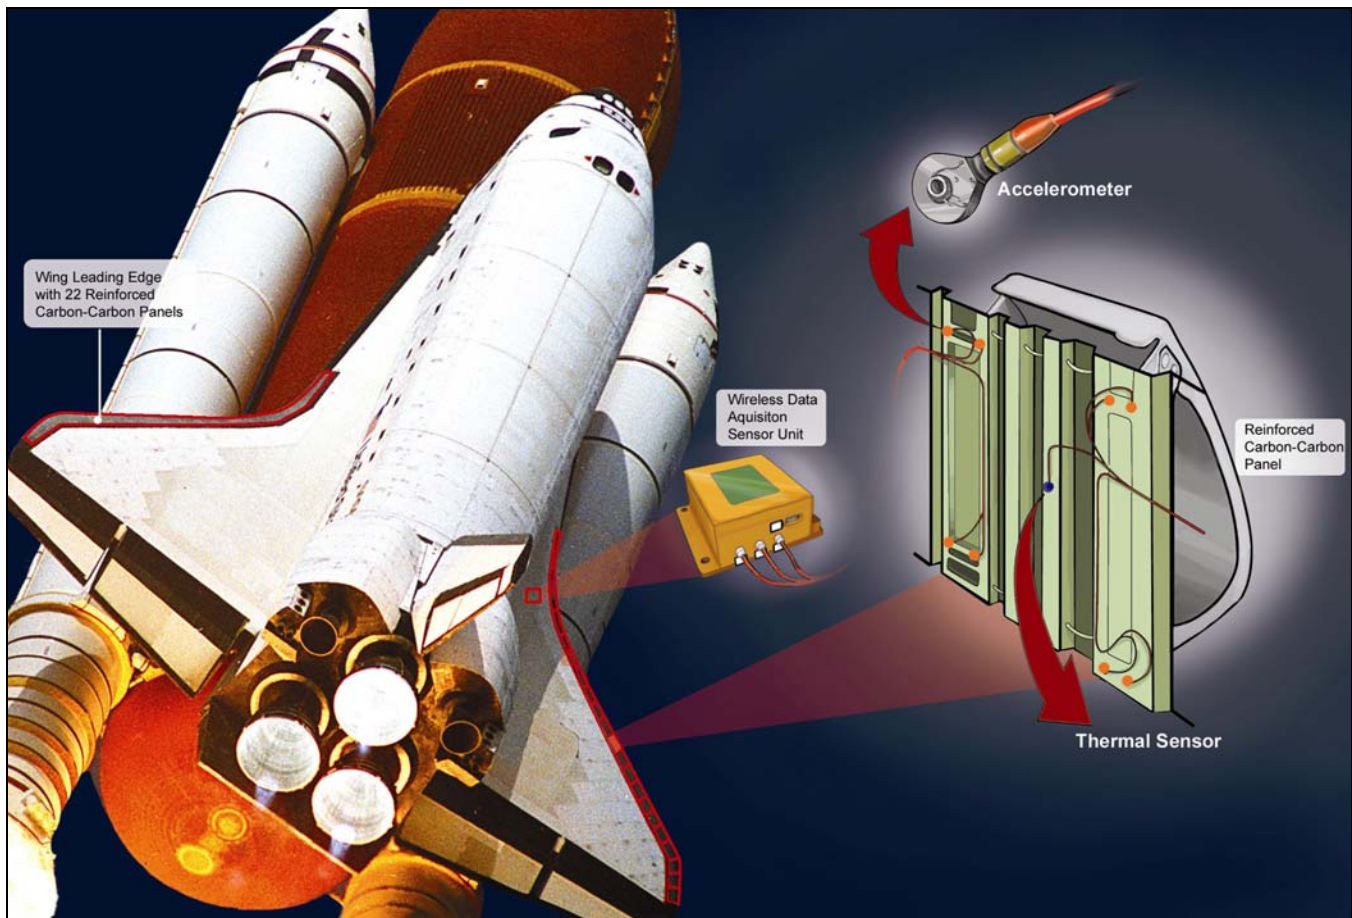
**Wing Leading Edge Impact Detection System**

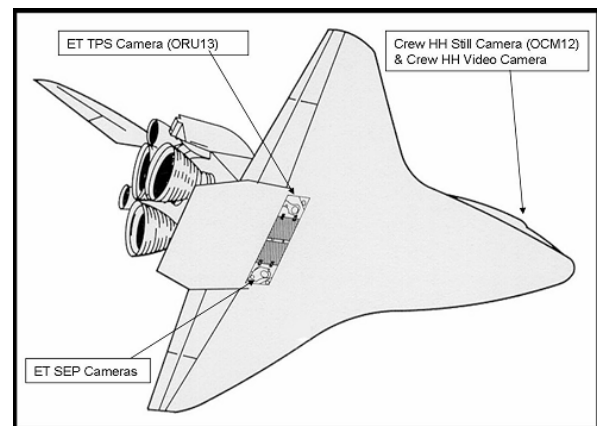
**Shuttle Orbiter-Based Photography for STS-114 Ascent**

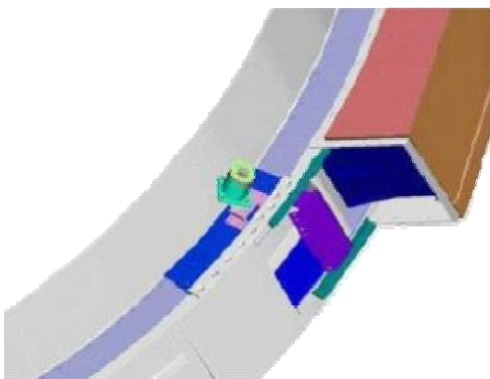
ET Ring Camera Housing Installed

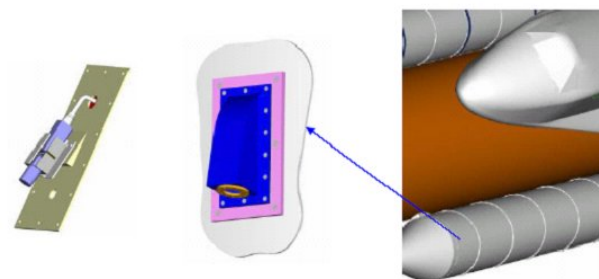
Forward Skirt Aft-Pointing Camera Prototype Housing

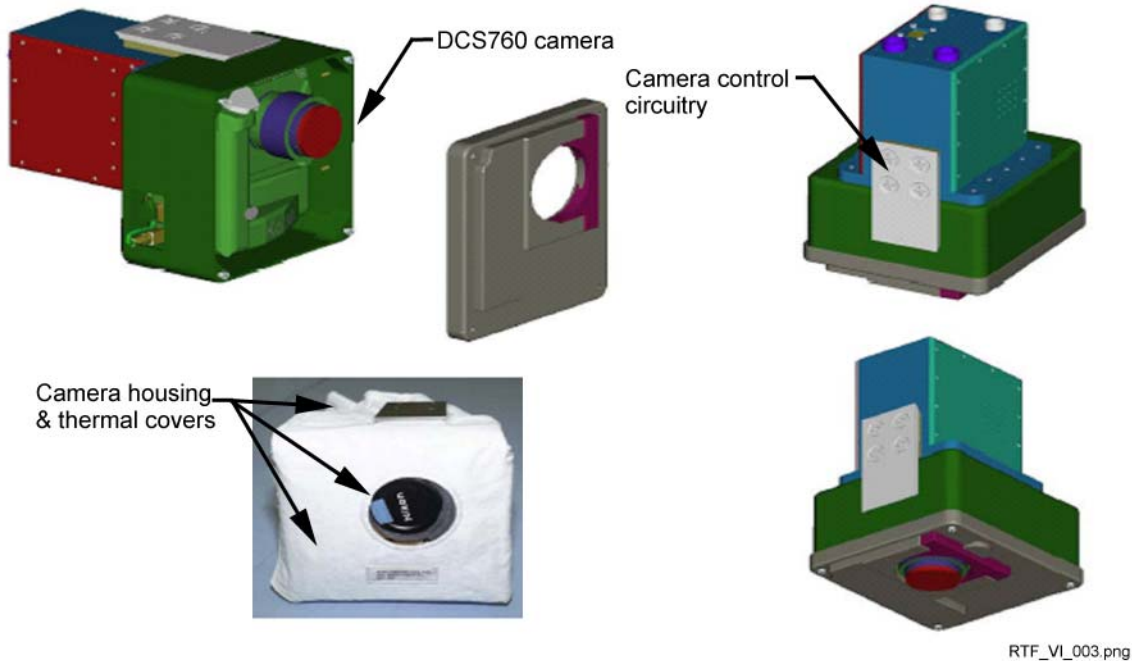
**Digital Umbilical Still Camera System**

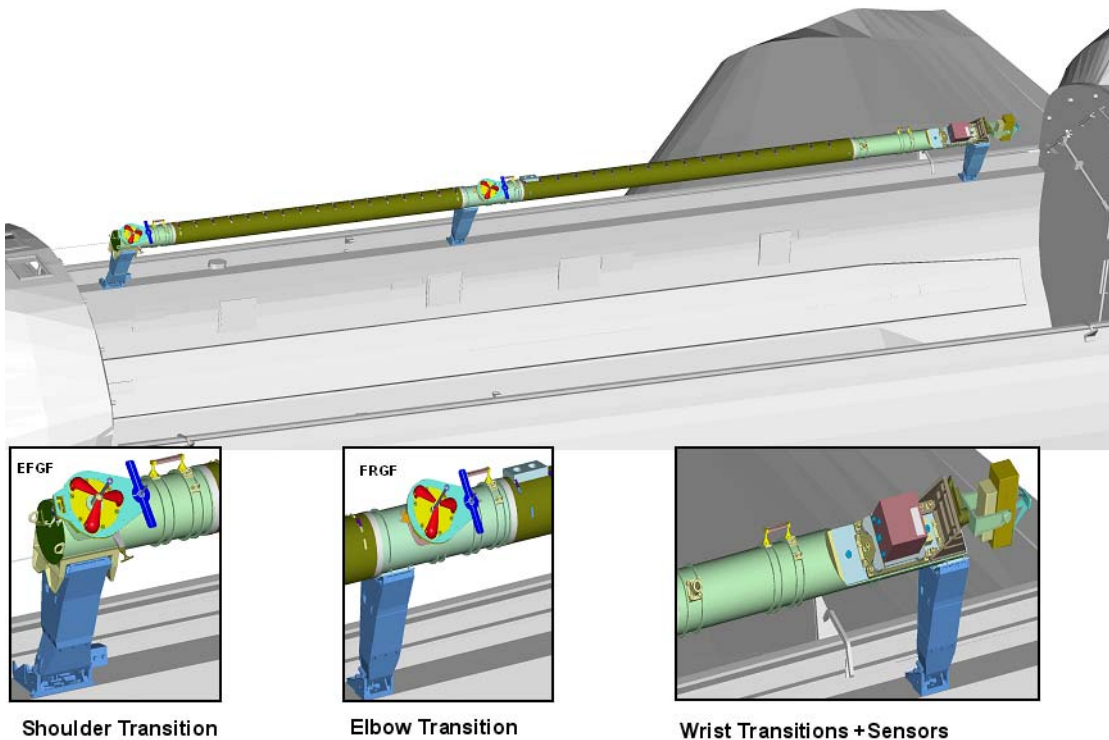
**Orbiter Boom Sensor System Installed on Starboard Sill**

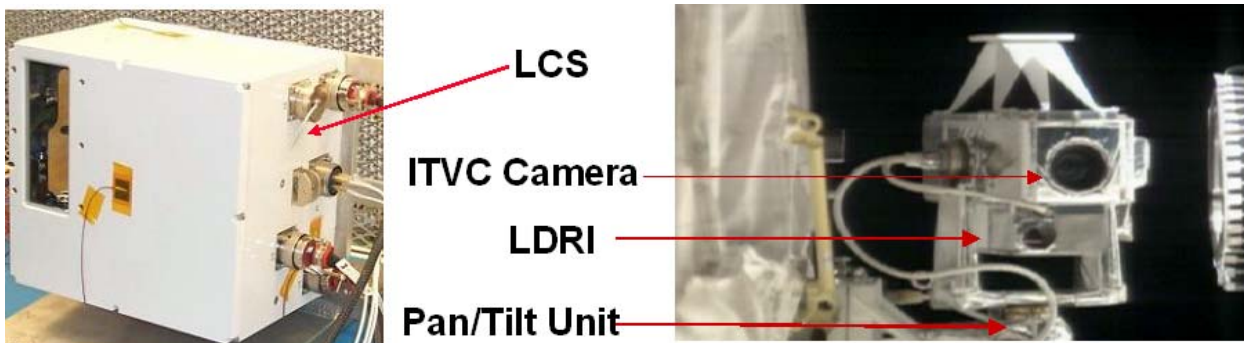
- Neptec Laser Camera System (LCS)
- Triangulates 3D position with a small diameter scanning laser beam
- Sandia Laser Dynamic Range Imager (LDRI)
- Illuminates the FOV with modulated laser light. Images on a camera CCD are processed to provide depth information.
- Designed & flown as an integrated package with an ITVC and pan & tilt unit (PTU)
