RE: Freedom of Information Request #08-F-00760: Copy of documents released for FOIA Log #2007040099 ~ SUNL Group, Inc., Tao Group, Aim-EX Industry

Sample 06-840-7240 Sunl Group, Inc. SLA-90MR (90cc) ATV 060707CRC1127
Pink in color VIN not identified on shipping materials. No model year associated.

Evaluation Of The SunL SLA-90 CC ATV

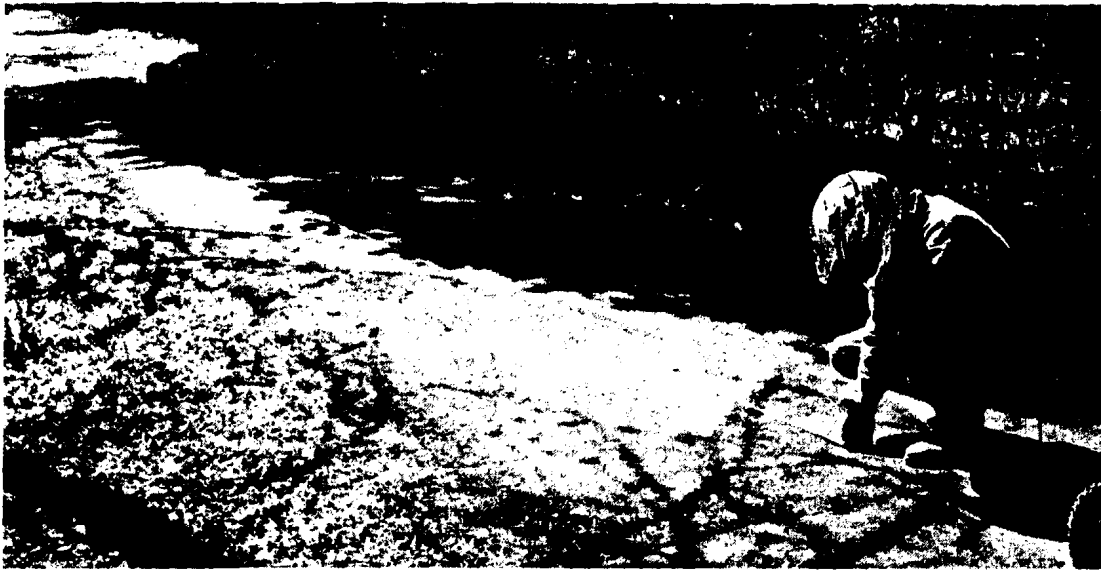
Figure 4. Brake Test Measurement

Four tests were conducted with the following stopping distances: 37'0"; 43'4"; 47'2"; and 52'6" (See Figure 4). As all the stopping distances exceed the requirement, this ATV fails the service brake performance requirements.

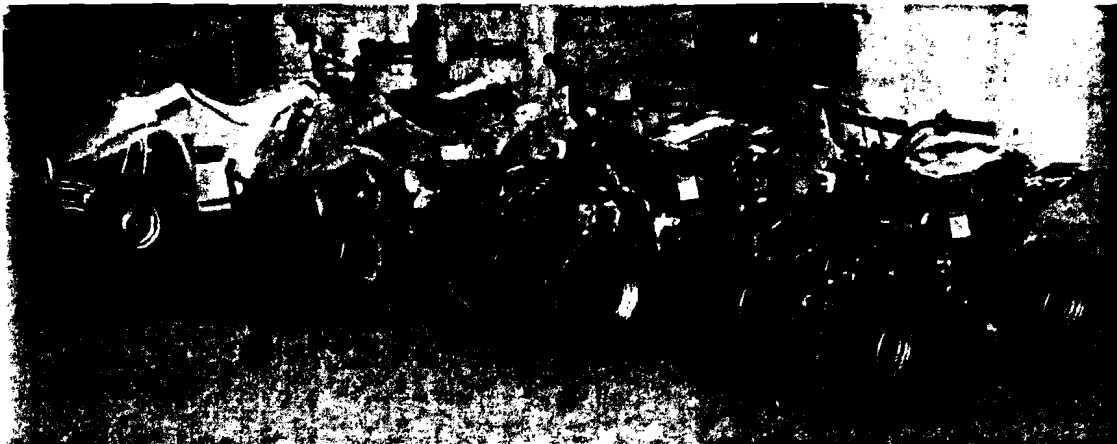
Figure 1: Sample ATVs with smaller frames

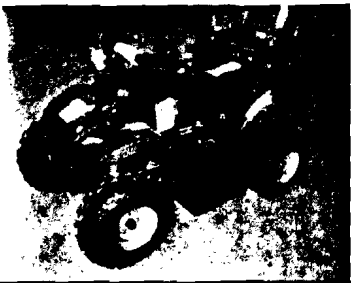
SAMPLE NO.	MANUF/MODEL/ ENG. SIZE/AGE	NON-COMPLIANCE W/ VS
<p>06-840-7265</p>

<p>Lifan/ A12S 125 ST</p> <p>Engine: 125 cc</p> <p>Ages: 16 min</p> <p>Max load: 220 lbs.</p>	<ul style="list-style-type: none"> • Section 4.4-engine stop switch • Section 4.9- neutral indicator • Section 4.15-handlebars • Section 4.19-tire markings • Section 4.20-tire pressure gauge • Section 4.22-owner's manual storage
<p>06-840-7240</p>

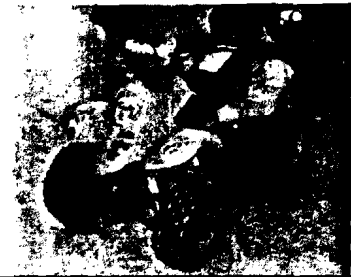
<p>SUNL/ SLA 90</p> <p>Engine: 90 cc</p> <p>Ages: 16 min</p> <p>Max load: 188 lbs.</p>	<ul style="list-style-type: none"> • Section 4.1-service brakes • Section 4.3-mechanical suspension • Section 4.12-carry bar • Section 4.13-flag pole bracket • Section 4.14-manual fuel shutoff • Section 4.15-handlebars • Section 4.20-tire pressure gauge • Section 4.22-owner's manual storage
<p>06-840-6803</p>

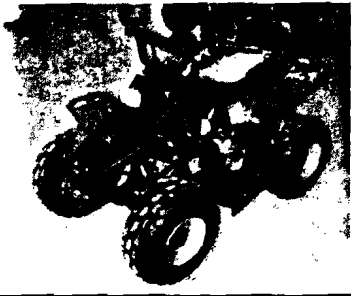
<p>Kazuma/ Meerkat 50-4A</p> <p>Engine: 49 CC</p> <p>Ages: 12 min</p> <p>Max load: 88 lbs.</p>	<ul style="list-style-type: none"> • Section 4.1-service brakes • Section 4.3-mechanical suspension • Section 4.9-neutral indicator • Section 4.13-flag pole bracket • Section 4.19-tire markings • Section 4.20-tire pressure gauge • Section 4.22-owner's manual storage

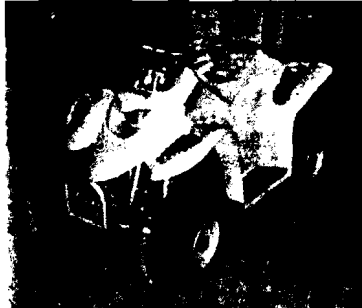
SAMPLE NO.	MANUF/MODEL/ ENG. SIZE/AGE	NON-COMPLIANCE W/ VS
<p>06-810-2113</p>

<p>Xtreme Motor Co/ X-49</p> <p>Engine: 49.5 CC</p> <p>Ages: 6-12</p> <p>Max load: 100 lbs.</p>	<ul style="list-style-type: none"> • Section 4.1-service brakes • Section 4.3-mechanical suspension • Section 4.4-engine stop switch • Section 4.13-flag pole bracket • Section 4.15-handlebars • Section 4.20-tire pressure gauge • Section 4.22-owner's manual storage
<p>06-840-6290</p>

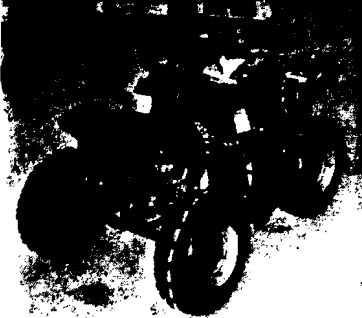
<p>Ohalee, Inc./ Cruiser ATV-05</p> <p>Engine:72 cc</p> <p>Ages: 12 min</p> <p>Max load: 88 lbs.</p>	<ul style="list-style-type: none"> • Section 4.1-service brakes • Section 4.3-mechanical suspension • Section 4.13-flag pole bracket • Section 4.19-tire markings • Section 4.20-tire pressure gauge • Section 4.22-owner's manual storage
<p>06-810-2944</p>

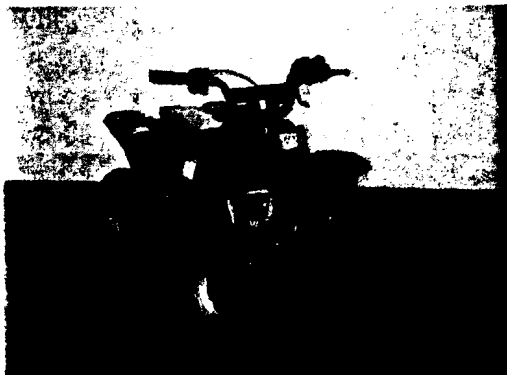
1. Ohalee, Sample # 06-840-6290

Included with this ATV are an Owner's Manual, two Parts Explored View, and Maintenance and Lubrication guide, and a Consumer Motor Vehicle Delivery Preparation and Inspection Form. There were no assembly instructions included with this ATV. Compliance staff noted that the ATV came in a crate assembled except for the handlebars and battery. It was also noted that the tires were over-inflated.

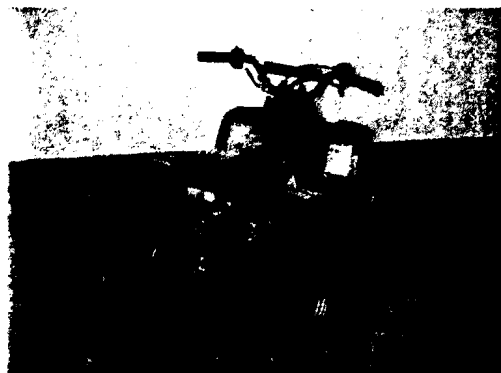
2. Kazuma, Sample # 06-840-6803

Included with this ATV is an Owner's Manual, two Parts Explored View. There were no assembly instructions included with this ATV. Compliance staff noted that the ATV came in a crate assembled except for the handlebars, battery and rear wheels.

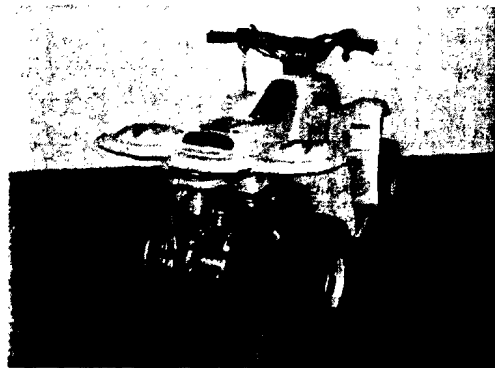
3. XTreme Motor, Sample # 06-810-2113

Included with this ATV are an Owner's Manual and Maintenance Guide, a Parts Manual, and a Service Manual. There were no assembly instructions included with this ATV. Compliance staff noted that the ATV came in a crate assembled except for the handlebars, front push bar, and battery.

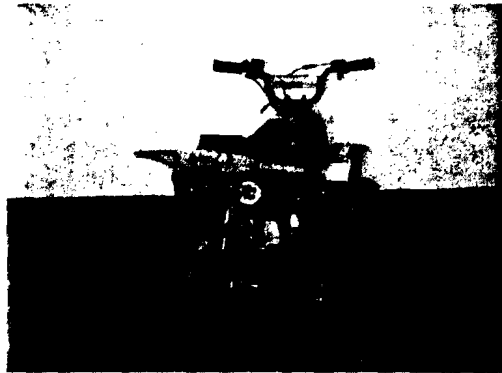
4. SUNL, Sample # 06-840-7240

Included with this ATV is an Owner's Manual. There were no assembly instructions included with this ATV. Compliance staff noted that the ATV came in a crate fully assembled except for the battery.

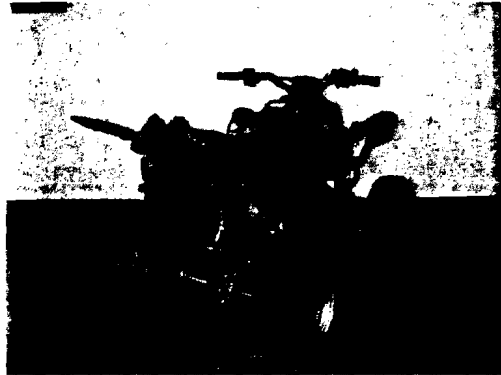
5. Long Chang, Sample # 06-810-2455

Included with this ATV is an Owner's Manual. There were no assembly instructions included with this ATV. Compliance staff noted that the ATV came in a crate with none of the four tires assembled, as well as the front push bar, handlebars, and battery.

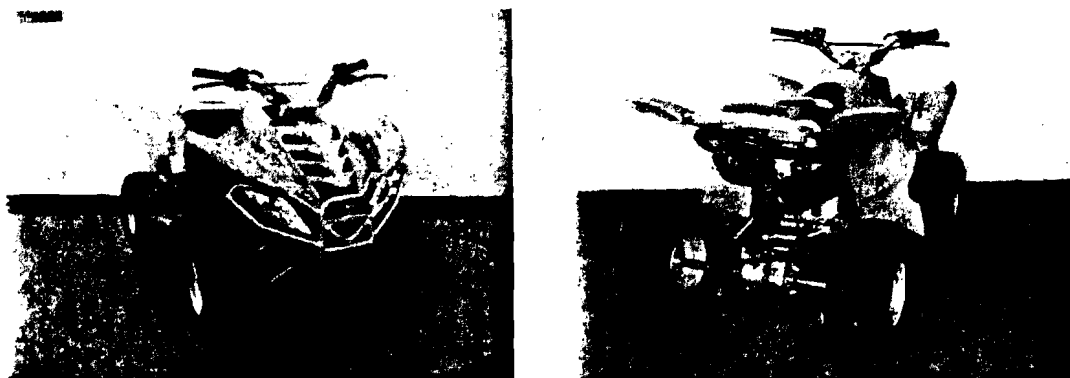
6. Baja, Sample # 06-840-6430

Included with this ATV are an Owner's Manual and Set-up Instructions. Compliance staff noted that the ATV came assembled except for the front push bar, grill cover, handlebar cover, and battery.

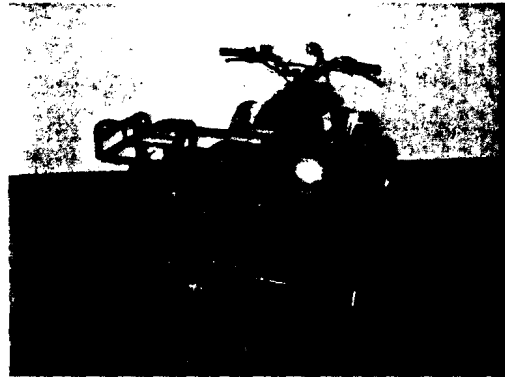
7. Lifan, Sample #06-840-7265

Included with this ATV are an Owner's Manual and Parts Catalog. There were no assembly instructions included with this ATV. Compliance staff noted that the ATV came assembled except for the front wheels, racks, fenders, wheel wells, light, and brush guard.

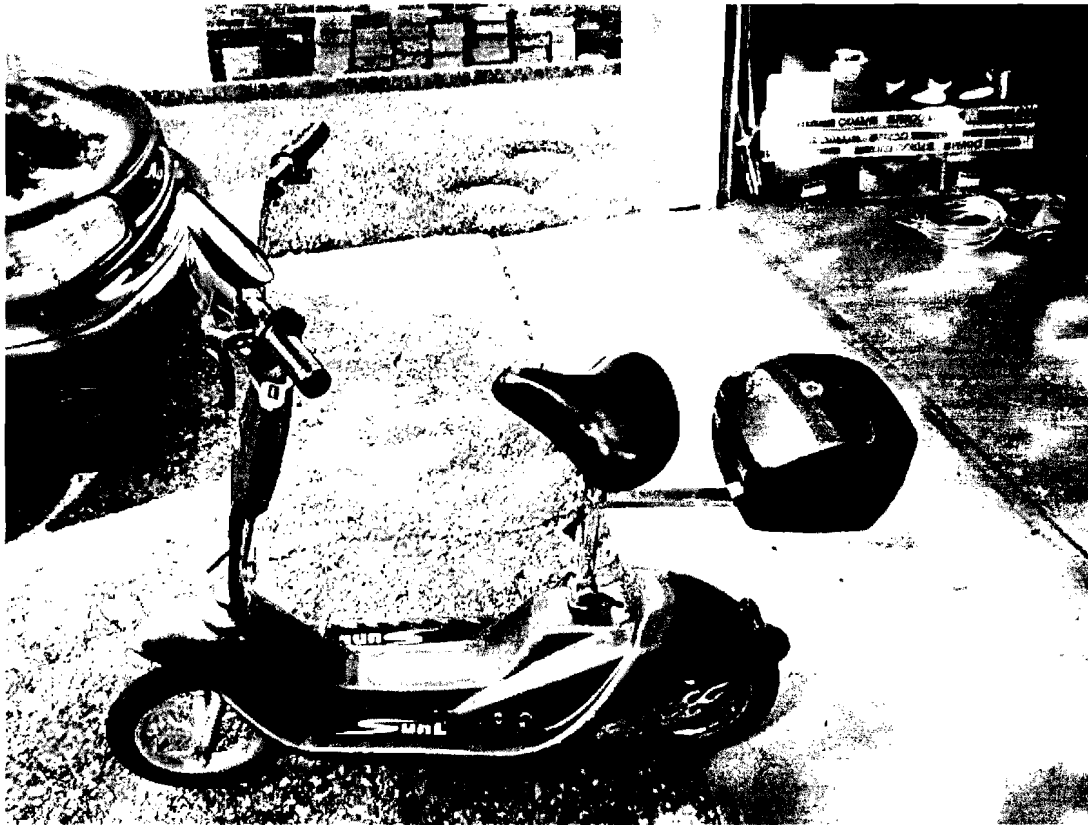
IDI 040914CCN0982 – Photo 1 – Overall view of the electric scooter.

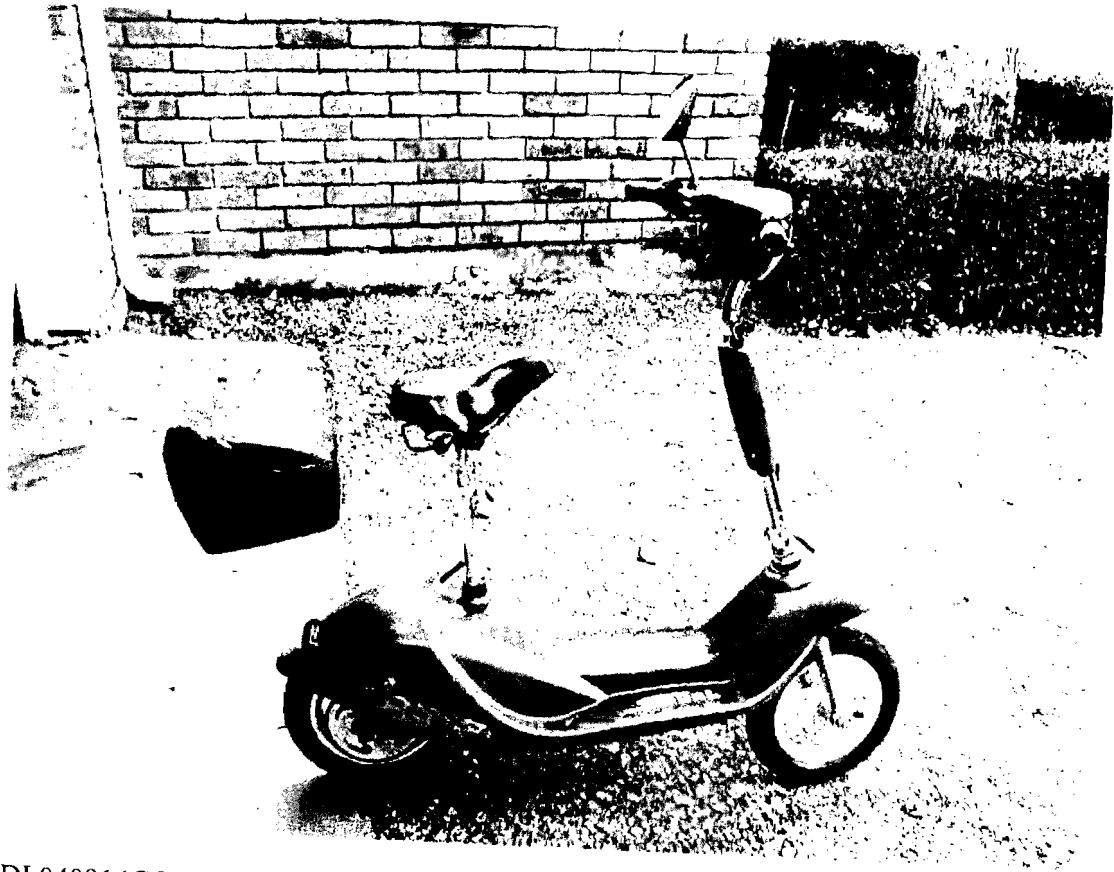
IDI 040914CCN0982 – Photo 2 – Another overall view of scooter.

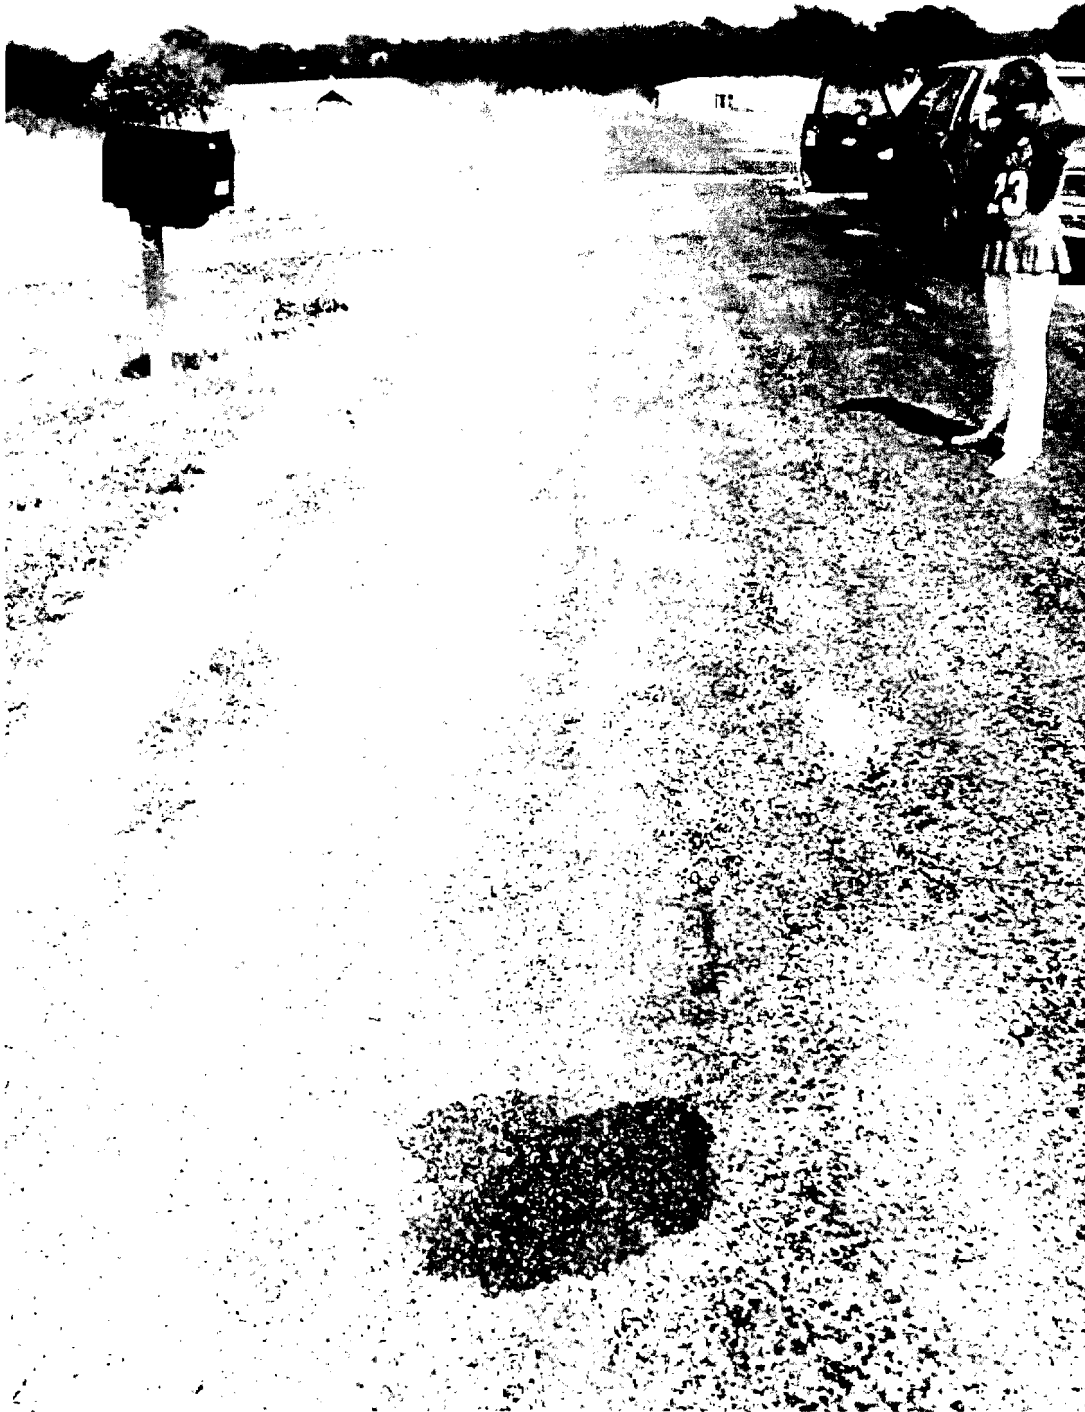
050909CCN0854 – Photo 2 – This photo shows an area in the road where the gas line ruptured and gas spilled onto the road.

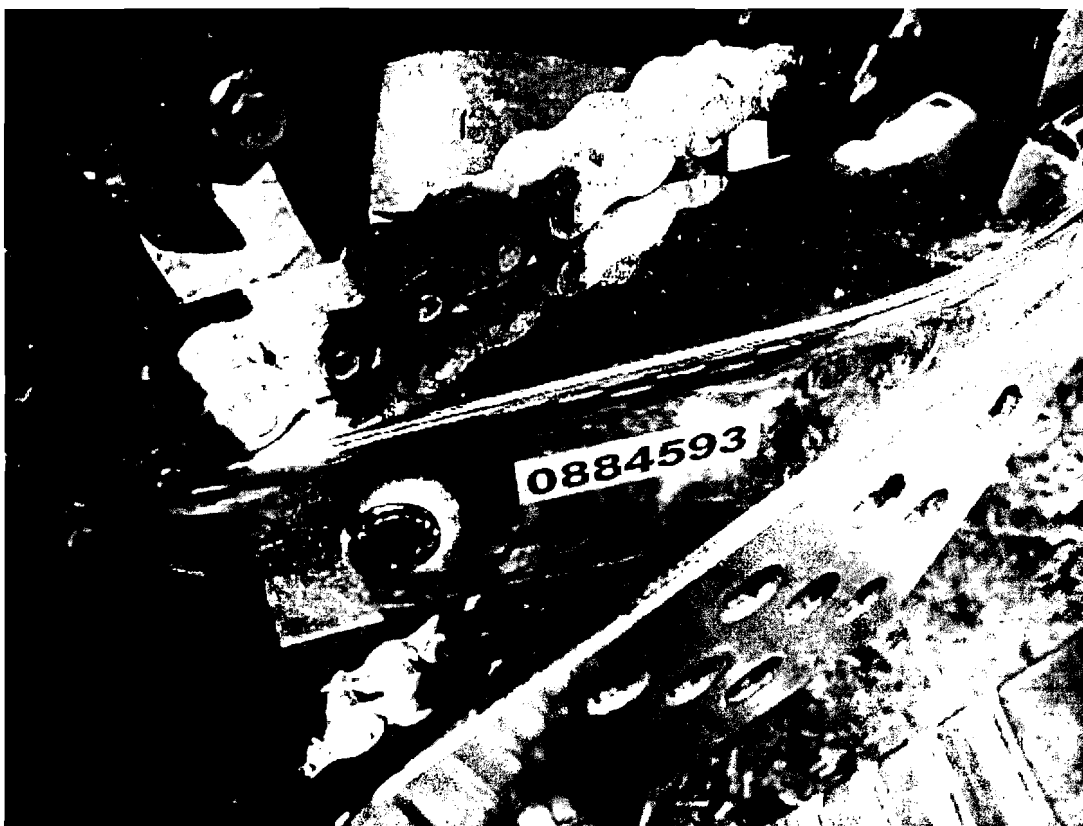
050909CCN0854 – Photo 9 - This photo shows the number “0884593” noted on the motor bike.

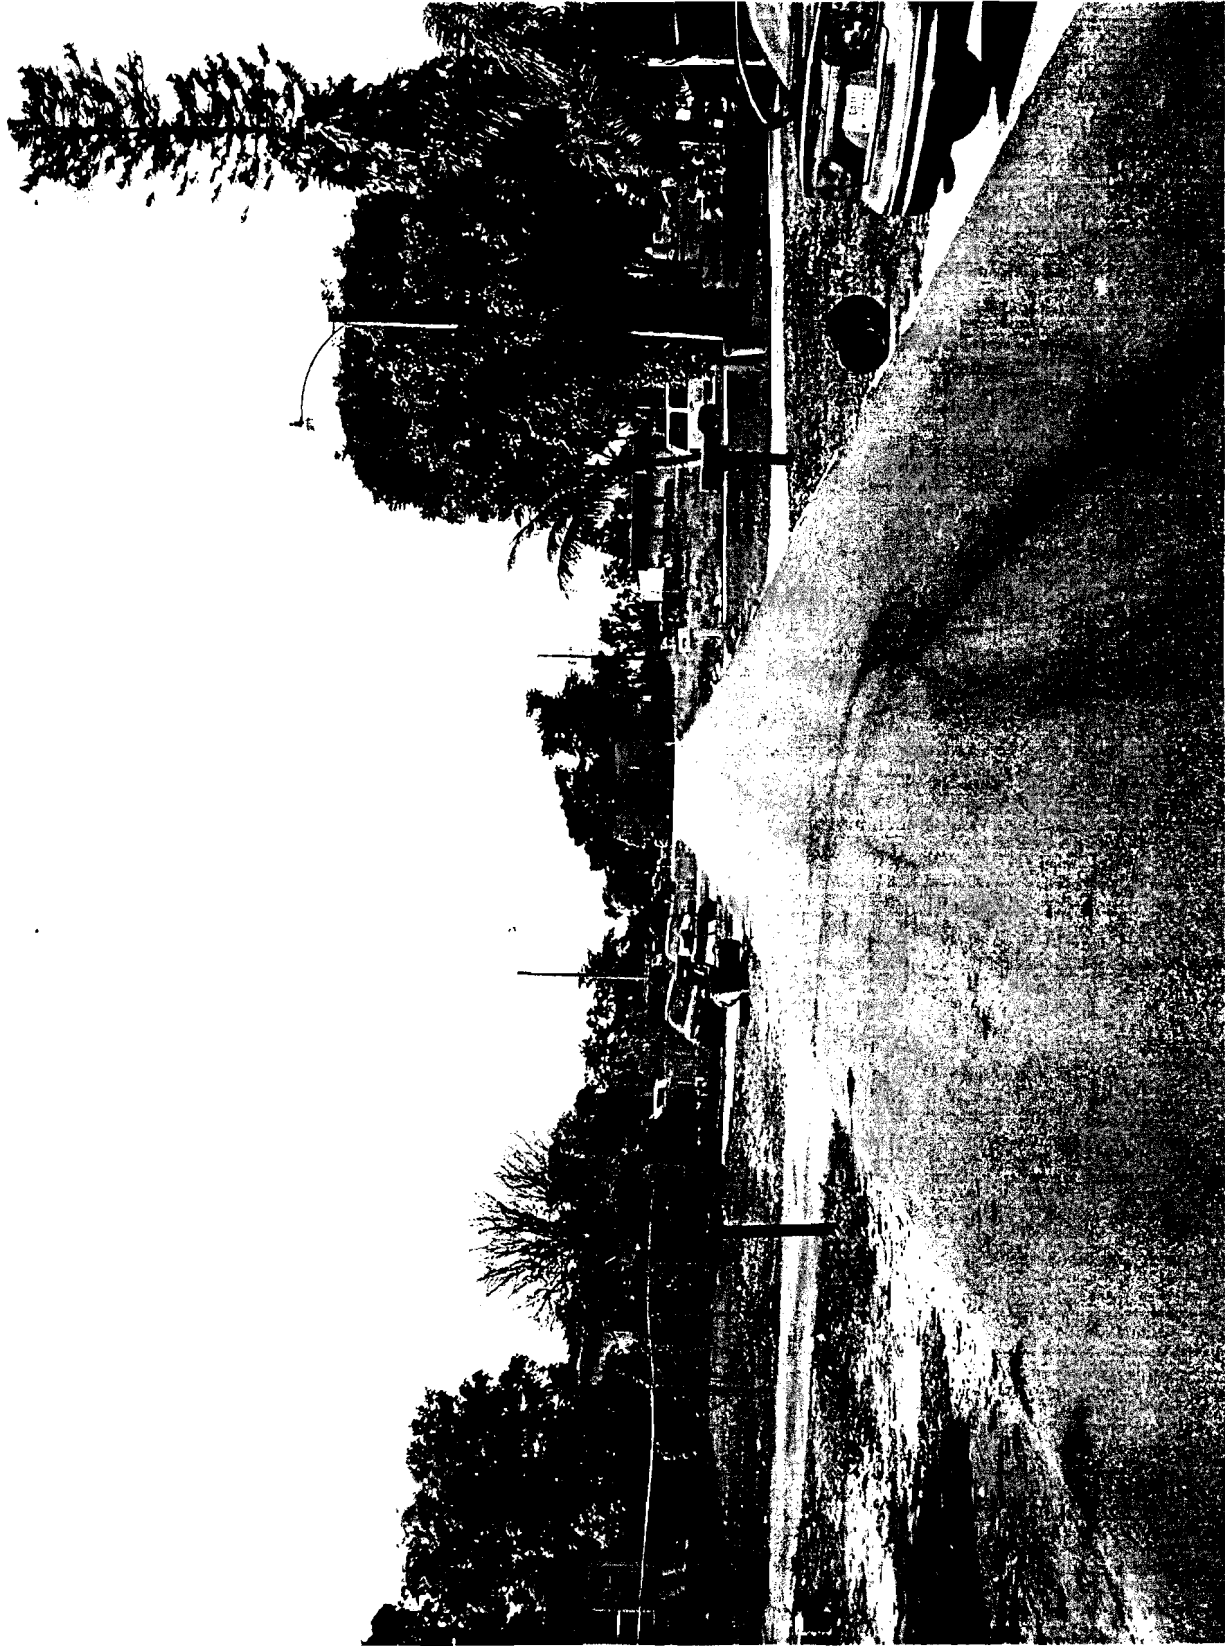
Photograph looking toward the struck building.

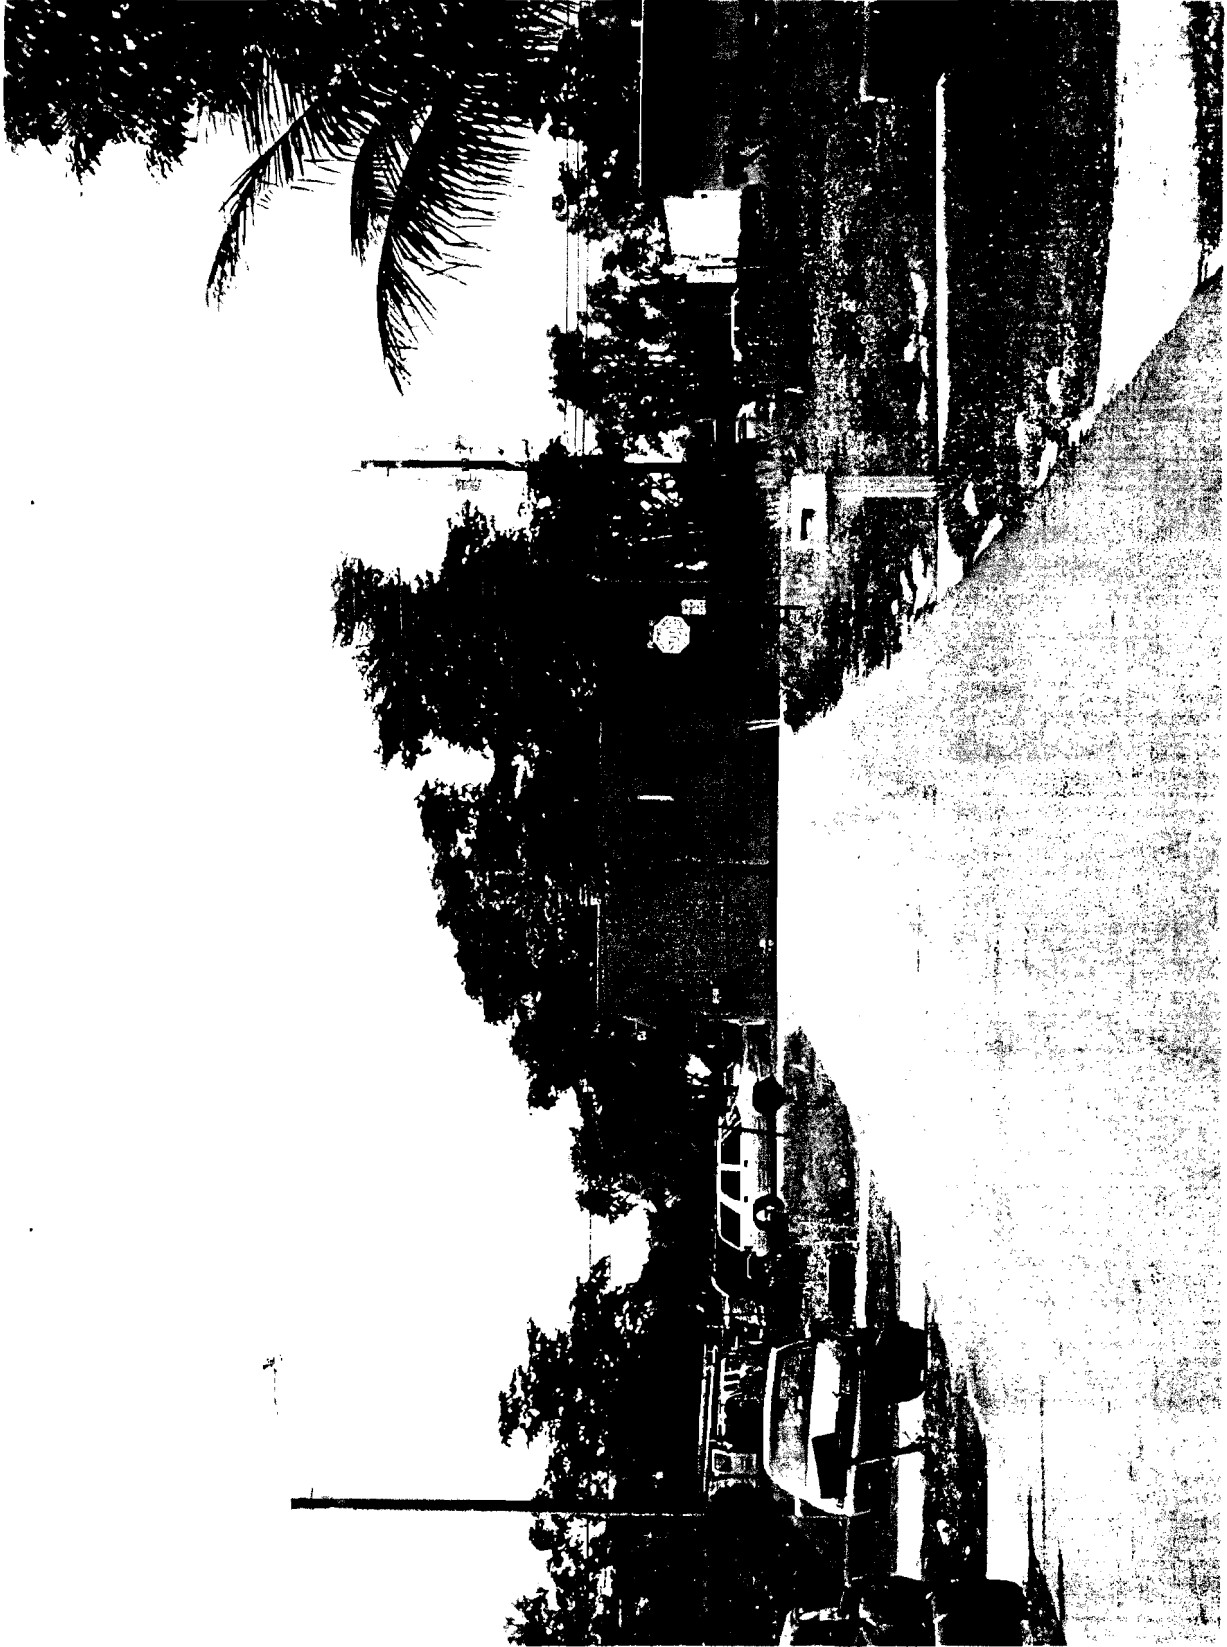
Close up of the above photograph.

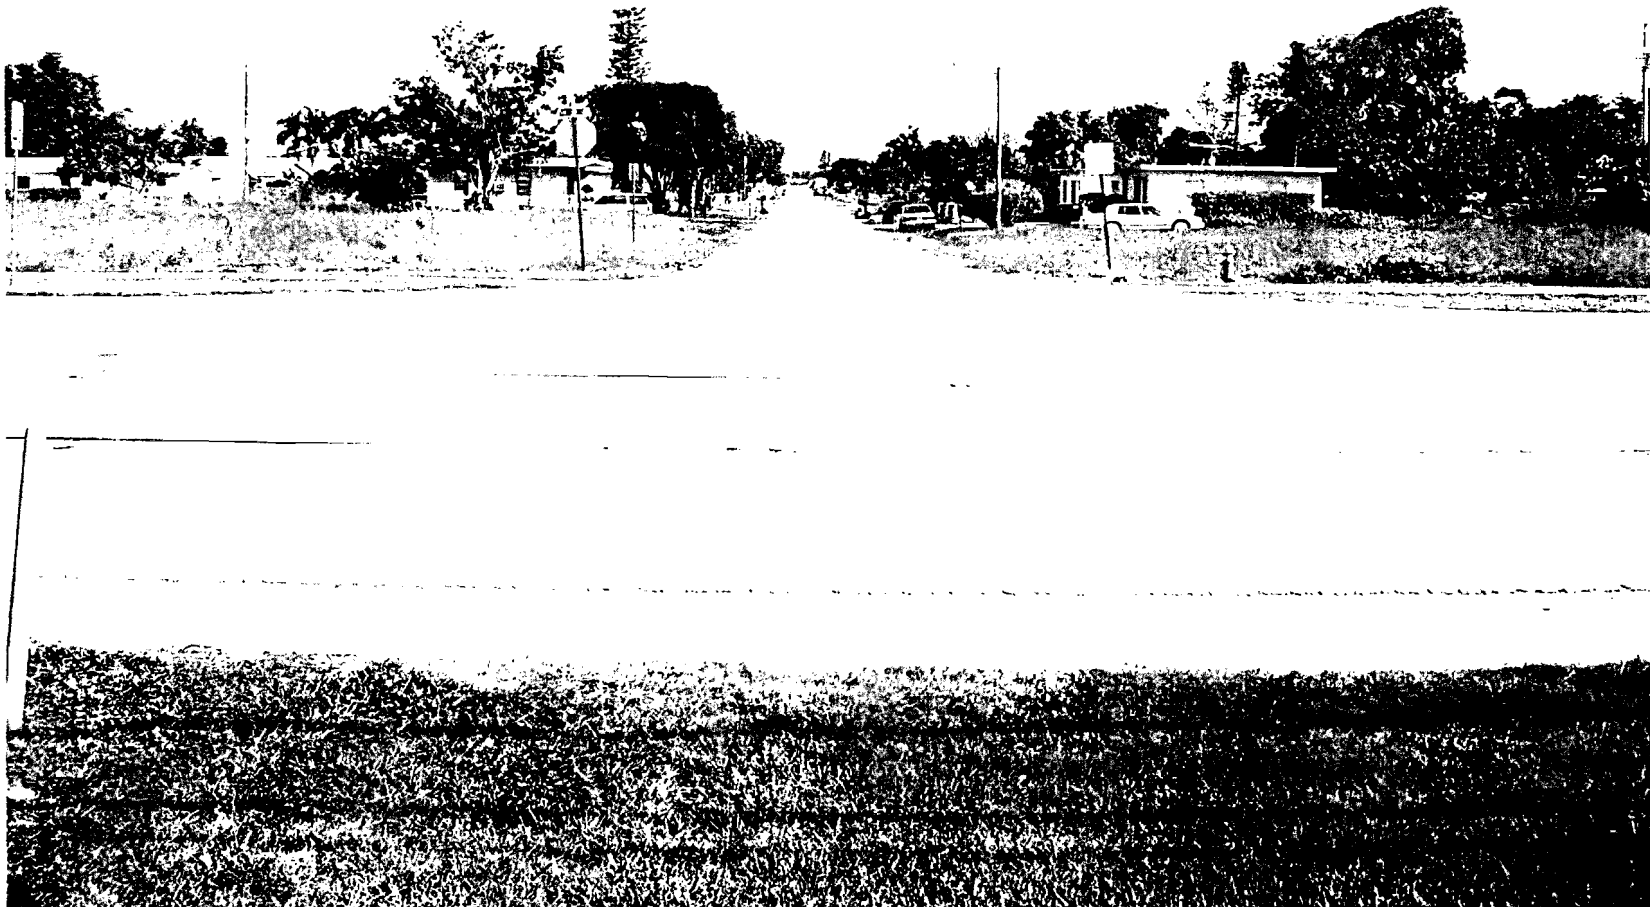
Photograph looking back towards the origination point.
