The Lake Wabamun Spill

The Incident

- At 10:00 August 6 Canadian National Railways had a derailment on their main east-west line through the town of Wabamun, on Lake Wabamun spilling a total of about 800,000 litres of heavy fuel oil (Bunker C) and about 90,000 litres of lube oil (then stated) (11 + 1 cars out of about 70 derailed)

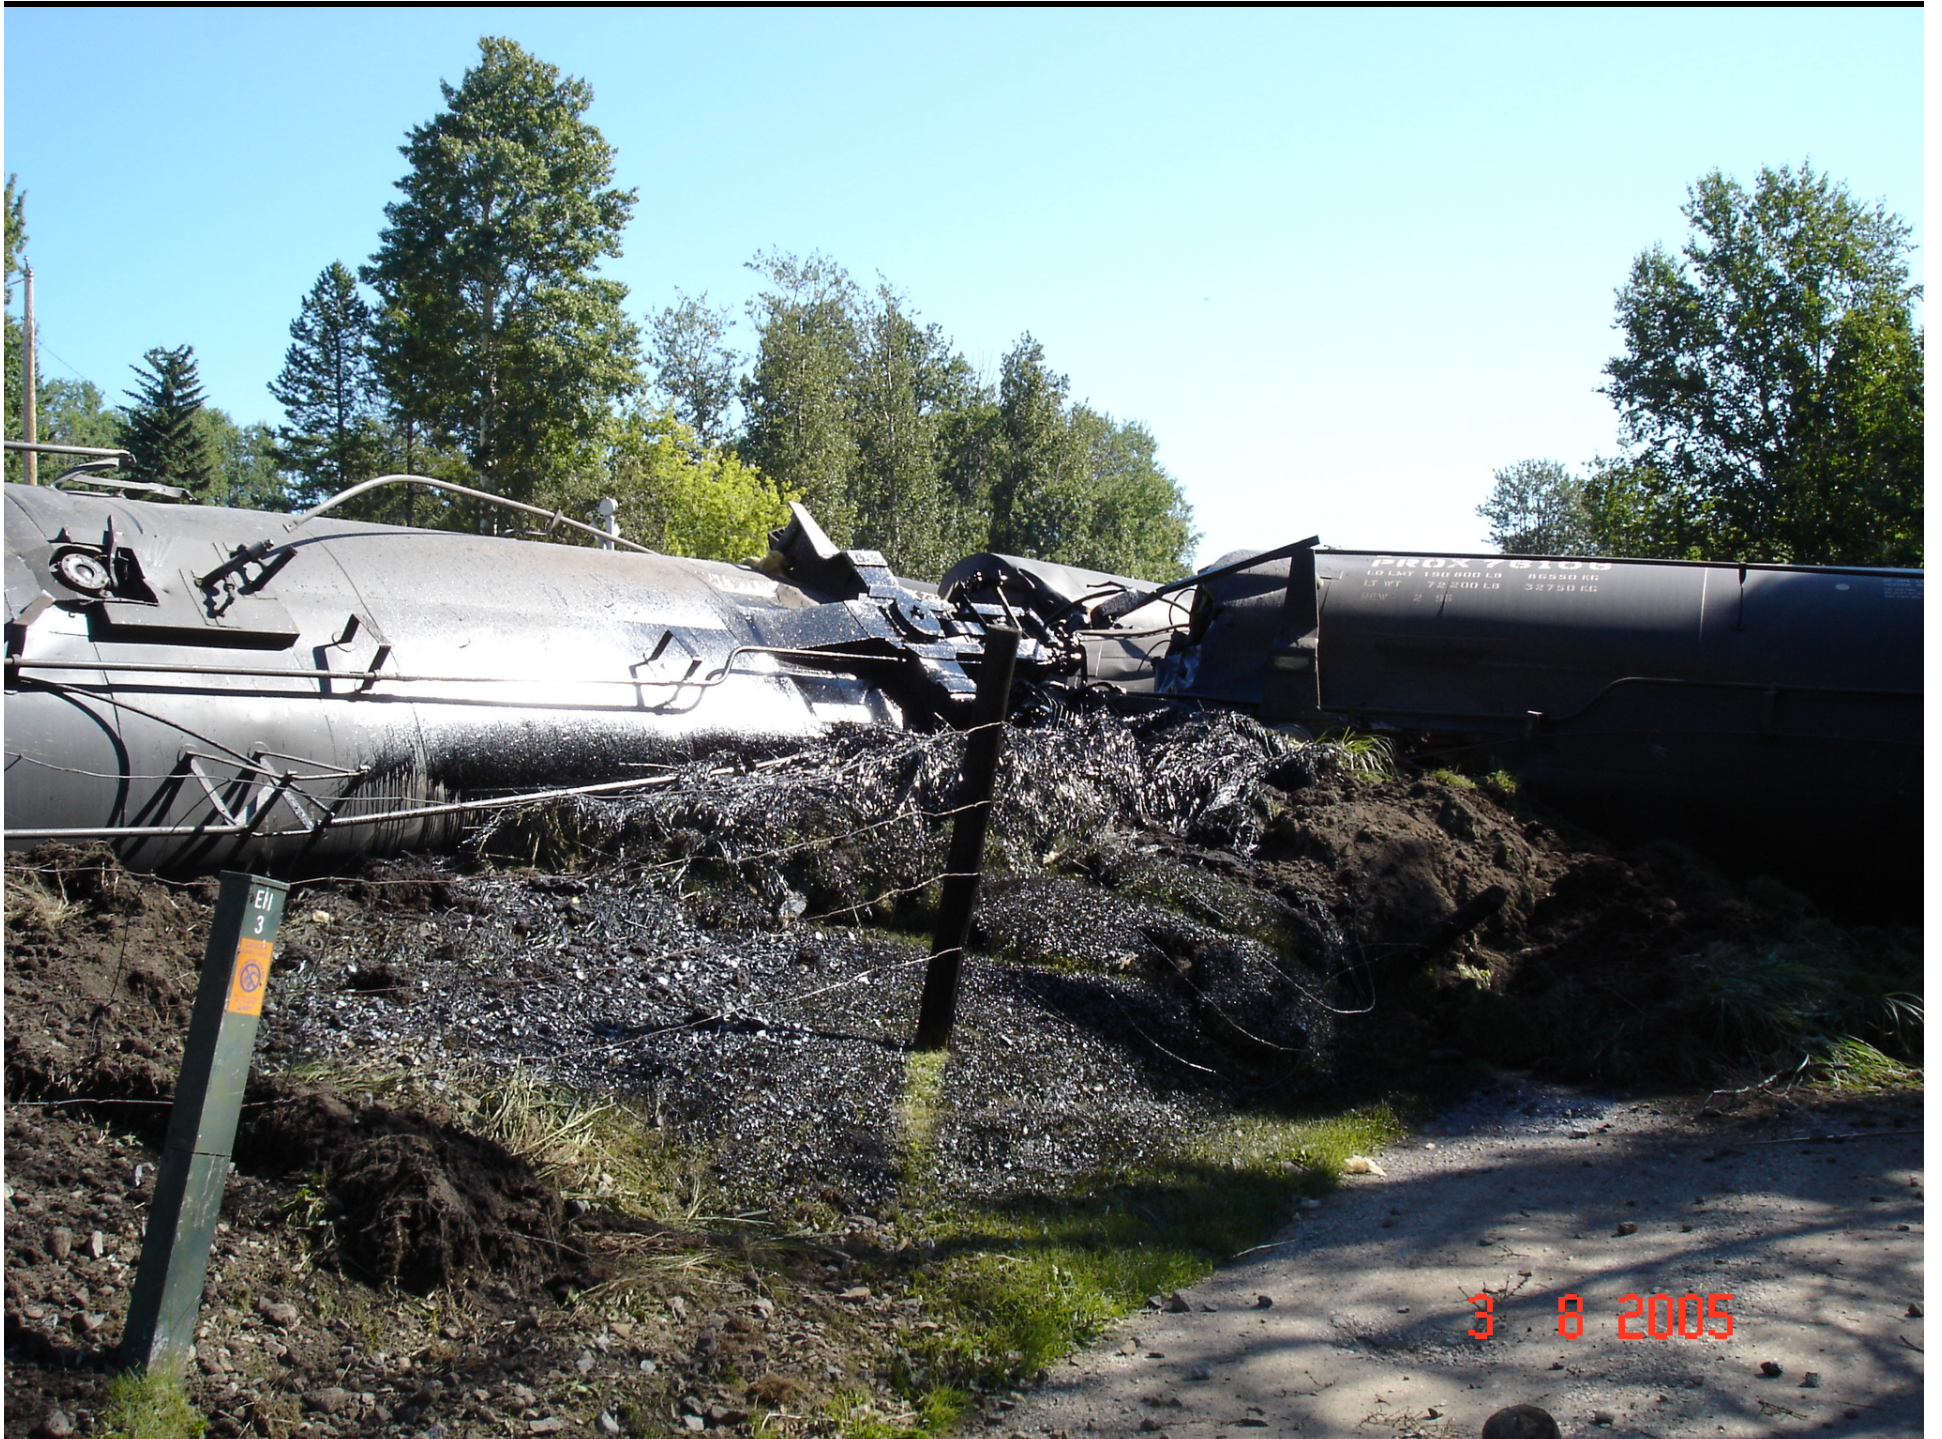
- The CN main line is between the power plant, coal strip mines and cottages
- Cottages are directly on the CN right-of-way and on the lake on the other side
- The track is busy and has between 70 to 100 trains per day and each train is about 100 to 200 cars

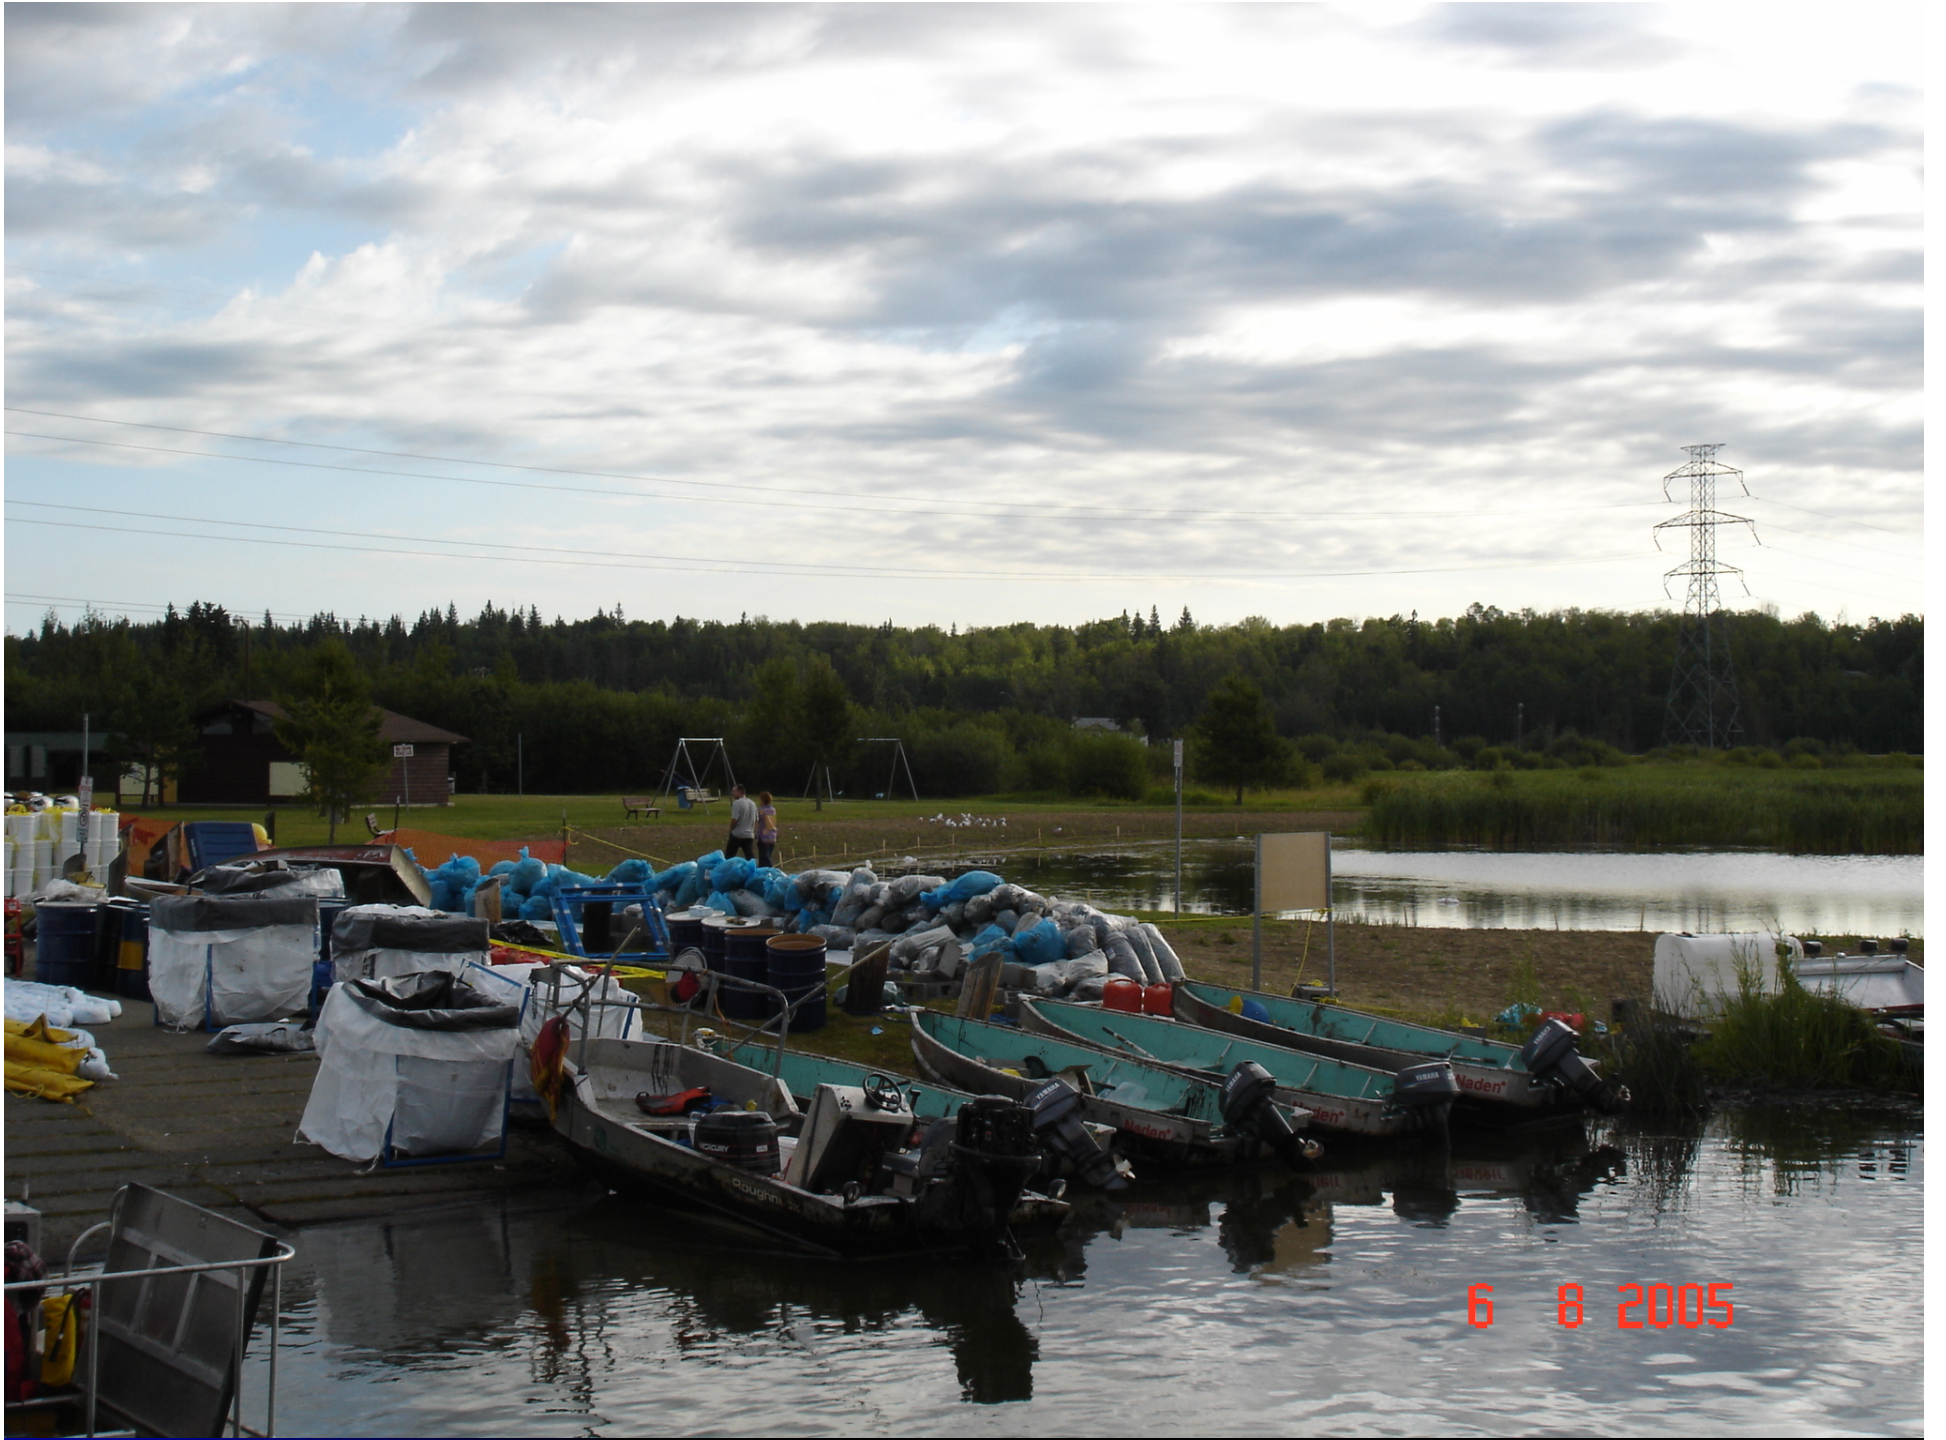
- Number of knowledgeable individuals came on-scene – Ron Goodman for Alberta, Environment, about 20 Environment Canada persons, etc.
- **ECRC – major co-op contacted and had in 800 response personnel and major equipment**
- Oil was now over much of the eastern half of the lake, but was prevented from going to western half by lake-intersecting booms
- **Within 2 days 80,000 feet of boom deployed and over 20 skimming crews**

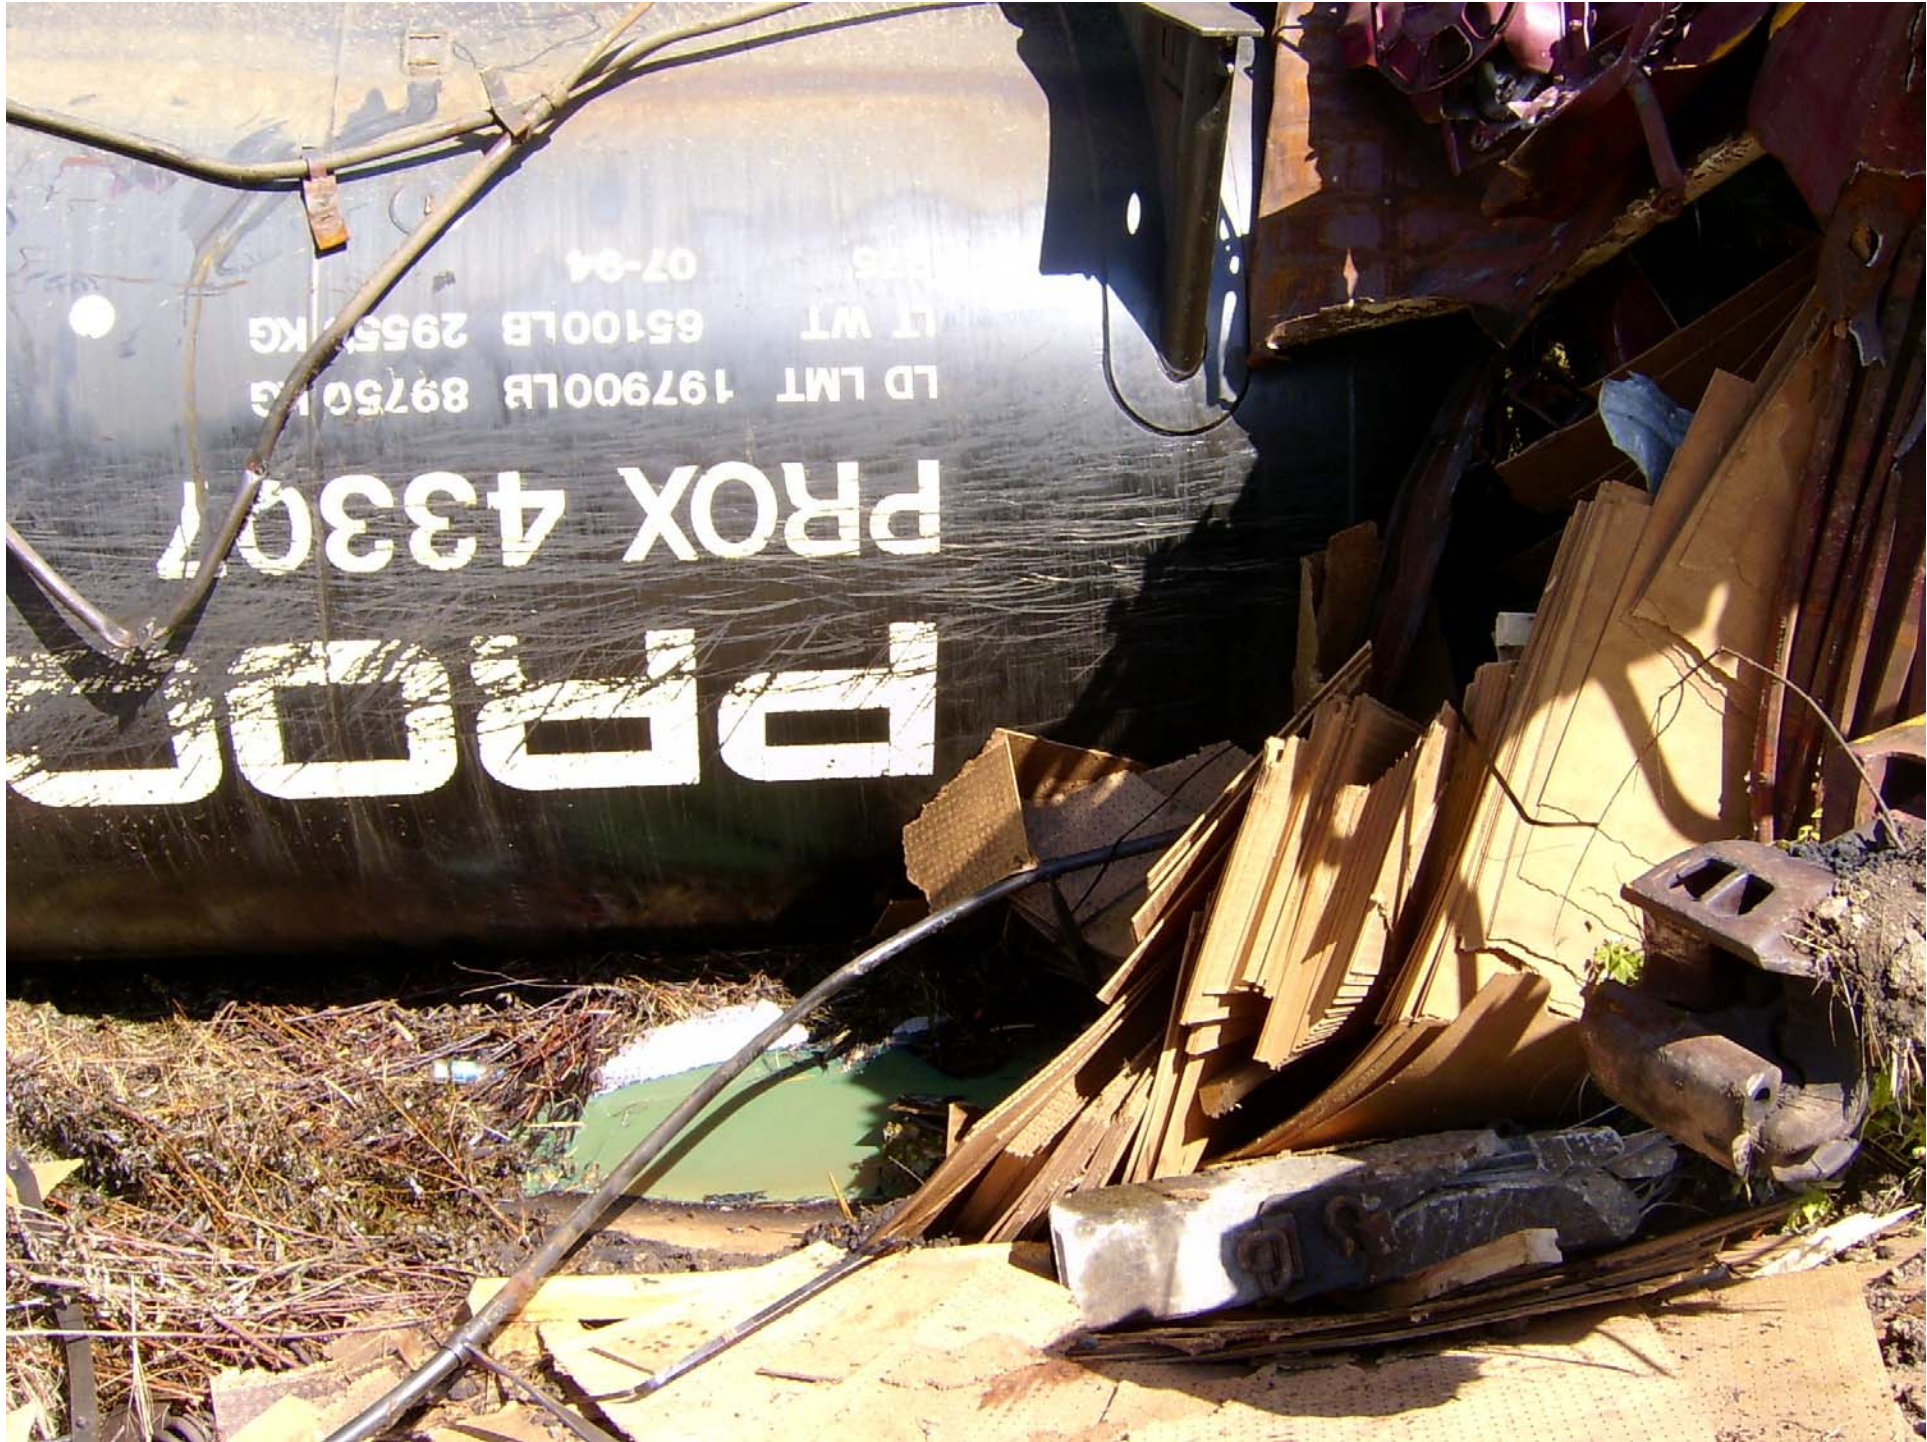
- After arrival, EC personnel (Pat Lambert) noted that the 'lube' oil did not look like lube oil – it was non-viscous, green and fluoresced
- Further checking showed that this was 'pole oil', highly-toxic pole oil treating compound – over 80% PAHs

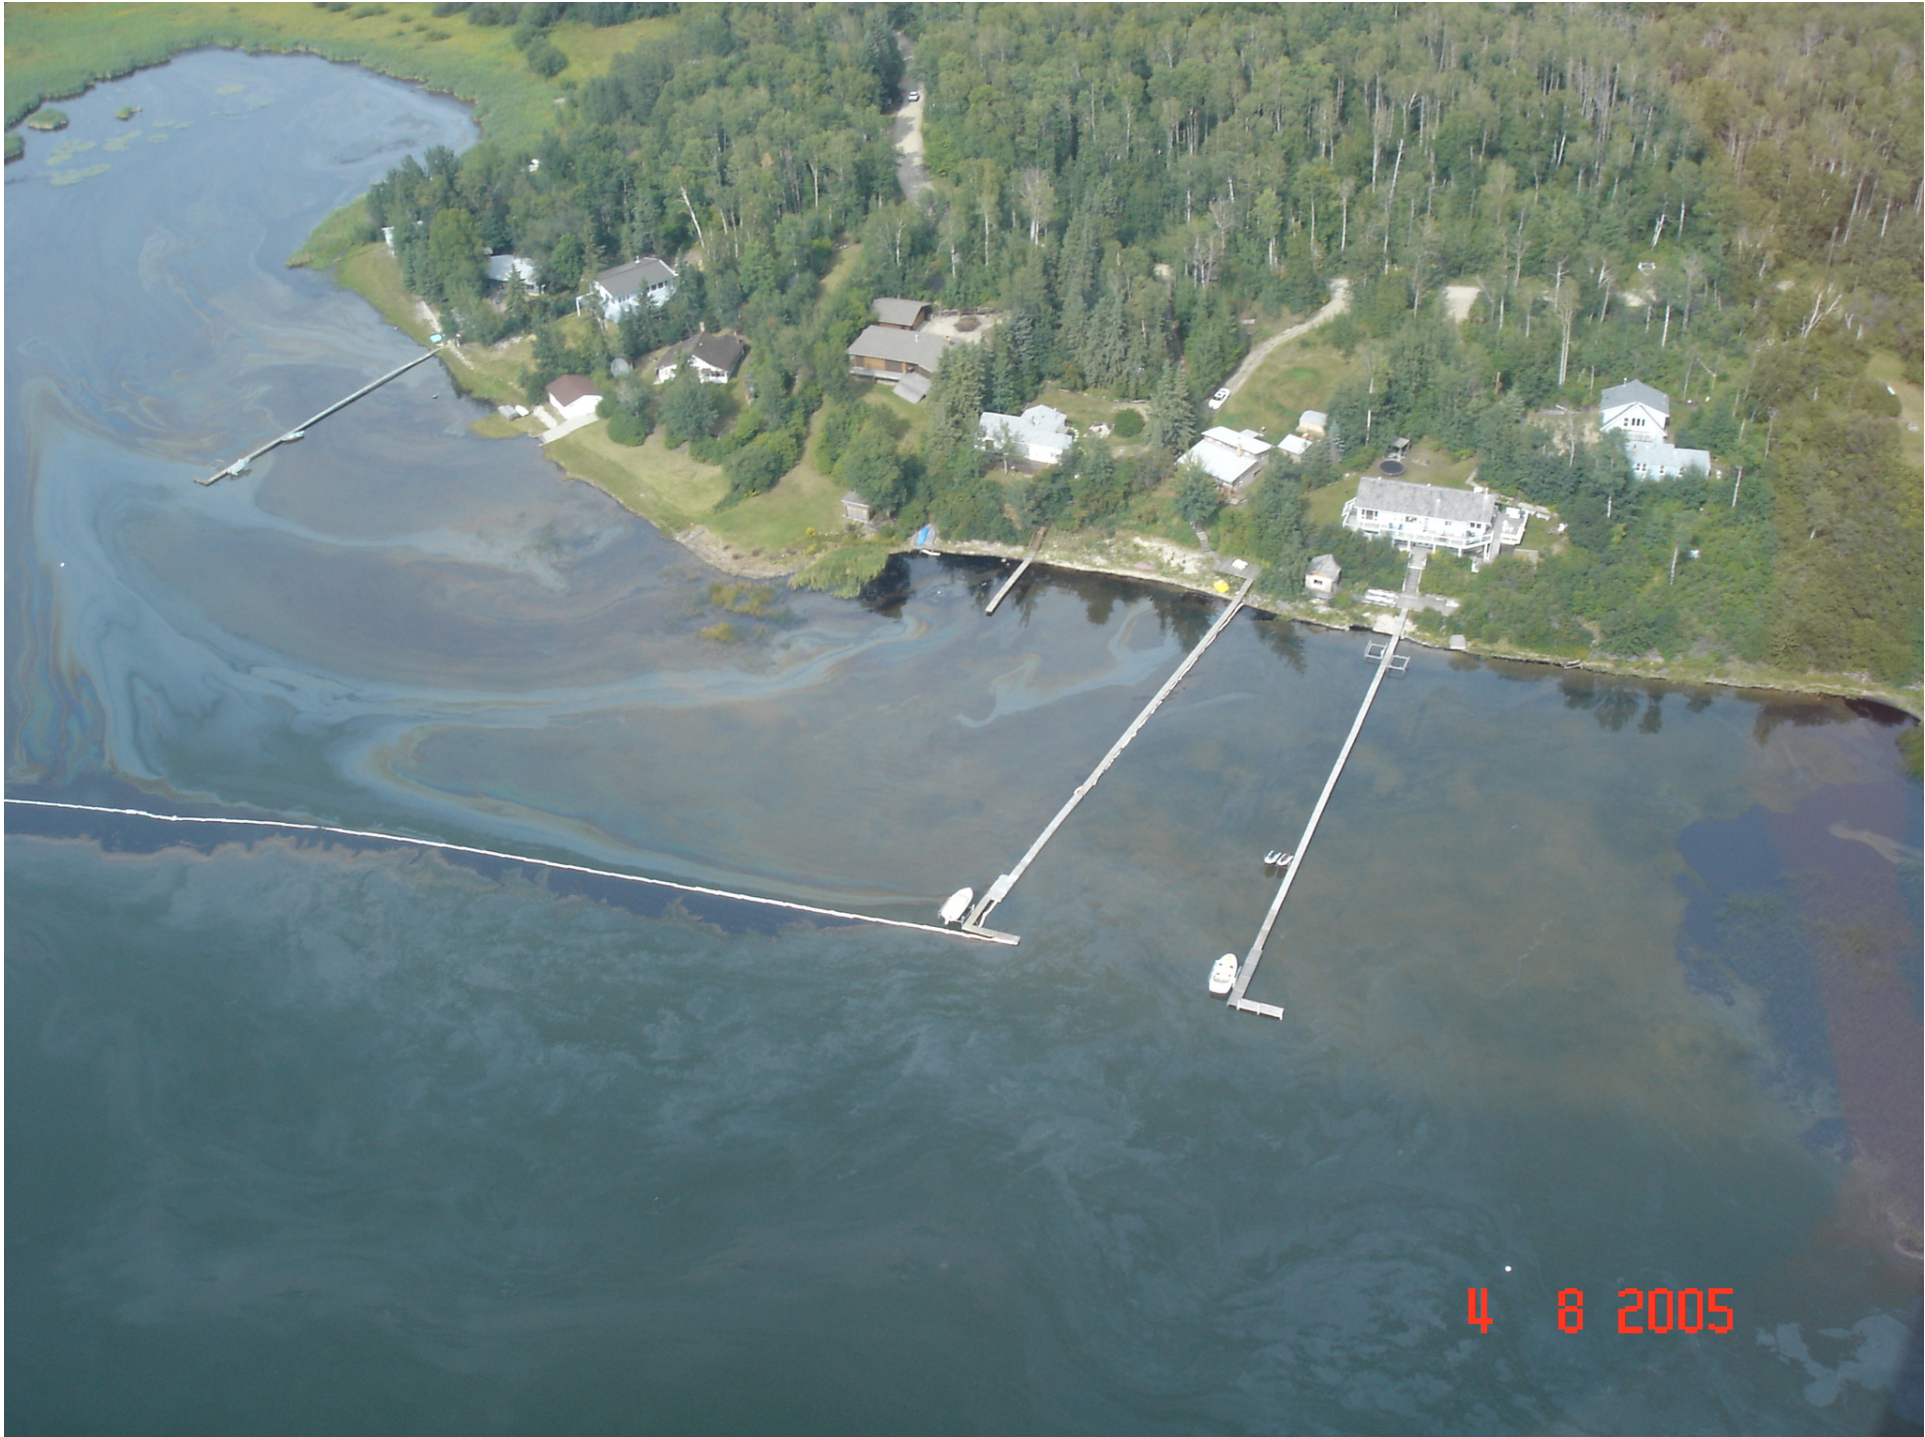
- Is an old Transalta power plant on the way to being decommissioned – had to be shut down shortly after the spill – but only 250 kilowatts (1/4 power)
- **Great deal of effort expended to return this unit to operations**
- Other power plants not affect – Sundance (Transalta) 3 Megawatts, others slightly more remote Epcor 3 Megawatts and another Transalta at about 2 Megawatts

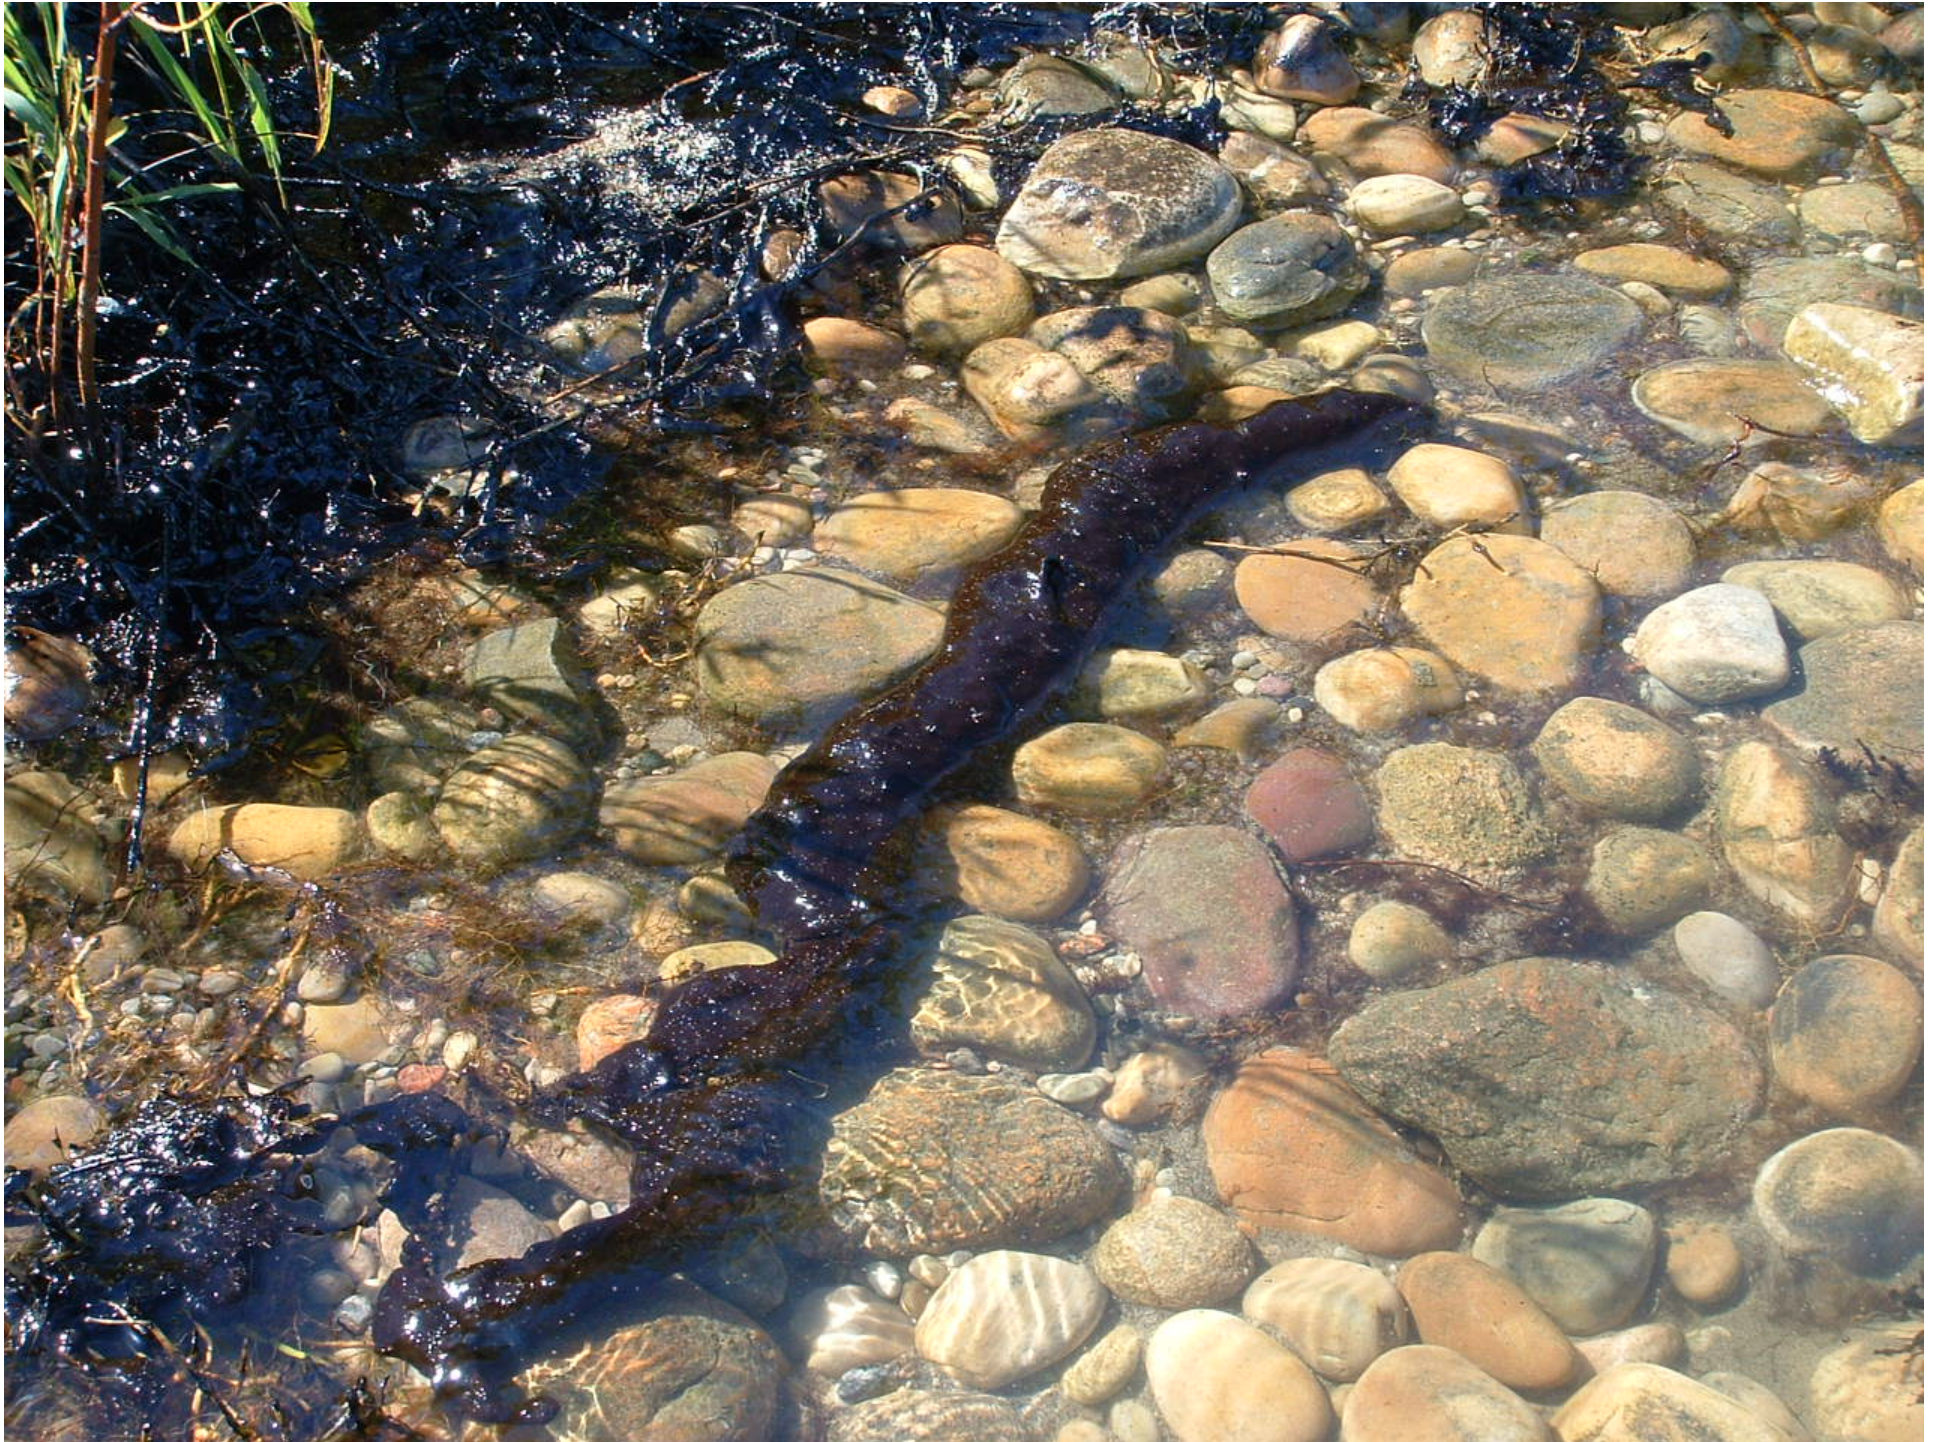
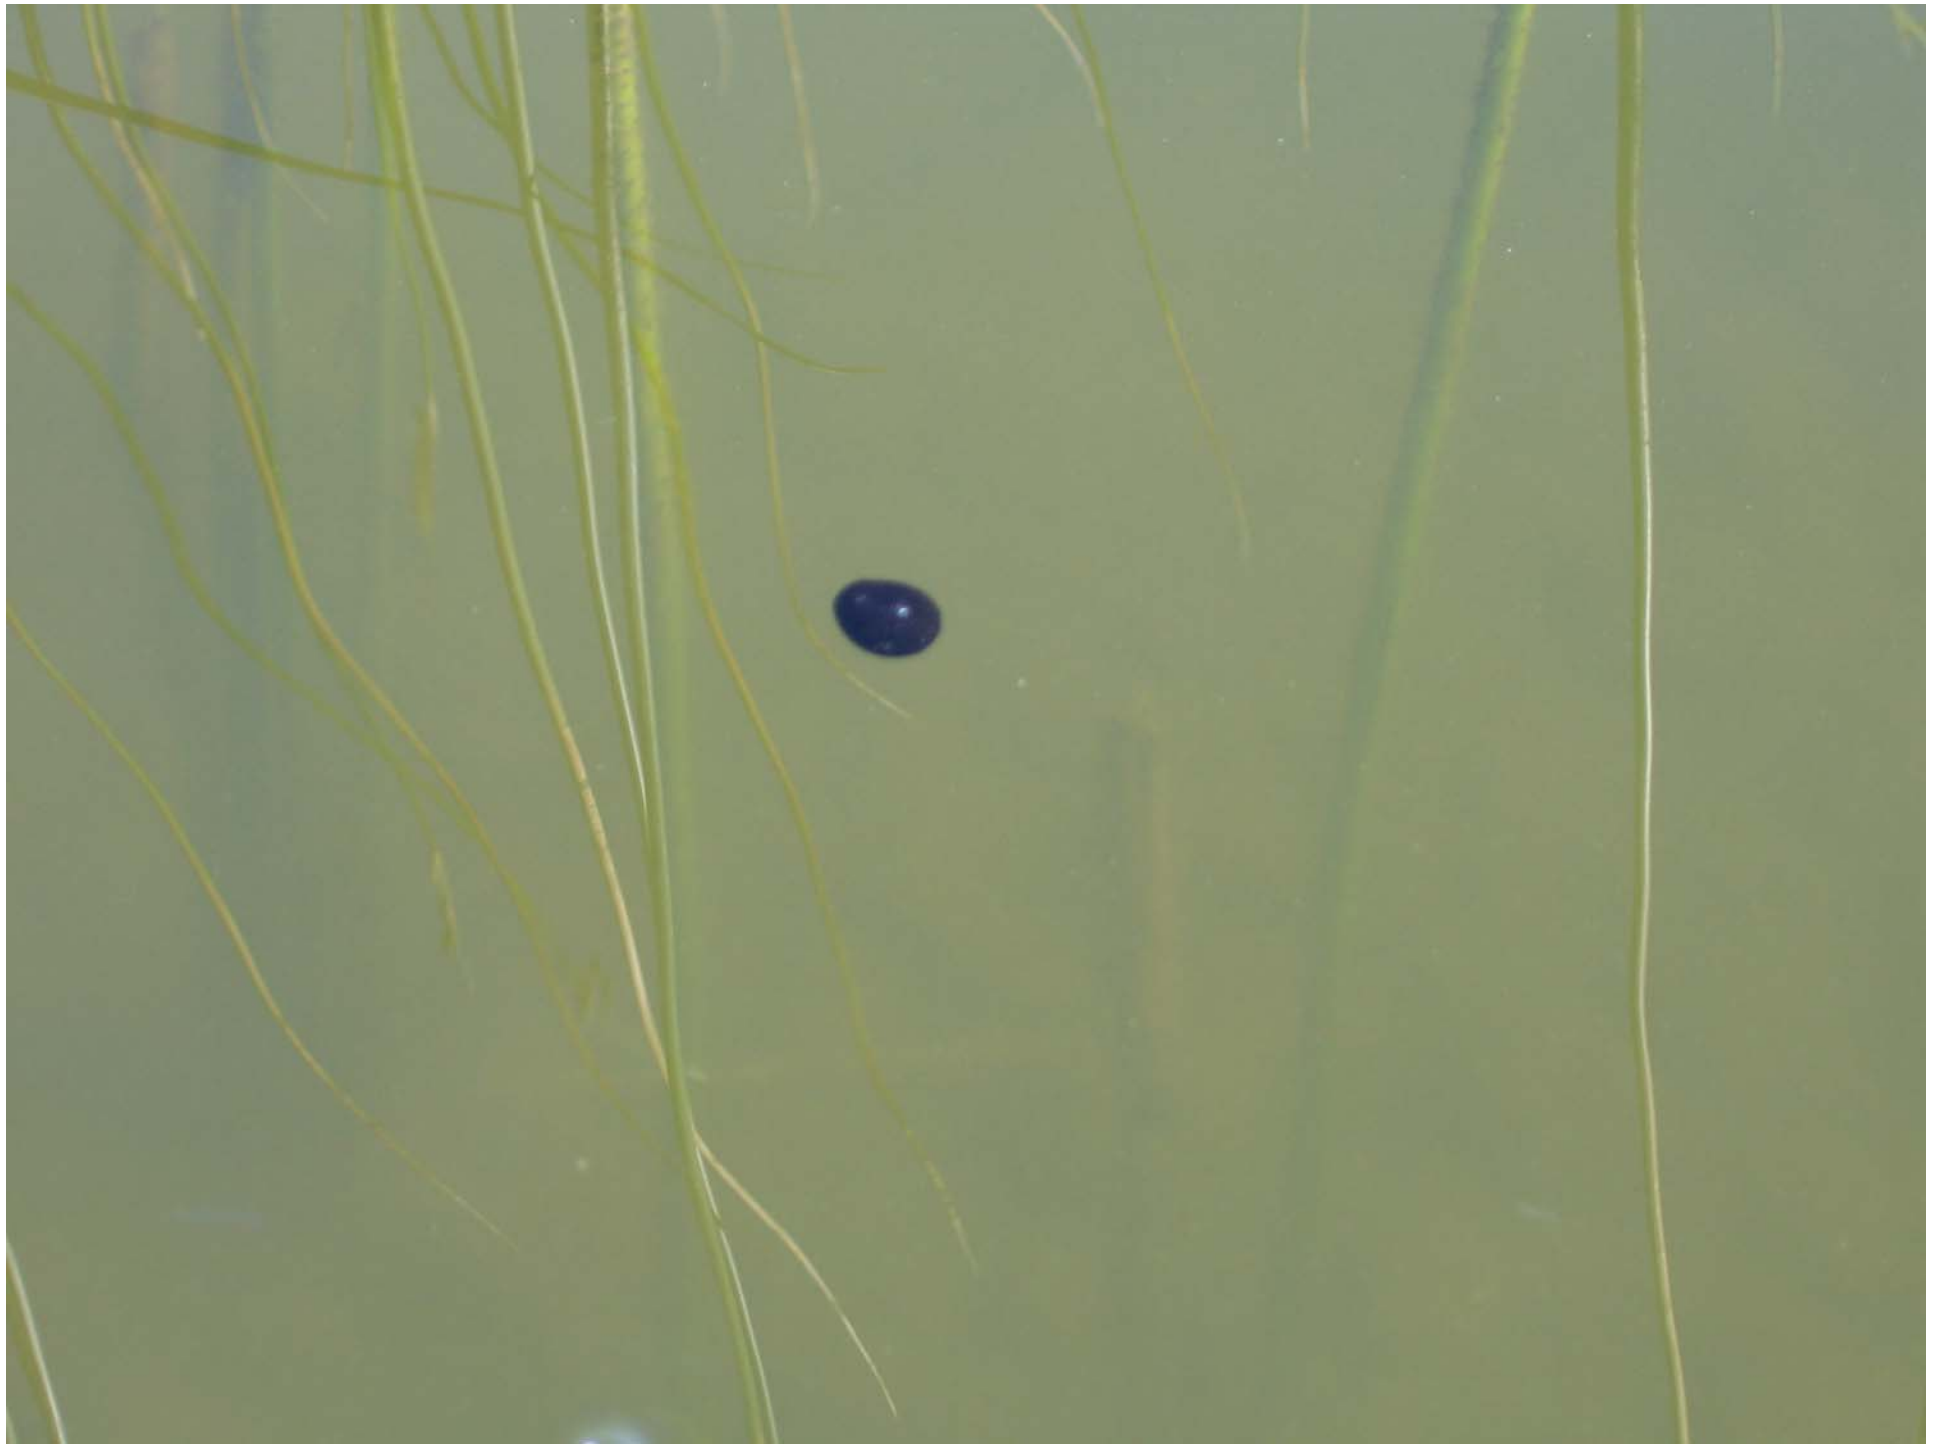
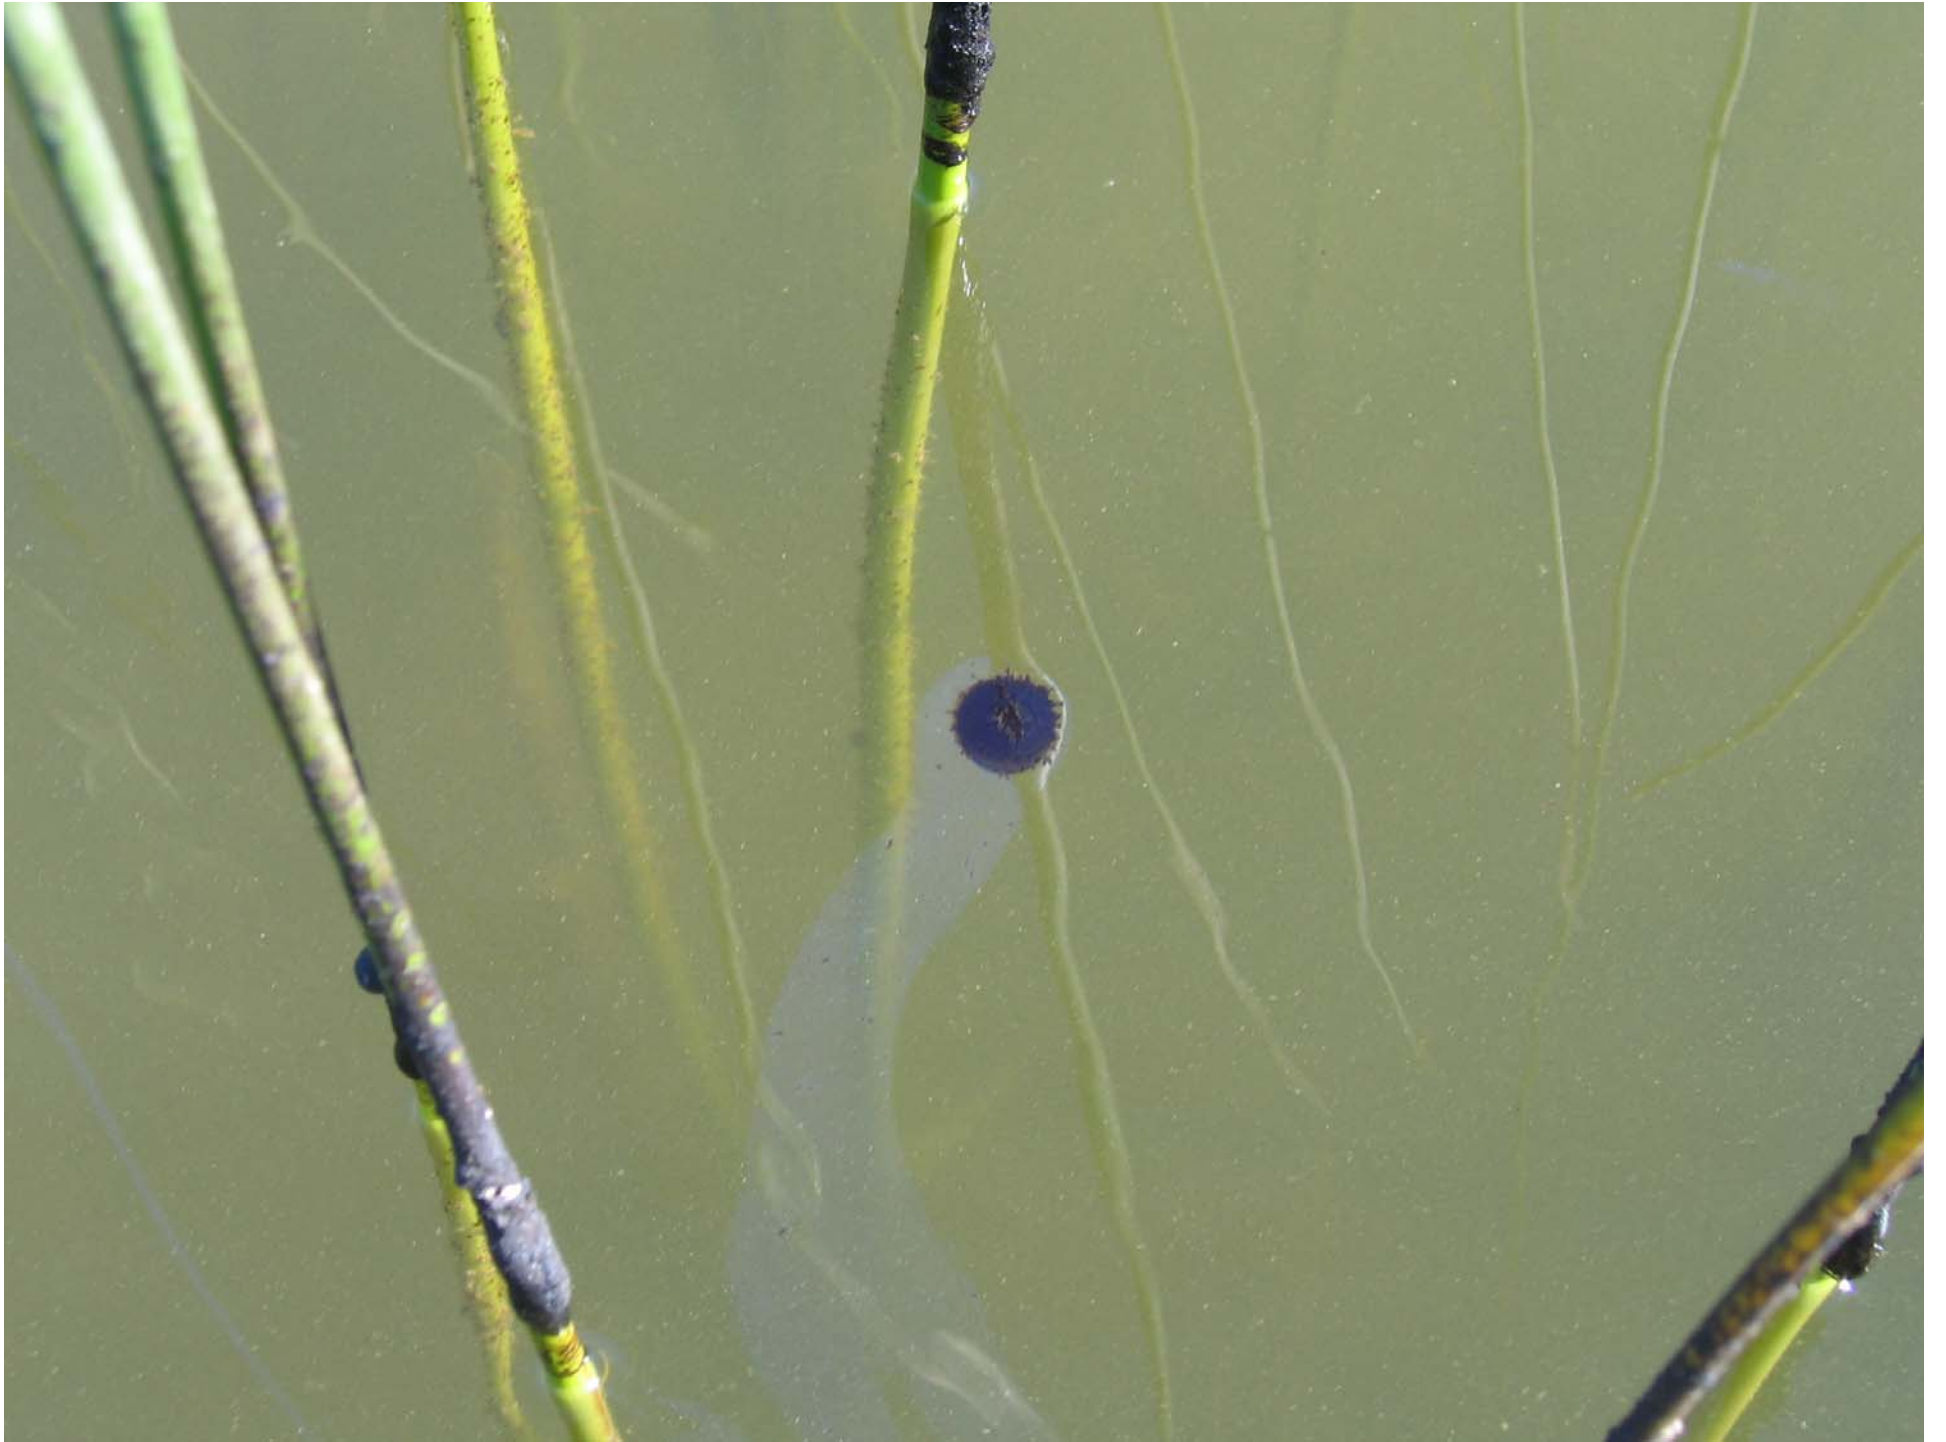
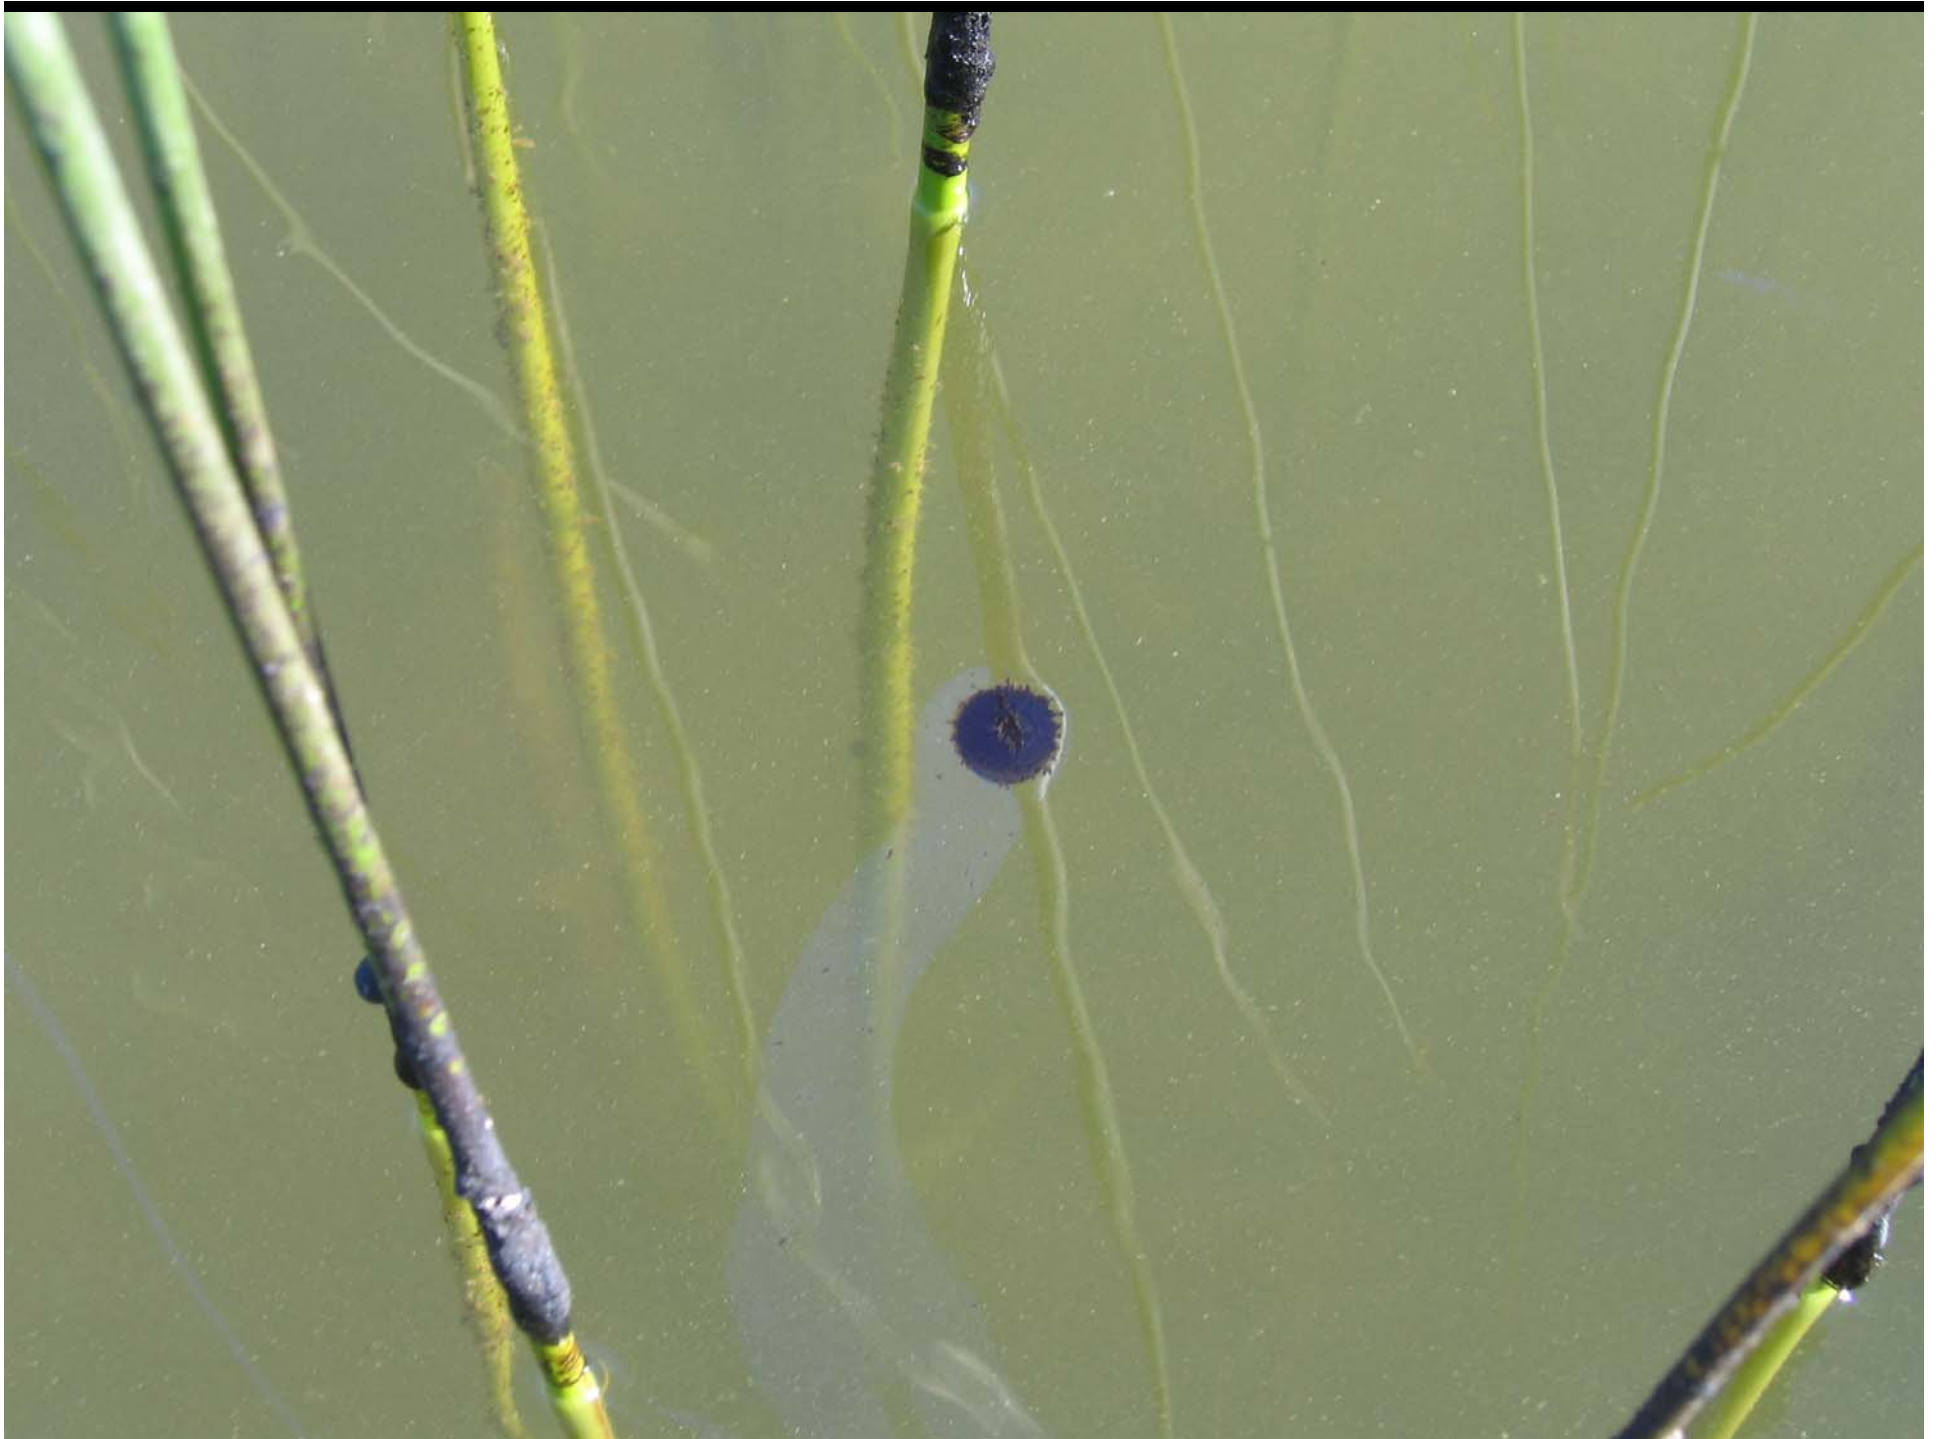
- As oil was heavy fuel oil and flowed over land to get to the water, some of it picked up sediment
- **Several phenomena observed: oil re-surfacing, neutrally-buoyant tar balls, oil on bottom, daily re-oiling of shoreline – even after bulk oil skimmed**
