The Lake Wabamun Spill

The Incident

- At 10:00 August 6 Canadian National Railways had a derailment on their main east-west line through the town of Wabamun, on Lake Wabamun spilling a total of about 800,000 litres of heavy fuel oil (Bunker C) and about 90,000 litres of lube oil (then stated) (11 + 1 cars out of about 70 derailed)

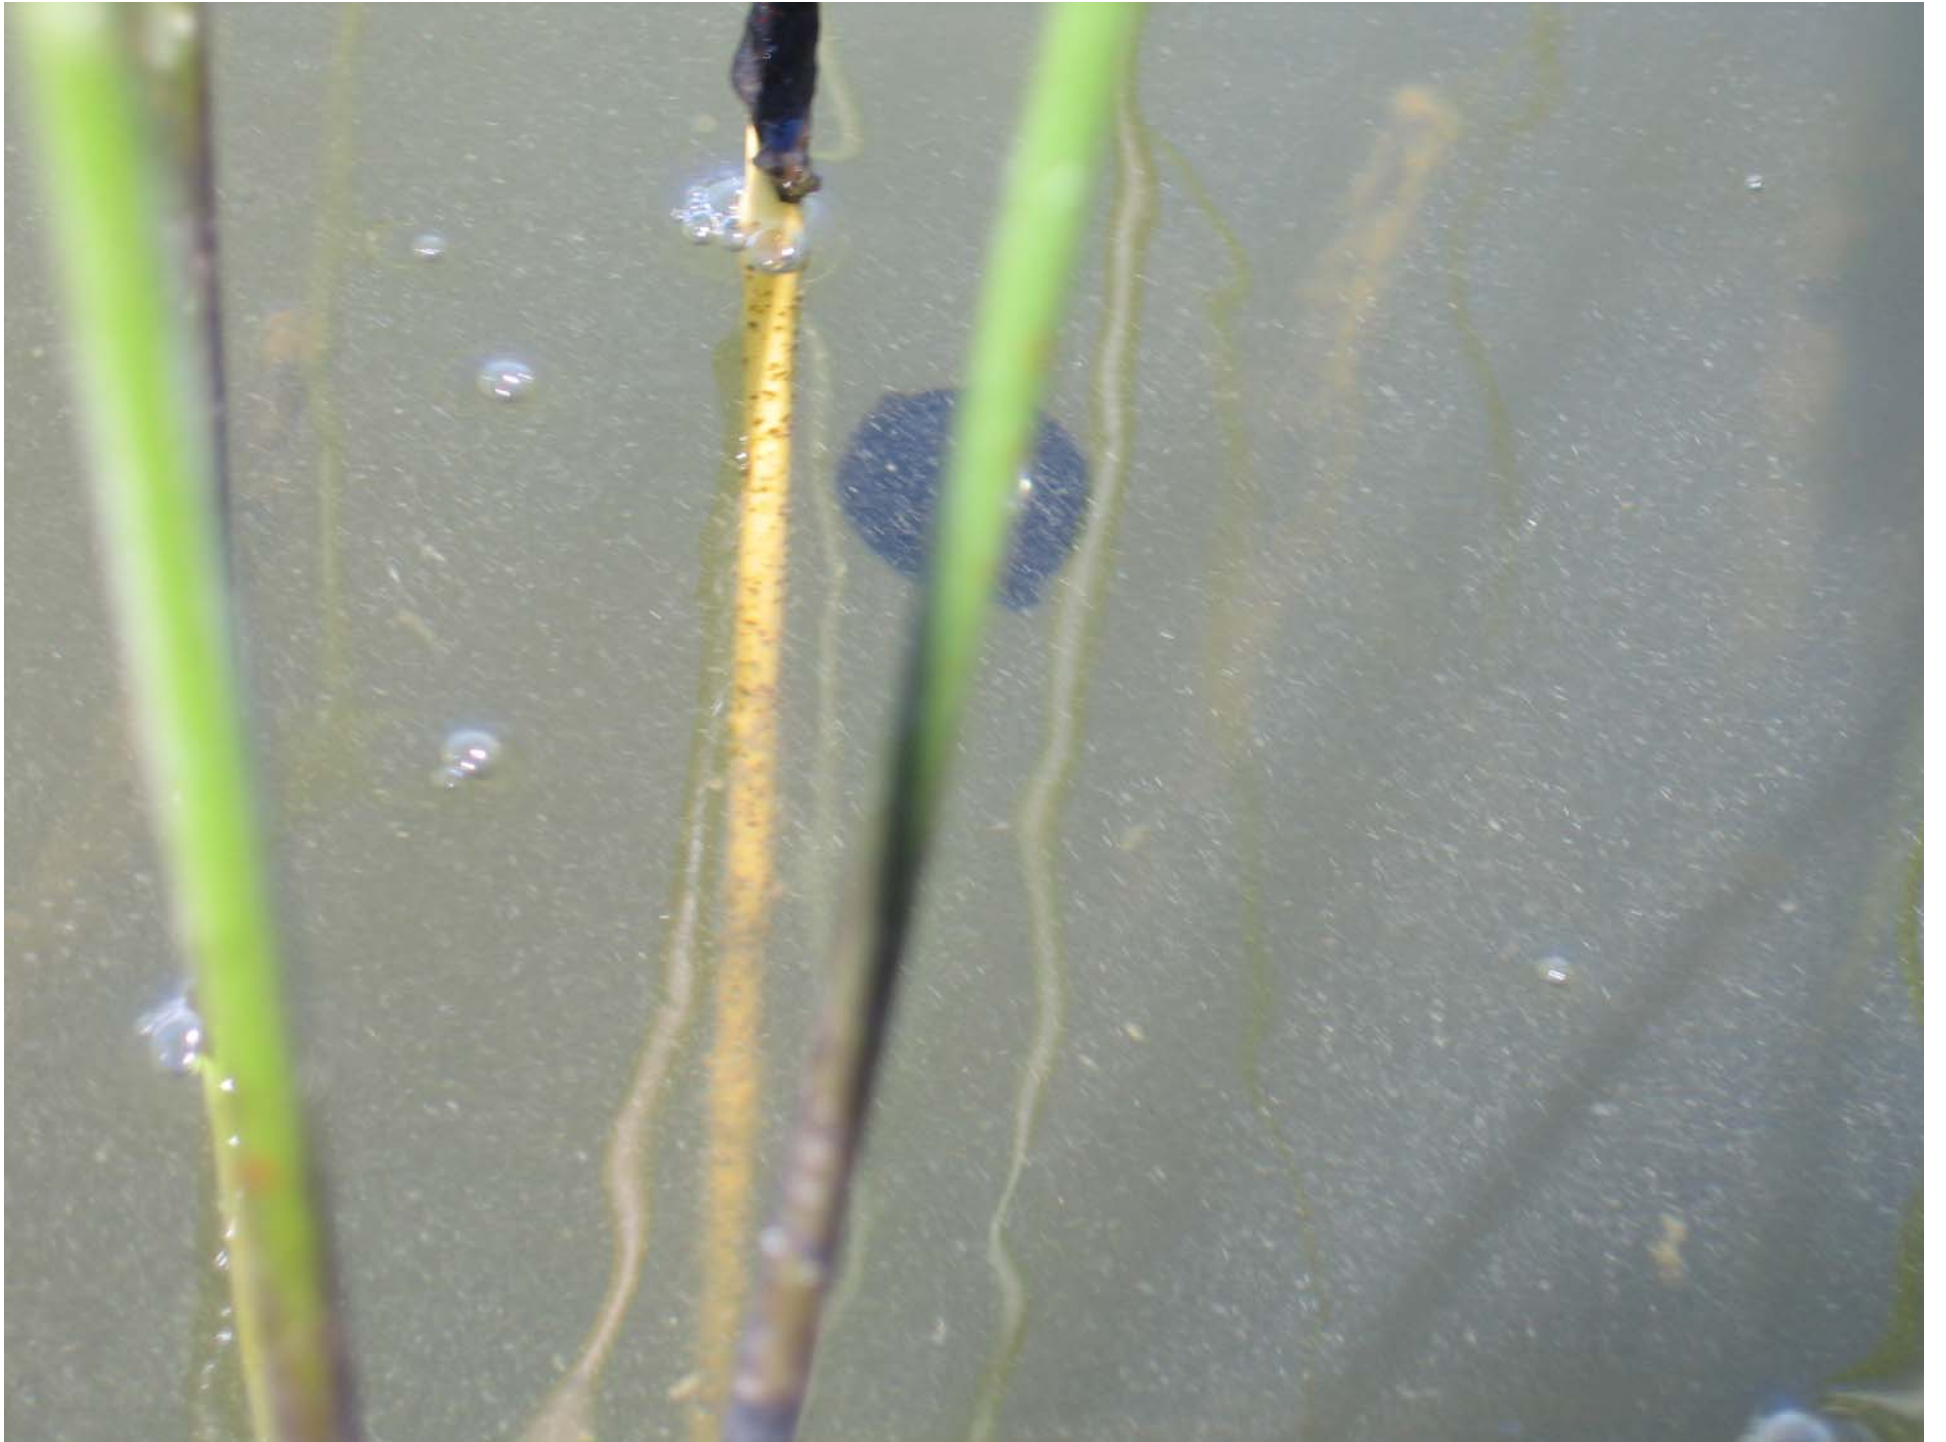
Cleanup proceeds

- By September 1 – about one month later – cleanup was still in full tilt
- **Big problems at this time – new oiling – maybe from sunken oil, maybe from weed beds**
- Second problem weed beds – solution – cut the weeds

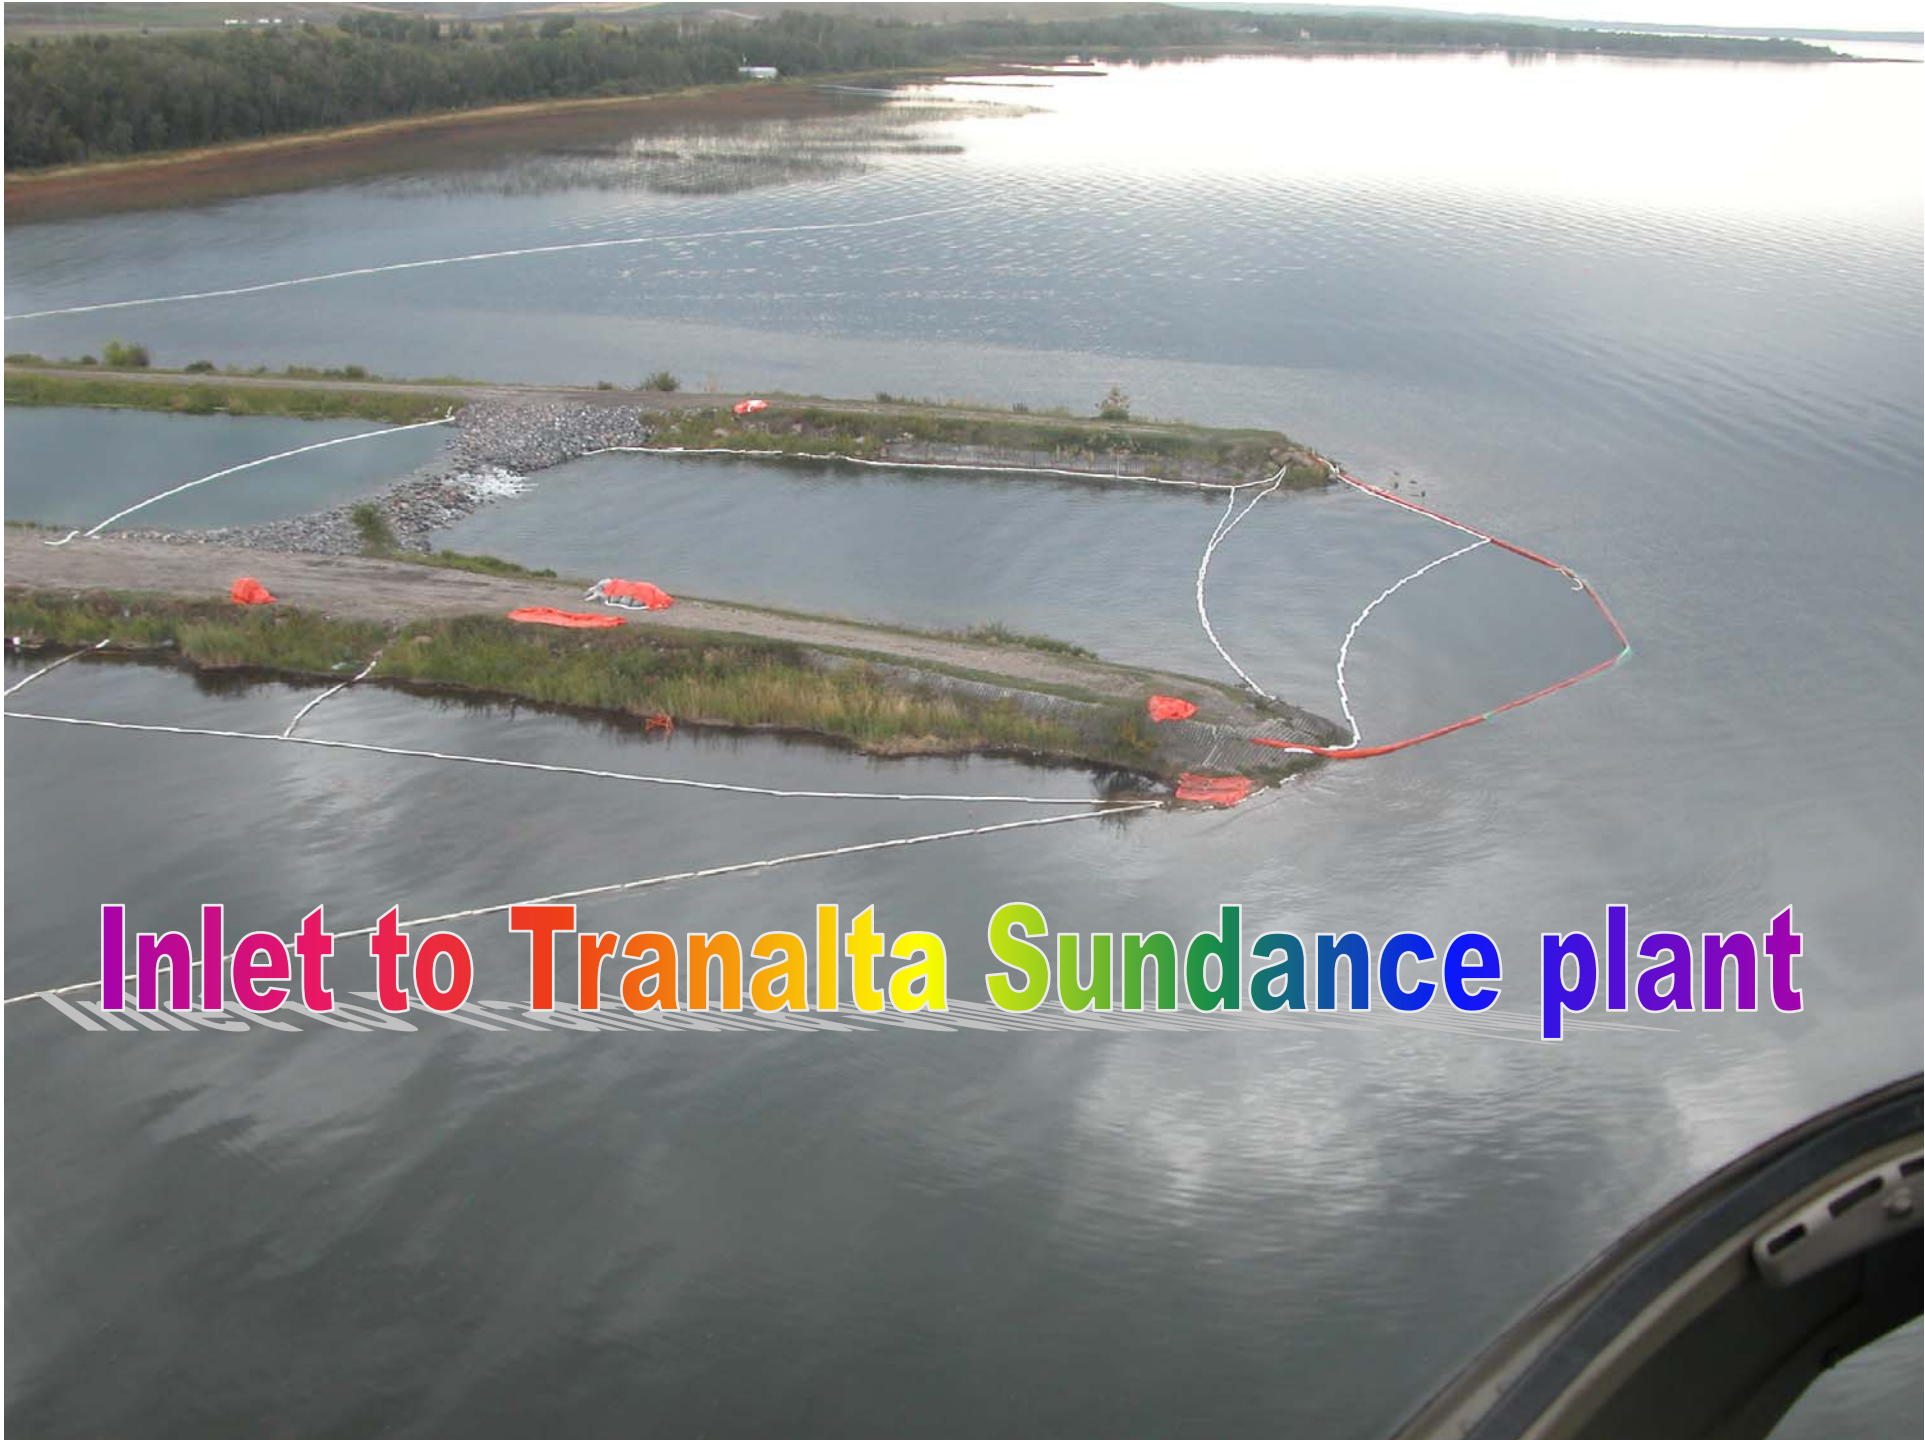
Inlet to Tranalta Sundance plant
