Georgian Well Blow-Out 2004

Paul Foley

Introduction

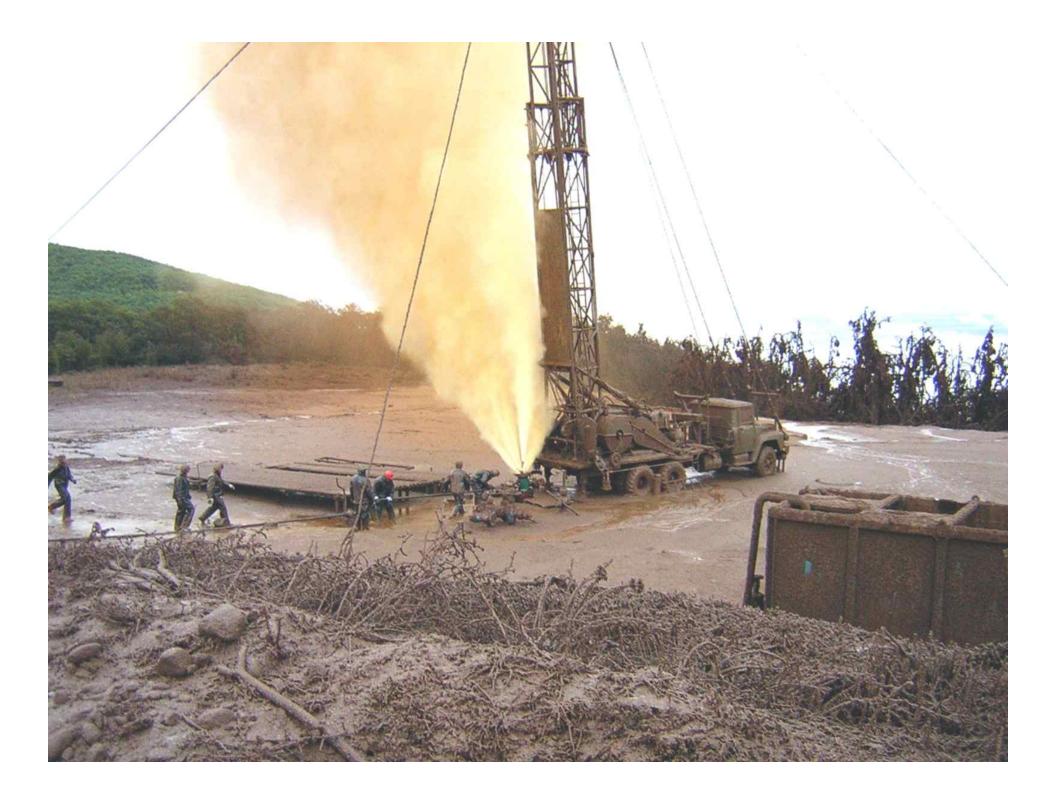
- Well blow-out (September 2004)
- Ninotsminda, 70km East of Tbilisi
- Decommissioning without BOP
- 800m above sea-level
- Deciduous Forest
- Flowing at 5 10,000 bbls/day

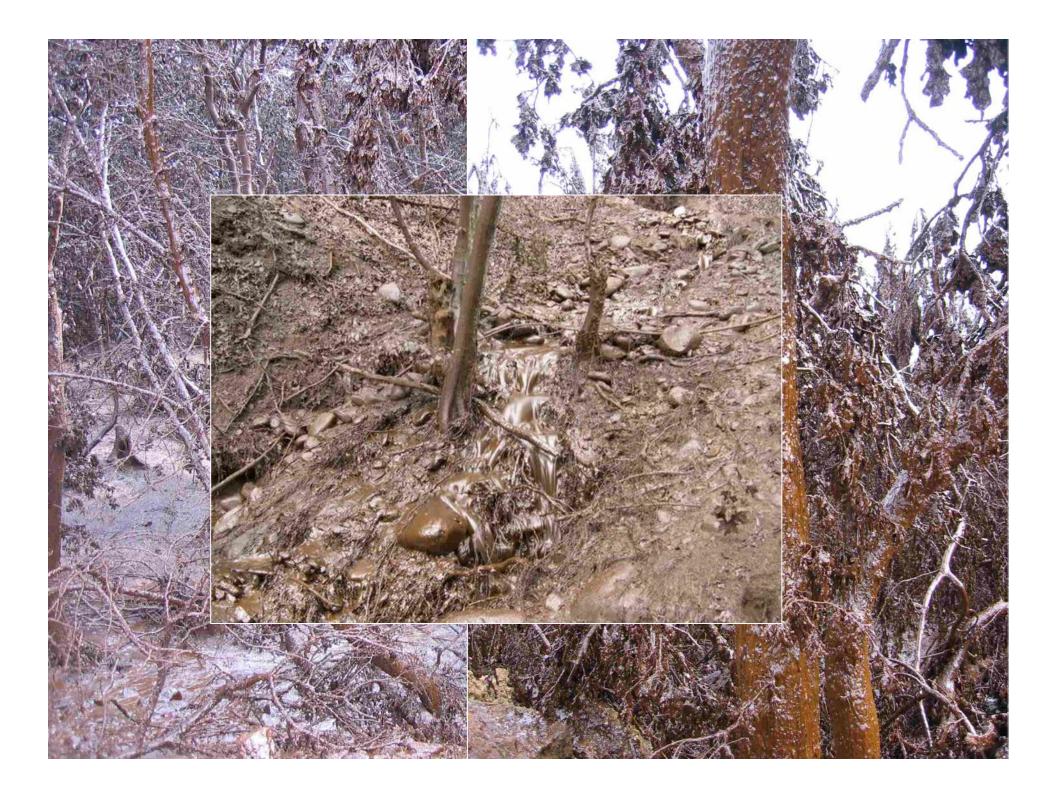
- Deciduous trees and shrubs
- Ecosystem disturbance
- Output: Potential contamination of food crops
- Potential contamination of water for livestock and crop irrigation

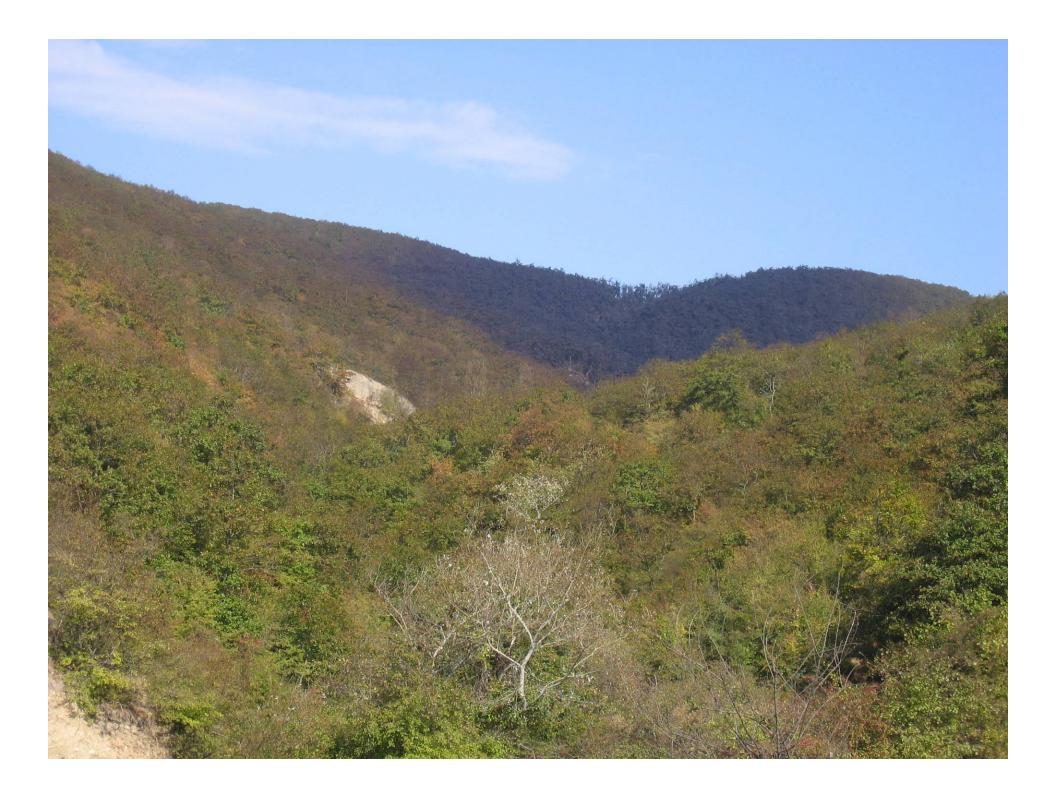
- Warm and dry in September
- Freshwater stream
- Clay substrate
- Deep water tables
- Poor accessibility

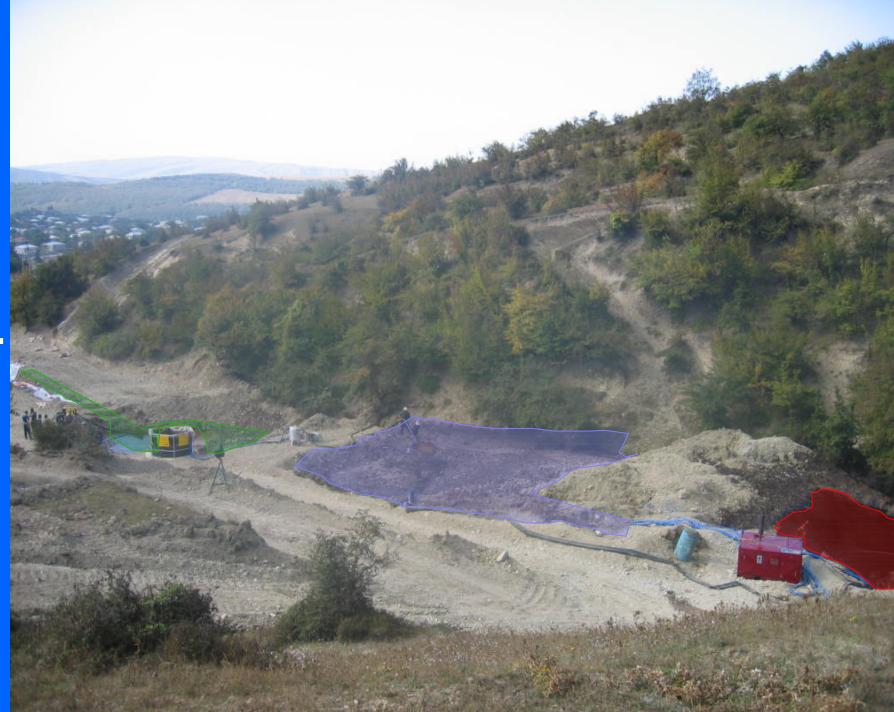
Zone C – Separator Pits

- Build an ICS to integrate with company's management
- Minimise impact and spread of oil
- Remove gross oil from the wellhead and then the woodland
- Final cleaning
- Site surveys established 3 work areas:
 - Zone A: Wellhead area
 - Zone B: Woodland
 - Zone C: Separator pits and storm gully

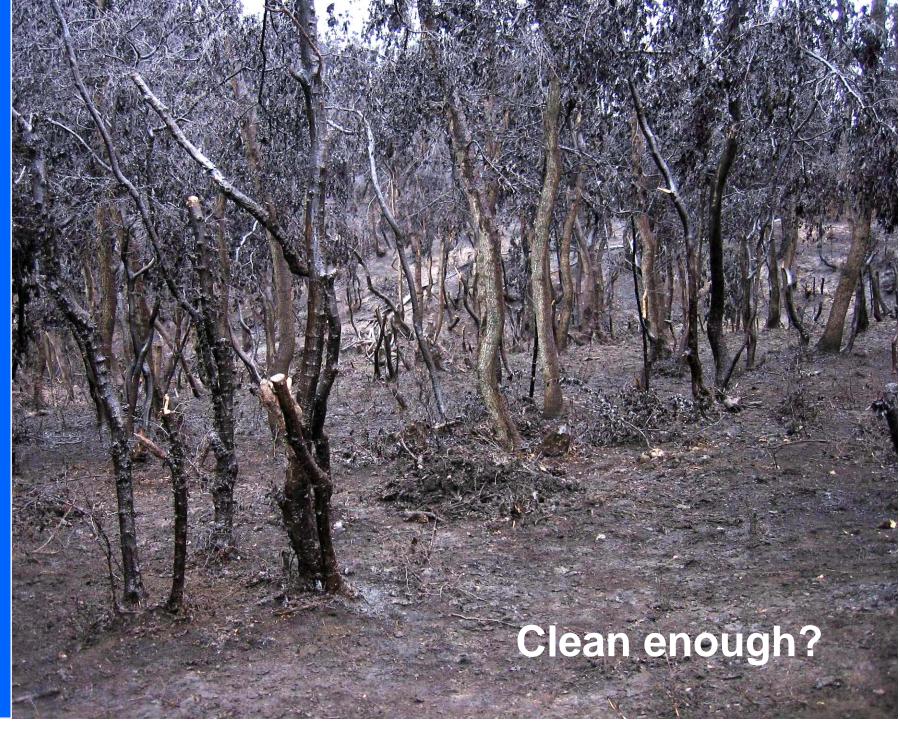
Zone B – Woodland

- The following cleanup options were employed
 - Flushing and manually re-mobilising the bulk oil
 - Manual recovery of the heavily oiled leaf litter
 - Structured and managed felling and lopping
 - Regeneration program

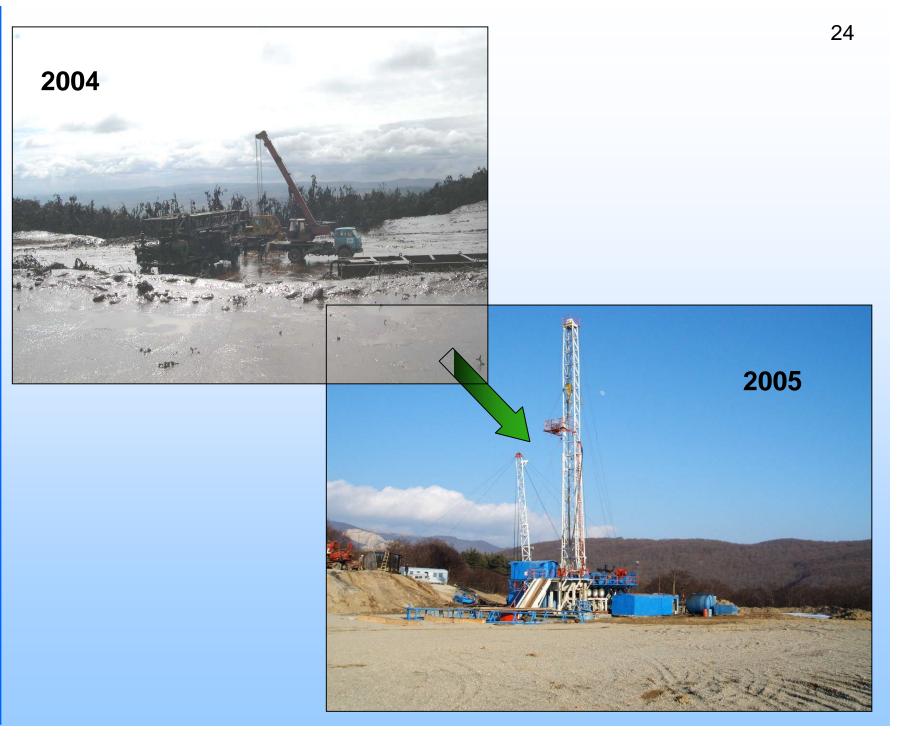
- Continued site rehabilitation
- Selective felling & oiled debris removal
- Continued monitoring of water quality
- Bioremediation scheme ongoing
- Replanting scheme planned
- Drinking water well drilled
- Well N100 still producing
