## Cooperative Efforts to Use *In-situ* Burning in Empire, LA, in an Intermediate Marsh Following Hurricanes Katrina and Rita

Amy Merten, Ph.D.  
NOAA Scientific Support/Biological Assessment  
7600 Sandpoint Way, NE, Building 3  
Seattle, WA 98103  
amy.merten@noaa.gov

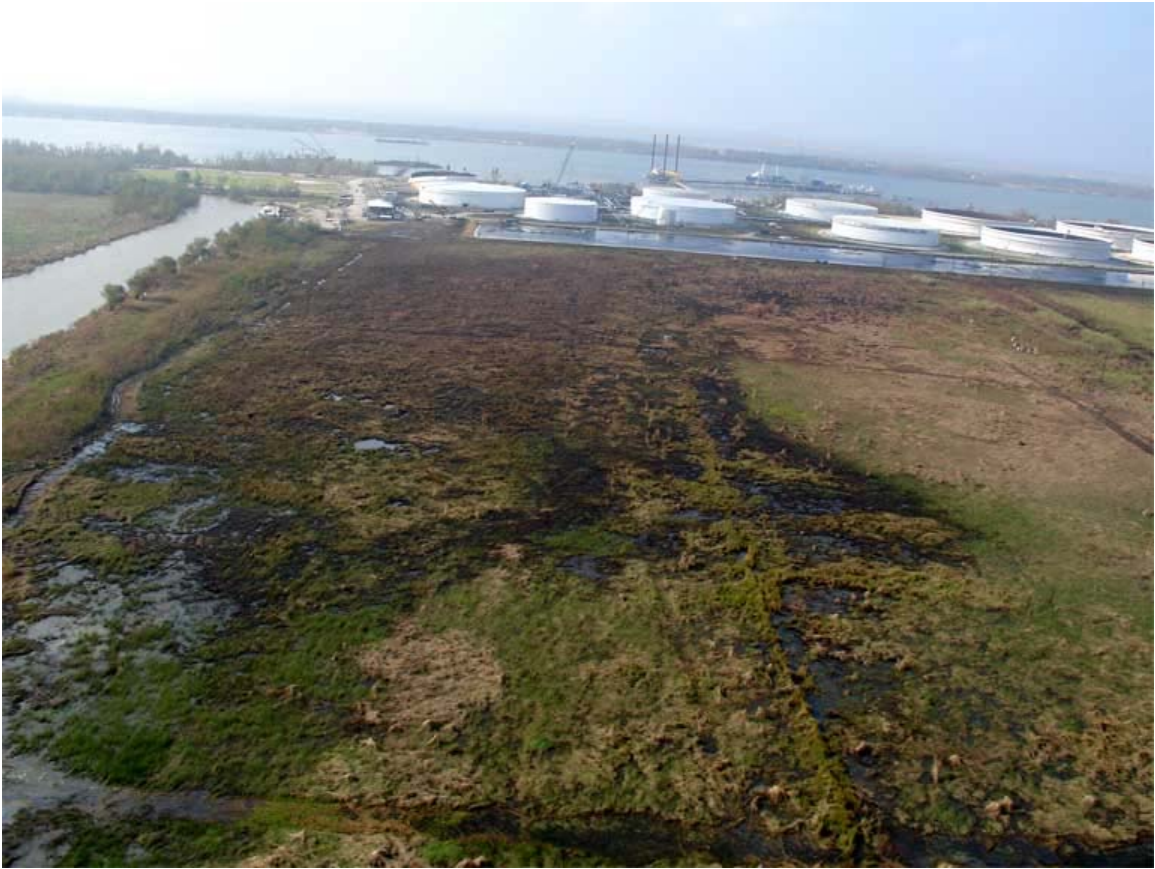
Figure 2. Oiled marsh north of facility (October 10, 2005).

Five weeks post-Katrina: During several aerial surveys since Hurricane Rita, heavily oiled marsh was observed adjacent to the Chevron Empire facility (Figure 2). On October 6<sup>th</sup>, the Environmental Unit Team, ground surveyed the impacted marsh to delineate approximate amounts of pooled or mobile oil on the water surface, vegetation, and sediment, and to provide cleanup recommendations to the Unified Command. The marsh was divided into six zones containing oiled marsh and potentially burnable areas (Figure 3). After providing cleanup recommendations to Chevron and the Unified Command, a more thorough survey was conducted on October 10<sup>th</sup> by Chevron and the Environmental Unit Team. The survey found the following:

Overall, the burn was successful in terms of removing heavily oiled areas with a burn efficiency estimated to be roughly 80-90% removal. The burn confirmed visual characterization of the oil as burnable, however, this was also due to the oiled condition of the vegetation. The above ground vegetation in Zone 1 and 4 was dead and dry due to the oiling duration and concentration. Thus, the burn was sustained by the oil on the vegetation, and the dry state of the vegetation itself. This is confirmed by comparing Zones 2 and 5 where the oiling was moderate and the vegetation was variable in that there were pockets of dead vegetation within areas of live vegetation. See Figure 2, pre-burn conditions and Figure 16, post-burn conditions.

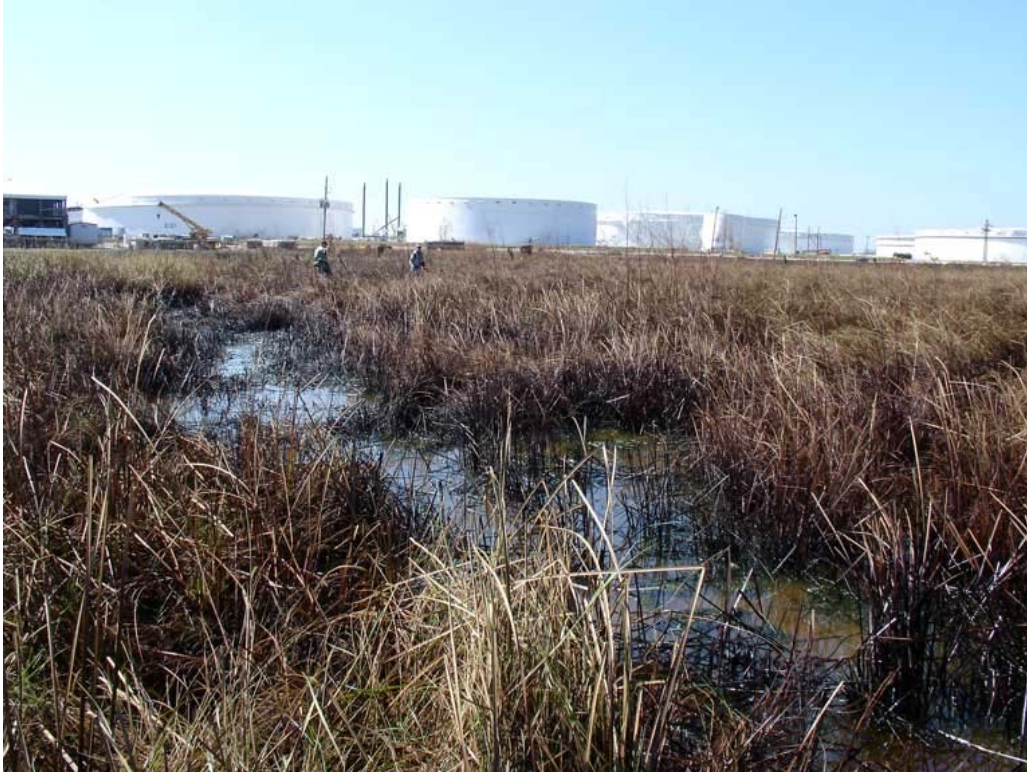
Figure 4. Two Days, pre-burn (October 10, 2005). Example of heavily oiled vegetation in Burn Zone 1. Note the lack of green vegetation.

1. Dominant species composition. The area most heavily impacted (Burn Zones 1 and 4) was an intermediate to high marsh environment dominated by *Spartina patens*, *Scirpus olneyi*, and *Distichlis spicata*. (See Figures 4-5).
2. Description of oil weathered state and oiled vegetation: The marsh contained trapped oil in the thick vegetation that was easily mobilized when agitated. Surprisingly, the oil was relatively “fresh” in characteristics such as odor, viscosity, lack of emulsification, and its propensity to remobilize off of the oiled vegetation onto the water surface. The

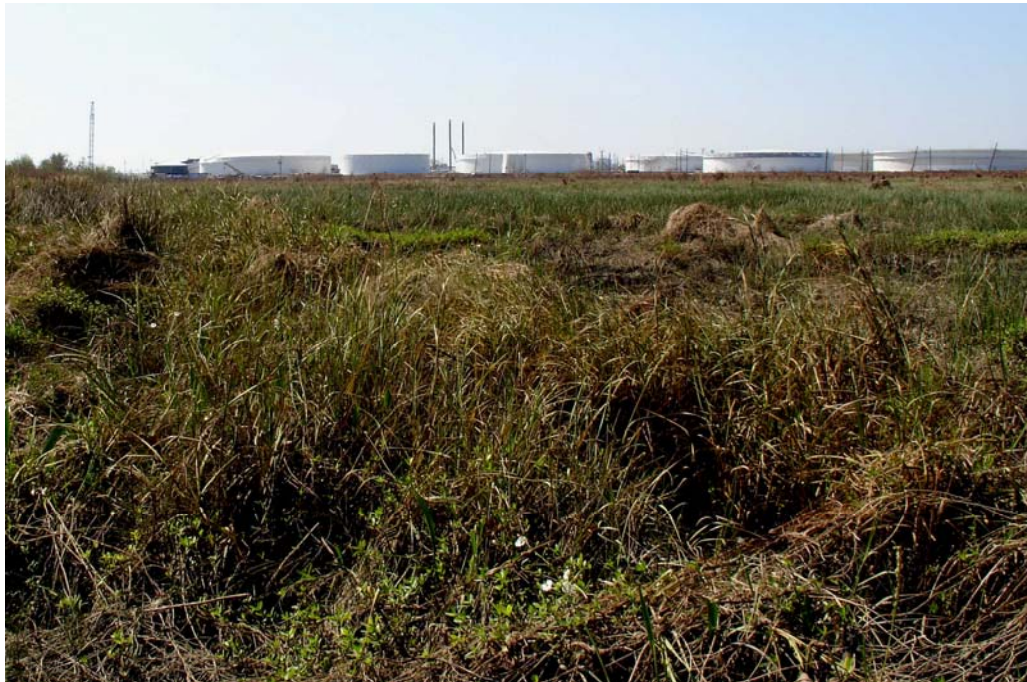
Figure 5. Two days pre-burn (October 10, 2005), standing at the border of Zones 2 and 3, facing South overlooking Zone 2. Note the amount of green vegetation compared to Zone 1.

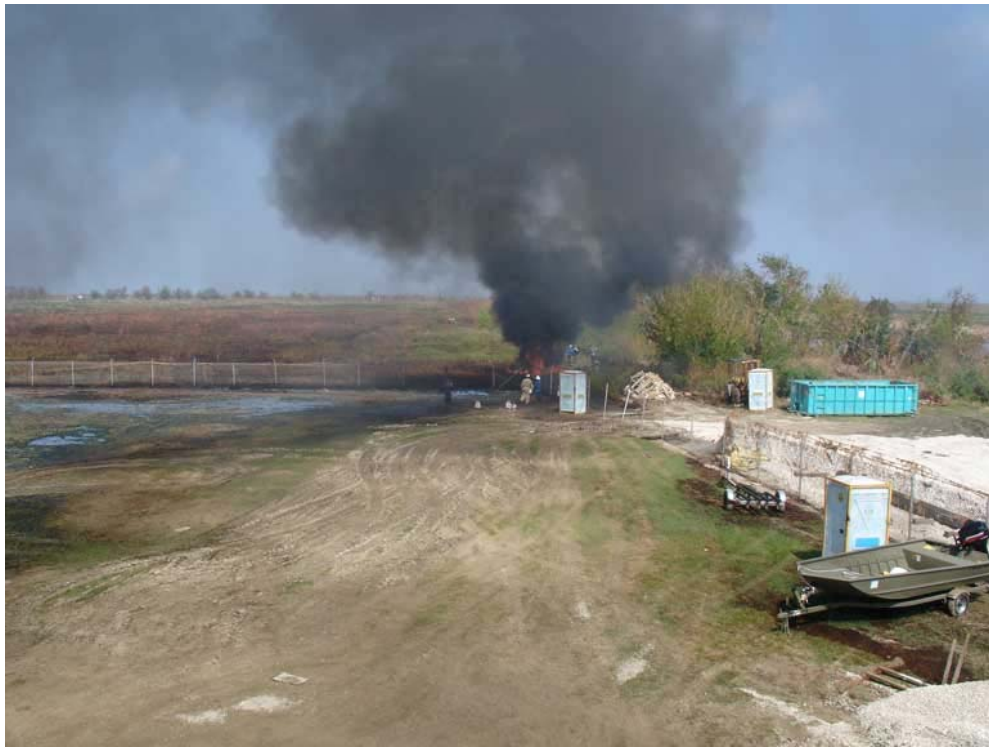
Figure 6. Day 1. One minute post-start of burn (October 12, 2005). Facing the oiled marsh from the Chevron Bunkhouse. The burn was started in the SE corner of burn Zone 1.

facility fence line. However, the control burn became “the burn” (Figure 6). The source of ignition was a propane torch. The fire started immediately, and quickly became a sustained fire producing large amounts of black smoke (Figure 7). Because of the intensity, loft and direction of the smoke plume, Chevron had moved all of the crew members to the MSRC GULF RESPONDER, and moved further down-river for the duration of the burn.

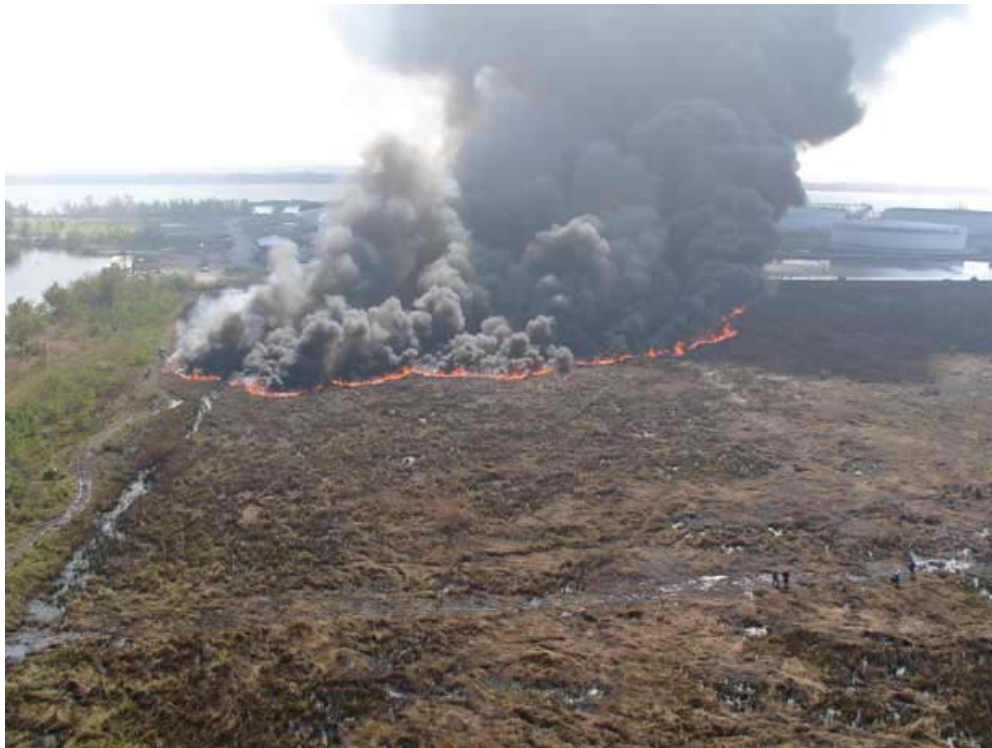
Figure 7. Aerial photo 1.25 hours into the burn (October 12, 2005). The fire has burned about a third of Zone 1, and has crossed the boundary into Zone 4. The people standing in the bottom right hand corner of the photo are behind the fire breaks of Zone 1.

The fire quickly engulfed the oiled area and burned rapidly to the west from Zone 1 into Zone 4. The burn speed was more controlled as it burned upwind (north across Zone 1 to Zone 2, and across Zone 4 to 5). At 1440 (1.1 hours into the burn), 90% of Zone 1, and 25% of Zone 5 had burned (Figure 7). Flames were observed to be as high as 30 feet, continuous across the burn Zone, with a plume loft of approximately 500 – 1000 feet (See Figure 7). Around 1500, the burn was progressing faster to the west, and with more intensity than predicted, and all teams were evacuated to a safe zone inside the facility, according to the plan. The burn crossed the power lines, and burned ~100 feet beyond the original fire break on the west edge of Zone 4. However, once the fire ran out of pooled oil, and oiled vegetation, it quickly turned to white smoke, and burned out. After the fire was mostly out, airboats snuffed out the remaining flames.

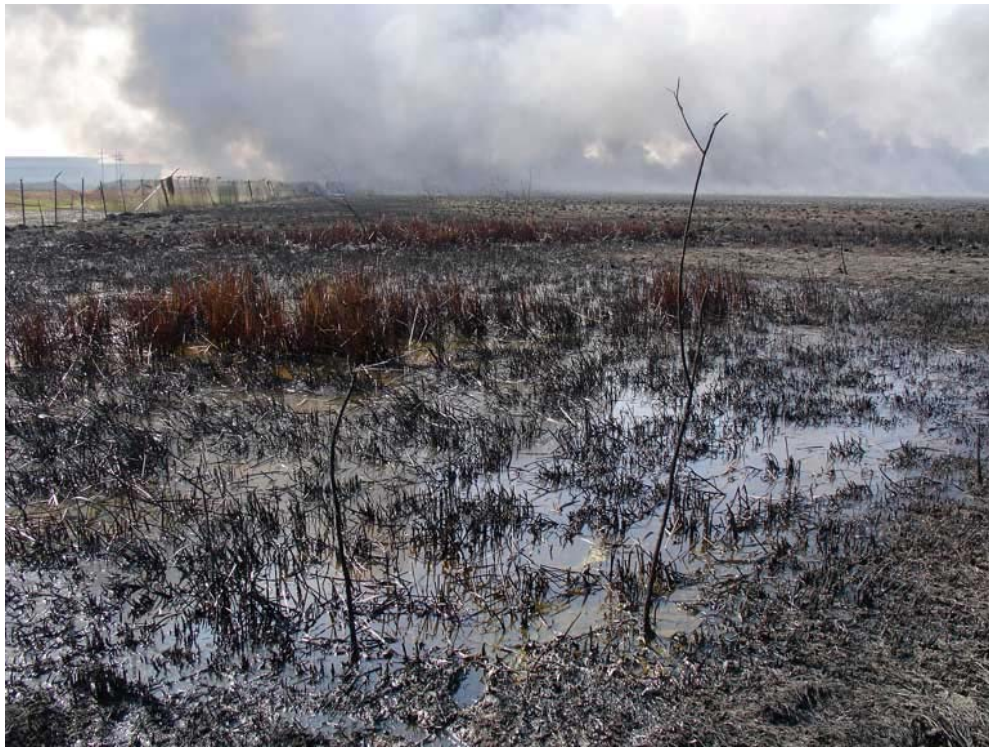
Figure 8. Post-Burn, Day 1 (October 12, 2005), standing in the Zone 1. This was a heavily oiled pocket of floating oil, and the remaining above vegetation (*Scirpus*).

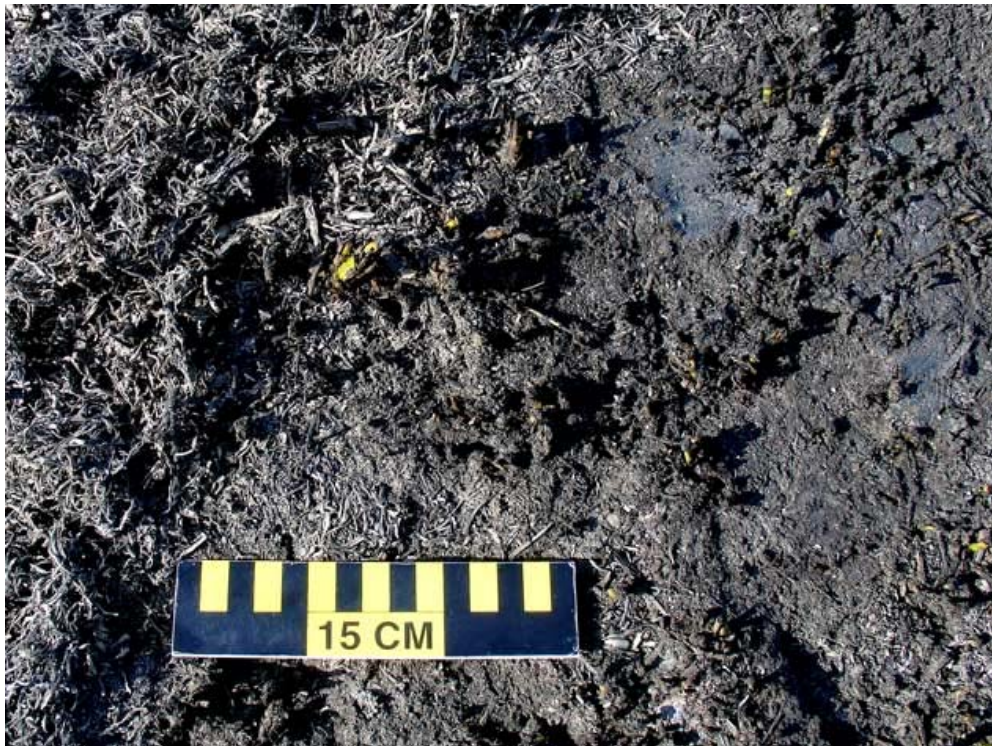
Figure 9, Post Post-Burn, Day 1 (October 12, 2005), standing in the Zone 1. Note the green roots (*Distichilis*).

In Zones 1 and 4, subsurface oiling was observed, mainly in crab burrows. This oil was not burned, and cannot be burned, and will remain in the environment. Removing this oil would require excavation of the top 5 cm of sediment, and is NOT recommended because of physical destruction of the marsh structure. The subsurface oiling will be agitated from tidal action, and light sheening will be expected. Recovery should be through passive means, and foot traffic should be minimized. Foot traffic will drive the oil deeper into the substrate, delaying the natural removal and degradation of the remaining oil. This phenomenon is not as prevalent in Zones 2 and 5, but is in discrete pockets (Figures 14 and 15). Most of the above ground remaining vegetation contained water content that prevented total combustion. Obviously, there is more above ground vegetation remaining in Zones 2 and 5 than 1 and 4 (Figure 16). This is due to different degrees of oiling, water content of the vegetation, standing water levels, and differences in fire intensities (a function of the degree of oiling and plant water content). Despite the more acute effects in Zones 1 and 4, the root systems of the plants were observed to be unburned (Figure 9). Because the root systems were left in tact, the prediction for recovery of vegetation is high.

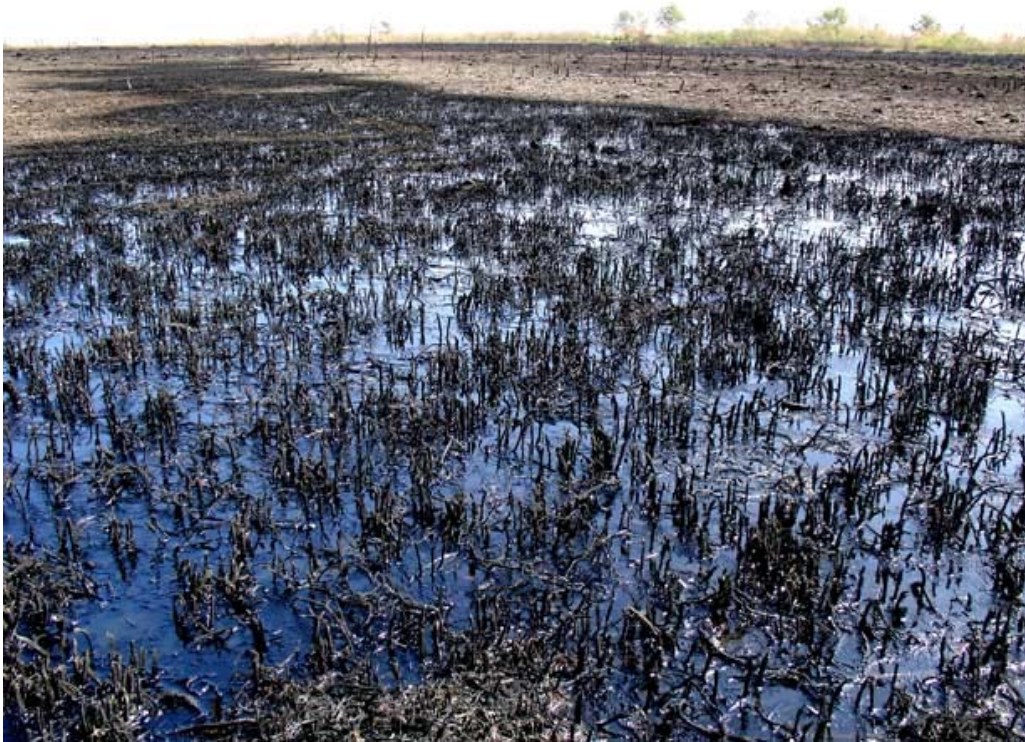
Figure 10. Post Burn, Zone 4 (October 13, 2005). Note root stumps (*Scirpus*) and residual oil/residue on the surface of the water.

Small amounts of mobile oil remained in the original pools. This was most prevalent in Zones 1 and 4. The residual oil was not burnable because its change in chemical composition (loss of lower molecular weight compounds), and burn residue was observable. However, the remaining oil was recoverable with sorbent material or netting. The remaining residue was “sticky” and presented a hazard to wildlife, especially opportunistic birds that will prey on the crab carcasses and live crabs that no longer have pre-burn protection from vegetation. Immediately after the smoke abated, shorebird individuals were observed to forage in Zone 1.

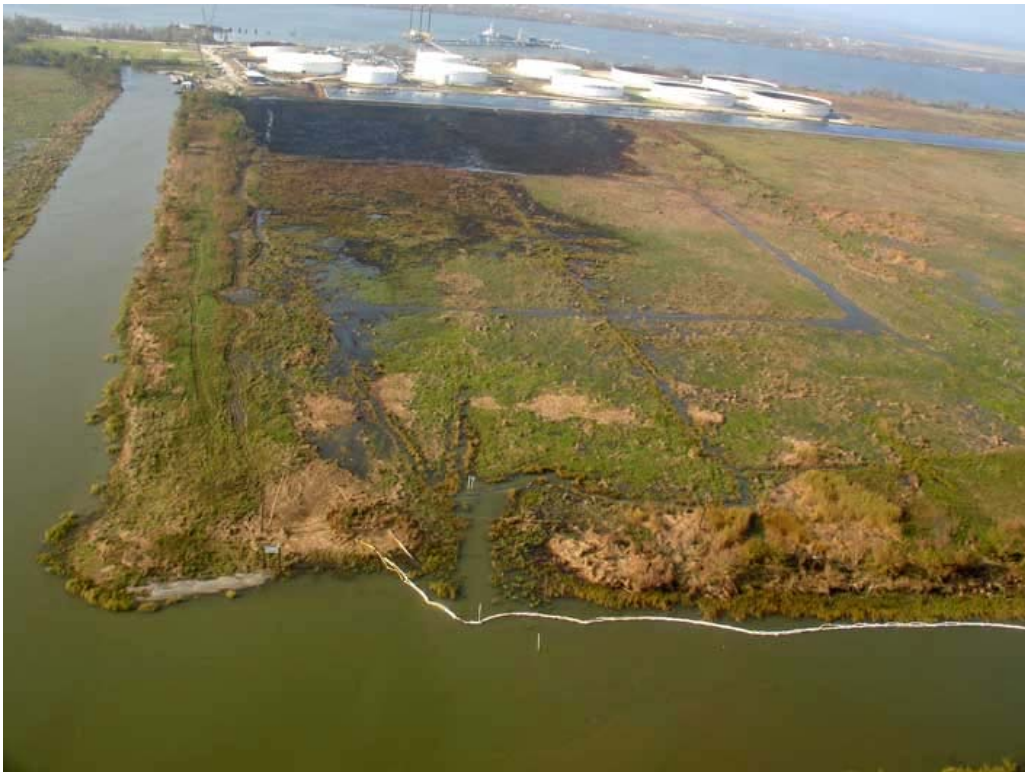
Figure 11. Post-Burn Day 1 (October 12, 2005). All zones are clearly visible. Burned Zones: 1 and 4. Oil contamination visible in Zones 2 and 5. Zones 3 and 6 are in the fore front.

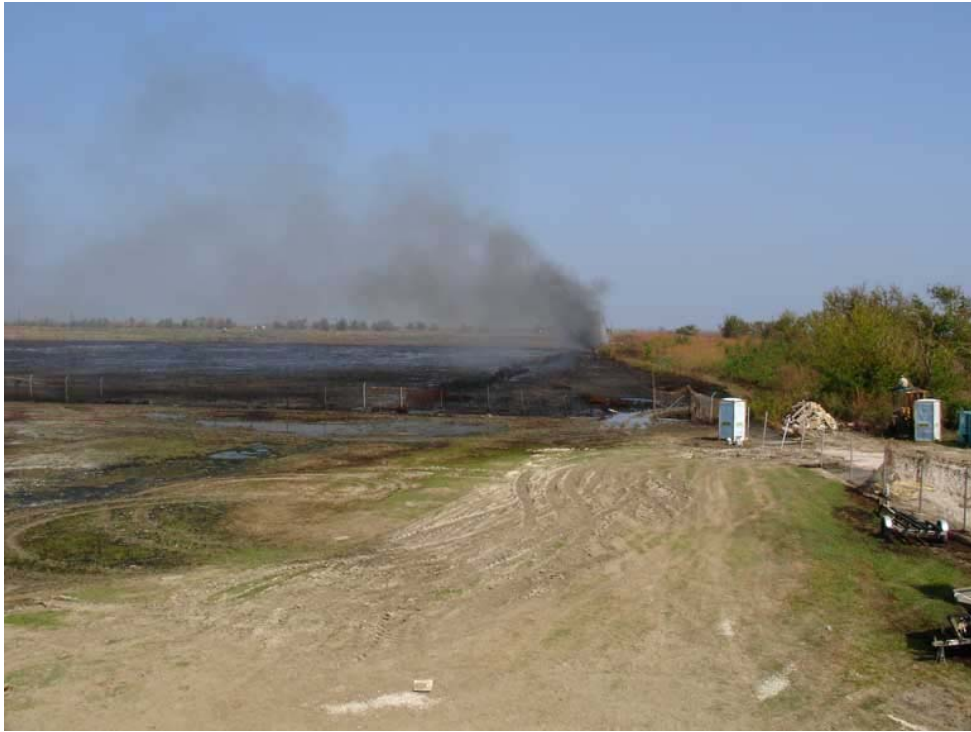
Figure 12. Day 2. 1 minute post-start of burn (October 13, 2005).

After the teams finished wetting down the east levee, the second burn started at 1145 in the SE corner of Zone 2. The burn was again started with propane torches. The winds were out of the N/NE, and ranged from 5 – 10 mph throughout the burn period. Visibility was high, with no clouds, and a sunny 80-85°F throughout the burn period. The burn behavior was considerably different than the first burn (Day 1). In comparing Figures 6 and 12, one-minute post ignition, the Day 1 fire started much more quickly, produced blacker smoke, and continued to burn without any other manual ignitions. In comparing Figures 7 and 13, the Day 1 fire was more intense, self-sustained, and produced a larger, blacker and denser smoke plume. The difference in burn behavior was due to several factors: higher water level, less gross oiling, and higher water content in vegetation (a function of less oiling).

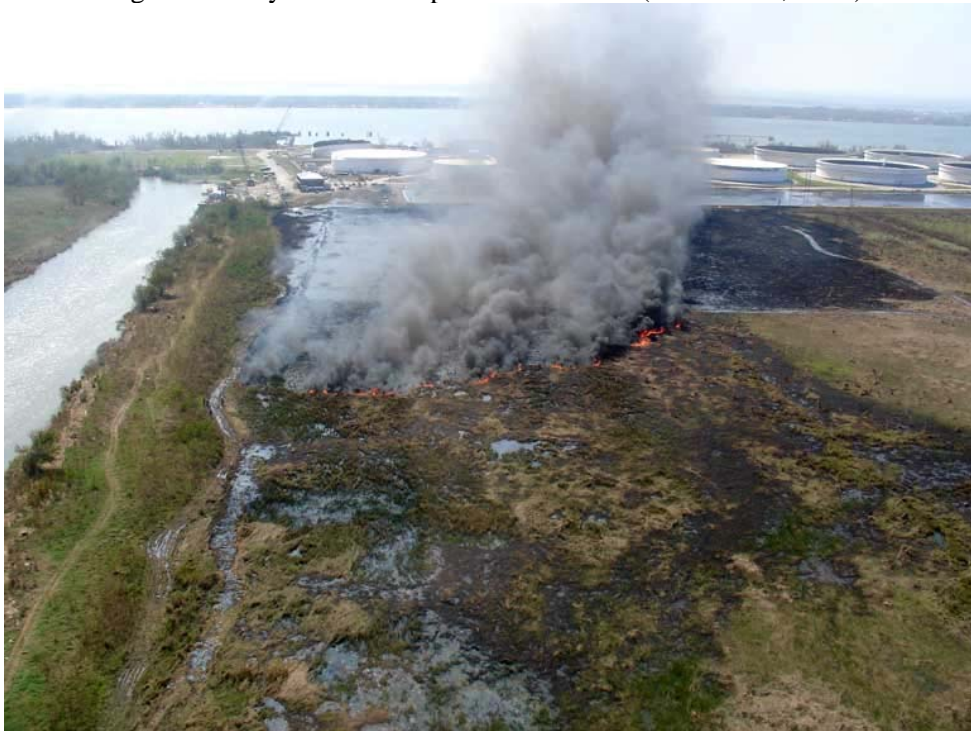
Figure 13. Aerial photo 1.1 hours into the burn (October 13, 2005). The fire is in Zone 2. The leading edge is almost in Zone 5. Note the difference in smoke volume, density and color from Day 1.

By 1240, roughly an hour after the start of the burn, thirty percent of Zone 2 had burned. This was determined during an overflight, and quickly communicated back to the ground crew to make sure they were oriented correctly within their zones. The fire was continuously re-started throughout the day. The burning was ceased at 1500 after it was determined that most of the combustible oil/oiled vegetation had been burned. Eighty-five percent of Zone 2 was burned, and only about 50% of Zone 5 was burned (Figure 16). The total burned area was about 28 acres.

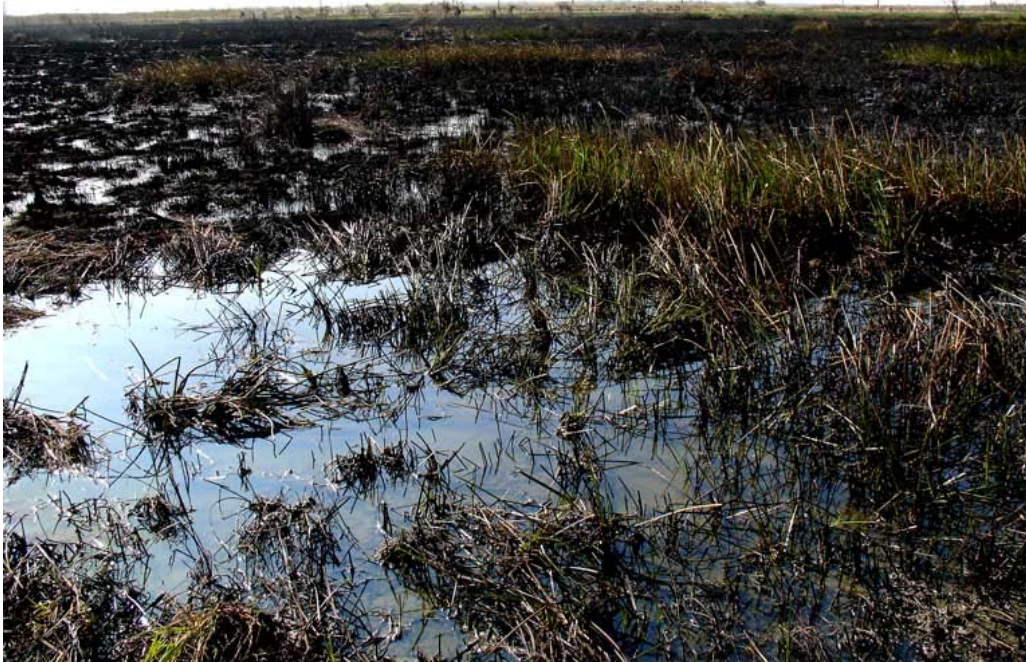
Figure 14. Post-Burn, Day 2 (October 13, 2005), Zone 2. Note the amount of remaining, unburned vegetation and water levels.

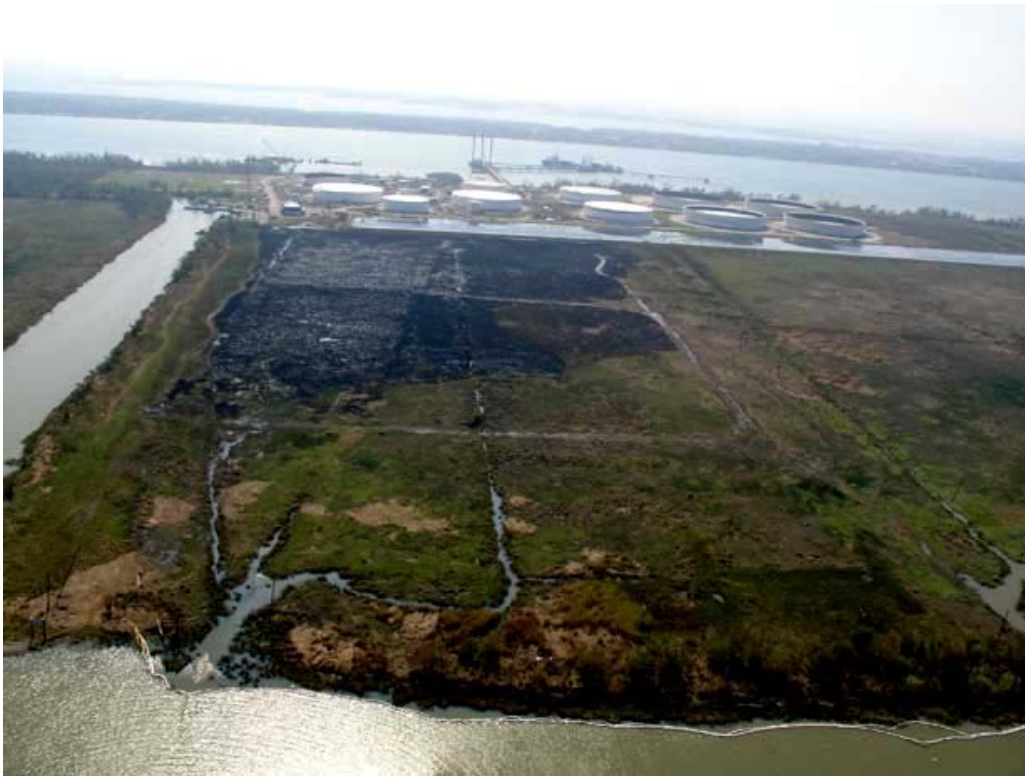
Figure 16. Final Footprint of the burn area. Note Zone 2 is about 85% burned, but Zone 5 only about 50% is burned.

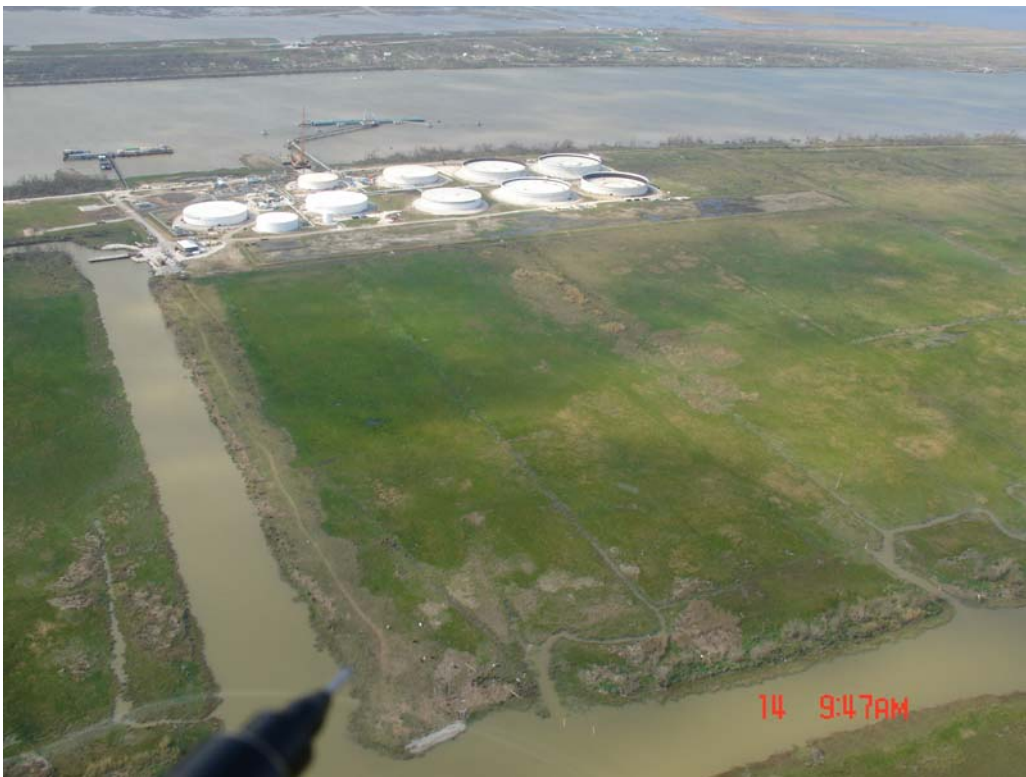
Figure 17. Aerial photo of burn site, March, 16, 2006, 5 months post-burn. Photo credit: Gary Shigenaka (NOAA)

Preliminary observations (photo-documentation) show signs of rapid recovery suggesting that burning was the most appropriate decision. NOAA has continued to monitor the site opportunistically during overflight missions for marine debris and hazardous debris cleanup operations. See Figure 17.
