# Sedimentation History of Lago Dos Bocas, Puerto Rico, 1942-2005

Scientific Investigations Report 2007-5053

By Luis R. Soler-López

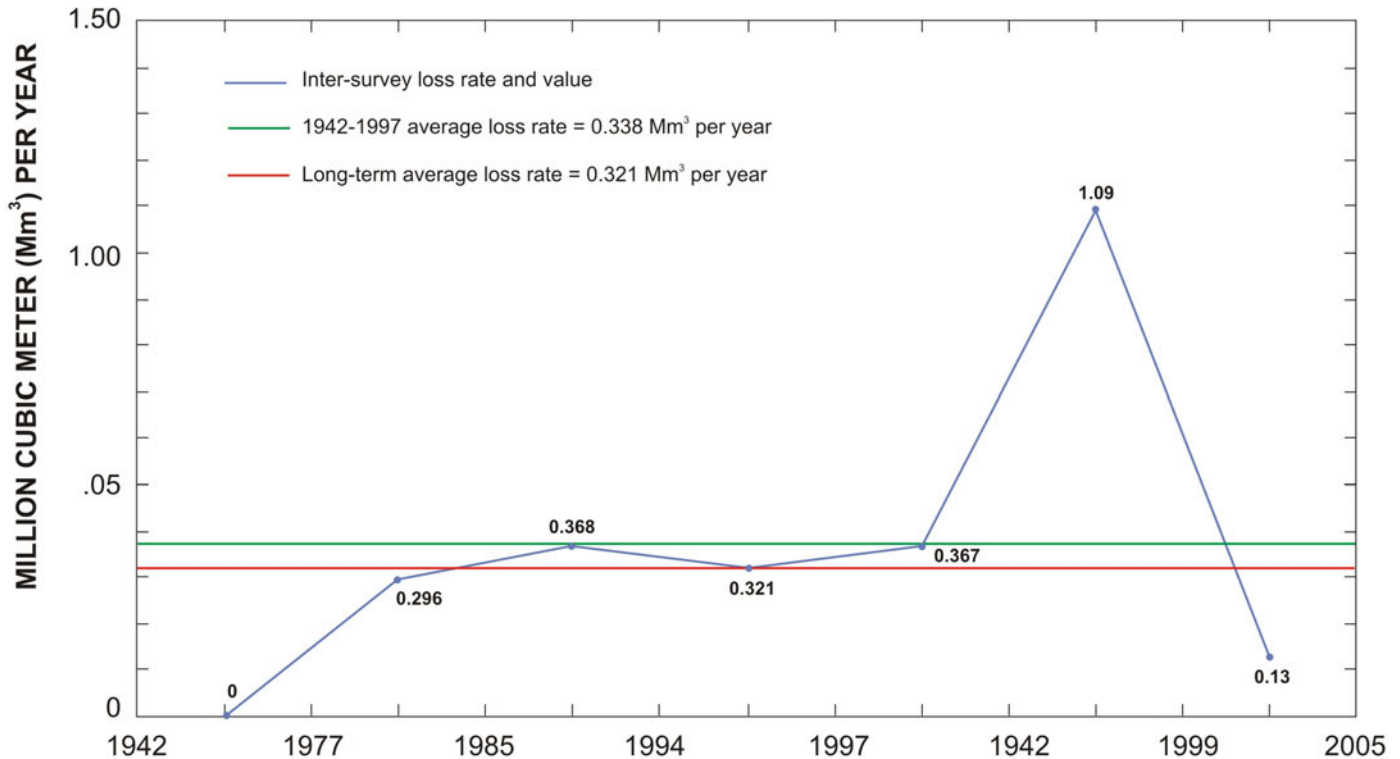
Figure 10. Lago Dos Bocas inter-survey storage capacity loss rates for 1942, 1977, 1985, 1994, 1997, 1999, and 2005.

losing storage capacity at a somewhat constant average rate of about 338,000 cubic meters per year between 1942 and 1997  $[(0.296 + 0.368 + 0.321 + 0.367)/4]$  (table 2 and fig. 10). The 1999 bathymetric survey indicated an inter-survey loss of capacity rate increase of more than 300 percent from the long-term average rate of about 338,000 cubic meters per year until 1997, to a rate about 1.09 million cubic meters per year between 1997 and 1999 (fig. 10). Between both bathymetric surveys, Hurricane Georges passed over Puerto Rico during September 21-22, 1998. The 2005 bathymetric survey data indicate an inter-survey storage capacity loss rate of about 40 percent below (0.13 million cubic meters per year) the 1942-1997 historical rate (fig. 10).

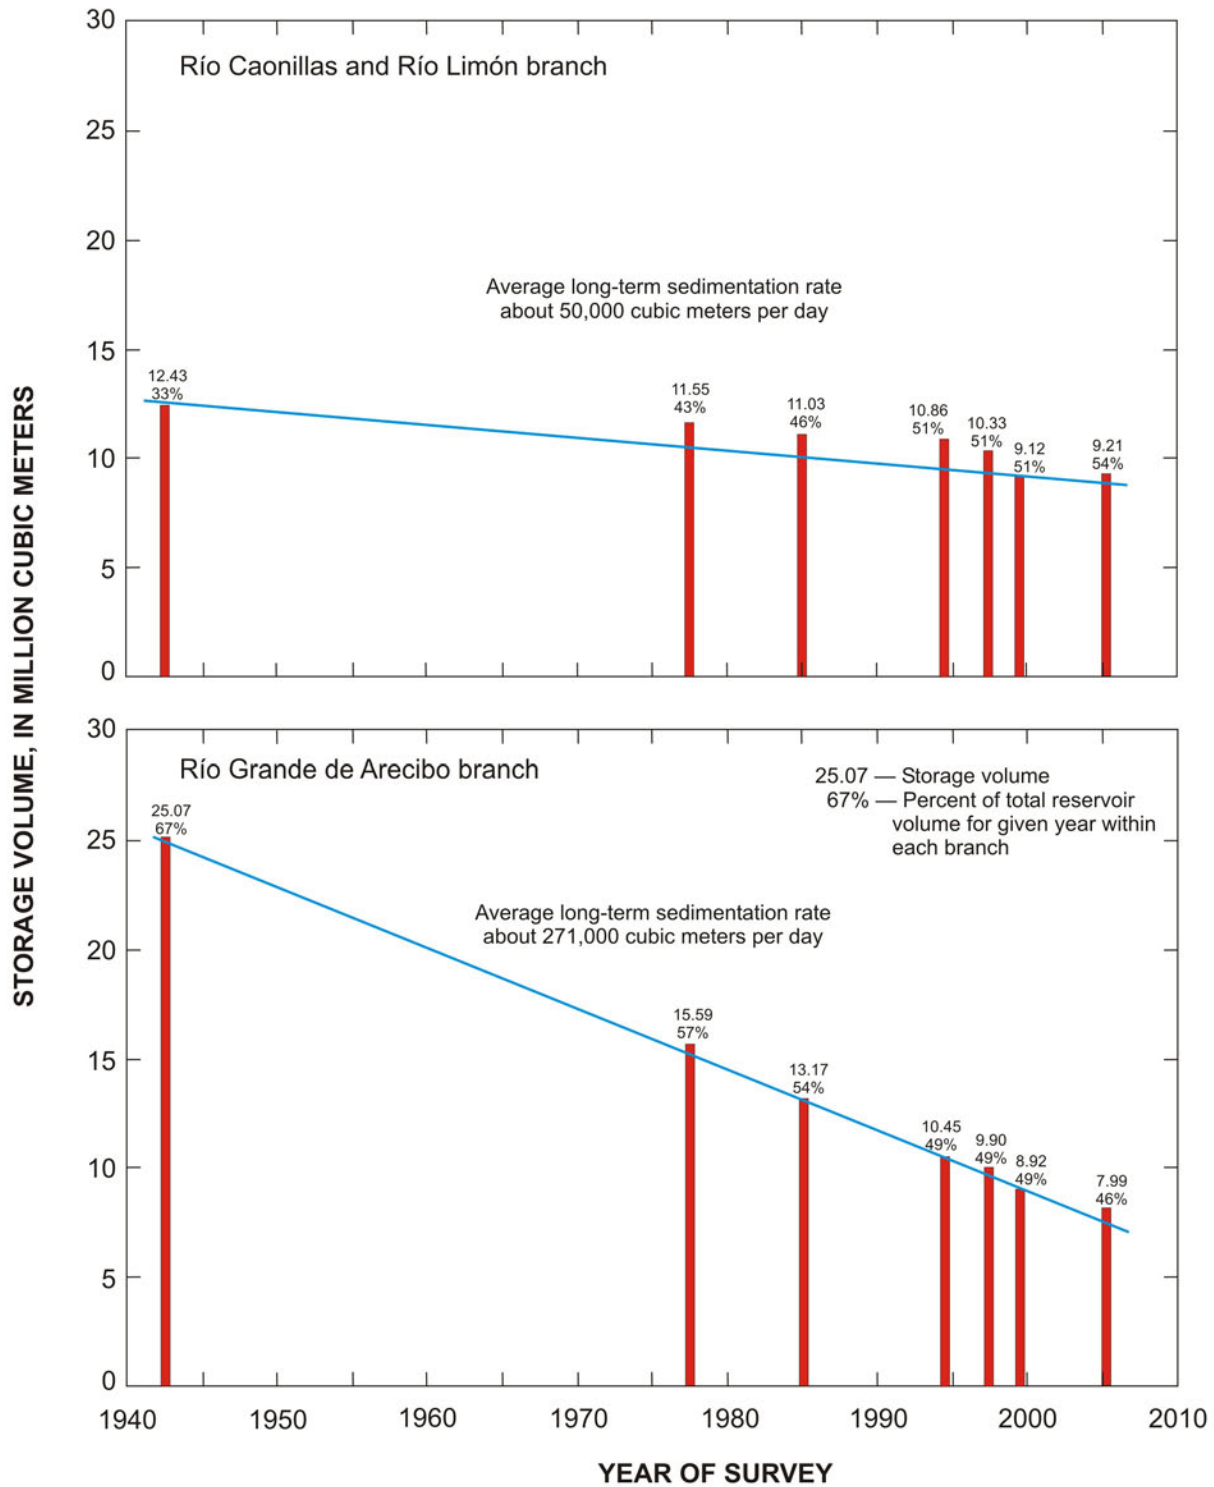
**Figure 11.** Lago Dos Bocas storage volume by tributary branches for 1942, 1977, 1985, 1994, 1997, 1999, and 2005 (refer to figure 7 for sub-basin areas used in calculations).

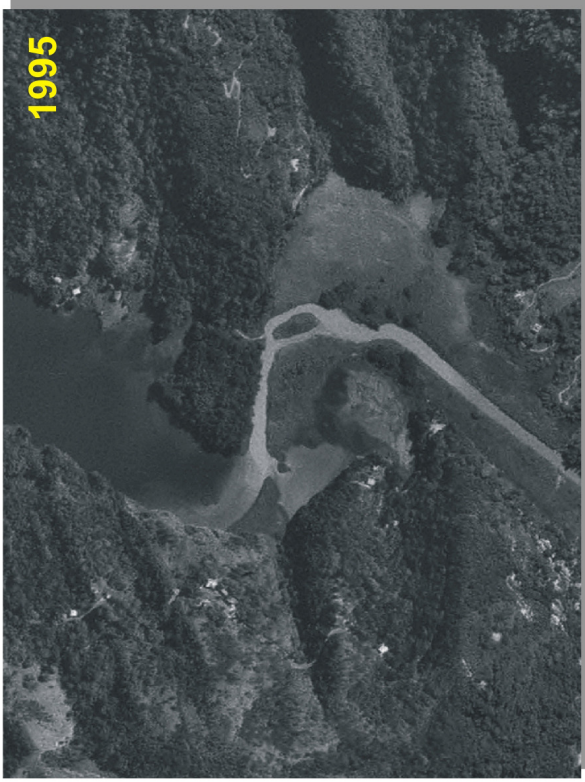
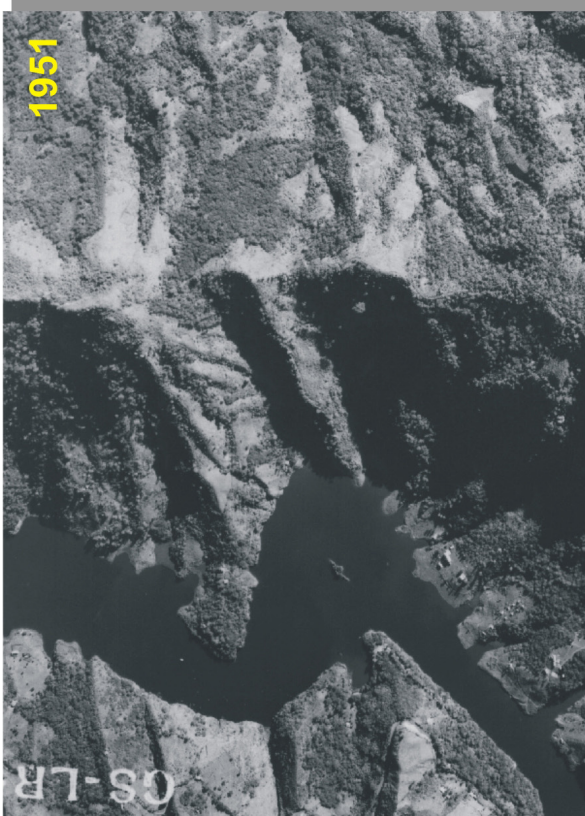
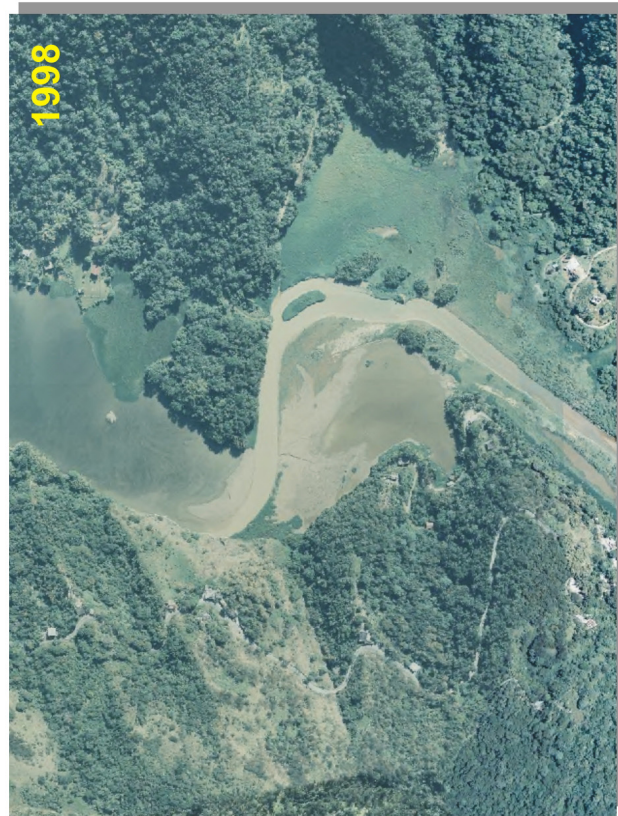
**Figure 13.** Aerial photographs of Lago Dos Bocas reservoir showing sediment accumulation in the upper reach of the Rio Grande de Arecibo branch in 1951, 1995, 1998, and 2004.

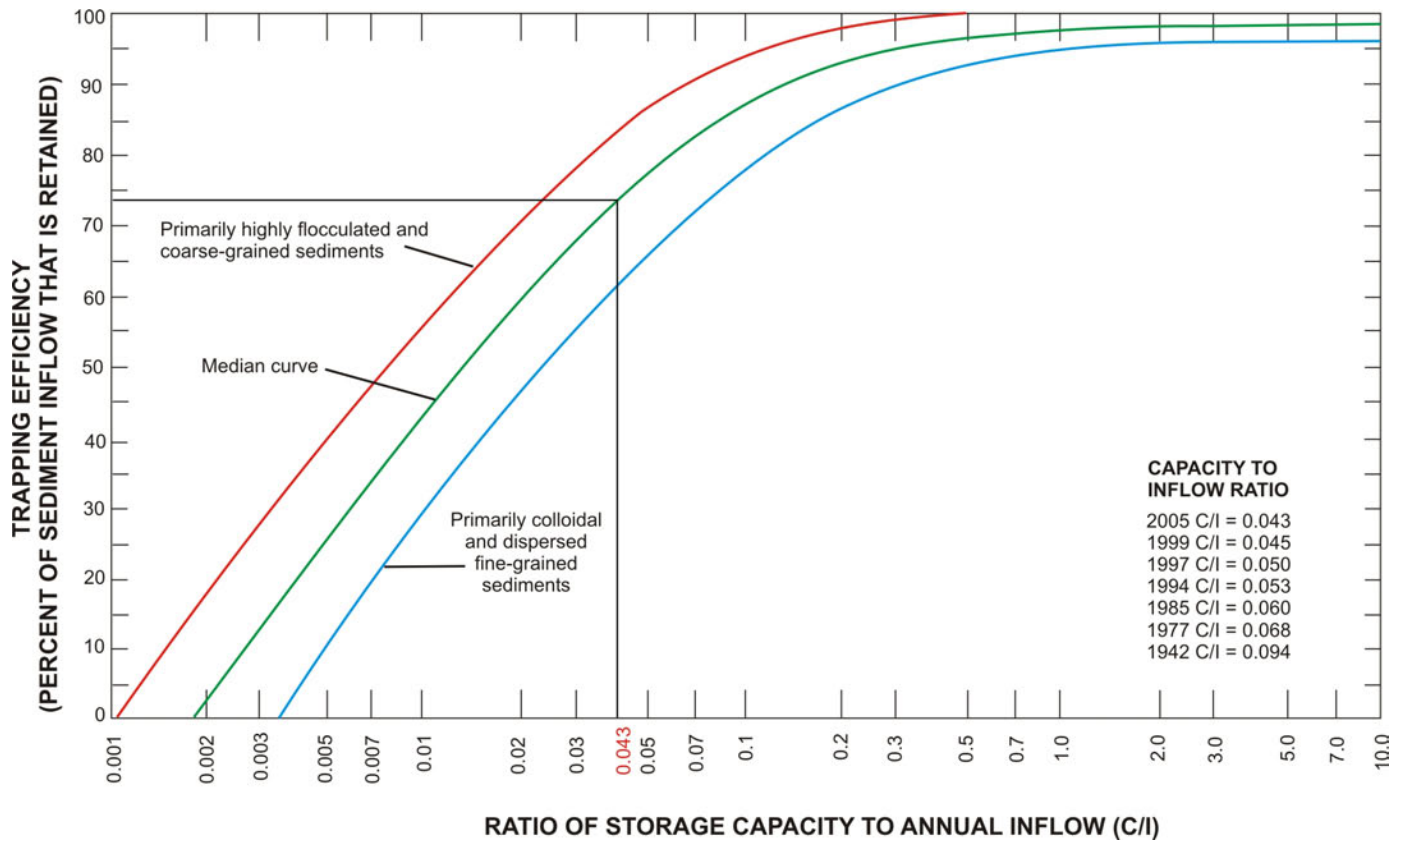
**Figure 14.** Reservoir trapping efficiency as a function of the ratio between storage capacity and annual water inflow volume (Brune, 1953).

Many empirical studies showing the relation between reservoir storage capacity, water inflow, and trapping efficiency have been conducted in the past, of which Brune's (1953) is the most widely used and accepted. Brune developed a curve (fig. 14) that estimates the sediment trapping efficiency of a reservoir based on the ratio of storage capacity to annual water inflow volume. The trapping efficiency of Lago Dos Bocas was estimated using the relation established by Brune (1953). Since no particle-size distribution analysis was performed on the reservoir's bottom sediments, the median curve of Brune's relation was used. On the basis of the 2005 storage capacity of 17.26 million cubic meters and a mean annual runoff of 400 million cubic meters (Quiñones and others, 1989), the capacity to inflow ratio is 0.043 for 2005. Extrapolating this value in Brune's curve, the trap efficiency using relations established by Brune (1953) is about 73 percent. Under normal dam operating conditions, about 73 percent of the sediment entering the reservoir is accumulated, the remaining 27 percent is either spilled over the dam or discharged downstream during releases for hydroelectric power generation. The estimated historical sediment trapping efficiency of Lago Dos Bocas since 1942 is given in table 2.
