**4.19 Visual Resources**

**Figure 4.19-01 The "Ring Effect" from Lower Water Levels - Observed from Fontana Reservoir at an Overlook Site near the Dam**

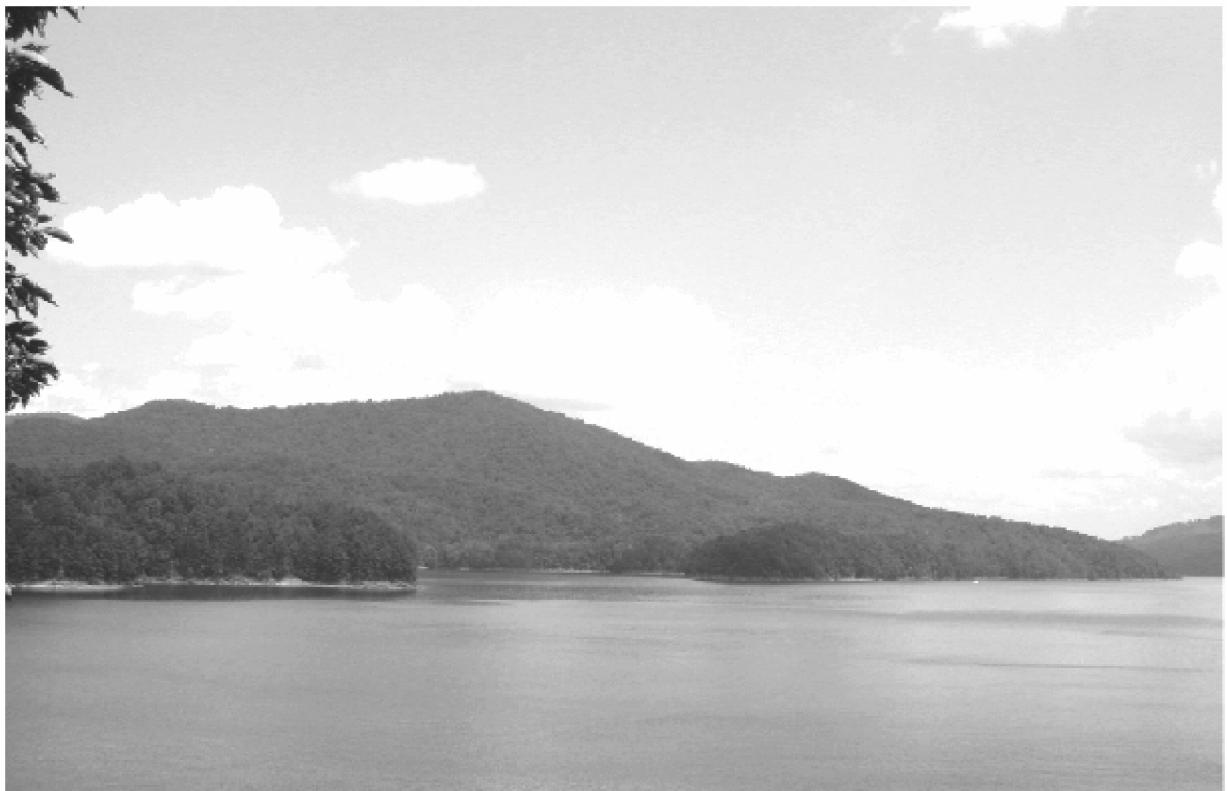
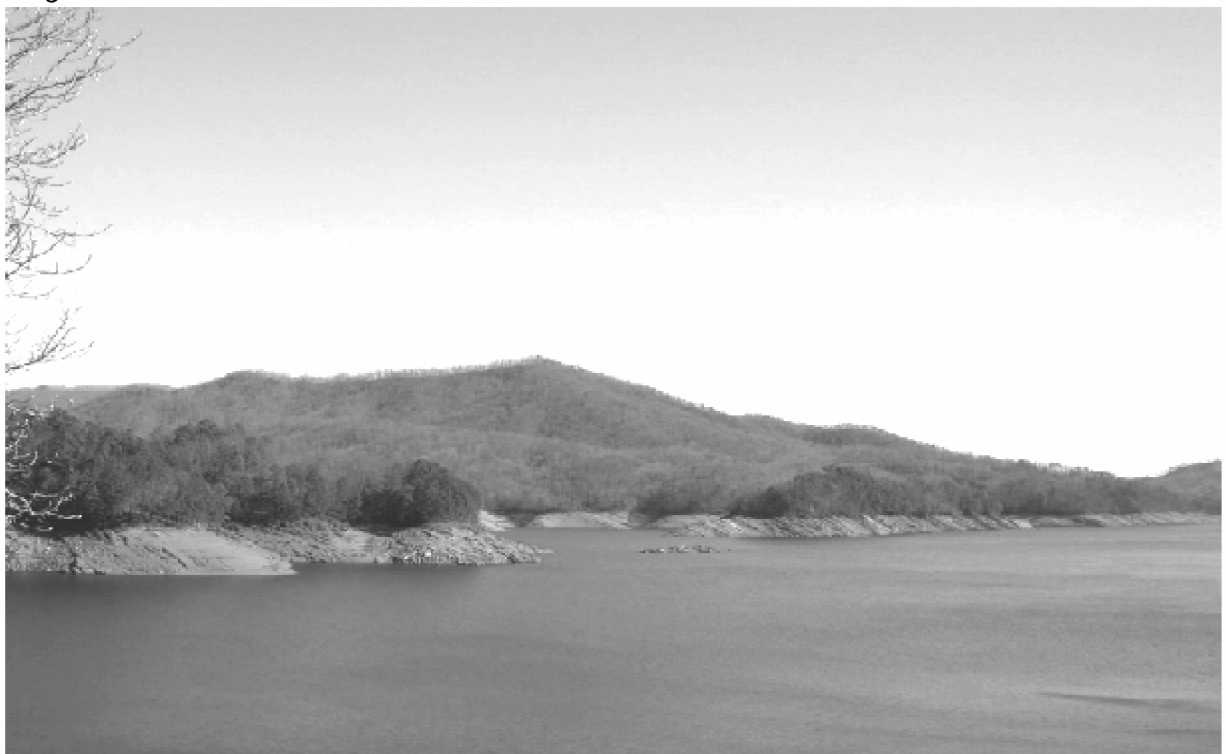
August reservoir level in 2002 - 1,698 feet

January reservoir level in 2003 - 1,642 feet (56 feet lower than August level)

Fluctuation of pool levels, in combination with the steeper slopes of the tributary reservoirs, exposes what is referred to as the bathtub ring or barren drawdown zone around the shoreline (Figure 4.19-01). Soil coloration also affects the visual impact of the exposed shoreline; the light brown to orange colors contrast with those of the water and shoreline vegetation.

This ring may be evident at any time throughout the year. The degree of contrast created is in proportion to the drop in water level and amount of shoreline exposed. Contrast becomes maximized in reservoirs such as Fontana that experience the largest difference in pool elevations. In some cases, especially when the effects are extreme, the contrast may be observed in a different context and viewed as a point of interest. This occurs when a large amount of highly contrasting shoreline takes on a layered sculpture appearance.

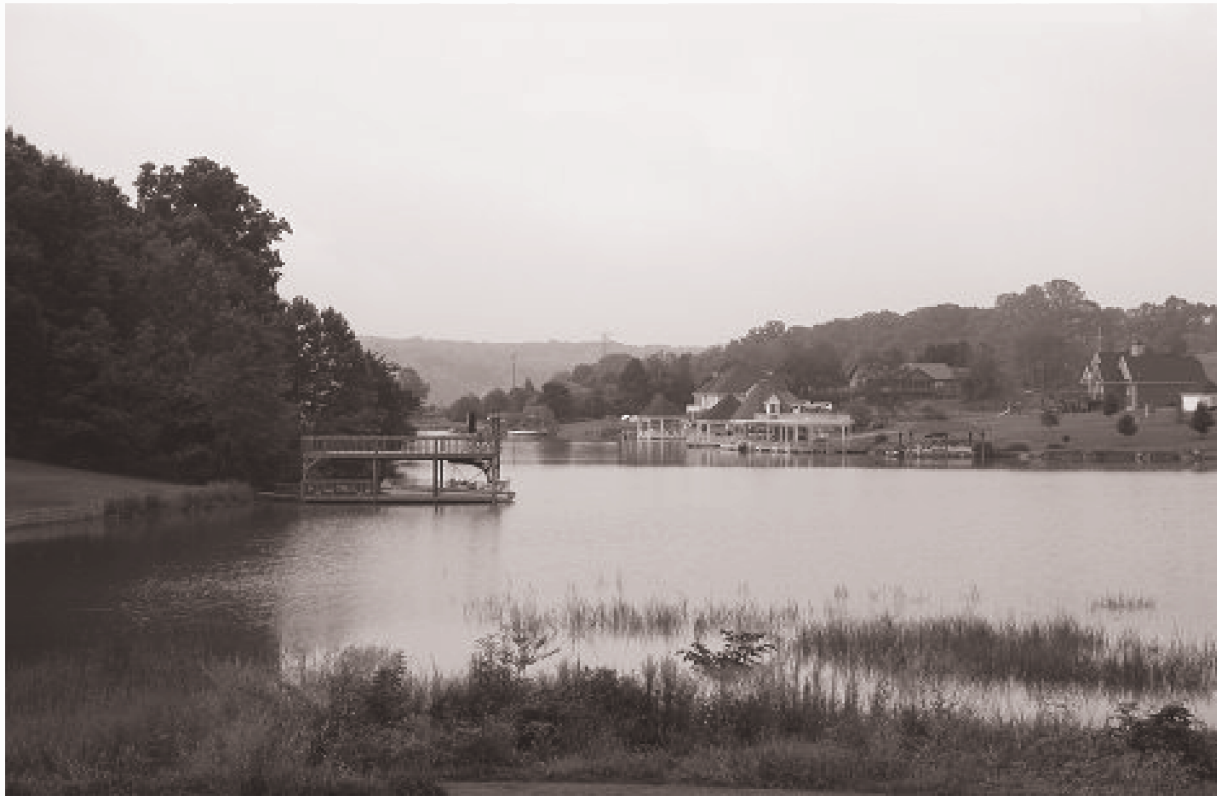
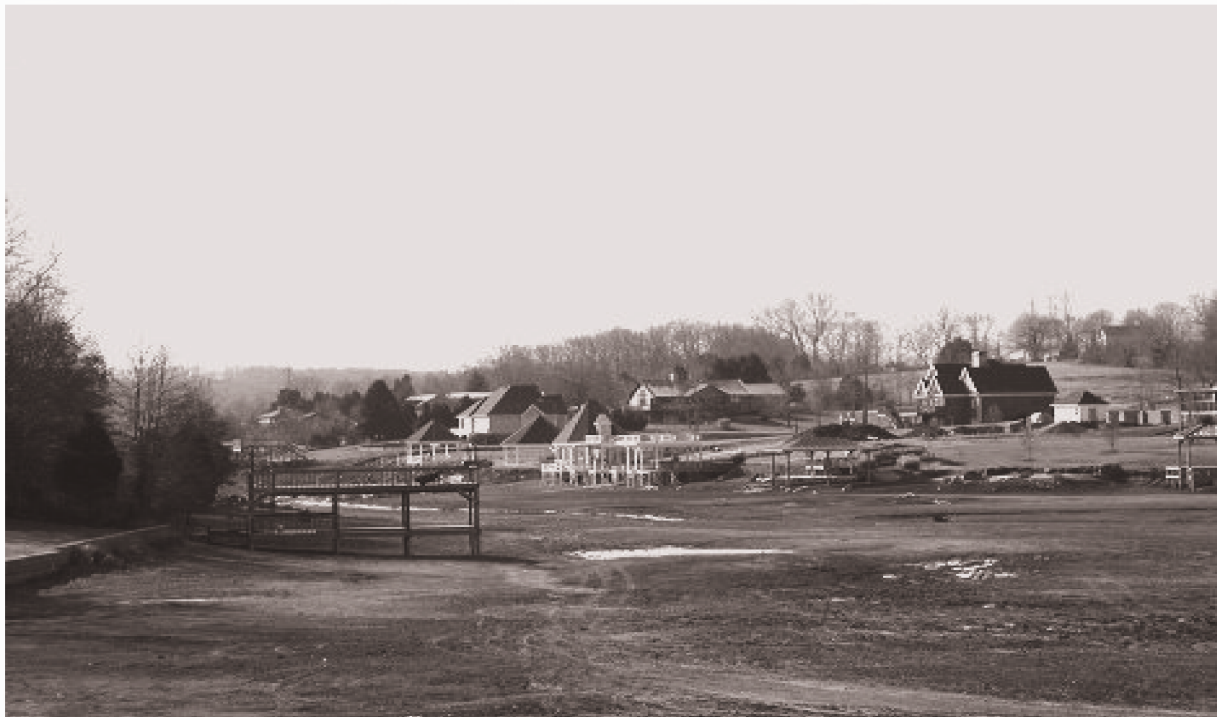
**Figure 4.19-02 The Effects of Lower Pool Levels on Exposing Reservoir Bottom and Flats-- Boone Reservoir Observed from a Rural Road Adjacent to a Residential Area**

August reservoir level in 2002 - 1,382 feet

January reservoir level in 2003 - 1,361 feet (21 feet lower than August level)

Lower winter pool levels often result in the exposure of reservoir bottoms and flats. This visual change in reservoir character is created in shallower portions of the reservoir and becomes most evident in the tailwater and embayment areas (Figure 4.19-02). Tailwater areas often revert to characteristics common of the original river environment, including wide, barren shorelines, and may create discoloration of rock bluffs along the river channel (Figure 4.19-03). Exposure of reservoir bottom areas is common to both tributary and mainstem reservoirs but occurs more frequently in the mainstem reservoirs.

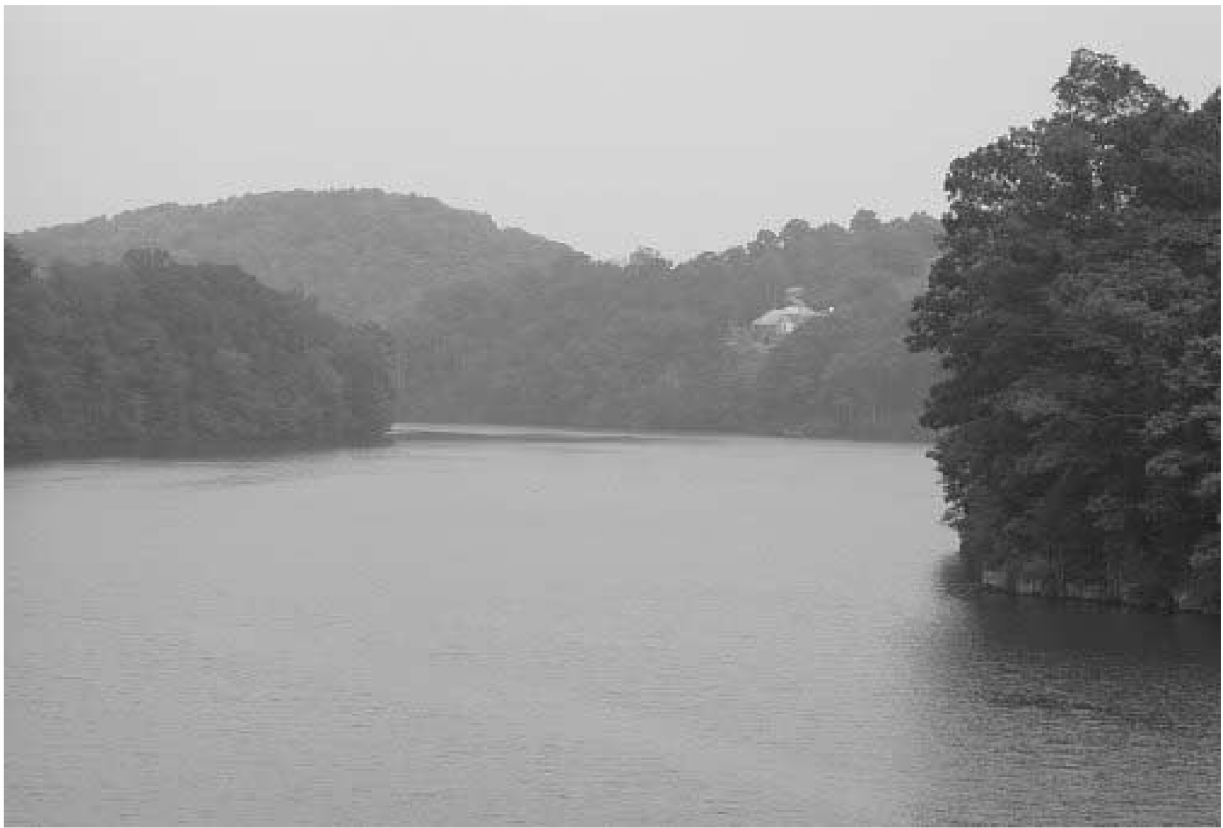
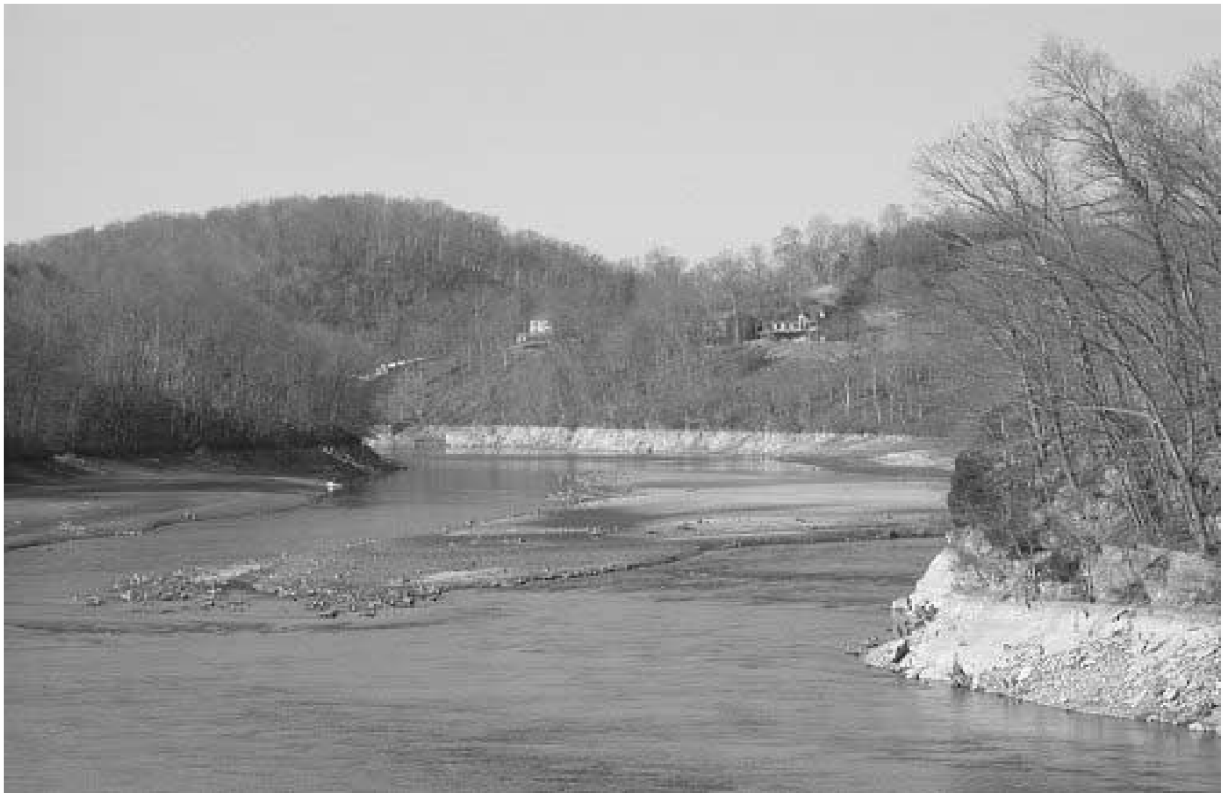
**Figure 4.19-03 The Effects of Lower Pool Levels - Upper Boone Reservoir Observed from Highway 11E near Bluff City**

The upper and lower photos illustrate a summer and winter elevation difference of 21 feet.

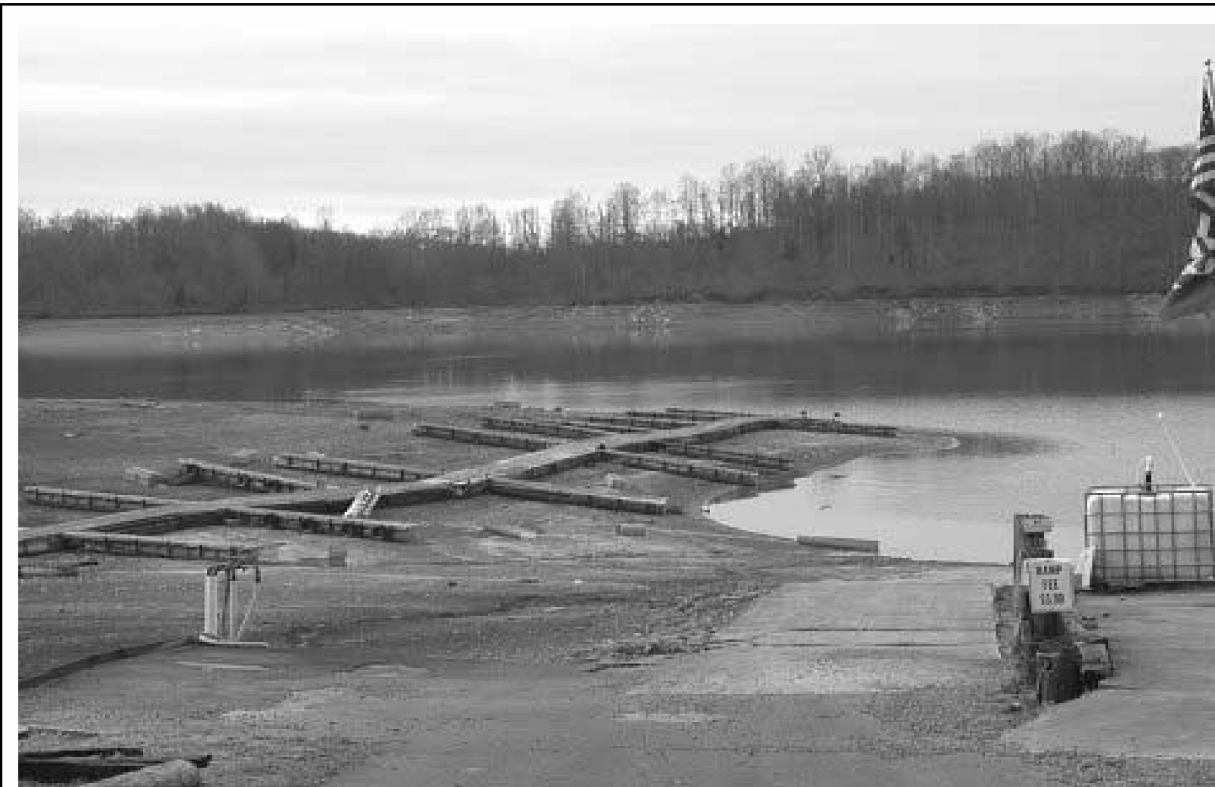
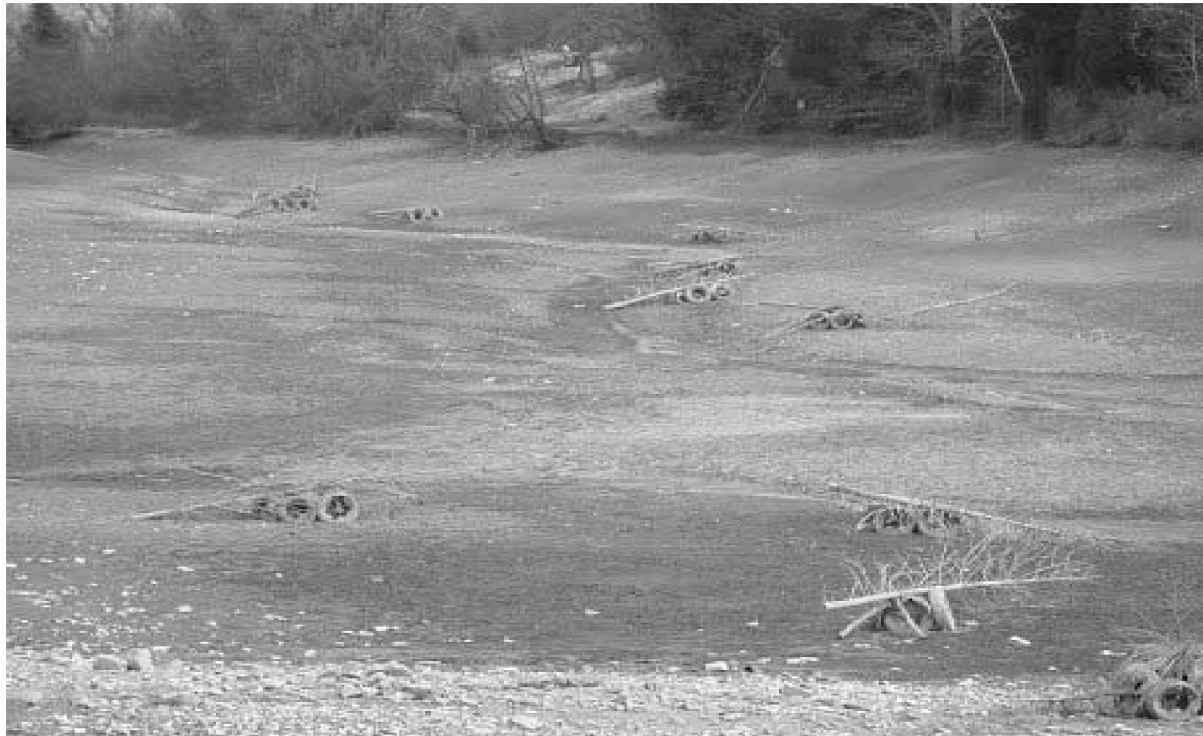
**Figure 4.19-04 Effects of Floating Structures Sitting on Exposed Reservoir Bottom and Other Exposed Structures, Resulting in Lowered Scenic Integrity**

Boat docks sitting on exposed reservoir bottom at a marina on Boone Reservoir

Exposed fish habitat structures viewed from a rural road on Boone Reservoir

It was noted during field observations that exposed shorelines or reservoir bottoms alone do not create the lowest level of scenic integrity, but rather exposure of other visible elements from lower water levels. Woody debris, trash, riprap, underwater structures such as rubber tires used for fish habitat, and floating structures sitting on the bottom add unattractive visual contrast to the area viewed (Figure 4.19-04).
