# 1. INTRODUCTION

The Integrated Chemical Effects Test (ICET) project was a joint effort by the United States Nuclear Regulatory Commission (NRC) and the Electric Power Research Institute (EPRI) to simulate the chemical environment present inside a containment water pool after a loss-of-coolant accident (LOCA) and to monitor the chemical system for an extended time to identify the presence, composition, and physical characteristics of chemical products that may form. The ICET series was conducted by Los Alamos National Laboratory (LANL) at the University of New Mexico (UNM), with the assistance of professors and students in the Departments of Civil and Mechanical Engineering.

## 1.1. Objectives and Test Conditions

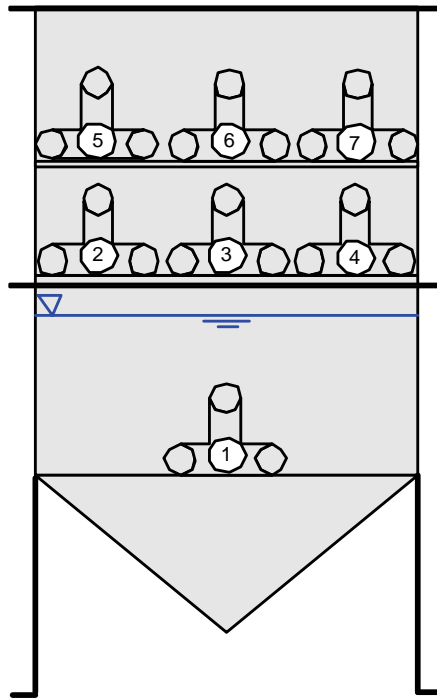
**Figure 2-2. Coupon rack configuration in the ICET tank. The blue line represents the surface of the test solution.**

The arrangement of coupon racks in the test tank is schematically illustrated in Figure 2-2. The figure shows a side view of the ICET tank, with the ends of the seven CPVC racks labeled. The normal water level is indicated by the blue line in the figure. Rack 1 was the only submerged rack, and it sat on angle iron supports. It was centered in the tank so that flow from two opposing distribution headers reached it equally. Racks 2–4 were positioned above the water line, supported by angle iron brackets on the side of the tank. Racks 5–7 were positioned at a higher level and were also supported by angle iron brackets. Racks 2–7 were exposed to spray. In Figure 2-2, north is to the right and south is to the left. Compass directions were used subsequently to identify rack locations and sediment sample locations. Appendix A contains more details on the tank internals.

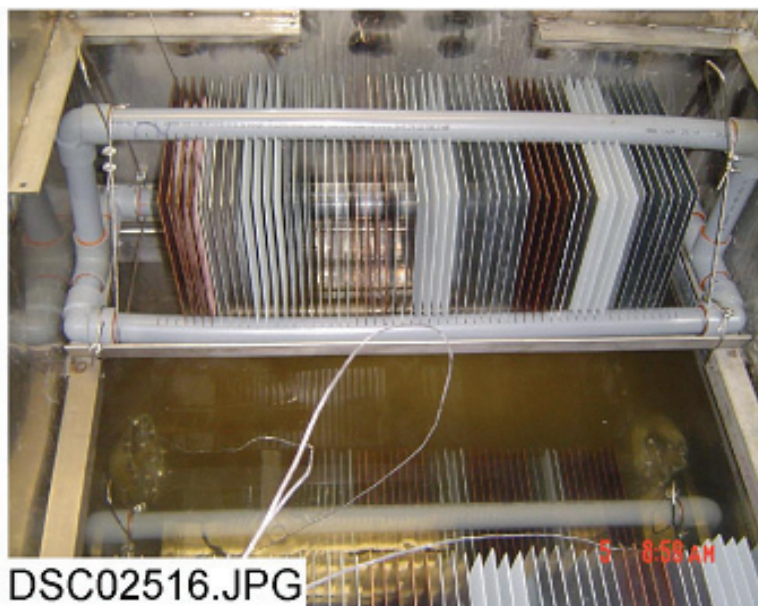
**Figure 2-3. A typical loaded coupon rack in the ICET tank.**

Figure 2-3 shows the configuration of a typical unsubmerged coupon rack loaded with metal coupons in the ICET tank. The loading pattern of all suspended racks was nearly identical, varying by only one or two coupons. Shown in the figure from left to right, the coupons are arranged as follows: four Cu, four Al, four coated with inorganic zinc (IOZ), seven GS, four Cu, three Al, four IOZ, and seven GS.

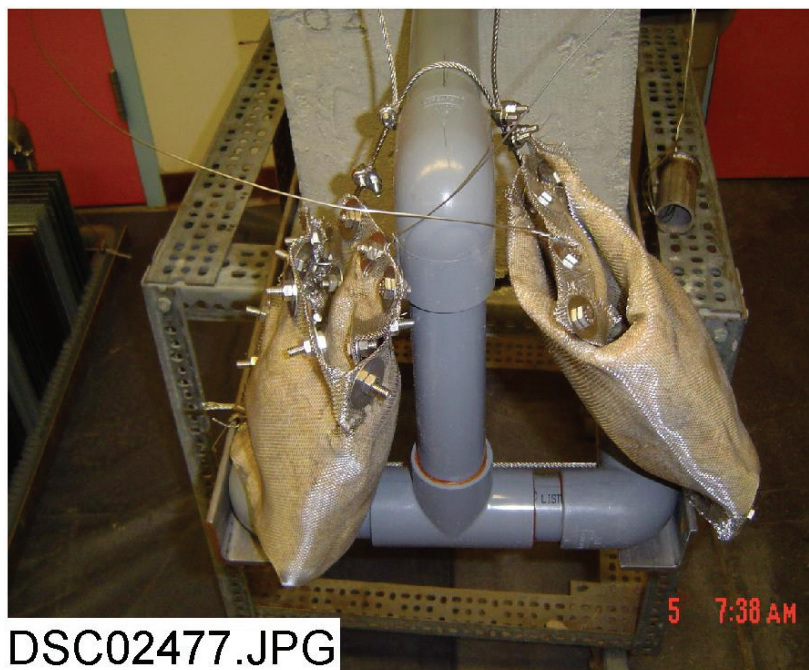
Figure 2-4. Fiberglass samples attached to a coupon rack.

Several fiberglass samples were placed in the ICET tank. These samples were either submerged or suspended above the water level. The unsubmerged fiberglass samples were positioned so that they would be exposed to sprays. All fiberglass samples were contained in SS wire mesh bags or “pouches” that allowed water flow while confining the fiberglass material. Both loosely packed and more tightly packed samples were used. In addition, some submerged fiberglass samples were located where they would be exposed to relatively high-flow conditions, and others were located in quiescent regions of the tank. Figure 2-4 shows the so-called “sacrificial” fiberglass samples in wire mesh pouches attached to the submerged coupon rack (Rack 1 in Figure 2-2). Each pouch contained ~5 g of fiberglass. Sacrificial samples were attached with SS wire; removed from the tank on Days 4, 15, and 30; and examined for possible time-dependent changes. As shown in the figure, bigger insulation bags were wrapped around the sacrificial specimens during the test. In addition, small sacrificial samples called fiber pucks were added to the solution beginning with Test #3. Fiber puck fabrication and post-test analyses are described in Ref. 5. Appendix A contains more detailed descriptions of the standard fiberglass samples. Appendix B contains additional details on the fiberglass insulation, including heat treating.

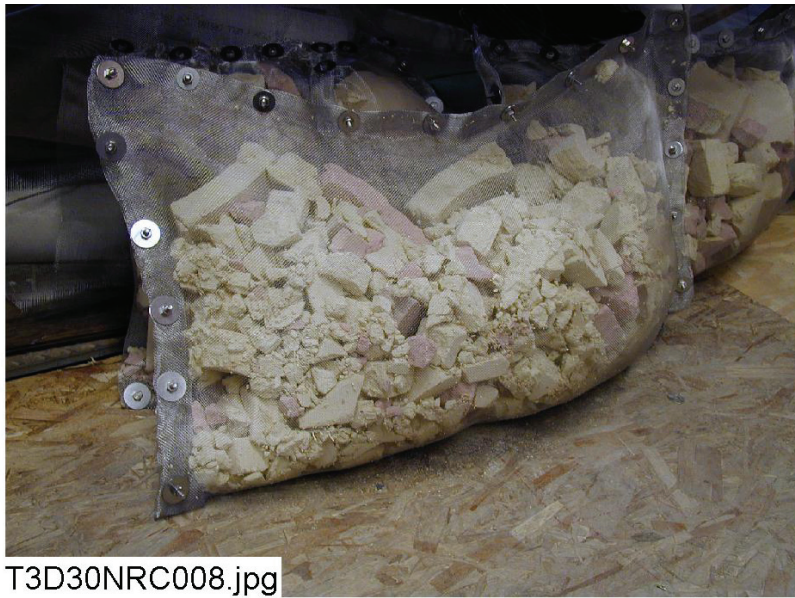
**Figure 2-5. Solid pieces of cal-sil samples in SS mesh.**

Several cal-sil samples were also placed in the ICET tank for Tests #3 and #4. Samples were either submerged or suspended above the water level. The unsubmerged cal-sil samples were positioned so they would be exposed to sprays. In addition to solid cal-sil pieces (Figure 2-5), 43.5 lb of cal-sil dust (Figure 2-6) were added to the tank solution before the test began. As with the fiberglass samples, all of the cal-sil samples (except for the dust) were contained in SS wire mesh that allowed water flow while confining the cal-sil material. Appendix B contains additional details on the cal-sil insulation, including heat treating.

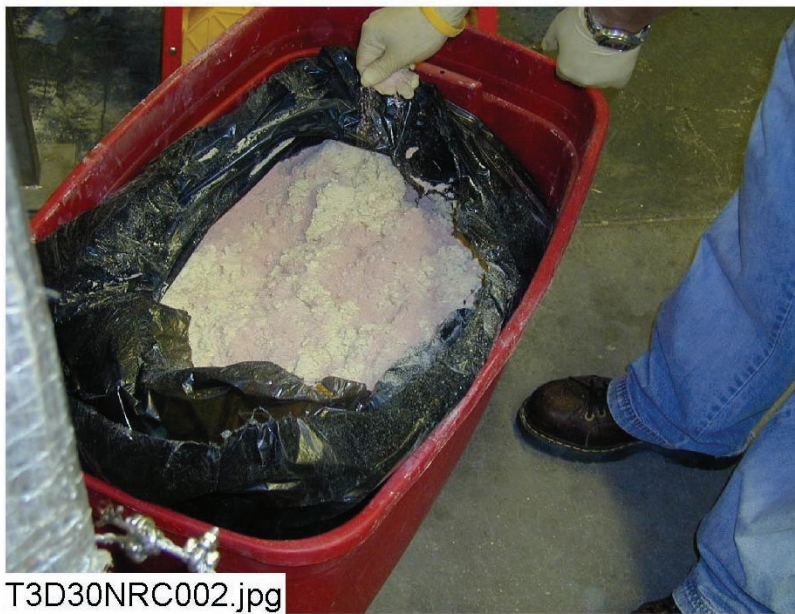
**Figure 2-6. Pulverized cal-sil insulation before addition to the ICET tank.**
